report no. CDOH-DTP-R-85-10

# BRIDGE DECK EXPANSION DEVICES

Second Interim Report  
September 1985

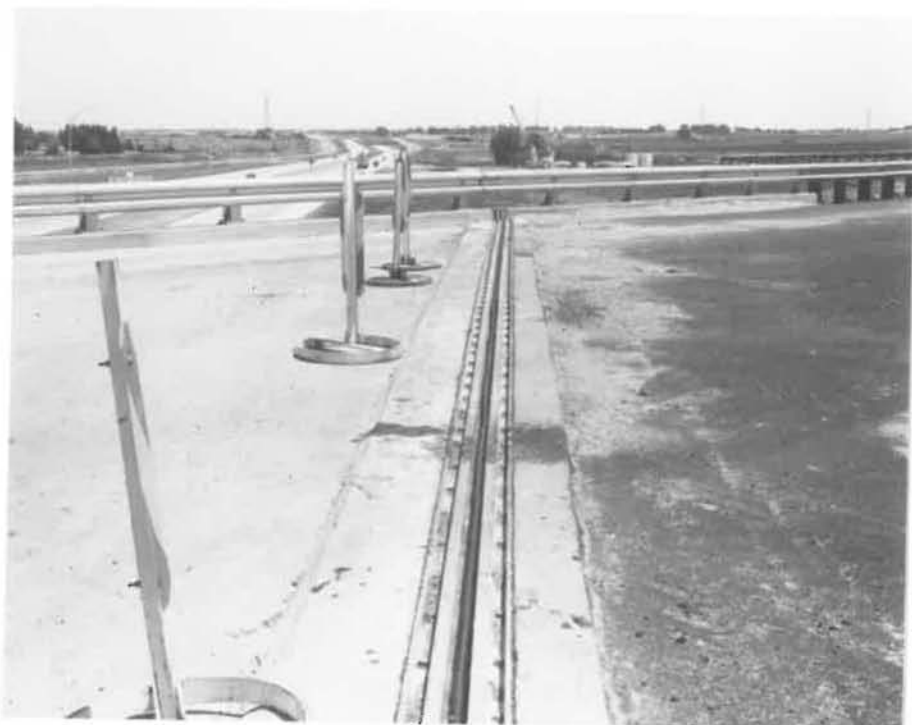
PHOTO #1

The two ONFLEX 45 seals were placed on structure E-18-AM at Lochbuie in June of 1981 with ease. No particular problems were encountered and the finished structure with joints looked good.

ONFLEX 45 in Place  
on E-18-AM During  
Construction

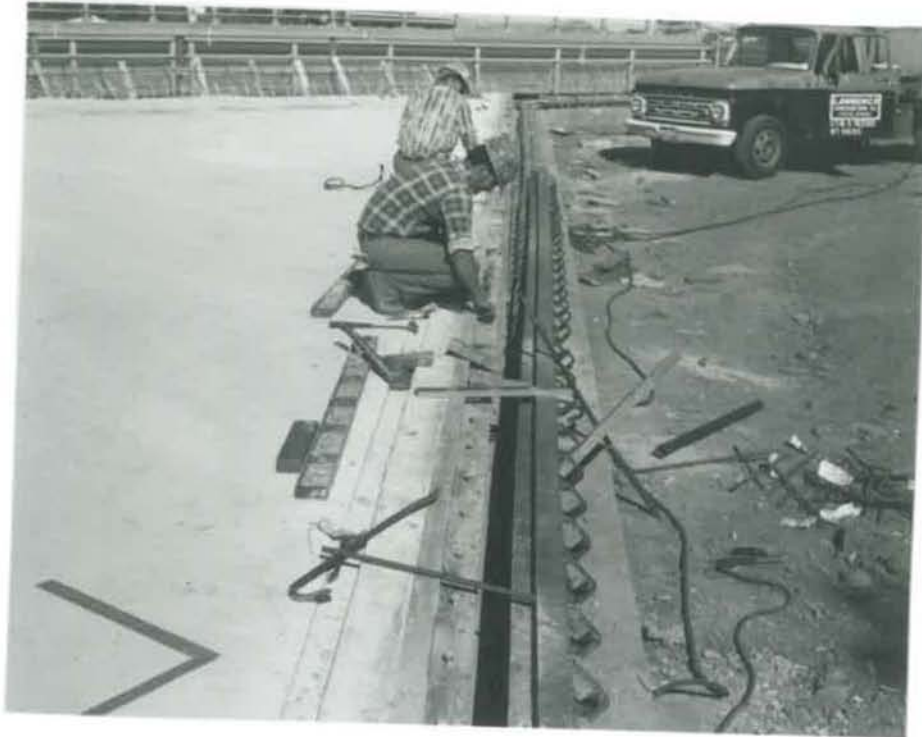
PHOTO #3

Workmen Preparing  
The Expansion  
Joint on E-16-KC

After the construction of this structure E-16-KC, there were several places where the expansion joints were slightly higher than the concrete structure or the approach or both. This was a difficult structure to get everything to match with such small or no tolerances. The structure is on a grade, horizontal and vertical curve, super elevated and on a different skew angle at each end.

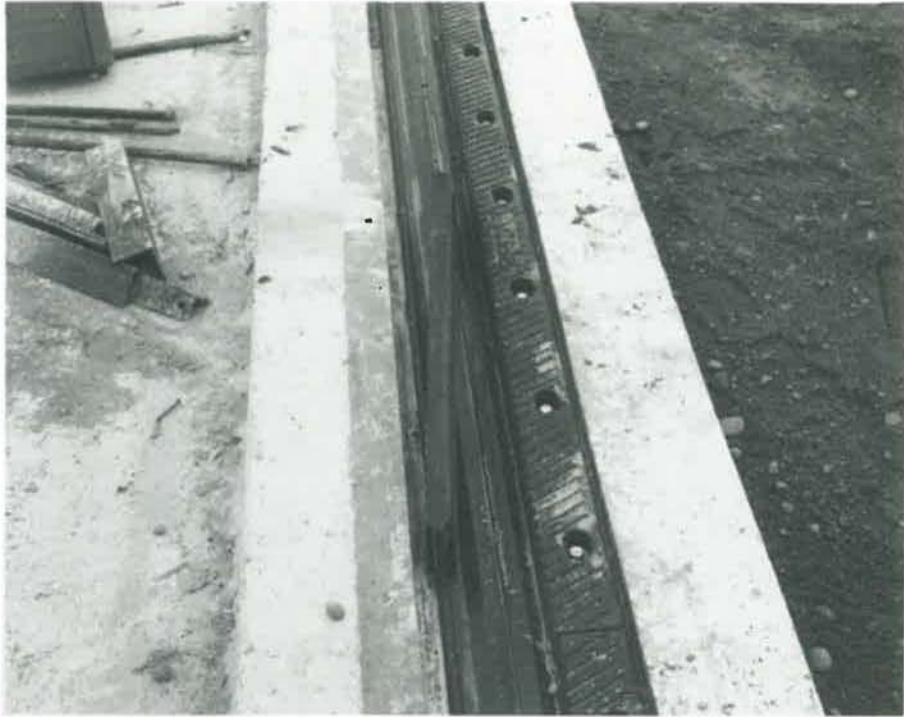
PHOTO #5

Acme TR 300 joint seals were placed on structure E-17-MD in the late summer of 1981. A good seal was obtained but members of the research section noticed that the rubber gland was in upside down. Staff Bridge Design offered the opinion that the seal should work either way (see Photo 5 and Diagram D).

ACME TR 300

installed on E-17-MD

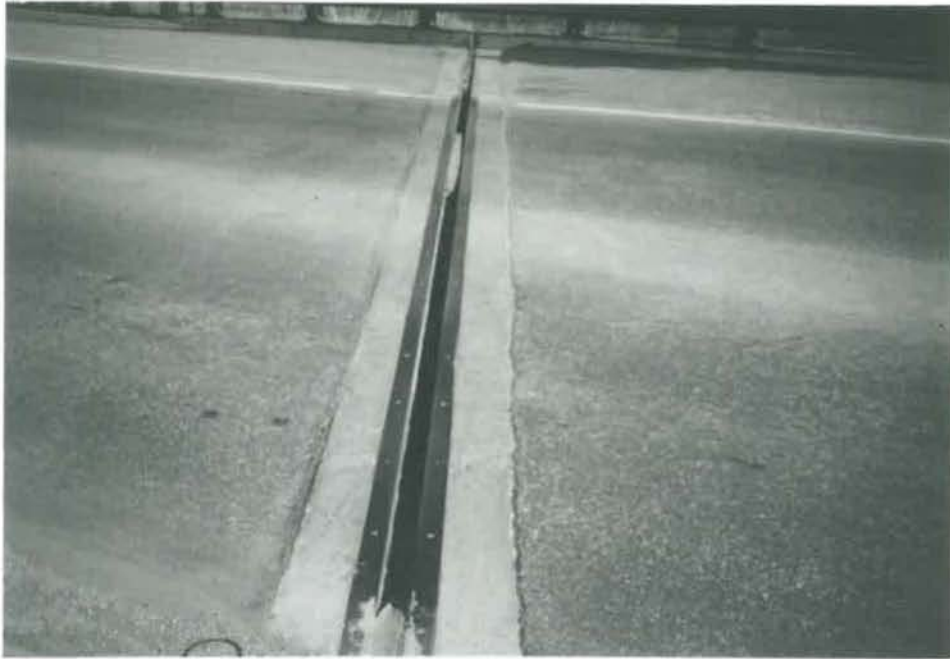
PHOTO #6

Evazote was installed on structure D-16-CW in the fall of 1982. One fourth of it, the east half of the north joint, lost adhesion and fell down through the joint within two months. The manufacturer and supplier attributed this adhesion failure to incomplete sand blasting and cleaning of the steel angle iron joint edges. The project engineer suggested that the use of an opened partially used can of epoxy cement, which was used on this section of the joint, could have caused the failure. This particular section of Evazote has failed and been replaced and reinstalled three times by the manufacturer and/or supplier.

Four-Inch Evazote  
Material Failed  
Before It Was  
Opened to Traffic  
And Twice Since  
Then

The failure of Evazote is adhesion. The Acme TR 300 gland was punctured as shown in Photo 9, however, this is rare. Most of the other leak failures appear to be between the concrete end dams and the elastomeric or rubber joint material. Repair of a leaky joint is not generally feasible, therefore, replacement is probably the best alternative.

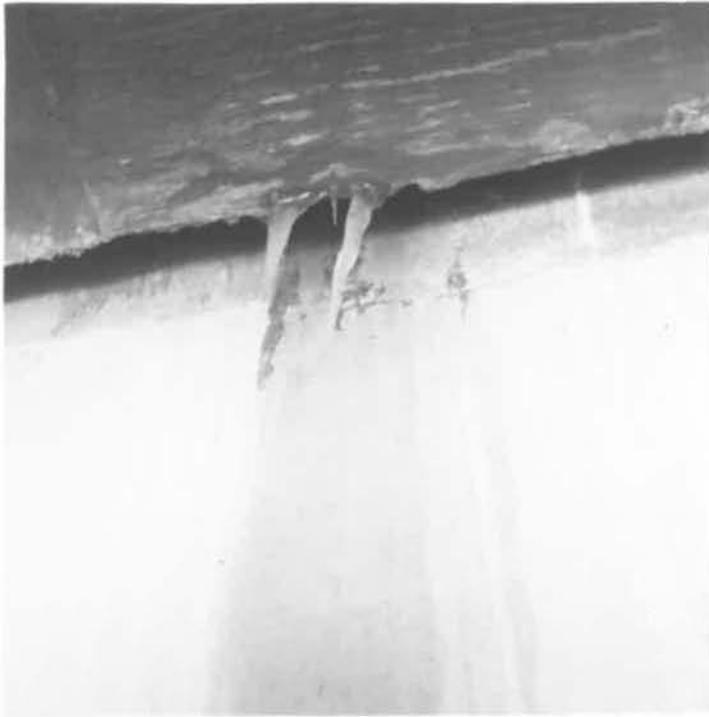
PHOTO #7

Structure D-18-BN  
Near Hudson has  
Leaking Wabo  
Alu-Strip Joints.  
Icicles Can Be Seen  
Hanging From the  
Joints in Several  
Places Under the  
Bridge.

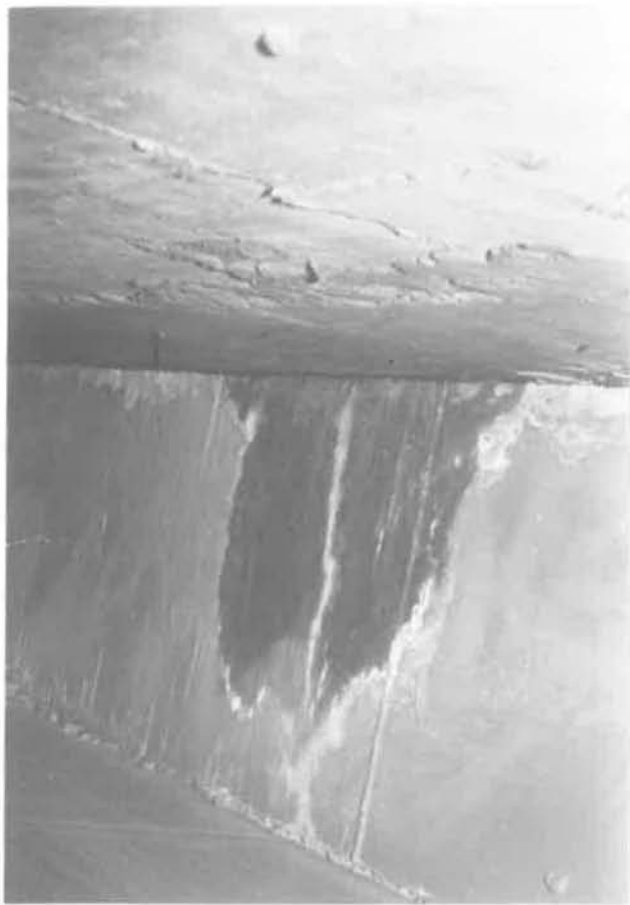
PHOTO #8

Water is Running  
Down the Abutment  
Wall After a Rain.  
This Water Came  
Through A Gen Strip  
250 Joint On  
Structure No E-16-KC
