# STATE HIGHWAY 9 WILDLIFE CROSSINGS MONITORING – YEAR 4 PROGRESS REPORT

*December 2015 through April 2019*

Study Number 115.01

Report to the Colorado Department of Transportation  
Applied Research and Innovation Branch

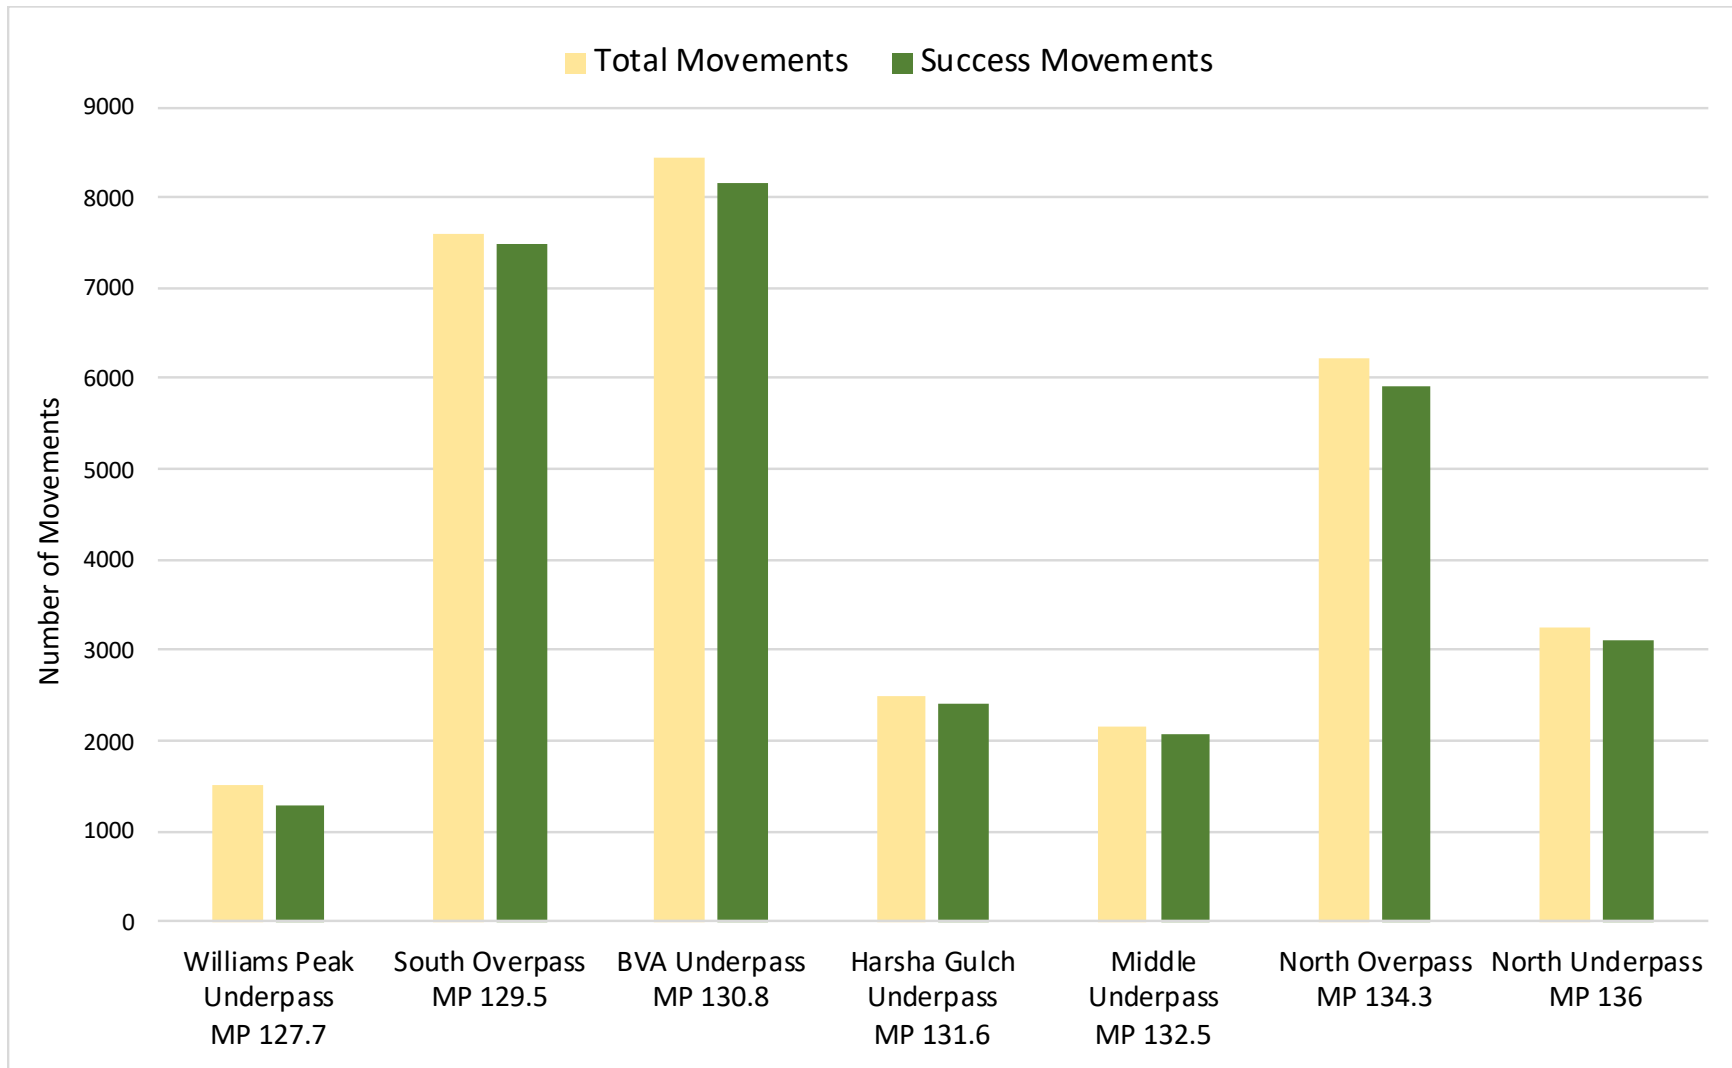
Figure 4. Total number of mule deer movements and success movements at each crossing structure location during Winter 2018-19.

As in the previous winter, mule deer total movements and success movements varied substantially among the wildlife crossing structures during Winter 2018-19 (Fig. 4). The greatest number of success movements was documented at the BVA Underpass and the South Overpass, followed by the North Overpass. This pattern is similar to what was observed in Winter 2017-18.

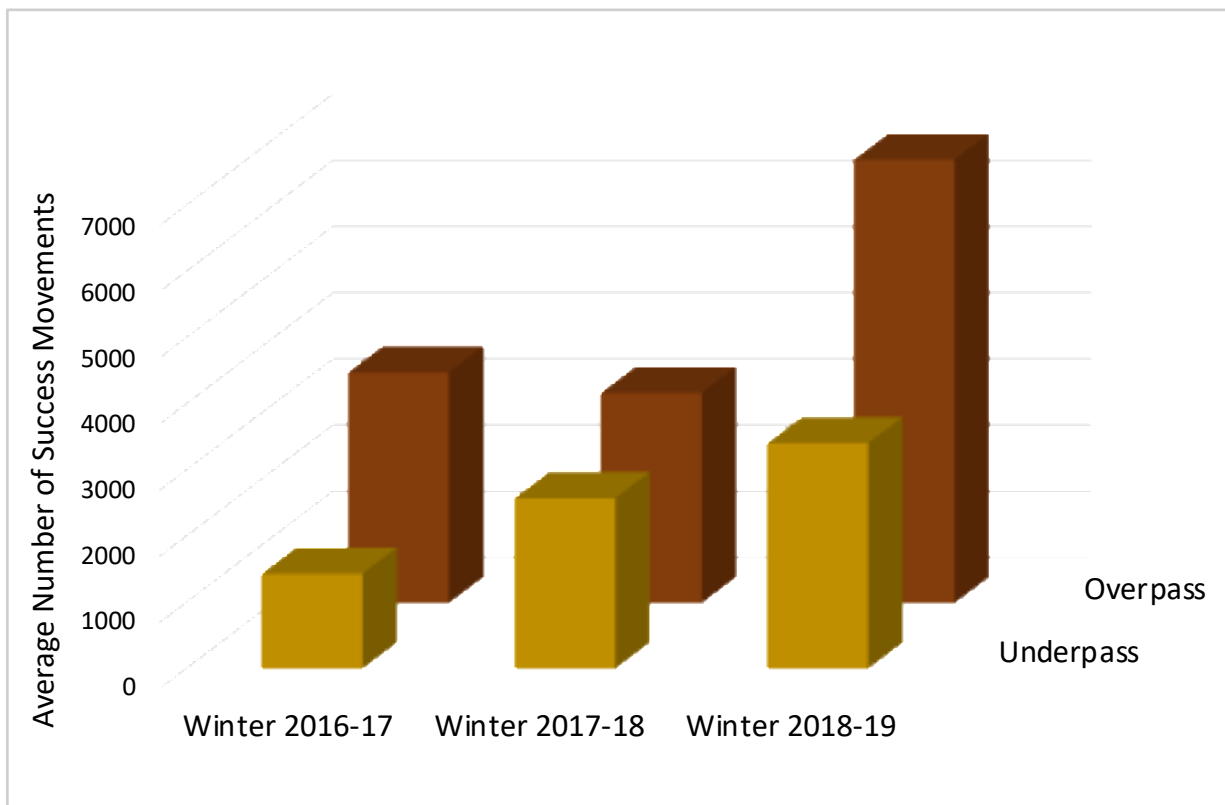
Figure 5. Average number of success movements per winter by mule deer at overpass versus underpass structures each winter from Winter 2016-17 to Winter 2018-19.

Mule deer use of overpass structures versus underpass structures was compared between Winter 2018-19 and the two previous winters (Fig. 5). The averages for the combined number of success movements at underpass structures ( $n=5$ ) versus the combined overpass structures ( $n=2$ ) was used to account for the unequal number of underpasses versus overpasses. Over all three years of post-construction monitoring, 58% of all mule deer success movements occurred at the five underpasses and 42% at the two overpasses. However, when considered on an average per unit basis, mule deer use of an overpass structure remained higher than use of an underpass structure in all three winters. In Winter 2017-18, mule deer success movements at overpasses and underpasses appeared to be comparable to Winter 2016-17; however, in Winter 2018-19, while the total number of success movements increased at both overpass and underpass structures, the increase in the number of success movements at overpasses (111%) was greater than the increase at underpasses (32%).

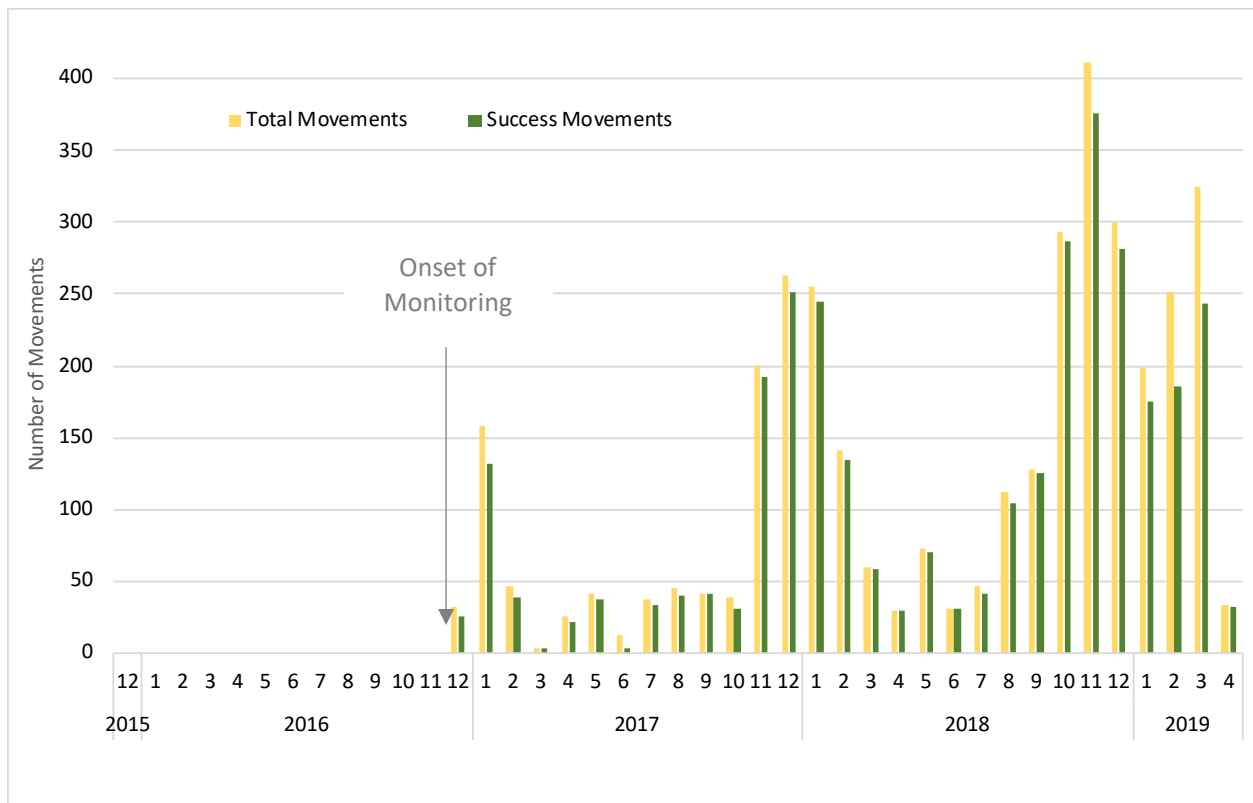
Figure 7. Mule deer total movements and success movements by month and year at the Williams Peak Underpass (MP 136) from December 2016 through April 2019. Note y-axis scale is 0 – 400.

Mule deer total movements and success movements by month at the Williams Peak Underpass are presented in Figure 7. Wintertime movements increased at this structure each year with the highest peak in Winter 2018-19 occurring in November. Mule deer use continued through the summer months each year of the research. The total number of mule deer success movements at this location since construction was completed was 3,271. The number of annual success movements by calendar year was: 25 (2016, December only); 828 (2017); 1,783 (2018); and 635 (2019, January through April only). Success rates at this location have fluctuated each winter, from 83% in Winter 2016-17, to 96% in Winter 2017-18, and 85% in Winter 2018-19.

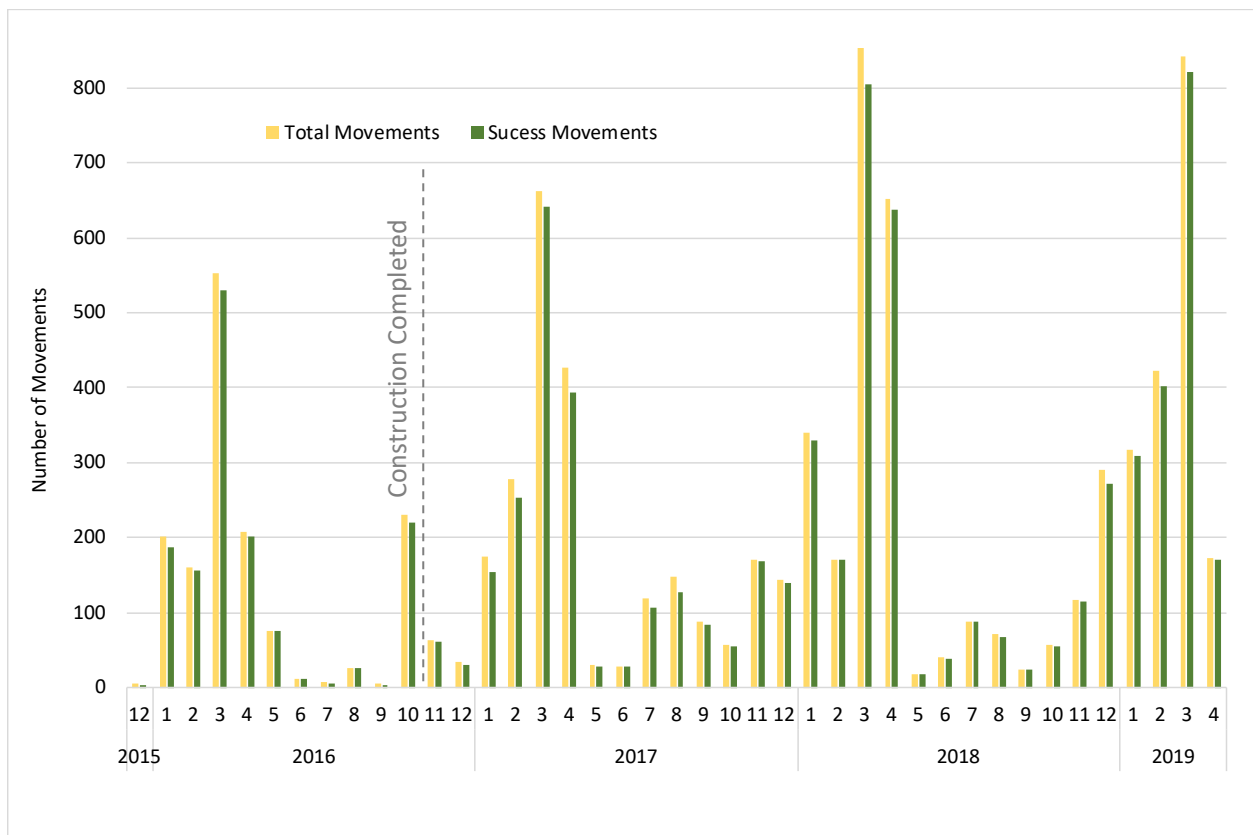
Figure 11. Mule deer total movements and success movements by month and year at the Middle Underpass (MP 132.5) from December 2015 through April 2019. Note y-axis scale is 0 – 800.

Mule deer total movements and success movements by month at the Middle Underpass are presented in Figure 11. Peak activity has remained consistently in March at this structure and was nearly equivalent in 2018 and 2019. Each year of the research, activity dropped off sharply following these peak movement periods, in April or May. Mule deer use continued through the summer months each year of the research, with the highest levels of summertime activity occurring in 2017. Ongoing construction activities in the project area in Summer 2016 may have inhibited some wildlife activity during that timeframe. The total number of mule deer success movements at this location since construction was completed was 6,526. The number of annual success movements by calendar year was: 4 (2015, December only); 1,506 (2016); 2,178 (2017); 2,617 (2018); and 1,700 (2019, January through April only). Success rates remained relatively stable throughout the research study (94-97%).

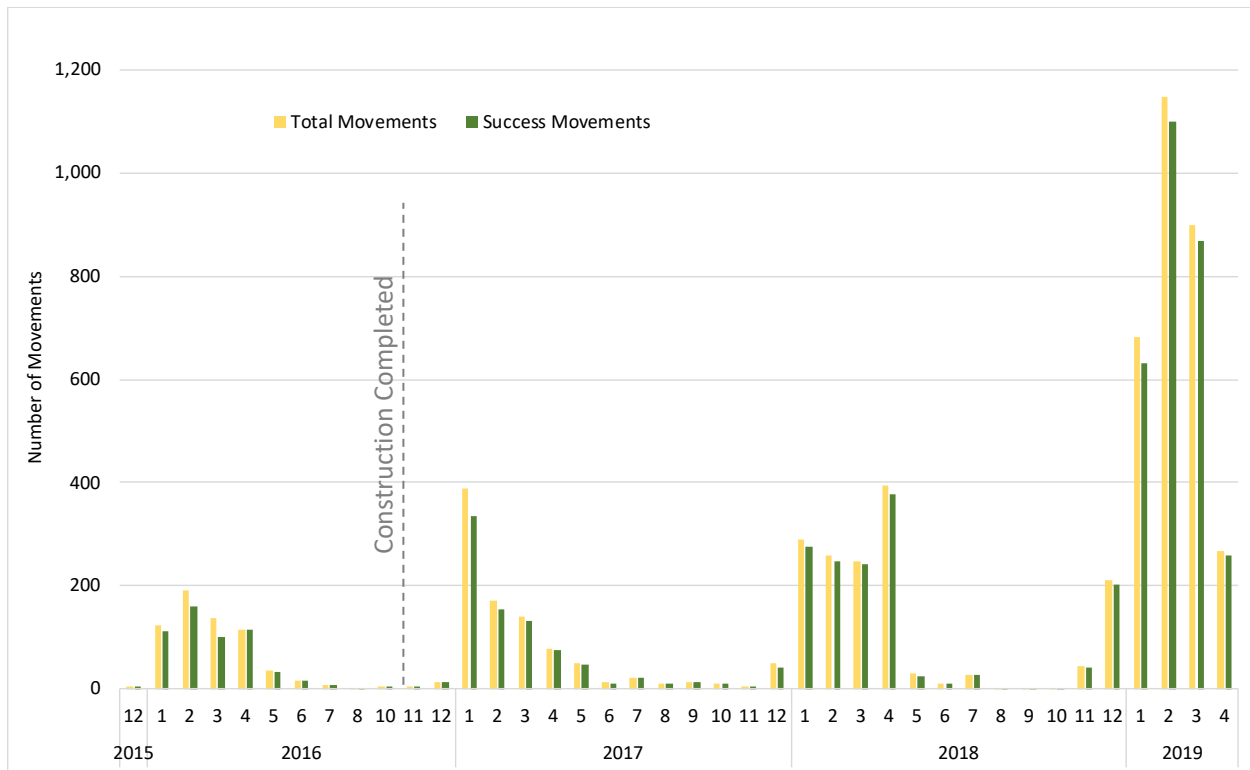
Figure 13. Mule deer total movements and success movements by month and year at the North Underpass (MP 136) from December 2015 through April 2019. Note y-axis scale is 0 – 1,200.

Mule deer total movements and success movements by month at the North Underpass are presented in Figure 13. Mule deer total and success movements increased each year of the research, with the greatest increase in Winter 2018-19. Total movements and success movements peaked in February and March 2019. Mule deer use of the structures was seasonal – consistently low during the summer months and higher during the winter months. The total number of mule deer success movements at this location since construction was completed was 5,180. The number of annual success movements by calendar year was: 4 (2015, December only); 566 (2016); 854 (2017); 1,453 (2018); and 2,861 (2019, January through April). Success rates fluctuated somewhat from year to year, ranging from 90% in Winter 2016-17, to 96% in Winter 2017-18, and 95% in Winter 2018-19.

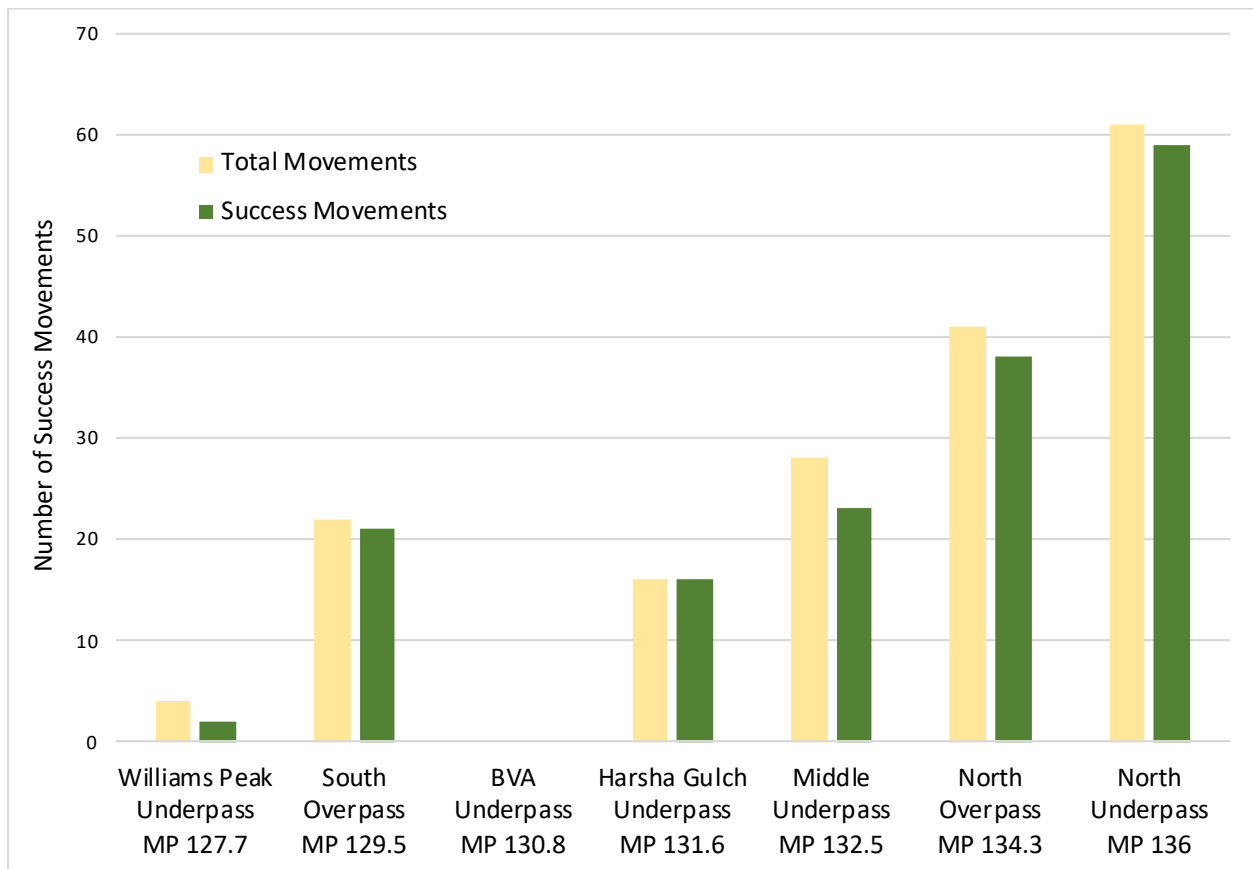
Figure 14. Elk total and success movements detected at wildlife crossing structures, Years 1-4.

Elk movements through and over the crossing structures increased each year of the study. Elk success movements were documented year-round each year of the study, with the exception of Year 3, during which success movements and approaches to the crossing structures were documented only during the summer months. Elk success movements also varied across the structure locations (Fig. 14). In Years 1-3 of the research, elk success movements were highest at the North Overpass. During that time there were also approximately a dozen success movements recorded at each the North Underpass, Middle Underpass and Harsha Gulch Underpass. In Year 4, these patterns shifted, with the greatest number of elk success movements occurring at the North Underpass ( $n=45$ ). In Year 4, elk also used the Williams Peak Underpass in limited numbers ( $n=2$ ) for the first time. No elk were documented using or attempting to cross through the BVA Underpass. Overall, elk have successfully used both overpass and underpass structures. More elk success movements have occurred at the five underpasses ( $n=109$ ) than the two overpasses ( $n=63$ ), but the repel rate was higher at the underpasses than at the overpasses (10% and 5%, respectively).

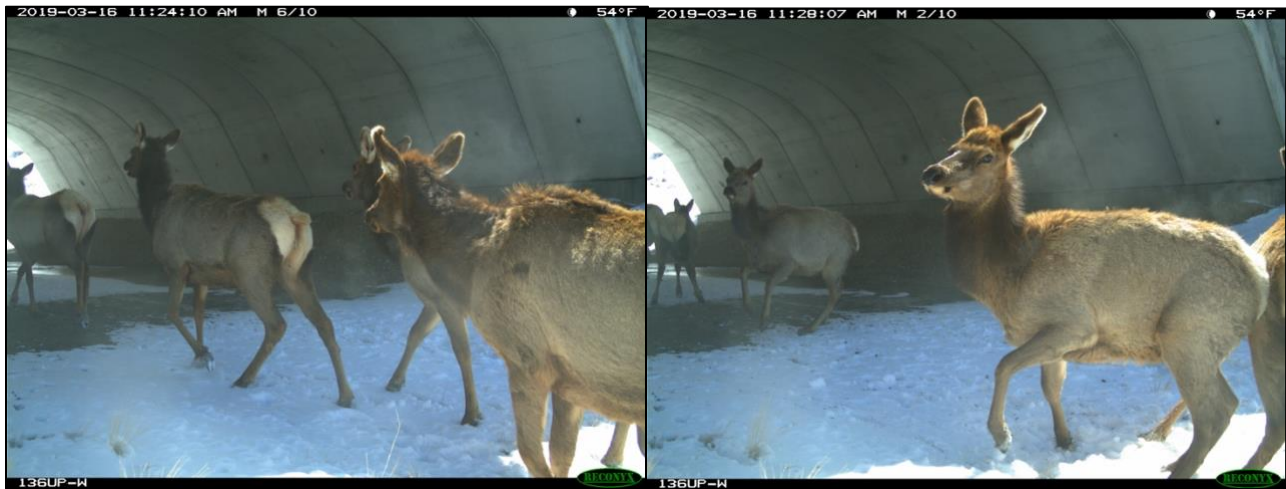
Figure 15. Group of elk attempting to cross through the North Underpass (left) with some individuals initially repelling from the structure (right) before completing success movements through the structure.

Winter 2018-19 marked the first success movements by small herds of elk. In March 2019, two groups of elk composed of cows and calves (numbering 17 and 12 individuals) were documented crossing through the North Underpass on successive days. In the first instance, the crossing event took place over more than five minutes as individual animals repelled multiple times before finally crossing through the structure successfully (Fig 15). During the second of these events, elk and deer movements through the underpass were intermixed over the course of ten minutes.

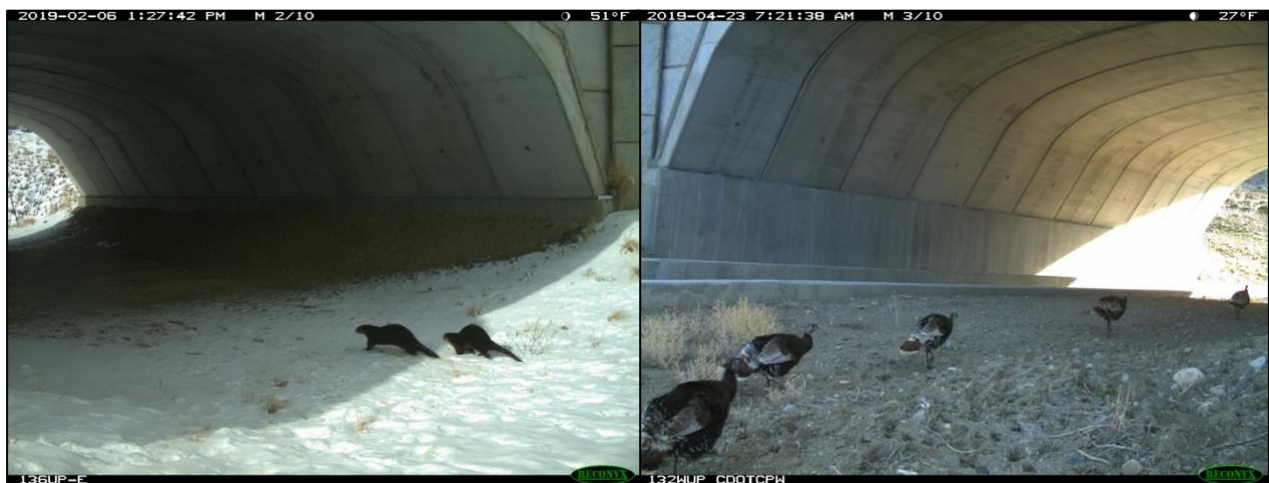
Figure 16. Two river otters (left) crossing through the North Underpass and five of six turkeys (right) crossing through the Middle Underpass.

In addition to mule deer, a variety of other species were documented using the wildlife crossing structures. Table 4 lists the total number of success, repel and parallel movements for each species across all crossing structures and the corresponding success and repel rates for those species. Two new species were documented successfully using the crossing structures in Year 4 – river otter (*Lontra canadensis*) and wild turkey (*Meleagris gallopavo*). Each species was recorded in isolated events consisting of multiple individuals: two river otters successfully passed through the North Underpass in February 2019, and a group of six turkeys used the Middle Underpass in April 2019 (Fig. 16).

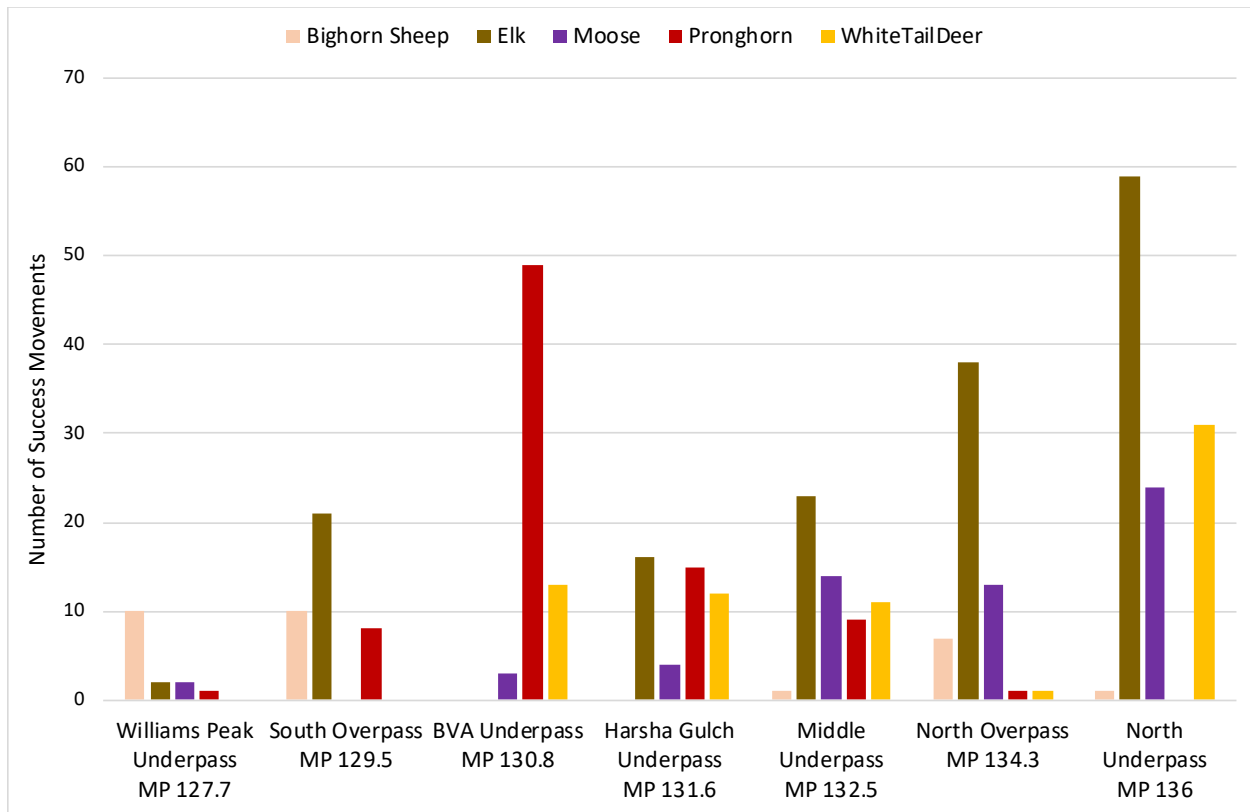
Figure 18. Success movements for ungulate species other than mule deer at each wildlife crossing structure location, Years 1-4.

Figure 18 displays success movements for ungulate species other than mule deer at each of the wildlife crossing structures in the study area. In previous years of this research, it was reported that pronghorn and white-tailed deer had only been documented using the underpass structures; however, in Year 4, both species were also documented using overpasses, albeit in low numbers. As in previous years, the majority of pronghorn success movements occurred at the BVA Underpass in Year 4, while the majority of elk and white-tailed deer success movements occurred at the North Underpass. Elk, moose and bighorn sheep have made success movements at both underpasses and overpasses. The majority of moose success movements occurred in the northern portions of the study area (the North Underpass, North Overpass and Middle Underpass). Bighorn sheep success movements occurred primarily at crossing structures located in the southern portion of the project area, specifically, at the South Overpass and the Williams Peak Underpass (69% combined), or at the North Overpass (24%).

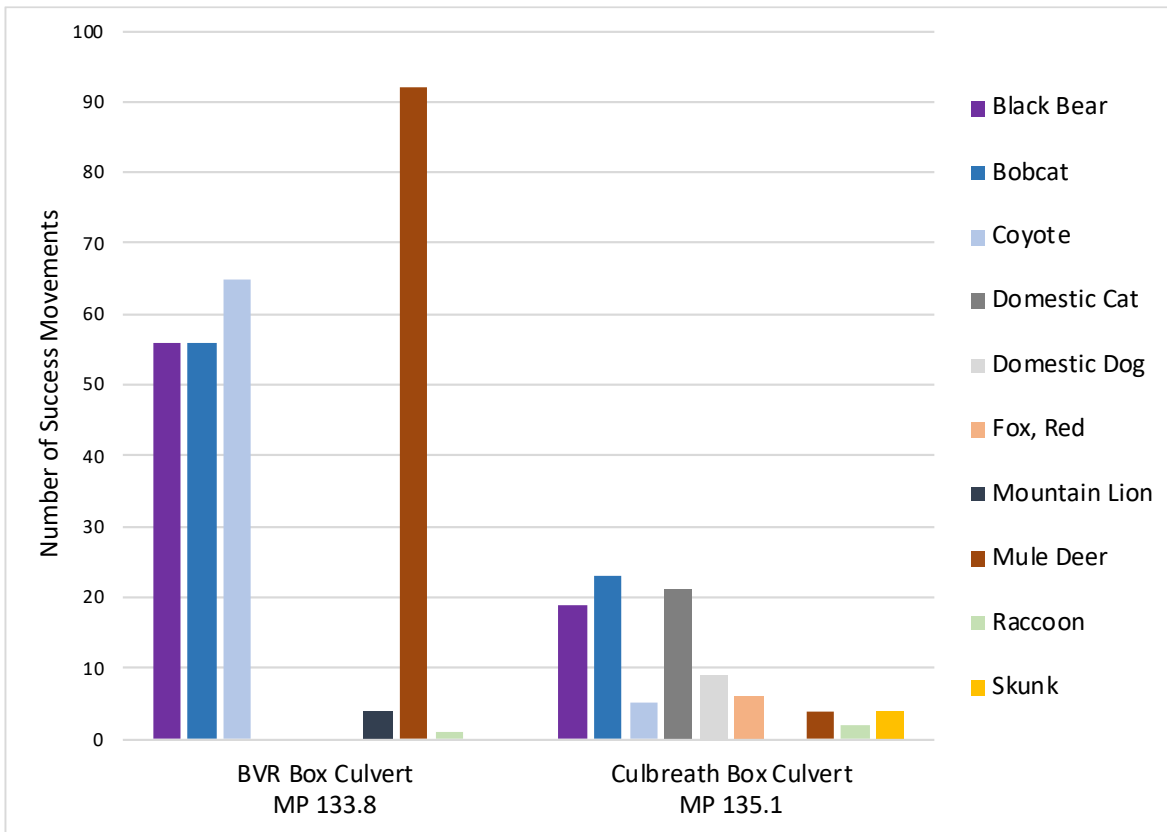
Figure 20. Success movements by species at each of the small culverts. Total monitoring days at each location are: BVR Box Culvert – 816 days; Culbreath Box Culvert – 773 days.

at the culverts during the winter months. Figure 20 displays success movements by small culvert location. Wildlife species were detected in higher numbers at the BVR Box Culvert, in particular, mule deer, coyote, black bear and bobcat. Domestic dogs and cats were recorded passing through the Culbreath Box Culvert 30 times and may have deterred some wildlife activity at this location. Success movements at small culverts were also made by red fox, hares, northern raccoon, and striped skunk.

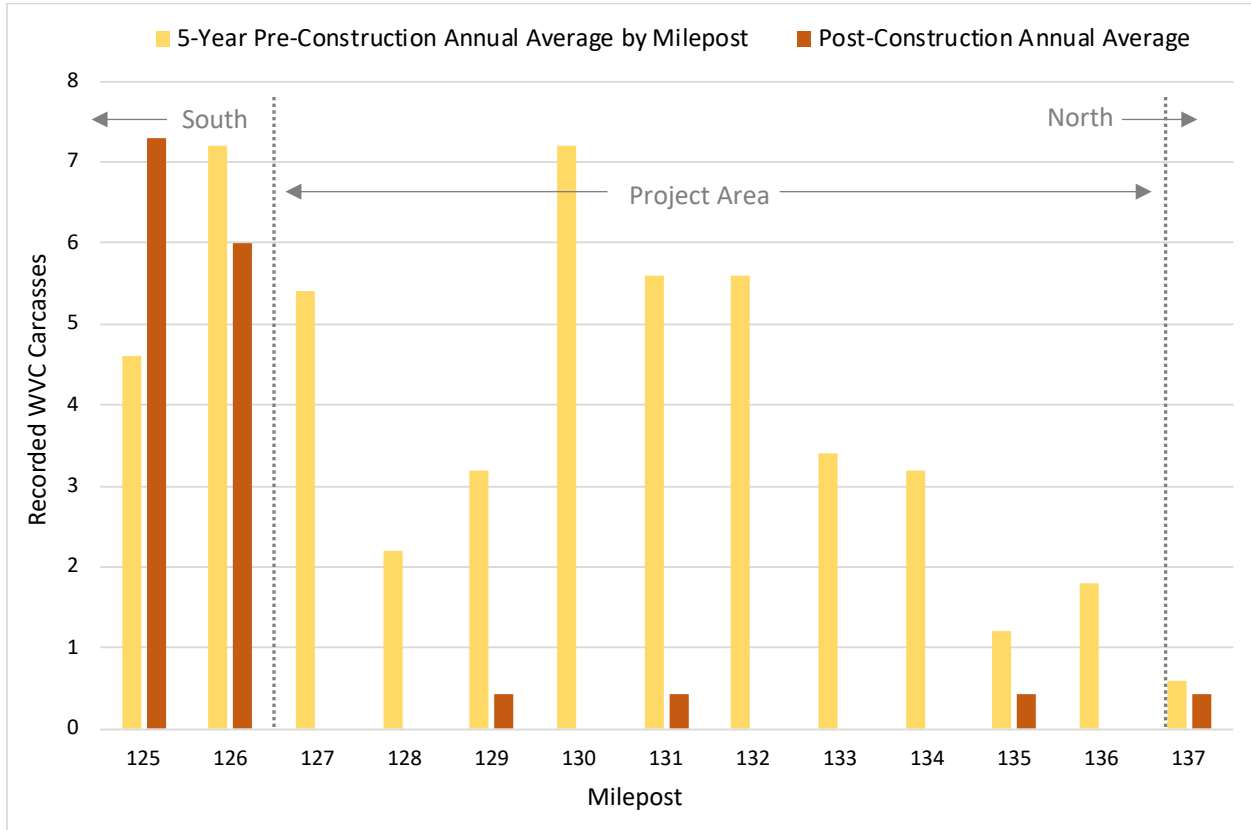
Figure 25. Five-year pre-construction annual average and post-construction annual average mule deer and elk carcass counts recorded by CDOT Maintenance by milepost. The post-construction annual average is based on the timeframe from 11/1/2016 through 4/30/2019).

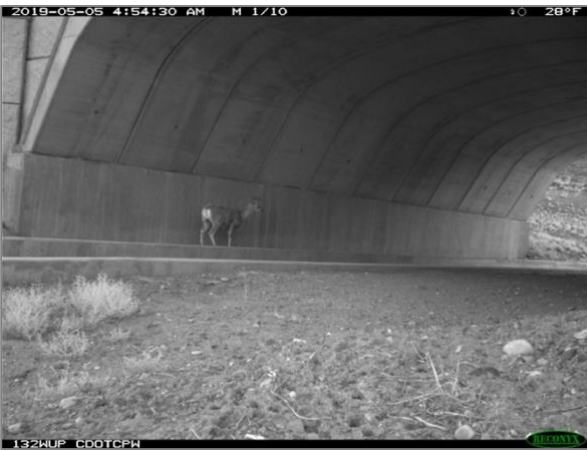
Figure 28. Mule deer crossing through the Middle Underpass along the narrow pathway adjacent to the drainage trough.

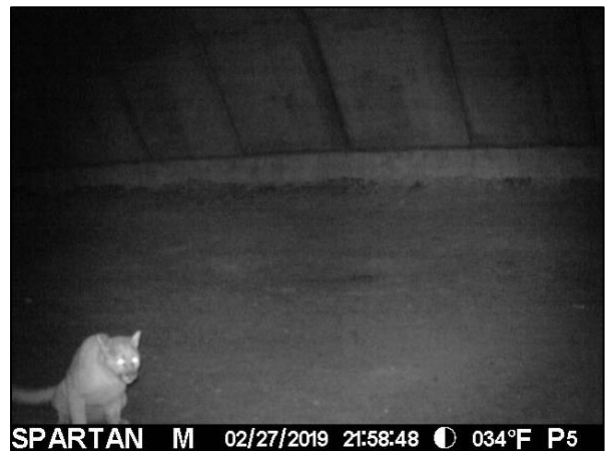
Figure 30. Mountain lion scent marking at the Williams Peak Underpass.

While mountain lion success movements have been documented at most of the wildlife crossing structures, the majority of these movements occurred at the Williams Peak Underpass, where mountain lion activity increased substantially in Winter 2018-19 ( $n=78$ ). Mountain lion movements at this structure culminated in an interesting event during which a small group of mountain lions appeared to 'take over' the underpass for a period of several days. On February 25, 2019, two lions crossed through the underpass and later the same day a mule deer passed through. Then, between February 26 and March 1, a total of 60 lion movements were recorded, including a lion marking the underpass with urine on the 27<sup>th</sup> (Fig. 30). From March 2-4, no wildlife activity was recorded, and on the 5<sup>th</sup> mule deer began returning to the crossing structure. Mule deer did not permanently avoid the underpass as suggested by recent research in California (Caldwell and Klip 2019); however, deer and other wildlife did avoid the underpass during and immediately following the mountain lion 'take over'.

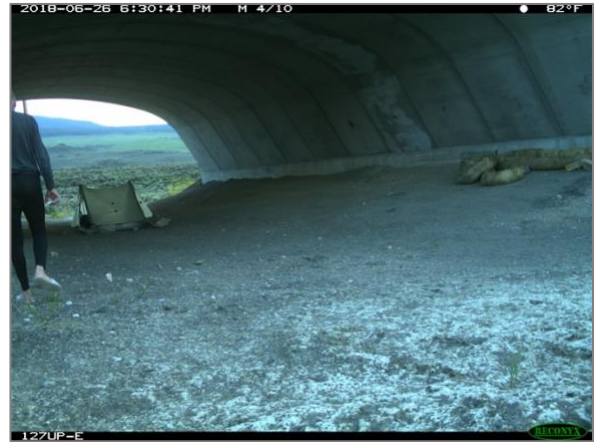
Figure 31. Camper at the Williams Peak Underpass.

Human activity continued to be documented intermittently across the crossing structures. During the summer months of 2018, people were detected on several occasions camping in the underpasses (Fig. 31). Camping at the underpasses is not desirable – in addition to deterring wildlife from the structures for the duration that people are present, in the event pictured, mule deer were not detected at the structure again for two days following the departure of the campers.

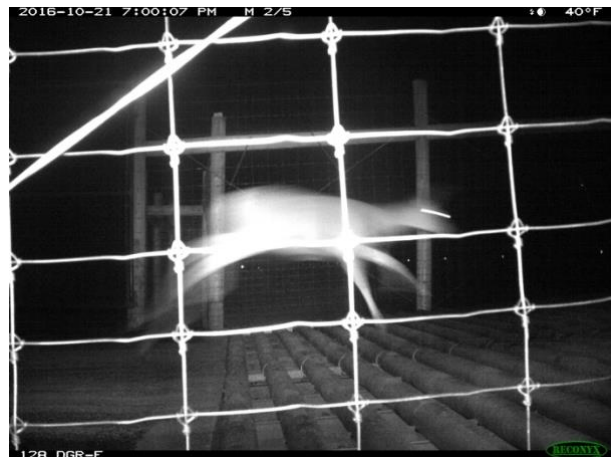
Figure 32. Mule deer breach at the Triangle Road Deer Guard (round bar).

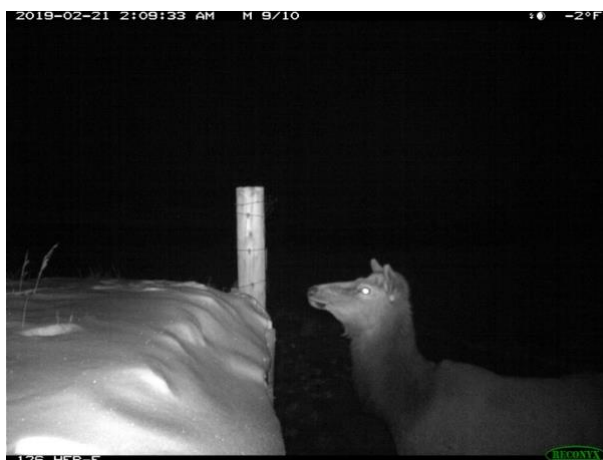
Figure 33. Cow elk investigating an escape ramp from the habitat side of the fencing.

In addition to mule deer and elk, multiple other ungulate, carnivore and meso-mammal species have been documented inside of the right-of-way fence at the escape ramps. Several of these species, including black bear, bobcat, coyote, red fox, mountain lion and white-tailed deer have used the ramps to escape back to the habitat side of the fencing. All of these species were also documented by the cameras on the habitat side of the fence line; in general, animals passed by without consideration for the ramps, although on a few occasions, animals were curious to check out the backside of the ramps although they made no attempts to jump up onto the ramp (Fig. 33). The high number of parallel movements indicates that animals had many opportunities to breach the wildlife exclusion fencing by jumping up from the back side of a ramp, but no such attempts were made, suggesting that the ramp height of six feet is sufficient in discouraging a jump up attempt by deer or elk. However, given the low escape rates even at ramps with higher intercept rates, the six-foot ramp height may be too high to encourage successful escape movements.

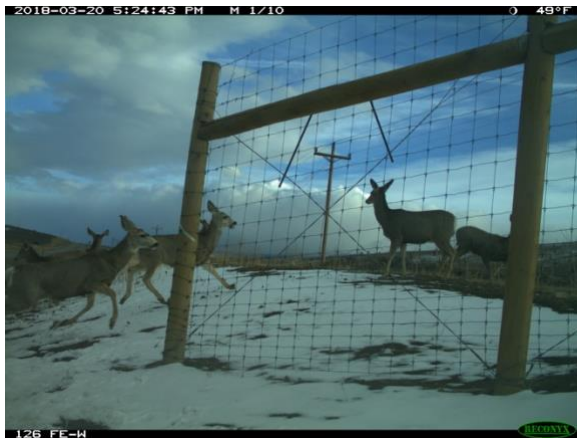
*Figure 34. Mule deer attempting to cross SH 9 at-grade just beyond the south fence end.*

at-grade without entering into the fenced right-of-way. Most of these movements were made by mule deer ( $n=974$ ), although elk were also photographed moving across the roadway beyond the fence end ( $n=75$ ). In several cases, the cameras documented a group of animals approaching the road and repelling several times before either finally making a successful at-grade highway crossing or completely repelling from the highway (Fig. 34).

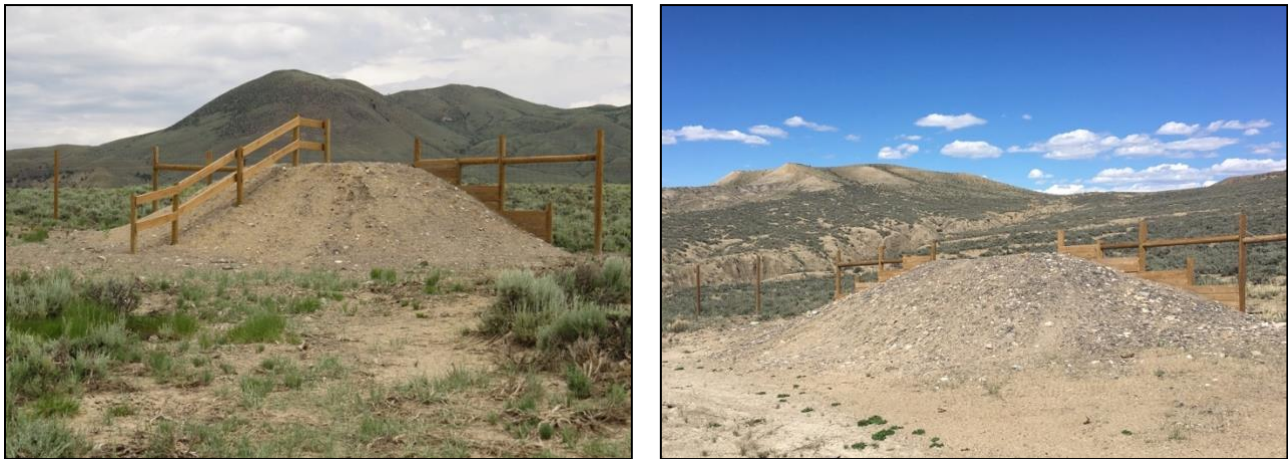
*Figure A-2.* Example of an escape ramp with a 2:1 slope with perpendicular rail fence (left) and a ramp with a 3:1 slope with no rail fence (right).
