Little Thompson Watershed Restoration Master Plan

Little Thompson Watershed Restoration Coalition
sponsored by the Big Thompson Conservation District
with support from the Colorado Water Conservation Board

December 2014

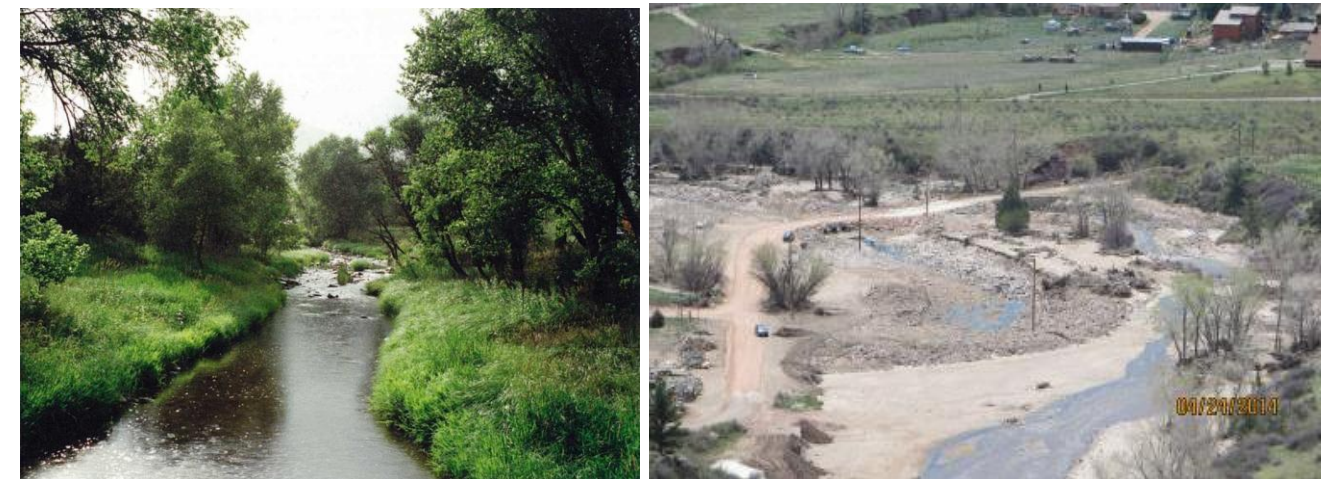
Figure 1.2. Little Thompson River at Blue Mountain neighborhood (formerly X-Bar 7) before and after the September 2013 flood.

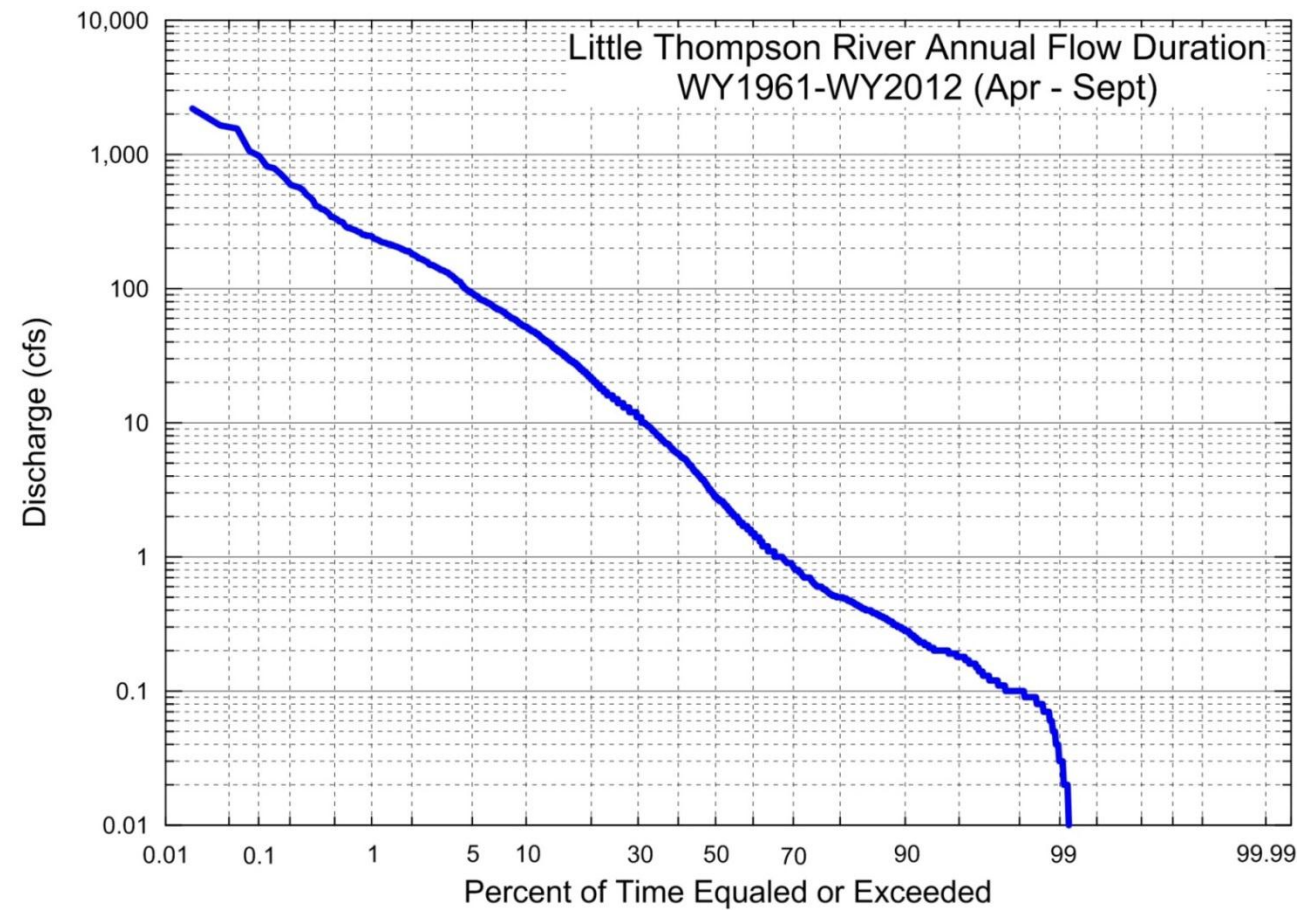
Figure 2.7. Computed mean daily flow-duration curve for the Little Thompson River near Berthoud gage for the broken period-of-record between Water Years (WY) 1921 and 2012 and months April through September.

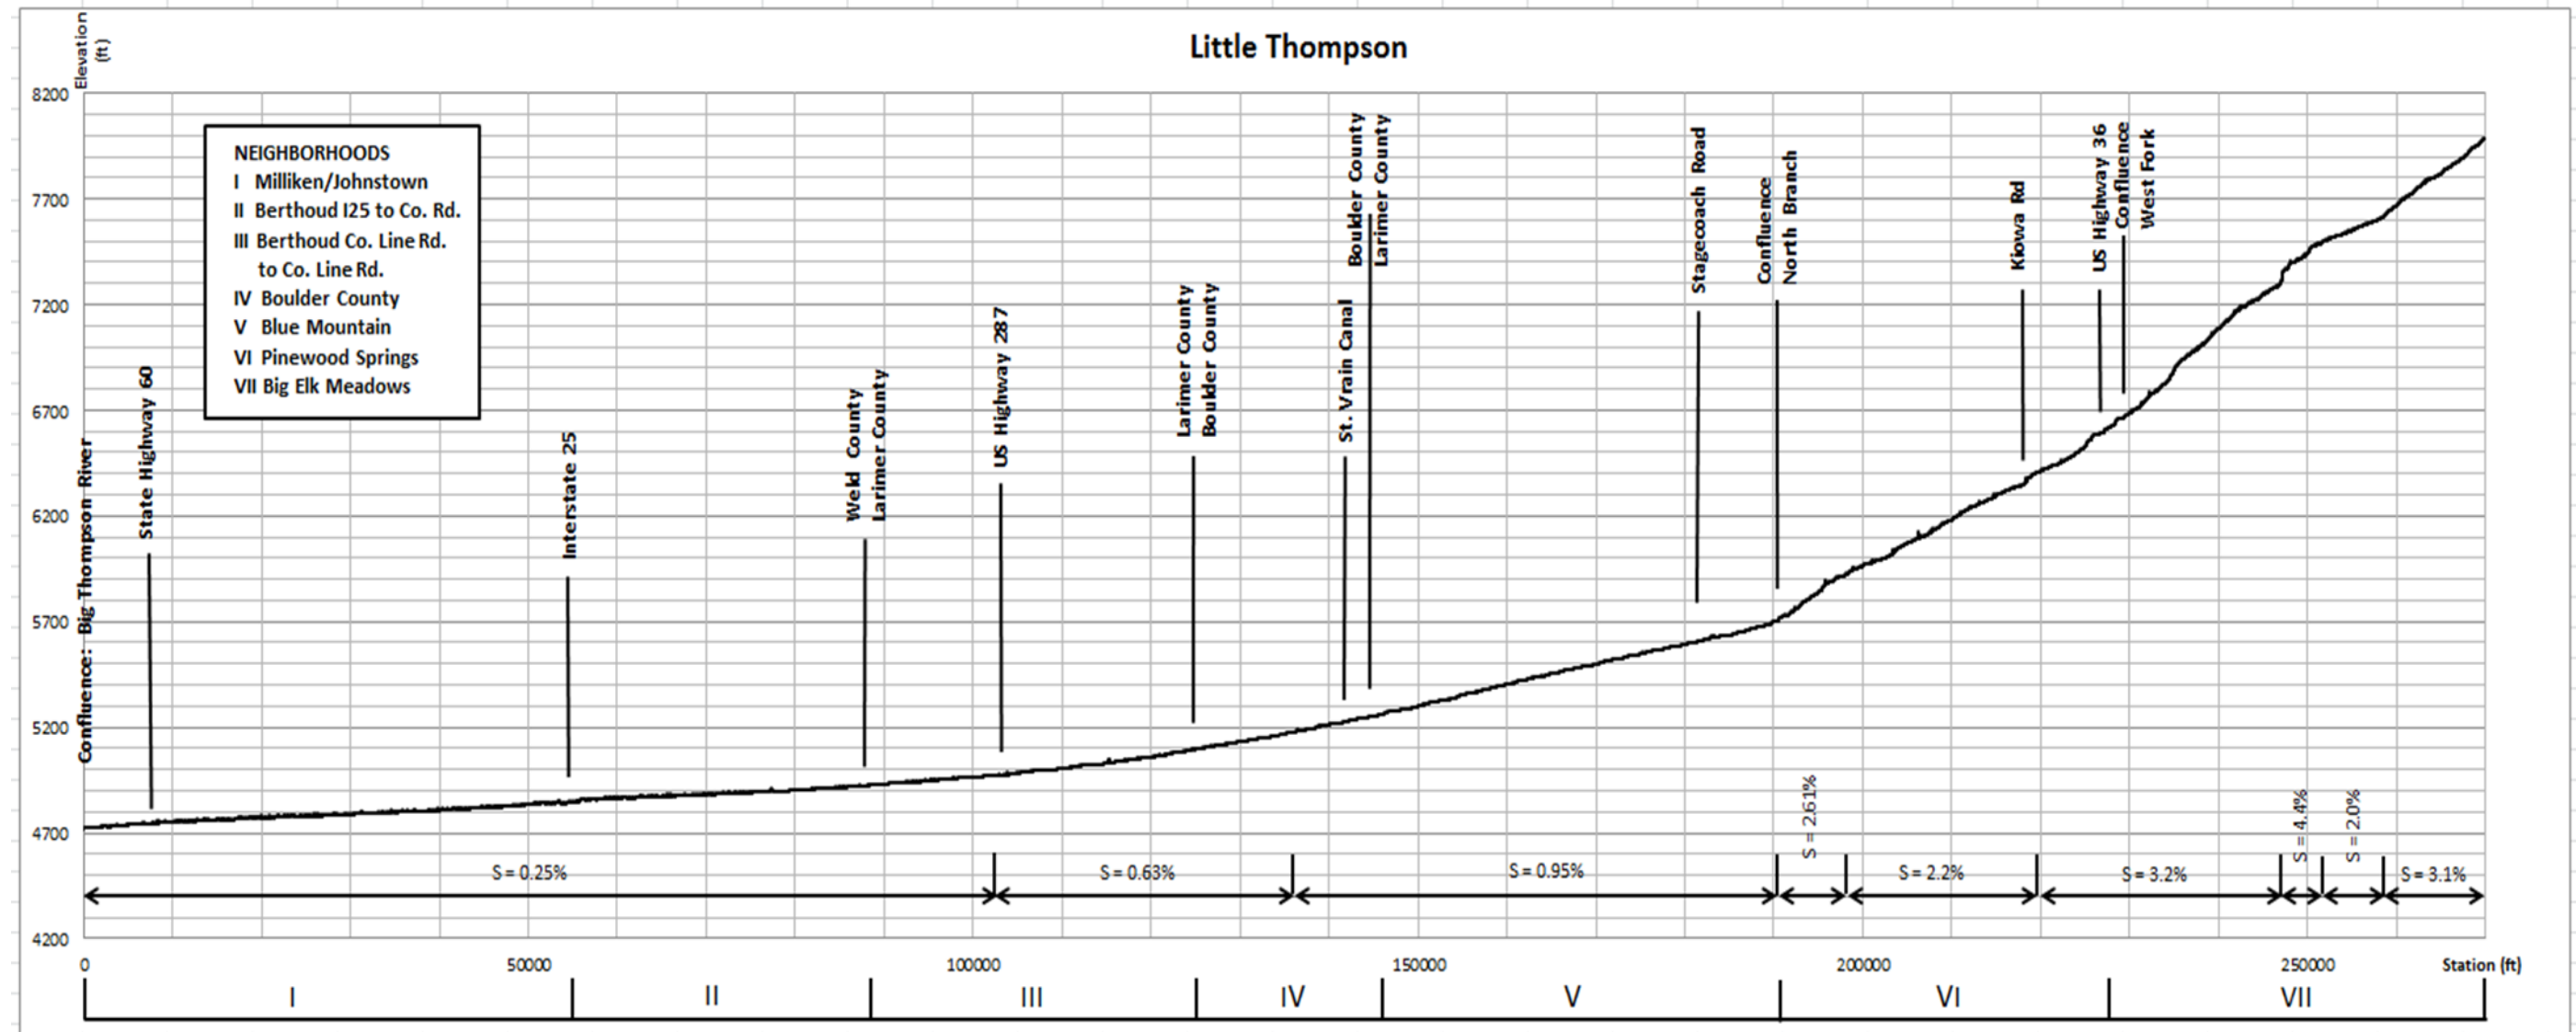
Figure 3.1. Little Thompson channel thalweg profile.

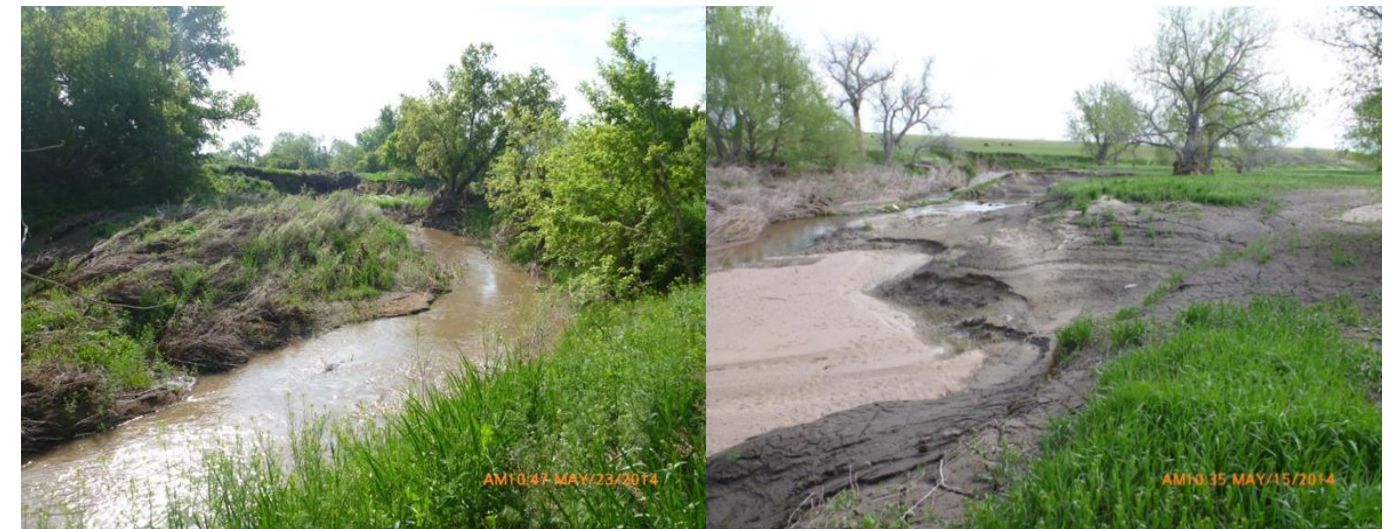
Debris accumulations were significant and in some sections sufficiently large enough to affect flood conveyance. Aggradation along the overbanks was estimated to be, in some cases, as deep as 6 feet. Overbank aggradation consisted primarily of sand. Bridges within this reach typically scoured at the abutment toes, including an exposed footing at the I-25 Bridge. Many of the bridges had already been repaired by spring 2014.

Typical channel conditions, Reach II

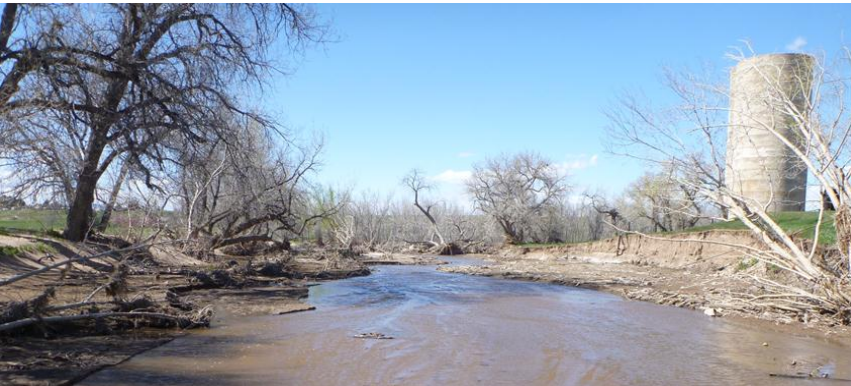
Downstream of W. County Rd 4

was also observed immediately downstream of W. County Road 4 that could undermine an existing silo. Considerable channel repairs and debris removal were completed or underway by spring 2014 by individual property owners, FEMA, and Larimer County.

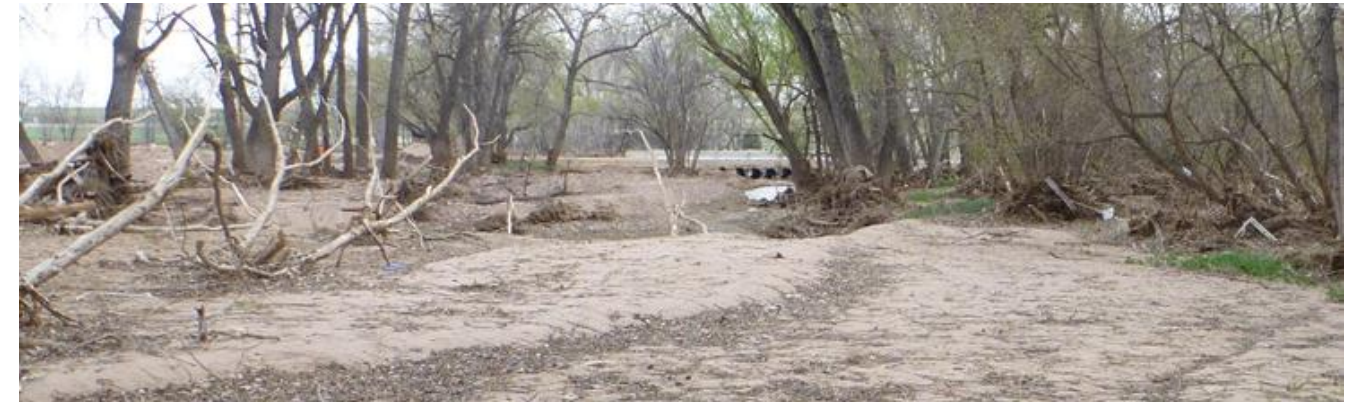
Looking downstream at temporary culverts placed at 83rd Street

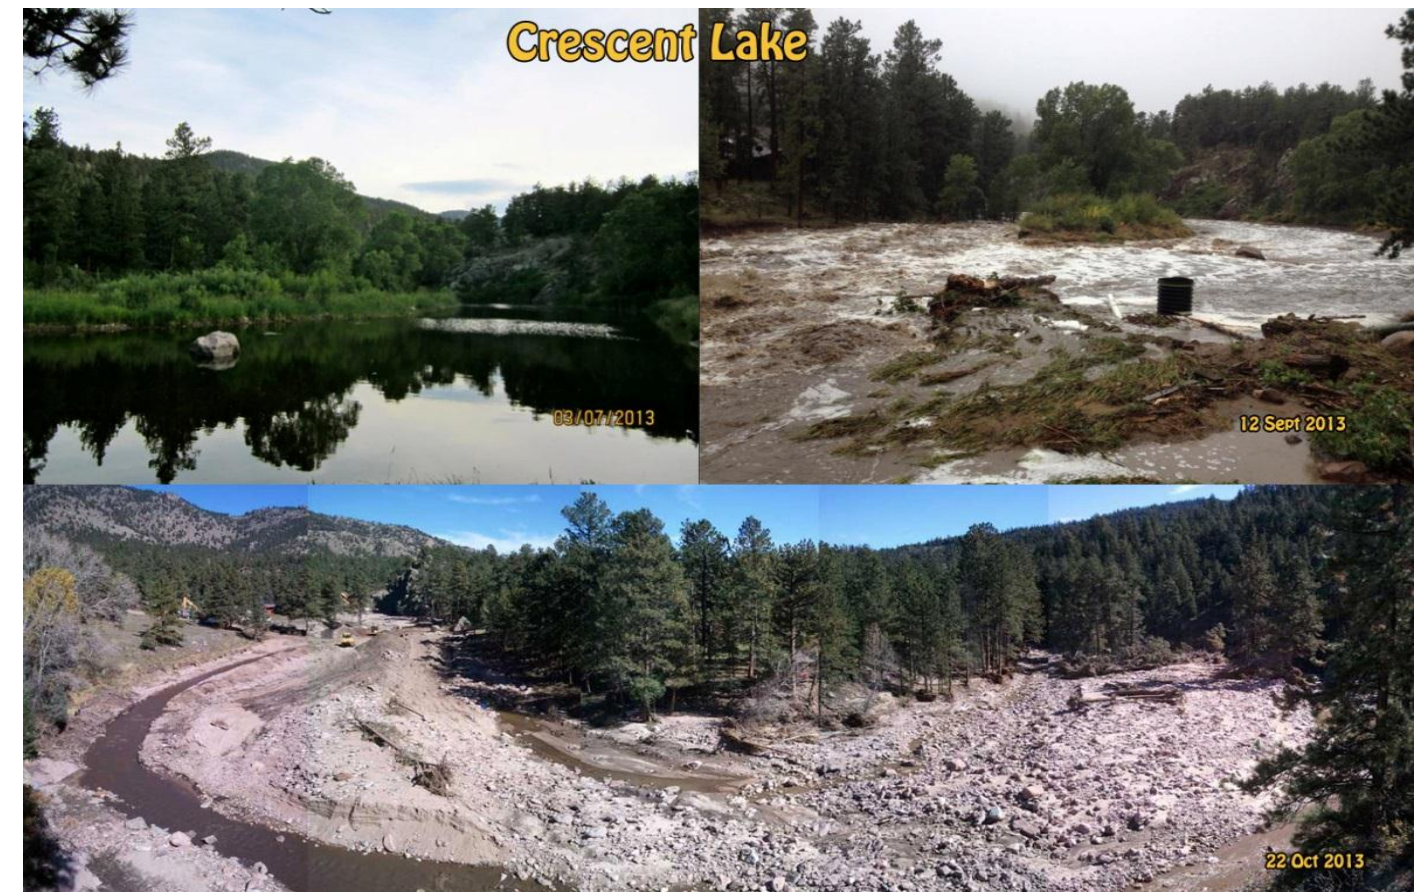
Crescent Lake: before (upper left), during (upper right) and after (lower) flood of 2013

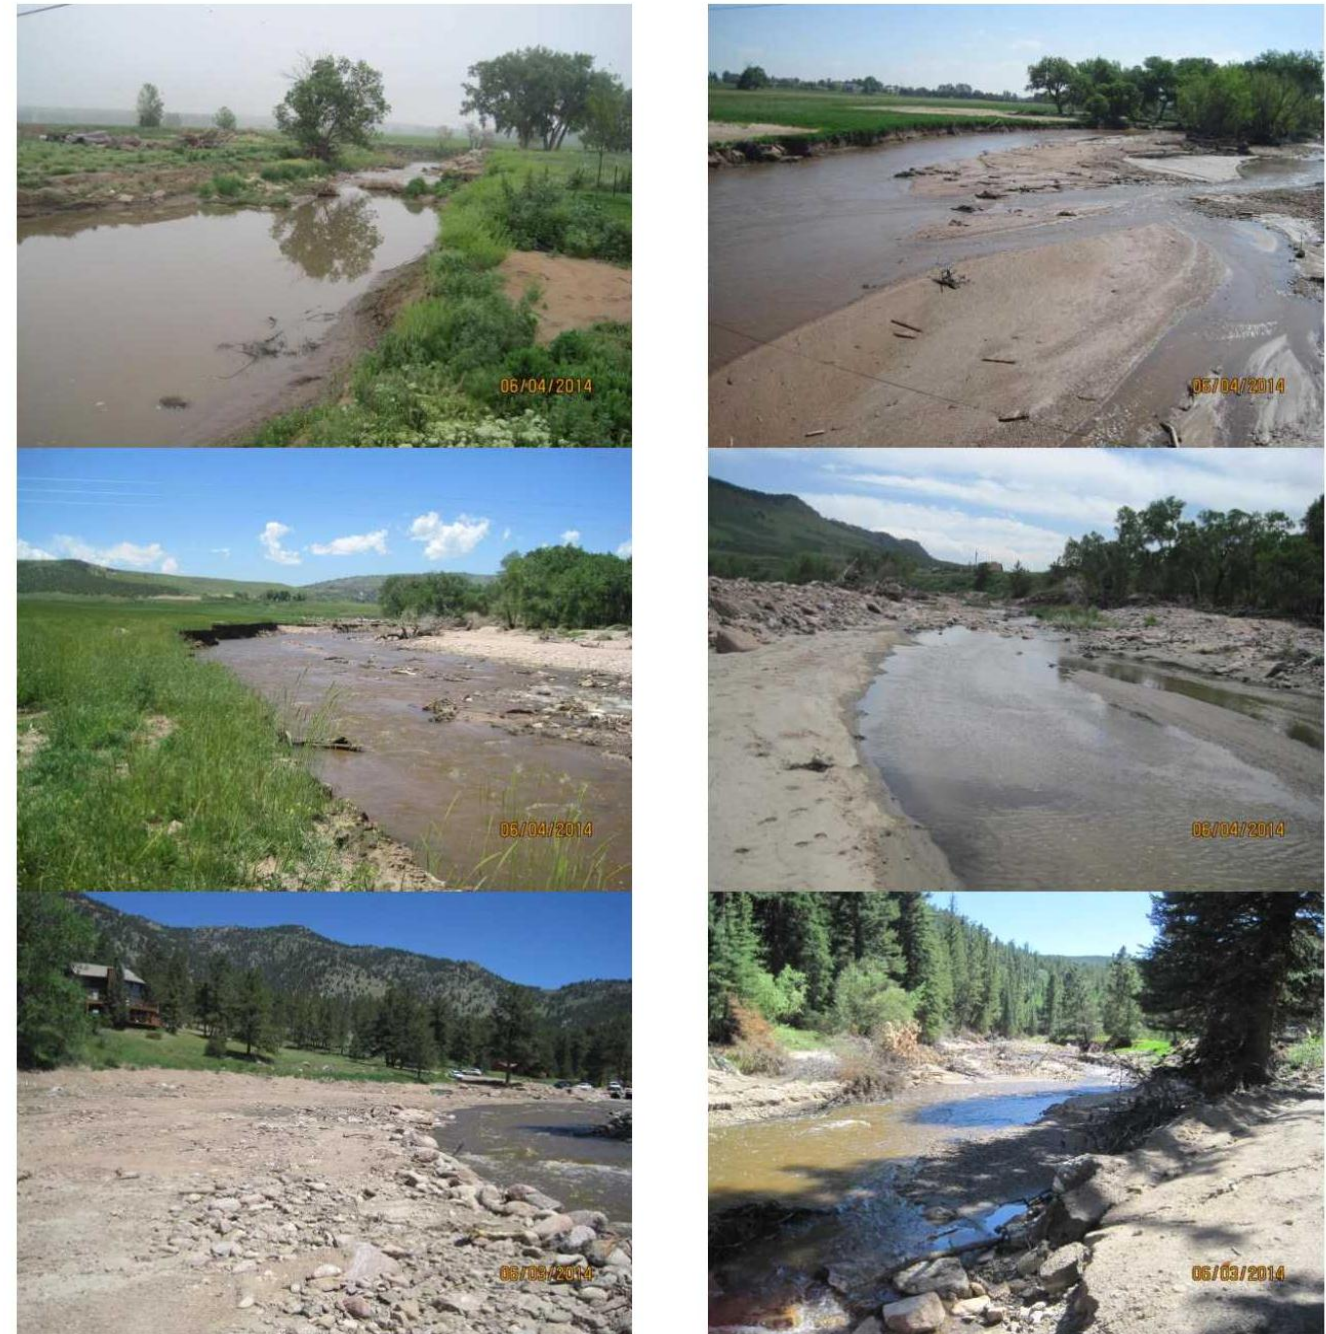
Figure 3.3. Aquatic habitat conditions observed on the Little Thompson River, June 3 and 4, 2014. Upper Left: Near Milliken, Co; Upper right: At County Road 21 near Berthoud, Colorado; Middle Left: Near Parrish Ranch; Middle Right: At Blue Mountain; Lower Left: At Pinewood Springs; Lower Right: West Fork near Big Elk Meadows.

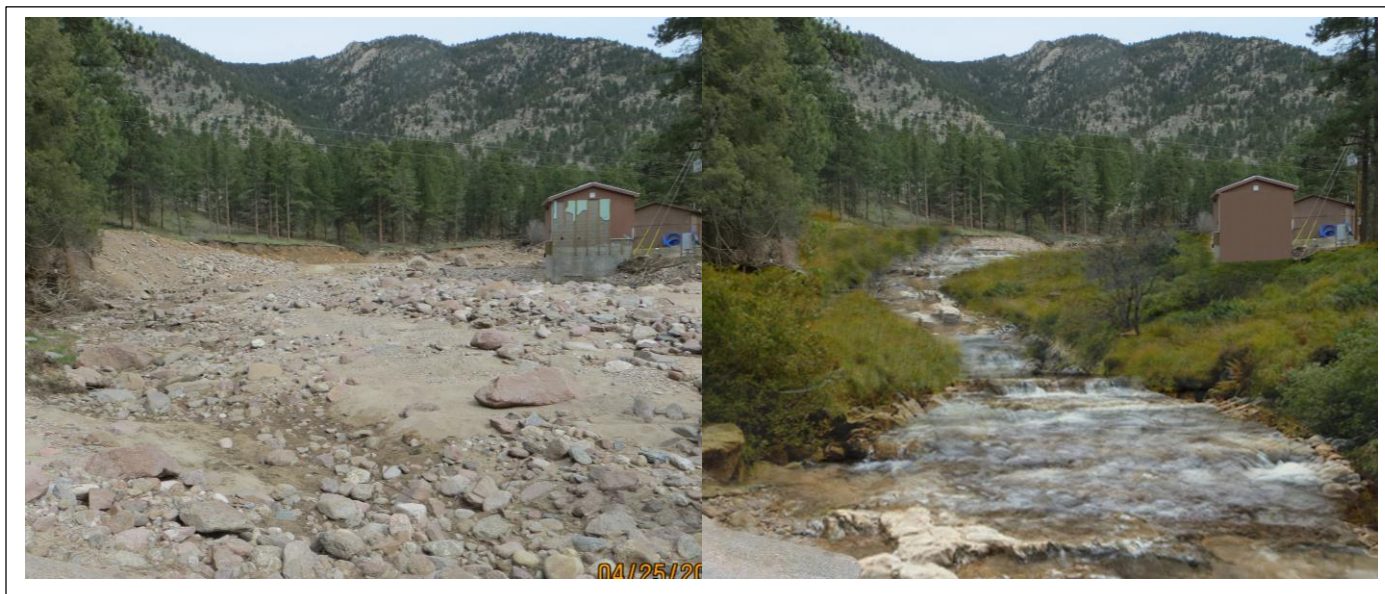
Figure 4.1. Simulation depicting active restoration on Little Thompson River near water treatment plant in Pinewood Springs, Colorado.

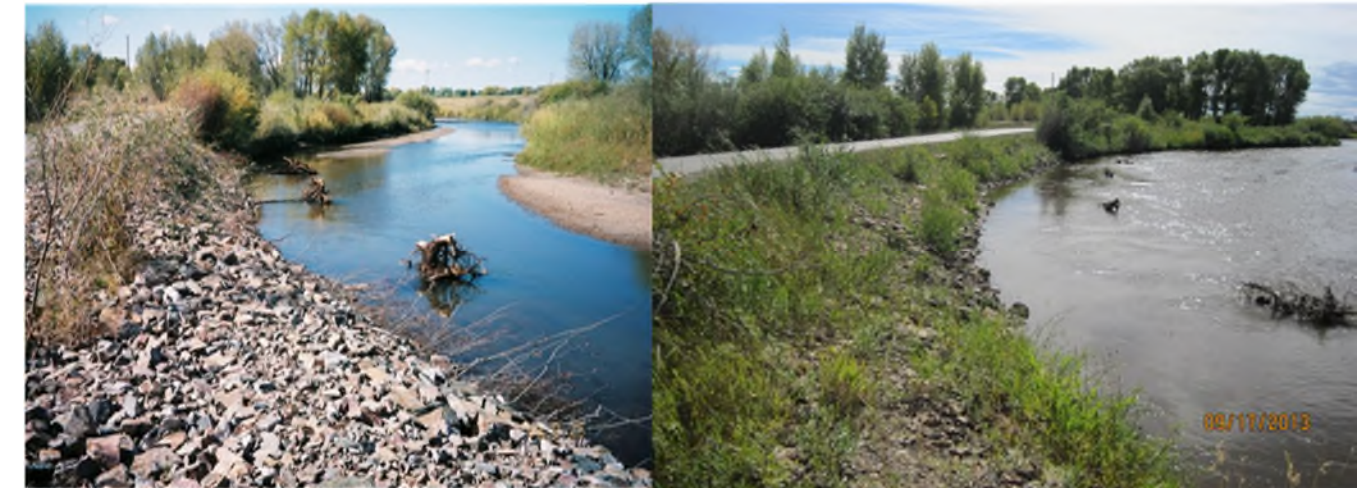
Rootwad revetment with scour toe protection and vegetated bank stabilization, Laramie, WY

Typical rootwad detail

Figure 4.6. Level 2 - Rootwad revetment with scour toe protection example.

Level 2 bank protection includes a range of bio-engineered techniques that typically combine some type of revegetation with scour toe protection to minimize the loss of the vegetation through scour failures while the vegetation becomes established. Level 2 protection could include rootwads with scour toe protection (**Figure 4.6**), coir-encapsulated deformable banks, and channel bend banks with scour toe protection. The two details in **Figure 4.7** include the use of coil encapsulated soil lifts with live willow plugs and scour toe protection. The coir fabric is a biodegradable material that requires about 3 to 5 years to degrade. The purpose of coir fabric lifts is to stabilize the newly constructed channel banks for a sufficient period of time to allow for the establishment of the vegetation, primarily willows, which will in turn provide stabilization with its roots and take over the role of bank stabilization. As the coir fabric degrades, the banks will lose some of the soil immediately under the willow layers, which in turn simulates an undercut bank (hence the term deformable) and creates an undercut bank. Level 3 includes bank construction with native bed material, planting live willow layering, and grading and seeding in the overbank. Level 3 bank protection also includes the use of rootwads without the scour toe protection (**Figure 4.8**).

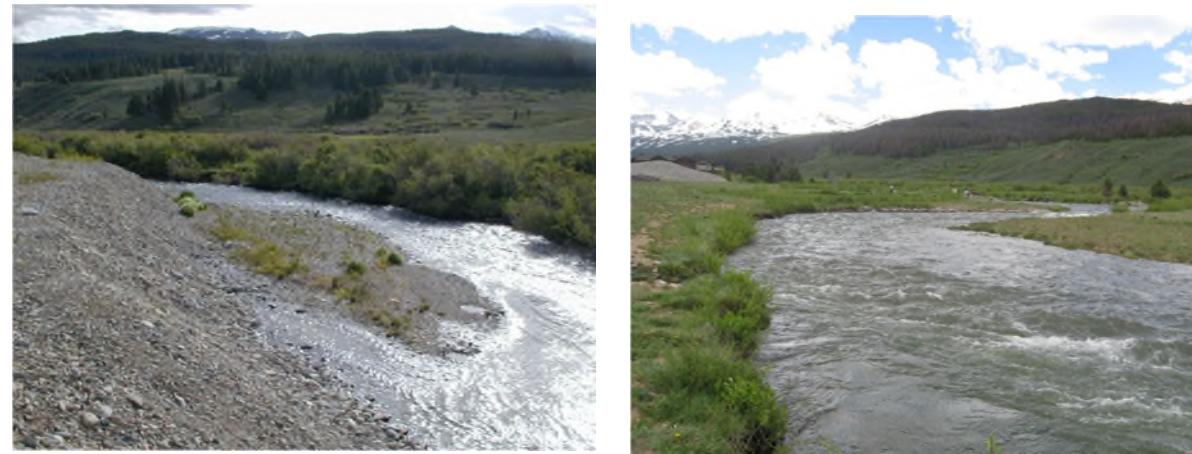
Before and after pictures of deformable bank construction along the Blue River in Summit County Colorado

Figure 4.7. Level 2 - Deformable bank examples.
