Prepared for OURAY COUNTY AND THE COLORADO WATER CONSERVATION BOARD By AS CONSULTANTS, INC. Montrose, Colorado April ,1978

FLOODPLAIN INFORMATION REPORT

UNCOMPANGRE RIVER OURAY TO DALLAS CREEK Ouray County, Colorado

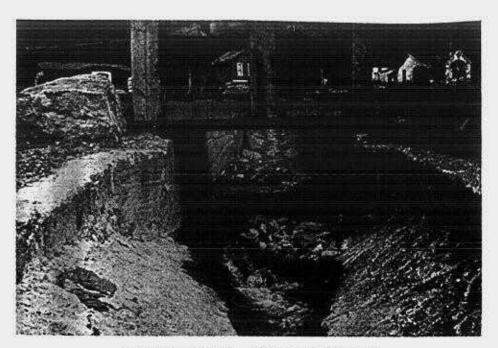
CASCADE CREEK - CONCRETE FLUME

The following pictures show the Uncompangre River stream character at several points.

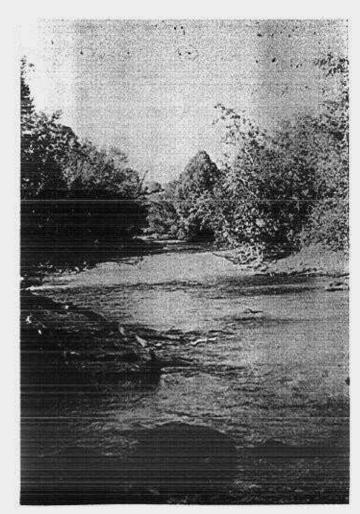
UNCOMPANGRE CHANNEL NEAR DALLAS TOWNSITE - STATION 10+

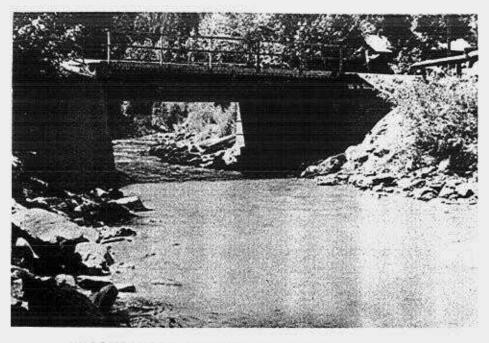
UNCOMPANGRE CHANNEL AT 7th STREET BRIDGE

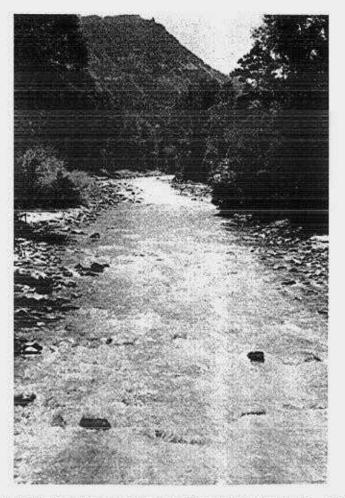
UNCOMPANGRE CHANNEL NEAR PORTLAND TOWNSITE - STATION 510+

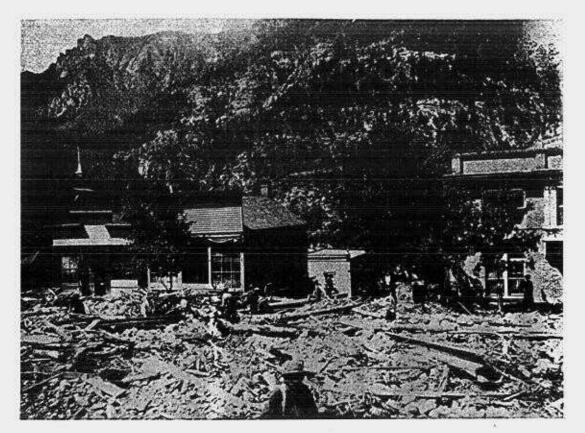
OURAY - 1909 - PORTLAND CREEK

The 1909 flood was given the following headline in the August 23rd Montrose Daily Press. "Flood of Water Almost Wipes Town of Ouray Off Map, Cloudburst Which Eclipsed All Previous Ones Does Immense Damage." The August 26th Montrose Enterprise reported "the cloudburst which took place above Ouray last Sunday was responsible for damages estimated at \$50,000. That portion of the city adjacent to the Portland Creek channel which extends east and west through the town between Fourth and Fifth Avenues was damaged the worst, although the flood extended down First, Second and Third Streets as far as Sixth Avenue." Photographs, compliments of Mr. and Mrs. Marvin Gregory, vividly portray the damage inflicted by this storm. Following this flood, concrete "flumes" were constructed to improve the capacity and, hopefully, confine the flow of both Cascade and Portland Creeks through the Town of Ouray. These flumes replaced the severely damaged wooden flumes which had been installed sometime earlier in an effort to restrict the streams flow and prevent their natural wanderings over the cumulative alluvial fans on which much of Ouray has been built.

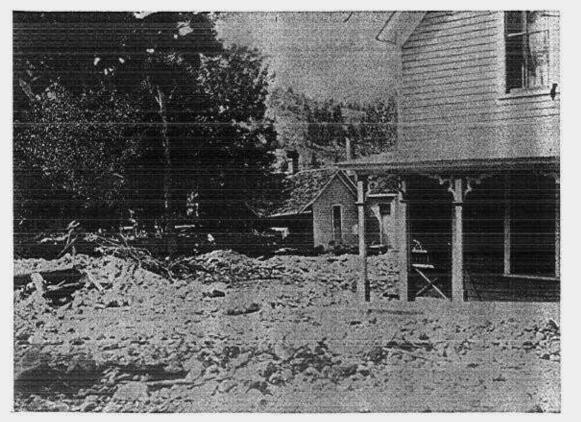
OURAY - 1909 - PORTLAND CREEK

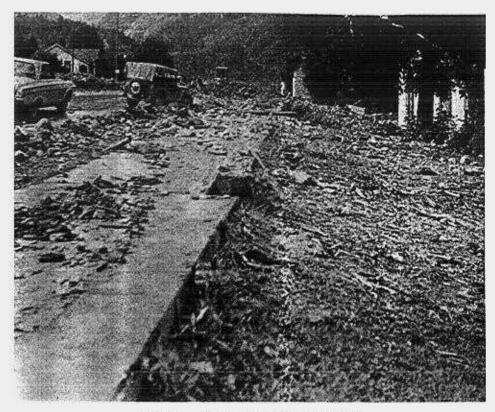
OURAY - 1952 - CASCADE CREEK

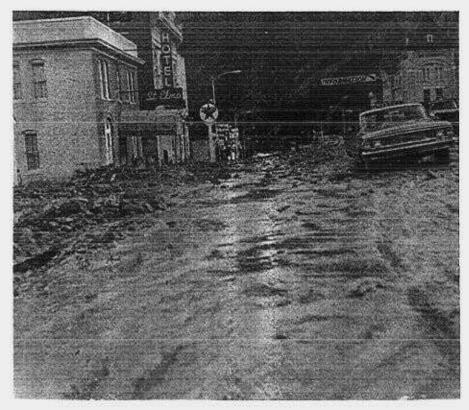
OURAY - 1965 - PORTLAND CREEK
