SELF-RESTORING BARRIER (SERB)
GUARDRAIL
DEMONSTRATION PROJECT NO. 939

Initial Report
August, 1983

INITIAL REPORT
SELF RESTORING BARRIER
(SERB)

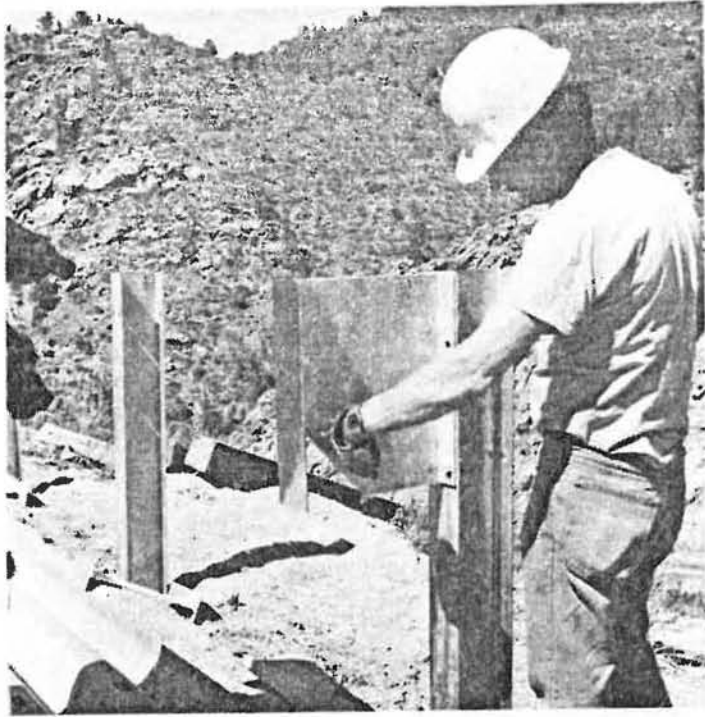
5. M 14 X 17.2 Spacer is attached to the W 6 X 9 steel post for the modified thrie beam guard rail.

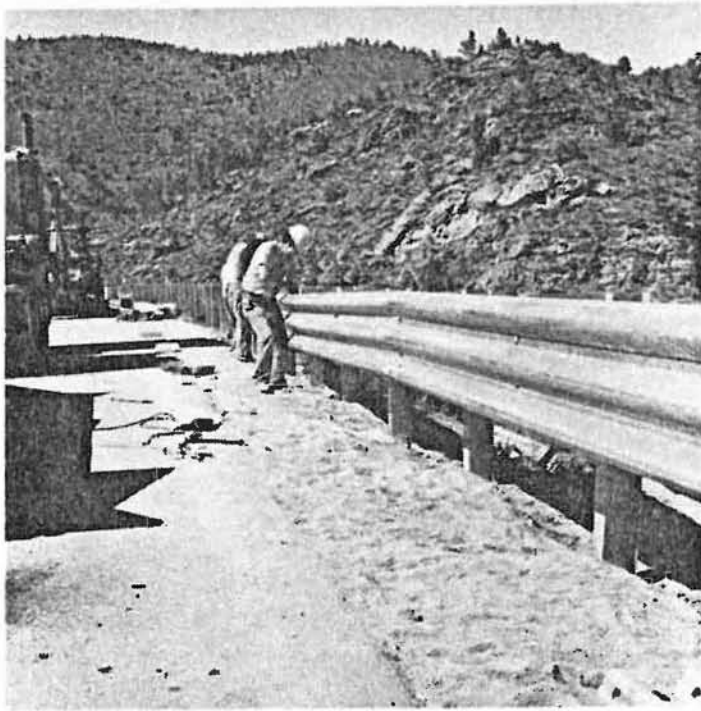
6. The thrie beam is attached to the spacer. One 5/8 in. bolt is used.

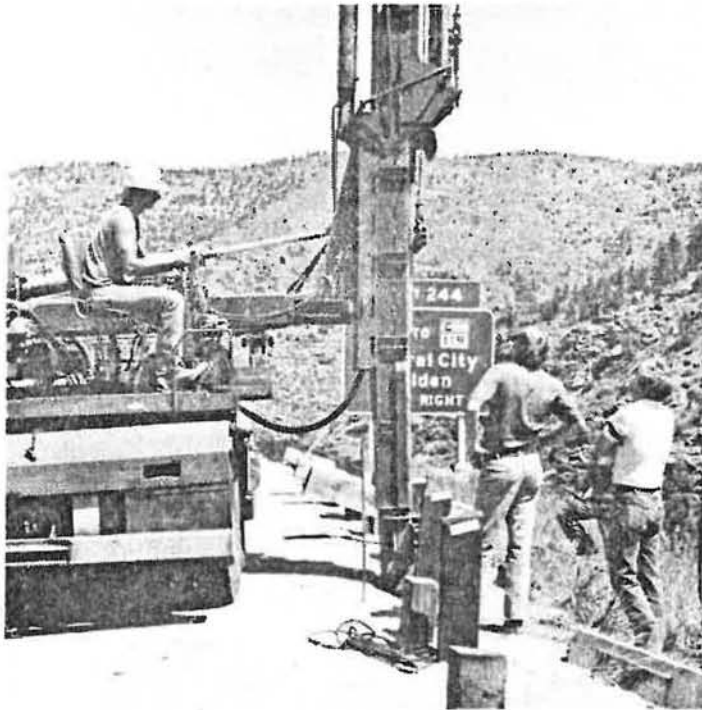
9. PDE 1500 post driver was used to set the wood posts for the SERB.

A major installation problem was placing the 10"x10"x10' wood posts. A PDE 1500 post driver was the largest available to the contractor. The fill area where the posts were to be set contained rocks and boulders of various sizes. The PDE hammer was used to pre-punch a pilot hole about 5' deep. Then the post was set under the hammer and the post was pounded down. The initial few posts were driven satisfactorily. Other posts were stopped or skewed when large boulders were encountered when driving the posts. See photo 16 of sample boulder removed from a post hole. Predrilling of the post holes was considered, but because of the large boulders in the soil and the loose fill material this was not attempted. Skewing of posts resulted in alignment offset of up to 4" between post center line and pivot bar mounting holes.

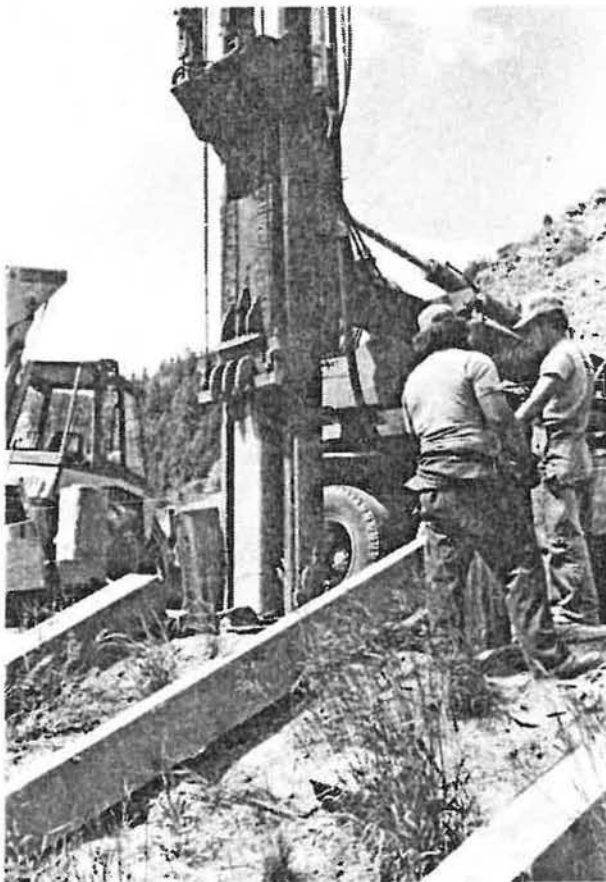
10. The PDE hammer was used to punch a pilot hole about 5' deep to facilitate driving the wood posts.

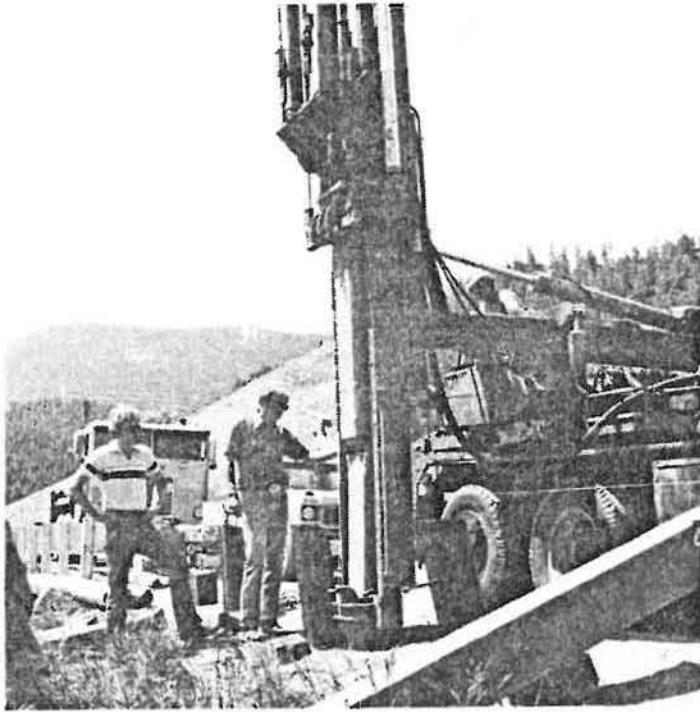
11. The post driver is shown driving a wood post. Due to damage to top of post, subsequent posts were driven using a steel cap on the top of the post.

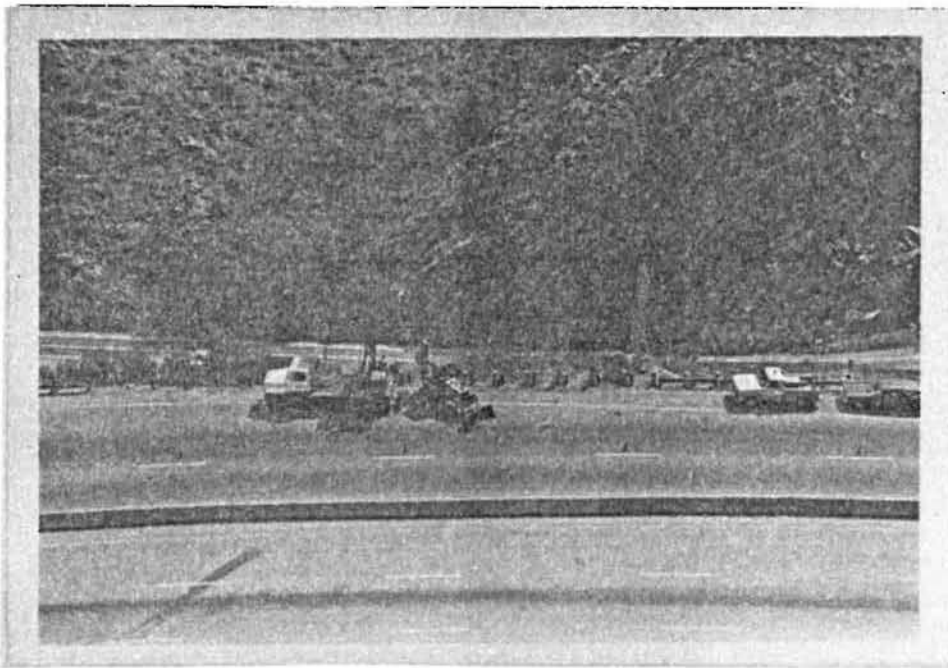
12. View showing equipment in use at site. The back hoe is used to lift the wood posts and position them under the post driver hammer.

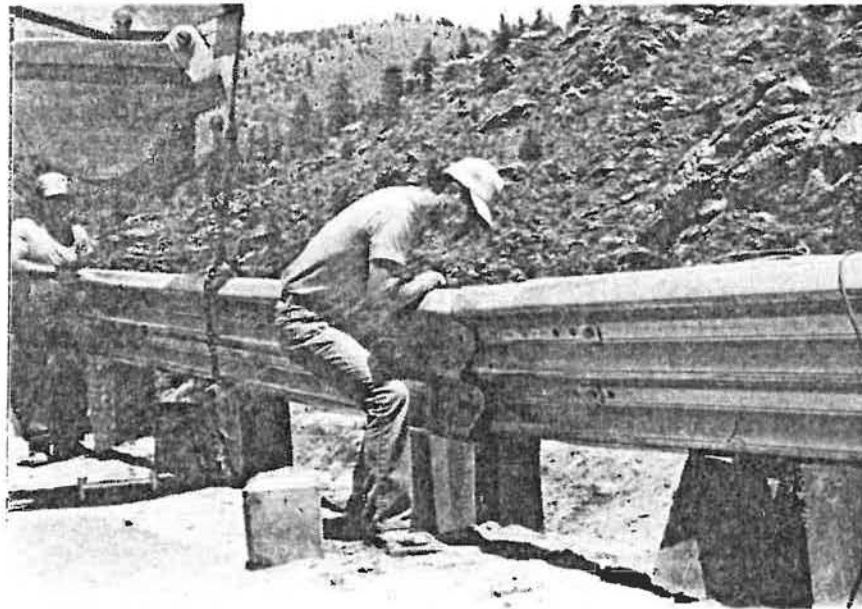
13. Back hoe being used to support tubular thrie beam as the beam sections are being joined.

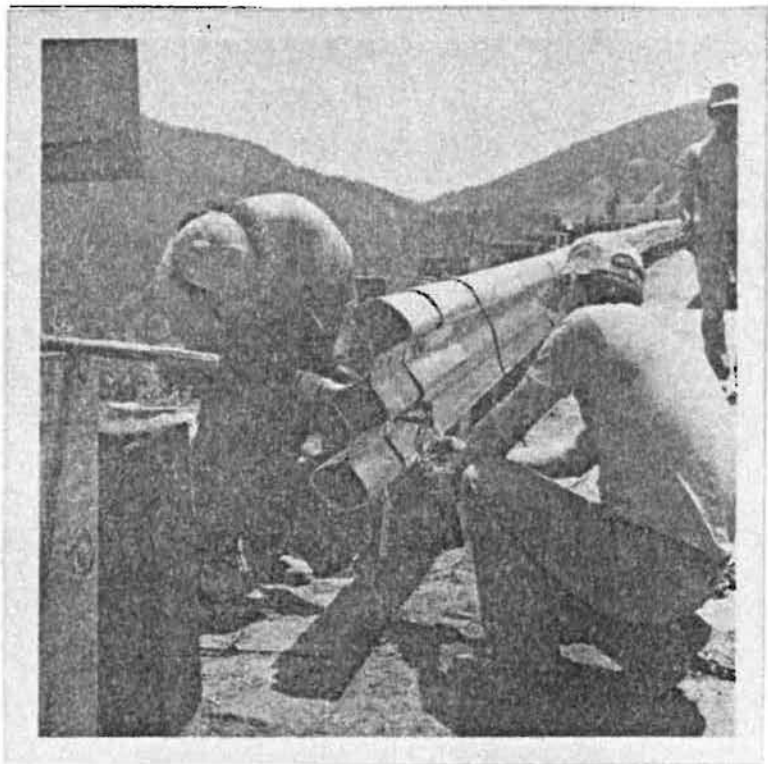
14. Straight internal splice sections were used to connect the tubular thrie beam sections.

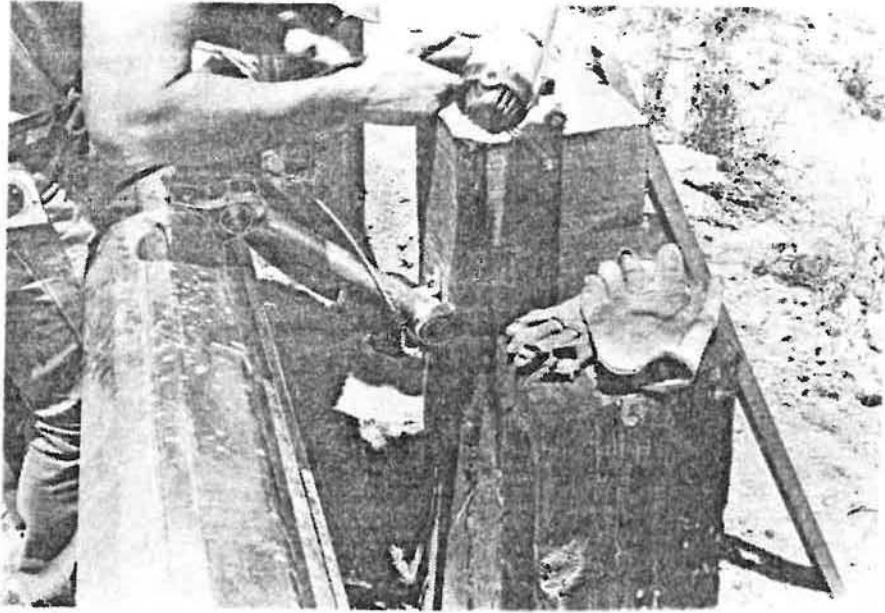
15. The pivot bar is shown being attached to the wood post using lag screws. The support cable will be attached last to hold the tubular thrie beam at the proper height.

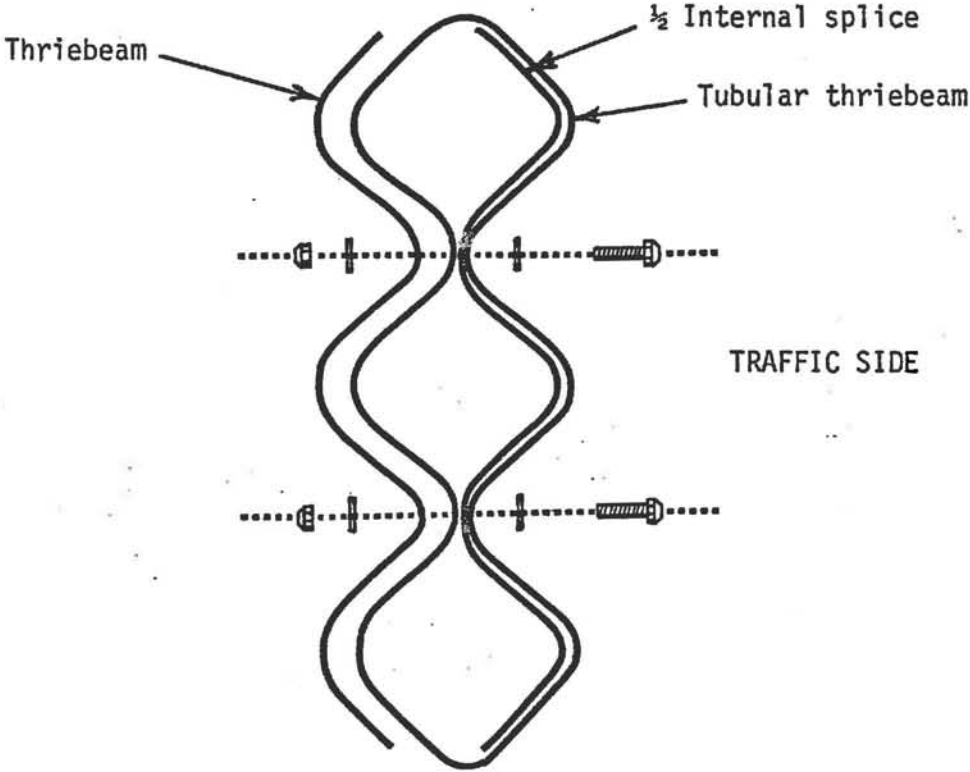
Proposed splice for repair of SERB

One end of the new tubular thrie beam section is connected in the usual manner using a normal internal splice piece. The remaining connection is made using one-half of an internal splice and a two foot section of thrie beam. The cross section sketch on Page B-3 shows the position of the components in place.

① A straight internal splice piece is cut at the top and bottom and one piece (1/2 splice) is used for the internal part of the splice. ② A two foot section of thrie beam, with connecting bolt holes to match the splice piece is used for the back piece of the splice.

To complete the splice, ③ the internal piece is inserted completely into the fixed section of SERB with a length of wire loop attached. ④ This wire is led back through the new section of tubular thrie beam and out through a connecting
