report no. CDOH-DTP-R-85-15

MONITORING THE TWO-PHASE WALL SYSTEM

INTERIM REPORT
March 1986

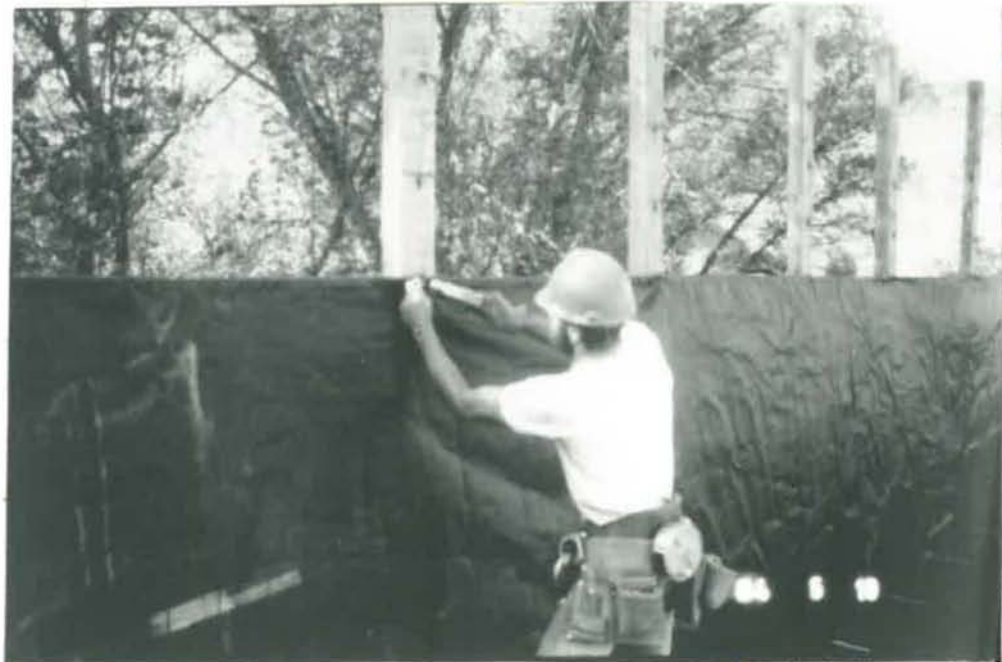
FIGURE 3 - NAILING THE REQUIRED GEOTEXTILE FABRIC TO THE FASCIAL WOODEN FRAME

Figures 2 through 8 show the erection of the reinforced earth-wall with the temporary facing. The actual plans and specifications on the temporary wall facing are presented in Appendix A.

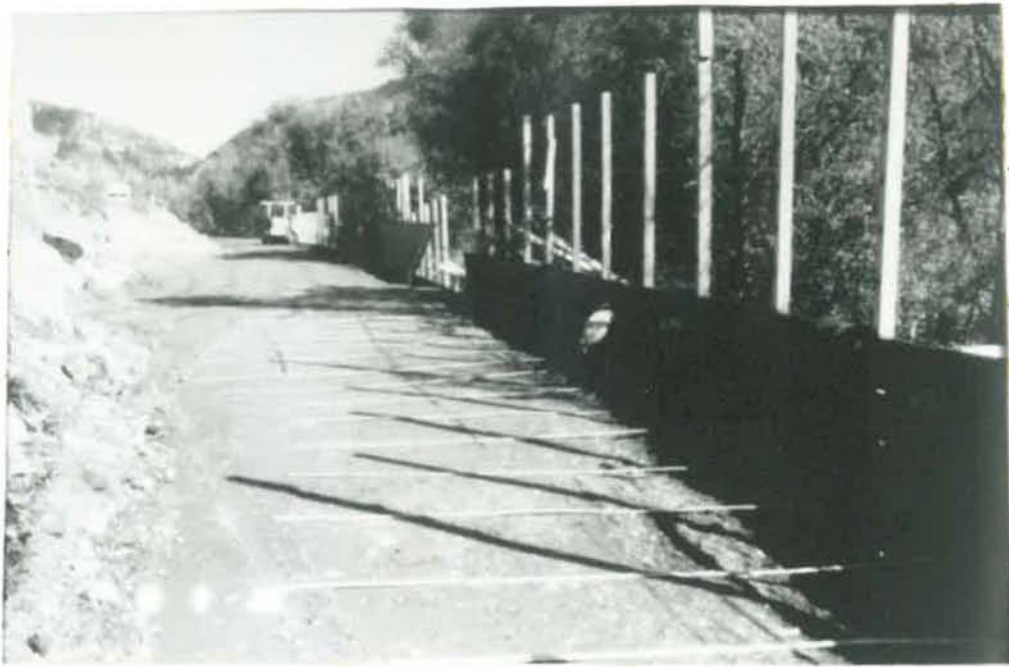
**FIGURE 4 - PLACING A LAYER OF REINFORCEMENT STRIPS AND
CONNECTING THEM TO THE TEMPORARY FACING**

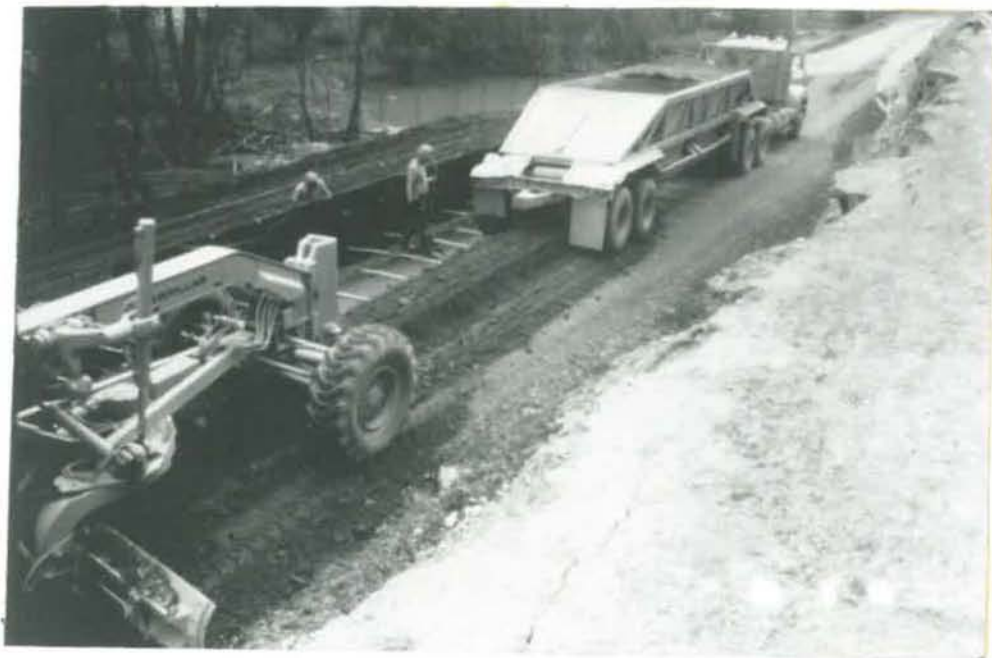
**FIGURE 5 - PLACING BACKFILL SOIL TO COVER THE
REINFORCING STRIPS**

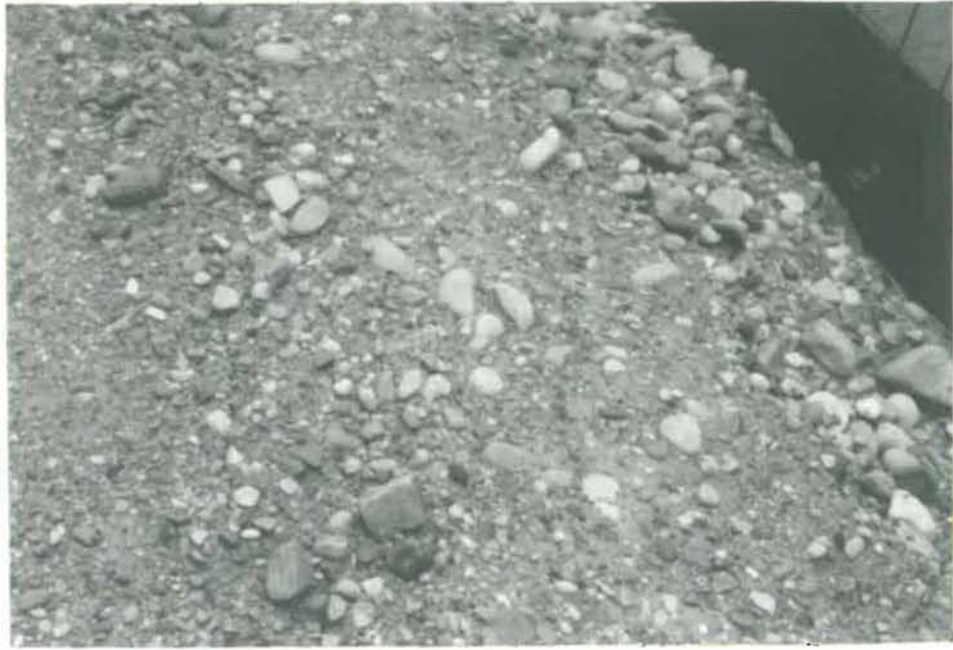
FIGURE 6 - CLOSE UP OF THE BACKFILL MATERIAL

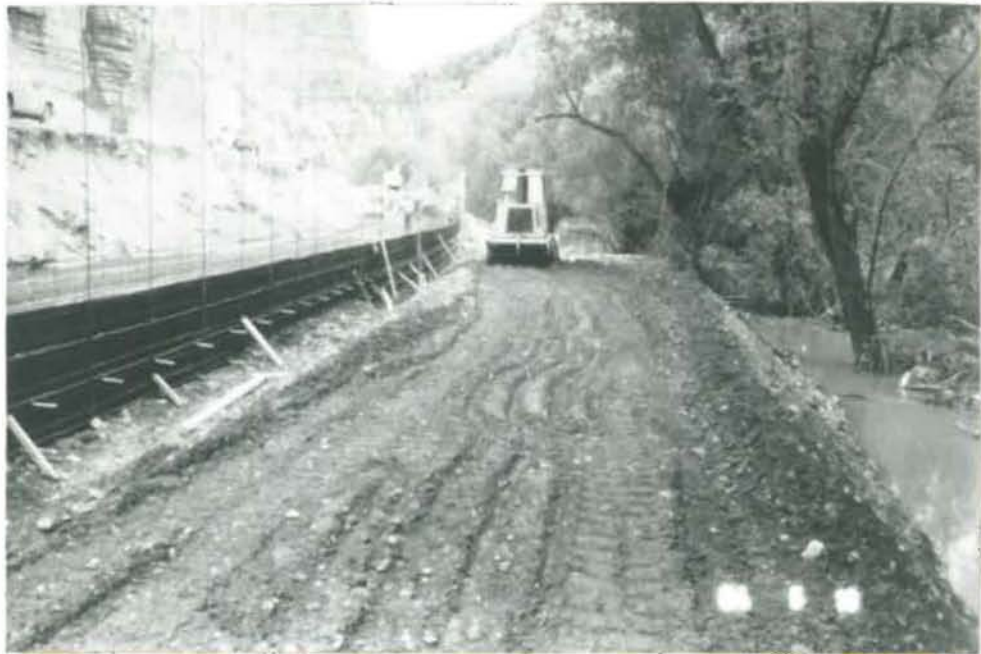
FIGURE 7 - COMPACTING THE SOIL PLACED IN FRONT OF THE REINFORCED EARTH WALL TO PROVIDE STABILITY AND THE NECESSARY AREA FOR THE FUTURE BIKE-PATH PLATFORM.

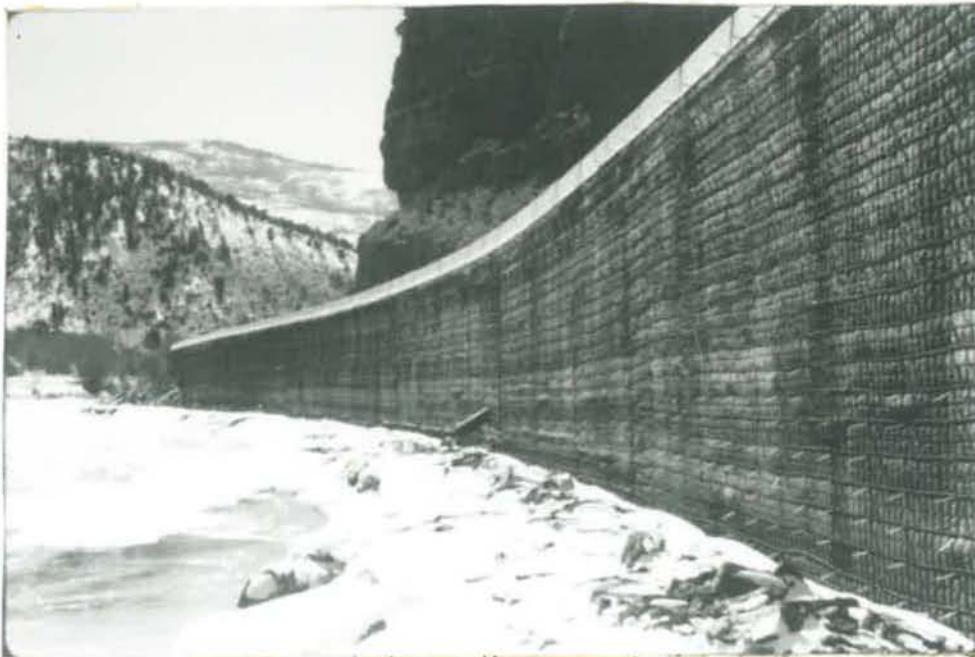
FIGURE 8 - COMPLETED WALL AT THE END OF PHASE ONE CONSTRUCTION. THE TEMPORARY FACING IS CLEARLY ILLUSTRATED.

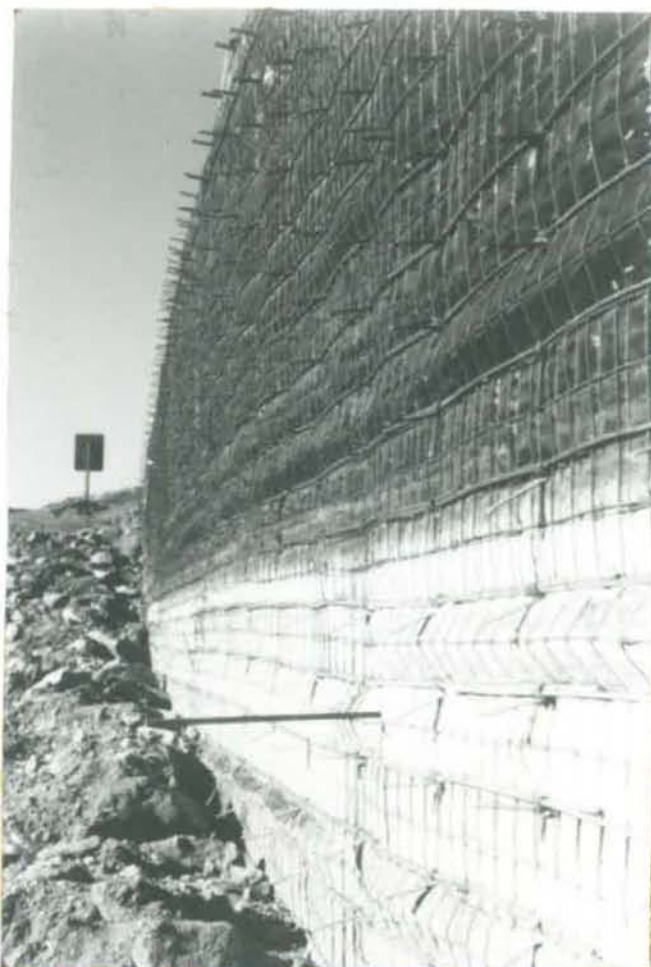
FIGURE 9 - REBARS STICKING OUT OF THE REINFORCED EARTH WALLS WERE USED AS SURVEY STATIONS

Settlements were measured by standard surveying techniques. Eight survey stations, as shown in table one, were used to monitor two 300-ft. sections of the wall. Survey readings were initiated when backfill was at the 17-ft. high level. Readings have been taken with frequency diminishing from three times per week to four times per year. Figure 9 shows one of the survey stations used in this project.

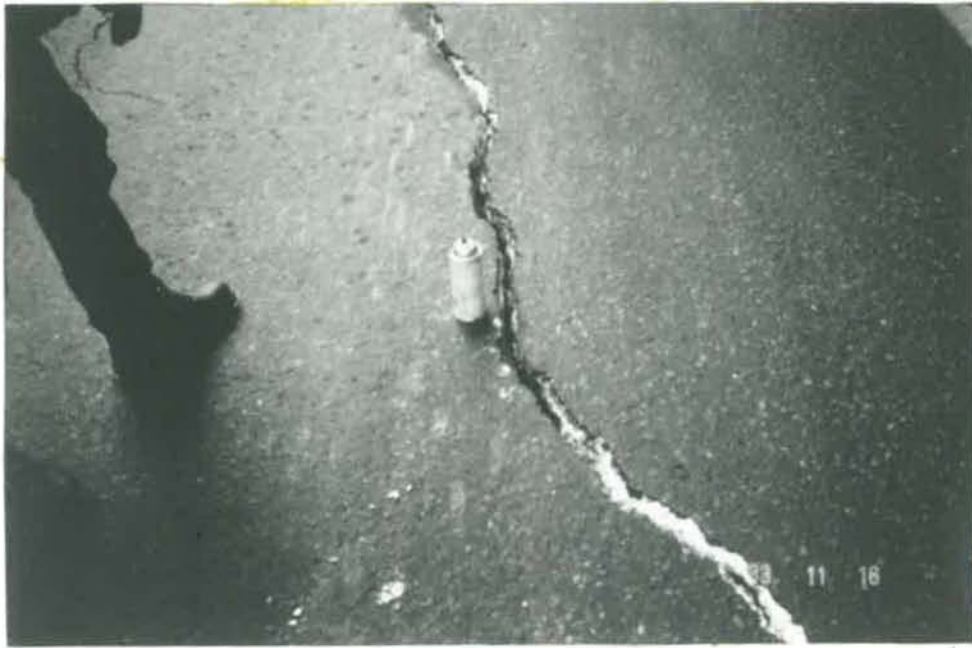
FIGURE 13 - CLOSE UP VIEW OF THE PAVEMENT CRACKS

The road on top of the reinforced earth wall was immediately paved upon completion of the retaining structure. The road was then opened to public to avoid any traffic congestion in the east end of the canyon. Some pavement cracks, as shown in Figures 13 and 14, were observed shortly after completion of the wall. These cracks were attributed to the differential settlements of the retaining structure and were patched immediately. According to survey data, the primary settlements across the wall profile have ceased and most likely secondary consolidation will occur in the future. These settlements are expected to be too small to damage the wall or the present pavement.

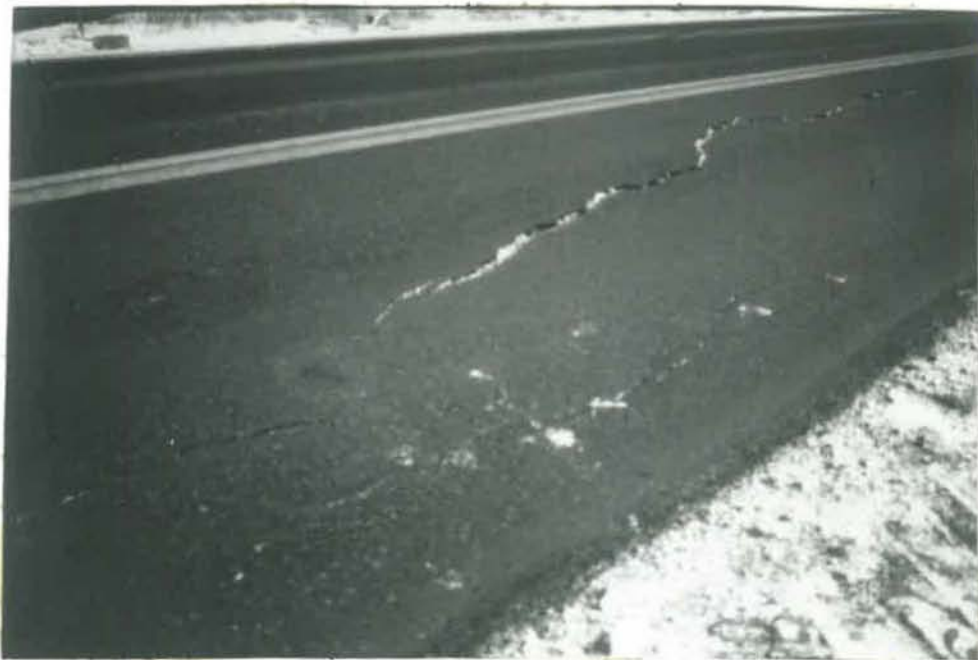
FIGURE 14 - PAVEMENT LONGITUDINAL CRACKS ON TOP OF THE TWO PHASE WALLS
