CITY OF LAMAR, COLORADO  
CULTURAL RESOURCE SURVEY

SHF PROJECT # 2010-M1-013

## Architectural & Historical Survey Report

History Colorado - State Historical Fund  
Project Number 2010-M1-013  
Project Deliverable #8

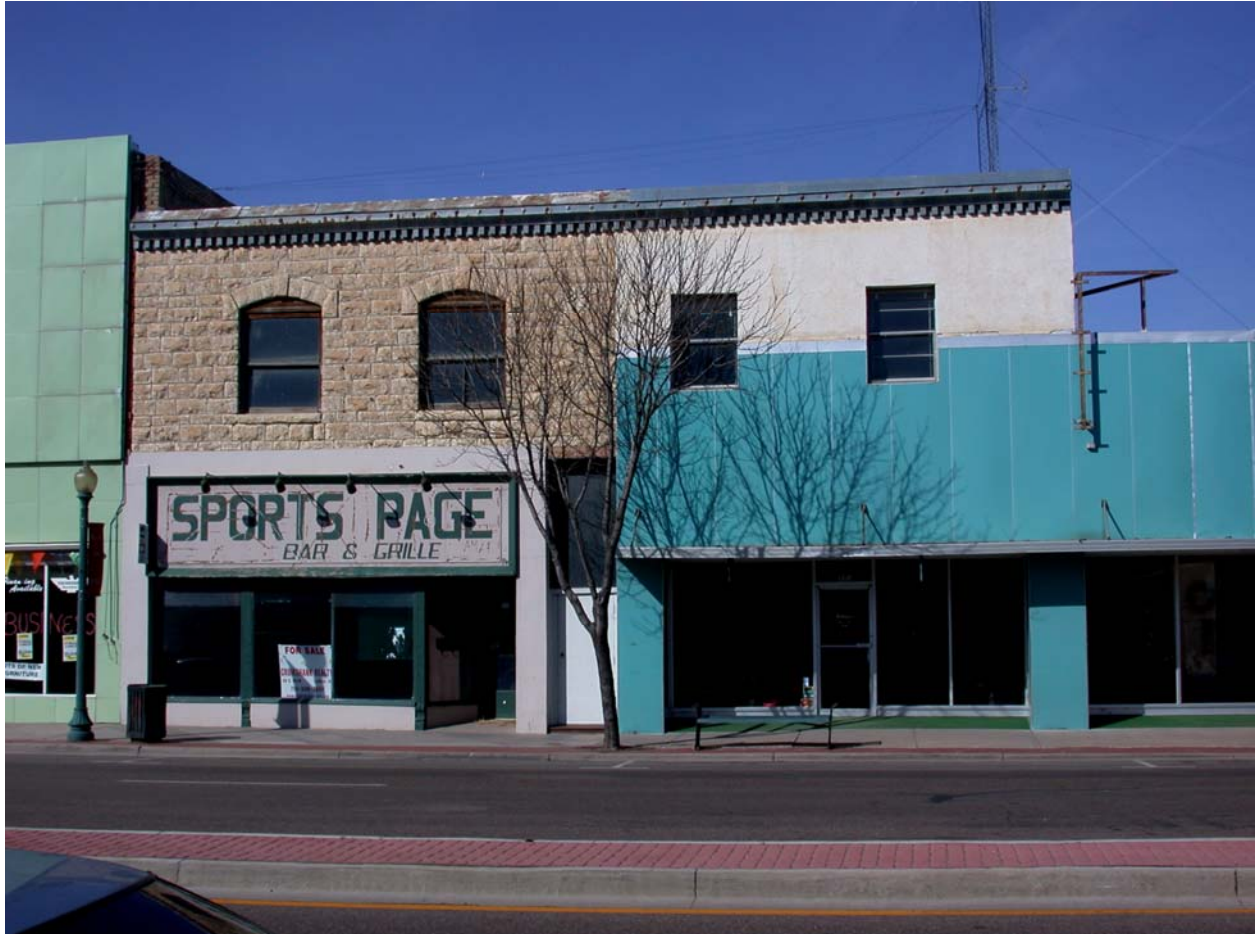
**Figure 18.**

**NOW:** The building at 112-114 South Main Street (5PW.337 – 5PW.338), known as the Pike and Deeter Block. The addition of metal siding and stucco to the exterior walls, the replacement of the first floor storefront with an anodized aluminum framing system, and the reduction in size of the second floor window openings at 112 South Main Street (5PW.337) was possible because each half of the building is separately owned.

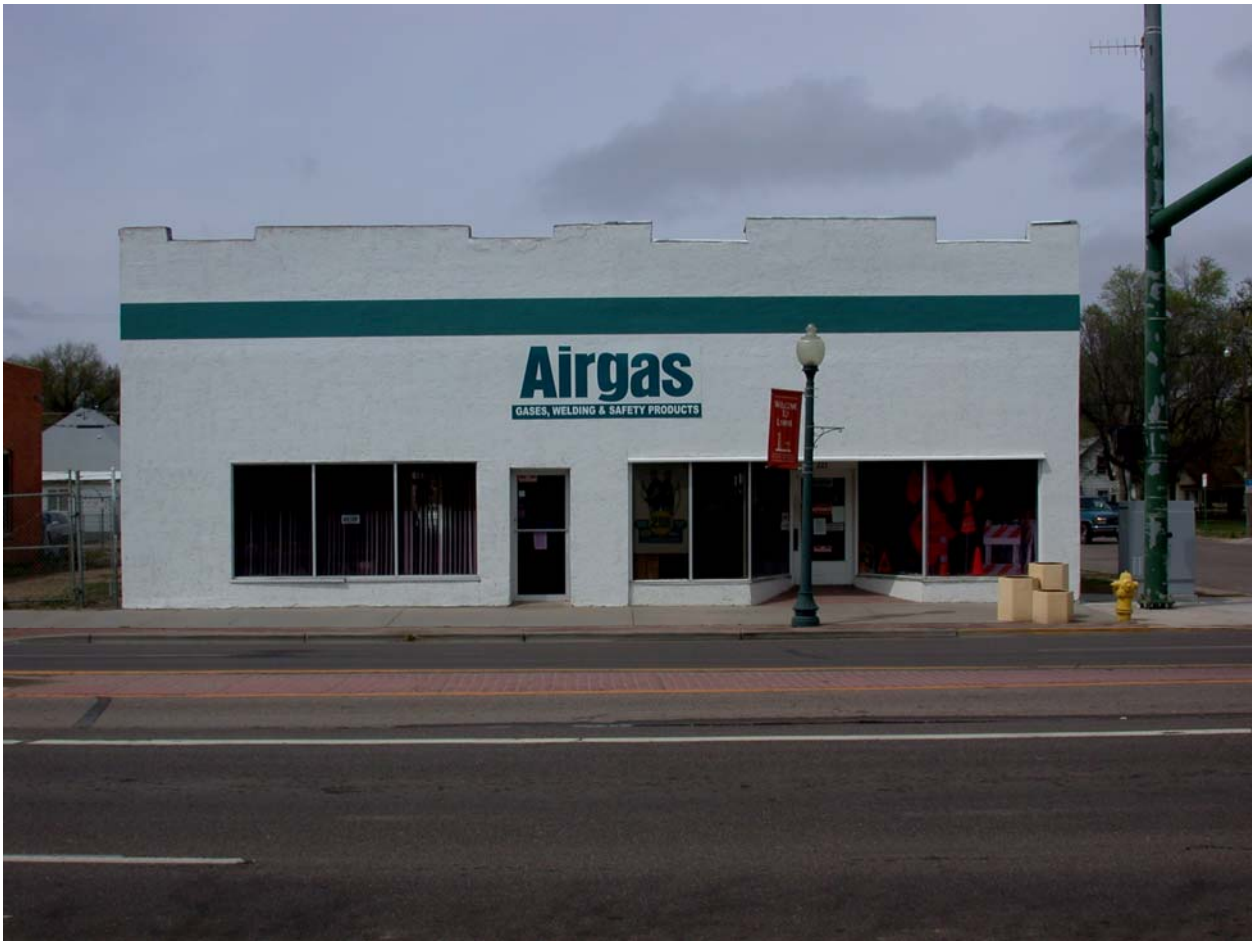
**Figure 20.**  
**NOW:** The original stepped parapet remains at 223 North Main Street (5PW.301) but the building’s other original architectural features from its circa 1931 construction have been modified as seen in Figure 19.

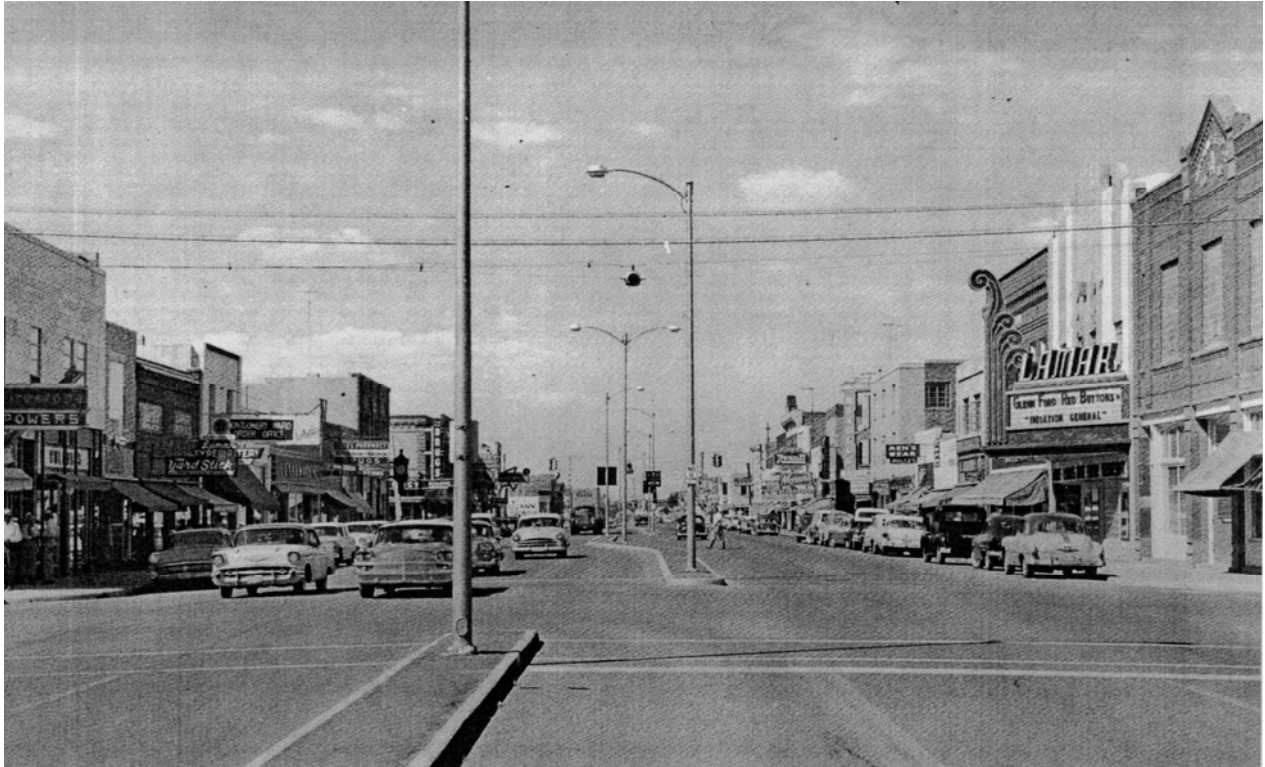
**Figure 21.**

The 200 block of South Main Street was featured on the cover of the 59<sup>th</sup> Annual Convention of the Colorado State Council in April of 1960. The storefronts remain intact on both sides of the street, indicating that many of the building alterations seen today occurred sometime after 1960.
