Report No. CDOT-2007-2
Final Report

SERVICE LIFE AND COST COMPARISONS FOR FOUR TYPES OF CDOT BRIDGE DECKS

September 2007

COLORADO DEPARTMENT OF TRANSPORTATION
RESEARCH BRANCH

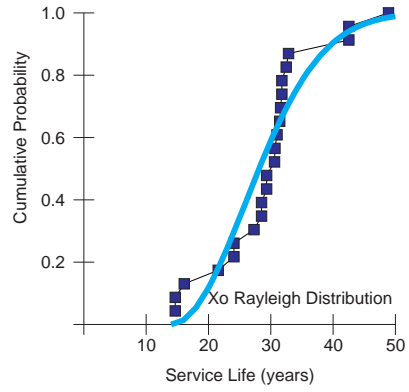
Figure 8 - Element 23 Service Life Distributions

Element 23 - Epoxy-Coated Steel, Penetrating Sealers

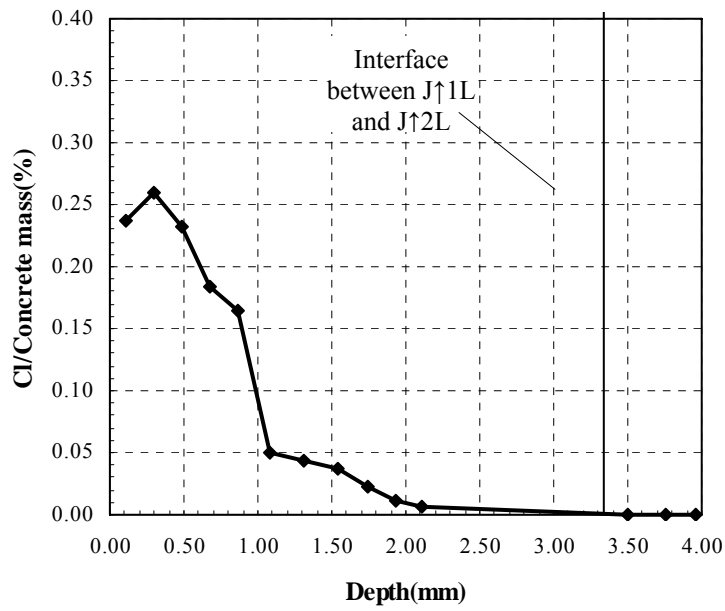
Figure 16 - Chloride Profile in Concrete Core J↑1L and J↑2L
