Report No. CDOT-DTD-R-2003-13 Final Report

# STUDIES ON THE USE OF HIGH-PERFORMANCE CONCRETE AND FRP REINFORCEMENT FOR THE I-225/PARKER ROAD BRIDGE

P. Benson Shing Yunping Xi

COLORADO DEPARTMENT OF TRANSPORTATION RESEARCH BRANCH

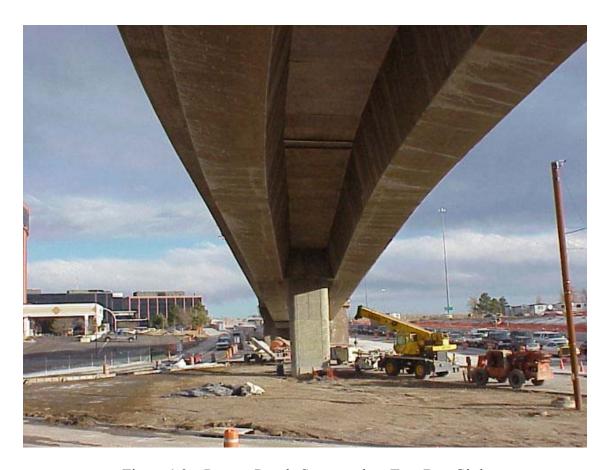
Figure 1.2 – Precast Panels Supported on Two Box Girders

The Colorado Department of Transportation (CDOT) recently completed a bridge structure at the I-225/Parker Road Interchange southeast of Denver using innovative construction materials. As shown in Figures 1.1 and 1.2, the bridge consists of post-tensioned cast-in-place reinforced concrete box girders with precast prestressed panels as stay-in-place forms and a cast-in-place topping slab for the deck. Part of the bridge deck was constructed of a crack resistant high-performance concrete (HPC) mix and fiber reinforced polymeric reinforcement (FRP) under the sponsorship of the Innovative Bridge Research and Construction (IBRC) program of the Federal Highway Administration (FHWA). The goal of this was to explore the use of innovative materials to prolong the life span of a bridge by reducing corrosion problems.

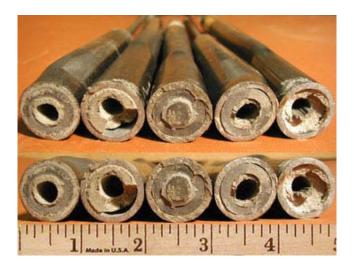
Figure 3.4 - Unconditioned CFRP Grip Failure

Figure 3.4 shows the failure of the carbon fiber bars near the grips. The cement binder did not provide adequate bond strength to prevent pullout from the anchorage before failure in the free-length of the specimen could occur. A supplementary anchorage system was designed using epoxy.

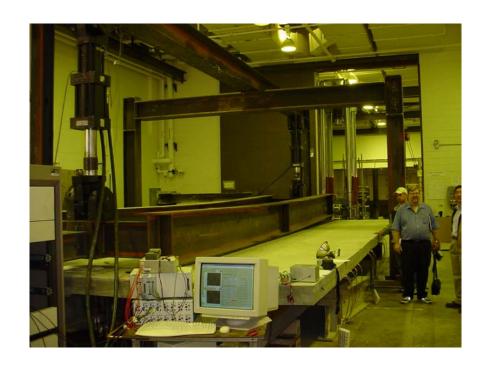
Figure 5.9 – Picture of Fatigue Test Setup

The dimensions of the curve beams were selected based on the footprint of an HS-25 truck tire and the 2/3-scale of the test deck. According to the AASHTO LRFD Specifications (AASHTO 1998), the tire area of an HS-25 truck is 20-in long and 18.6-in wide. This leads to a scaled tire area of 13.3 in x 12.4 in. For this reason, a 12.3-in-wide steel beam section was chosen. The radius of curvature of the beams was determined by the total stroke of the actuators, which was 10 in. The contact length between a curve beam and the surface of the deck was estimated with the elastic contact theory to be close to the scaled length of a tire. Since it depends on the beam curvature, bending stiffness of the beam, and the stiffness of the rubber pads, it is difficult to estimate the contact length in an accurate manner. The distance of the wheels in a single axle of an HS-25 truck is 6 ft. For a 2/3-scale model, this leads to a wheel spacing of 4 ft. However, a 5-ft spacing was chosen to impose a more severe loading condition on the deck. A picture of the test setup is shown in Figure 5.9.

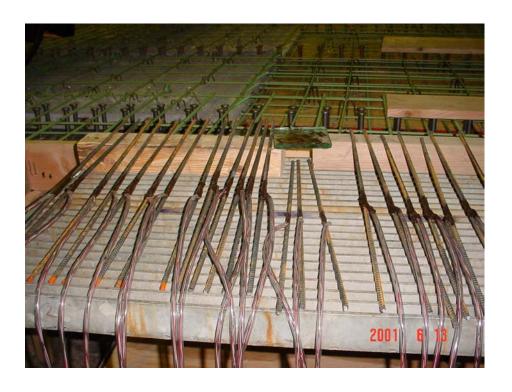
Figure 5.13 –Bars with Strain Gages
