Report No. CDOT-DTD-R-2005-10
Final Report

MONITORING THE RESPONSE OF A RIPARIAN ECOSYSTEM TO HYDROLOGIC RESTORATION

**COLORADO DEPARTMENT OF TRANSPORTATION
RESEARCH BRANCH**

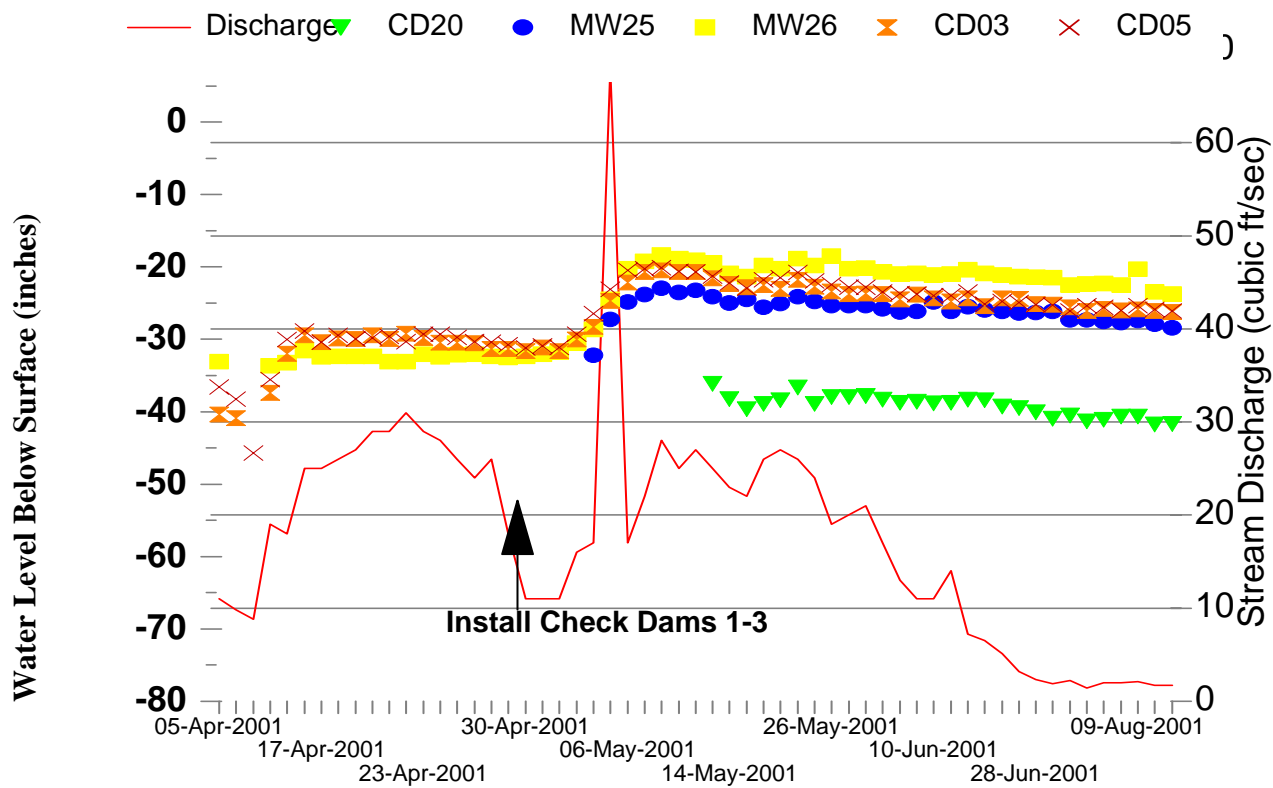
Figure 8. Groundwater Elevations Between Check Dams 2 and 3 with Stream Discharge, 2001 Growing Season, East Plum Creek, Douglas County, CO

Note: Groundwater levels rise after installation of CDs1-3 at nearly the same time of a peak in stream discharge in early May. But groundwater elevations remain elevated above 30 inches during the growing season even after stream discharge falls.

Unfortunately, the April-May 2001 trend could not be evaluated in non-dam areas because deeper wells in these locations had not yet been installed. However, once the spring storms had subsided, groundwater levels were observed to have stabilized at higher levels than prior to check dam installation (See Figure 8).
