# TIRE/PAVEMENT AND ENVIRONMENTAL TRAFFIC NOISE RESEARCH STUDY

# TIRE/PAVEMENT AND ENVIRONMENTAL TRAFFIC NOISE RESEARCH STUDY INTERIM REPORT – 2006 TESTING

Robert Otto Rasmussen, Ph.D., P.E. (TX)
Vice President & Chief Engineer
The Transtec Group, Inc.

Report No. CDOT-2008-2

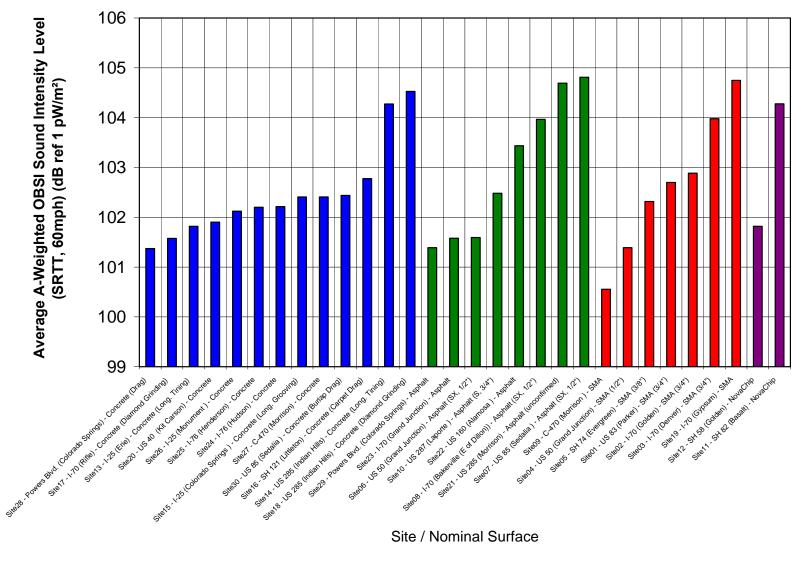
Figure 1. Summary of Estimated OBSI A-weighted SILUsing Aquatred III Tire (dB ref 1pW/m²).

A summary of the source data can also be found in Tables 3 and 4. Table 3 summarizes the CPX data (A-weighted Sound Pressure Level (SPL) in dB ref 20  $\mu$ Pa), and Table 4, the OBSI data (A-weighted Sound Intensity Level (SIL) in dB ref 1 pW/m²). It should be noted again that the standard tire for the OBSI testing is the SRTT; however, some testing using the Aquatred III tire was conducted for informational purposes. Table 5 contains a summary of the SPB wayside testing.

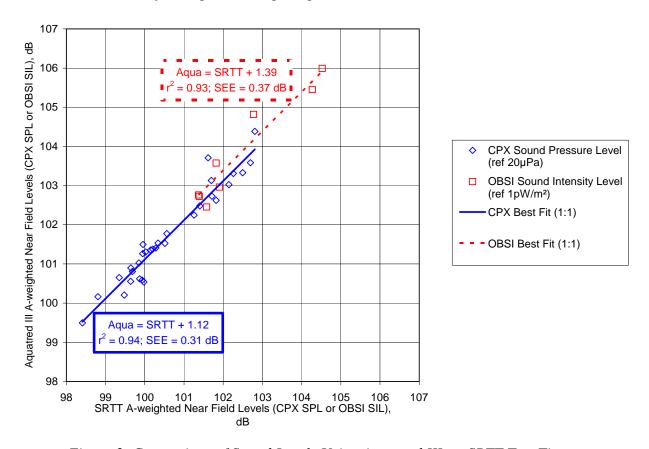
Using the information that has been collected to date, a comparison can be made of the average sound levels of the various test sections using the Aquatred III and SRTT tires. Figure 2 includes the trend that emerges. Two trend lines are drawn that separate this relationship between the CPX and OBSI techniques. In both cases, it can be noted that when the Aquatred III tire is used, the resulting sound level is approximately 1.1 to 1.4 dB higher than when the SRTT tire is used. The trends are also very strong, indicating a high correlation between these two tires.

Figure 2. Comparison of Sound Levels Using Aquatred III vs. SRTT Test Tires.

Based on the testing conducted to date, it is recommended that the SRTT test tire serve as the standard for all subsequent testing in Colorado under this study. The Goodyear Aquatred III is no longer in production, and while care is taken to protect the remaining test tires, changes in their properties are inevitable.

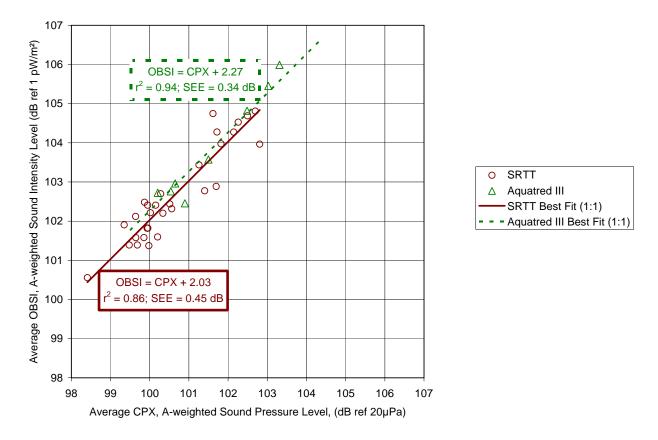
A second comparison could be made using the data to compare the average sound levels of each of the pavements as measured using the two source techniques: CPX and OBSI. In both cases, this comparison is separated by tire type; the resulting trends can be seen in Figure 3. Here as

well, a strong relationship can be noted, indicating a correlation between these two measurement techniques, as expected.

Figure 3. Comparison of Sound Levels from the OBSI and CPX MeasurementTechniques.

It is also recommended that all future source testing be conducted using OBSI. This will allow more robust analyses to be conducted in future years due to the increased testing efficiency. It also appears now that the OBSI technique will become the standard for tire-pavement noise testing in the USA.

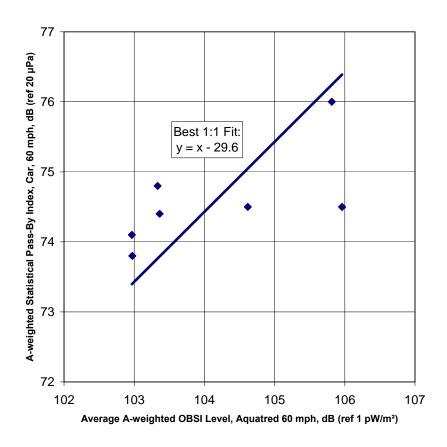
A comparison can be made of the SPBI levels for cars and the corresponding estimated average OBSI levels using an Aquatred III tire at 60 mph. This is shown in Figure 4. At first glance from this plot, the relationship is rather weak. However, when forcing a best-fit 1:1 slope, the offset is 29.6 dBA, which is comparable to reported offsets of controlled pass-by (CPB) data compared to corresponding OBSI data. Dr. Paul Donavan of Illingworth & Rodkin has reported that offset to be 30.4 dBA. Iowa State University has calculated an offset of 29.5 dBA based on its database.

Figure 4. Comparison of OBSI and SPBI Levels.

Finally, it is recommended that all subsequent testing continue to be conducted at both the source and wayside. The relationship between these measurements is simply too weak to rely on one to correlate to the other. This recommendation is in line with recommendations made by experts both in the USA and abroad. In addition, every effort will be made to conduct the environmental wayside measurements in the subsequent testing periods.

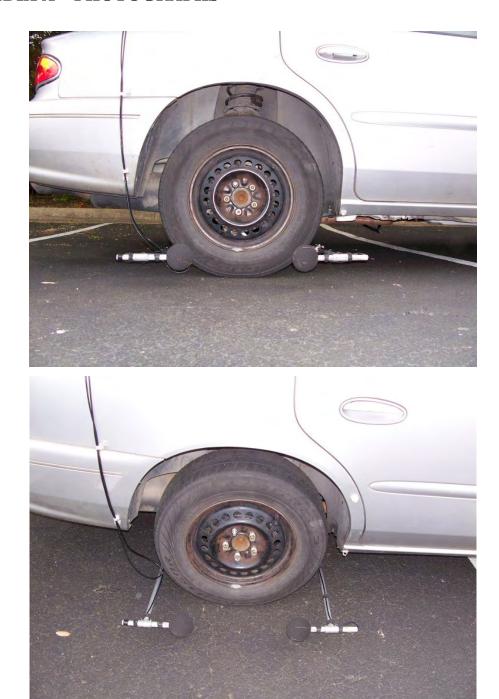
Figure A.1. CPX Measurement Bracket Configuration.

Photographs of some of the test equipment can be found in Appendix A. Additional details for each site, along with the types of measurements collected in 2006 are listed in Table 2.

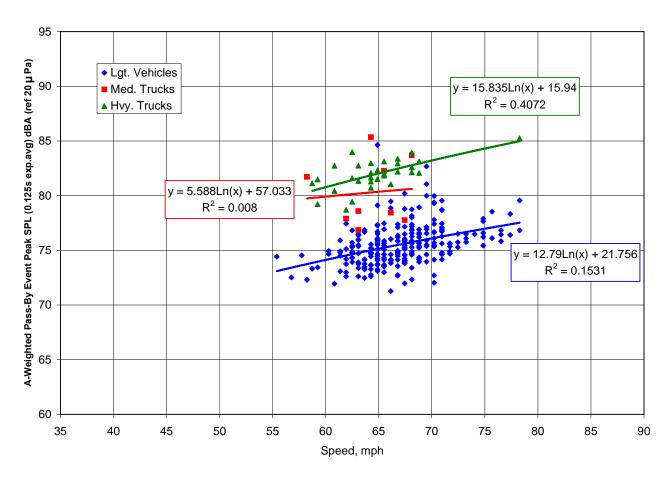
Site: 04 SPB Wayside Test Information

SPBI (Car, 60mph):
 74.1 dBA

SPBI (M. Truck, 60mph):
 79.9 dBA

SPBI (H. Truck, 60mph):
 80.8 dBA

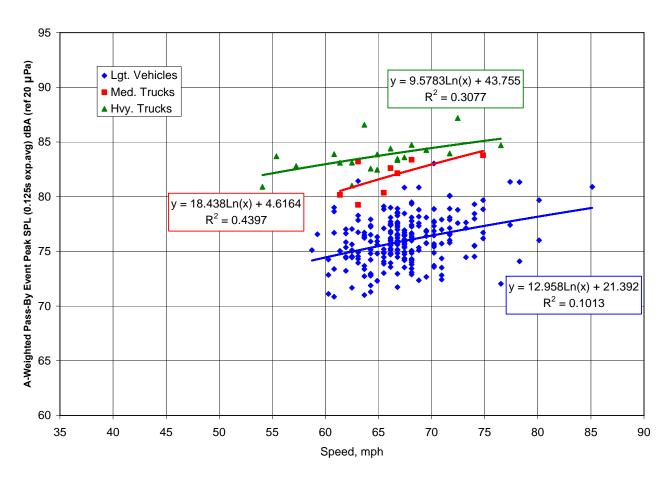
Site: 06 SPB Wayside Test Information

SPBI (Car, 60mph):
 74.4 dBA

SPBI (M. Truck, 60mph):
 80.1 dBA

SPBI (H. Truck, 60mph):
 83.0 dBA

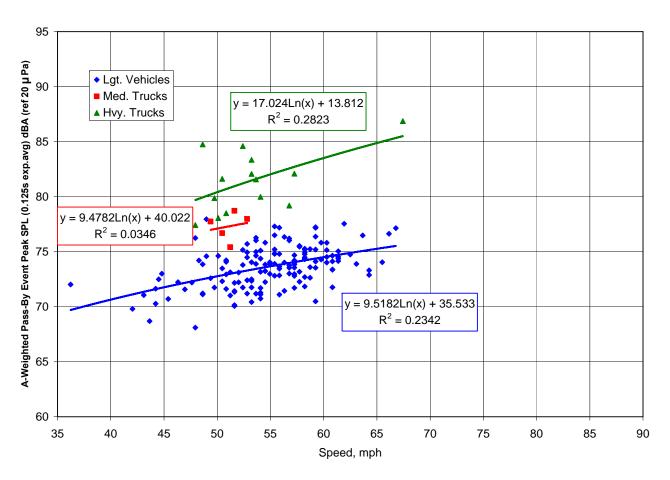
Site: 07 SPB Wayside Test Information

SPBI (Car, 60mph):
 74.5 dBA

SPBI (M. Truck, 60mph):
 78.8 dBA

SPBI (H. Truck, 60mph):
 83.5 dBA

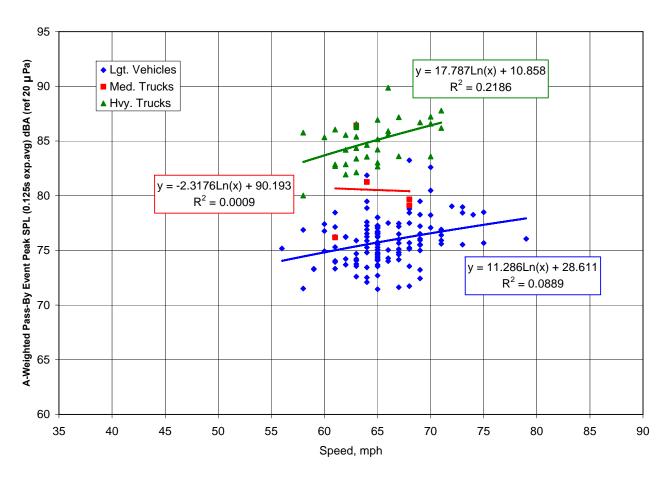
Site: 10 SPB Wayside Test Information

SPBI (Car, 60mph):
 74.8 dBA

SPBI (M. Truck, 60mph):
 80.7 dBA

SPBI (H. Truck, 60mph):
 83.7 dBA

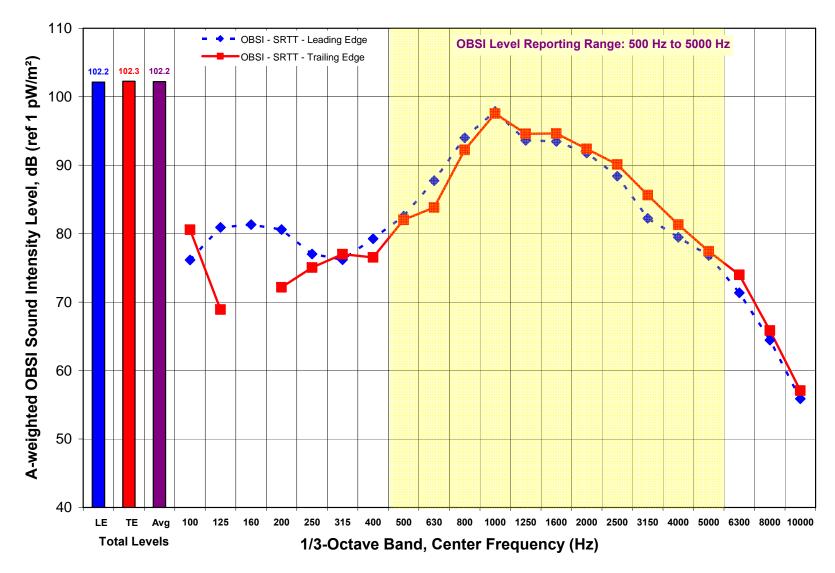
Site: 24 OBSI Test Information

Note: Break in data for OBSI trailing edge is the result of negative intensity calculation at this frequency.
