**Report No. CDOT-DTD-R-2005-22**  
**Final Report**

# **PCCP TEXTURING METHODS**

**COLORADO DEPARTMENT OF TRANSPORTATION**  
**RESEARCH BRANCH**

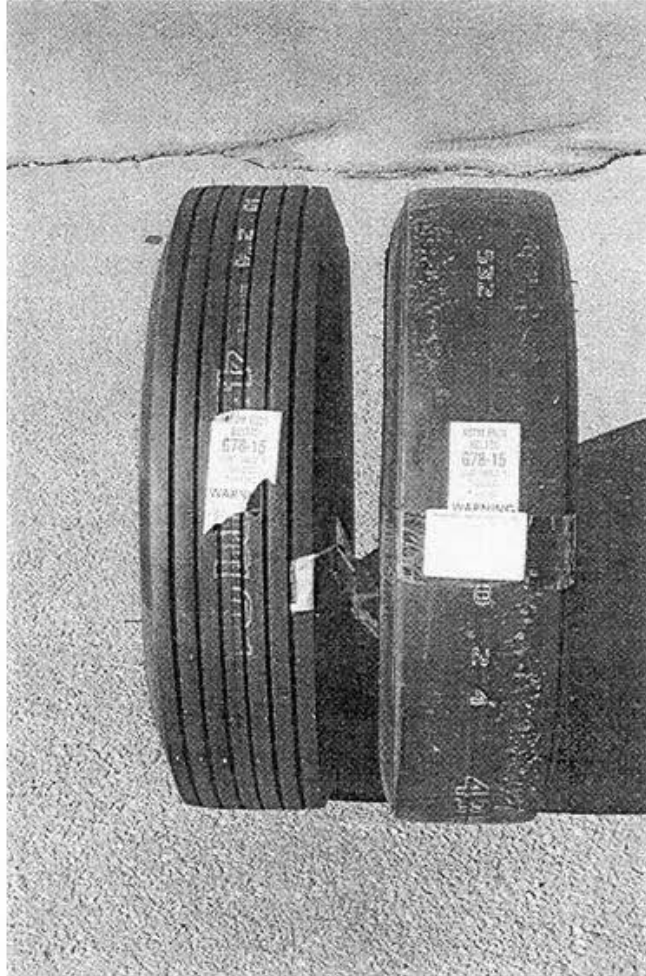
Photo 1: View of the ribbed tire (ASTM E 501 and  
The smooth tire (ASTM E524)

The primary reason for the ribbed tire's insensitivity to macrotexture is its deep grooves, which provide drainage for water regardless of pavement macrotexture. On the other hand, tests with the smooth-tire (ASTM E 524) have produced skid-resistance data which are sensitive to both macrotexture and microtexture (5). Another advantage of using a smooth tire is that the influence of tire wear on the friction data is eliminated (6). Photograph 1 compares the ribbed and the smooth tires.

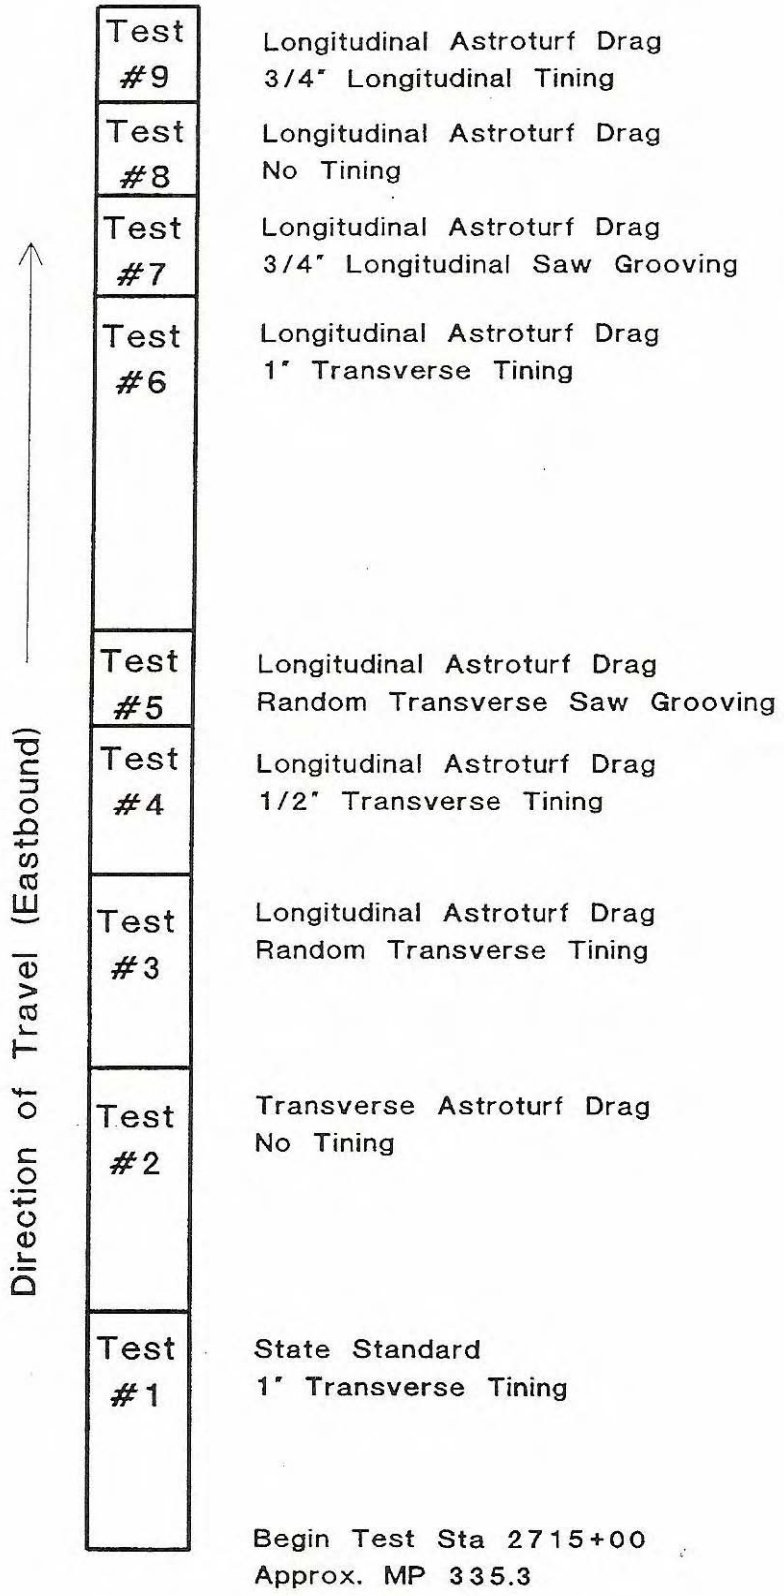
Figure 2  
 CONCRETE TEXTURING STUDY on I 70 at DEER TRAIL  
 TEST SECTION LAYOUT  
 (Length is to scale)

<b>Stations</b>	<b>Texturing Method Used</b>	<b>Length in ft.</b>
1) 2715 - 2743	transverse tining 1"/ state standard	2800
2) 2743 - 2768	trans. astro-turf/ no tining	2500
3) 2768 - 2789	long. astro-turf/ trans. tining random	2100
4) 2789 - 2806	long. astro-turf/ trans. tining 1/2"	1700
5) 442 - 452	long. astro-turf/ trans. sawing random	1000
6) 452 - 480	long. astro-turf/ trans. tining 1"	2800
7) 480 - 490	long. astro-turf/ long. sawing 3/4"	1000
8) 490 - 500	long. astro-turf/ no tining	1000
9) 500 - 510	long. astro-turf/ long. tining 3/4"	1000

Figure 2 shows the sequence of the test sections as constructed.

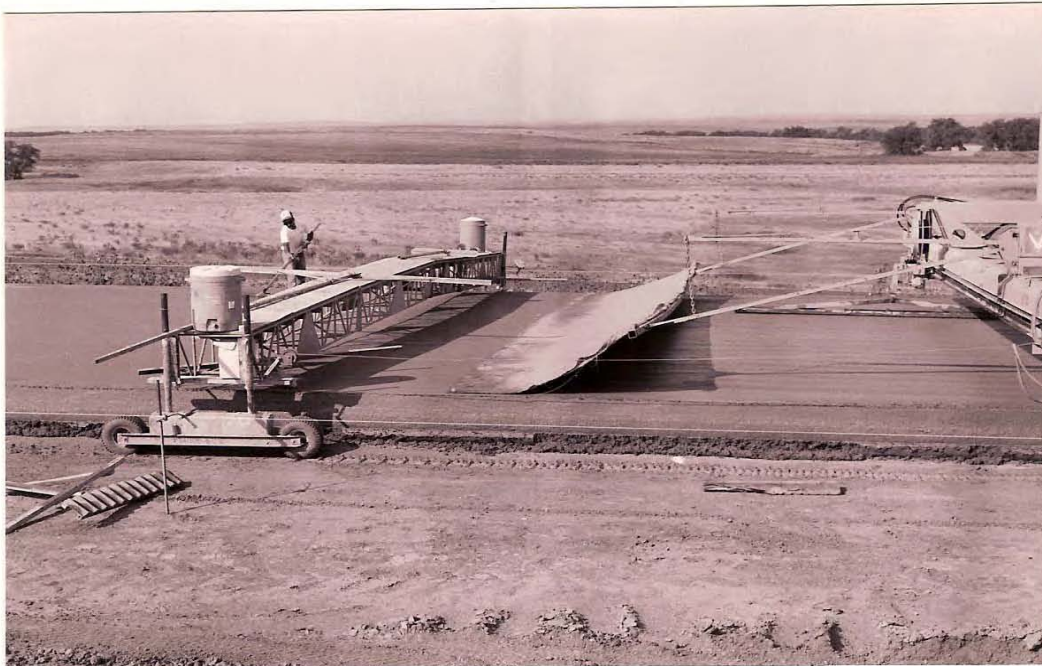
Photo 2: Burlap drag was applied to all test sections

Note: Burlap drag was applied to all test sections immediately behind the paver as shown in Photograph 2. The depth and the width of all the tining and sawing were specified at  $1/8" \pm 1/16"$ .

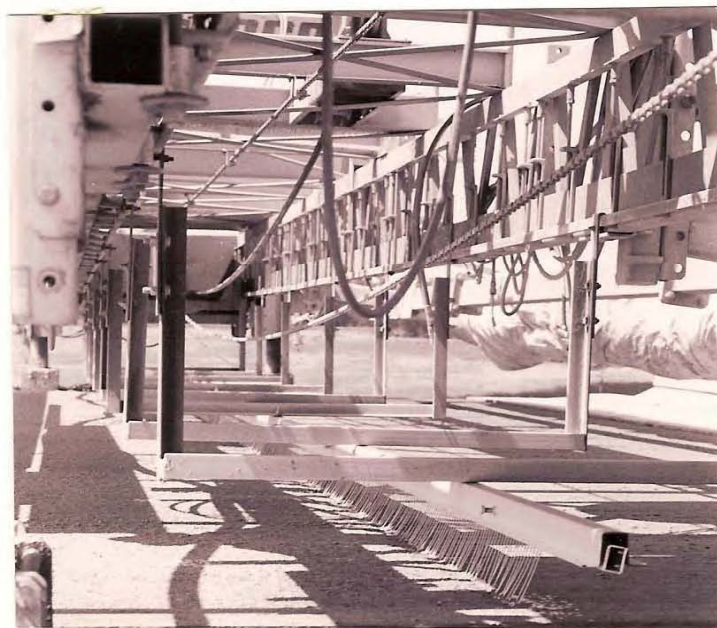
Photo 3: View of the longitudinal tining assembly

The tining-bridge was also used to drag astro-turf in the front and to apply curing compound from the back. During the installation of the longitudinal tining, the tines rolled the concrete paste (mortar) into popcorn-like balls all over the surface of the pavement (Photograph 4). However, once the concrete cured, these mortar balls were crushed by the traffic at the construction site and then easily removed by brooming.

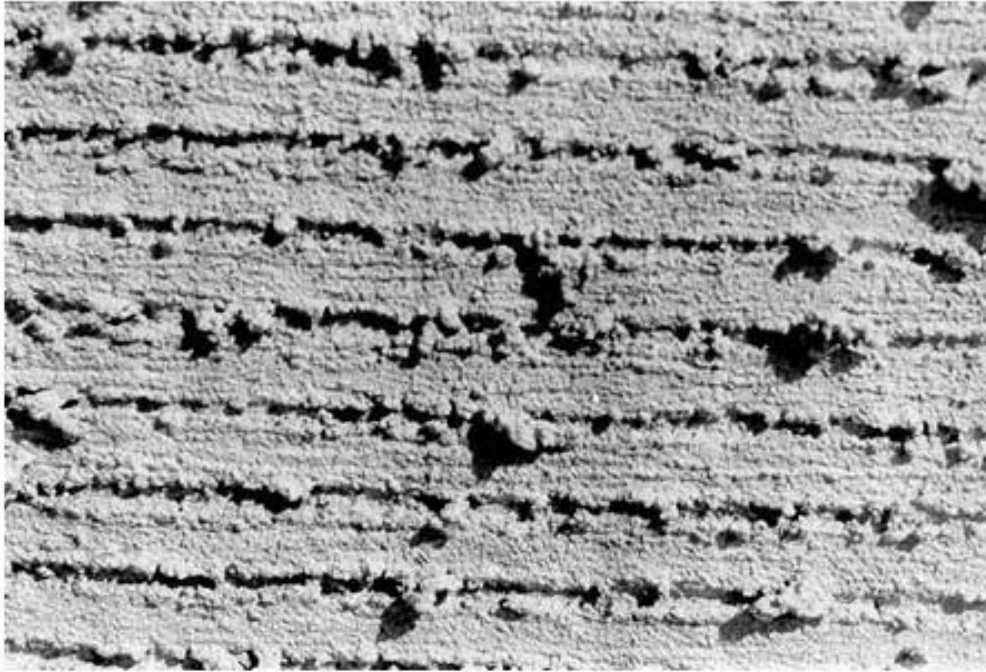
Photo 4: Popcorn-like mortar balls (longitudinal tining)

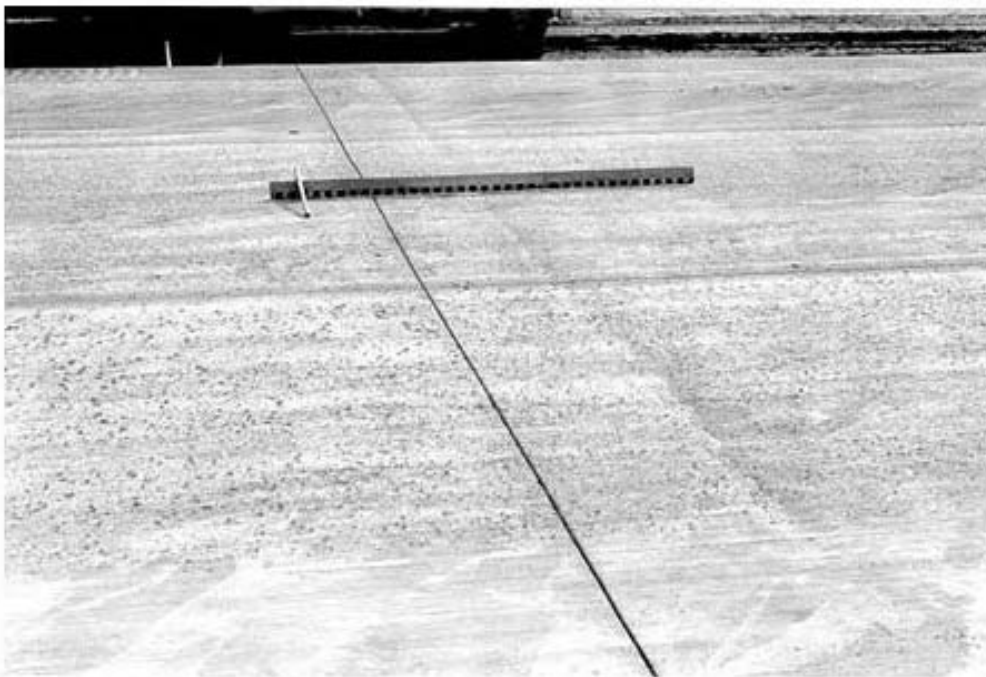
Photo 5: Transverse indentation of plastic concrete

Every time the tining operation was stopped, the tines formed a transverse indentation across the pavement surface as shown in Photograph 5. For future longitudinal tining, the contractor should be required to make provisions for raising the tines when the tining operation is stopped. This should prevent indentation of the plastic concrete surface.

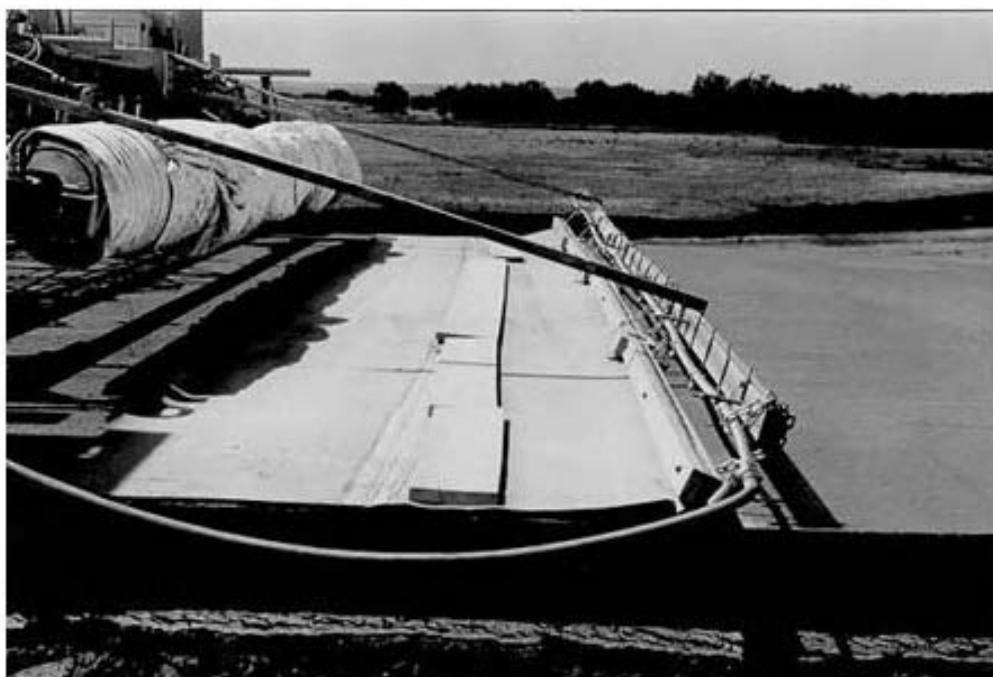
Photo 6: View of the astro-turf drag with planks for added weight

The longitudinal astro-turf drag was applied from the front of the bridge simultaneously with longitudinal tining. The astro-turf used was 38 feet wide, covering the entire width of the pavement surface and 5.8 feet long, of which 4.8 feet contacted the surface. Due to a very stiff mix (slump of less than 1") the astro-turf was not capable of forming deep enough texture. To make the texturing more pronounced, several boards were placed on the astro-turf as shown in Photograph 6. Occasionally, the surface of the contact area became plugged with mortar (Photograph 7) and the tining operator had to raise the astro-turf and shake out the excess grout.

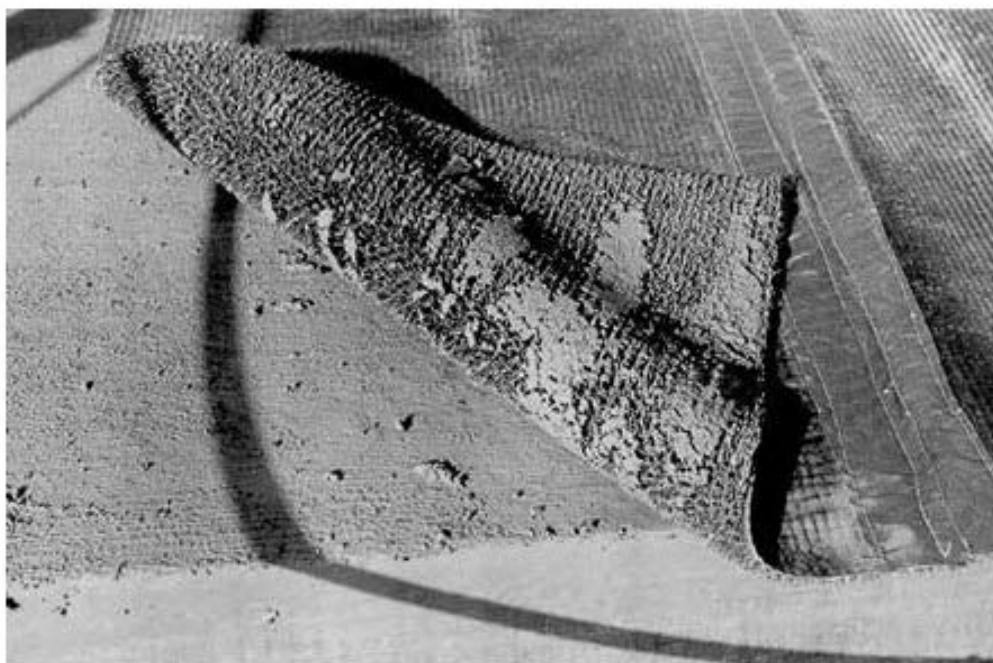
Photo 7: Astro-turf plugged up with grout

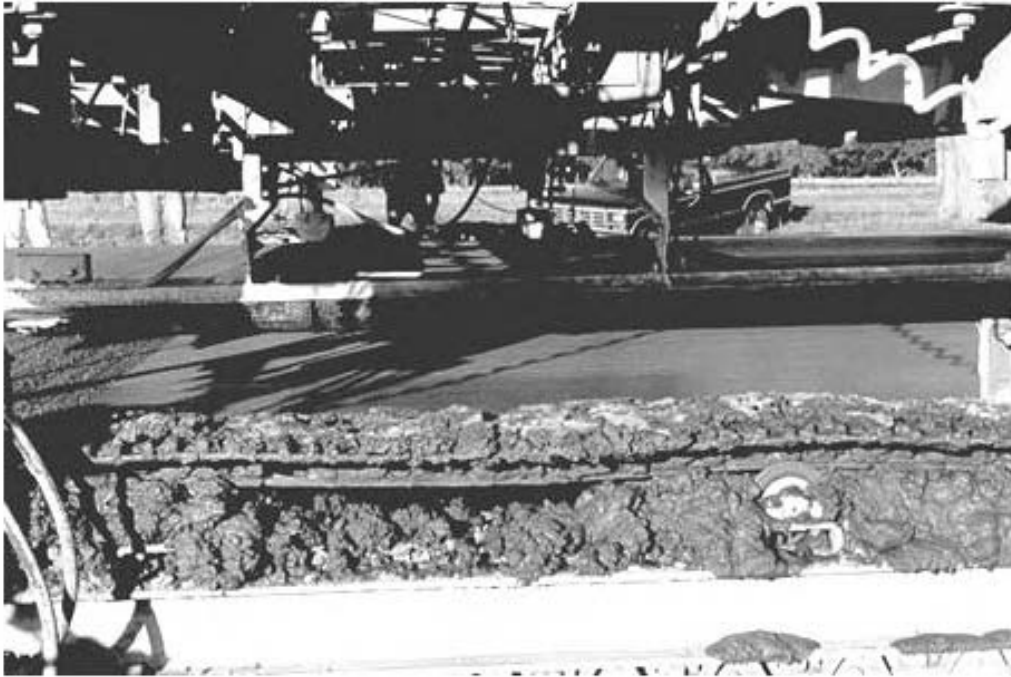
Photo 8: Installation of transverse astro-turf texture

Prior to installing transverse astro-turf test section the Principal Investigator (P.I), the Region I Materials Engineer, and the contractor met to discuss the possibility of encountering problems with the transverse texturing operation. It was decided to texture only the first 100 feet of the day's paving with this method to determine its feasibility and its possible continuation for the entire day's paving. If it was determined that transverse astro-turf was not adequately texturing the pavement surface, the contractor could then be directed to convert from transverse astro-turf texturing to longitudinal astro-turf texturing. However, as it can be seen in Photograph 9, the astro-turf adequately textured the pavement surface and as a result, transverse astro-turf texturing was continued for the entire day.

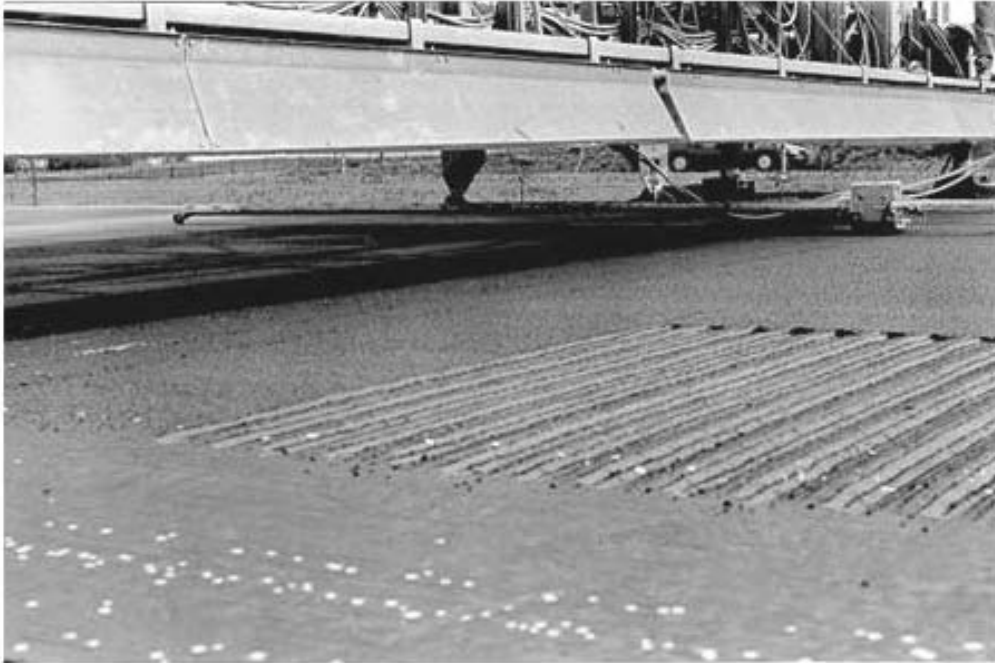
Photo 10: Typical transverse tining operation

Photograph 10 shows a typical transverse tining operation. The state standard test section (control) which uses combination of burlap drag and 1" uniform transverse tining is shown in Photograph 11. Photograph 12 shows the combination of astro-turf drag with transverse tining of 1/2" uniform spacing. Transverse tining with random spacing of 5/8", 7/8" and 3/4" is shown in Photograph 13.

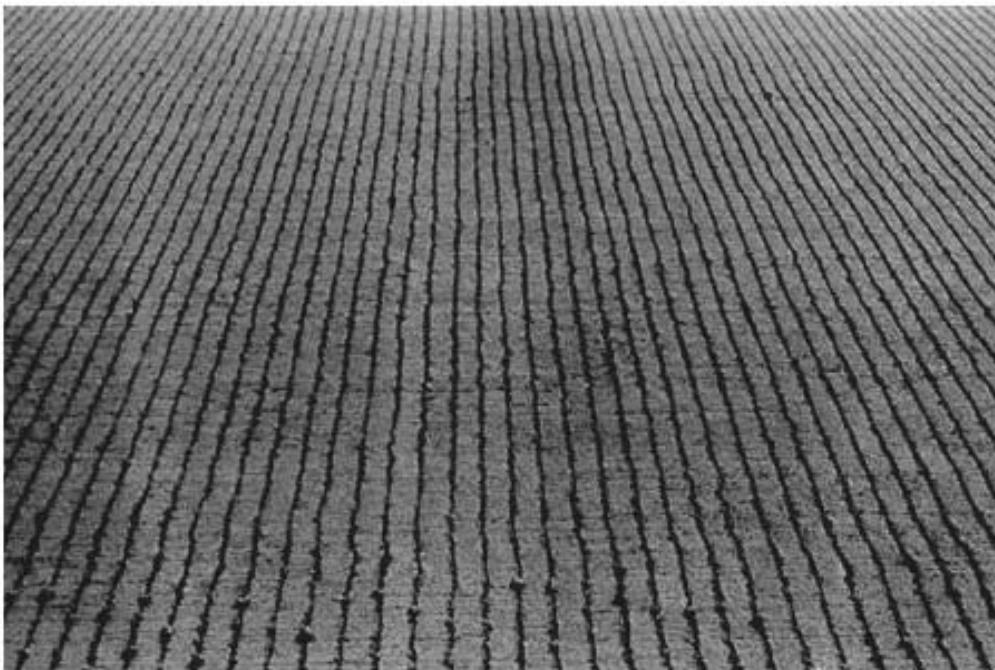
Photo 11: 1-inch uniform spaced transverse tining (state standard)

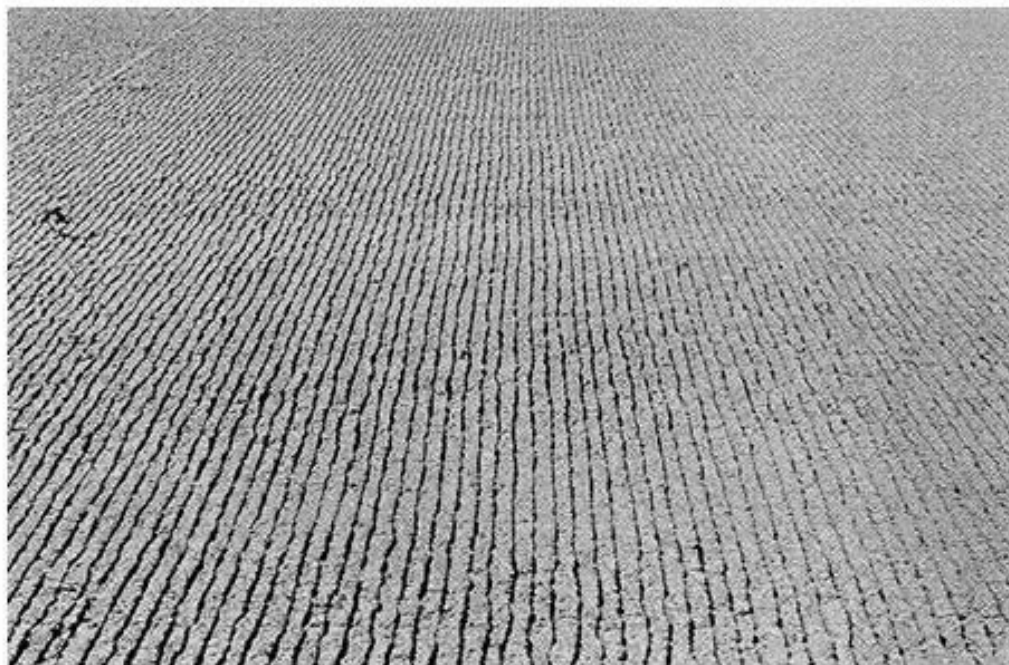
Photo 12: 1/2-inch uniform spaced transverse tining

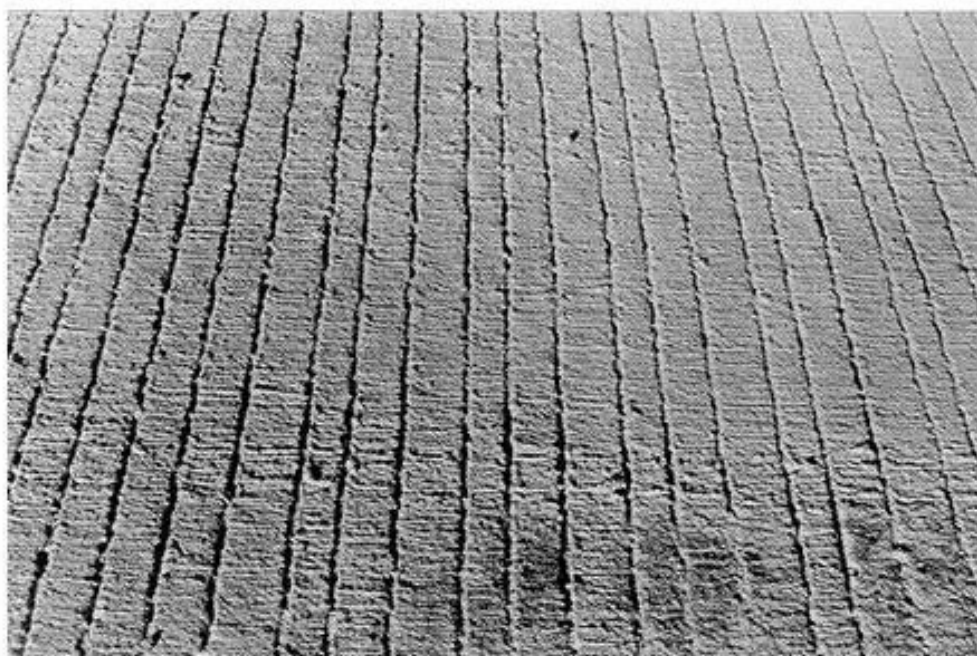
Photo 13: Random transverse tining with 5/8", 7/8", and 3/4" spacing

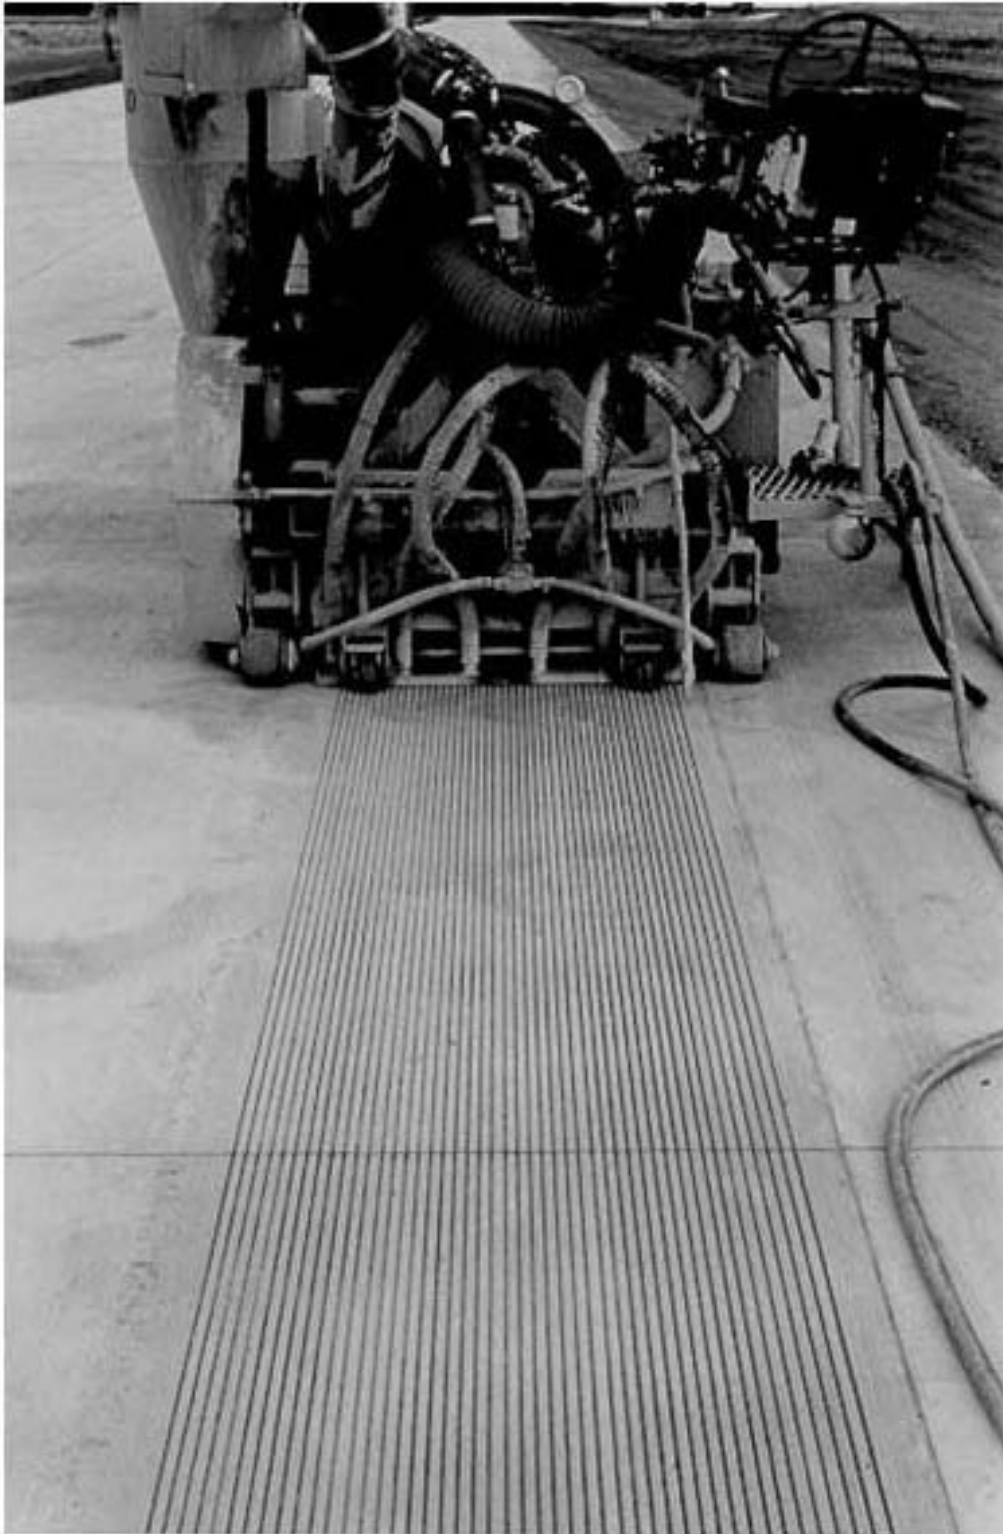
Photo 14: Installation of the longitudinal grooves

A self-propelled sawing machine (CUSHIN CUT, HG-130) was used to install the longitudinal grooves with uniform spacing of  $\frac{3}{4}$  of an inch (Photograph 14). The grooving machine was equipped with 46 blades, 14 inches in diameter each, and had a total effective cutting width of  $34\frac{1}{2}$  inches. The machine, which had an approximate cutting rate of 1000 linear feet per hour, required 12 passes to groove the entire test section. Photograph 15 shows a close-up view of the longitudinal grooving. The rumble-strips on both the left and the right shoulders were also grooved. Photograph 16 shows a grooved rumble strip on the right shoulder.

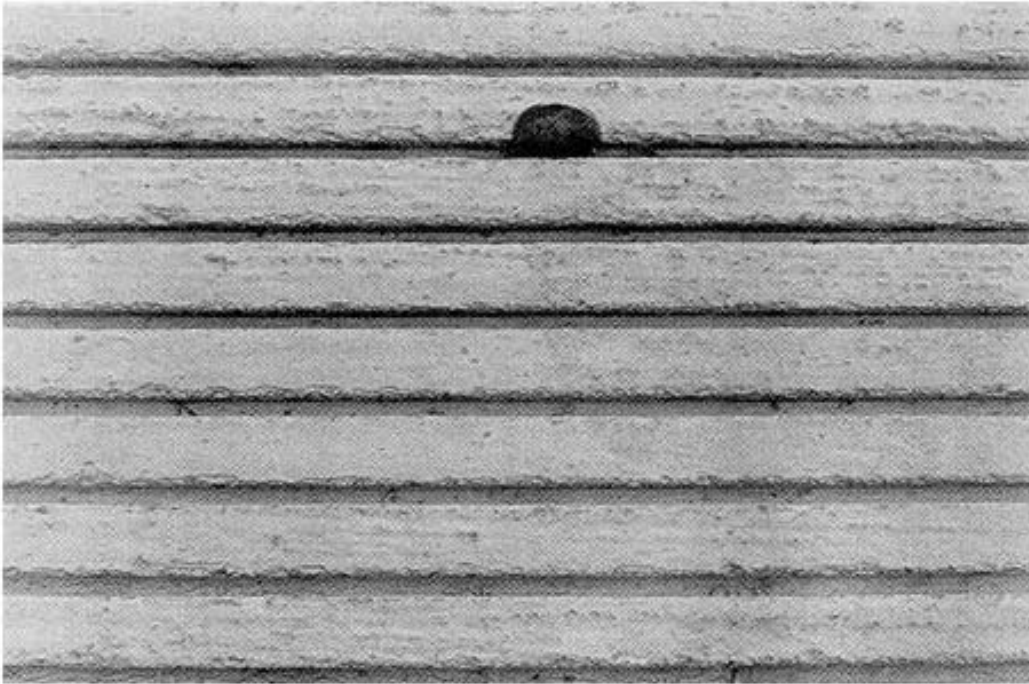
Photo 15: Close up view of longitudinal grooves

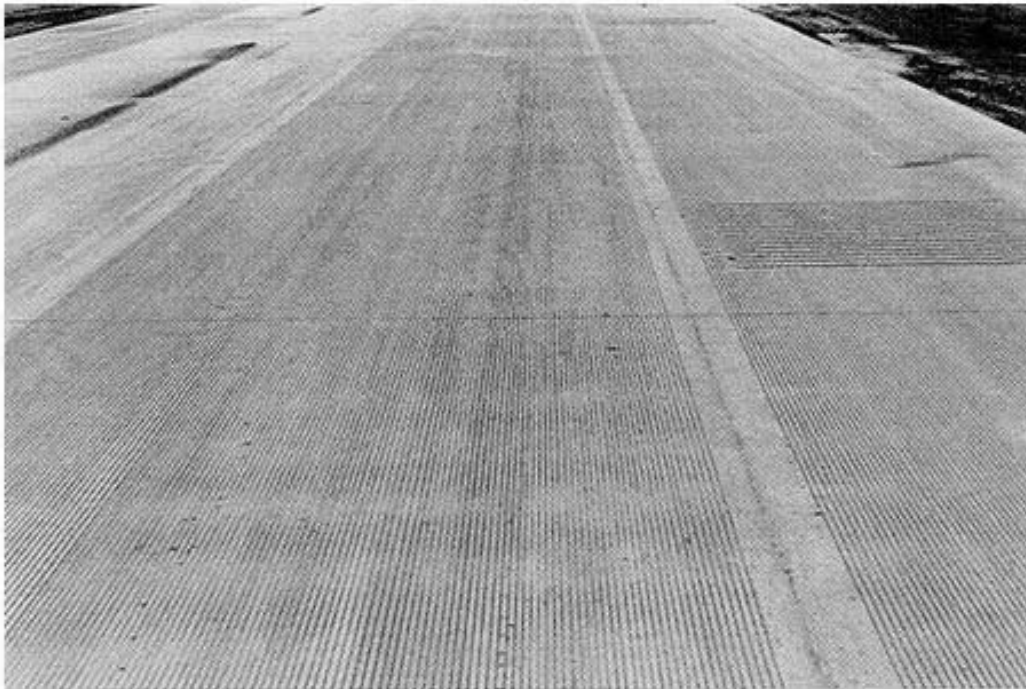
Photo 16: Grooved rumble strip in the right shoulder

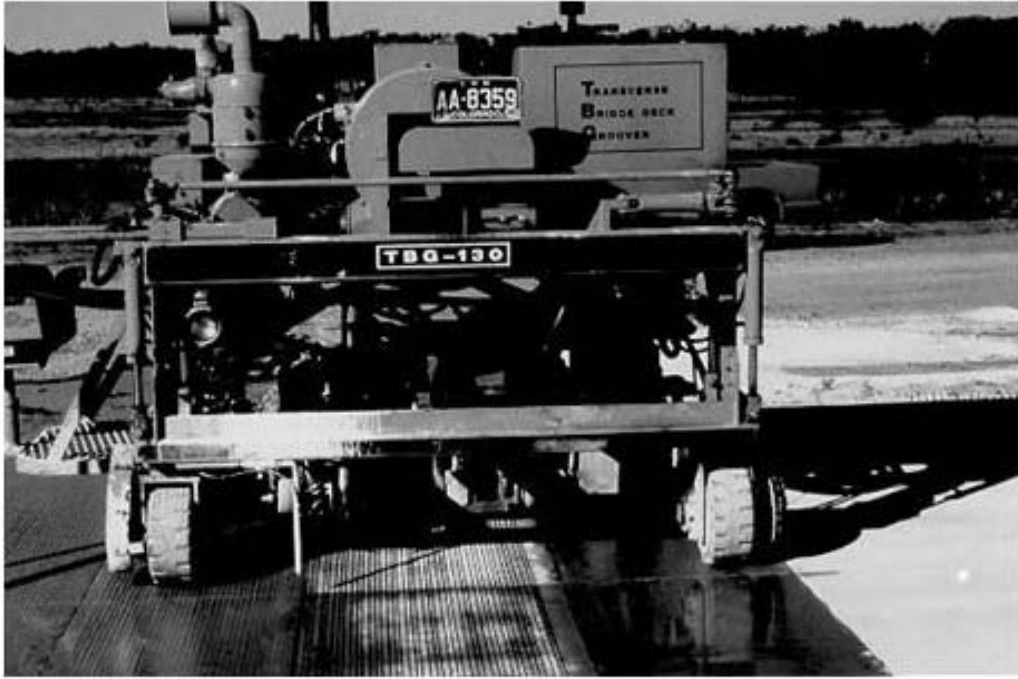
Photo 17: Installation of transverse grooves

A self-propelled Transverse Bridge Deck Groover (TBDG) was used to install the transverse grooves with random spacing of  $\frac{5}{8}$ ,  $\frac{7}{8}$ , and  $\frac{3}{4}$  of an inch, as shown in Photograph 17. The transverse grooving machine was equipped with a moving head, with 38 blades, 14 inches in diameter each, and with a total effective cutting width of 29 inches. A close-up view of the transverse grooving is shown in Photograph 18.

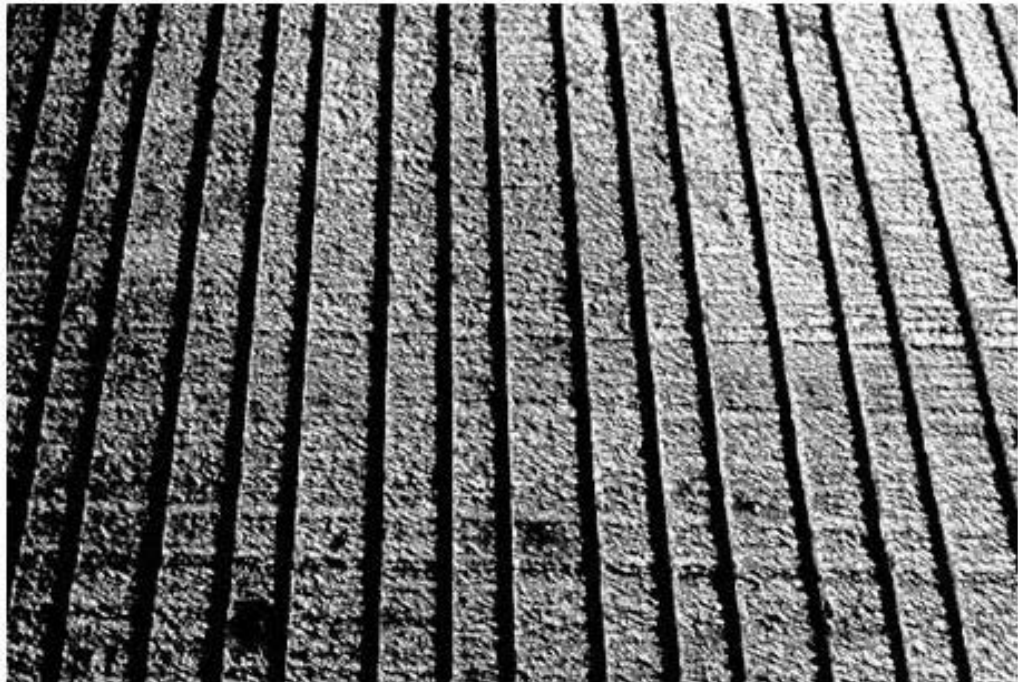
Photo 18: Close-up view of random transverse grooves with 5/8", 7/8", and 3/4" spacing

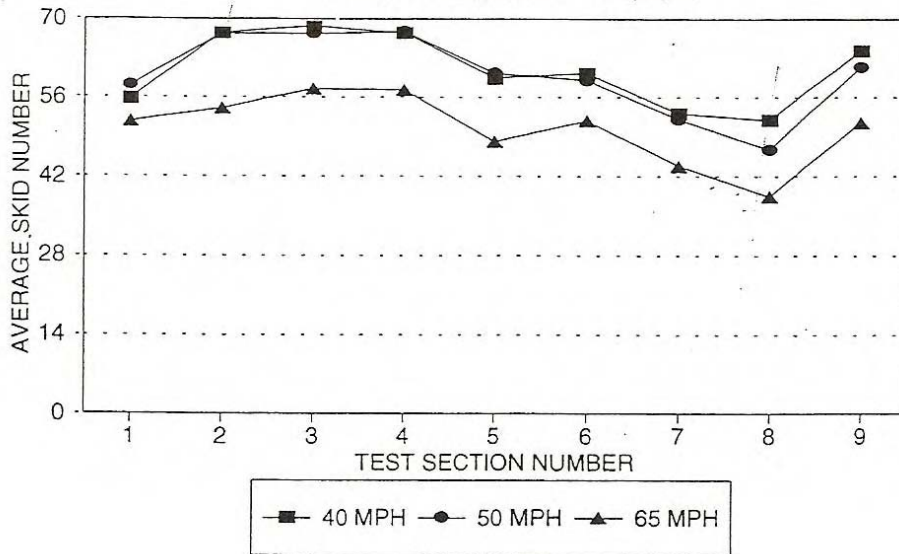
Figure 3

## RIBBED-TIRE SKID NUMBERS OCTOBER 1994

The difference in skid numbers for microtexture and macrotexture were not as evident or consistent using the ribbed tire. This phenomenon confirms the findings of many research papers, revealing the insensitivity of the ribbed-tire towards macrotexture. The primary reason for the

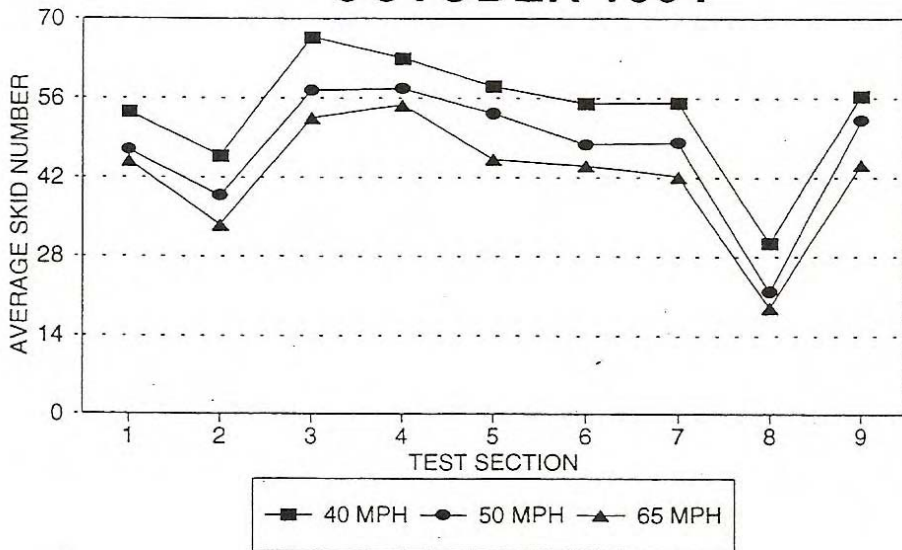
Figure 4

## SMOOTH-TIRE SKID NUMBERS OCTOBER 1994

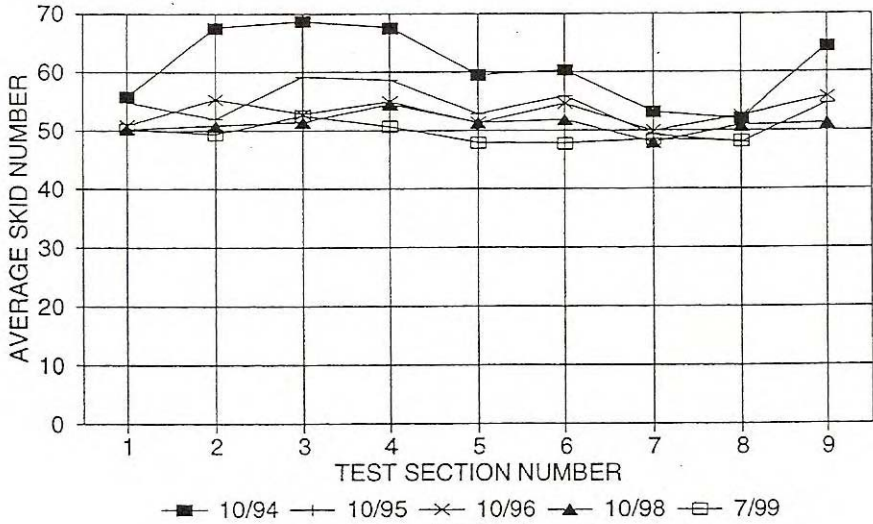
Figure 5

# RIBBED-TIRE SKID NUMBERS 40 MPH

It should be noted however, that even though the 1995 SN40R were much lower than the 1994 SN40R, they were still much higher than the skid number of 35, which is being used by many states as their minimum acceptable limit. The drop in the magnitude of 1995 skid numbers taken with smooth-tire at 40 mph (SN40S) was even more pronounced. The 1995 SN40S were an average of 11 points lower than their corresponding 1994 SN40S. As before, test section 2 showed the highest drop, approximately 24 points.

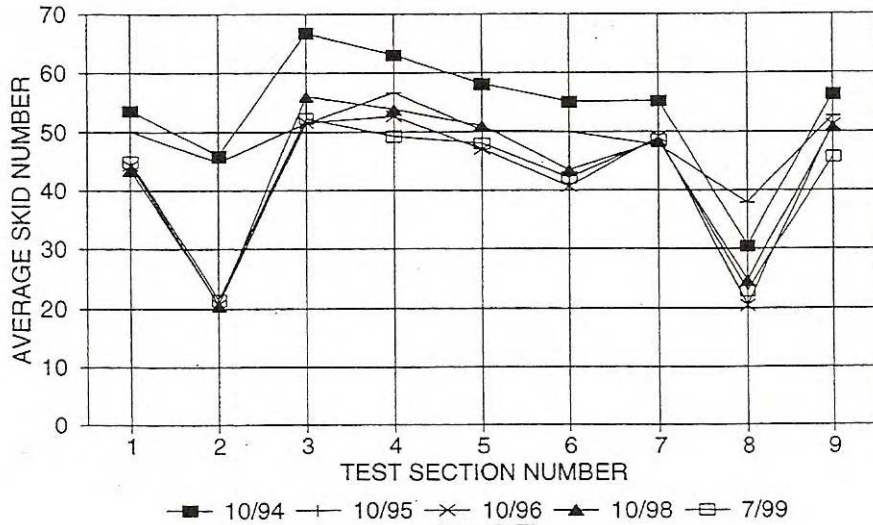
Figure 6

# SMOOTH-TIRE SKID NUMBERS 40 MPH

The rate of reduction in skid numbers for the smooth-tire were also minimal. The drop in the skid numbers magnitude from 1995 to 1996 averaged less than 1 point (.80 to be exact), while the rate of drop from 1994 to 1995 averaged 11 points. As before, the two microtexture test sections (test sections 2 and 8) showed very low skid numbers, SN40S = 20.6 and SN40S = 20.4

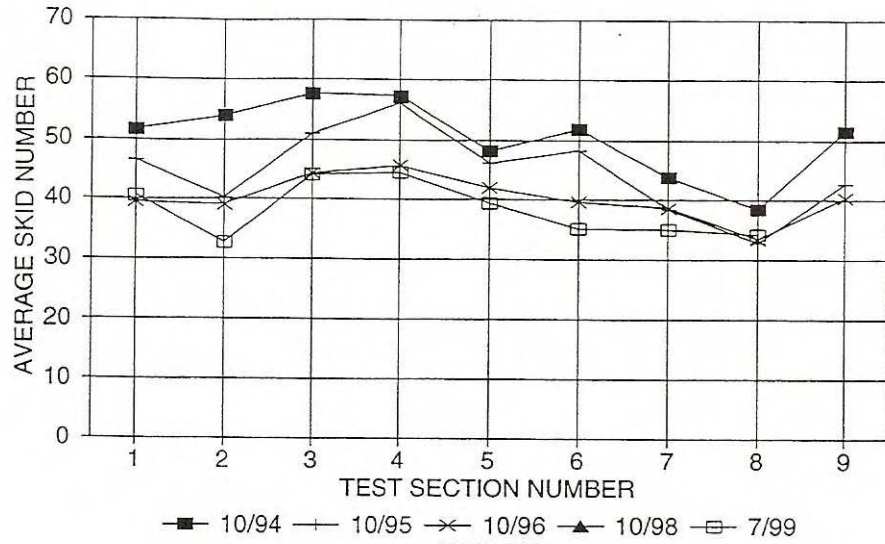
Figure 7

## RIBBED-TIRE SKID NUMBERS 65 MPH

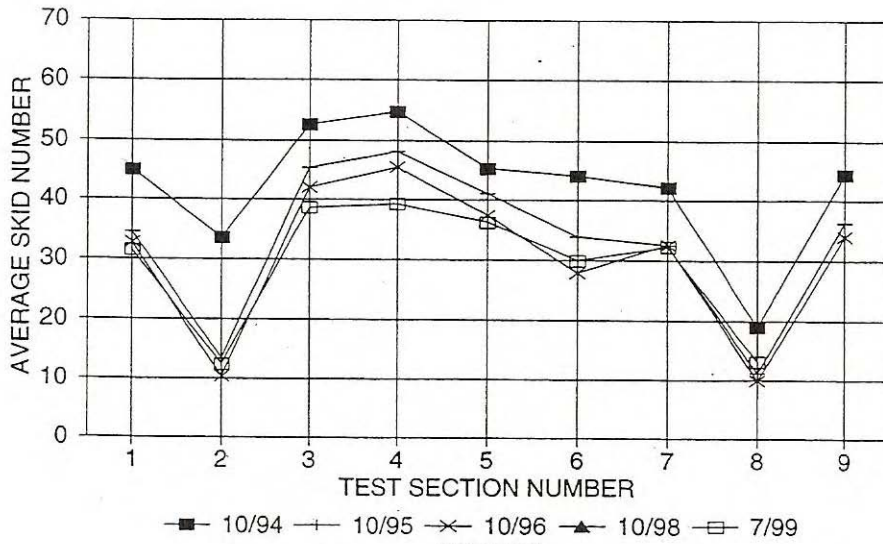
Figure 8

## SMOOTH-TIRE SKID NUMBERS 65 MPH

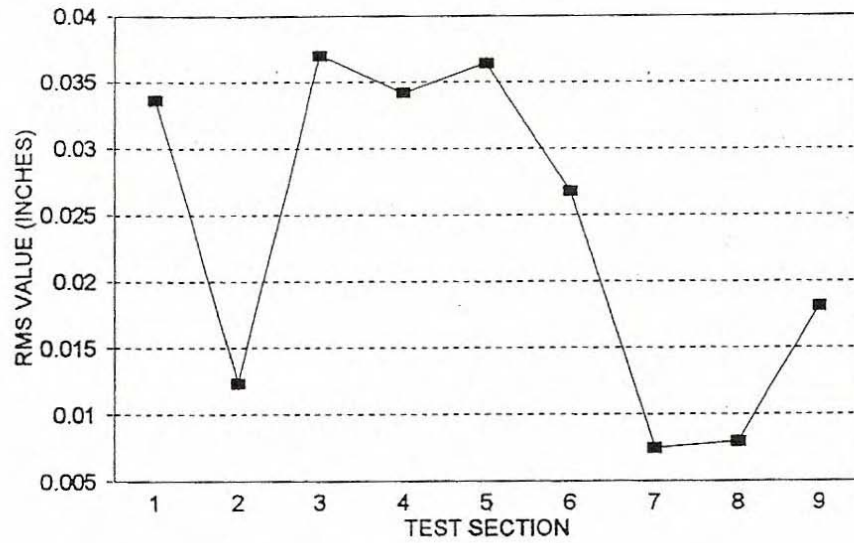
# TEXTURE MEASUREMENT LASER VAN

An rms (root mean square) value is computed for each of the two profiles. The final output is an average rms value for the test section. Figure 10 compares the average rms values for the

individual test sections. As expected, the texture van showed lower values for sections 2 and 8 with microtexture; however, it also showed low values for longitudinal sawing (test section 7) and for longitudinal tining (test section 9). This may indicate that the laser van is more sensitive to the transverse texture than to the longitudinal texture. It should also be noted that, of the two microtexture (section 2 and 8), section 2 with the transverse orientation showed higher rms values.

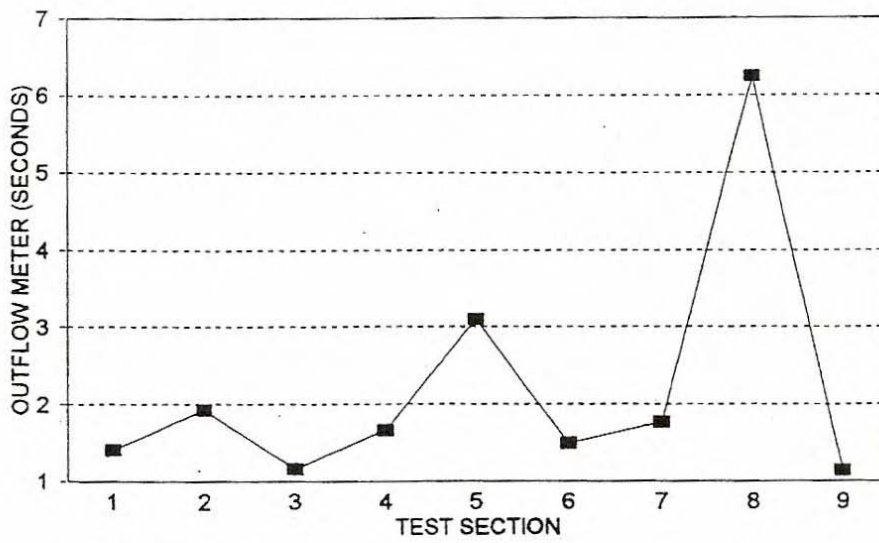
Figure 11

# INDIRECT TEXTURE MEASUREMENT WATER FLOW METER

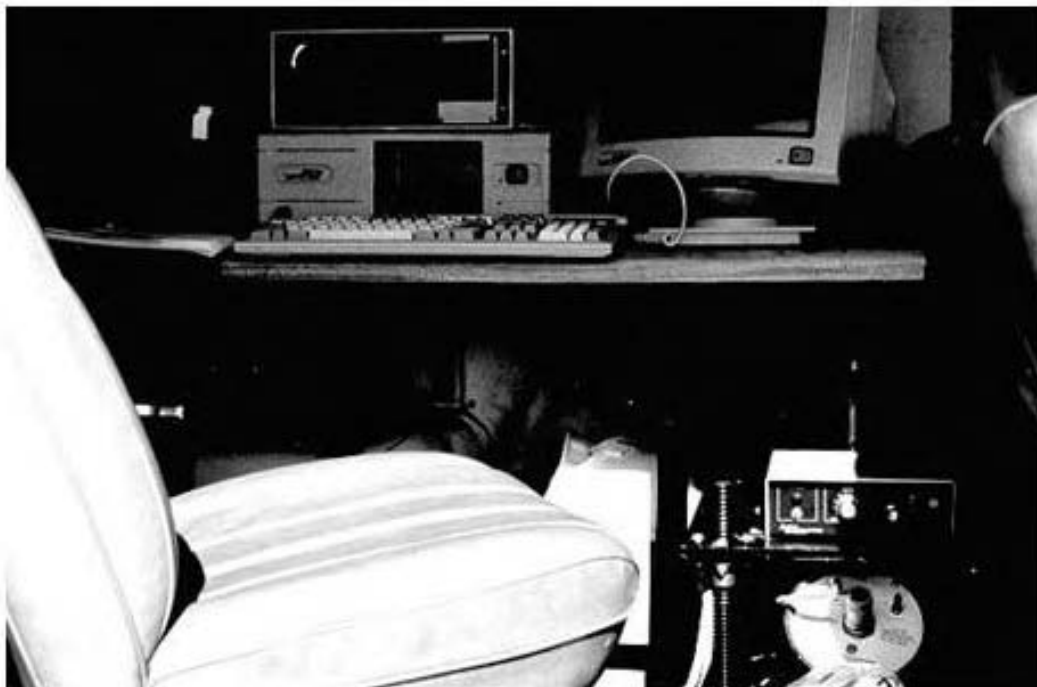
Photo 19: Inside of a texture measuring van

The texture van equipment (Photograph 19) can measure texture at travel speeds and does not interfere with normal traffic. It uses a television camera to take snapshots of a small pavement section in the wheel track (about 4 inches long). It takes a pre-selected number of exposures spaced about 50 feet apart at 50 miles per hour. To assure image sharpness the exposure time is given by a strobe light, and an infrared sensor assures that the field of view is in focus. A slit mask forms the images over the lens, giving two profile edges at every exposure.

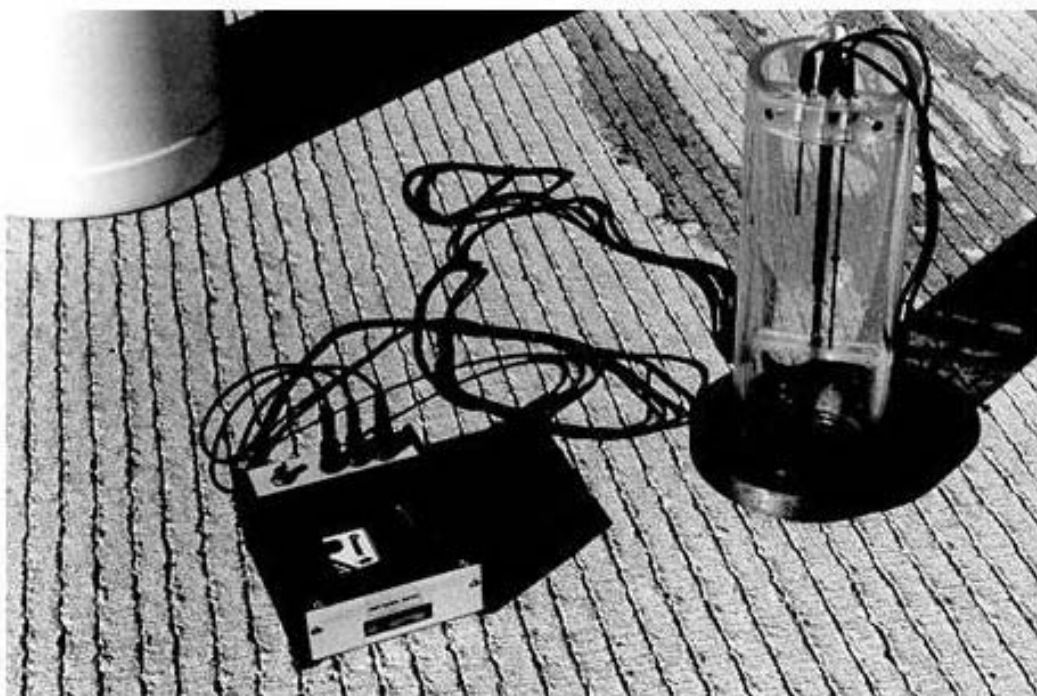
Photo 20: View of an outflow meter

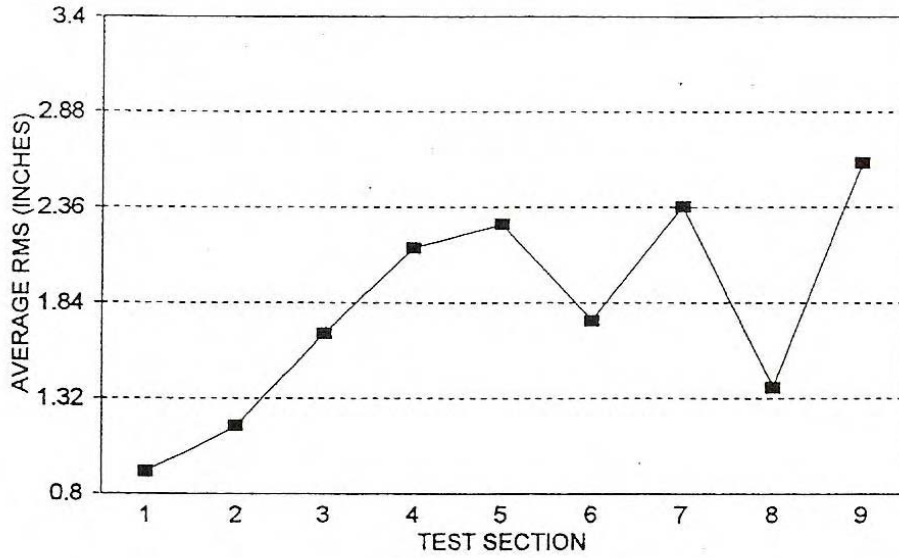
Figure 12

# TEXTURE MEASUREMENT

## LVDT BEAM

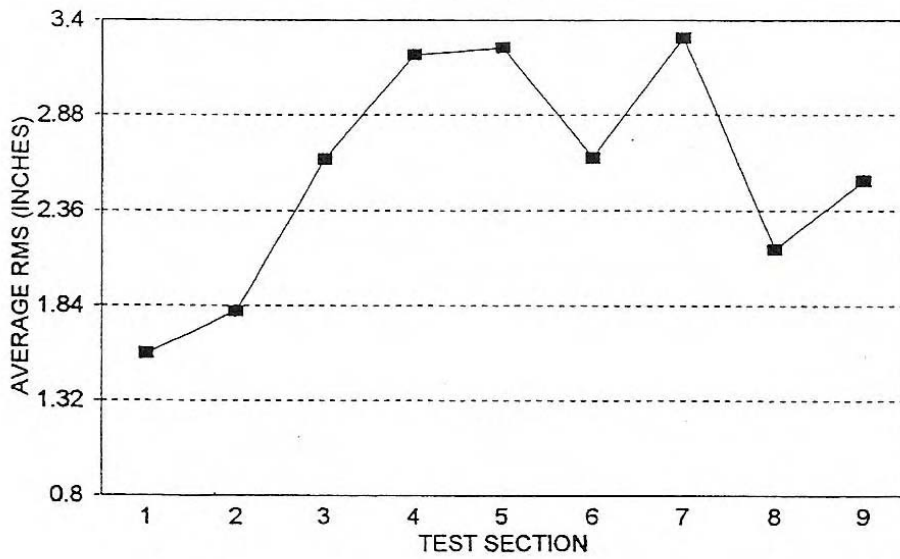
Figure 13

# TEXTURE MEASUREMENT

## LASER BEAM

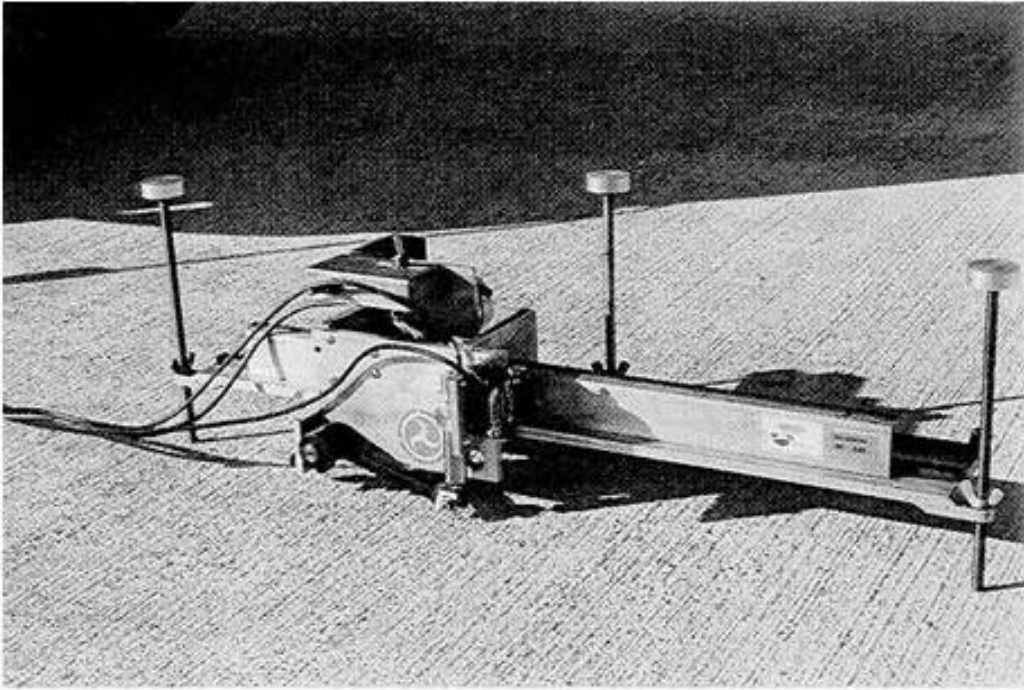
Photo 21: Texture beam, equipped with an LVDT and a laser stylus
