**Report No. CDOT-DTD-R-2005-22**  
**Final Report**

# **PCCP TEXTURING METHODS**

**COLORADO DEPARTMENT OF TRANSPORTATION**  
**RESEARCH BRANCH**

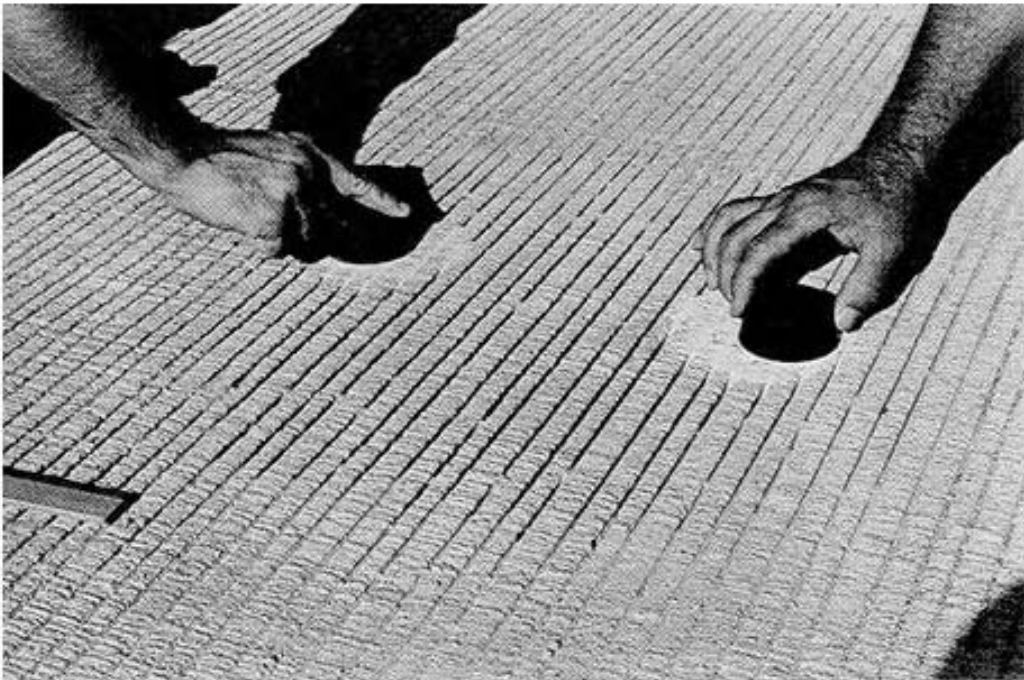
Photo 22: Sand patch test for measuring texture depth

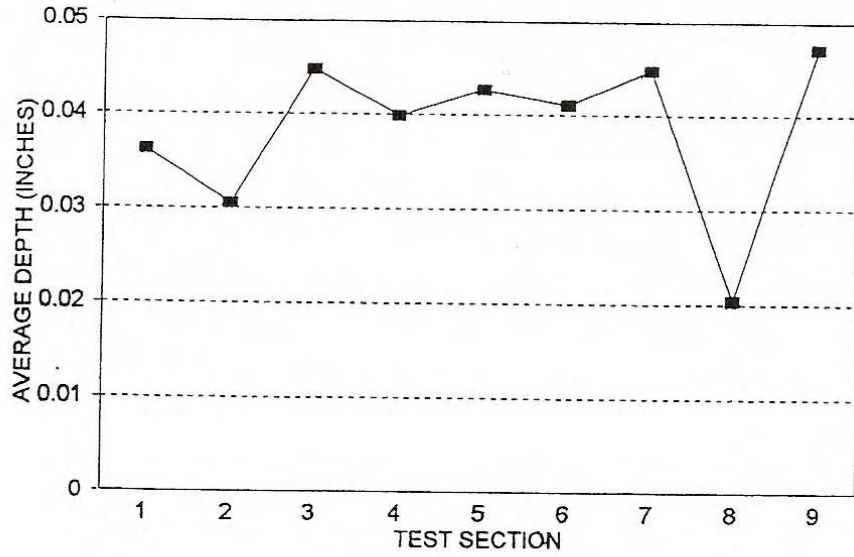
Figure 14

# TEXTURE MEASUREMENT SAND PATCH METHOD

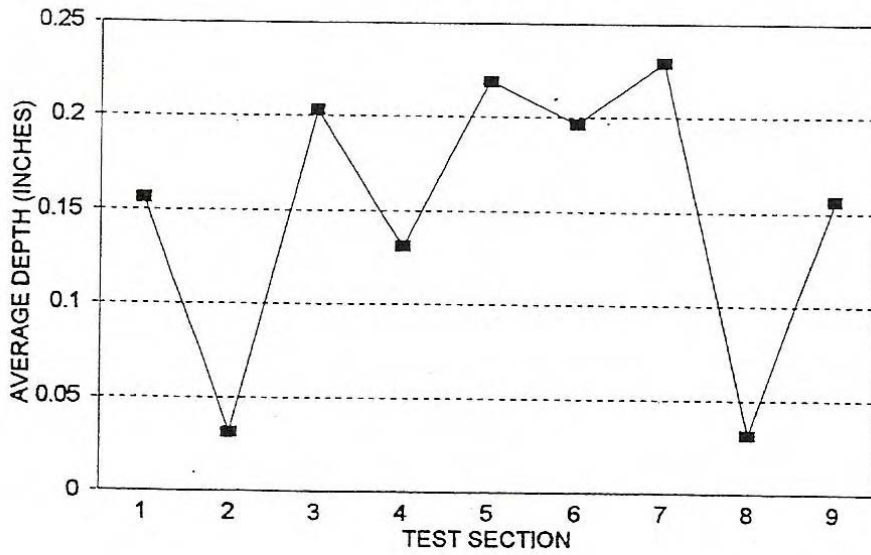
Figure 15

# TEXTURE MEASUREMENT TIRE GAUGE

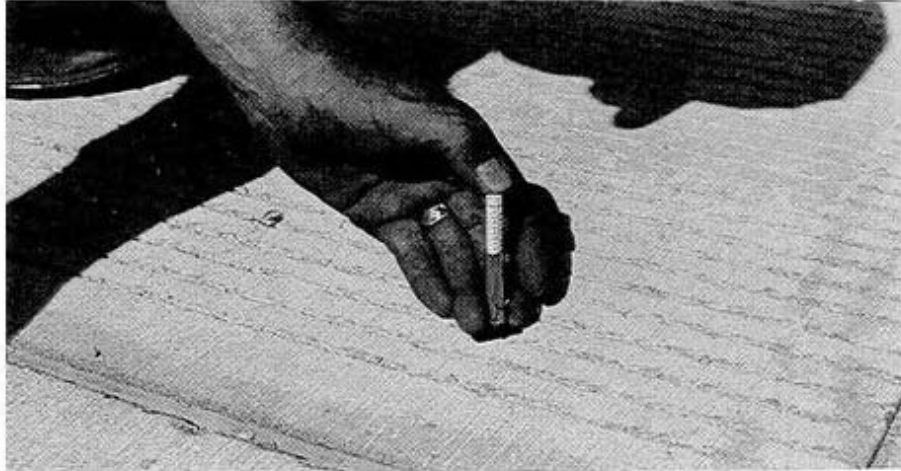
Photo 23: Texture depth measurement using a tire tread depth gauge

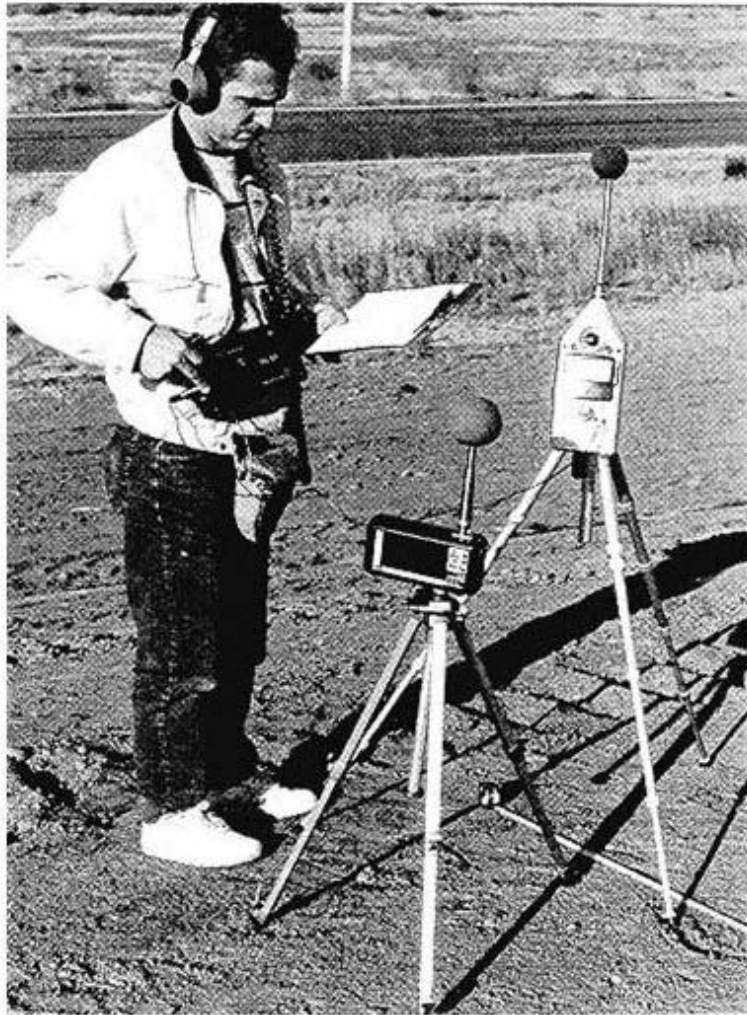
Photo 24: SPL measurement at the roadside

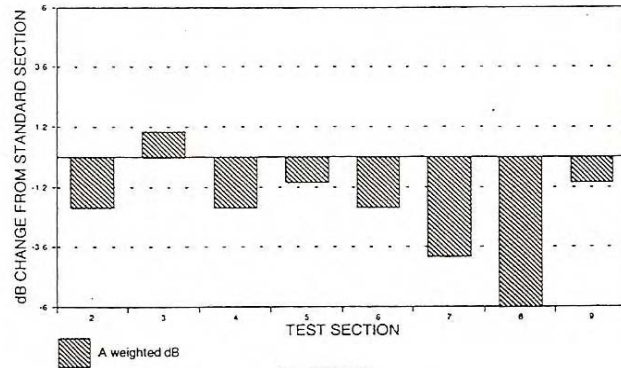
### SPL AT THE SHOULDER COMPARED TO STATE STANDARD SECTION

However, it should be noted that measurements taken with the engine on and with the engine off produced the same SPL, indicating that the tire noise was predominately louder than the engine noise. Figure 16 compares the change in SPL measurements of all the test sections relative to control section (state standard) at the shoulder. The sound generated at the control section was normalized to represent a datum (zero sound level pressure). Except for test section 3 (random transverse tining), all the other test sections showed lower decibels (dB) than the control section. Section 8 showed the lowest sound level pressure (6 dB lower than control).

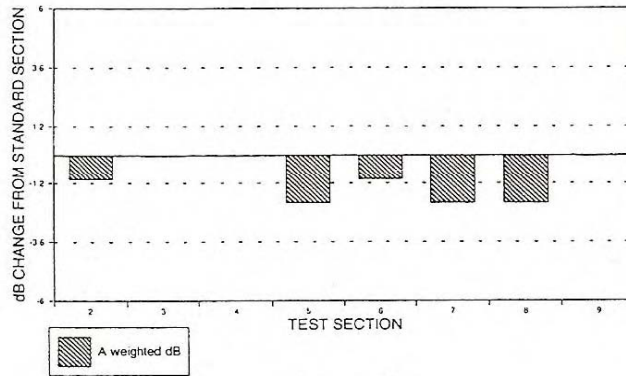
Figure 17

### SPL INSIDE TEST VEHICLE COMPARED TO STATE STANDARD SECTION

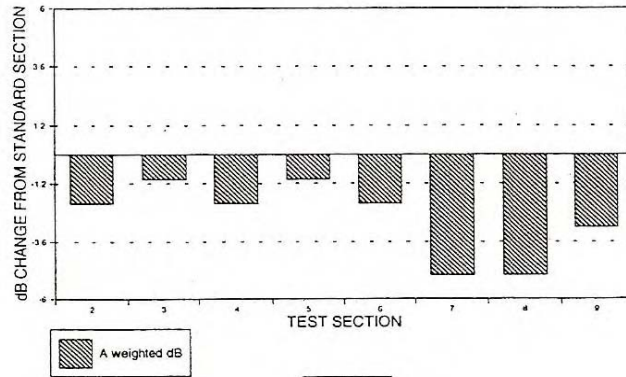
Figure 18

### SPL AT REAR TIRE COMPARED TO STATE STANDARD SECTION

All the test sections showed lower sound levels than the control section as shown in Figure 18. Section 7 and 8 showed the lowest dB, 5 1/2 dB lower than the control section. It should be noted that for all the conditions mentioned above, 3 sets of data were acquired and then averaged. Figure 19 compares the A-weighted SPL measurements of all the three conditions. As expected, the SPL measurements taken near the rear tire and inside the test vehicle showed the highest and lowest dB respectively.

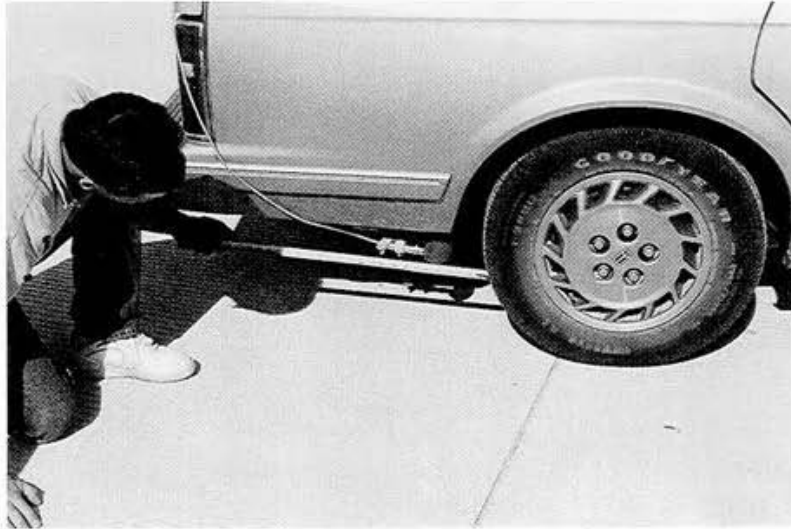
Photo 25: View of the microphone behind the rear tire

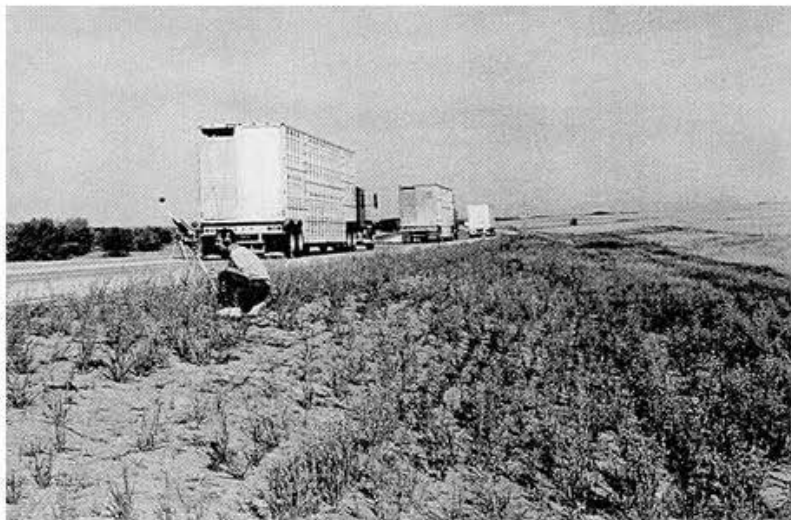
Photo 26: Acquiring truck noise levels at the roadside

seen in this figure, the SPL for both the truck and the test vehicle peaked at 1000 Hz. However, the figure shows the noise from the truck (Photograph 26) to be at the higher annoyance range (by about 8 dB) than the noise from the test vehicle. The A-weighted dB for the truck was also 7 dB higher than the A-weighted dB of the test vehicle.

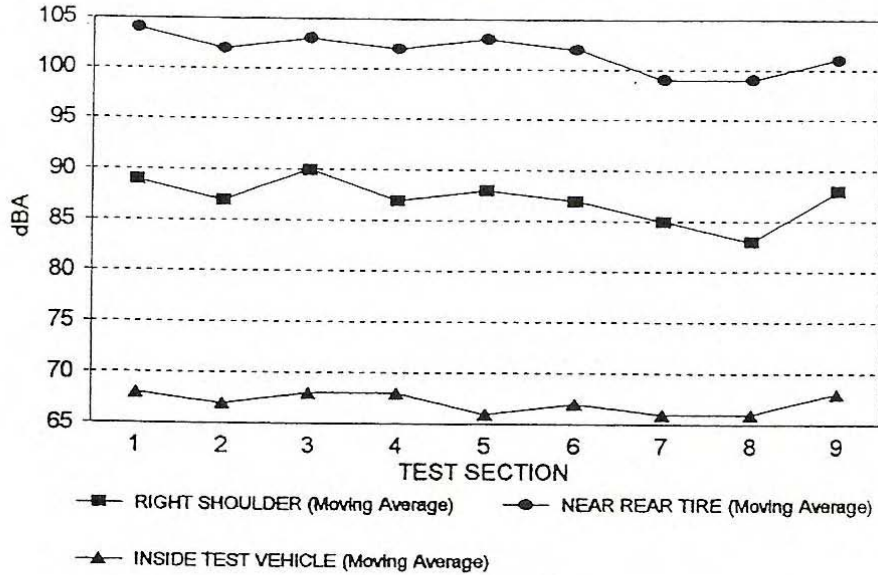
Figure 19

# A-WEIGHTED SOUND LEVELS

OCTOBER 1994

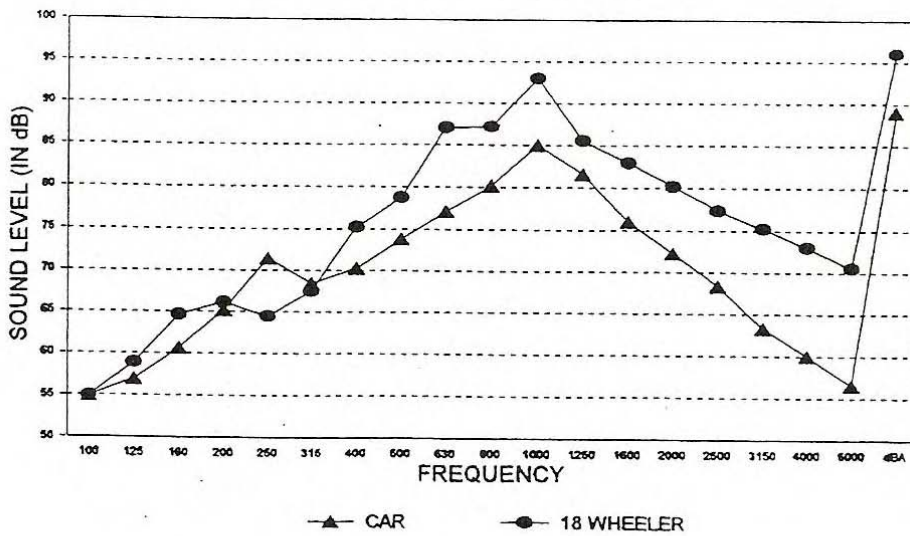
# SPL COMPARISONS

CAR vs. TRUCK (SHOULDER SECT 1)

Figure 20 compares SPL Frequency distribution of a semi-truck with the test vehicle in a 1/3-octave band format (100 – 5000 Hz), as well as A-weighted SPL at the roadside. As it can be

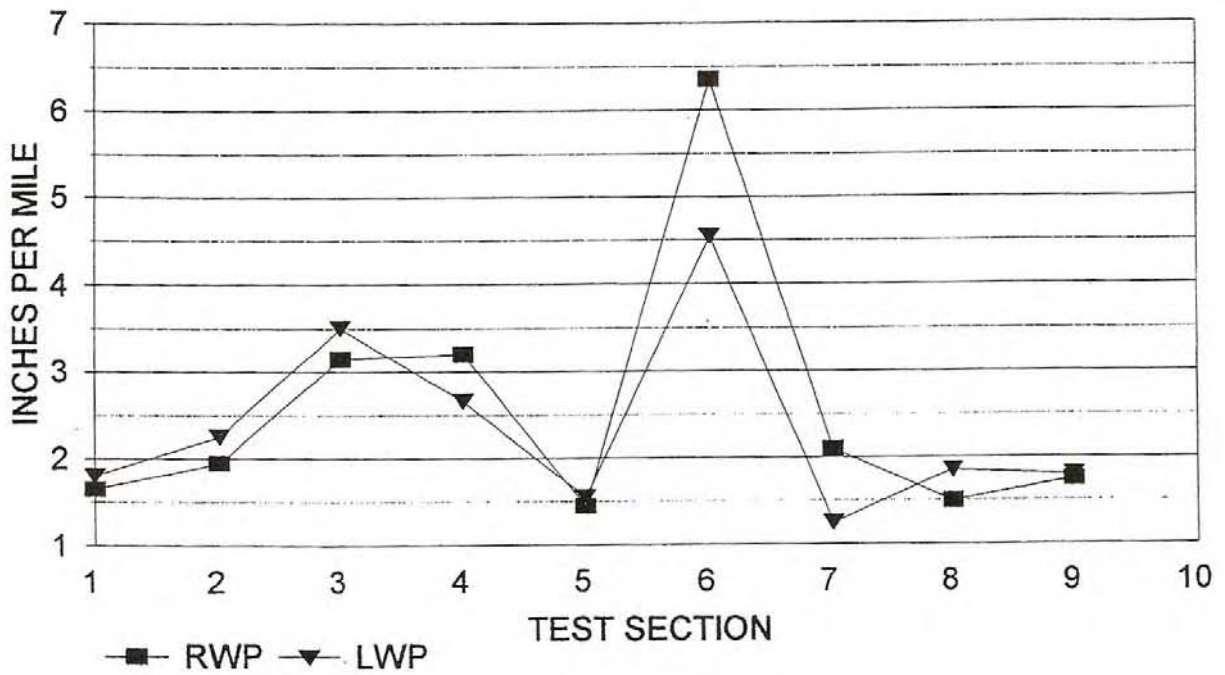
Figure 21

# PROFILOGRAPH

OCTOBER 1994

Test section 6, which was textured using a combination of longitudinal astro-turf and 1-inch uniform tining, exhibited the highest roughness. It should be noted that dynamic effects that act on suspension systems and generate vibrations inside vehicles are primarily due to megatexture or small-scale roughness (explained below). The influence of surface texture on ride quality, with the exception of noise level, is minimal.
