**Report No. CDOT-DTD-R-2001-8
Interim Report**

CENTERLINE RUMBLE STRIPS

**COLORADO DEPARTMENT OF TRANSPORTATION
RESEARCH BRANCH**

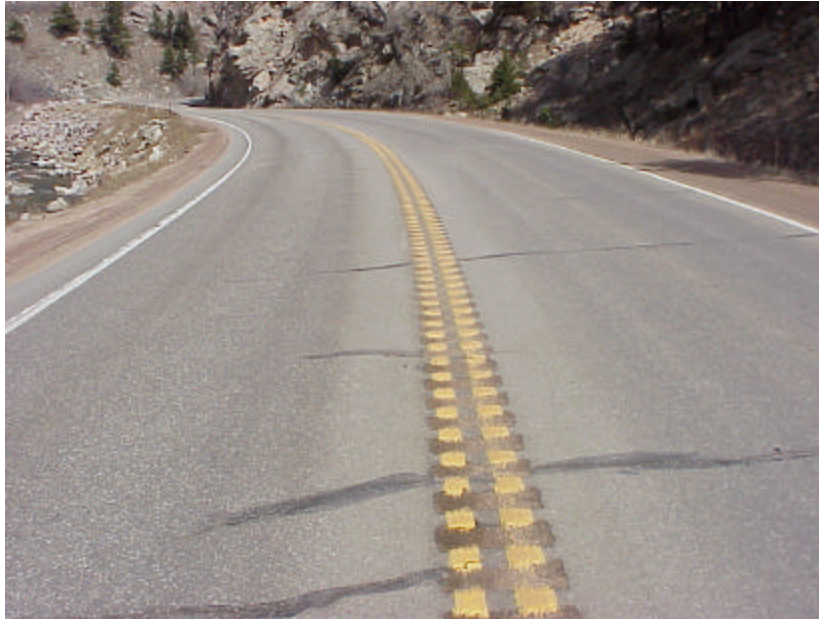
Figure 1. State Highway 119 in Boulder Canyon winds through Forest Service land.

The centerline rumble strip site is located in Boulder Canyon on SH 119 from Milepost (MP) 23, just east of Nederland, to MP 40, about two miles west of Boulder. This is a winding stretch of two-lane highway that has limited site distance and a double yellow "no passing" center stripe for most of its length (Figure 1). In the 17-mile stretch through the canyon, centerline rumble strips were placed at all no passing locations except through intersections. In areas where sufficient sight distance allowed safe passing, no rumble strip was installed.

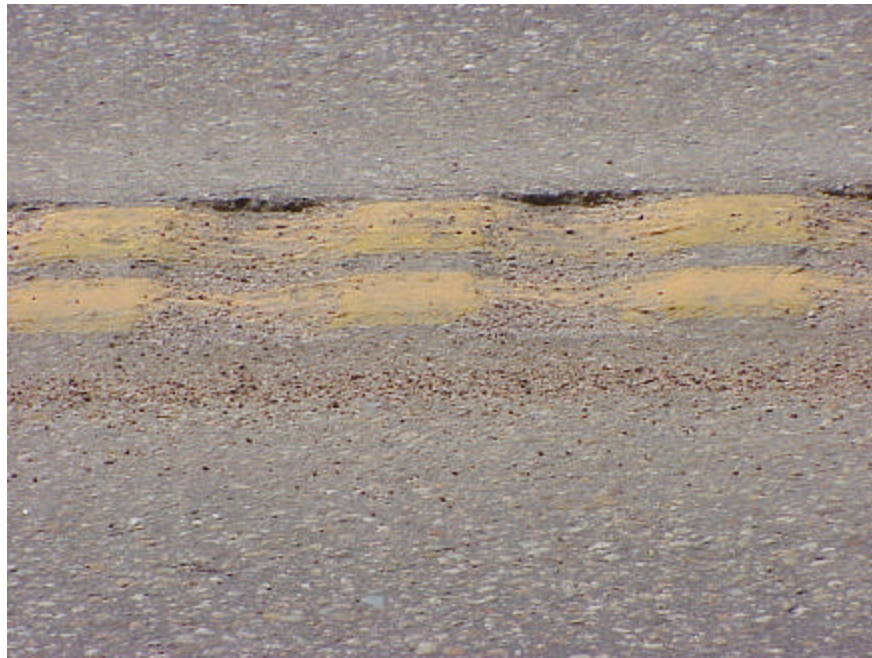
Figure 4. Sand collects in the bottoms of the rumble strip grooves.

During the winter, the grooves in the strip tend to collect some of the sand that is applied during snowstorms (Figure 4). The sand does not completely fill the grooves, however, it does obscure

the part of the paint stripe at the bottom of the grooves. The level of sound generated when a vehicle drives in the rumble strip does not seem to be affected by the sand. The action of traffic eventually clears most of the sand out of the grooves.

There does not appear to be any reduction in the effectiveness of the rumble strips caused by the accumulation of sand and debris in the grooves during the winter. The driver and passenger made subjective evaluations as a vehicle was intentionally driven over the rumble strips. The rumble strips functioned very well under these circumstances with no apparent reduction in sound and vibration level inside the vehicle.
