Europe's Flood Disaster of August 2002: Vienna's Evolving Flood Mitigation Projects

QUICK RESPONSE RESEARCH REPORT 175

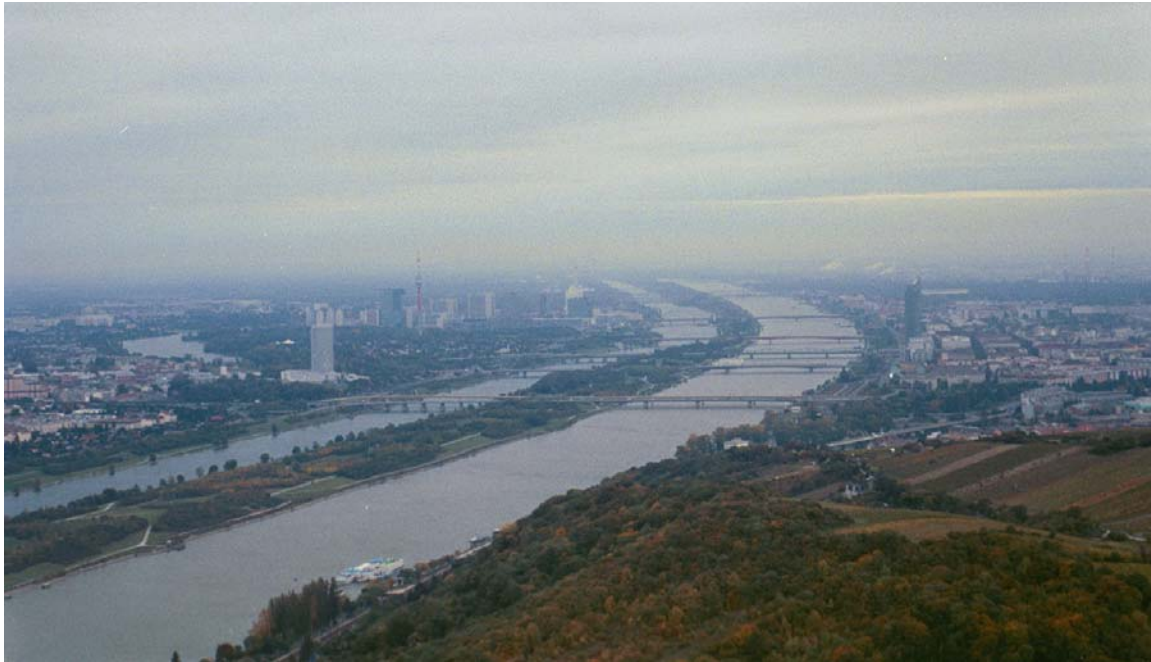
Figure 1. Phase 1 of the Flood Damage Reduction Project: New Danube in the foreground, Danube Island, and the regulated Danube.

Phase 1 had two principal components pertaining to flood hazard reduction: 1) constructing the New Danube canal and 2) creating the Danube Island between the New Danube and the Danube. The New Danube, a bypass channel parallel to the Danube, is approximately 20 kilometers long and an average of 200 meters wide. It is primarily fed by groundwater.

The Danube Island, which ranges in width from 70-210 meters wide, extends virtually the entire length between the New Danube and the Danube. (See Figures 1 and 5).

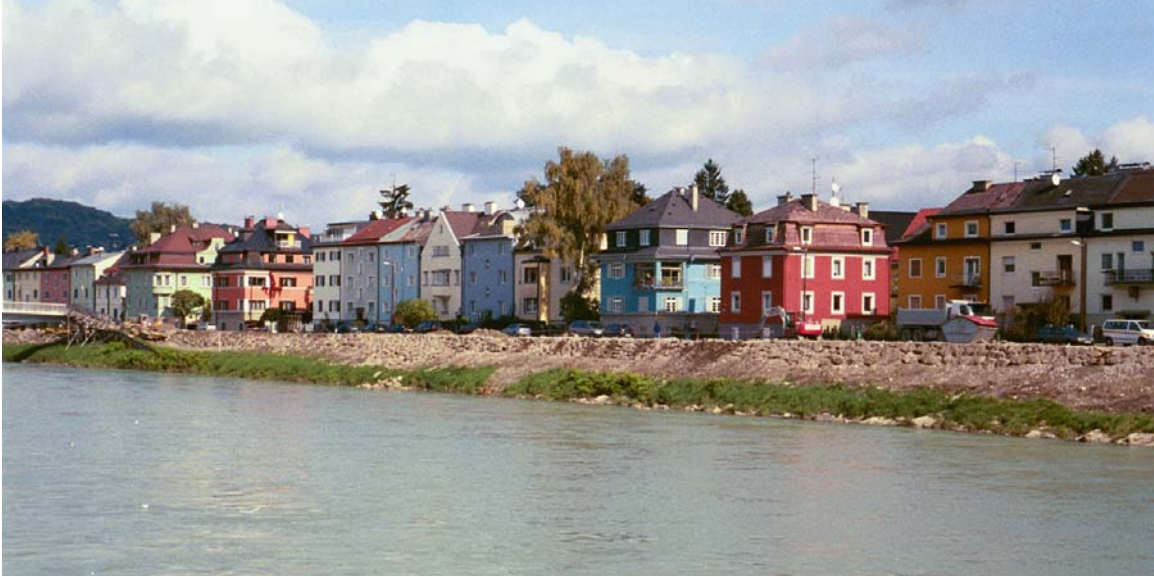
**Hart
verbautes ...**

... und naturnah rückgebautes Ufer

Nach der Initialpflanzung Ein Jahr später

Figure 2. Bank Restoration: Replacement of hard surface with vegetation; photos on right show initial planning and one year later.

increase self cleansing. In addition, meanders and refuge/habitat sites are being recreated (See Figure 2).

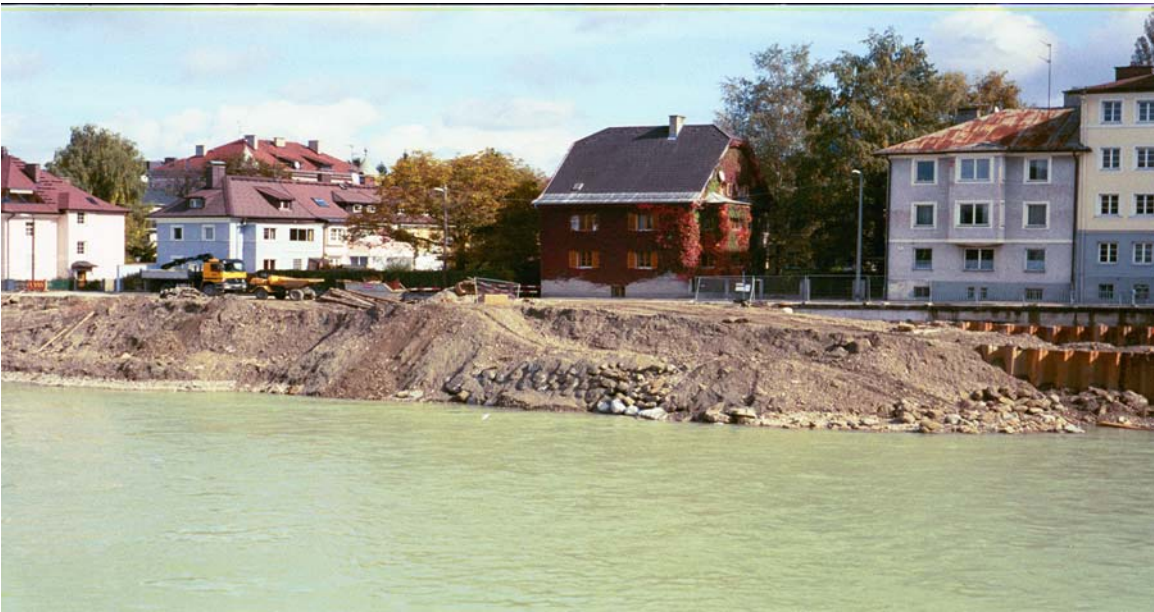
Figure 3. Salzburg: Bank overtopping occurred adjacent to residential sector of the old city.

The banks of the Danube as it flows through the old town of Salzburg had been hardened. In those areas the waters overtopped the banks (See Figure 3).

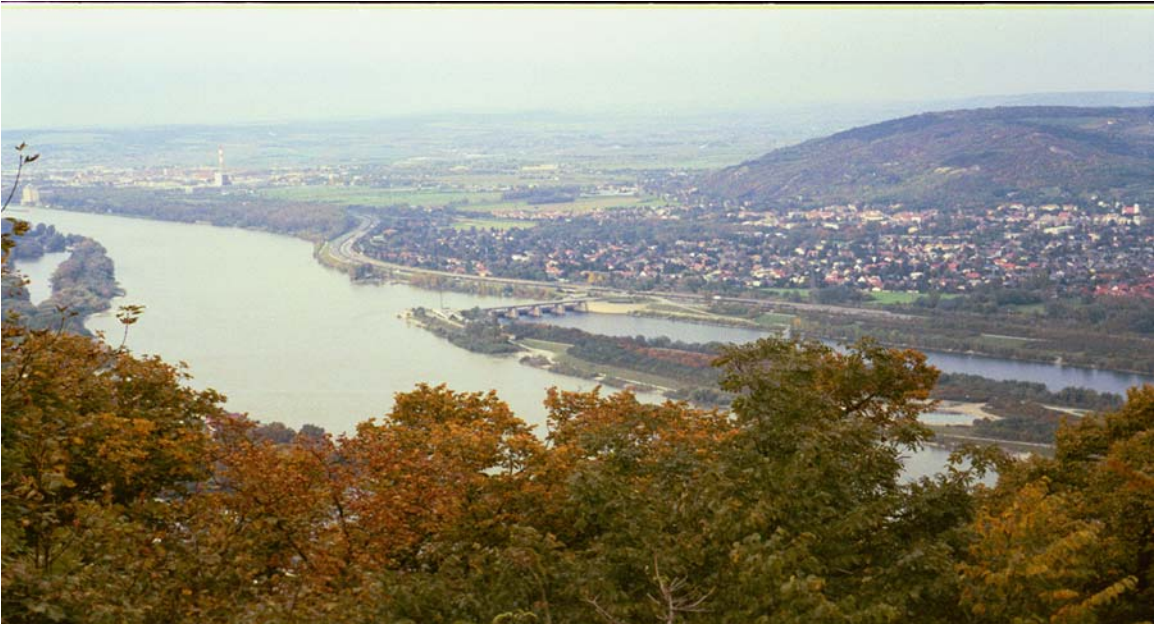
Figure 4. Confluence of the Danube and the New Danube, with Danube Island in the middle.
Note reconnection and restoration of habitat in upper left foreground.

Vienna’s project (See Figure 4) clearly demonstrates that floodplain restoration is an interdisciplinary and cooperative undertaking. Interdisciplinary cooperation has included hydrologists, hydraulic engineers, hydrogeologists, geotechnical engineers, biologists, landscape architects, urban planners, and others.

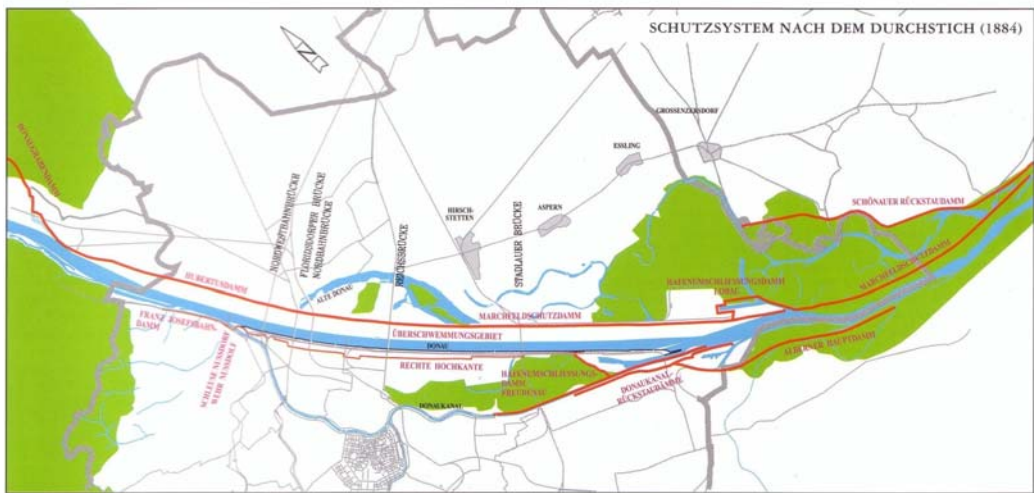
1884: After the Regulation
