# **Colorado's 1997 Flood Season in Review**

**The events, damages, and  
repercussions of the flooding that  
occurred in Colorado during the  
summer of 1997**

*Authorized by the*  
**Colorado Water Conservation Board**

*Produced by*  
**Riverside Technology, inc.**

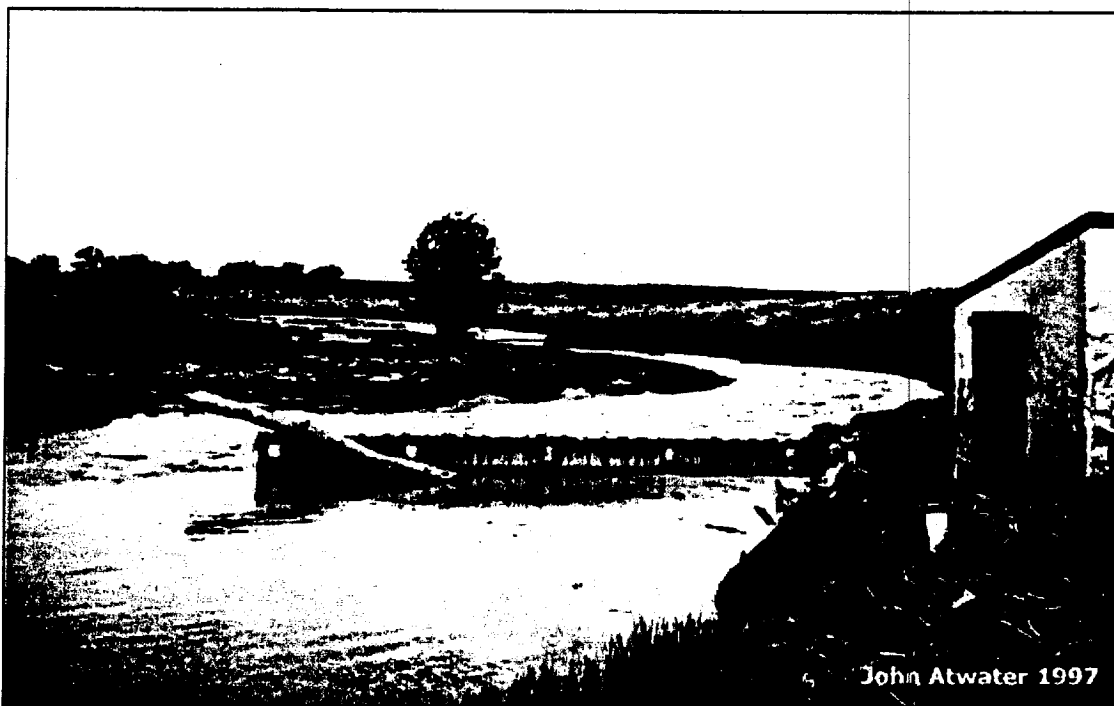
**Figure 4.4-7 Agricultural Damage Along South Rush Creek**

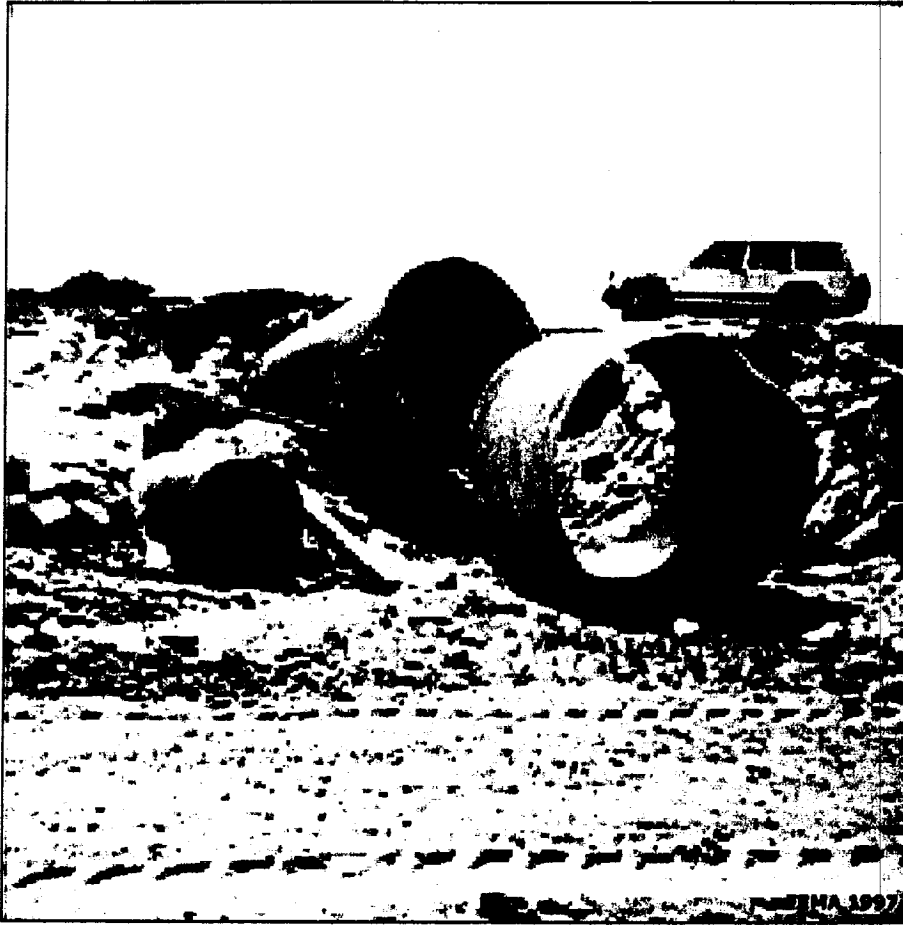
**Figure 4.5-6 Damaged Culvert Under County Road L in Western Kiowa County**

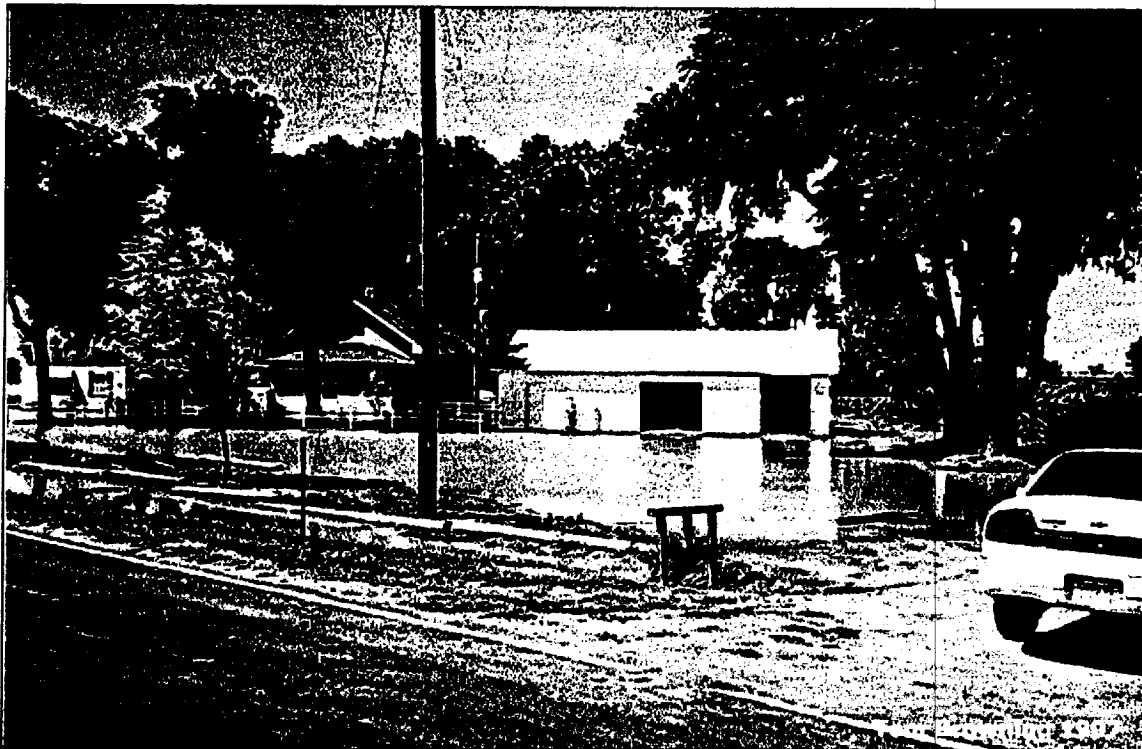
**Figure 4.9-4 Flood Waters in Weldona North of Highway 144**

Flow from County Road 8, including runoff from a large watershed to the west of Schaefer Draw, emptied into the Weldon Valley Ditch where the ditch crosses the road. The Weldon Valley Ditch was overtopped by as much as 2 feet between County Road 8 and County Road 9. These flood waters migrated in a southeasterly direction toward Weldona and eventually flooded a 6-block area with as much as 4 to 6 feet of water (see *Figures 4.9-4* and *4.9-5*).

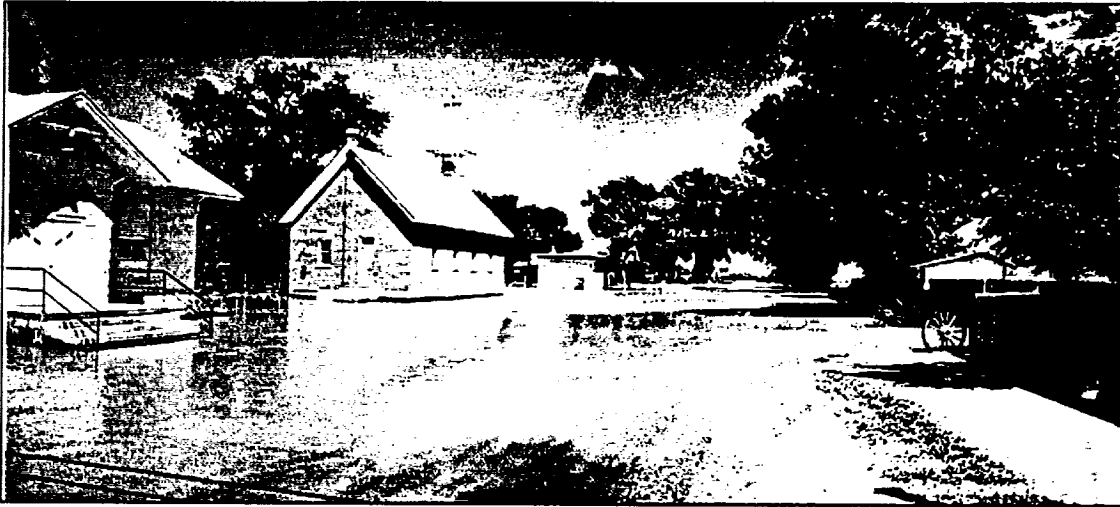
**Figure 4.9-9 Street Flooding at the Intersection of Warren Street and Cottage Street, Weldon**

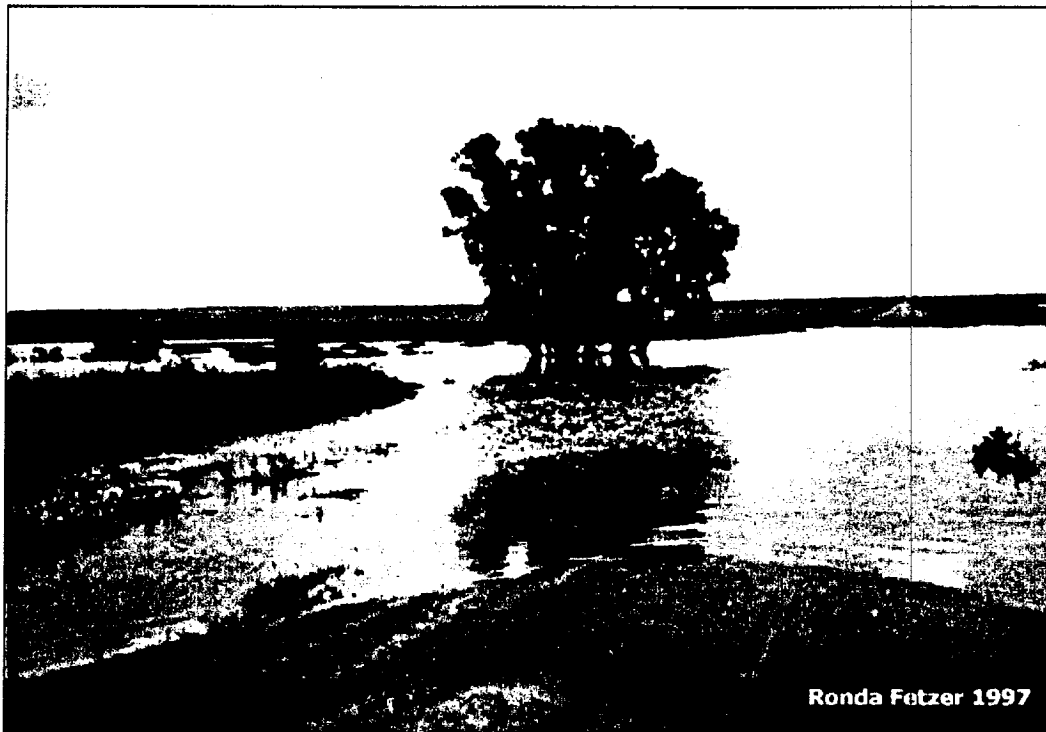
**Figure 4.11-4 Flooding Along Sandy Creek at Highway 59**

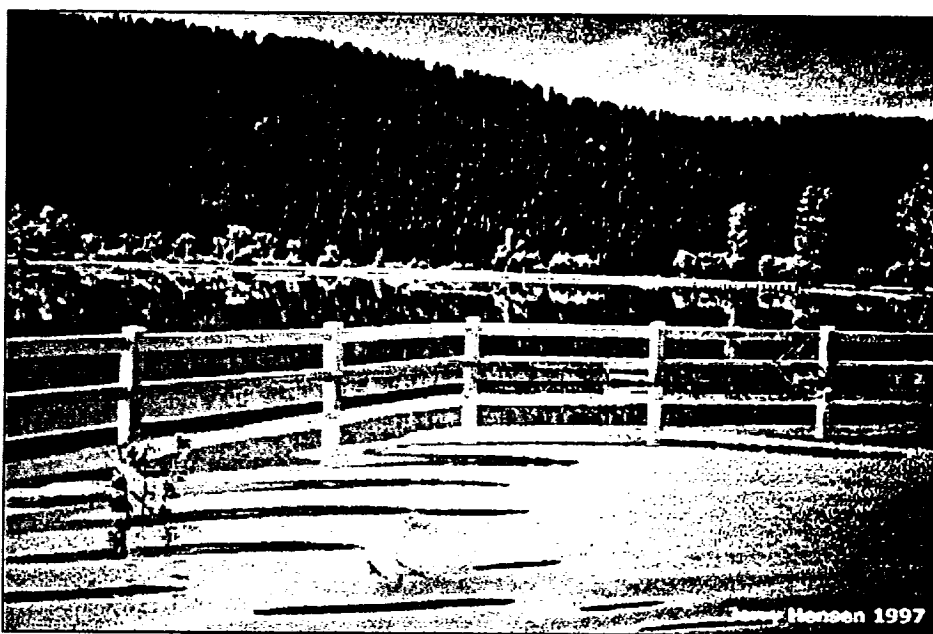
**Figure 4.13-6 Inundated Pasture**

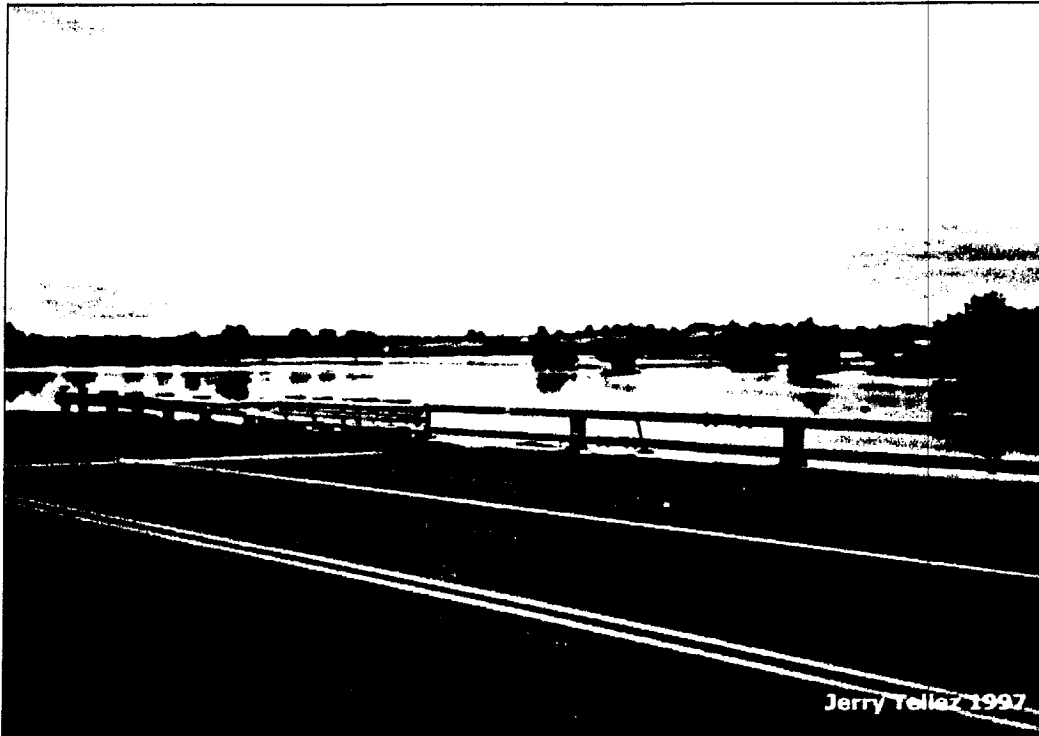
Figure 4.14-6 Flooding Downstream of Bridge Along Cache la Poudre River

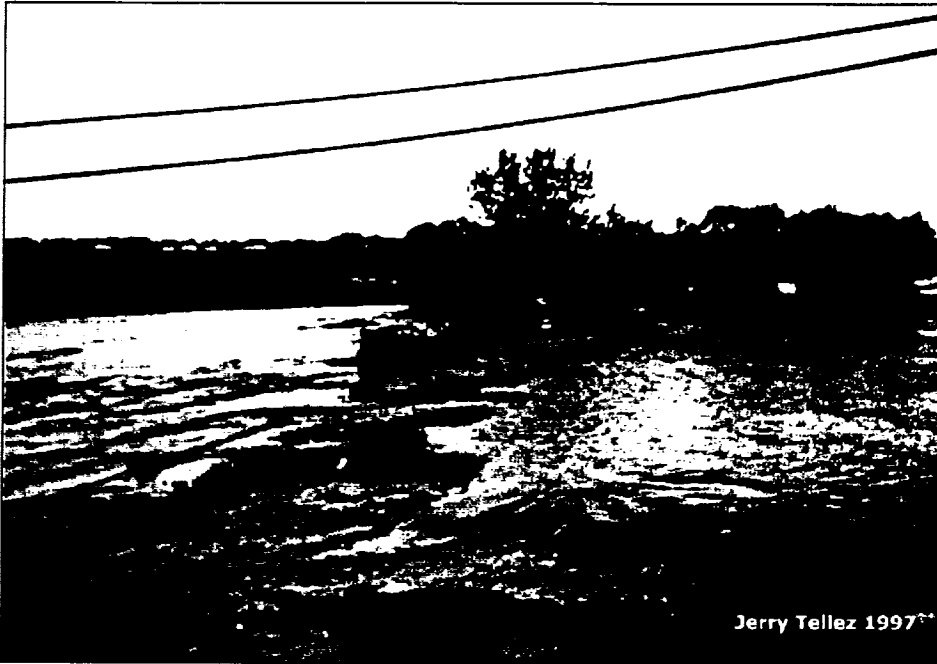
**Figure 4.14-8 View From 10th Street Bridge Looking South Along Sheep Draw**
