Open File Report 91-1

**Identification and Remediation  
of a Mine Flooding Problem in Rico,  
Dolores County, Colorado  
with a Discussion on the Use of Tracer Dyes**

By Mark W. Davis

Colorado Geological Survey  
Division of Minerals and Geology  
Department of Natural Resources  
Denver, Colorado  
1994

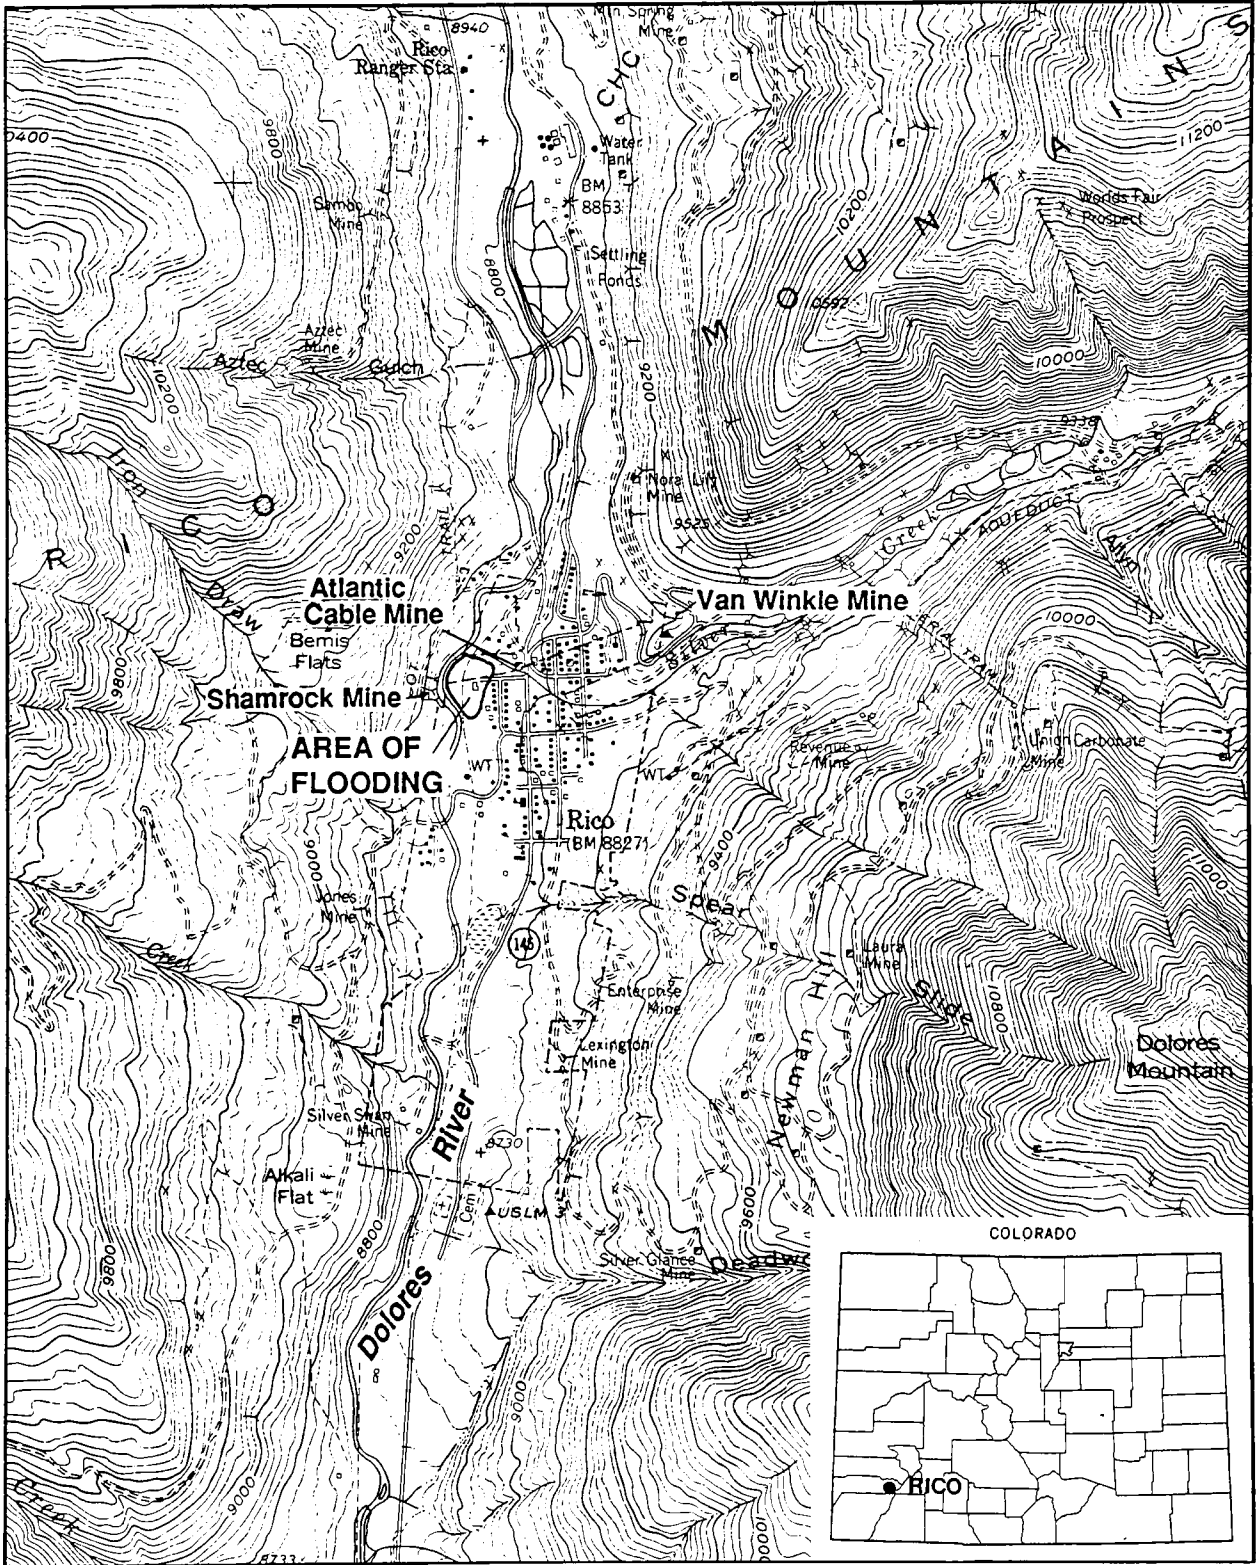
In late May, 1989, residents of Rico, Colorado, became concerned when water from Silver Creek and from an abandoned mine threatened several dwellings located on the Dolores River flood plain (Figure 1). The Department of Natural Resources was advised of this flooding and immediately dispatched a team to investigate the severity and causes of the problems and to recommend solutions. The team consisted of Dave Bucknam, Division of Minerals and Geology; Mark Davis, Colorado Geological Survey; Glen Humiston, Division of Water

Figure 1. Area of flooding, Rico, Colorado (modified from U.S.G.S. Rico topographic quadrangle, scale 1:24,000).

Remediation of the flooding entailed the installation of a steel culvert over the caved portion of Silver Creek by the property owner and construction of several drainage ditches near the residences. Backfill was added to the caved area and surface recontouring was done in selected areas.

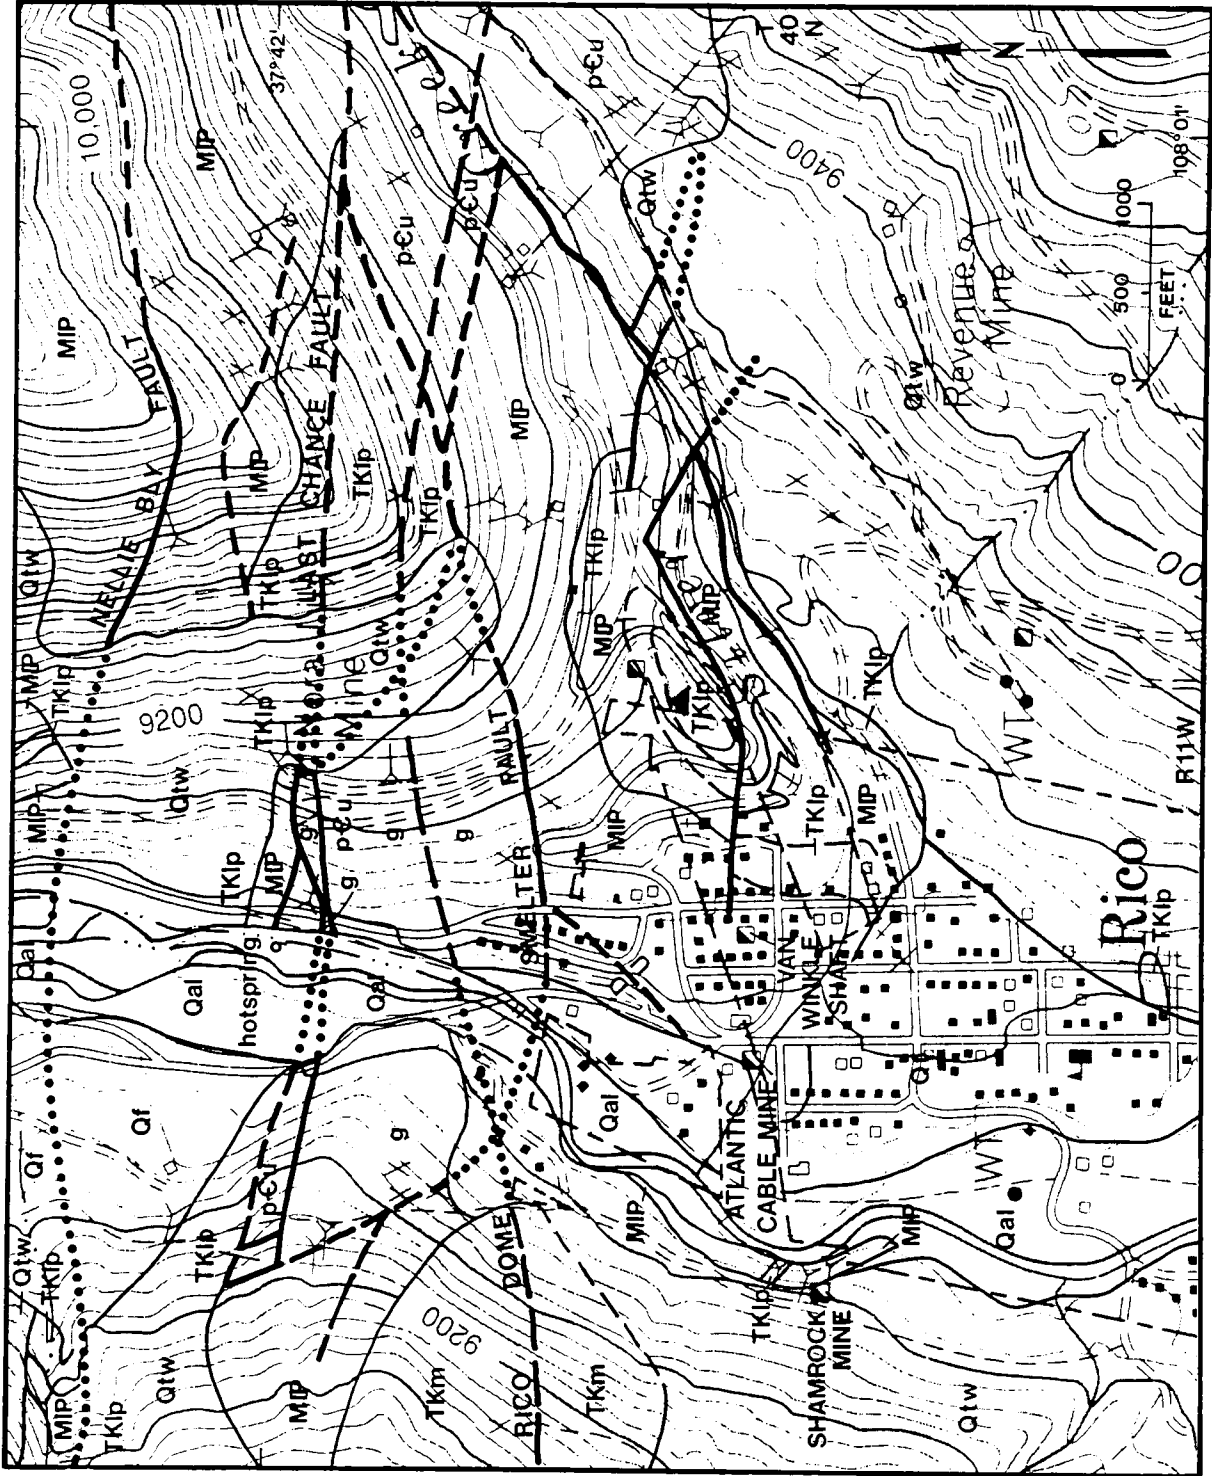
The geologic environment consists mainly of Paleozoic sedimentary rocks including limestones, shales, sandstones, and arkoses overlain in large part by Quaternary deposits of talus and slope wash, torrential fan deposits, landslide deposits, and alluvial gravel. The sedimentary units dip gently to the south and are cut by many east-west striking faults (Figure 2).

Figure 2. Generalized geology of Rico, Colorado (Modified from McKnight, 1974, Plate 1).

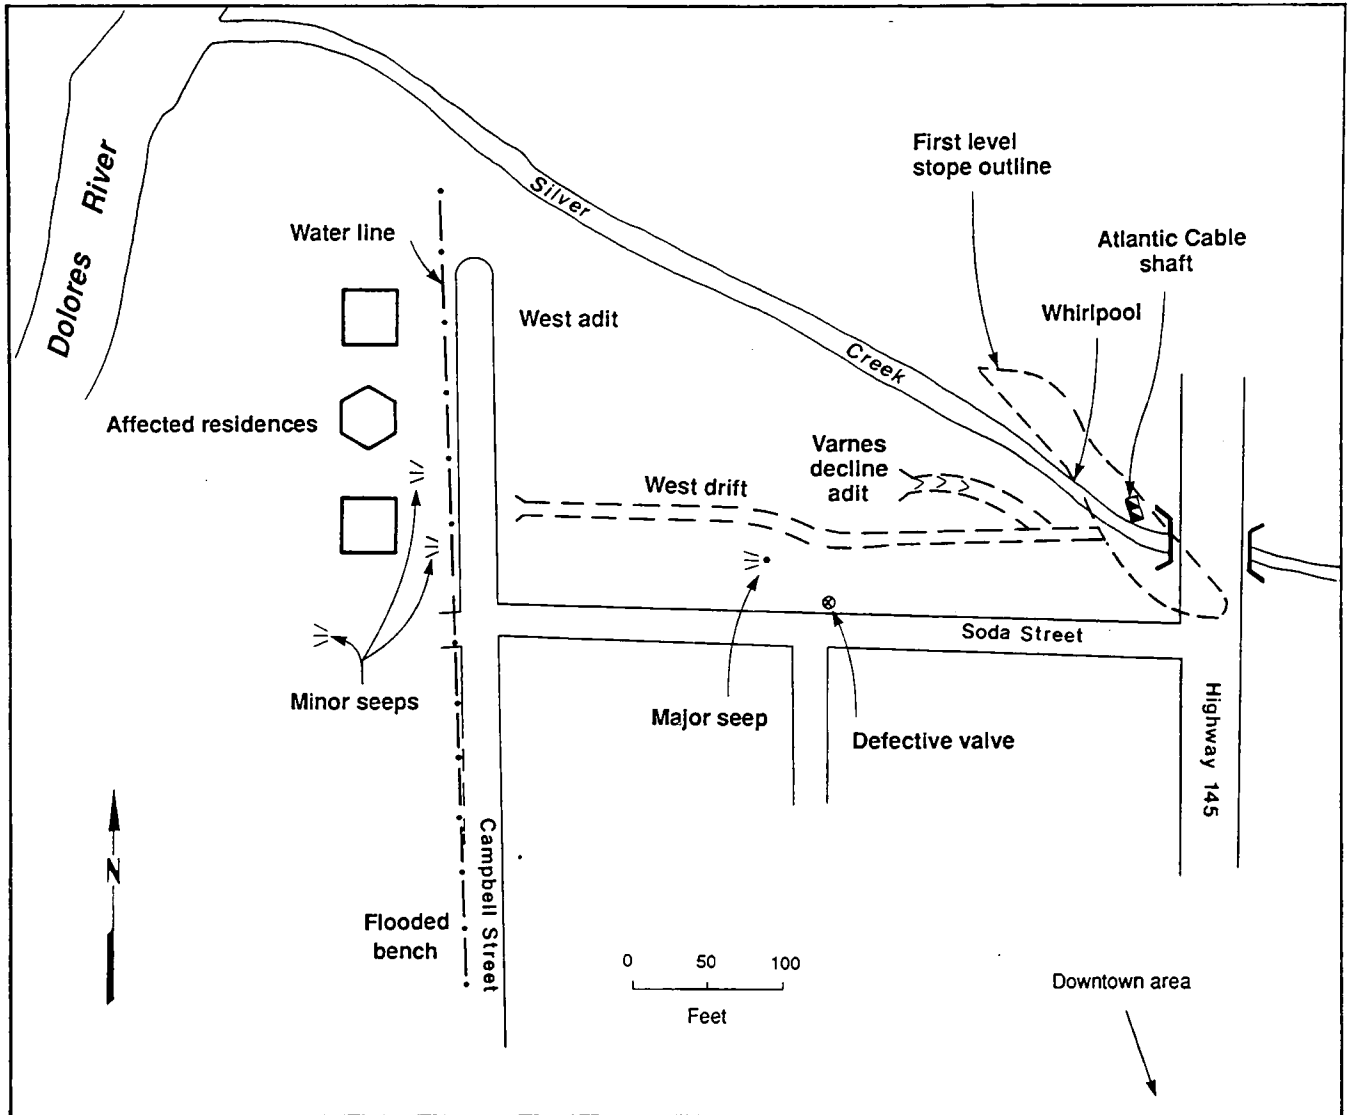
The flow discharging from the west adit was diverted to the north and temporarily channeled across the road. Some of this flow was thought to be seeping under the road and to the front yard of the southernmost residence in the affected area (Figure 8). The owner indicated that his leach field was located there but no odors or discoloration of the water was observed. However there was a slight discoloration and a septic field odor approximately 80 ft southeast of the residence near the Dolores River.

Figure 8. Affected residences and their relationship to Silver Creek and the west adit.

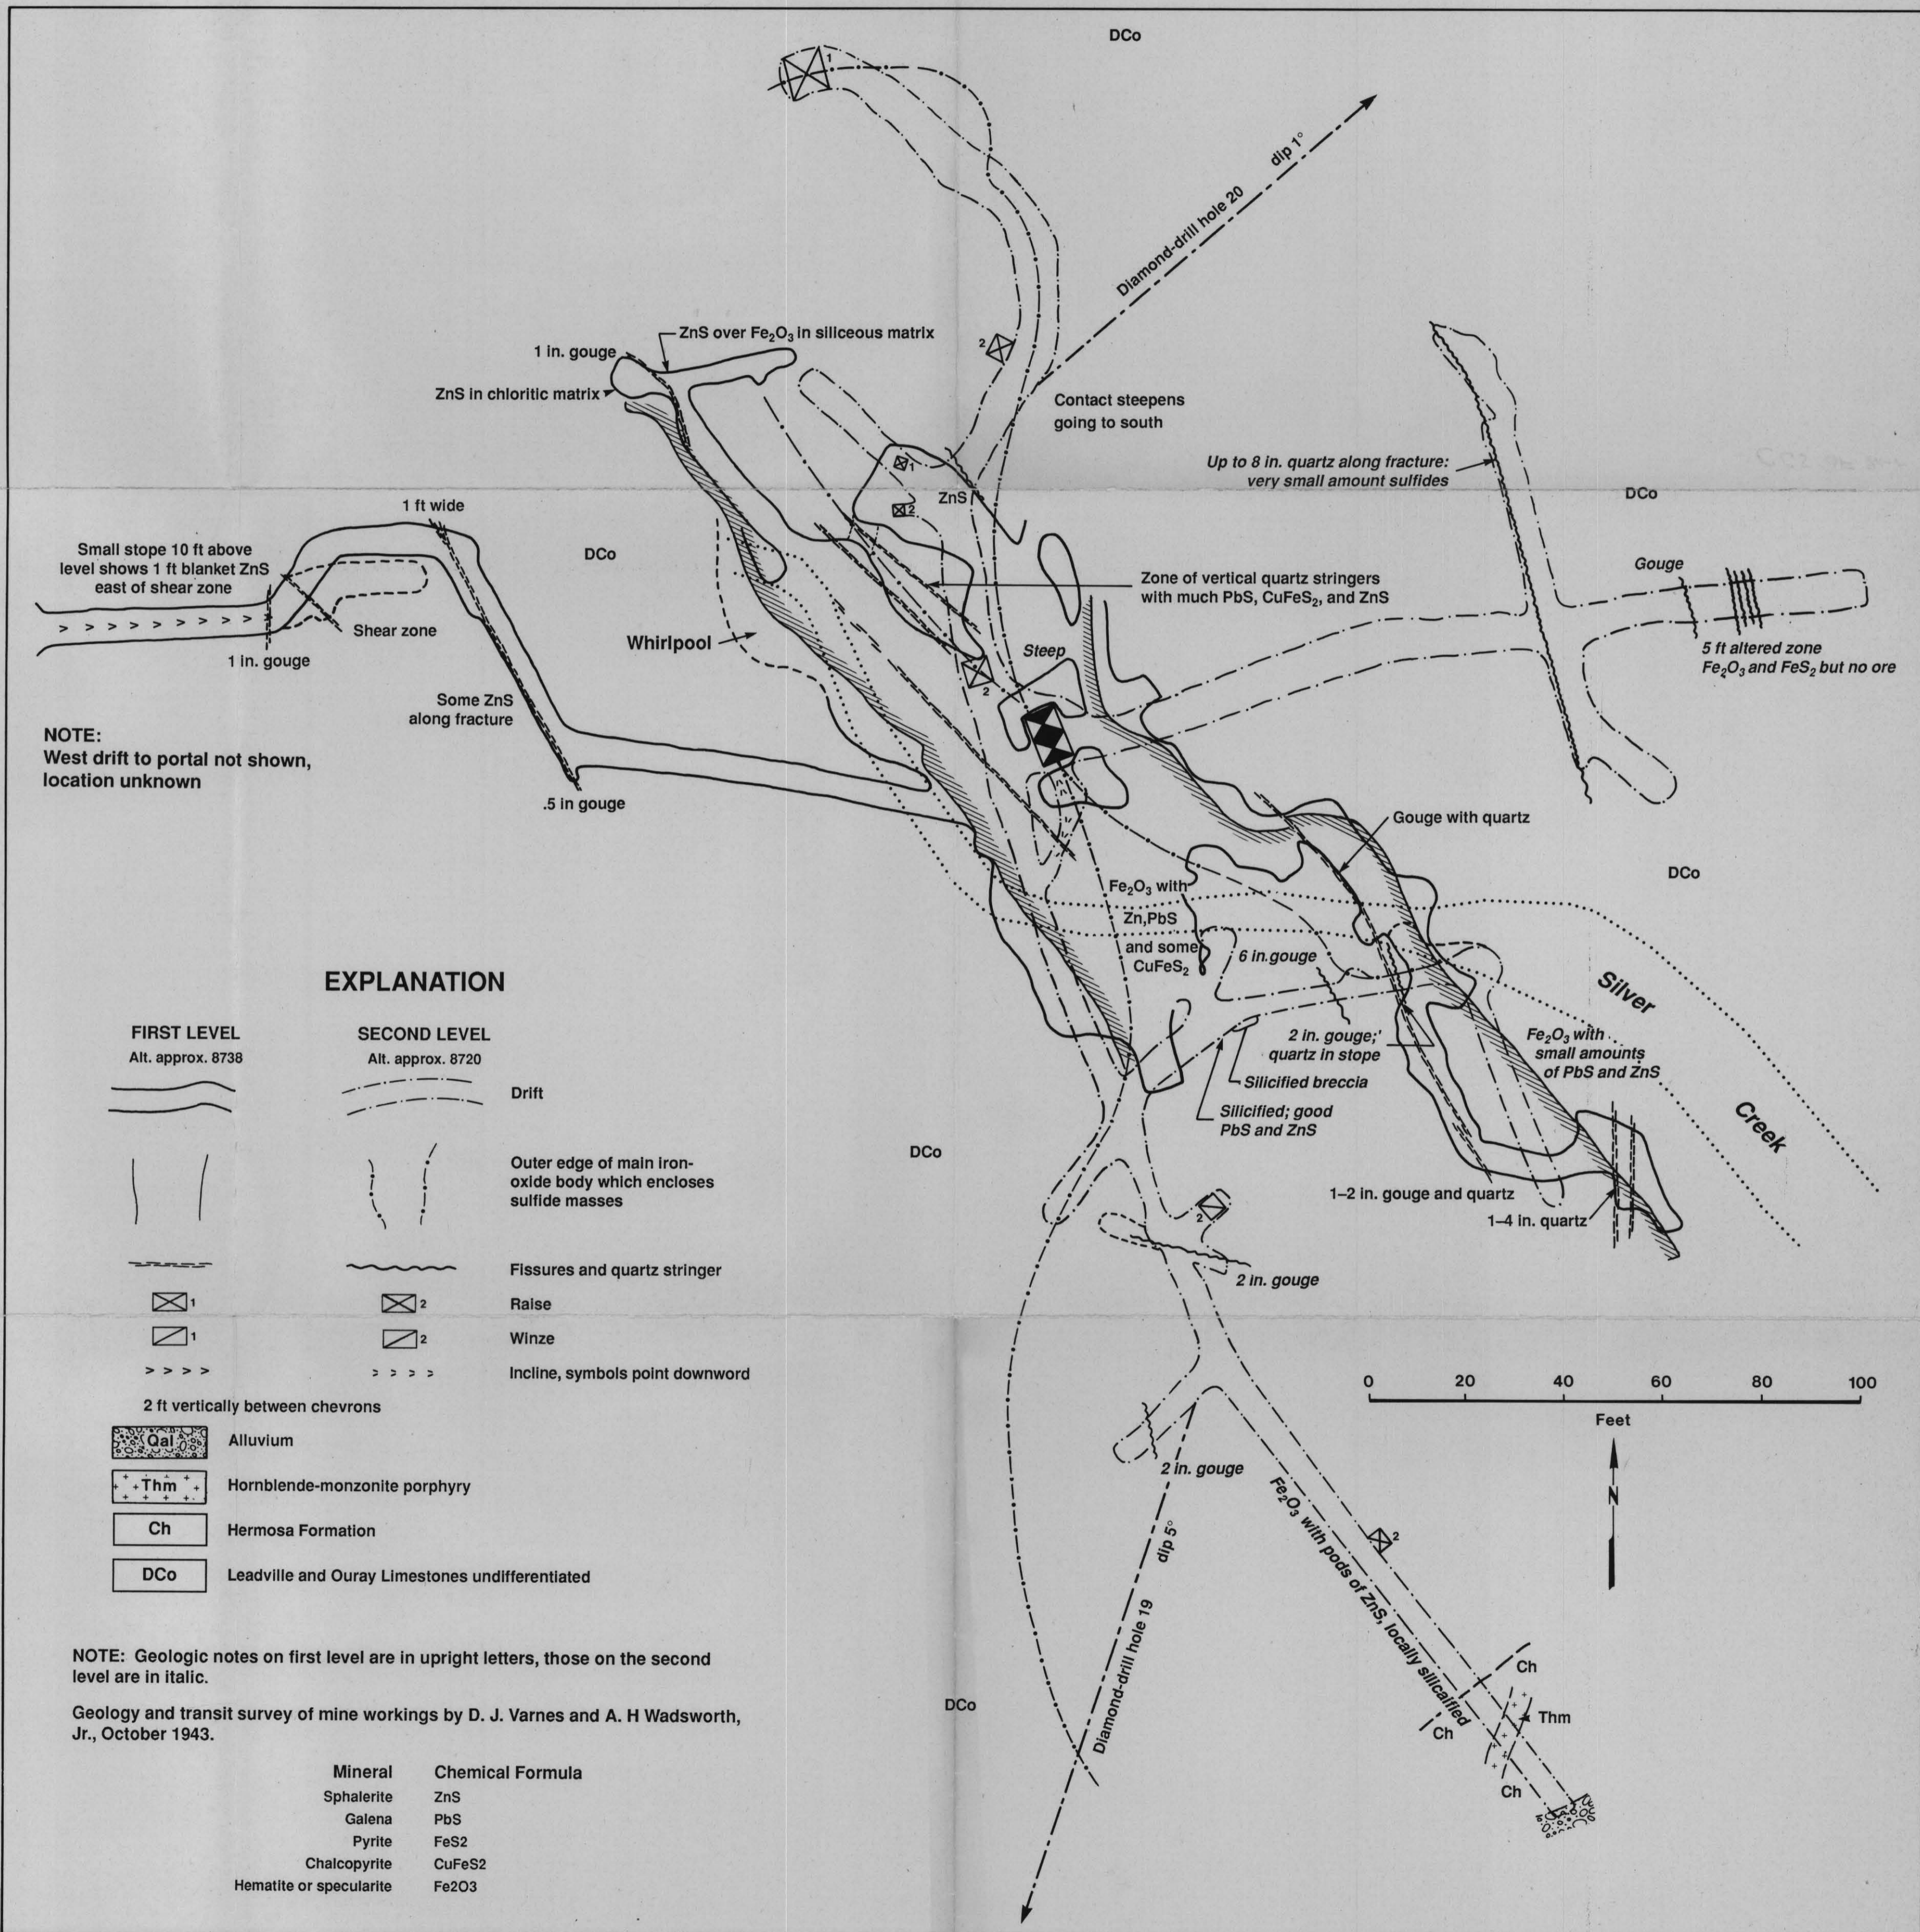
By D. J. Varnes and A. H. Wadsworth, Jr.  
 1943

The Atlantic Cable Mine was serviced by a two compartment shaft for men and equipment and for hoisting ore. There appear to be three levels at the Atlantic Cable Mine served by the shaft. The main stope was developed for approximately 400 ft in a northwest to southeast direction. Plate 1 depicts a drift driven to the west from the sill of the first level at an elevation of 8,738 ft. This westerly drift extends approximately 200 ft from the shaft to what is shown as an incline to the surface on Plate 1. Another heading was driven westward possibly as an extension of this drift for dewatering and haulage. This 500-ft west drift was utilized to dewater the Atlantic Cable to the first level.

## Geology and Transit Survey of Mine Workings

**NOTE:**  
 West drift to portal not shown,  
 location unknown
