# **LONG-TERM MONITORING OF MECHANICAL PROPERTIES OF FRP REPAIR MATERIALS**

**July 2013**

**COLORADO DEPARTMENT OF TRANSPORTATION**  
**DTD APPLIED RESEARCH AND INNOVATION BRANCH**

1. Report No. CDOT-2013-13	2. Government Accession No.	3. Recipient's Catalog No.	
4. Title and Subtitle LONG-TERM MONITORING OF MECHANICAL PROPERTIES OF FRP REPAIR MATERIALS		5. Report Date July 2013

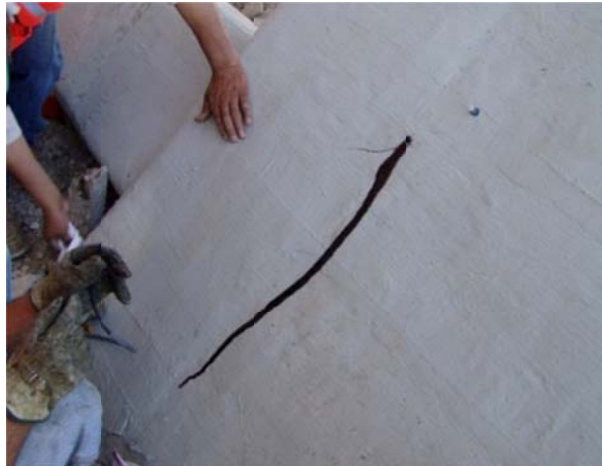
required number of layers of CFRP. A void that had been injected with resin directly following the CFRP application can be seen below in Figure 2.12. There was no documentation of this procedure or any information regarding the areas repaired or filled with resin, but it is assumed that this process was satisfactory.

**Figure 2.12.** Void injected with resin during 2003 renovation (Mohseni, CDOT)

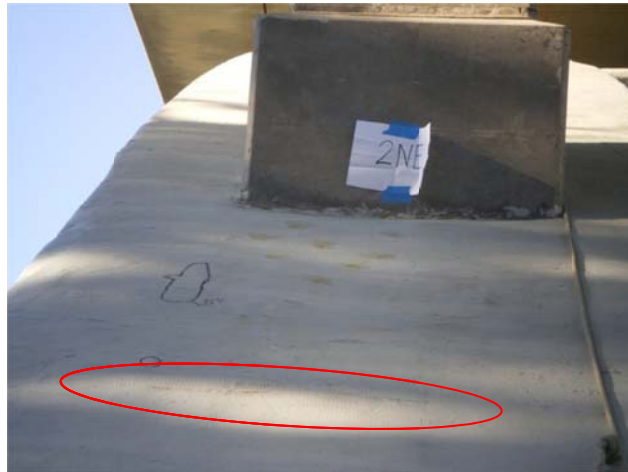
Markings made with a permanent marker on the bridge from the 2007 bridge inspection were barely visible at the time of the 2011 field assessment. Depending on the exposure from moisture and sun, markings on the bridge can exist for only a relatively short time with respect to the life span of the bridge. Below are three photographs of the areas identified from June 2007, two of which were barely visible at the time of the July 2011 visit. There were no markings found on the east arch from the inspections in 2005 and 2009. In addition to the three voids, three cracks in the CFRP were also identified in 2007, one of which can be seen below.

**Figure 2.16.** Crack identified in 2007

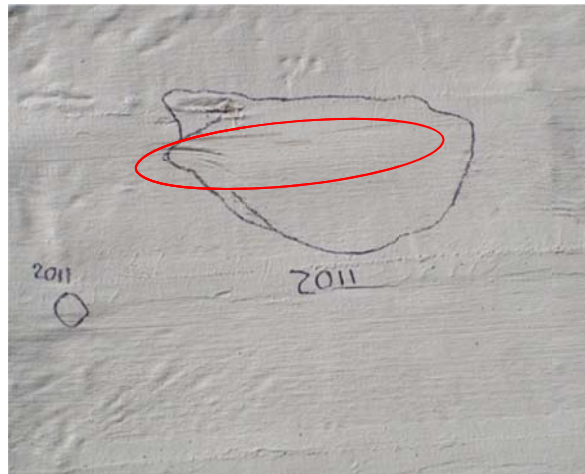
The images above are of two voids found in the 1<sup>st</sup> bay on the north end of the east arch. The area of the larger void was one of two areas eventually removed from the arch and is referred to as the

“smaller” patch removed from the arch. Note the horizontal or transverse cracks enclosed in the red oval near the top of the void in Figure 3.2.

**Figure 3.2.** Two identified voids during the 2011 inspection, visible cracks in CFRP

All three voids identified during the biannual inspection in 2007 had grown in size and all voids found in the 2011 field assessment that were not previously identified presumably developed in the time between the 2007 bridge inspection and the 2011 field assessment. It was not possible to determine whether the crack identified in 2007 had grown in size; the physical markings on the bridge only indicated the crack existed at the time of the 2007 bridge inspection. In terms of documentation, in addition to the physical markings left on the bridge from both the 2007 bridge inspection and 2011 field assessment, locations and sizes of voids found on the extrados of the east arch are tabulated in Appendix A. There were 28 voids, 3 cracks, and 1 rust spot found during the 2011 field assessment. The voids ranged in area from less than  $26 \text{ cm}^2$  ( $4 \text{ in}^2$ ) to  $9876 \text{ cm}^2$  ( $1530 \text{ in}^2$ ) averaging approximately  $580 \text{ cm}^2$  ( $90.3 \text{ in}^2$ ). Photographs of the identified areas on the arches can also be found in Appendix A as well as thermal images of voids.

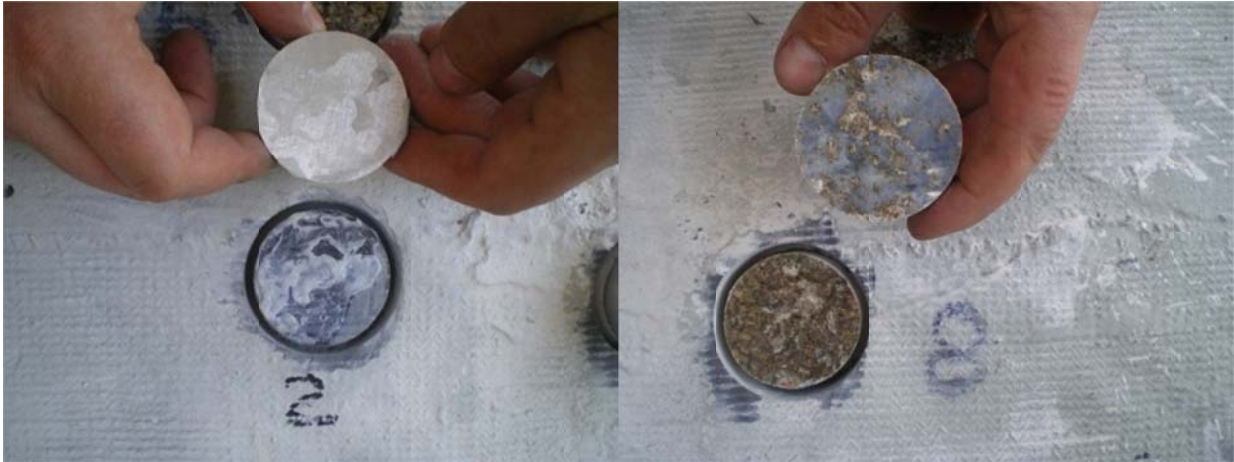
**Figure 3.14.** Failure Mode A: bonding adhesive failure at loading fixture (on left), failure Mode E: adhesive failure at CFRP/substrate adhesive interface (on right)

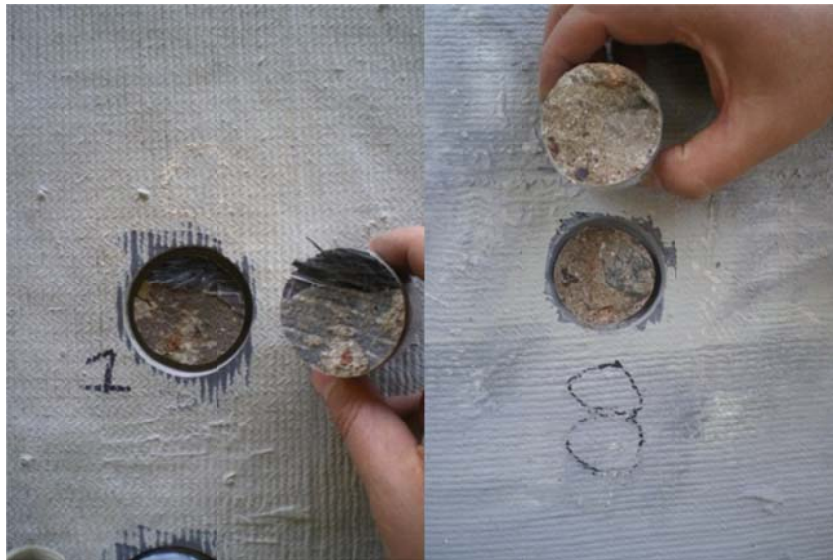
**Figure 3.15.** Failure Modes B and F: cohesive failure in FRP laminate, and mixed cohesive failure in substrate and adhesive failure at the adhesive/substrate interface, respectively (on left), failure Mode G: cohesive failure in concrete substrate (on right)

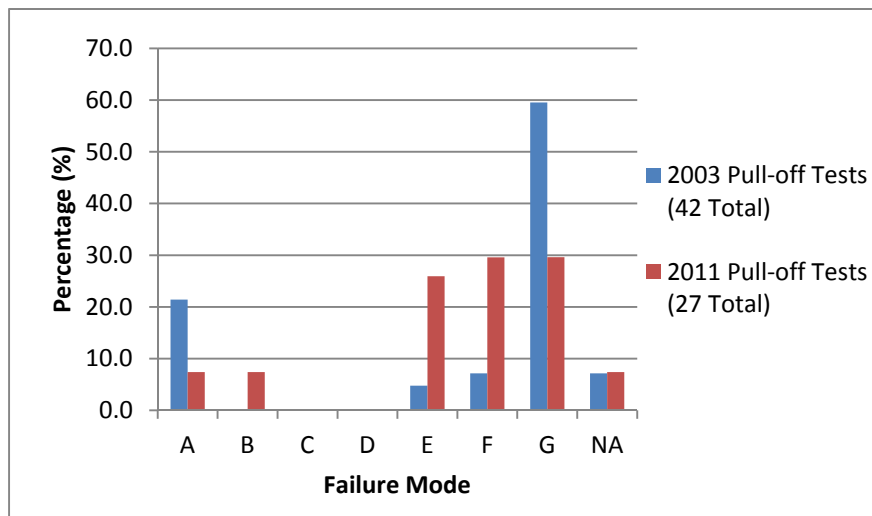
**Figure 3.16.** Failure modes of pull-off tests from 2003 and 2011

The number of failure Modes E, F, and G are roughly equal in number with only approximately 7% of the specimens failing in each of the A, B, and NA Modes for the tests conducted in 2011. From Figure 3.16 it is apparent that the high percentage of failure Mode G from 2003, significantly decreased to the evenly distributed Modes E, F, and G of the 2011 test results. Mode B was a failure mode that did not occur in 2003, but did in 2011 twice out of 27 tests. An increase in percentage of failure Modes B, E, and F indicates that other interfaces other than within the substrate are weaker and controlling. Failure Mode B is, according to ASTM D7522, “an indication of poor through-thickness properties of the FRP. Such failures may be due to incomplete wet-out of the fibers or plies comprising the laminate. Such failures may also result from environmental degradation of the FRP material itself.” The term “wet-out” is

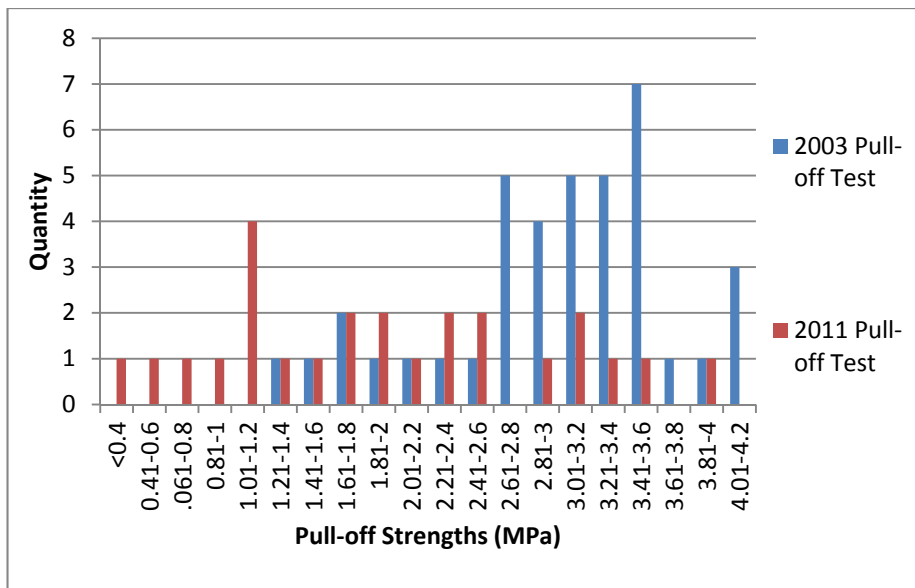
Of the 27 pull-off tests conducted in 2011, nine tests, two of which were failure Mode G, failed to meet the 200 psi minimum requirement of CDOT’s construction specifications (Revision of Section 602). Six of the nine tests that had strengths less than 200 psi had failure Mode E. This failure mode is a failure at the interface between the CFRP and the substrate. A relatively thick layer of resin was used to smooth the surface of the substrate at the time of the CFRP repair. The thick “filler” resin varied in thickness and in color. These pull-off tests with low values all appeared to have very similar failure modes and strengths as well as appearance of the failure plane. Only one of the 42 tests conducted in 2003 failed to exceed 200 psi. Below are two figures displaying the distribution of pull-off strengths and probability density functions based on a normal distribution of pull-off strengths.

**Figure 3.17.** Histogram of pull-off test strength

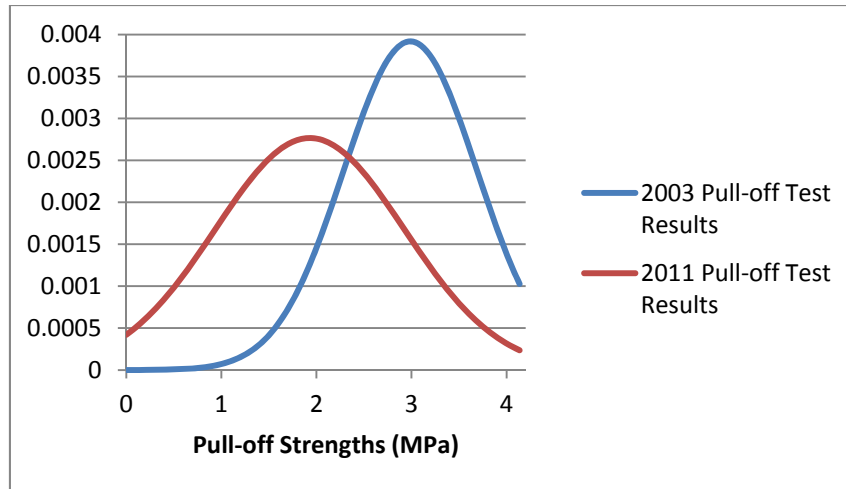
**Figure 3.18.** PDF of pull-off test results

The lower, wider, curve of the 2011 PDF in Figure 3.18 gives evidence that the standard deviation increased from 2003 to 2011. The data was fit with a normal distribution for the creation of the PDF and statistical analysis. In addition from 2003 to 2011 the mean lowered, shifting to the left. If the influence of the testing procedure could be disregarded, the larger variance of the 2011 results would likely represent the varying conditions in which the CFRP was exposed. The decrease in the mean from 2.98 to 1.93 from 2003 to 2011 gives indication of an overall decrease in the bond strength of the CFRP to the concrete. This indicates a possible durability concern for long-term applications.

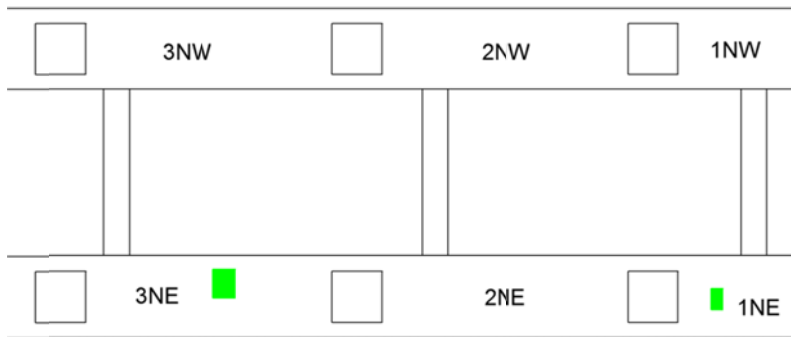
**Figure 3.19.** Areas removed are highlighted in green

The smaller of the two voids, approximately 28 cm x 51 cm (11" x 20") in size, was removed from the extrados of the 1<sup>st</sup> bay on the north end of the east arch. This void had a previously identified crack running in the transverse direction on the arch. A right angle-grinder mounted with 11.4 cm (4 ½") masonry cutting wheel was used to cut through the CFRP layer in a rectangular shape enclosing the area of the void. Once the CFRP was removed, it was reasoned that this area of CFRP was at one time bonded to the substrate, because the crack previously seen in the surface of the CFRP was also present in the substrate. It was likely that the concrete cracked due to service loads or shrinkage. It is possible the crack was present before the CFRP was applied and the crack opened more causing the CFRP to crack. According to CDOT's construction specifications, cracks in the substrate larger than 1.5 mm (0.06 in) in width were to be pressure injected with epoxy resin prior to the application of the CFRP. When the

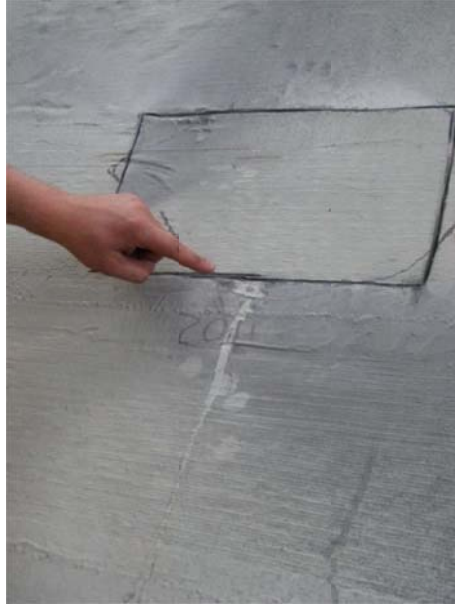
Upon cutting the lower edge of the CFRP rectangle, water exited the cut at the bottom of the void revealing standing water at the interface between the CFRP and substrate. Photographs of the void and the removal of the CFRP layer are shown in Figures 3.20, 3.21 and 3.22 below.

**Figure 3.21.** Water exiting the void area directly after the lower cut through the CFRP was completed

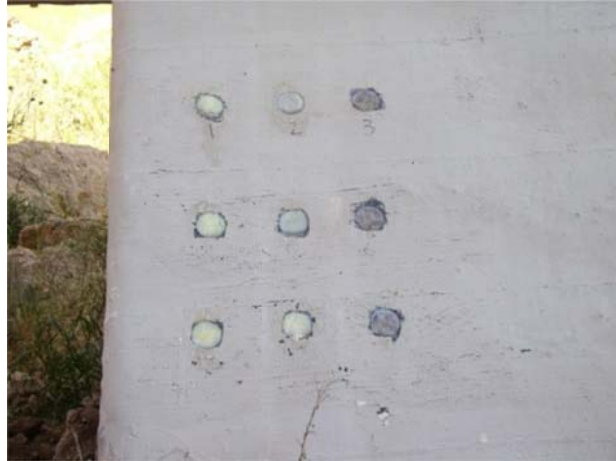
Due to the pull-off tests, a total of 27 – 57.15 mm (2 ¼”) diameter holes of varying depths, depending on the failure mode, were created on the arch. These areas were filled with epoxy to replace the cross-sectional area. Initially, the same epoxy used to adhere the aluminum pucks to the CFRP was used to fill the holes created from the pull-off tests. Due to the inclined angle, this epoxy, which is less

**Figure 3.24.** Epoxy filled holes following the pull-off tests

viscous before curing, would slump and run down slope on the locations near the base of the arches. This was undesirable and a more viscous epoxy, 3000 psi Loctite epoxy gel, was used to fill the holes created from the pull-off tests. These filled holes of varying depths can be seen below.

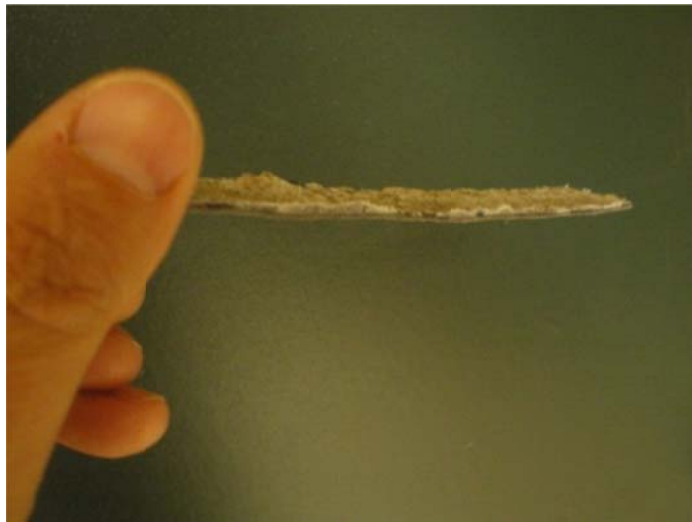
The thickness of the CFRP strips varied significantly due to the rough contour of the adhered side of the CFRP. As previously discussed in sections 3.2.4 and 3.2.5, a thick filler resin was applied to smooth the surface of the substrate prior to adhering the CFRP fabric to the arches. A photograph of the rough texture is below.

**Figure 4.1.** The rough contour of a tensile test strip of CFRP

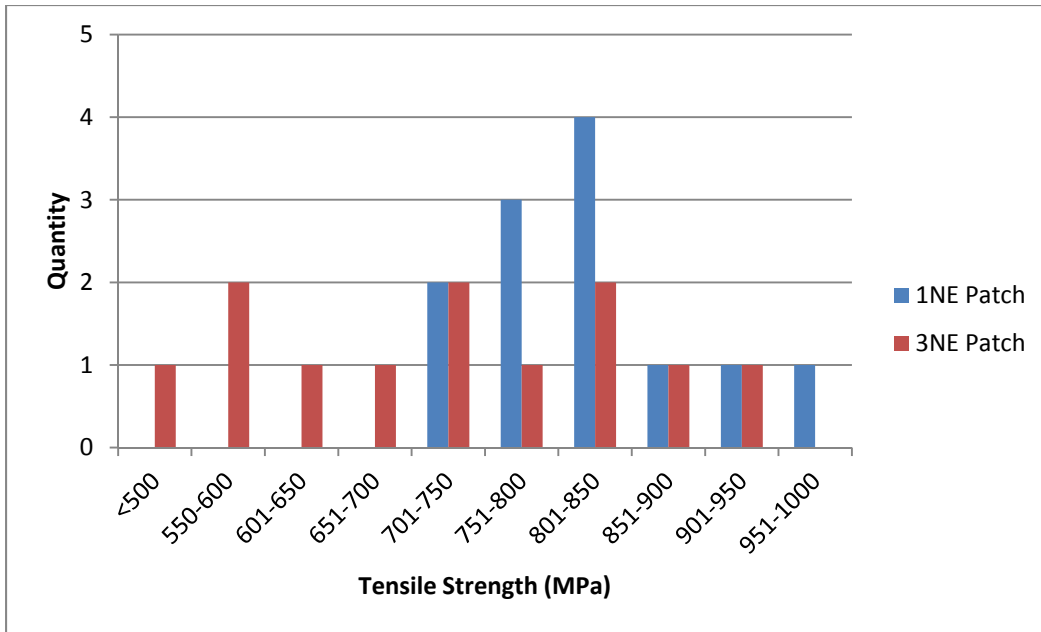
**Figure 4.4.** Distribution of tensile strength results

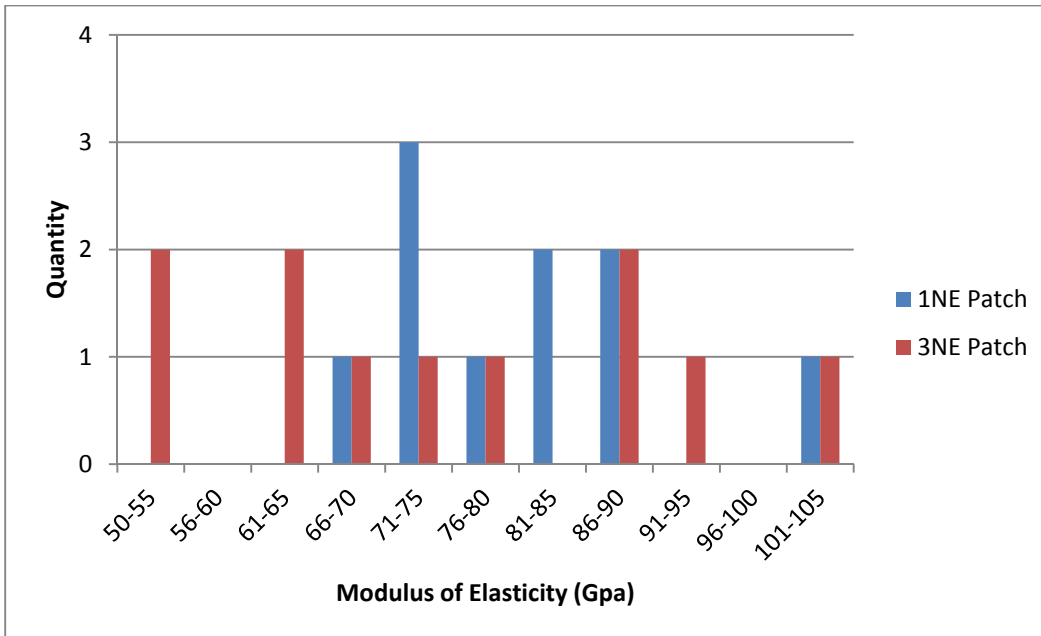
**Figure 4.5.** Distribution of modulus of elasticity results

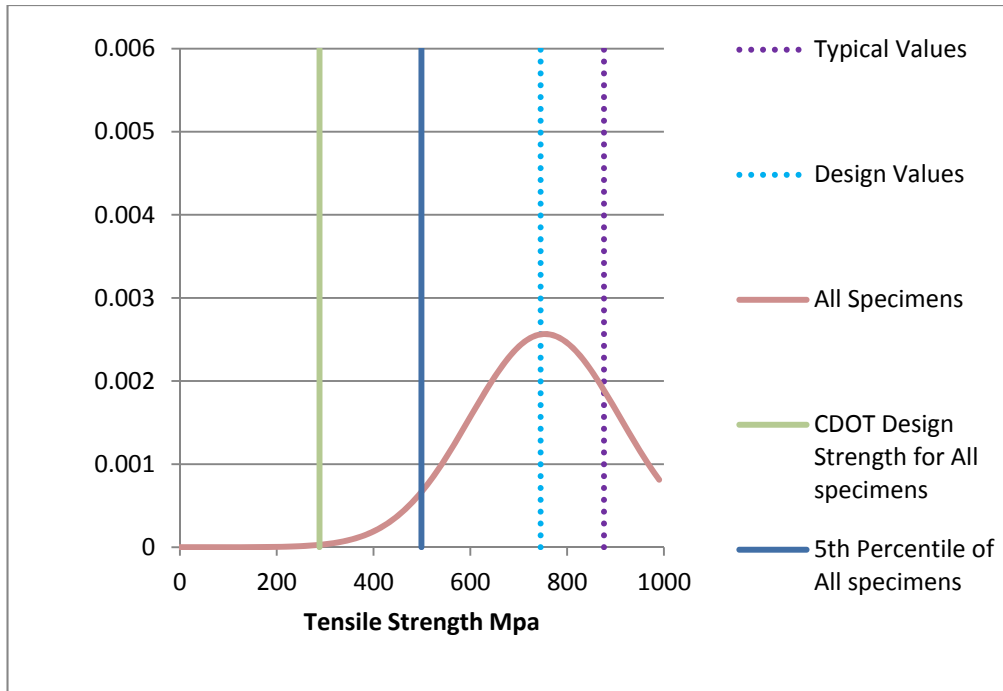
**Figure 4.7.** Probability density function of all tensile tests

Looking at the location of these values in Figure 4.7 above, there is a very concerning discrepancy between the values of tensile strength provided by the manufacturer and the values generated from the tensile tests. The values of modulus of elasticity are fairly representative of the values provided by the manufacturer.

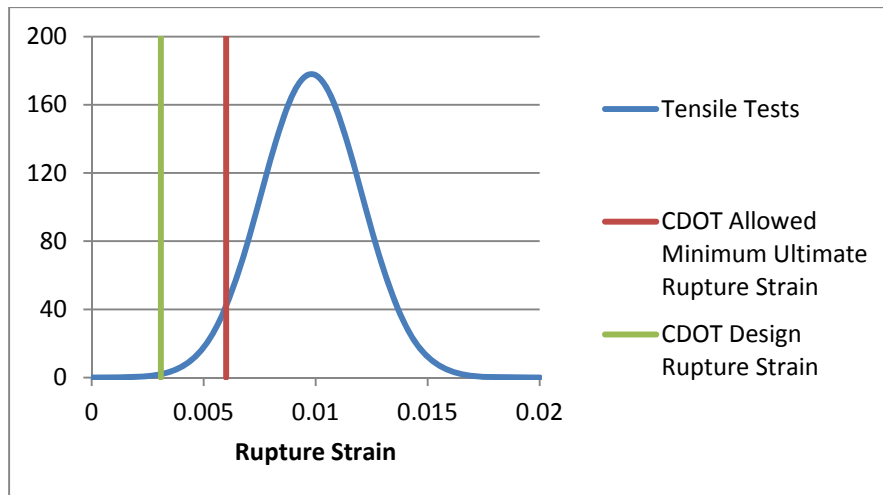
The 5<sup>th</sup> percentile value in the table above would satisfy the minimum rupture strain requirement of CDOT’s construction specifications (Revision of Section 602), but the “CDOT Design rupture strain” calculated per CDOT’s construction specifications (Revision of Section 602) is not adequate. A visual representation of this can be found in the probability density function in the figure below.

**Figure 4.10.** Probability density function of the rupture strain of all tensile tests

In summary, the tensile strengths were significantly lower than the values reported by the manufacturer, Fyfe and required by CDOT. It is difficult to determine whether these values are due to poor workmanship during the 2003 repair or degradation. Initial values at the time of repair would help make this differentiation if the samples tested in 2003 were representative of the material on the bridge. No results from such tension tests were recovered for comparison. The modulus of elasticity values were reasonably close to reported values considering the sample size. The rupture strain, similar to the tensile strength, had values lower than acceptable design values according to CDOT's construction specifications (Revision of Section 602).

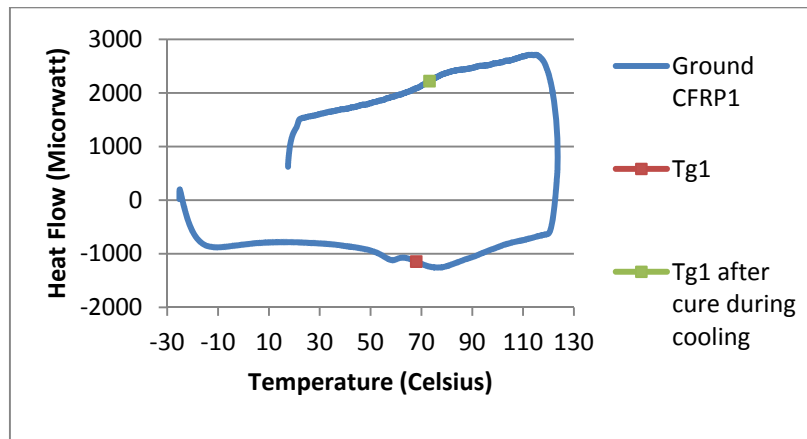
**Figure 4.14.** Ground CFRP specimen

During heating the glass transition temperature,  $T_g$ , was  $67.95^\circ\text{C}$ , while during the cooling process the  $T_g$  was  $73.19^\circ\text{C}$ . This increase in  $T_g$  is due to the curing process caused by the heating up to  $130^\circ\text{C}$ . The glass transition temperature of the CFRP composite was expected to be between  $60^\circ\text{C}$  and  $82^\circ\text{C}$  as quoted by the manufacturer as being the design value and typical test value respectively. The highest temperature of the composites thermal history was probably not much greater than  $40^\circ\text{C}$ , which explains the additional curing and the upwards shift in the  $T_g$  during the heating process up to  $130^\circ\text{C}$ .

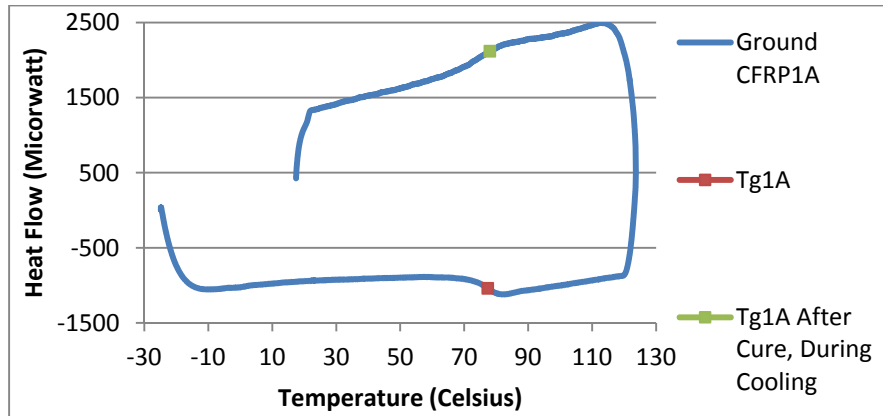
**Figure 4.15.** Ground CFRP1A

The erratic or irreversible behavior does not exist in the classic behavior of the DSC curve in the plot above. The behavior during heating and cooling are reversible and look identical. Subtracting the Ground CFRP1A curve from the Ground CFRP1 curve would yield an area that represents irreversible behavior.

The two glass transition temperatures were found to be  $77.38^{\circ}\text{C}$  and  $78.02^{\circ}\text{C}$  for the heating and cooling processes respectively. The second time the specimen was heated to  $130^{\circ}\text{C}$  the  $T_g$  increased by a much smaller amount due to the post-curing that occurred during the first test. The closer a specimen gets to being fully cured, the smaller the influence additional heat will have on  $T_g$ . Additionally, there is a relatively small shift in the  $T_g$  that is due to the different processes of heating and cooling that should be considered when comparing the  $T_{gs}$  found during the heating and cooling processes. During the heating the  $T_g$  is shifted to the right and during the cooling the  $T_g$  is shifted to the left; the glass transition temperature should be taken as the average of the two values found during the heating and cooling

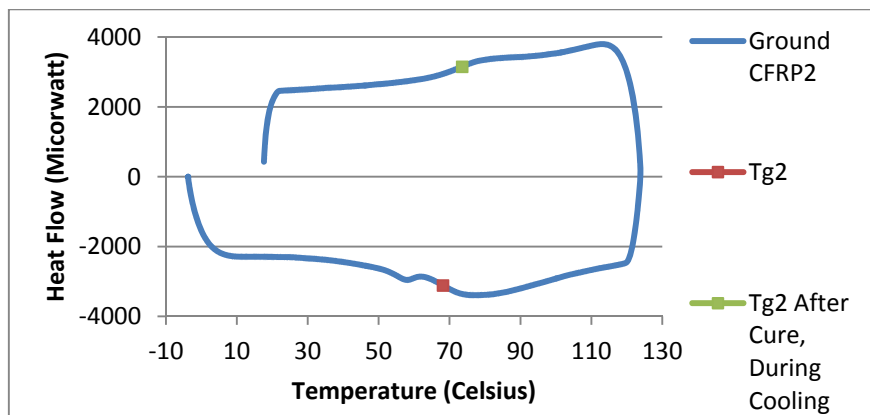
**Figure 4.17.** Ground CFRP2

The  $T_{gs}$  were very close to that of Ground CFRP1, 68.13°C and 73.56°C respectively, as was the general response and presence of the irreversible behavior. Diced CFRP was also analyzed as opposed to the ground CFRP. The diced CFRP had slightly lower values of  $T_g$ , possibly due to the heat added to the ground specimens but the difference was fairly marginal. All three plots are combined in the figure below.

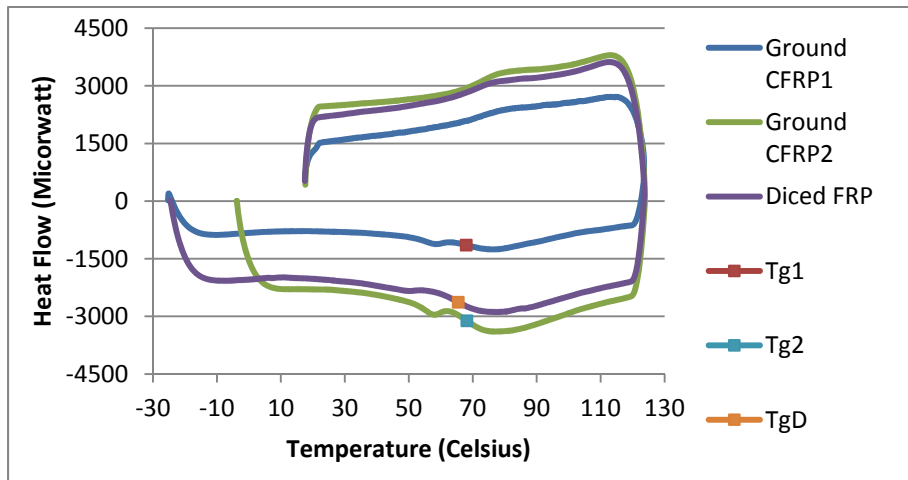
**Figure 4.18.** Ground and diced CFRP DSC results

The vertical shift in the DSC curves is due to the amount of reactive material within each specimen. The percentage of reactive material was likely very similar among the CFRP specimens but the different specimen sizes resulted in this vertical shift.

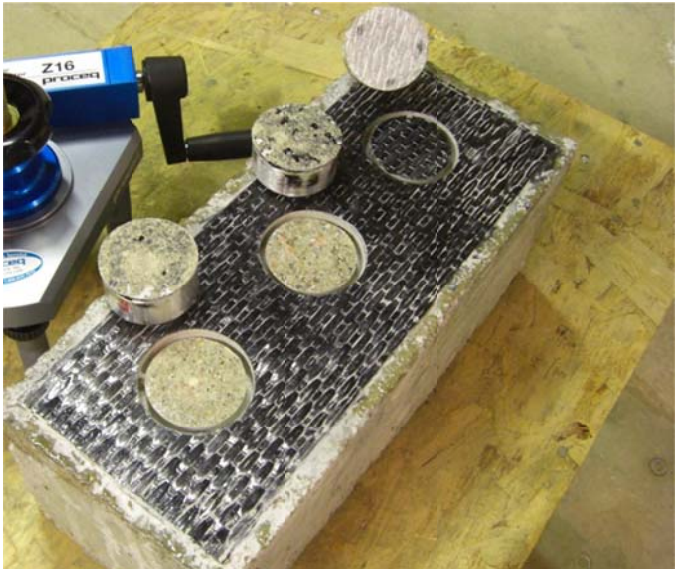
**Figure 6.19.** Pull-off tests 1, 2, and 3 failure modes

As illustrated in Figure 6.19, the dollies from tests #2 and #3 show mostly concrete failure but with some black spots in which the CFRP did not adhere to the concrete during the reinforcement process. In the case of block #2, equivalent to tests 4, 5, and 6, all three showed a Mode A failure, with strengths of 444 psi (3.06 MPa), 270 psi (1.86 MPa), and 266 psi (1.83 MPa).

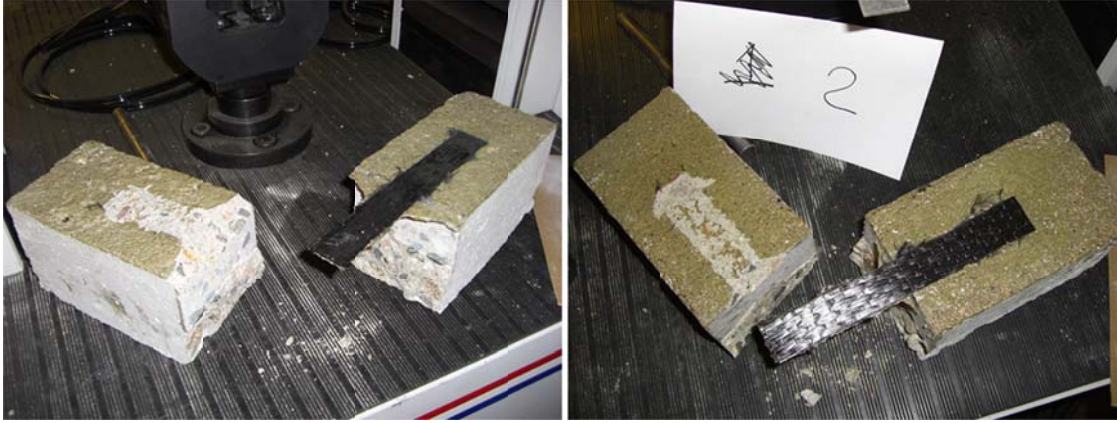
**Figure 6.23.** Beam 1 (left) and beam 2 (right) following testing

Both beams from this stage showed a fairly similar failure behavior, in which one side of the beam debonded before the other. However, the peak force witnessed on beam 1 was considerably higher, 0.563 kips (2.50 kN) greater than for beam 2. The larger force resisted by beam 1 also resulted in a displacement of 0.029 in (0.74 mm) greater than for beam 2. One possible reason for Beam 2 having a lower peak force is a weaker CFRP-concrete bond coming from the CFRP application. The darker spots on the failure surface for Beam 2 show that the CFRP did not completely adhere to the concrete substrate during application. Beam 1 contained little to no adhesive layer on top of the concrete surface after failure, which indicates that the CFRP was fully bonded to the concrete. Figure 6.23 shows the failure surfaces for both specimens and it is noticeable how beam 2 contained a significantly higher amount of adhesive on the concrete.

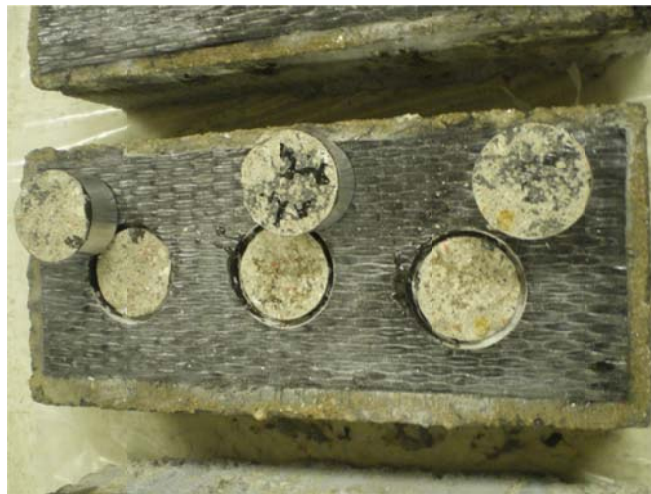
**Figure 6.25.** Mode F failures (ASTM D7522) during Stage 1 testing

The most common failure was identified by Mode F as labeled by ASTM D7522. Thirty three from the 45 dollies tested showed this type of failure, in which a partial adhesive failure of the FRP-concrete interface, combined with a partial concrete failure is seen. Figure 6.25 below shows a typical failure Mode F encountered during testing. The figure illustrates how the CFRP did not fully adhere to the concrete, and it is noticeable by the black spots of CFRP that are still visible, especially on the middle dolly.

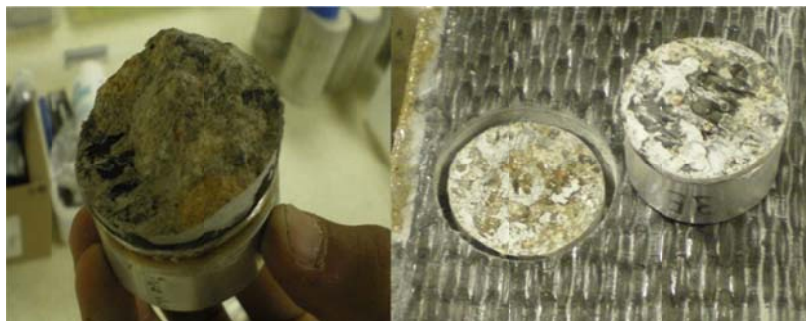
**Figure 6.26.** Test #35 (left) vs. test #38 (right)

Finally, throughout testing the forty five pull-offs, three special cases were encountered. A special note worth discussing in the chloride based deicer group with triple layer reinforcement is the large discrepancy encountered within the six pull-offs. Test #38 resulted in the absolute lowest value for the entire stage, with a strength of 80 psi (0.55 MPa). On the other hand, Test #35 resulted in the absolute highest value among the 45 pull-off tests performed in this stage, with a strength of 627 psi (4.32 MPa). This particular pull-off was characterized as an ideal concrete failure, Mode G in ASTM D7522. It is believed that the reasons for the extremely large discrepancies among the specimens that underwent the exact same conditioning is due to the large aggregate present on test #35, as well as the presence of moisture within the concrete-FRP interface on test #38. This moisture was noticed because of the lighter color of the concrete, as well as a softer and more clayey feel to the touch. Notice in Figure 6.26 the large aggregate on test #35, as well as the lighter color and thinner layer of concrete on test #38.

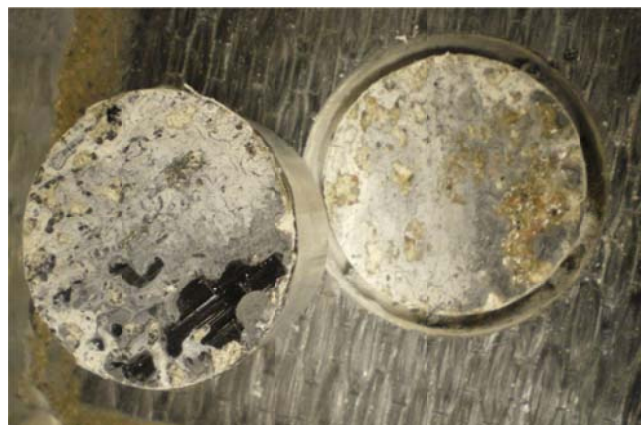
**Figure 6.27.** Presence of moisture at CFRP-concrete interface

The second special case encountered during testing has some relation to test # 38 above. The presence of moisture in the CFRP-concrete interface on Blocks #4, #9, and #13. This moisture was not present at the time of fabrication of specimens. Therefore, the deicing solution that these blocks were exposed to actually infiltrated into the bond either through the FRP or the concrete. This moisture was noticed in the specimens with different tonalities of gray in the concrete, as well as a softer, more clayey feel to the touch. It was determined that such moisture did decrease strength considerably. In the case of block #4 corresponding to wet-dry cycles, dollies #10, #11 and #12 showed moisture and did result in the ones with weaker strengths out of the whole group. In addition, dolly # 16 from the non-chloride based deicer group showed a strength of 271 psi (1.868 MPa) lower than the remaining dollies in that group, and it was the only pull-off that exhibited levels of moisture within that group.

The same moisture level – strength relationship was witnessed in dollies #25, #26, and #27 (Block 9) within the non-chloride based deicer group, as well as dollies #33 from Block 11, and dollies #37 and #38 from Block 13. With these patterns identified, one can draw the conclusion that the presence of moisture does in fact reduce the pull-strength. However, reasons why some dollies within the same group may or may not have exhibited moisture are unknown. A characteristic example of a dolly showing sign of moisture is illustrated in Figure 6.27.

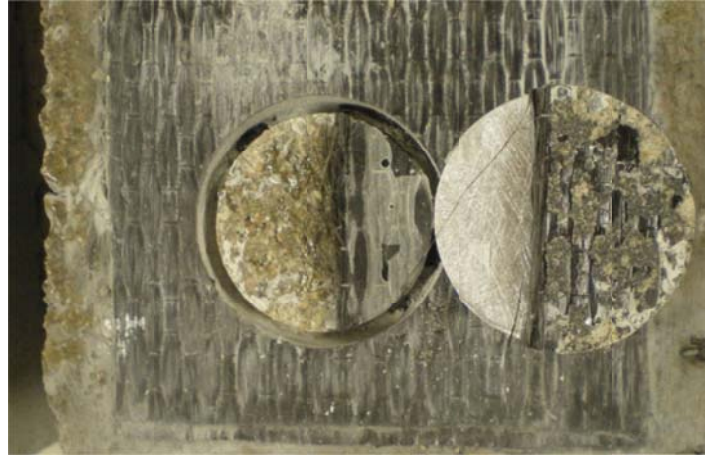
**Figure 6.28.** Combined Mode A and Mode F failure

The last special case consisted of having a mixed failure mode between Mode A and Mode F. In this special case, the CFRP fibers may not have been fully saturated during application, causing

separation of the bundles. Figure 6.28 shows how half of the dolly completely detached from the concrete at an adhesive level on the dolly-FRP interface, whereas the second half was seen as an adhesive failure on the concrete-FRP interface.

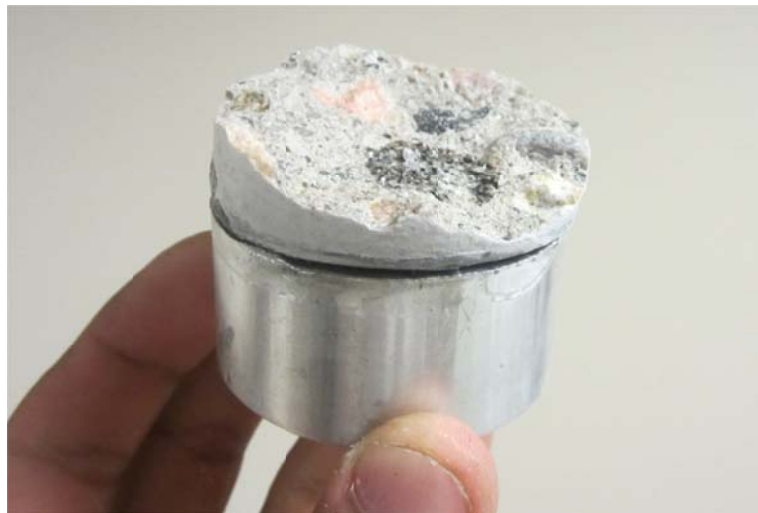
**Figure 6.31.** Mode G failure in dolly #20

Four blocks were exposed to a non-chloride based deicer, equivalent to a total of twelve pull-off tests. Two of these blocks were reinforced with two layers of CFRP, and the remaining two blocks with three layers of CFRP. Failure modes varied from Mode A in three pull-offs, Mode F in eight dollies, and the last one corresponded to an ideal Mode G failure. Figure 6.31 shows the Mode G failure that was witnessed on dolly #20 from this stage, corresponding to one of the blocks reinforced with two layers of CFRP.

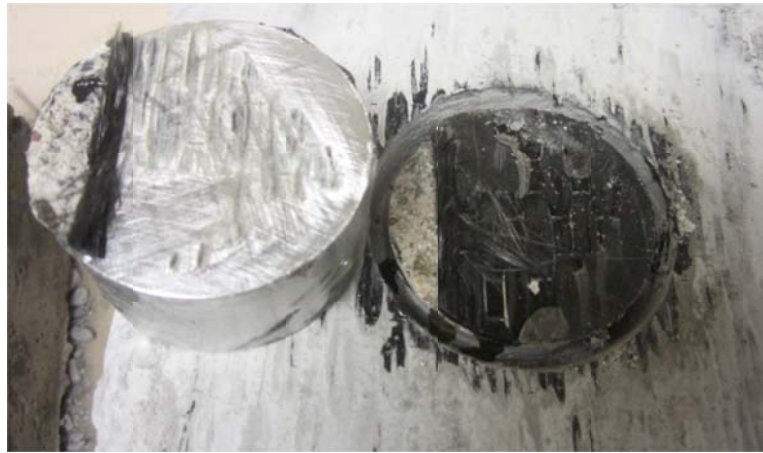
**Figure 6.33.** Combined Mode A and Mode F failure in dolly #42

Finally, the special case in which a combined Mode A and Mode G failure was witnessed in dolly # 31 from Stage 1, was also seen in Stage 2 in dolly #42. Figure 6.33 shows dolly #42 with this particular failure. The cause may have been once again due to improper adhesion of the fabric, causing separation of the bundles, or due to a weak pattern of concrete on one side.

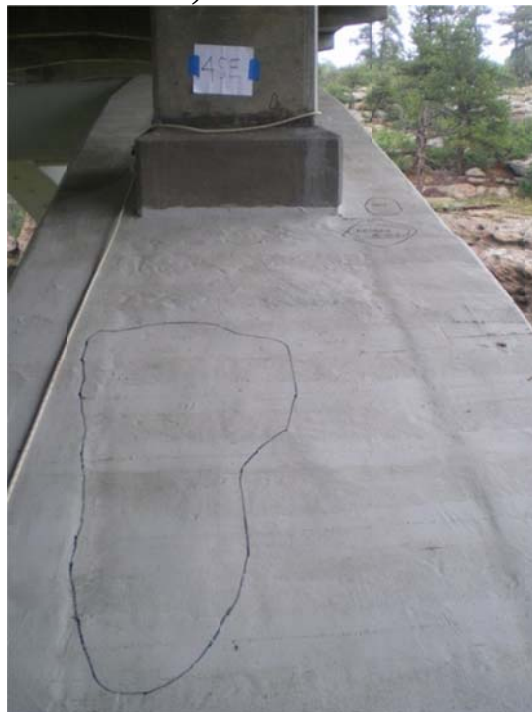
**Figure A16.** Bay 4SE

## **Bay 4SE: 3 Voids, 1 Was Identified in 2007**

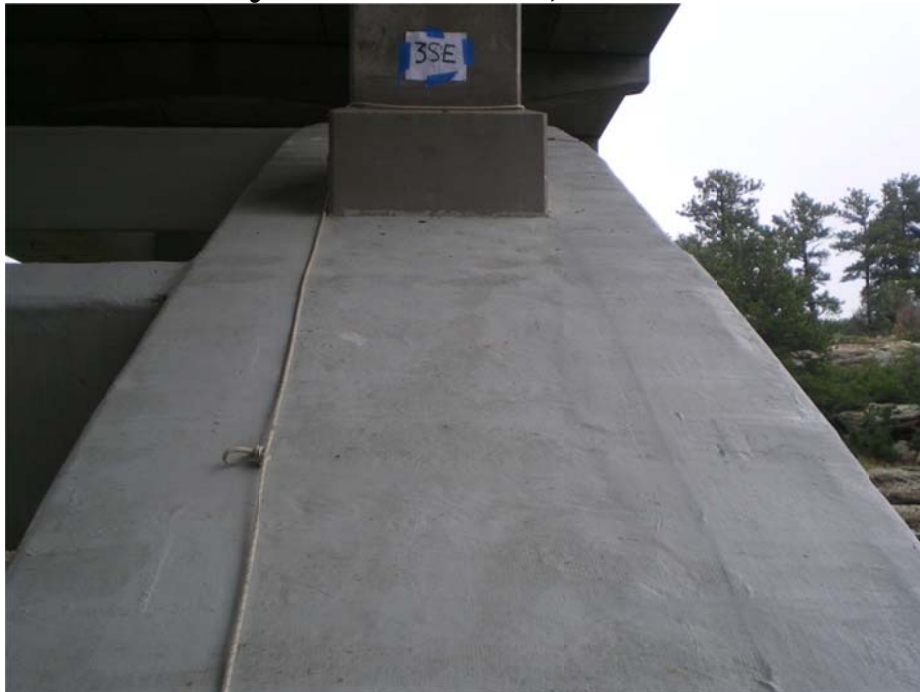
**Figure A18.** Bay 3SE

### **Bay 3SE: 2 Voids, 1 Crack**

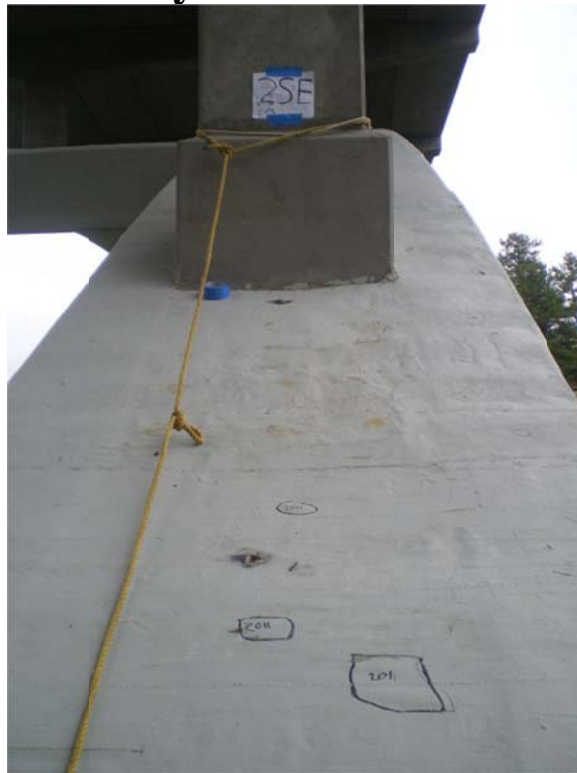
**Figure A20.** Bay 2SE

### **Bay 2SE: 3 Voids**

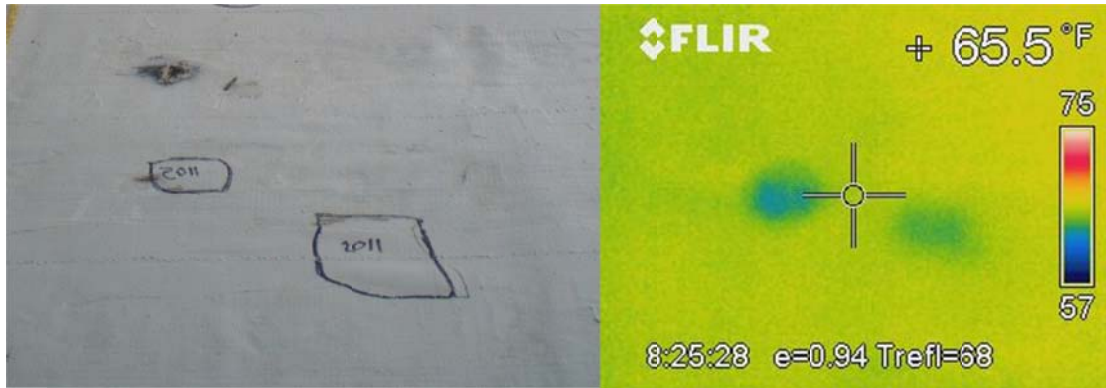
**Figure A21.** Photograph and thermal image of two voids

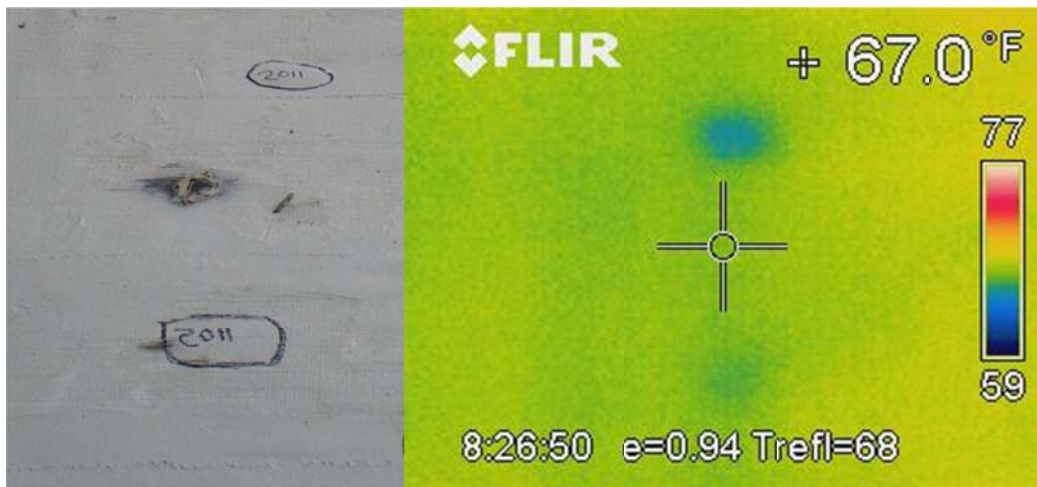
**Figure A22.** Photograph and thermal image of two voids, the black color in the photograph is leftover strain gauges from the work done by Colorado University of Boulder

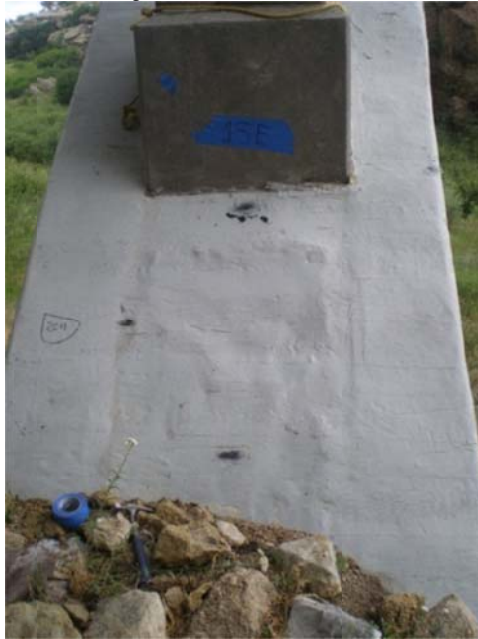
Figure A23. Bay 1SE, 1 void

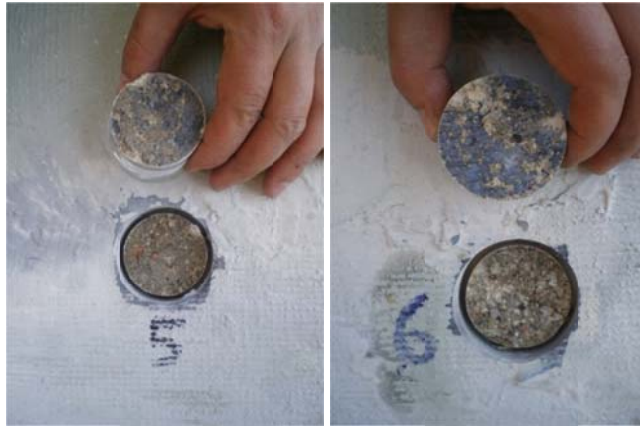
**Figures B4 and B5.** Test No.5, note puck slid off of center while epoxy was setting, and test No. 6

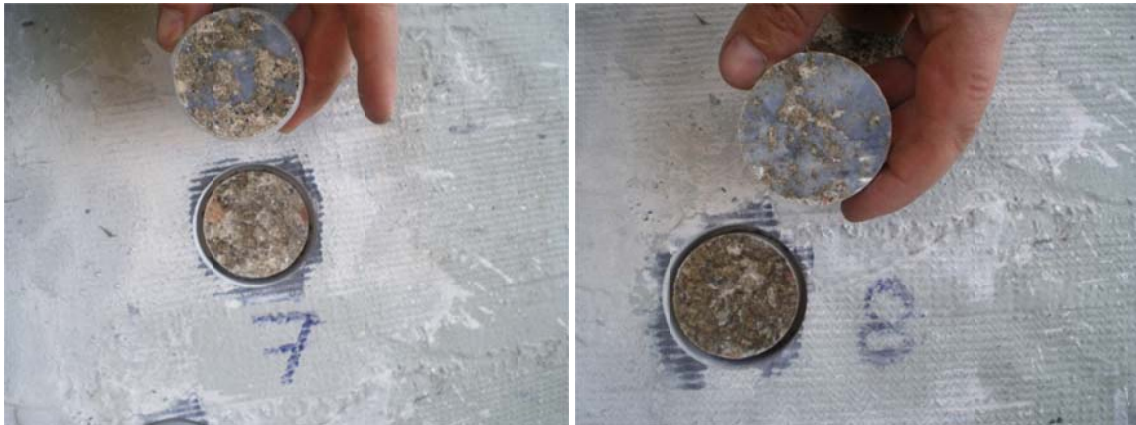
**Figures B6 and B7.** Test No.7 and test No.8, weak bond strength

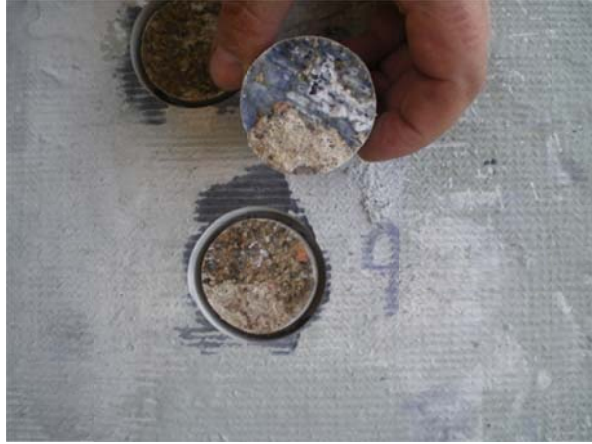
**Figure B8.** Test No.9, weak bond strength

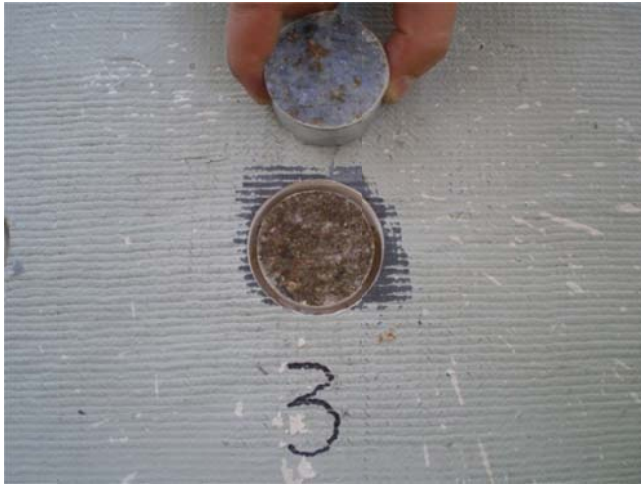
**Figures B10 and B11.** Test No.12, weak bond strength, and test No.13, weak bond strength

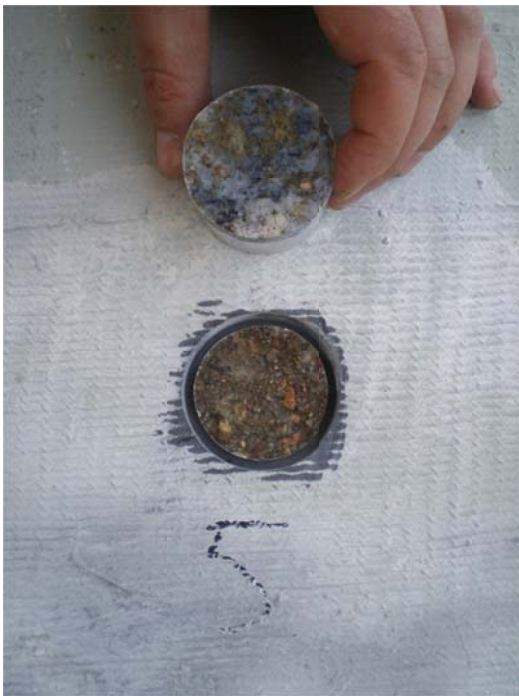
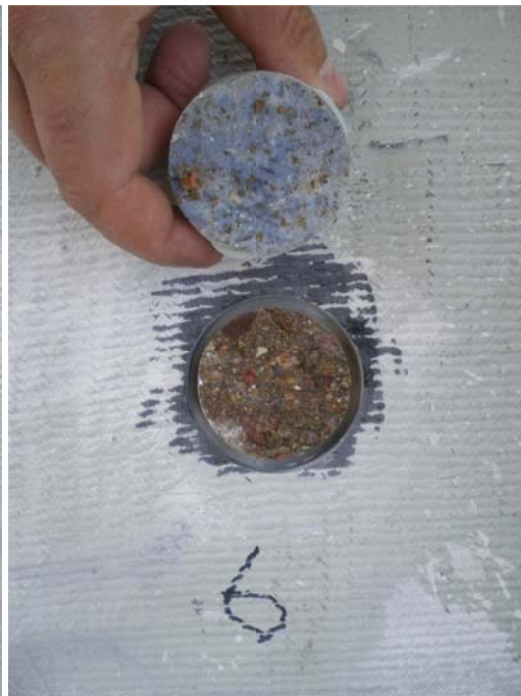
**Figures B12 and B13.** Test No.14, weak bond strength, and test No.15, weak bond strength

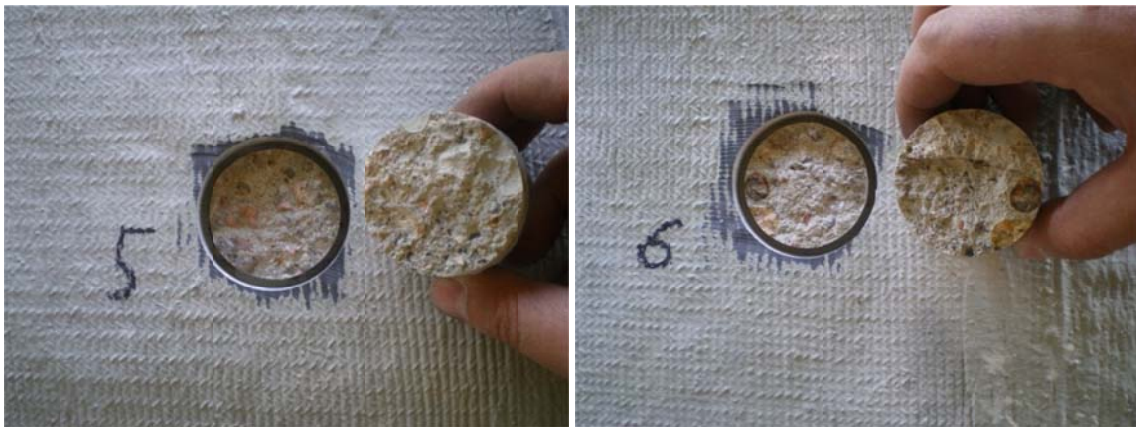
**Figures B20 and B21.** Test No.23, weak bond strength (poorly mixed concrete?), and test No.24
