# **City and County of Pueblo Flood Hazard Mitigation Plan**

## **The June 3, 1994 Flash Flood**

**August 1994**

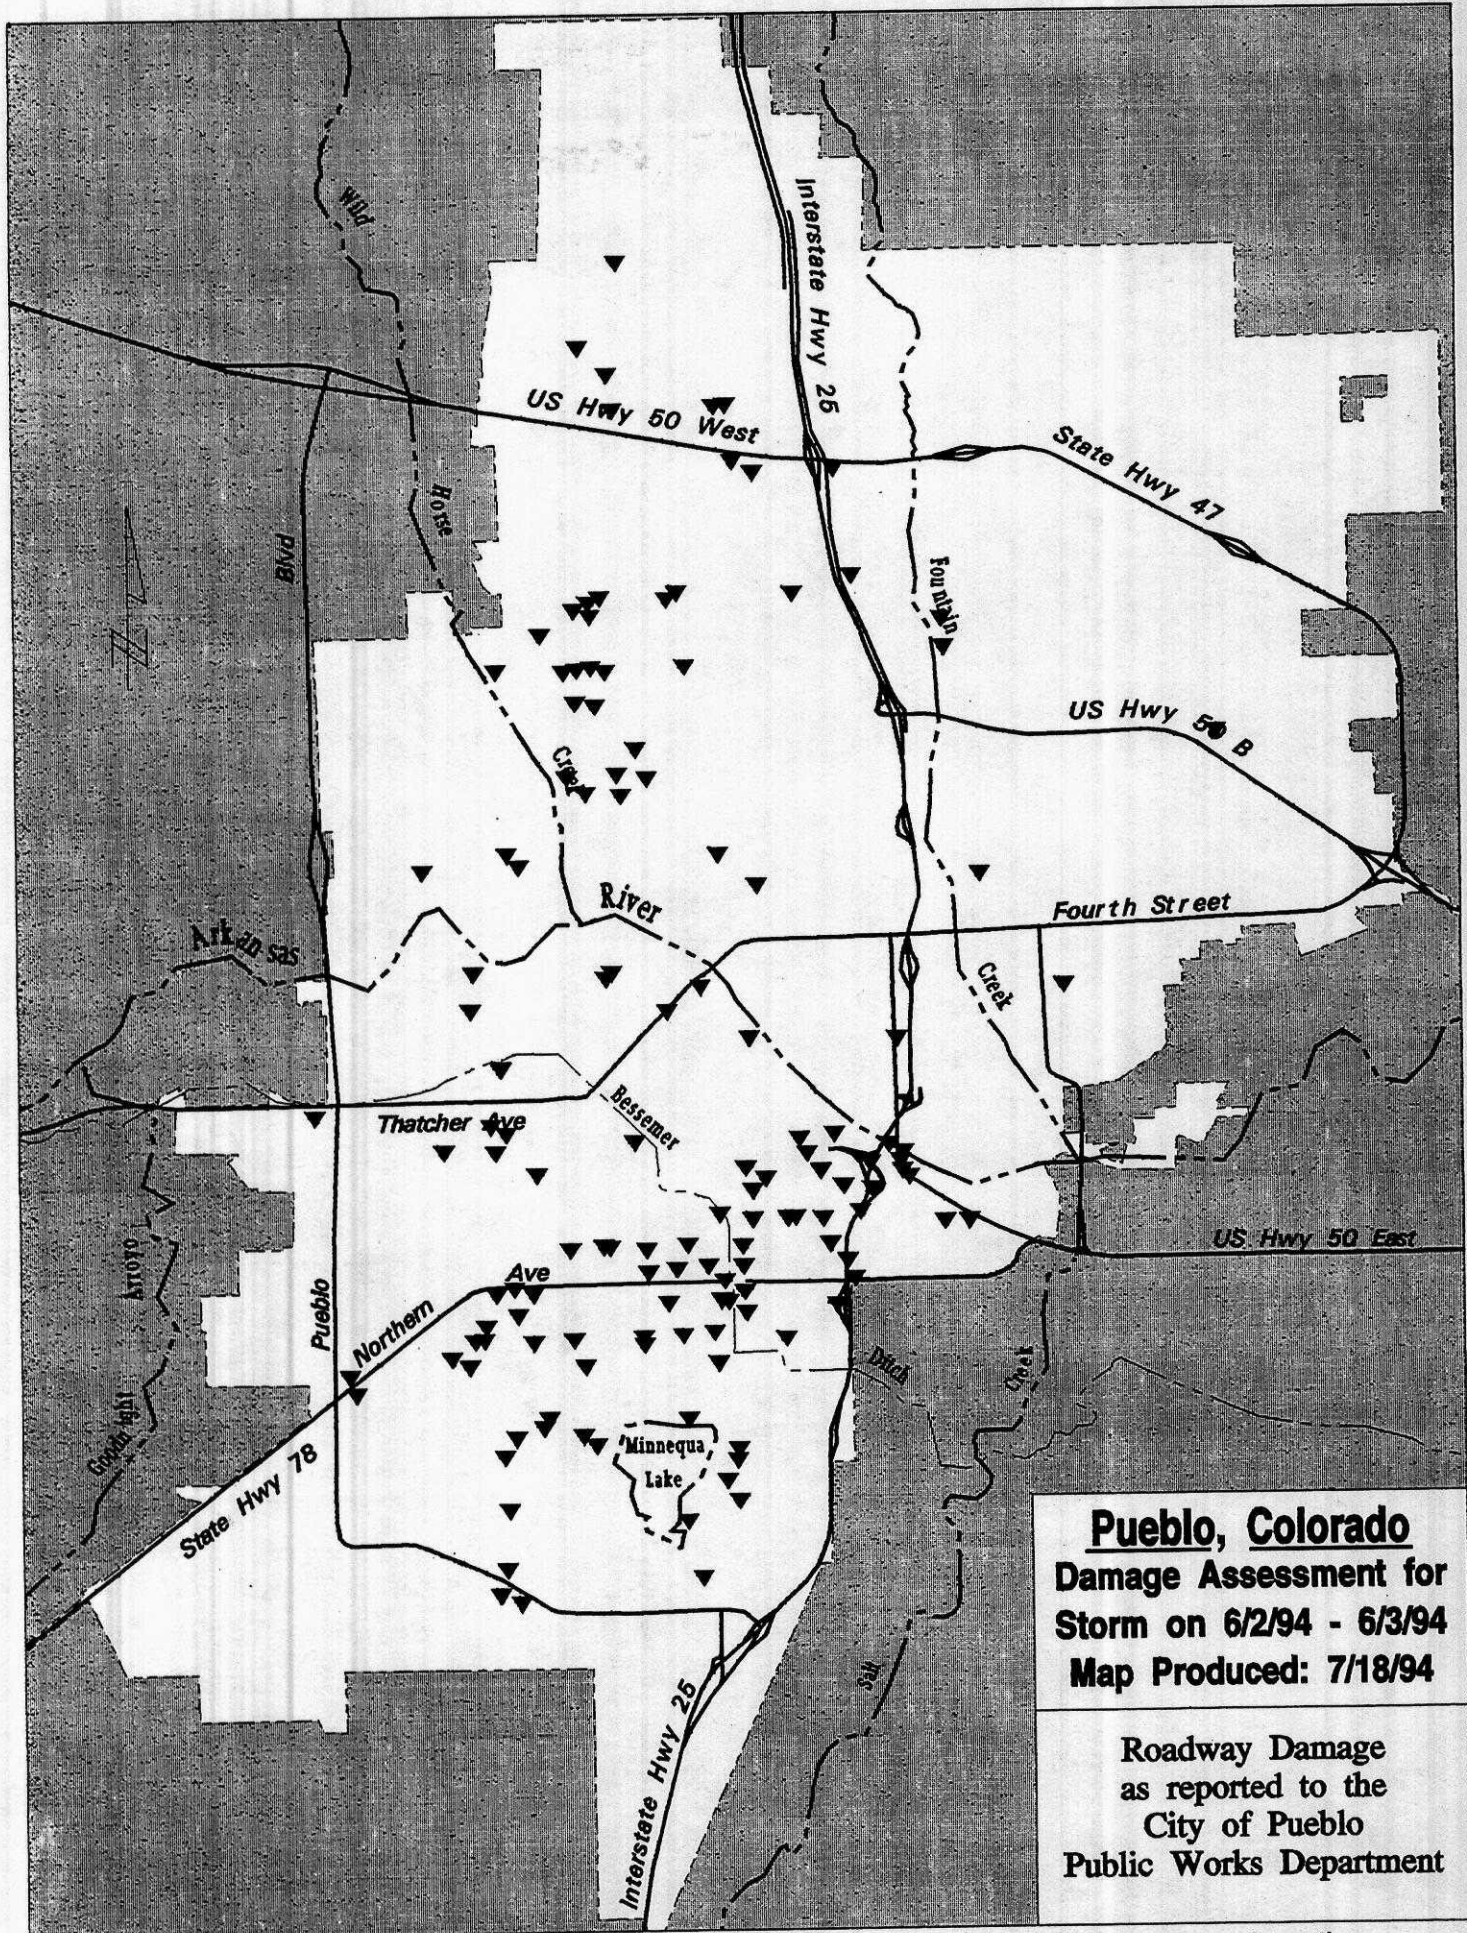
**Pueblo, Colorado**  
**Damage Assessment for**  
**Storm on 6/2/94 - 6/3/94**  
**Map Produced: 7/18/94**

Roadway Damage  
 as reported to the  
 City of Pueblo  
 Public Works Department

Map II: Each triangle on this city map represents a road or alley that sustained damage from the flash flood.

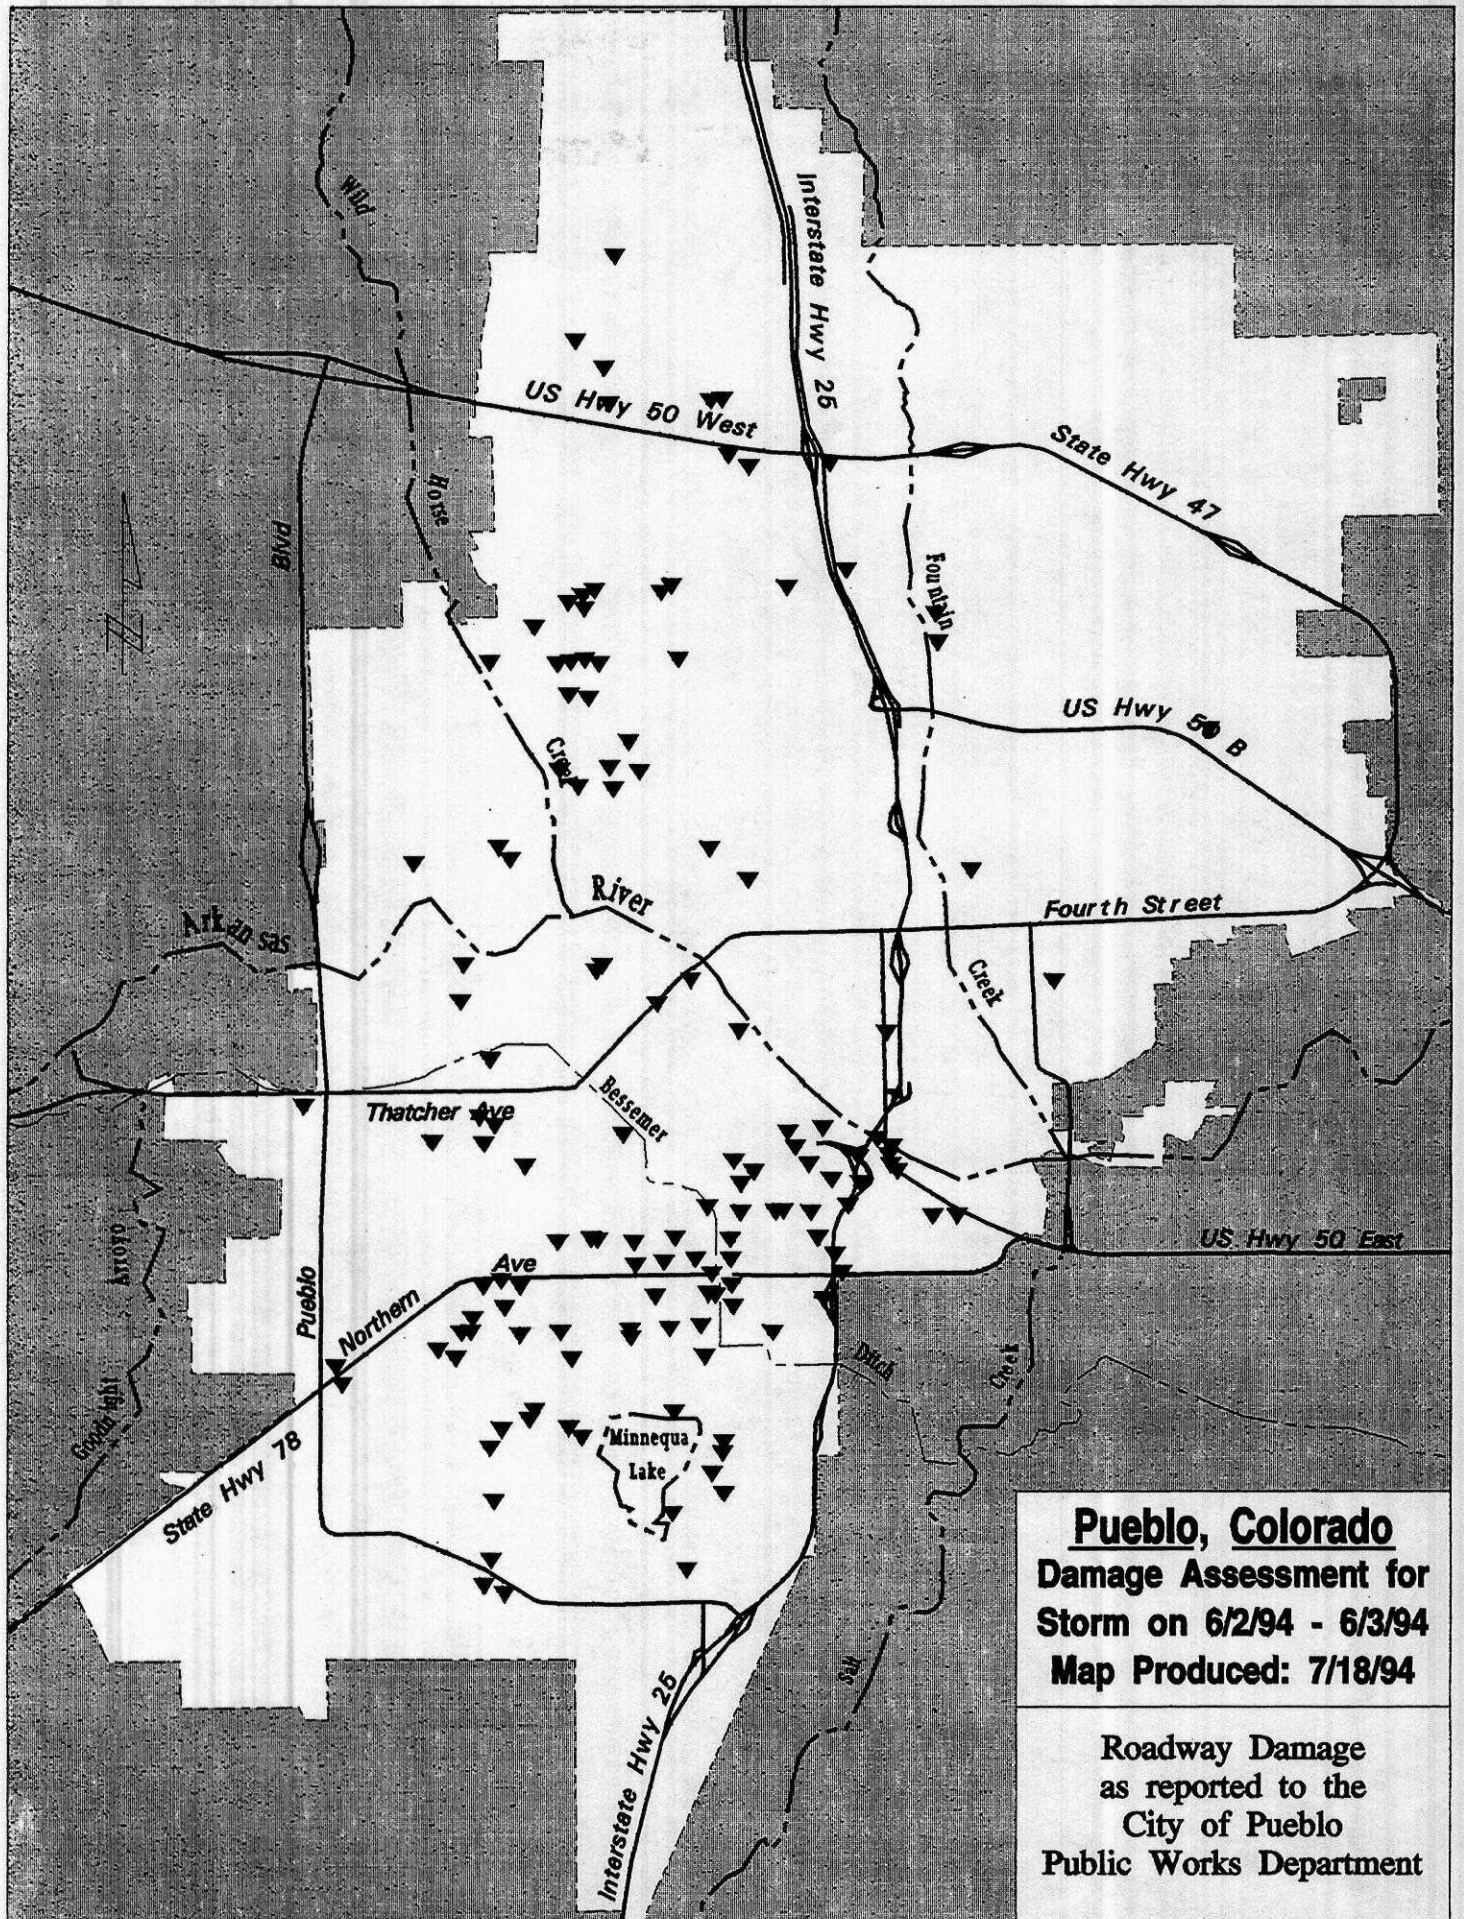
Map II: Each triangle on this city map represents a road or alley that sustained damage from the flash flood.

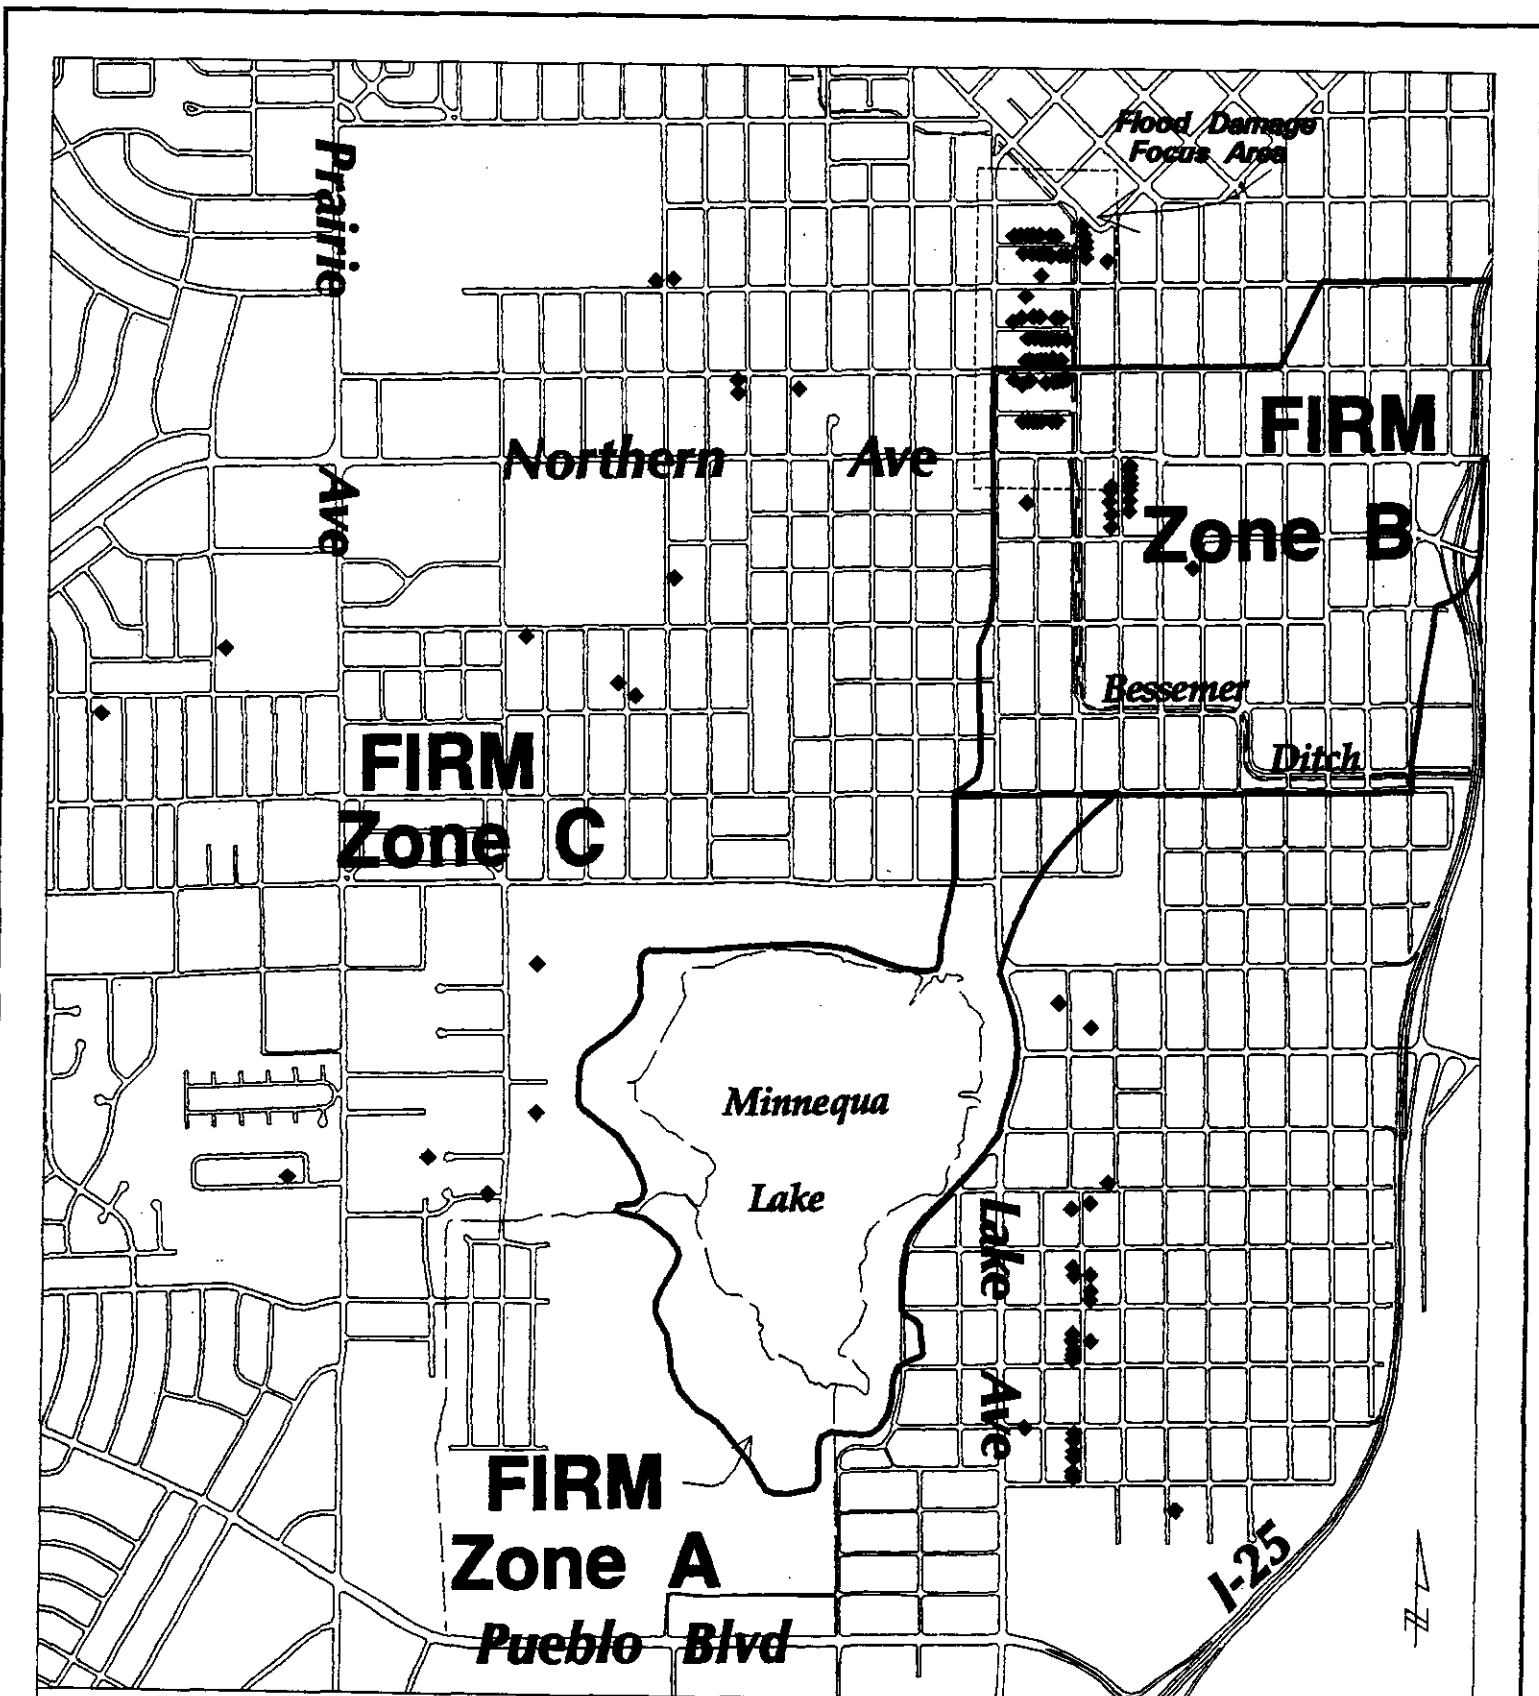
Map IV: This map zooms in on the area with the most reported damage (previous map). Again, the diamonds represent homes or apartments with reported damage. The map also shows Federal Emergency Management Agency (FEMA) National Flood Insurance Rate Maps (FIRM), from which the zone information on this map is taken. The maps show low to high risk zones for flooding. Zone A is an area of high risk, Zone B is an area of moderate risk and Zone C is an area of low risk in this map. Notice no reports of damage exist in the high risk or A Zone. This shows the importance of flood preparedness (e.g. flood insurance, structural mitigation) even for people who do not live in the flood plain. Many damaging floods along the Front Range occur from flash flooding and urban flooding can become more of an issue than riverine flooding.

Pueblo, Colorado  
 Damage Assessment for  
 Storm on 6/2/94 - 6/3/94  
 Scale 1:18000 Prepared 7/25/94  
 Damage to homes as reported  
 to American Red Cross and  
 City Public Works Dept.  
 National Flood Insurance Rate Maps

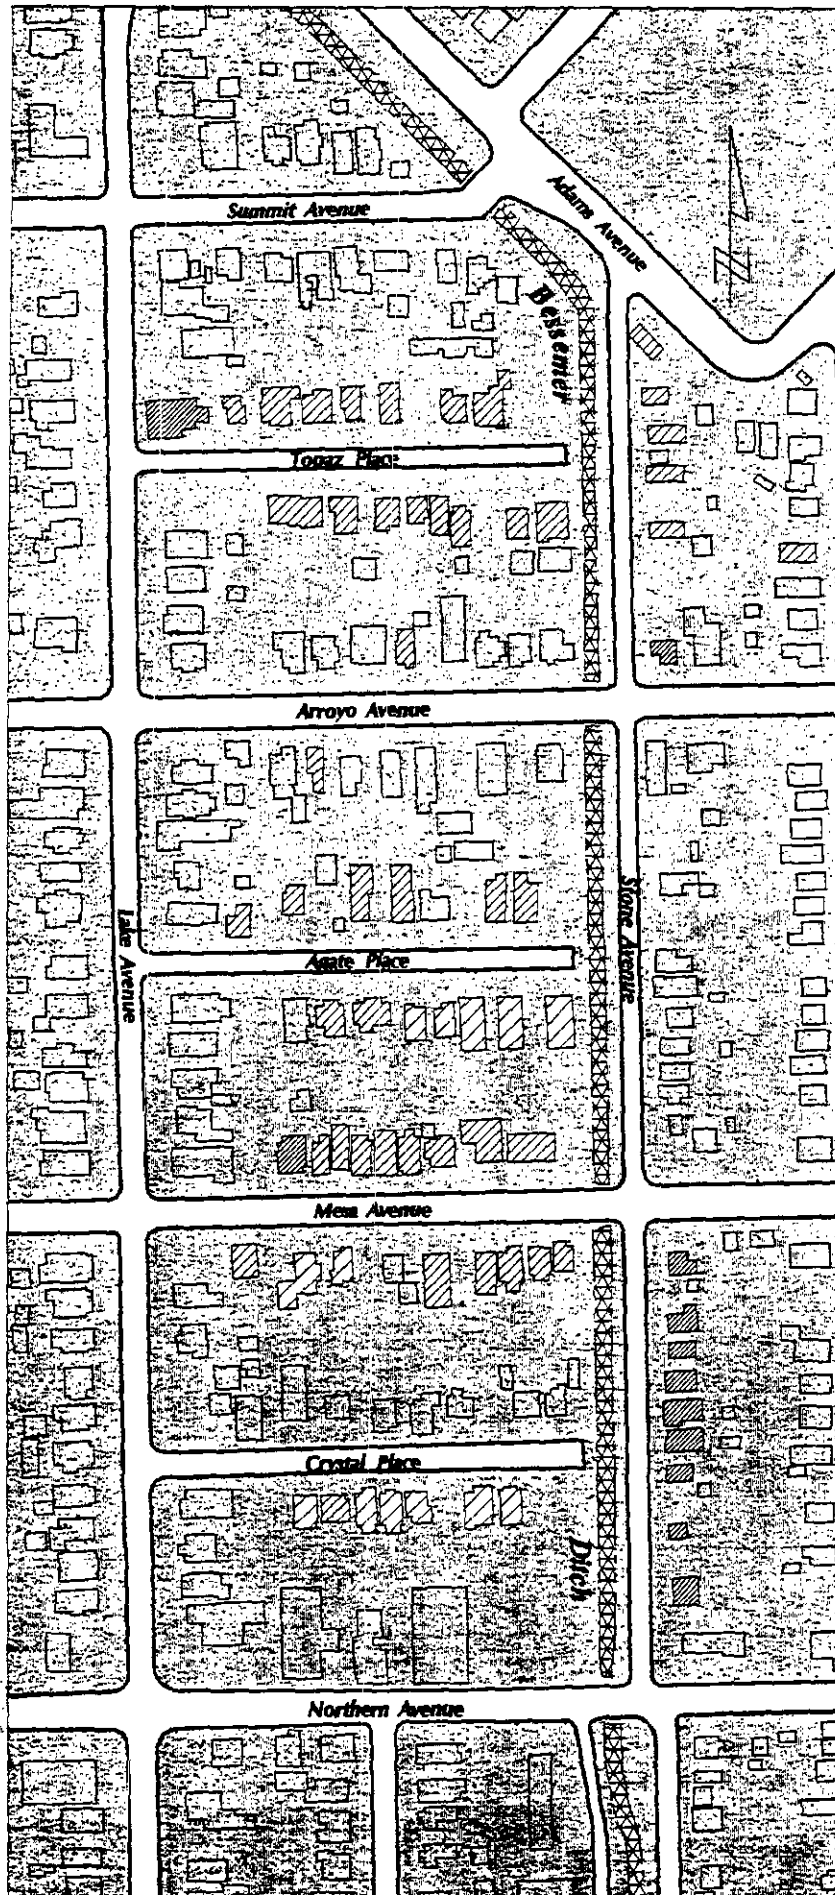
Extent of damage reported to American Red Cross Pueblo County Chapter

Map V: This map zooms in on the flood damage focus area on the previous map (Map IV). Notice the location of Bessemer Ditch in relation to the flood damage (see Flood Response and Recovery).

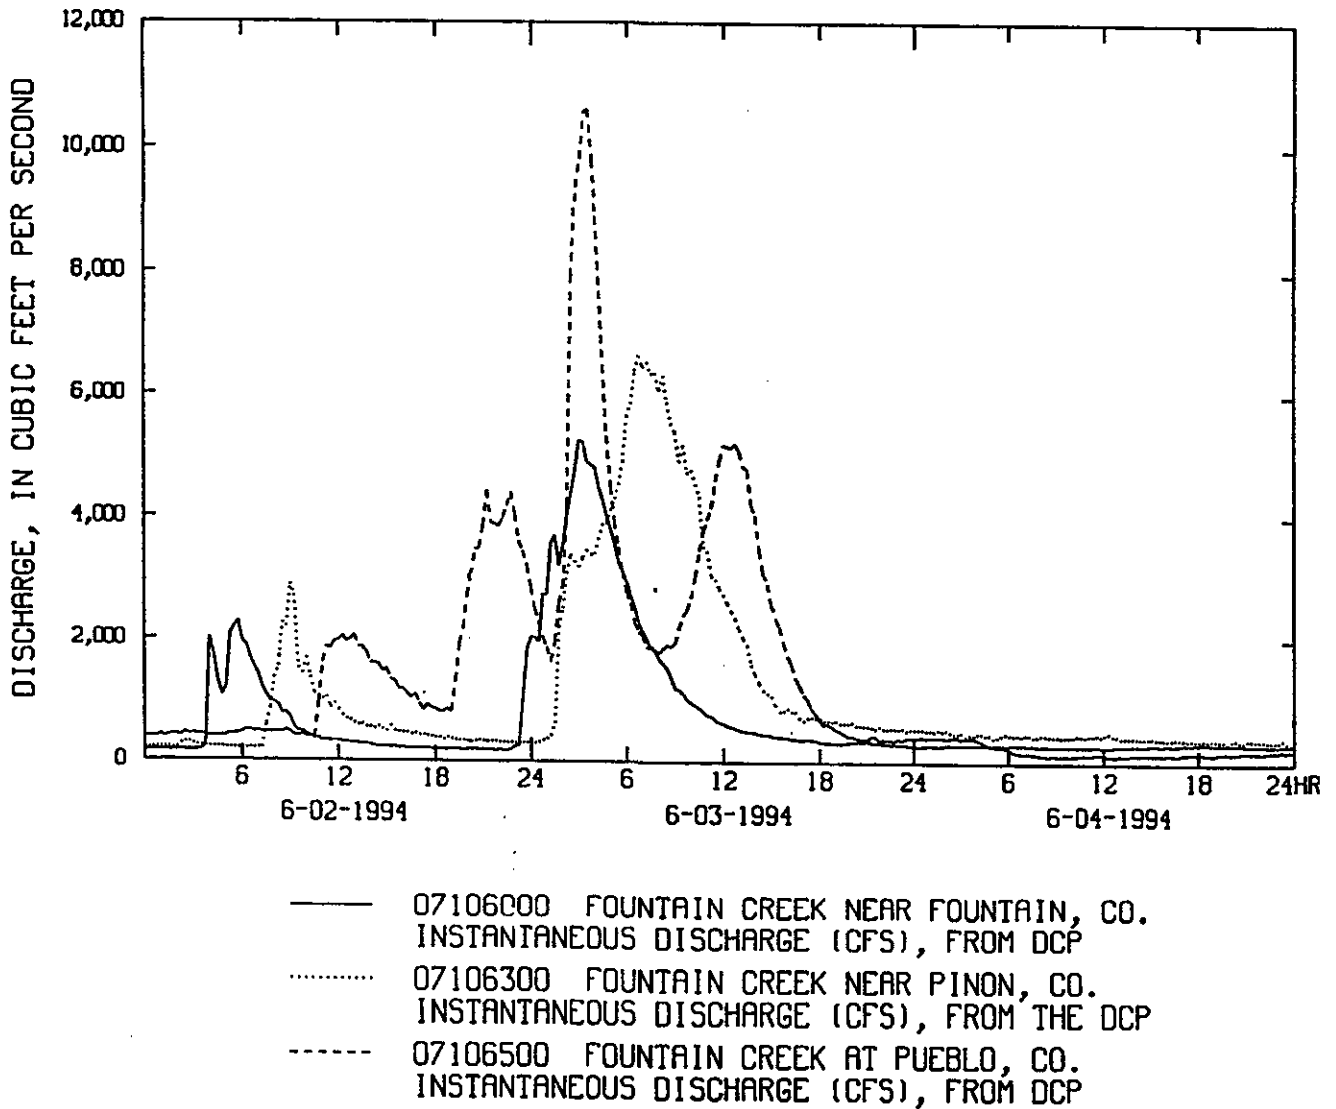
As you can see from the hydrograph, Fountain Creek at Pueblo reached approximately 11,000 cfs immediately following the June 3, 1994 storm. This magnitude is equivalent to about a 5-year flood on Fountain Creek. A 50-year flood on this stream would require the stream to run at 45,000 cfs. During the 1965 flood in Pueblo, Fountain Creek reached 47,000 cfs.

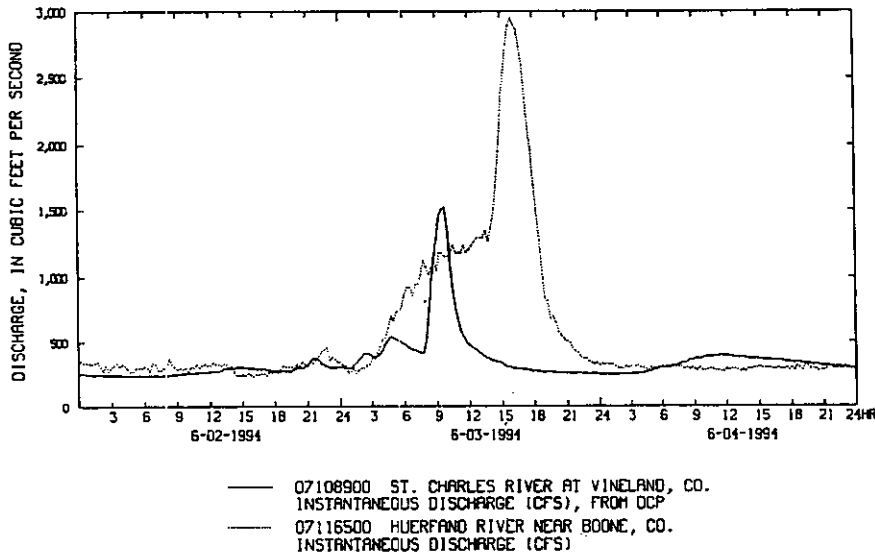
The tallest peak on this hydrograph shows the Huerfano River peaking at nearly 3,000 cfs near Boone (east of Pueblo). The Huerfano River flooded Highway 209 near Boone and pastureland in that area. The river peaked at 19,400 cfs during the 1923 flood. The St. Charles reached nearly 1,500 cfs during the June 3, 1994 flood, but peaked at 56,000 cfs during an incredible 1901 flood.

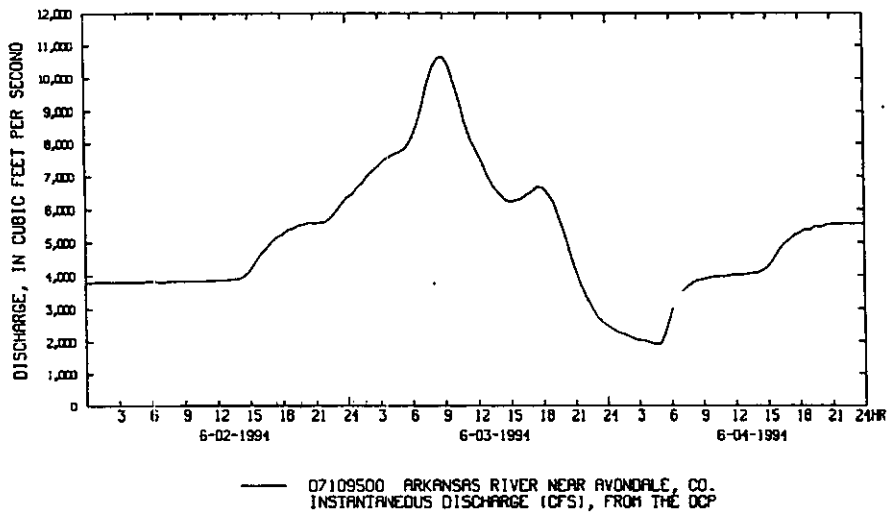
This hydrograph of the Arkansas River near Avondale reflects both the Thursday, June 2 and the Friday, June 3, 1994 storms. The Arkansas River reached approximately 100,000 cfs during the 1921 flood.
