Open-File Report 89-1

# Field Studies and Modeling Analysis of the Roan Creek Landslide, Garfield County, Colorado

By  
David Umstot\*

Colorado Geological Survey  
Department of Natural Resources  
Denver, Colorado  
1989

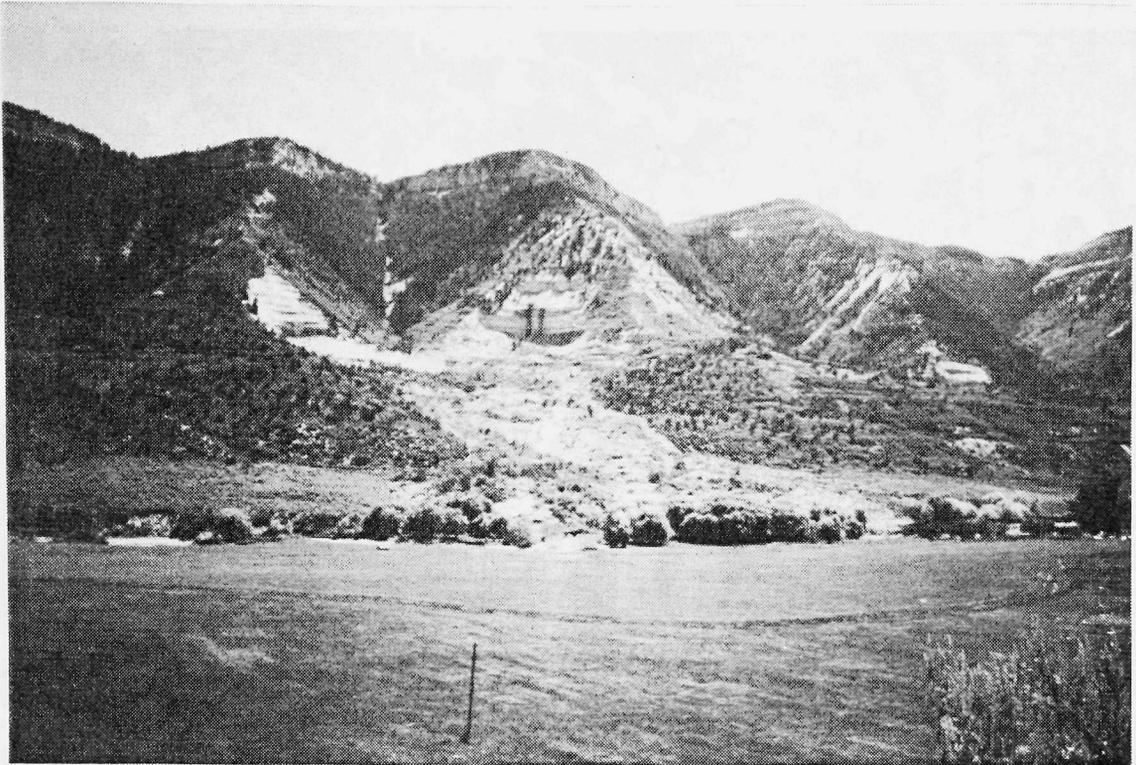
Figure 2. A view of the Roan Creek landslide looking south across Roan Creek valley.

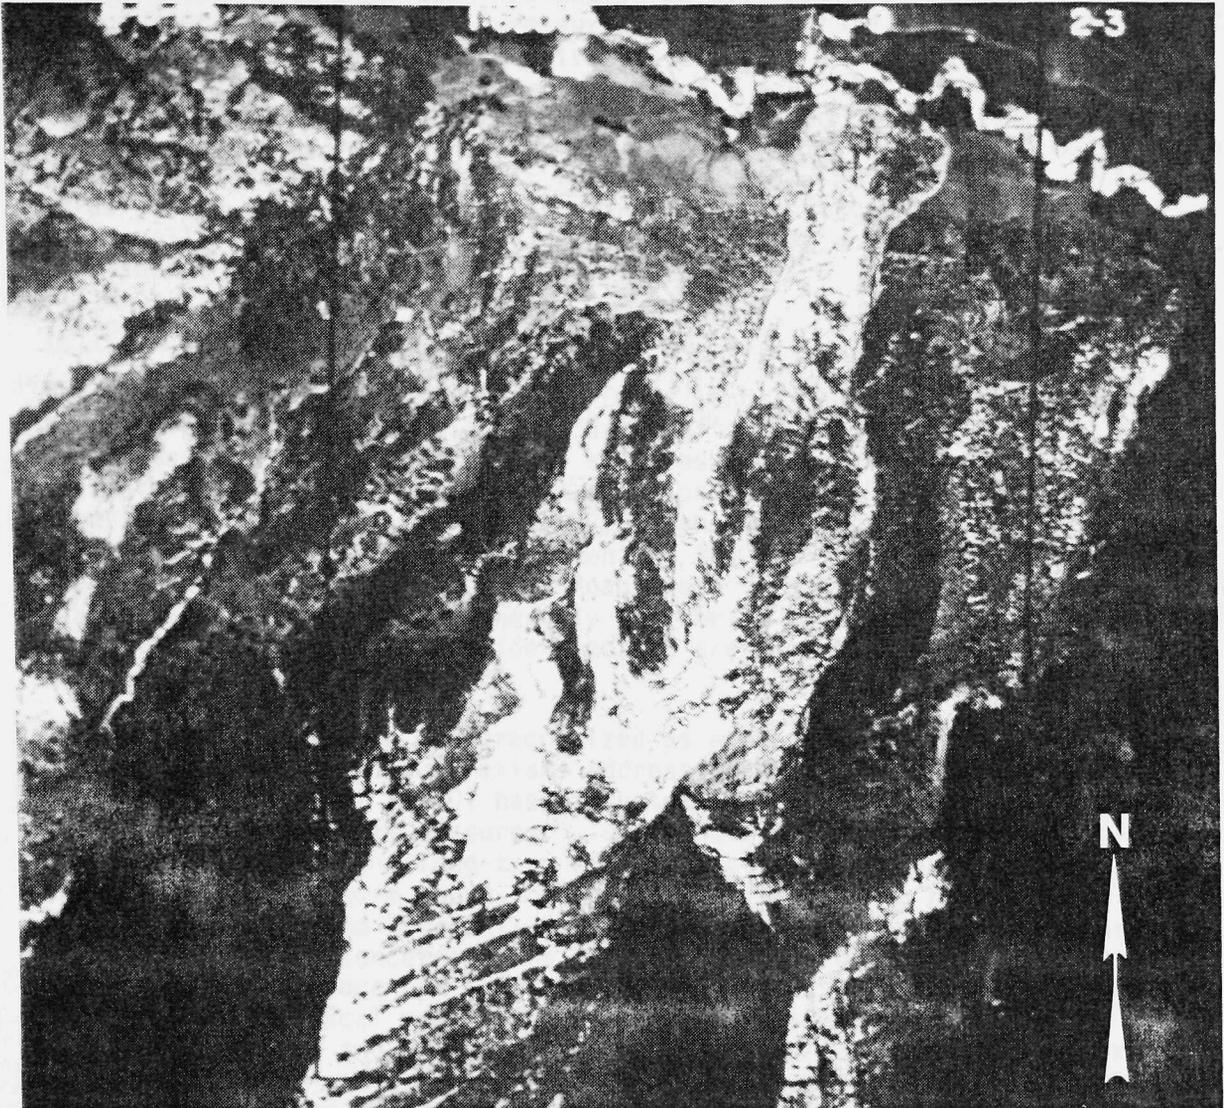
Figure 4. An aerial view of the Roan Creek landslide.

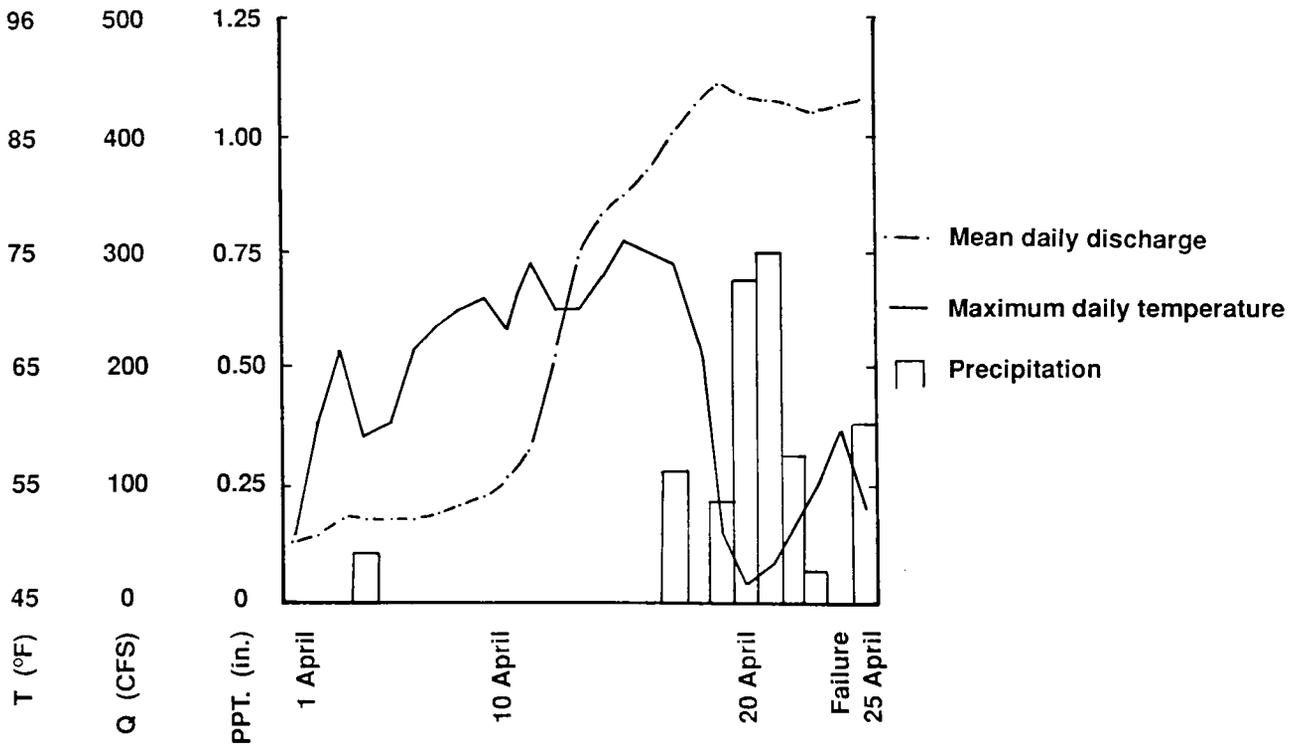
Figure 11 shows the relationships of temperature, Roan Creek discharge and precipitation during the first 25 days of April 1985. As temperature increased through the month, discharge also increased rapidly from 11 April to 19 April when discharge rose from 132 cfs to 443 cfs. The sudden drop in temperature on 17 April was accompanied by an increase in precipitation lasting seven days and a leveling off of discharge to a value of about 425 cfs.

Figure 11. Maximum daily temperature, daily precipitation and mean daily discharge of Roan Creek in the first 25 days of April 1985.

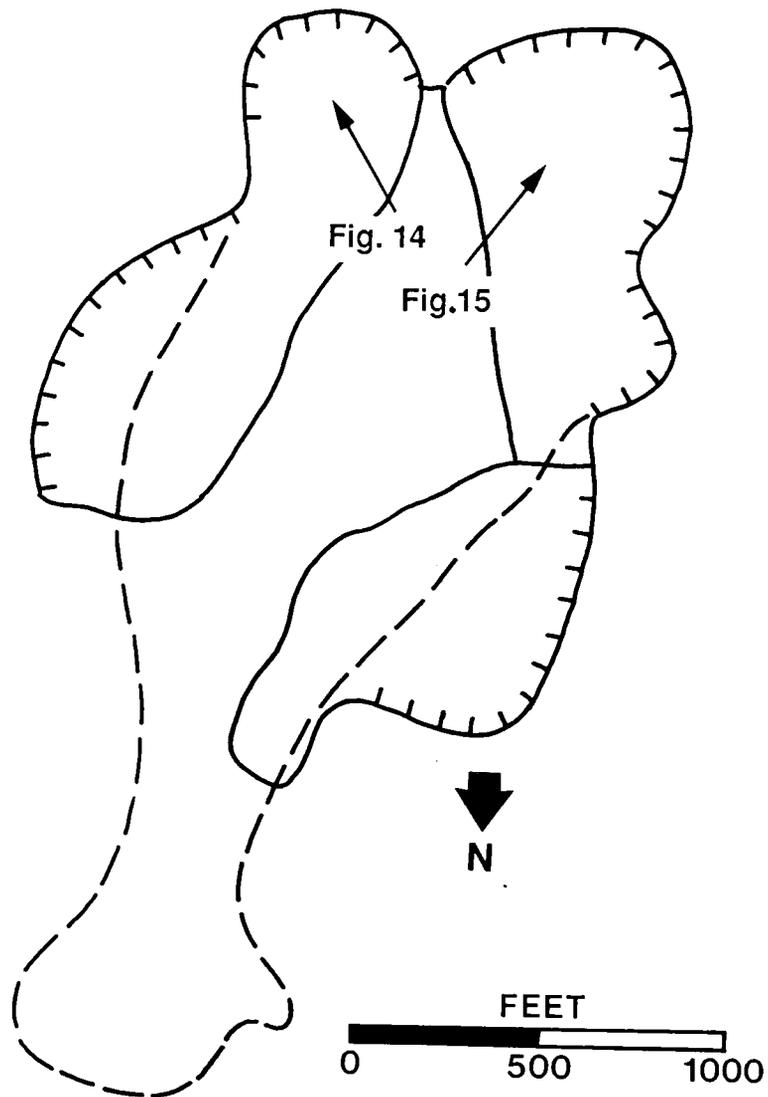
These cliff scarps do appear on aerial photographs flown for the United States Bureau of Land Management (BLM) in 1978. Figure 16 shows head scarp location and associated landslide deposits in 1978 with reference to scarp development and deposits currently observed. Comparing these aerial photographs with 1985 images shows that the cliff faces are larger and more pronounced after the most recent failure of the Roan Creek landslide. Currently the cliff scarps are approximately 150 feet high to the east of the drainage and 200 feet high west of the drainage. The cliff scarps dominate the upper reaches of the slide, but the head scarp is continuous along the upper perimeter of the slide reaching heights of 75 feet along the western margin (Figure 17). All scarps are presented on Figure 18 and Plate 1.

Figure 16. Scarp development and associated landslide deposits in 1978.

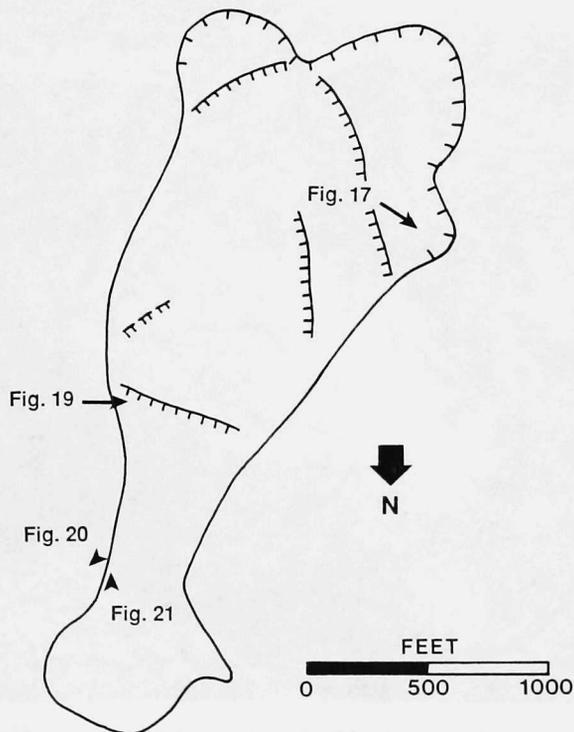
Figure 18. Scarp map of the Roan Creek Landslide.

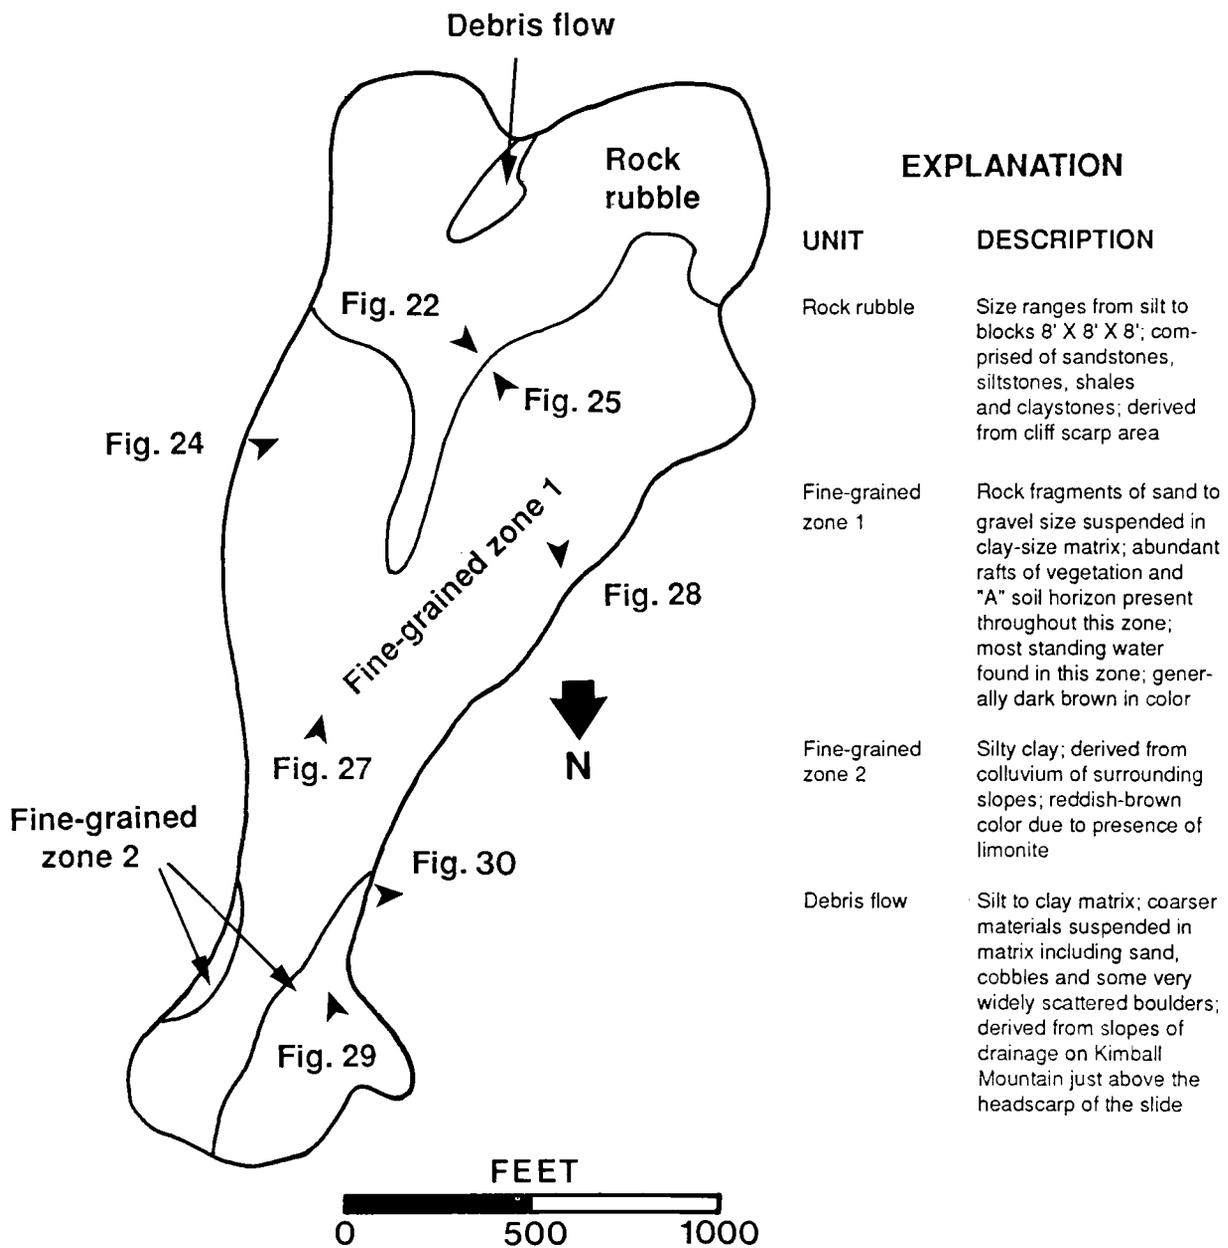
Distinct material zones exist within the slide (Figure 23). In the upper third of the slide, the predominant material present is bedrock rubble (Figures 24 and 25). Due to the heterogeneity of the material and the distance it has traveled, particle size ranges from silt to large blocks. Note the blocks of rock in Figure 25 are generally larger than those observed in Figure 24 due to closer proximity to the source area in the head scarp region. More friable and fissile material has been physically reduced to silt-size particles while stronger rock, such as sandstone, is present in large blocks with dimensions up to 8 feet by 8 feet by 8 feet. The rock rubble was derived from siltstones, fine-grained sandstones, claystones and shale of the Douglas Creek and Garden Gulch Members of the Green River Formation and of the Upper Shire Member of the Wasatch Formation.

Figure 23. Materials zone map of the Roan Creek Landslide.

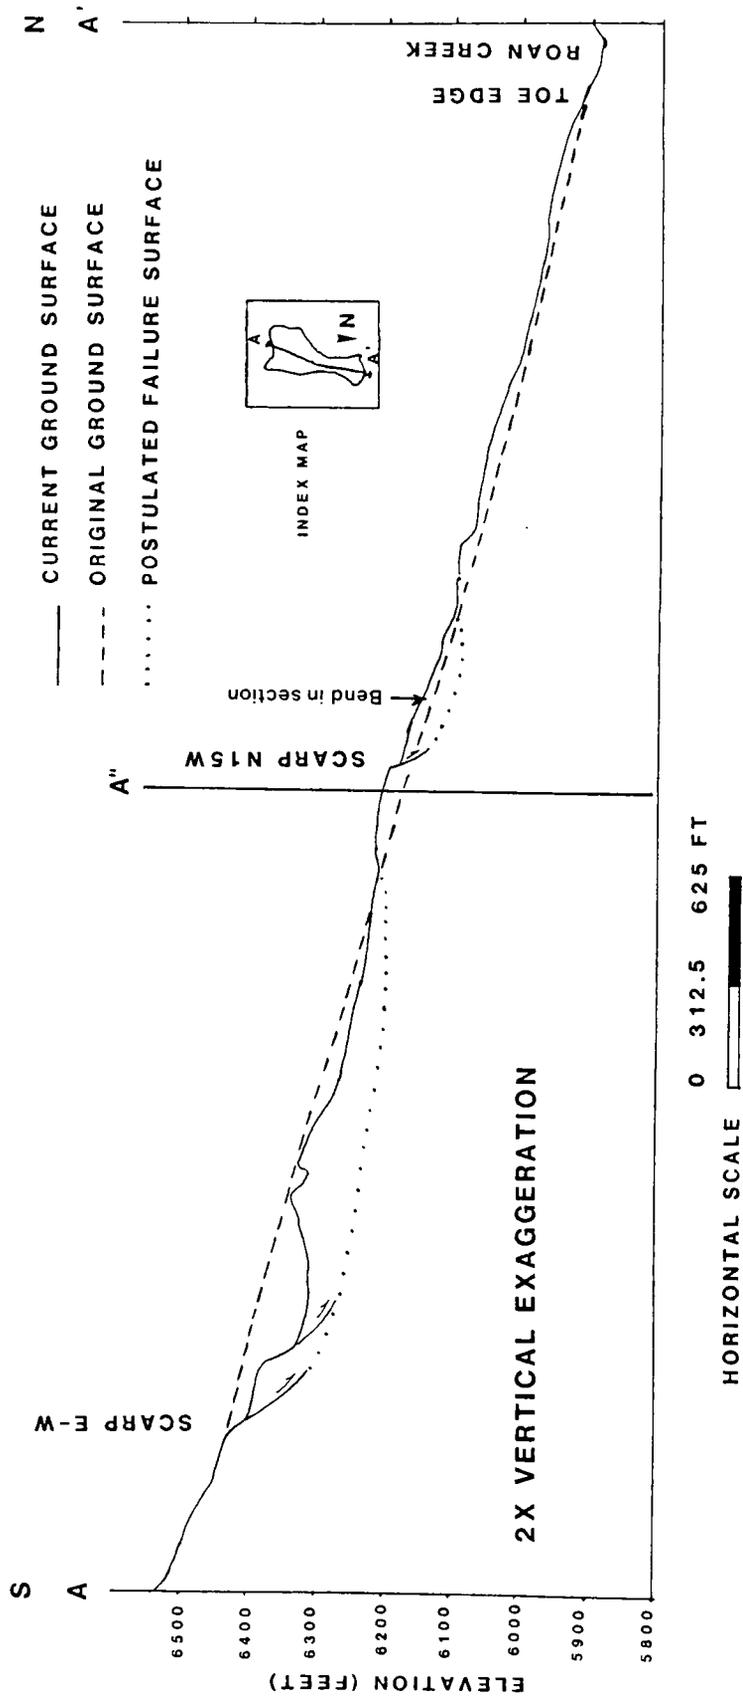
Figure 33. Cross-section along A-A'.

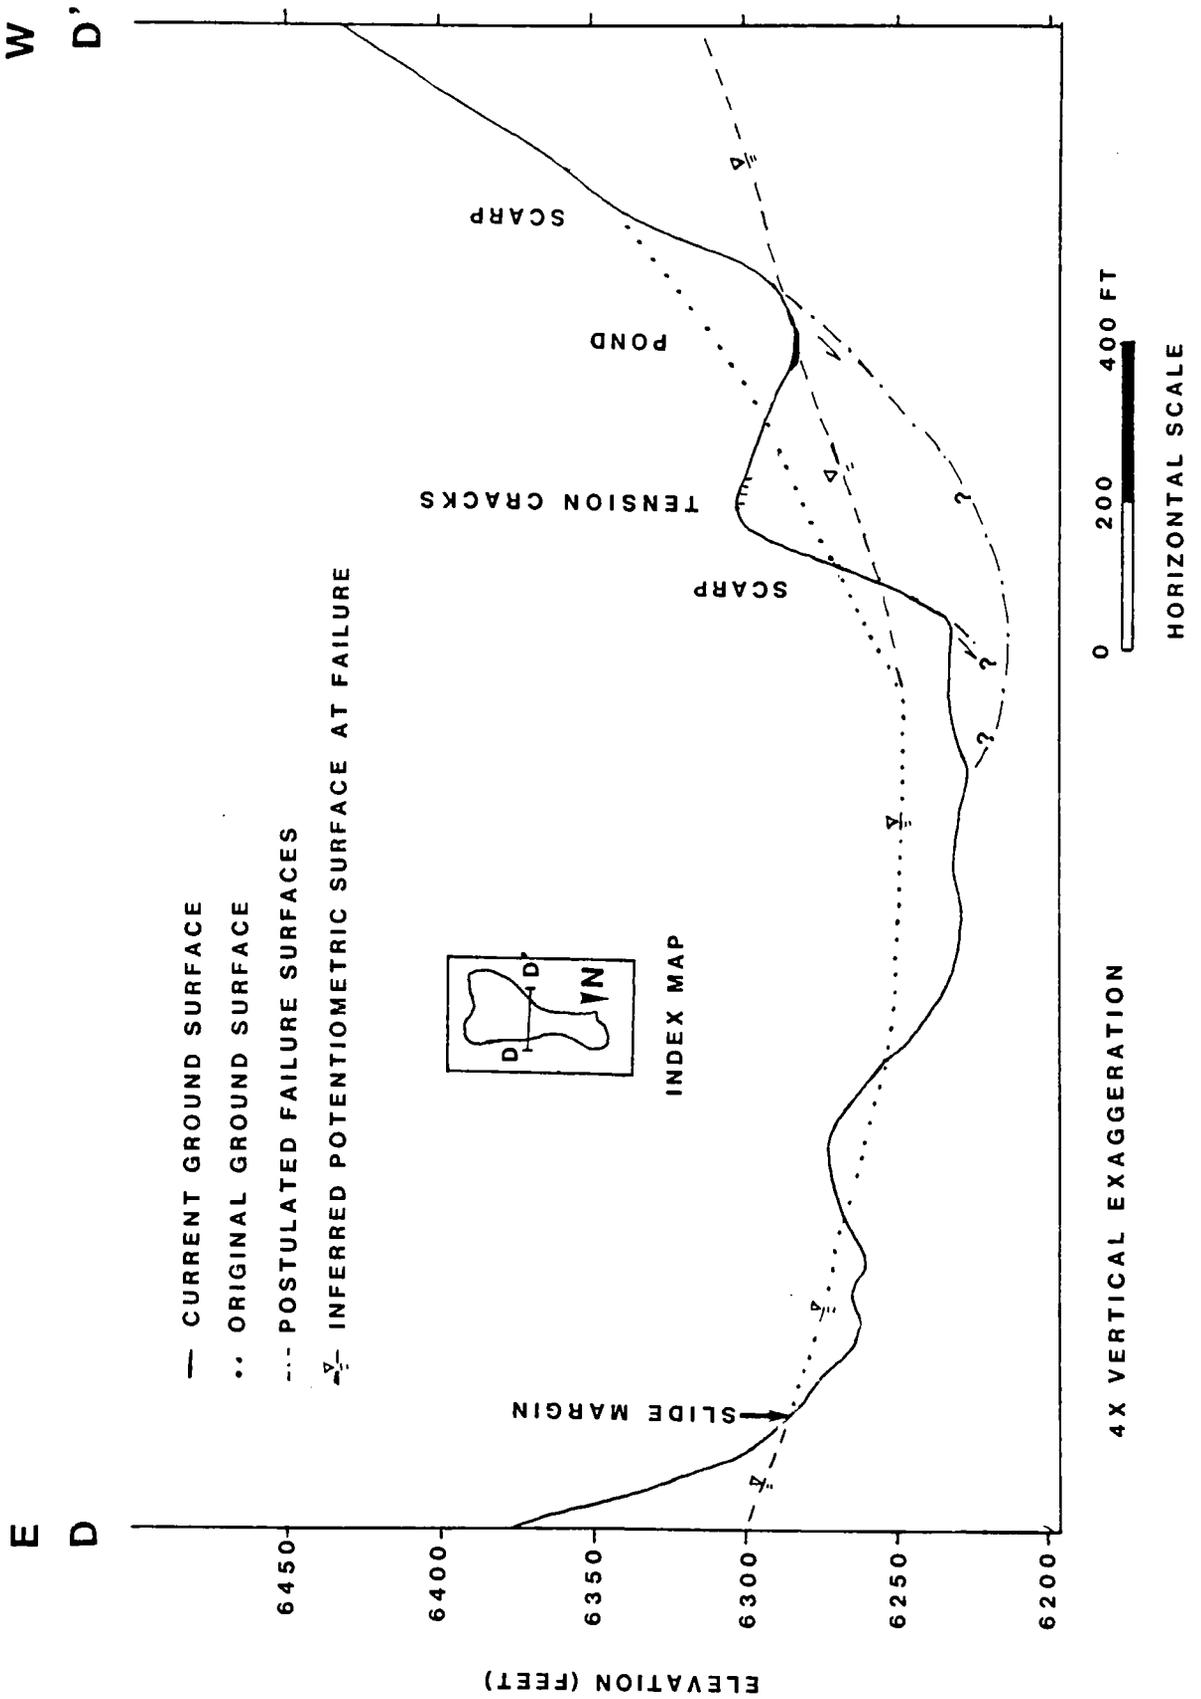
Figure 34. Cross-section along D-D'.

A diagrammatic sketch of the proposed mode of failure along the western section of D-D' (see Figure 34) is presented in Figure 41. Examination of Figure 34 shows that failure must have originated upslope due to current topography higher than that prior to failure in the central portion of D-D'. With this point in mind, it is most improbable that failure initiated at the drainage bottom and retrogressed, or migrated uphill. Upon failure along the western margin slopes, a single slump block broke up into two separate units labeled 5 and 6 on Figure 32/Plate 1. It should be noted that only slight movement has occurred upslope of the scarp defining the upper boundary of unit 5 on Figure 32/Plate 1. Therefore, the failure of units 5 and 6 had little effect on the stability of the northern section of unit 9.

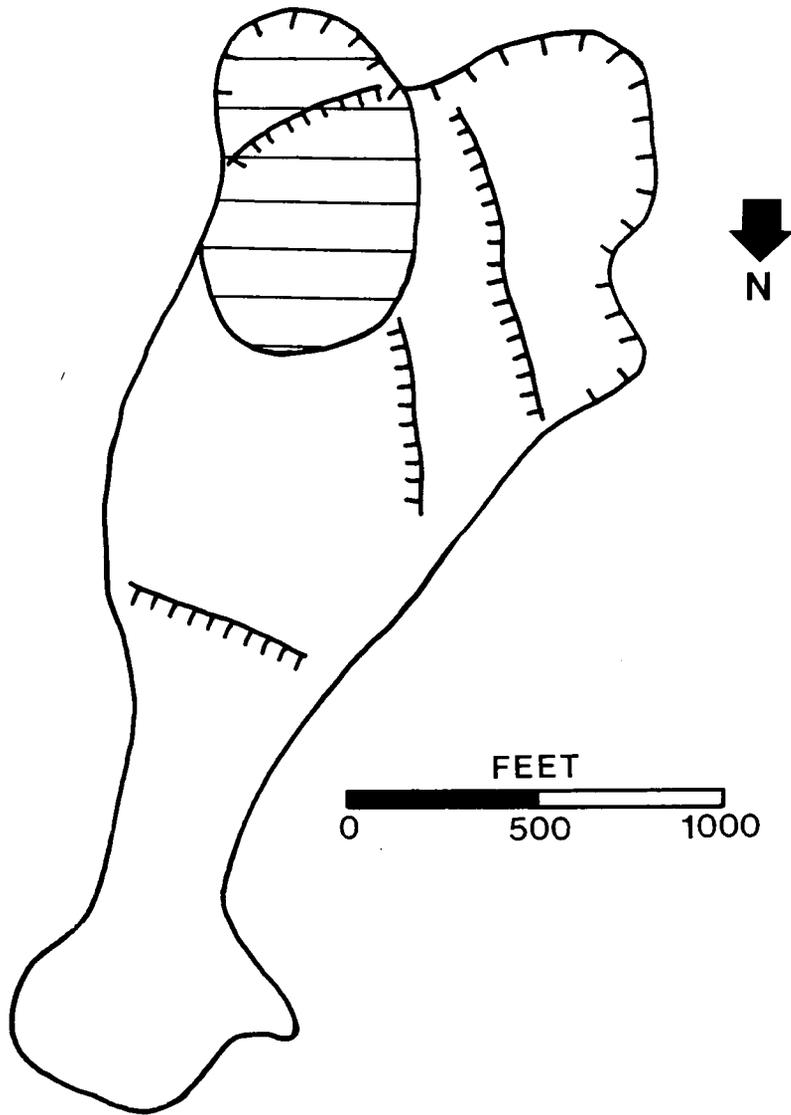
Figure 35. Phase 1 Movement of the Roan Creek landslide.

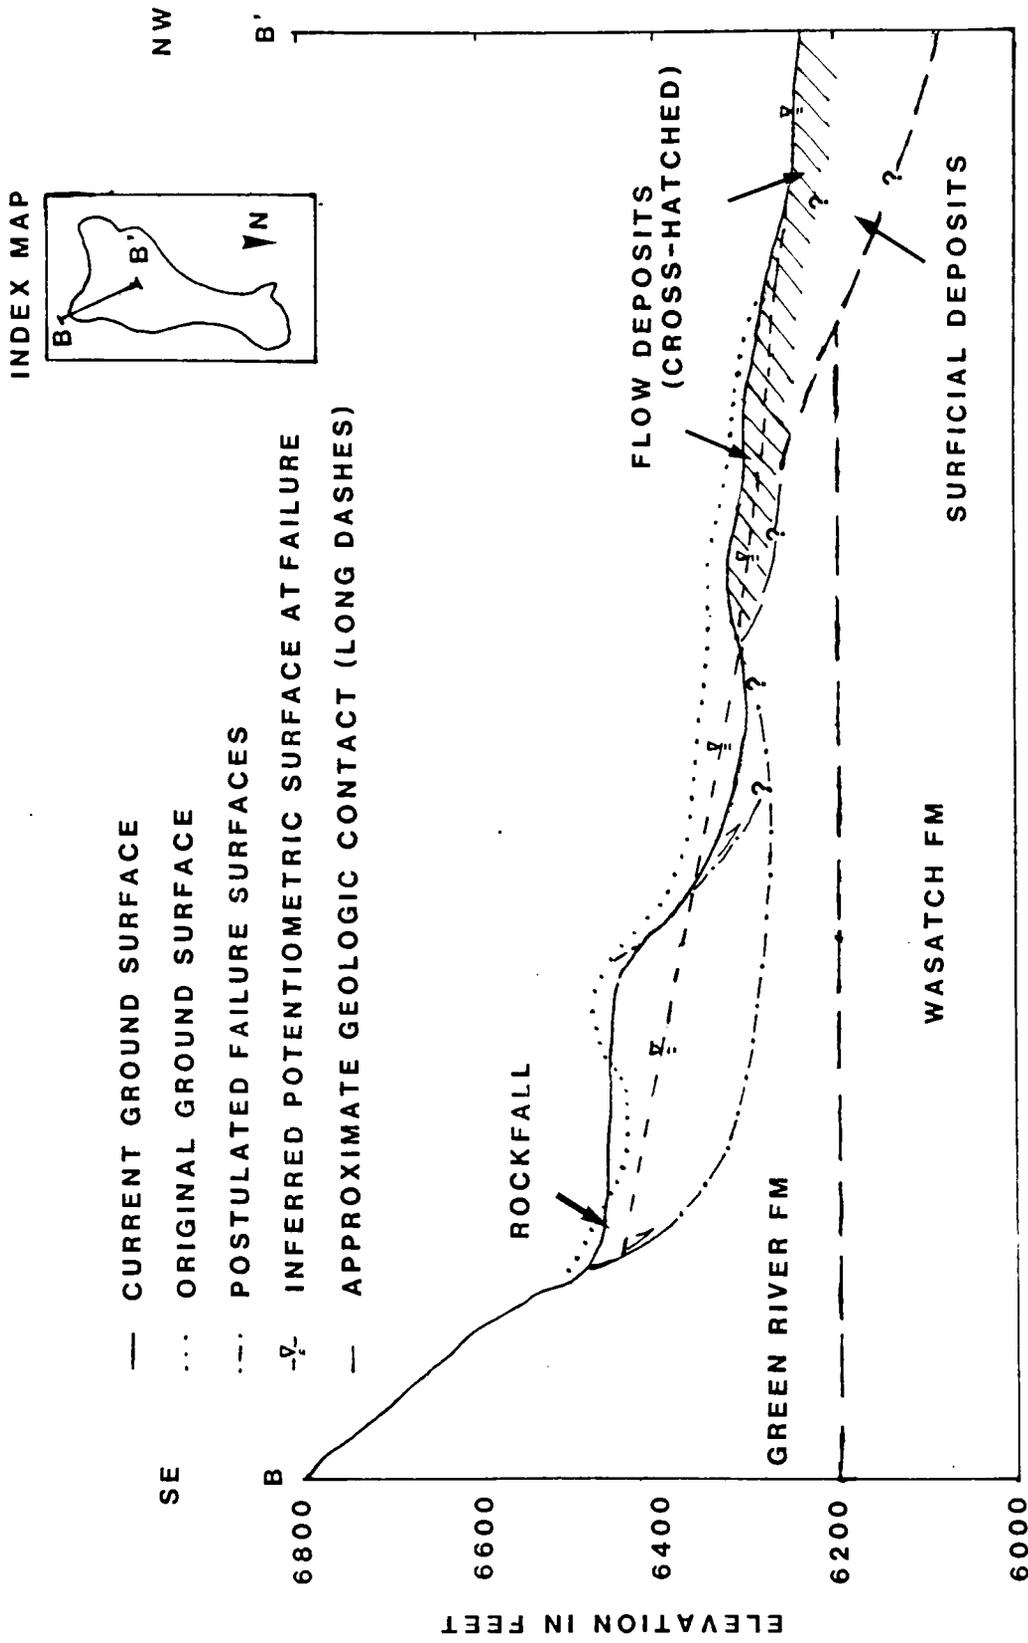
Figure 36. Cross-section along B-B'.

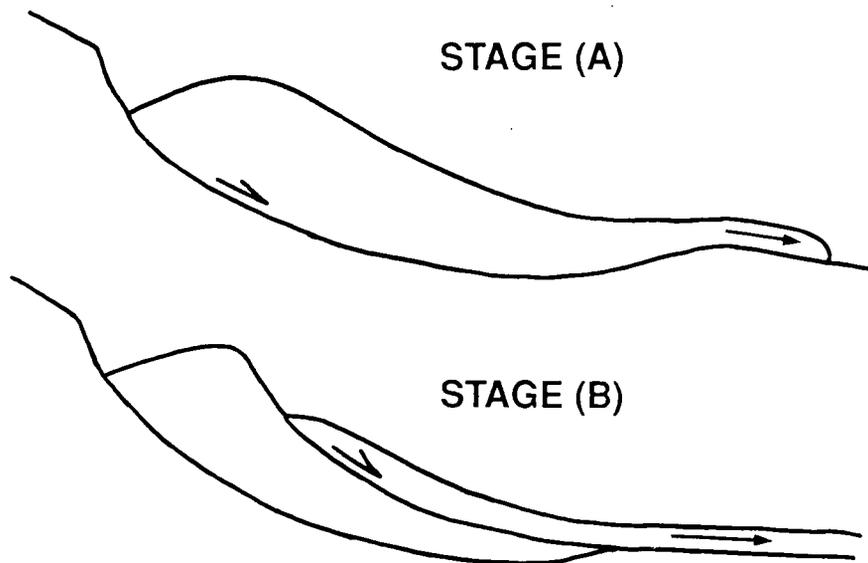
Figure 37 is a two-stage, diagrammatic representation of how failure is believed to have occurred along B-B'. Movement along the pre-existing failure surface daylighting at the eastern cliff scarp initiated failure of the Roan Creek landslide. As the slump block below the cliff scarp rotated back into the slope, secondary failure occurred along a new failure surface on the downslope side of the pre-existing transverse ridge. The postulated failure model then suggests that movement of waste material from this secondary scarp down the drainage generated a surcharge load on the surficial material in the drainage (Figure 38) subsequently reducing the stability of that zone and causing the second phase of failure (Figure 39). Unit 3 on Figure 32/Plate 1 is the last exposed remnant of the surcharge load material.

Figure 37. Diagrammatic representation of proposed failure sequence along cross-section B-B'. (Not to scale.)

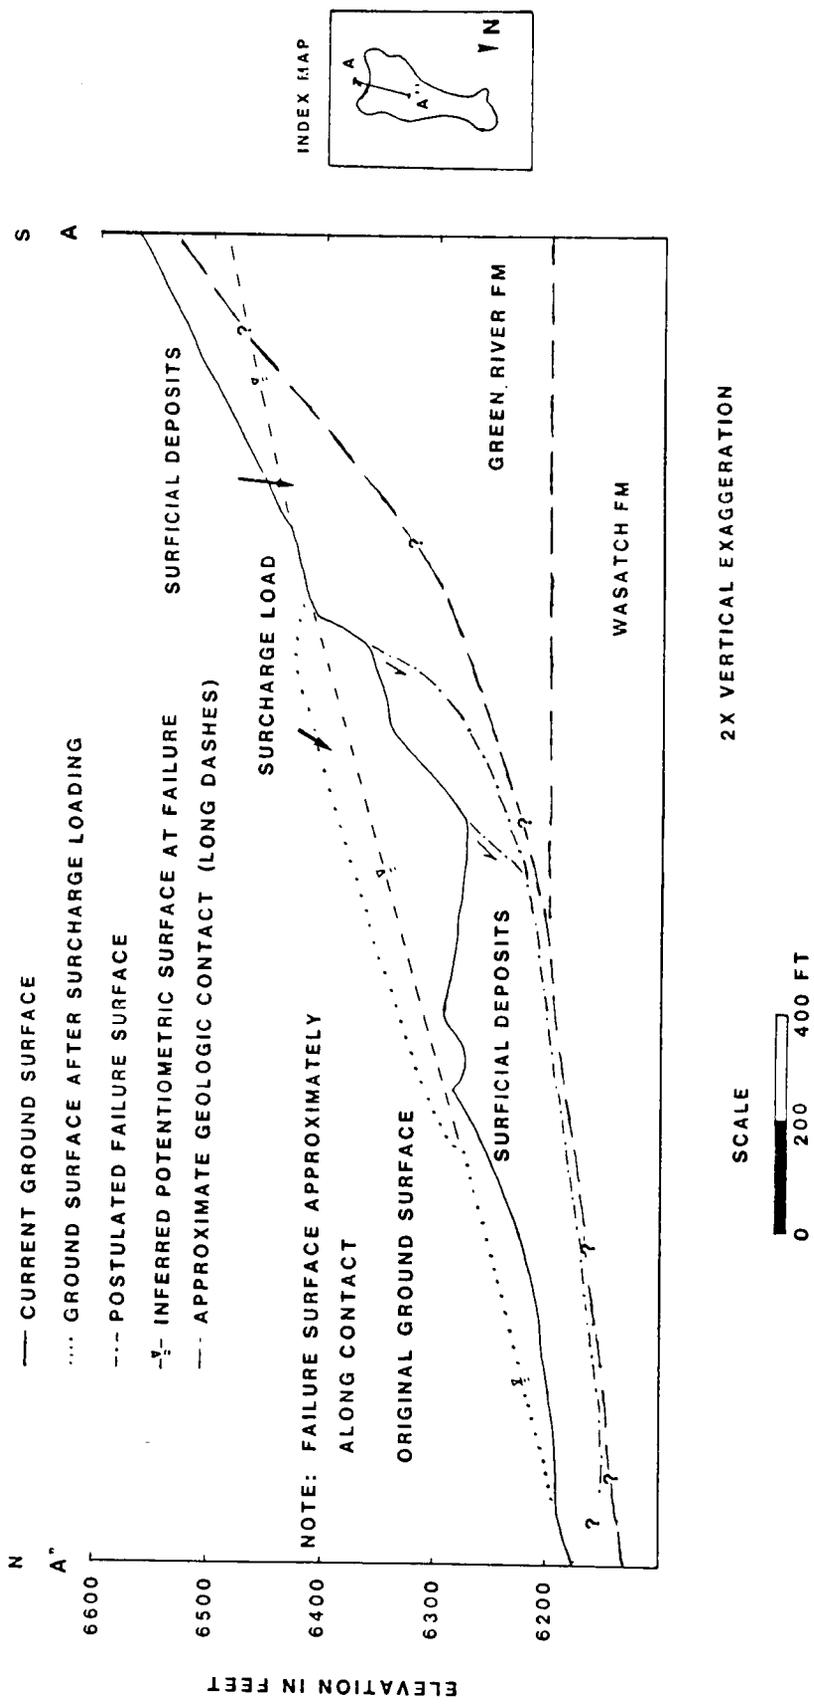
Concentric topographic contours on Plate 1 suggest the failure shown in cross-section along A-A' (Figure 38). One major scarp is present at the failure head with an additional scarp present downhill due to progressive, or downhill, failure. Failure most probably occurred due to surcharge loading by the rock debris from the eastern cliff scarp on soil previously saturated by high precipitation and accelerated snowmelt. The sudden loading also most probably generated excess pore water pressures within the soil mass. A zone

Figure 38. Cross-section along A-A' after surcharge loading.

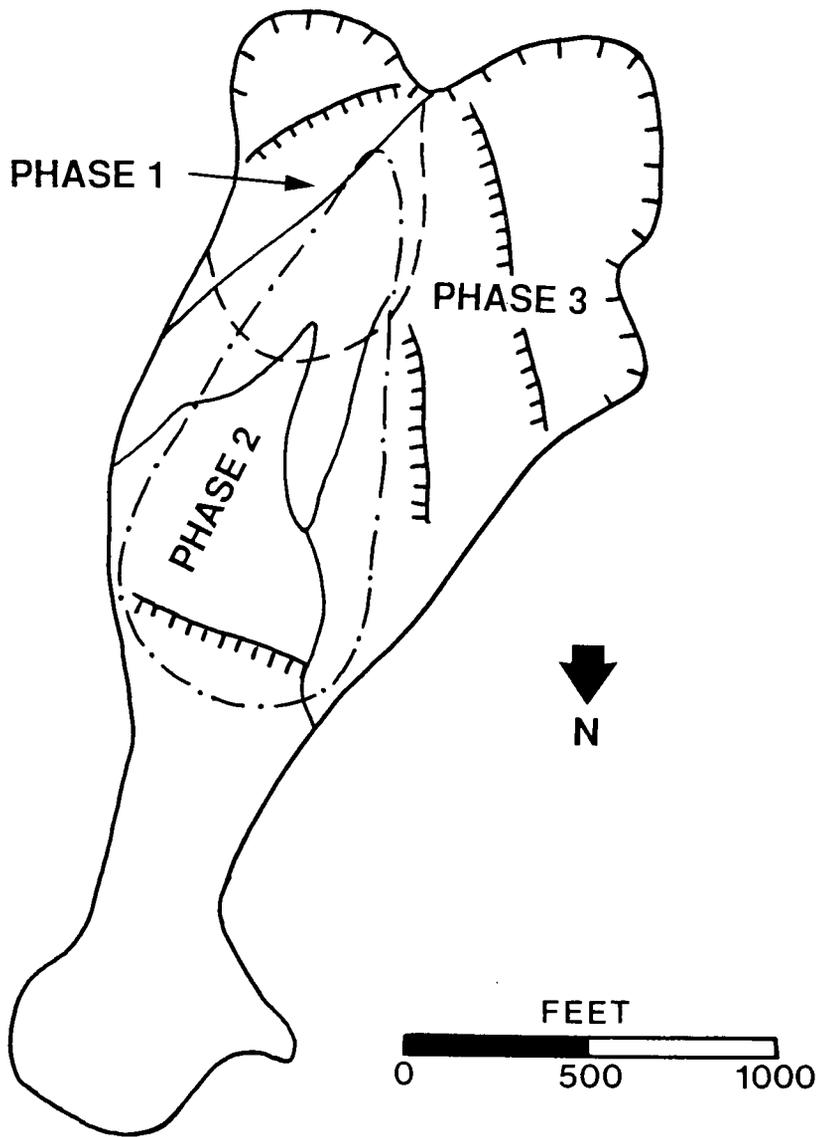
Removal of material in the zone of wasting in the second stage of failure resulted in a significant reduction of lateral confining pressures acting on the rotational block below the western cliff scarp and on the slopes to the west of the drainage. This led to the third phase of failure (Figure 40) which included renewed failure along the western cliff scarp and progressive, downward-migrating, mass wasting of the slopes to the west as evidenced in the field by a series of scarps and tension cracks oriented semi-parallel to the drainage.

Figure 40. Phase 3 movement of the Roan Creek landslide.

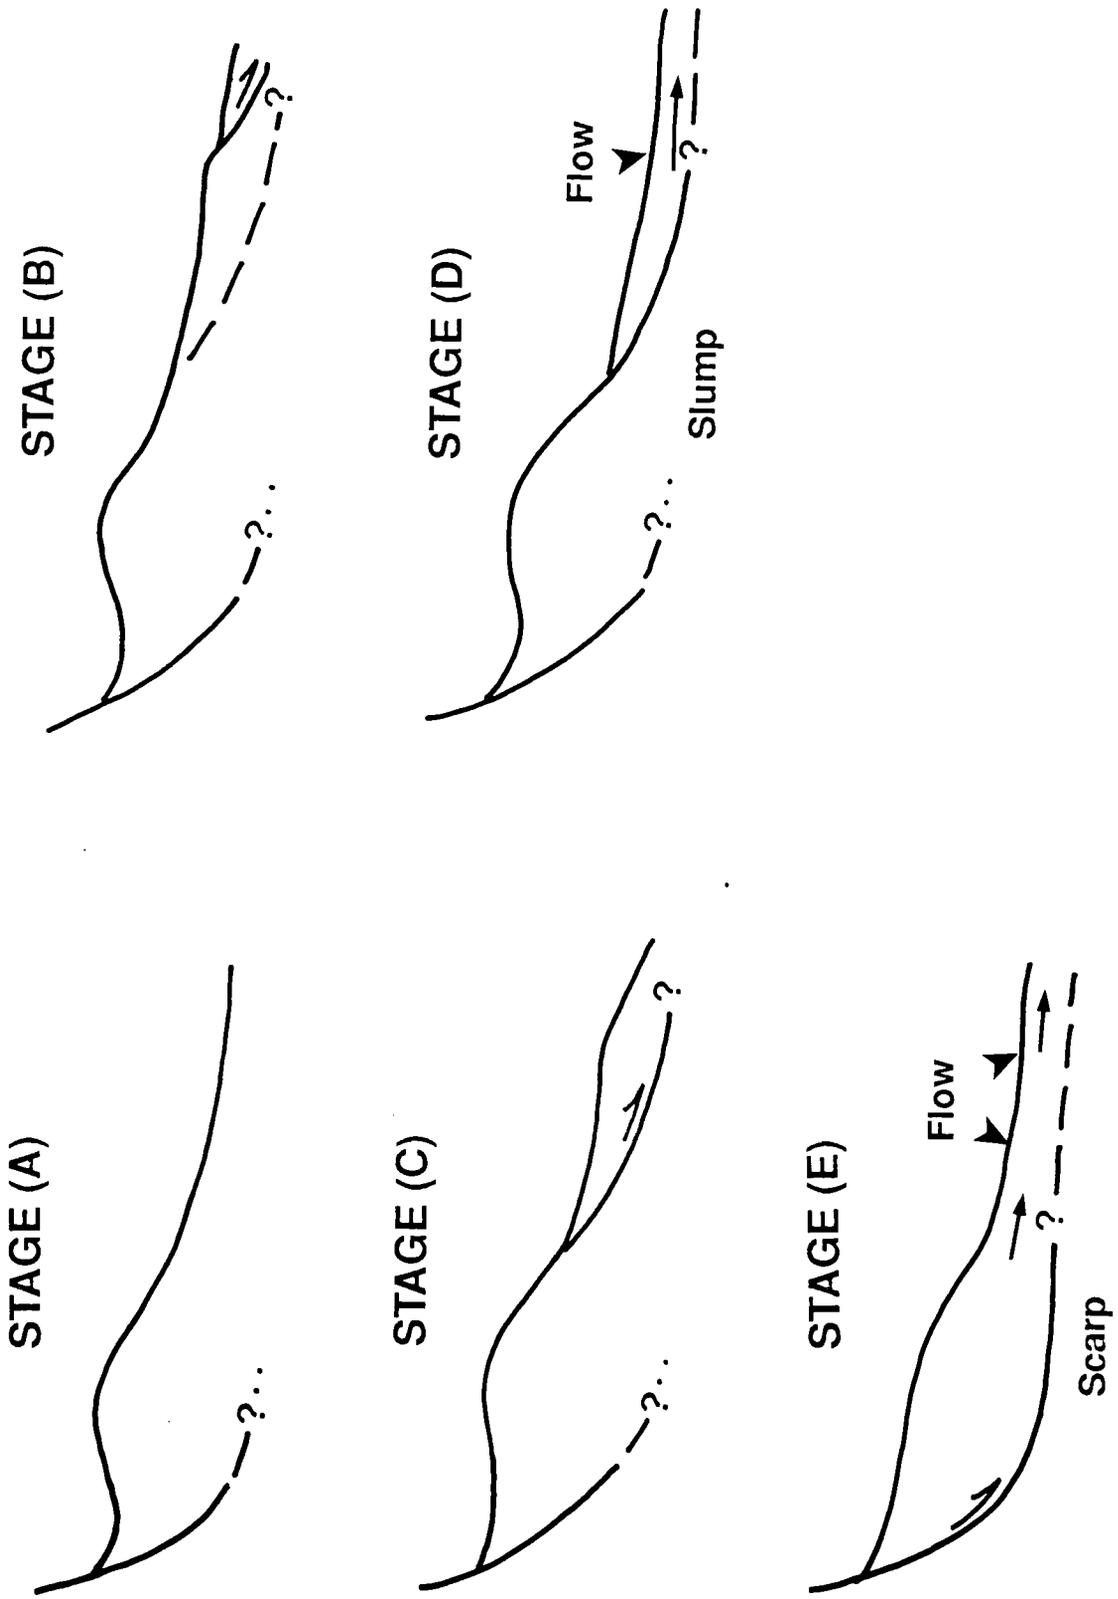
plane daylighting at the cliff scarp. The failure along A-A' and subsequent removal of lateral support is represented in stage (b). Failure due to removal of lateral support by failure along A-A' is shown in stage (c). The head scarp of this failure surface is coincident with that representing the upper boundary of unit 5 in Figure 32. Stage (d) shows the vertical displacement at the head scarp in (c) immediately after failure which resulted in reduced lateral support of the failure plane daylighting at the cliff scarp. Failure along the pre-existing failure plane is shown in stage (e).

Figure 43. Diagrammatic representation of proposed failure sequence along cross-section C-C'.

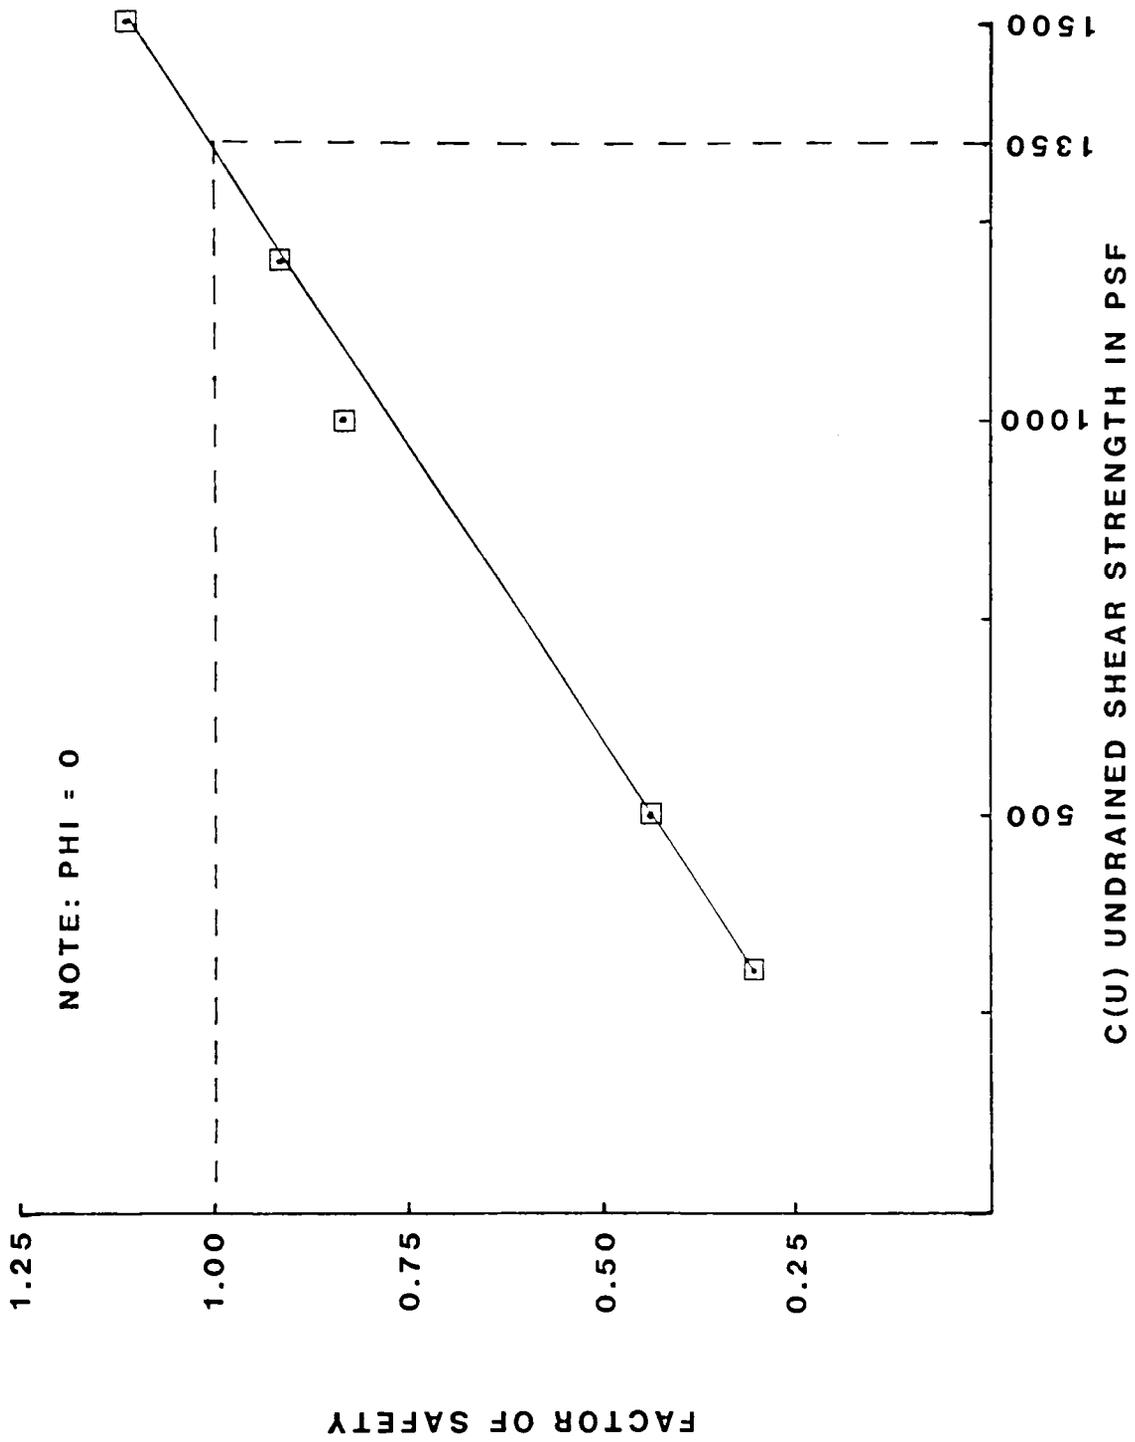
Values of undrained shear strength ranging from 300 to 1500 psf were utilized, in conjunction with the unit weights and groundwater conditions described above for the failure plane defined in Figure 38, to determine what shear strength yielded a factor of safety of 1.0 using the Janbu method of slices. Figure 44 is a plot of factor of safety versus undrained shear strength compiled from PCSTABL4 results.

Figure 44. Determination of undrained shear strength.

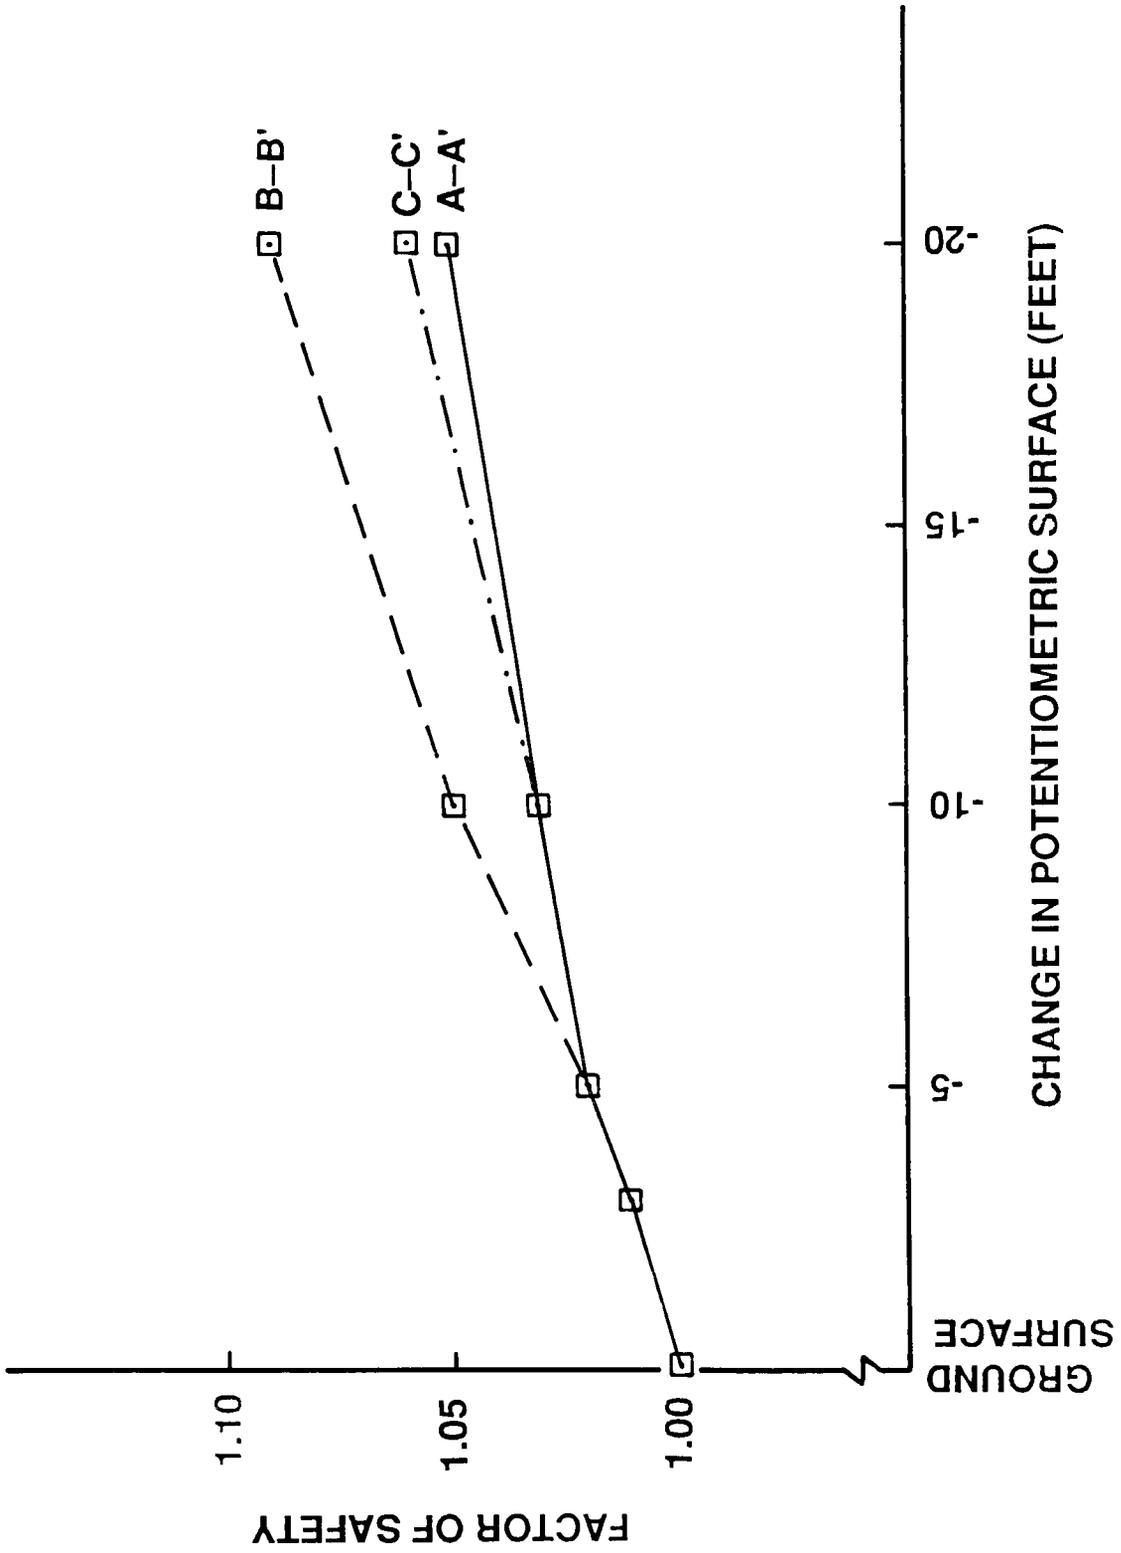
Figure 45. Effect of lowering potentiometric surface on factor of safety.

8.2.7 Effect of lowering potentiometric surface on factor of safety After analyses were conducted along the four profiles, the effect of the position of the inferred potentiometric surfaces on factors of safety was addressed. The potentiometric surfaces on factors of safety was addressed. The potentiometric surface was lowered from the position used in the analyses (see previous discussion and Appendix B data input files) by 5, 10 and 20 feet under the most critical failure conditions along profiles A-A', B-B' and C-C'. It should be noted that only the effect on the terminal failure condition along profile C-C' was analyzed. The results are plotted on Figure 45.
