Open-File Report 89-1

# Field Studies and Modeling Analysis of the Roan Creek Landslide, Garfield County, Colorado

By  
David Umstot\*

Colorado Geological Survey  
Department of Natural Resources  
Denver, Colorado  
1989

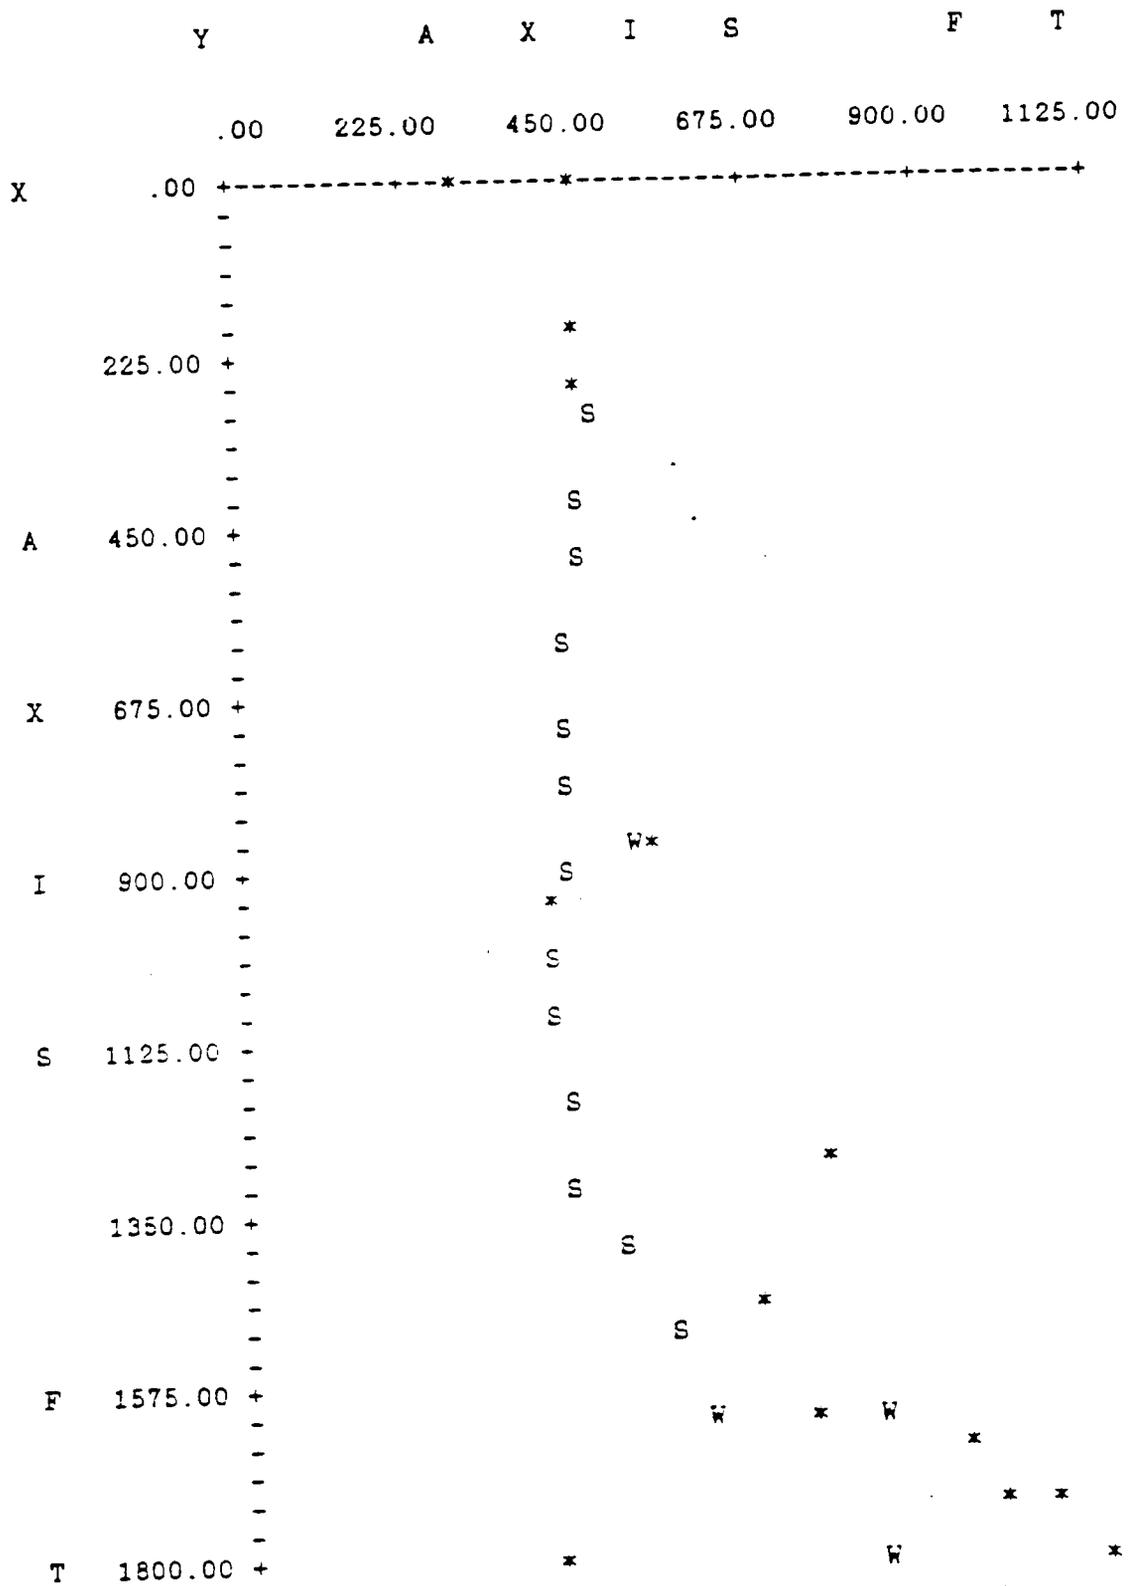
Factor Of Safety For the Preceding Specified Surface = 1.110

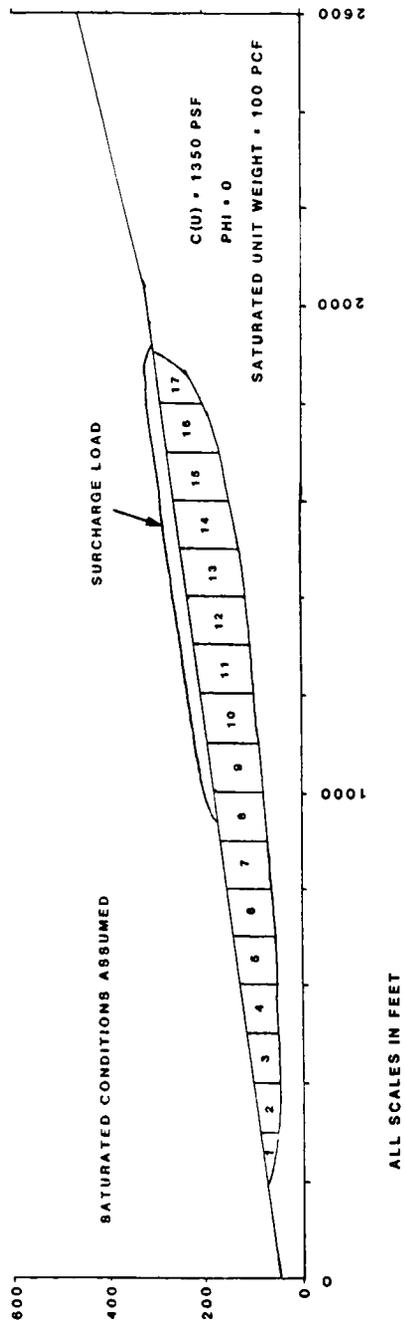
DIAGRAM USED IN TOTAL STRESS ANALYSES PRIOR TO AND AFTER SURCHARGE LOADING FOR HAND COMPUTATIONS  
OF FACTORS OF SAFETY ALONG PROFILE A-A'.

Back calculation using a total stress analysis yielded an undrained shear strength of 1350 psf. Analysis along profile A-A' prior to surcharge loading generated a factor of safety of 1.23 suggests that failure was caused due to surcharge loading.
