CULVERT PERFORMANCE  
AT  
TEST SITES IN COLORADO  
AUGUST 1968

RESEARCH REPORT 68-8

STATE DEPARTMENT OF HIGHWAYS  
DIVISION OF HIGHWAYS--STATE OF COLORADO

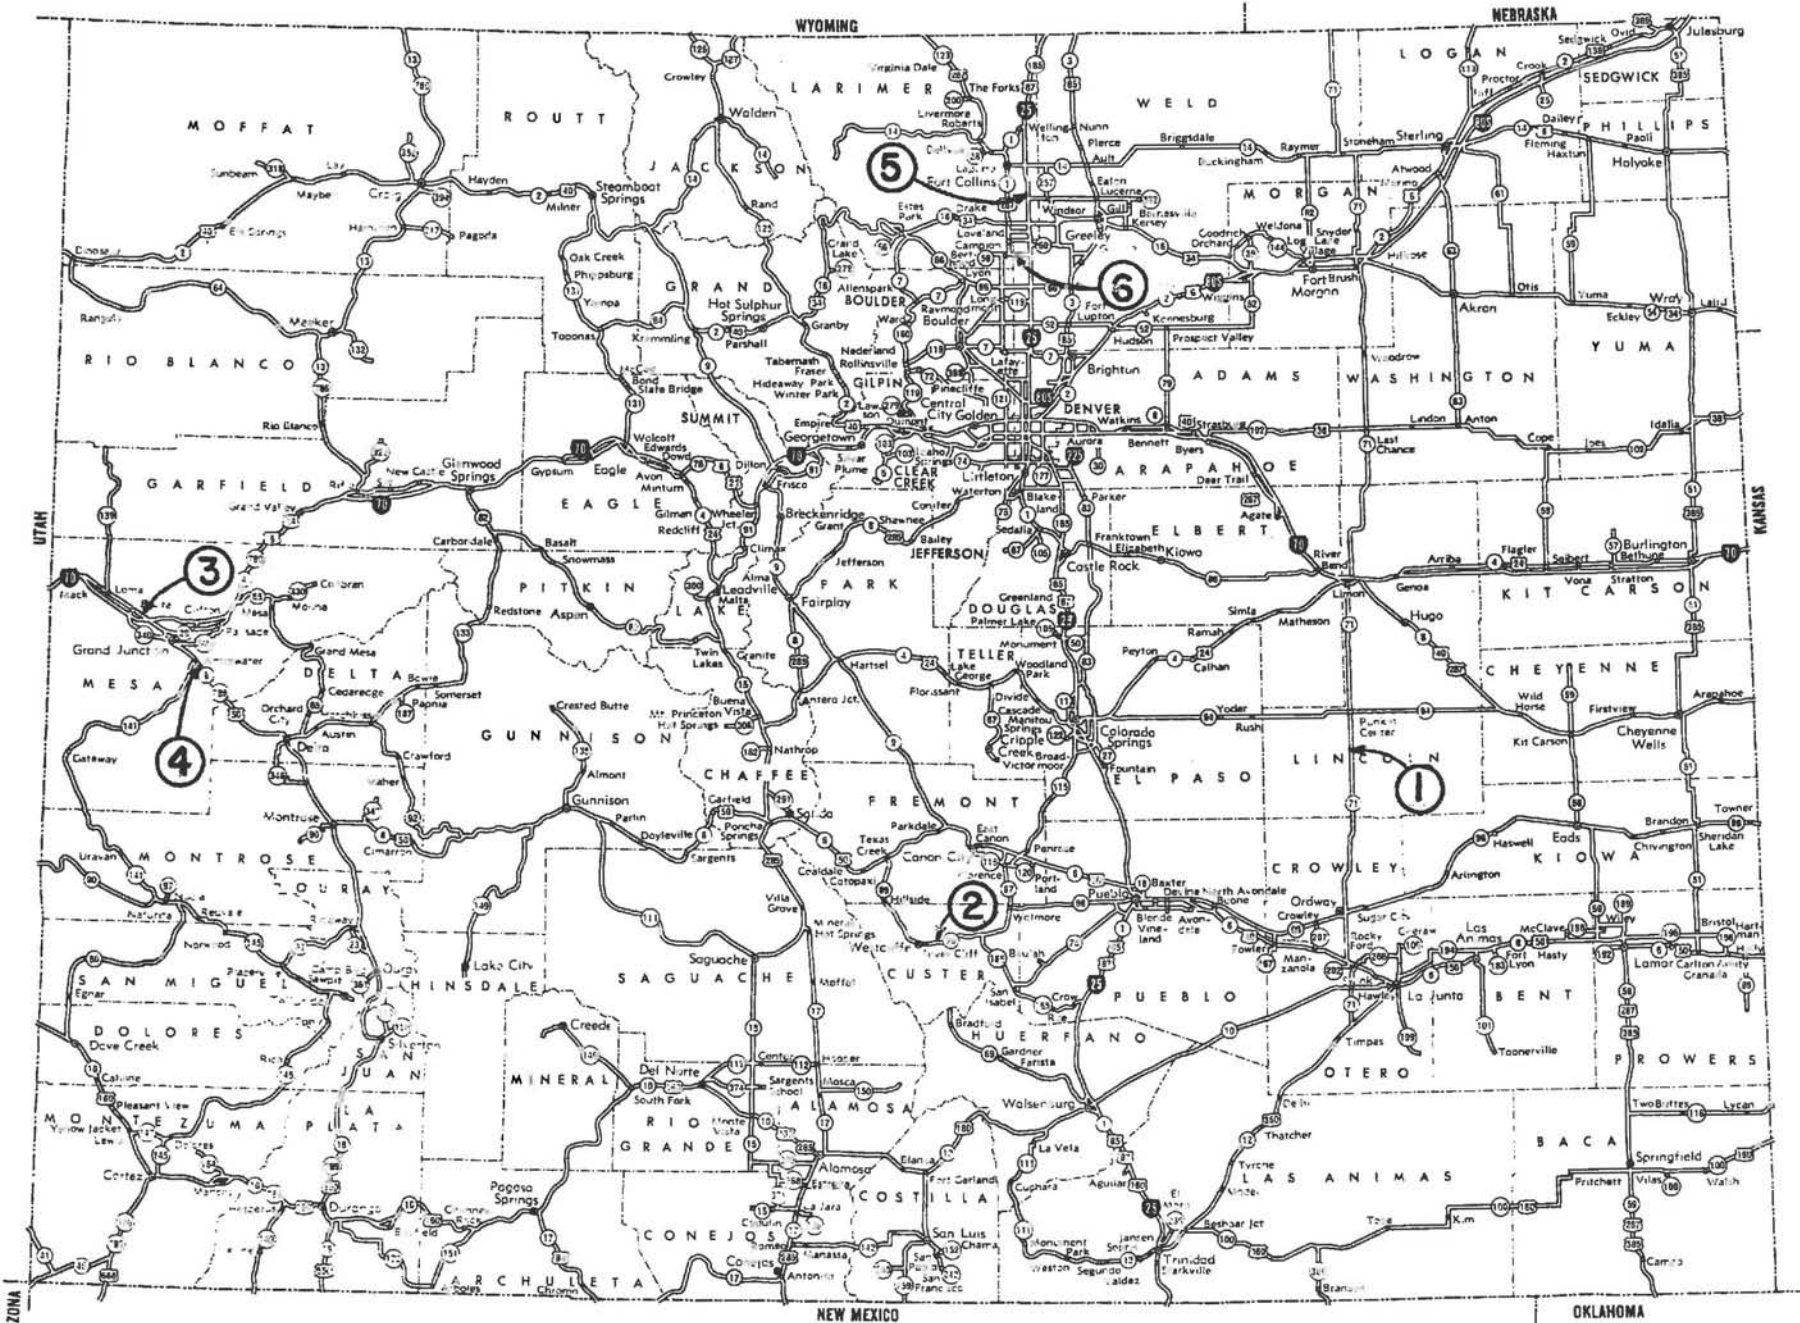
In 1964, two six-foot sections of concrete pipe 18 inches in diameter and made of Class II and Class V cement respectively were placed at the Fossil Creek site just north of the Windsor interchange on Interstate 25. The soil and water at this location have been detrimental to steel and aluminum, but corrosion was non-existent on the concrete pipe as of June 1968.
