Report No. CDOH-DTP-R-84-5

# EVALUATION OF CONCRETE PAVEMENT RESTORATION PROCEDURES AND TECHNIQUES

**K.L.WOOD**

INITIAL REPORT  
MARCH 1984

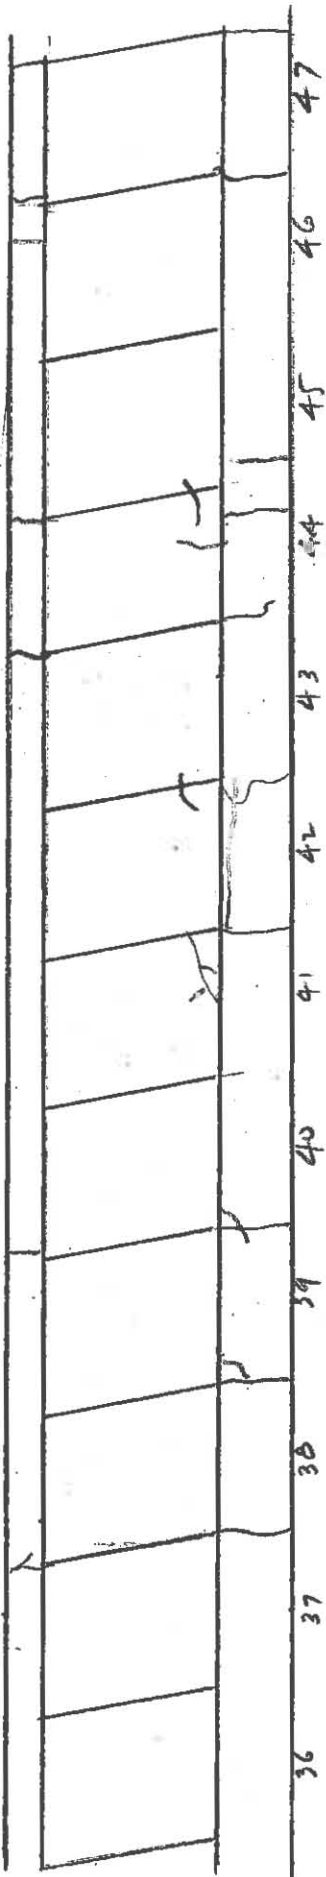
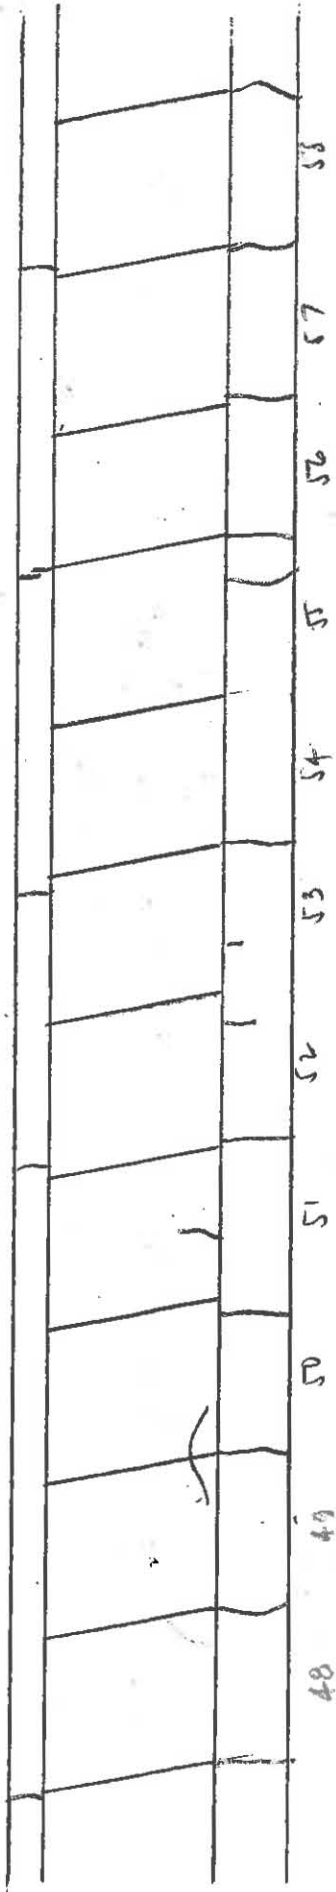
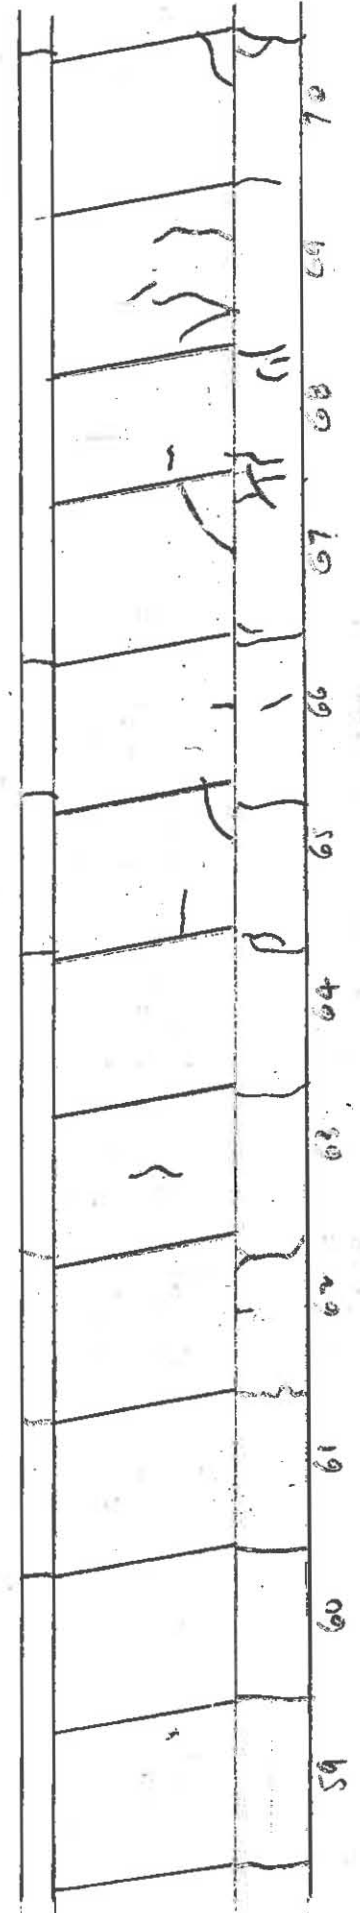
CONDITION SURVEY (Cracking Maps)  
 I-70, EBL (Chambers to Tower Rd.)  
 August '83

The Condition Survey is the guide for determining the rehabilitation alternatives. For example, a review of the crack maps indicate very few of the PCCP slabs are broken and that there is no joint spalling. This plus the roughness measurements made by the profilograph indicate the slabs are stable and the ride quality is good. Also, the deflections measured indicate the PCCP slabs are relatively stable. Using only the above information, alternatives such as reconstruction and thick overlays of asphalt or PCCP would not be recommended at this point in time. What is needed are restoration procedures and techniques to prolong the life of a PCCP that is in relatively good condition as shown by the very important Condition Survey.

Based on the Condition Survey, the Department decided to remove the few cracked and broken slabs full depth and replace them with new PCCP. (The few joints that were spalled would be repaired by partial depth removal and

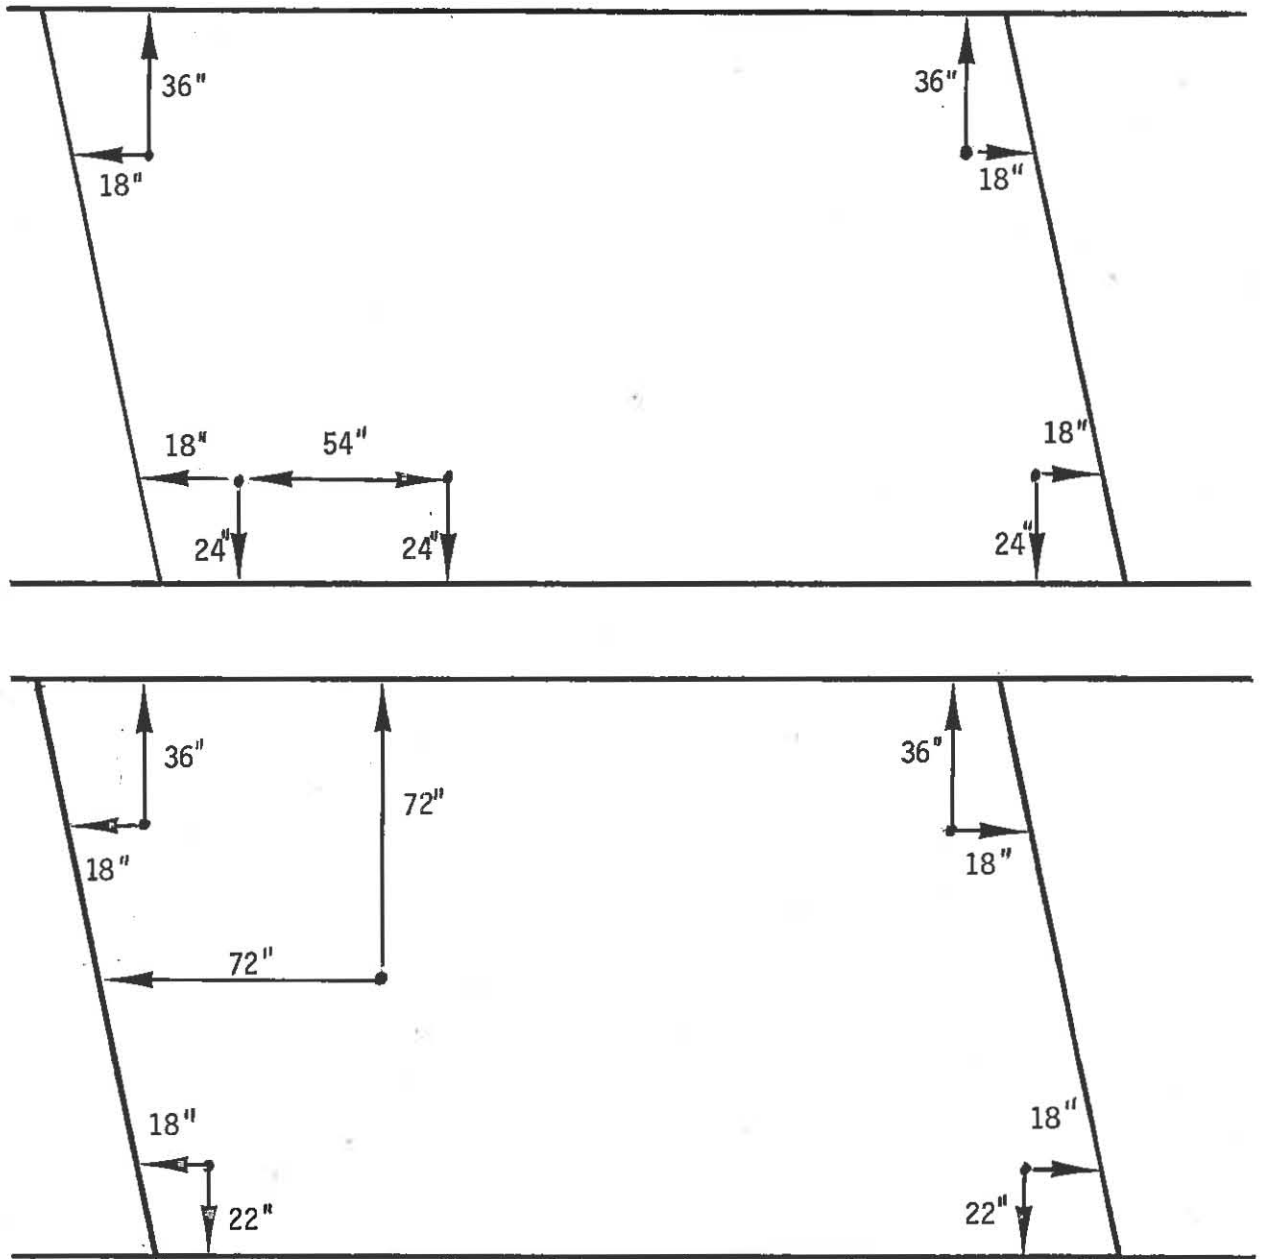
# HOLE PATTERNS

Two hole patterns were used on the 56 continuous slabs undersealed on this project. The intent was to measure the relative effectiveness of the two patterns by using the Benkleman Beam and/or Dynaflect. To date, there has not been any significant difference reported in deflections. Undersealing was performed in the truck lane only. The slabs are 12 ft. long and 20 ft. wide with skewed joints.

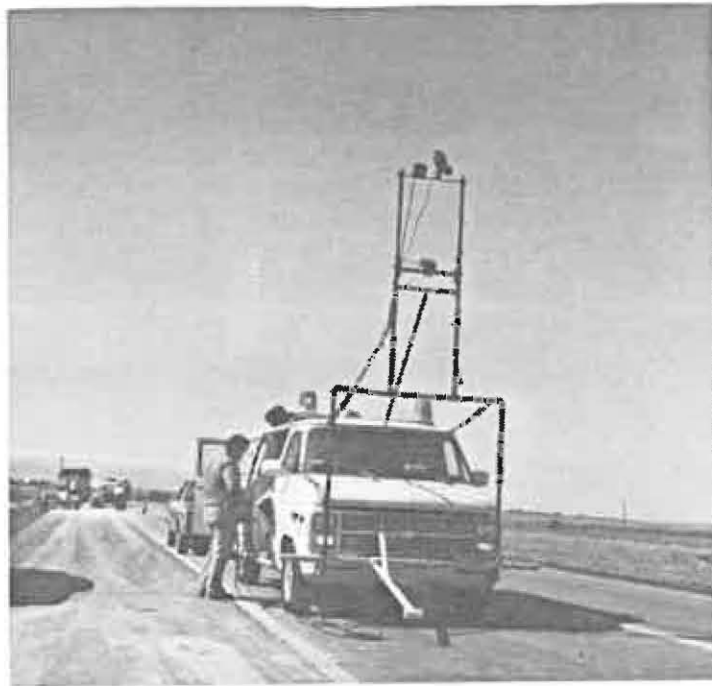
**Non-destructive testing (NDT) equipment used on the preliminary engineering condition survey. Donahue Radar Void Detector which was one of several pieces of NDT equipment on display at the project site. This device is used to detect voids under the faulted slabs.**

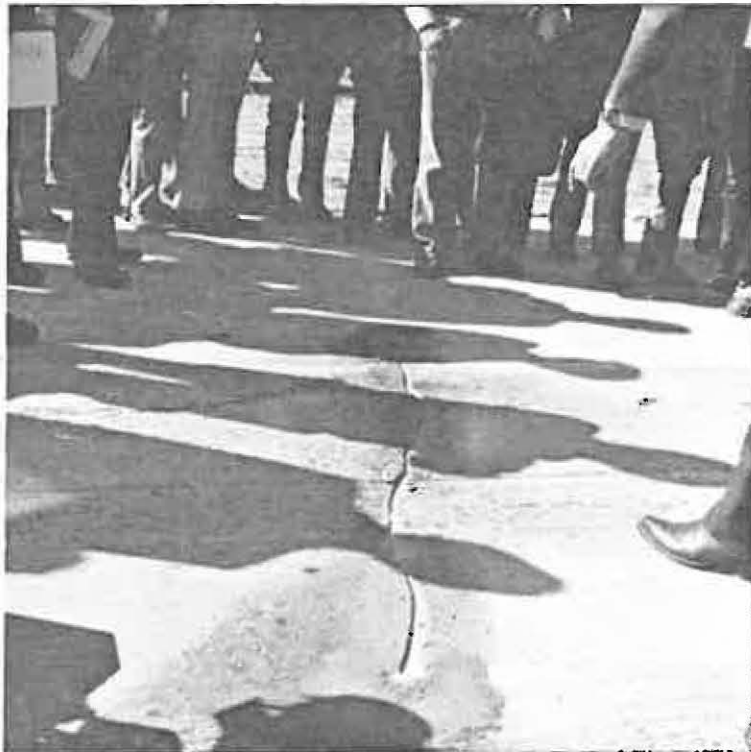
**The routed crack is inspected by a group of attendees just prior to cleaning and sealing. Sealing the cracks and joints is the last activity in the complete CPR system.**
