Mt. Vernon Canyon Runaway Truck Escape Ramp

Report No. CDOH-DTP-R-83-03

Final Report December, 1982

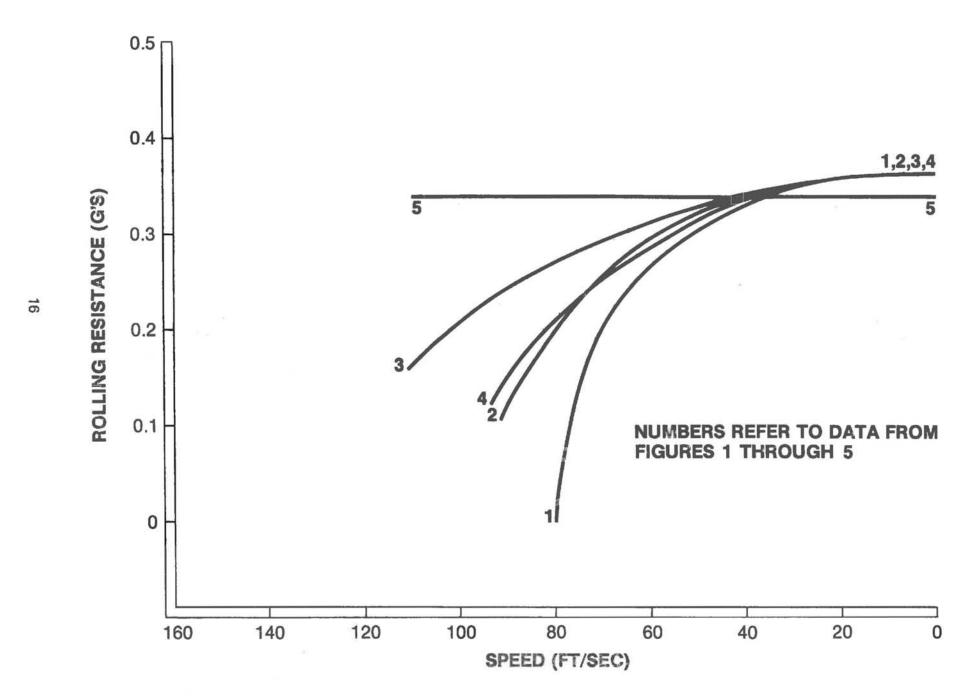
Figure 6 must be interpreted and used with caution. Curves 1, 2, 3, and 4, which are for heavy tractor-semitrailer units all converge to a rolling resistance of 0.36 as the speed reaches zero, but at high speeds they diverge widely. This could be related to the condition of the gravel at the ramp entrance or to completely unknown factors. The design value of 0.2 G seems to be a good average for entry speeds as high as 100 ft/sec (68 mph), but it could produce an inadequate design for higher design speeds. The rolling resistance for higher entry speeds cannot be estimated with the data available from Mt. Vernon Canyon.
