Bridge Deck Repair Investigation and Quantity Estimation

COLORADO
Department of Transportation

1. Report No. CDOT-2020-19		2. Government Accession No.		3. Recipient's Catalog No.	
4. Title and Subtitle Bridge Deck Repair Investigation and Quantity Estimation				5. Report Date Dec. 2020

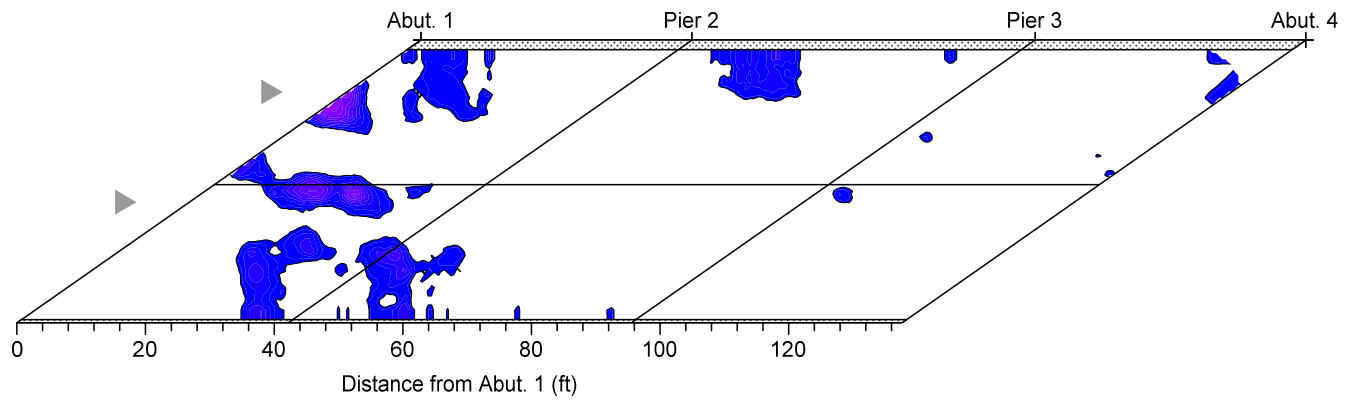
Concrete Condition Legend	Orientation	Quantity Summary	General Information				
<p>Deterioration</p> <p>Increasing severity --></p> <p> Condition not detectable by GPR</p>	<p></p> <p> Direction of traffic</p>	<p>Deck</p> <table border="1"> <tr> <td>Conc. Deterioration (%)</td> <td>10.7</td> </tr> <tr> <td>Conc. Deterioration (s.f)</td> <td>609</td> </tr> </table>	Conc. Deterioration (%)	10.7	Conc. Deterioration (s.f)	609	<p>Bridge ID: B-06-S (20 scans/ft) US 40 EB over Fortification Creek</p> <p>Analyzed by: IN Reviewed by: SB Completed: 9/14/18</p> <p>Sheet 1 of 1</p>
Conc. Deterioration (%)	10.7						
Conc. Deterioration (s.f)	609

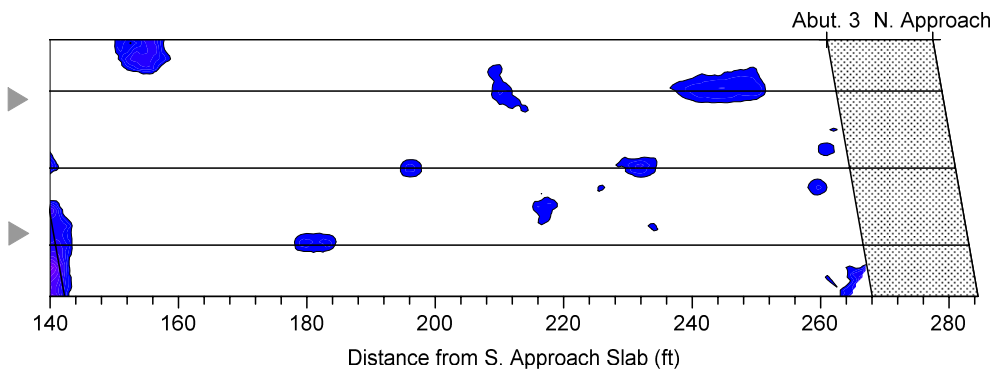
Concrete Condition Legend	Orientation	Quantity Summary	General Information
<p>Deterioration</p> <p>Increasing severity --></p> <p> Approach Slab</p>	<p> Direction of traffic</p>	Deck	<p>Bridge ID: B-06-V (4 scans/ft) SH 394 over Yampa River</p> <p>Analyzed by: IN Reviewed by: SB Completed: 9/14/18</p>
		<p>Conc. Deterioration (%) 11.5</p> <p>Conc. Deterioration (s.f) 1158</p>	<p>Sheet 1 of 1</p>

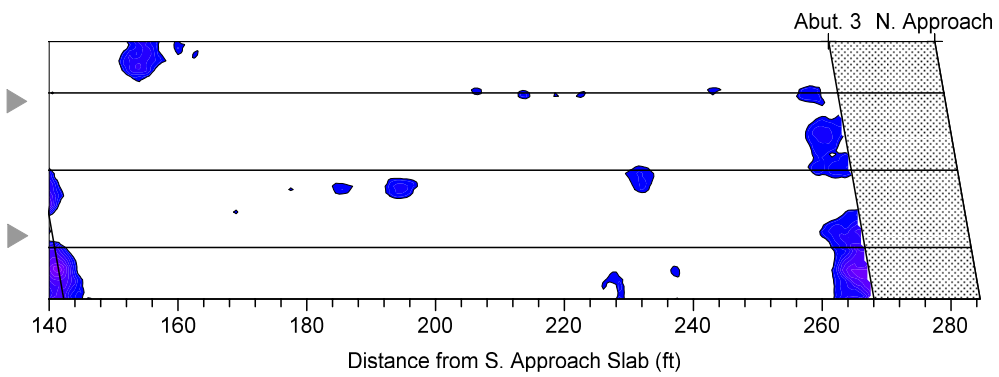
Concrete Condition Legend	Orientation	Quantity Summary	General Information		
<p>Deterioration</p> <p>Increasing severity --></p> <p> Approach Slab</p>	<p> Direction of traffic</p>	Deck	Bridge ID: B-06-V (8 scans/ft) SH 394 over Yampa River		
		<table border="1"> <tr> <td>Conc. Deterioration (%)</td> <td>10.3</td> </tr> <tr> <td>Conc. Deterioration (s.f)</td> <td>1030</td> </tr> </table>	Conc. Deterioration (%)	10.3	Conc. Deterioration (s.f)
Conc. Deterioration (%)	10.3				
Conc. Deterioration (s.f)	1030				
			Sheet 1 of 1

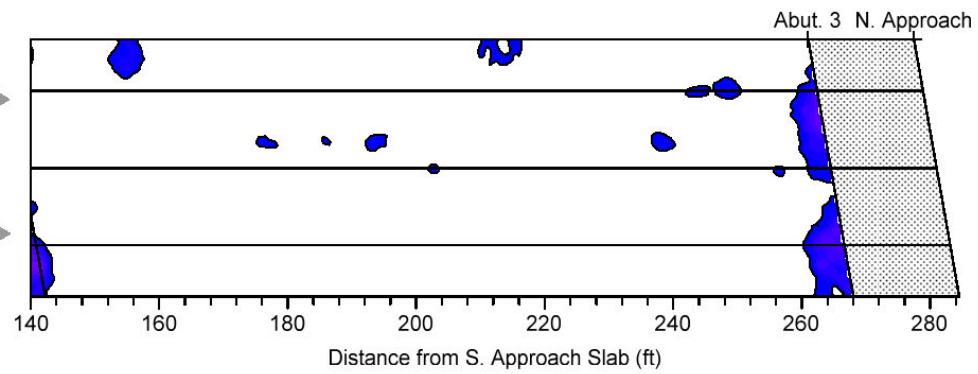
Concrete Condition Legend	Orientation	Quantity Summary	General Information		
<p>Deterioration</p> <p>Increasing severity --></p> <p> Approach Slab</p>	<p> Direction of traffic</p>	Deck	Bridge ID: B-06-V (20 scans/ft) SH 394 over Yampa River		
		<table border="1"> <tr> <td>Conc. Deterioration (%)</td> <td>12.3</td> </tr> <tr> <td>Conc. Deterioration (s.f)</td> <td>1238</td> </tr> </table>	Conc. Deterioration (%)	12.3	Conc. Deterioration (s.f)
Conc. Deterioration (%)	12.3				
Conc. Deterioration (s.f)	1238				
			Sheet 1 of 1

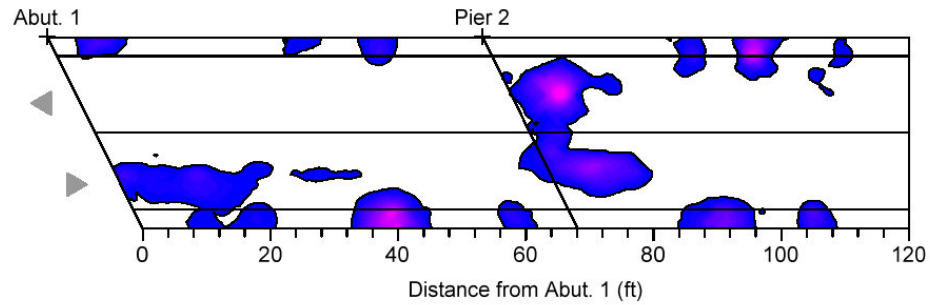
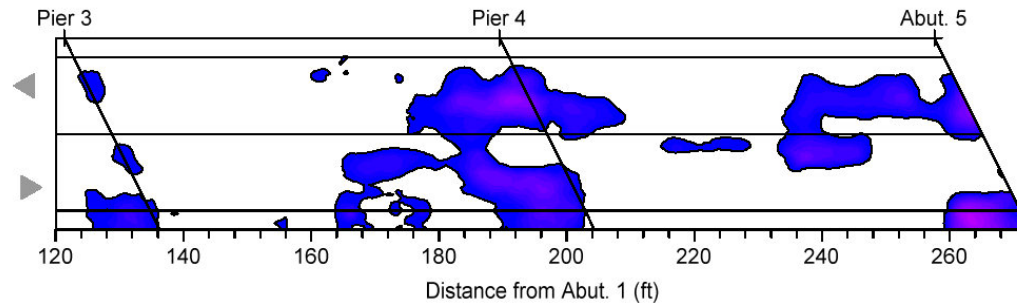
Concrete Condition Legend	Orientation	Quantity Summary		General Information	
<p>Deterioration</p> <p>Increasing severity --></p> <p> Condition not detectable by GPR</p>	<p></p> <p> Direction of traffic</p>	Deck	Conc. Deterioration (%)	20.6	Bridge ID: C-07-A (12 scans/ft) US 40 over Yampa River
			Conc. Deterioration (s.f)	1685	Analyzed by: IN Reviewed by: SB Completed: 9/14/18
				Sheet 1 of 1

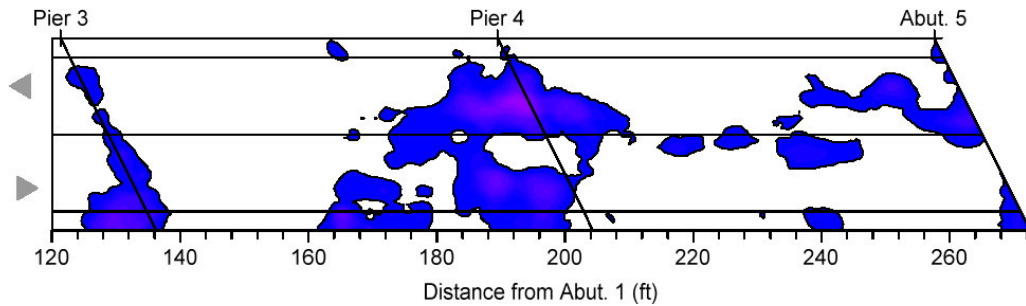
Concrete Condition Legend	Orientation	Quantity Summary	General Information				
<p>Deterioration</p> <p>Increasing severity --></p> <p> Condition not detectable by GPR</p>	<p></p> <p> Direction of traffic</p>	<p>Deck</p> <table border="1"> <tr> <td>Conc. Deterioration (%)</td> <td>22.7</td> </tr> <tr> <td>Conc. Deterioration (s.f)</td> <td>1853</td> </tr> </table>	Conc. Deterioration (%)	22.7	Conc. Deterioration (s.f)	1853	<p>Bridge ID: C-07-A (16 scans/ft) US 40 over Yampa River</p>
			Conc. Deterioration (%)	22.7			
Conc. Deterioration (s.f)	1853						
			<p>Analyzed by: IN Reviewed by: SB Completed: 9/14/18</p>				
			<p>Sheet 1 of 1</p>

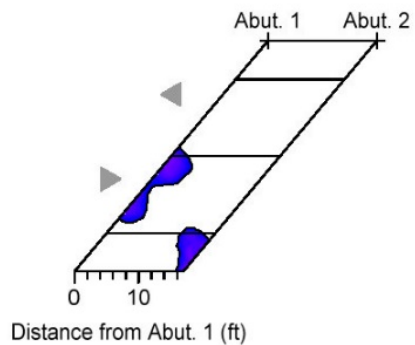
Direction of traffic</p>	<p>Deck</p> <table border="1" data-bbox="1117 1258 1402 1339"> <tr> <td>Conc. Deterioration (%)</td> <td>8.3</td> </tr> <tr> <td>Conc. Deterioration (s.f)</td> <td>48</td> </tr> </table>	Conc. Deterioration (%)	8.3	Conc. Deterioration (s.f)	48	<p>Bridge ID: C-08-A (8 scans/ft) US 40 over Shelton Ditch</p> <p>Analyzed by: IN Reviewed by: SB Completed: 9/14/18</p> <p style="text-align: center;">Sheet 1 of 1</p>
Conc. Deterioration (%)	8.3						
Conc. Deterioration (s.f)	48
