REPORT NO. CDOH-DTP-R-80-16

PAVEMENT PATCHING DEMONSTRATION
AND EVALUATION
DOT-FH-11-8188

Herbert N. Swanson
Denis Donnelly
Colorado Department of Highways
4201 East Arkansas Avenue
Denver, Colorado 80222

Final Report
December 1980

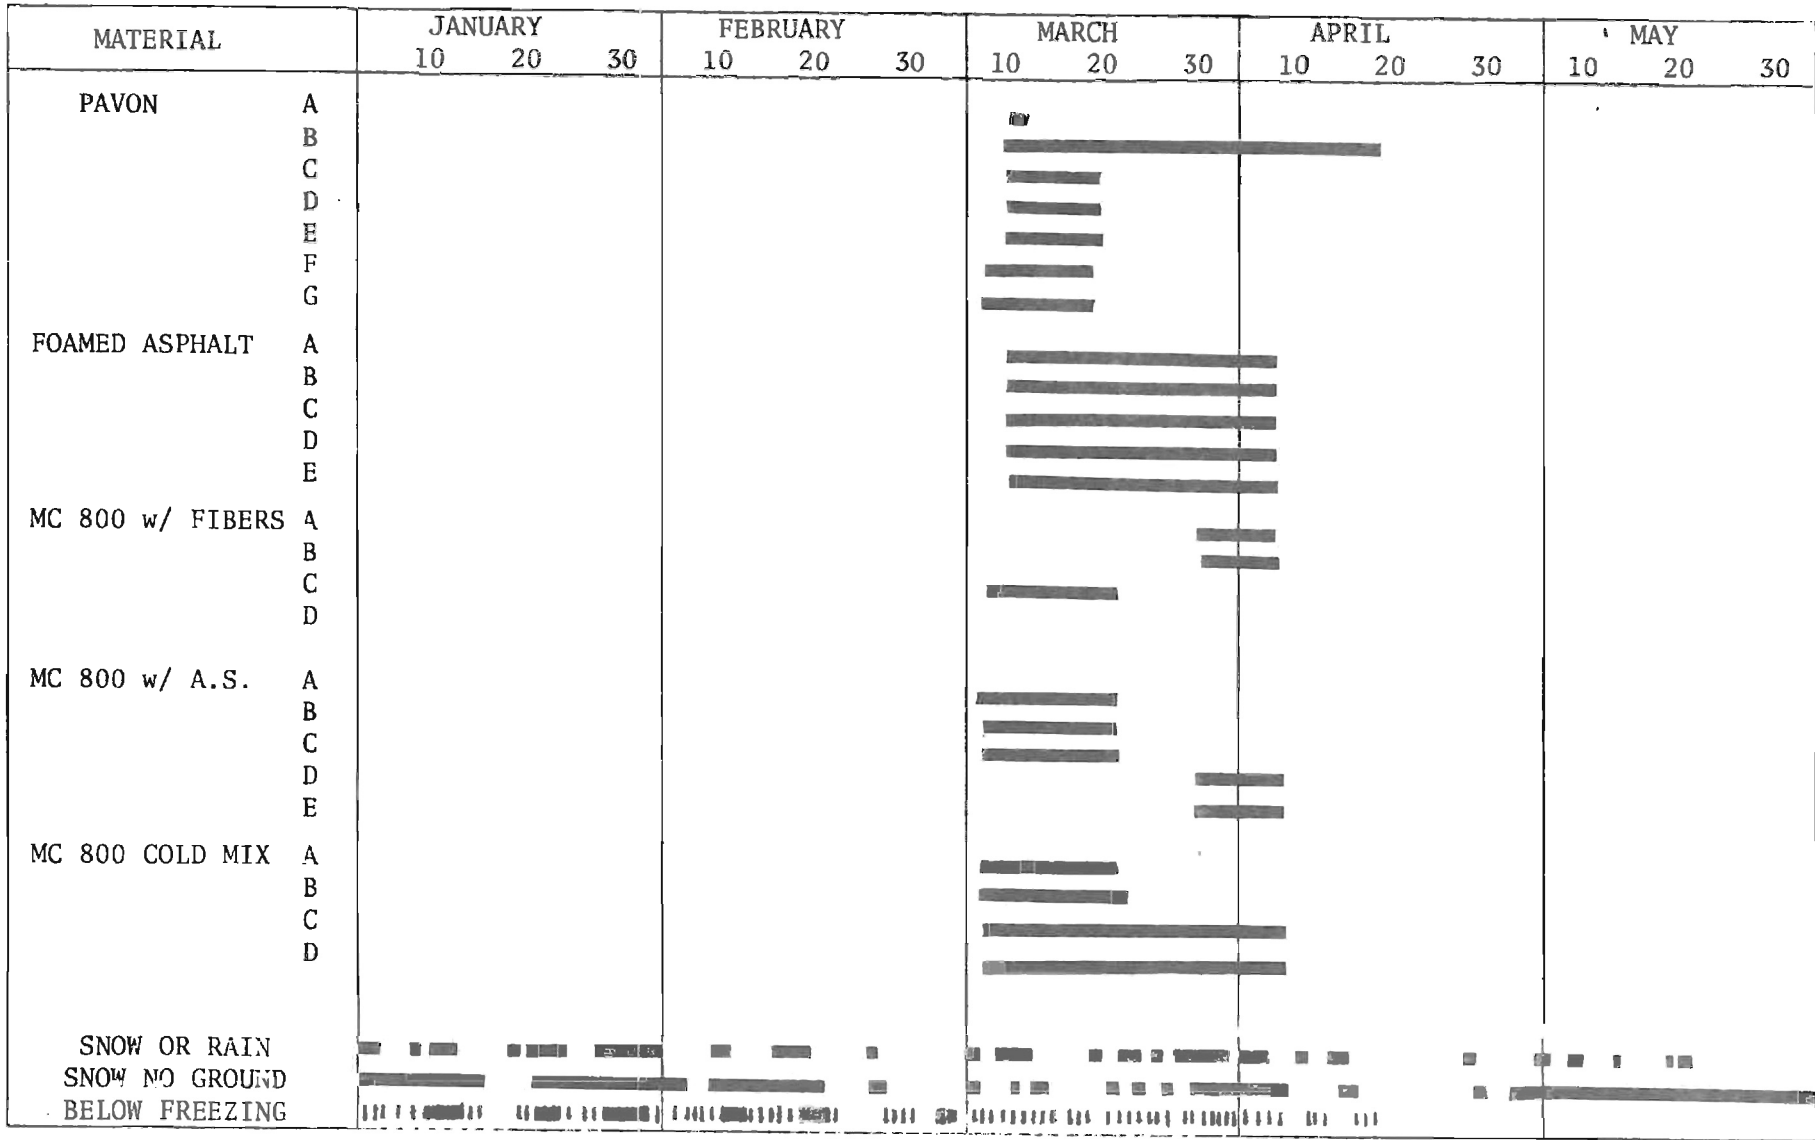
Figure 1a

Figures 1a and 1b are graphical representations of the longevity of the bituminous patches in the field. From the experience gained and observation of these graphs, it is apparent that hot bituminous pavement mix is the only permanent patch of the group tested.

One factor which caused early failure of some of the experimental bituminous patches was probably insufficient compaction. Compaction by the use of truck tires provides only the force equal to the tire pressure (65 to 100 psi). Small vibratory rollers are used when and if available. Hot Mix patches are more permanent, however, even when compacted by the truck tires.

ASPHALT PATCH LONGEVITY
