Report No. CDOT-DTD-R-92-3

# GILSONITE, AN ASPHALT MODIFIER

DONNA S. HARMELINK  
Colorado Department of Transportation  
4201 East Arkansas Avenue  
Denver, Colorado 80222

Final Report  
March 1992

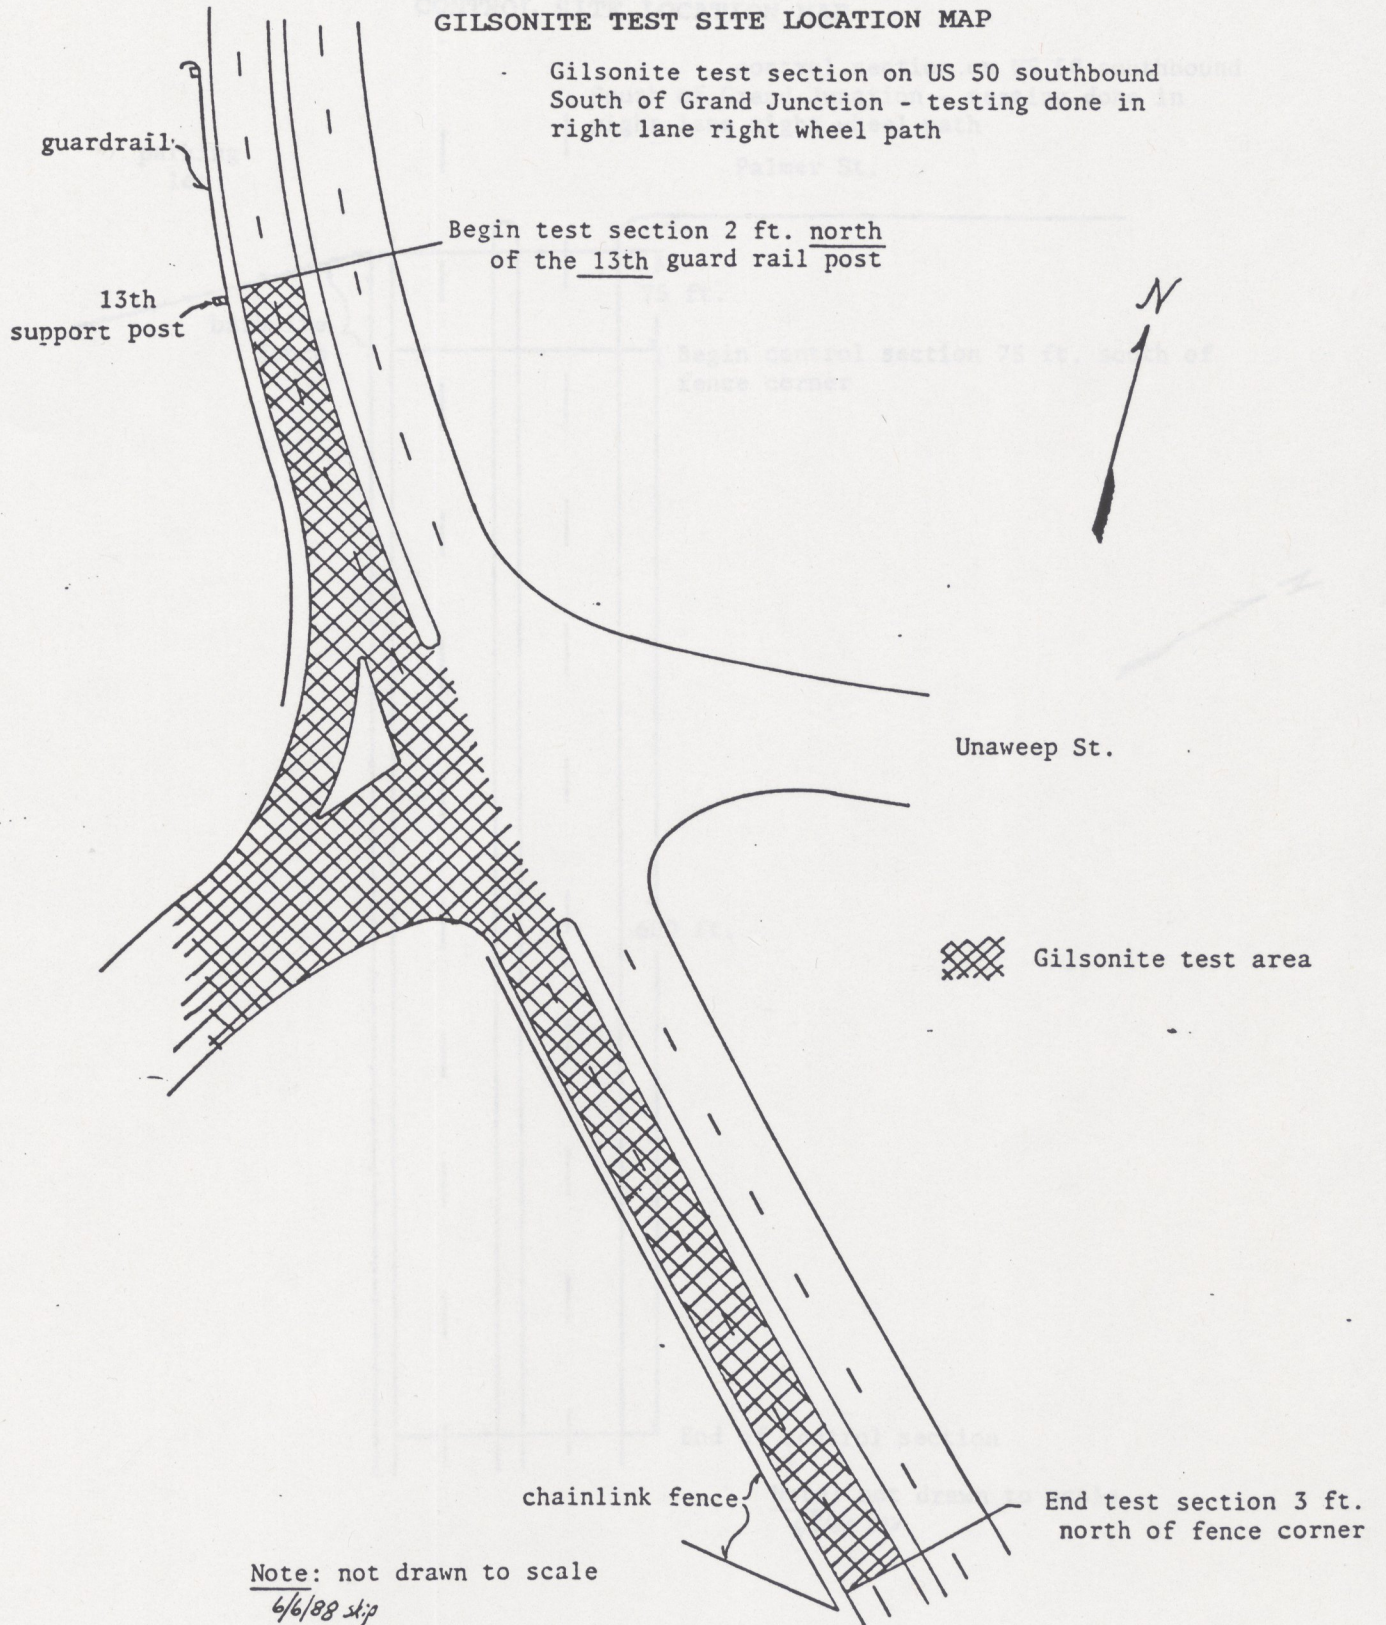
FIGURE 2

GILSONITE TEST SITE LOCATION MAP

Gilsonite test section on US 50 southbound  
South of Grand Junction - testing done in  
right lane right wheel path
