Survey of Seeps and Springs on Bureau of Land Management lands in northern Hinsdale County 2006-2007

**Prepared for:
Bureau of Land Management, Gunnison Field Office
216 N. Colorado
Gunnison, Colorado 81230**

**Prepared by:
Stephanie Neid, Delia Malone, and Jennifer Jones**

March 1, 2008

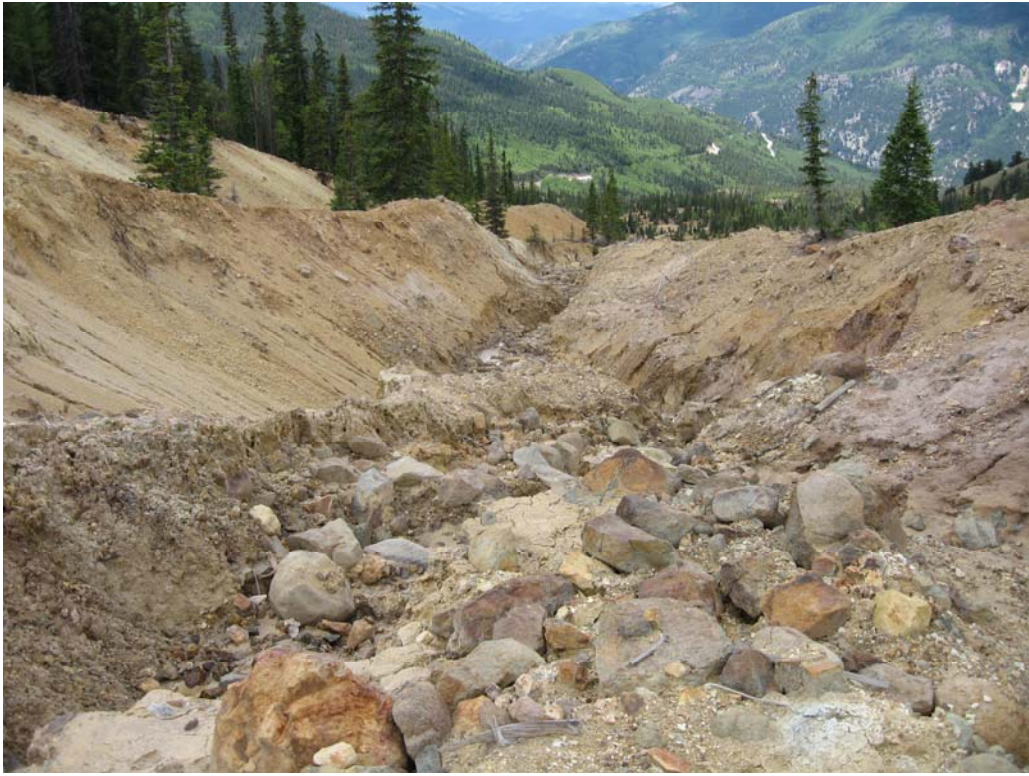
Slumgullion Slide Standard Checklist Non-Functional

Potential (ecological status that can be attained without above limiting factors or without limiting factors what is the ultimate goal for assessment area) Seep indicated by BLM not a functioning wetland. There is no consistent hydrologic regime present and no stable vegetation. Soils are highly erodible with little structure to support wetland vegetation.

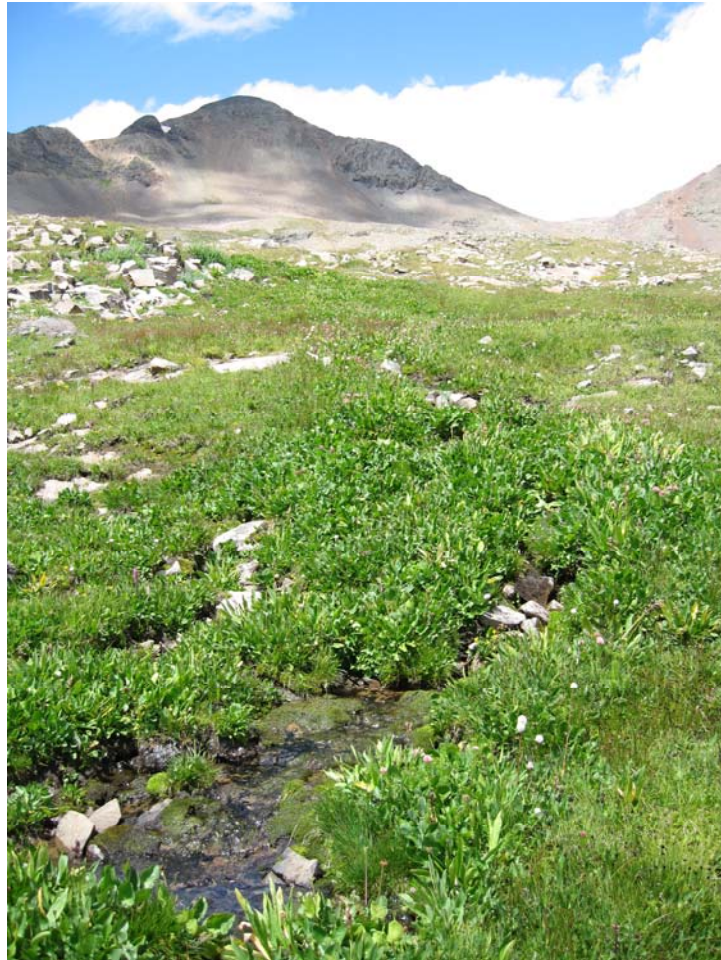
**Devil's Hole Spring
Lentic Standard Checklist
Functional – At Risk**

Other (specify e.g., grazing, irrigation, agriculture activities) Extensive grazing in the area is contributing to unacceptable conditions.

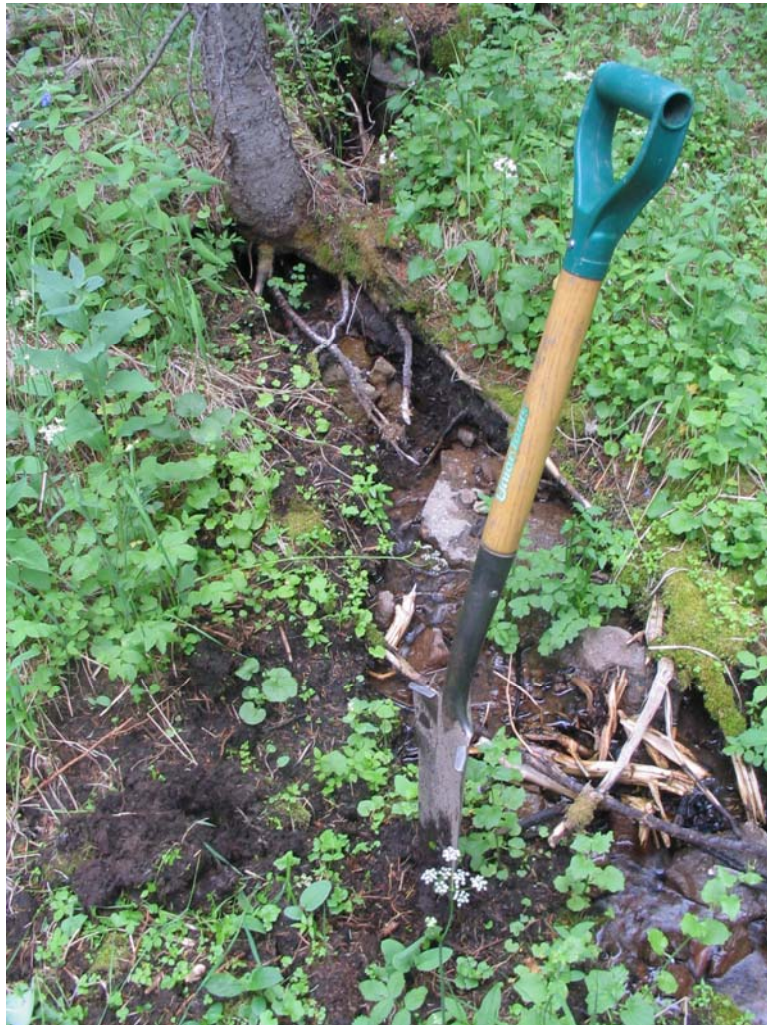
**Upper Cleveland Gulch
Standard Checklist
Functional – At Risk**

General Description: Wetland occurs as part of a series of seeps along the upper reaches of Cleveland Gulch, a first order tributary of the Lake Fork of the Gunnison River. Hydrology appears to be perennial. Area is moist to saturated throughout due to an extensive number of seeps along the toeslope of the basin floor. Anthropogenic disturbances present throughout the drainage include an old road and mining. Recreational use in surrounding drainages is extensive, but does not spill over into Cleveland Gulch. Mining and draining adits present along upper slopes may be contributing aluminum and other types of mineral deposition to the drainage. Seeps situated directly below largest mining operation observed in the gulch and may receive the most input of toxins from this disturbance. This also makes these small wetlands very important in filtering and retaining sediment from tailings. Mineral deposits were observed along the main drainage of the basin floor in the form of a white substance on rocks in the stream bottom. Uplands consist of unstable steep slopes of scree and unconsolidated rocks with little vegetation.

Soils: Soils consist of fibric to hemic peats up to 40cm. Soils are moist to inundated with multiple areas of open water.

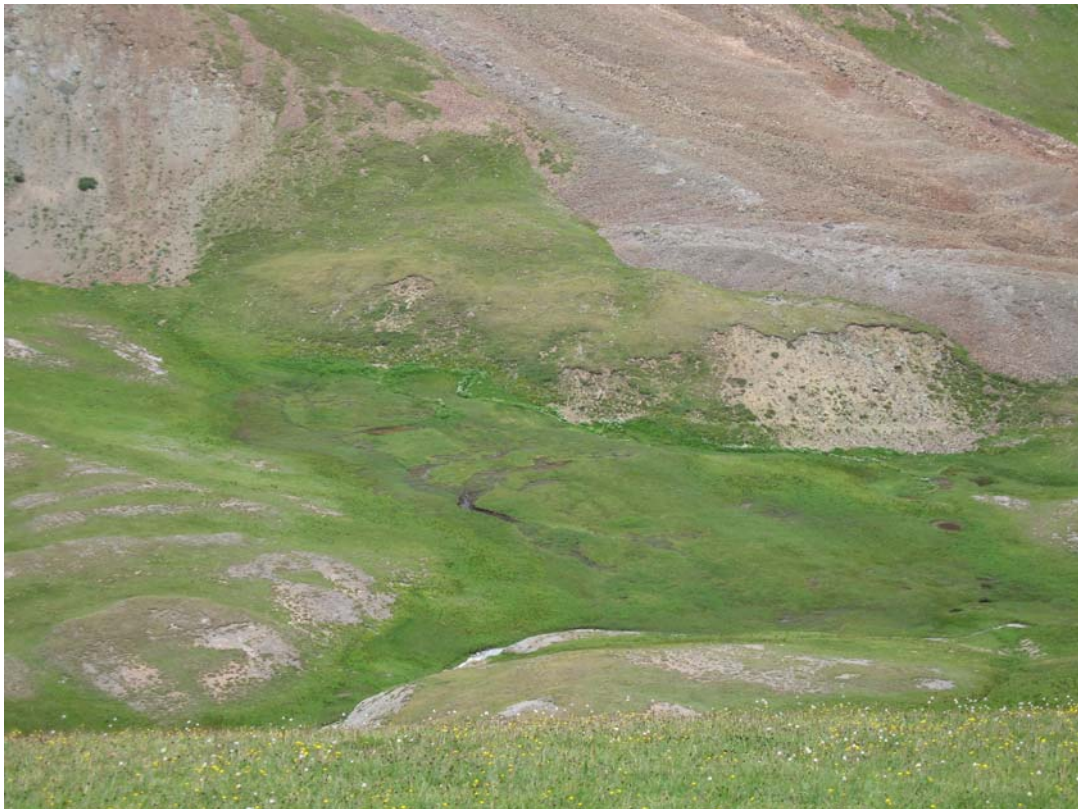
**Upper Cleveland Gulch
Standard Checklist
Proper Functioning Condition**

Soils: Soils consist of approximately 15cm of fibric peat over unconsolidated rock. Soils are moist to inundated throughout.

Potential (ecological status that can be attained without above limiting factors or without limiting factors what is the ultimate goal for assessment area) Site is functioning at its potential natural community. Hydrology and water quality may have been altered by mining activity in the drainage. Old roads and mines are evident throughout the drainage. Currently there is little anthropogenic use aside from occasional recreational use, but no established trails lead into the basin.

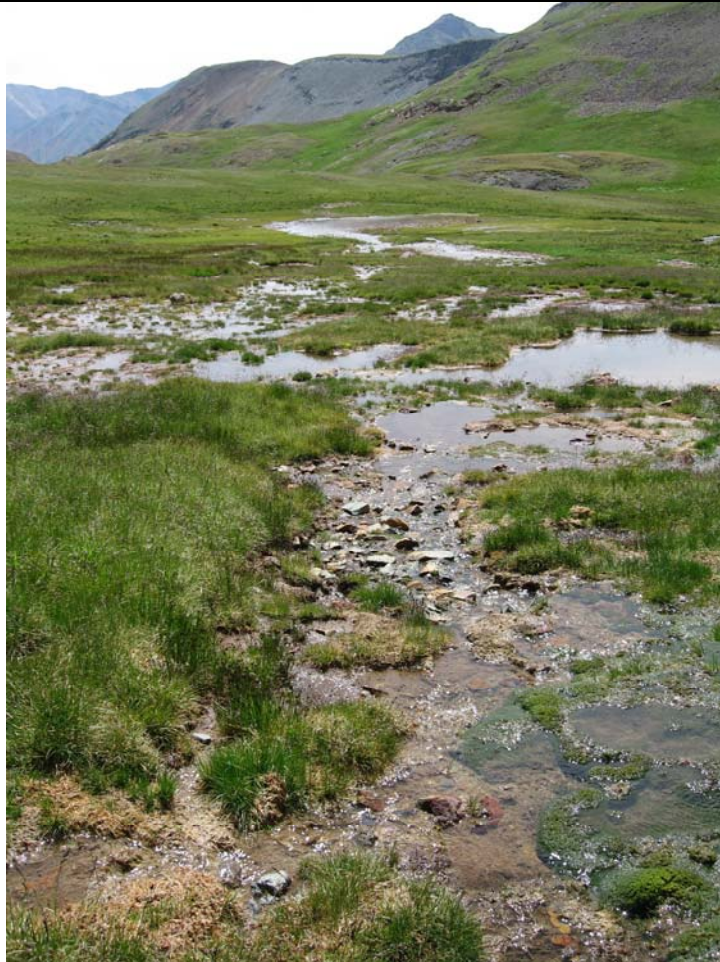
**Upper Cleveland Gulch
Standard Checklist
Proper Functioning Condition**

Plants: Wetland vegetation consists of mesic herbaceous species. Dominant species (25-35%) include *Caltha leptosepala*, *Cardamine cordifolia*, and *Carex aquatilis*. Common species (10-15%) include *Carex illota* and *Carex nigricans*. *Eriophorum altaicum* is also present in moderate cover at the site, is an uncommon species, occurring locally in the San Juan and Elk Mountains of Colorado. Approximately 500+ individuals of *Eriophorum altaicum* were found near spring along saturated soils. Species found in low cover at the site include *Pedicularis groenlandica*, *Juncus tracyi*, *Rhodiola rhodantha*, and *Luzula comosa*.

Potential (ecological status that can be attained without above limiting factors or without limiting factors what is the ultimate goal for assessment area) Site is functioning at its potential natural community. Hydrology and water quality may have been altered by mining activity in the drainage. Old roads and mines are evident throughout the drainage. Currently there is little anthropogenic use aside from occasional recreational use, but no established trails lead into the basin.

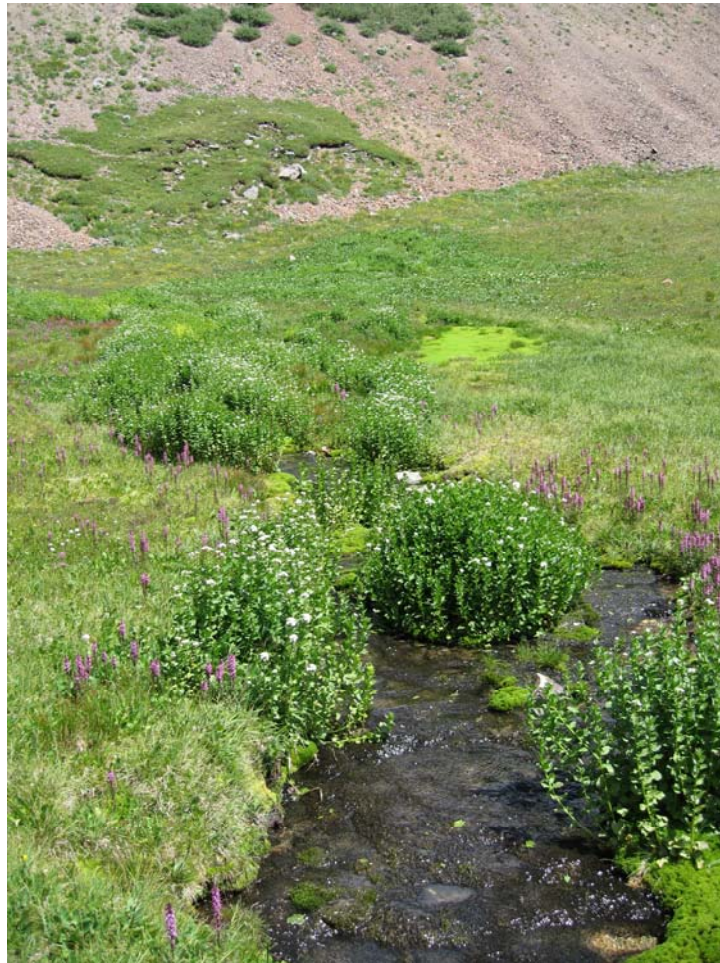
**Upper Cleveland Gulch
Standard Checklist
Proper Functioning Condition**

Potential (ecological status that can be attained without above limiting factors or without limiting factors what is the ultimate goal for assessment area) Site is functioning at its potential natural community. Hydrology and water quality may have been altered by mining activity in the drainage. Old roads and mines are evident throughout the drainage. Currently there is little anthropogenic use aside from occasional recreational use, but no established trails lead into the basin.

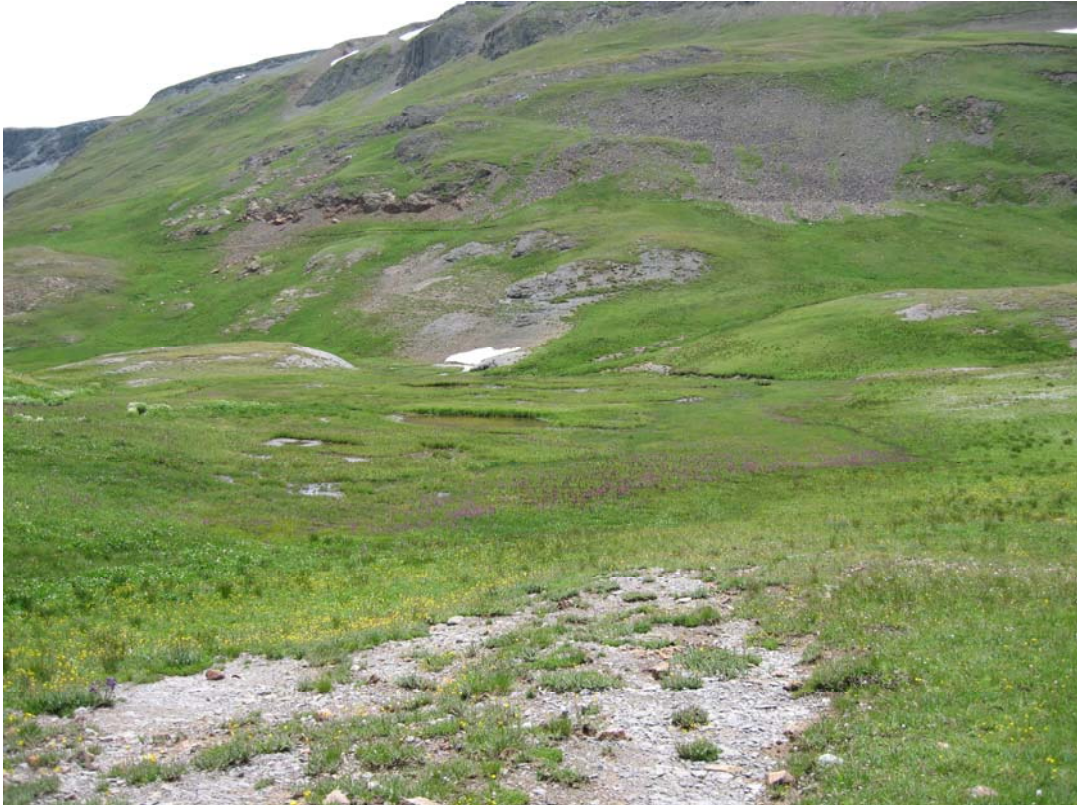
**Upper Cleveland Gulch
Standard Checklist
Functional – At Risk**

Other (specify e.g., grazing, irrigation, agriculture activities) Mining activities are not current, but may still be impacting wetlands and species in the area.

Potential (ecological status that can be attained without above limiting factors or without limiting factors what is the ultimate goal for assessment area) Site is functioning below its potential natural community due to impacts from mining along the upper slopes of the drainage. Water quality has obviously been altered as evident in photo. Old roads and mines are evident throughout the drainage. Currently there is little anthropogenic use aside from occasional recreational use, but no established trails lead into the basin.

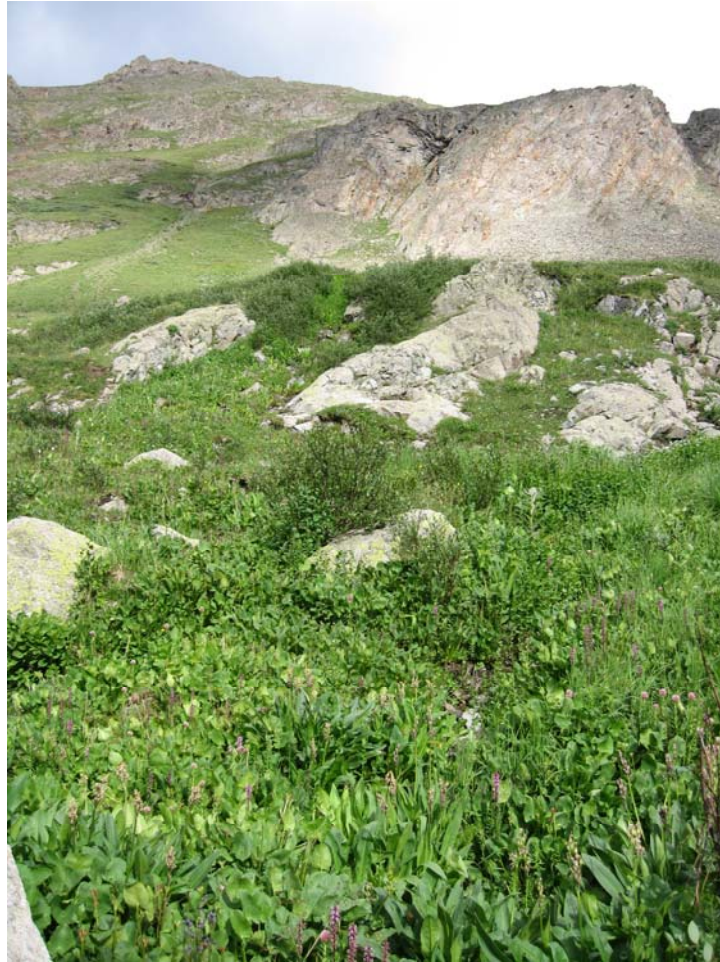
**American Basin
Standard Checklist
Proper Functioning Condition**

Potential (ecological status that can be attained without above limiting factors or without limiting factors what is the ultimate goal for assessment area) Wetland is functioning at its potential natural community. Disturbances in the area include recreational use and past mining which do currently not appear to impact the wetland.

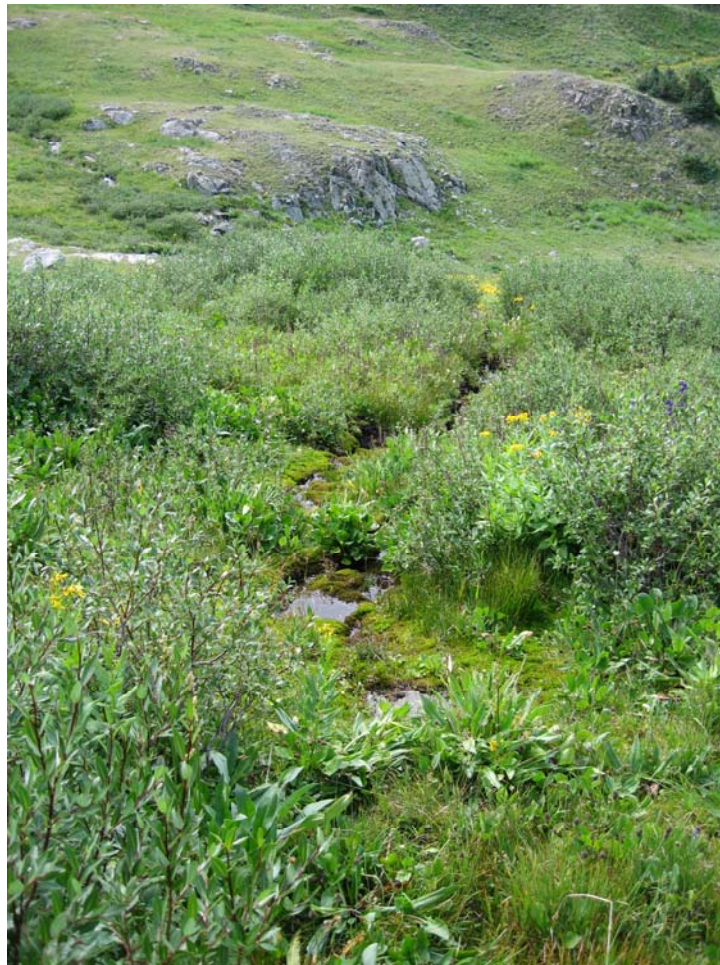
**American Basin
Standard Checklist
Functional – At Risk**

Potential (ecological status that can be attained without above limiting factors or without limiting factors what is the ultimate goal for assessment area) Wetland is functioning below its potential natural community due to mining and reclamation activities adjacent to the site. Vegetation appears to be healthy and vigorous, but disturbance has likely altered hydrology and water quality in the wetland. Other disturbances in the area include recreational uses which do not appear to currently impact the site.

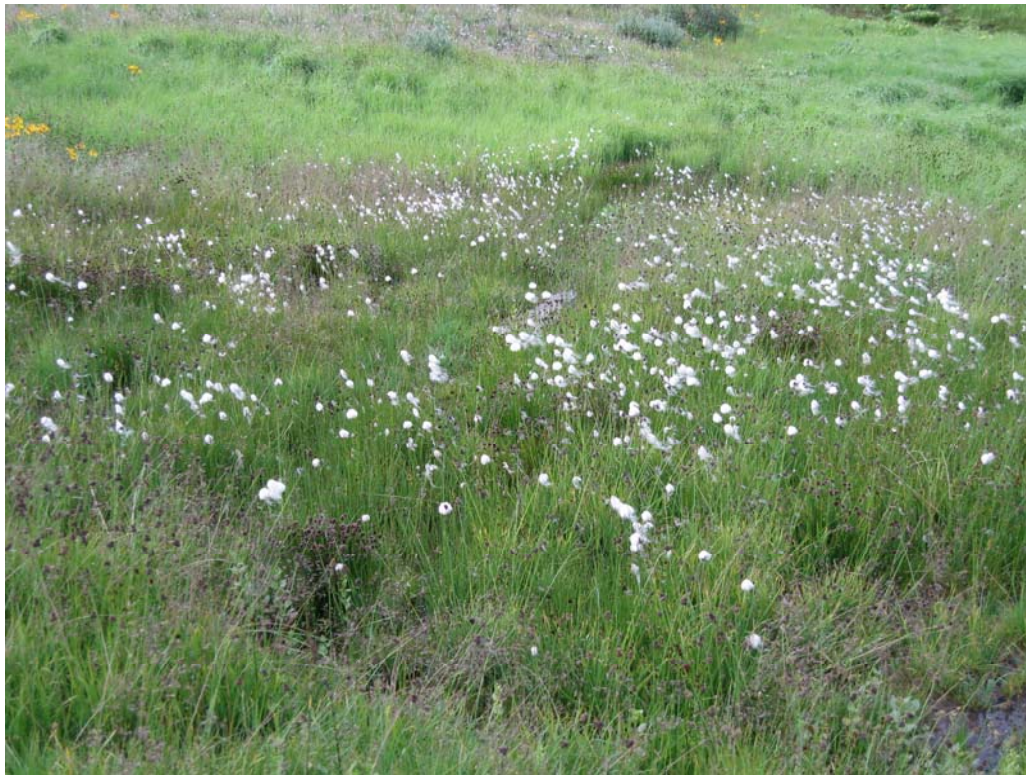
**Cinnamon Pass Seeps
Standard Checklist
Proper Functioning Condition**

Potential (ecological status that can be attained without above limiting factors or without limiting factors what is the ultimate goal for assessment area) Wetland is functioning at its potential natural community. Despite old roads and past mining use in the area, there are currently few disturbances in the area and none that appear to impact the wetland or create unacceptable conditions.

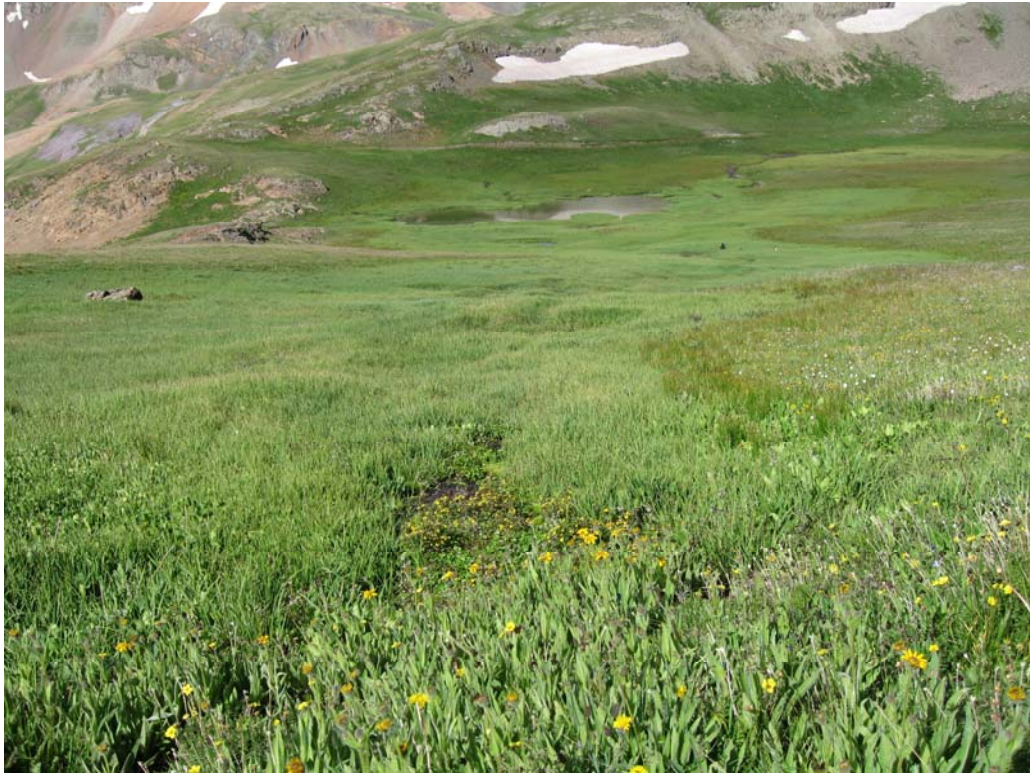
**Cinnamon Pass Seeps
Standard Checklist
Proper Functioning Condition**

Potential (ecological status that can be attained without above limiting factors or without limiting factors what is the ultimate goal for assessment area) Wetland is functioning at its potential natural community. Despite old roads and past mining use in the area, there are currently few disturbances in the area and none that appear to impact the wetland or create unacceptable conditions.

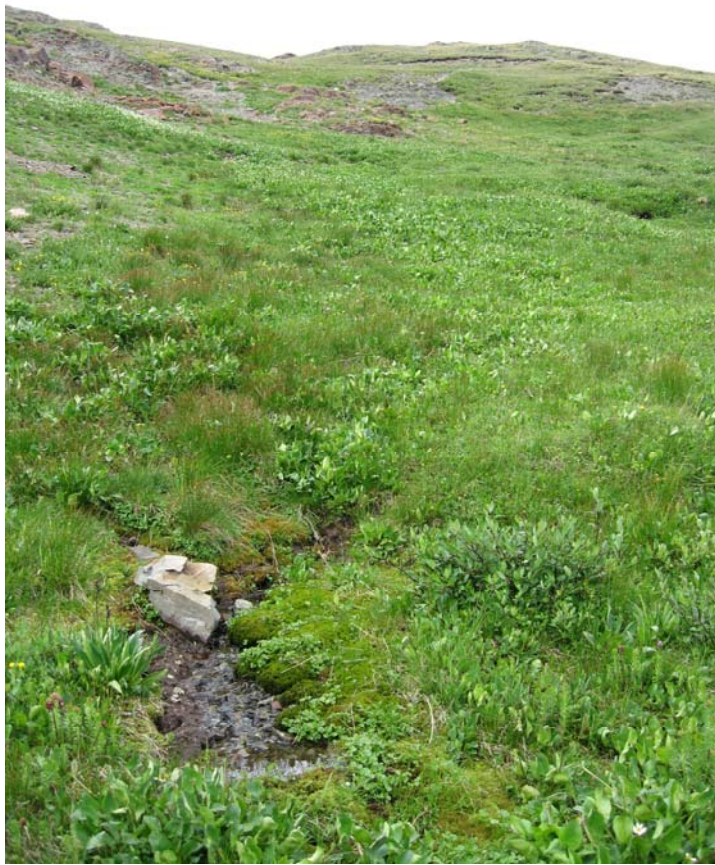
Cinnamon Pass Seeps Standard Checklist Proper Functioning Condition

Potential (ecological status that can be attained without above limiting factors or without limiting factors what is the ultimate goal for assessment area) Wetland is functioning at its potential natural community. Despite old roads and past mining use in the area, there are currently few disturbances in the area and none that appear to impact the wetland or create unacceptable conditions.

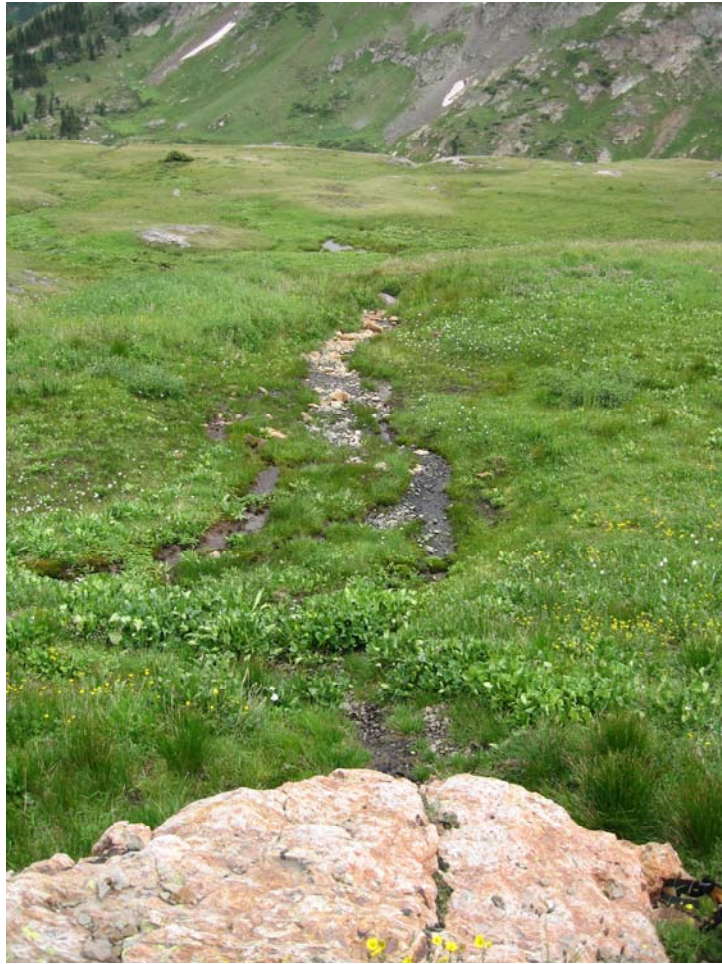
**American Flats
Standard Checklist
Proper Functioning Condition**

Potential (ecological status that can be attained without above limiting factors or without limiting factors what is the ultimate goal for assessment area) Wetland is functioning at its potential natural community with few disturbances in the area and no disturbances causing unacceptable conditions.

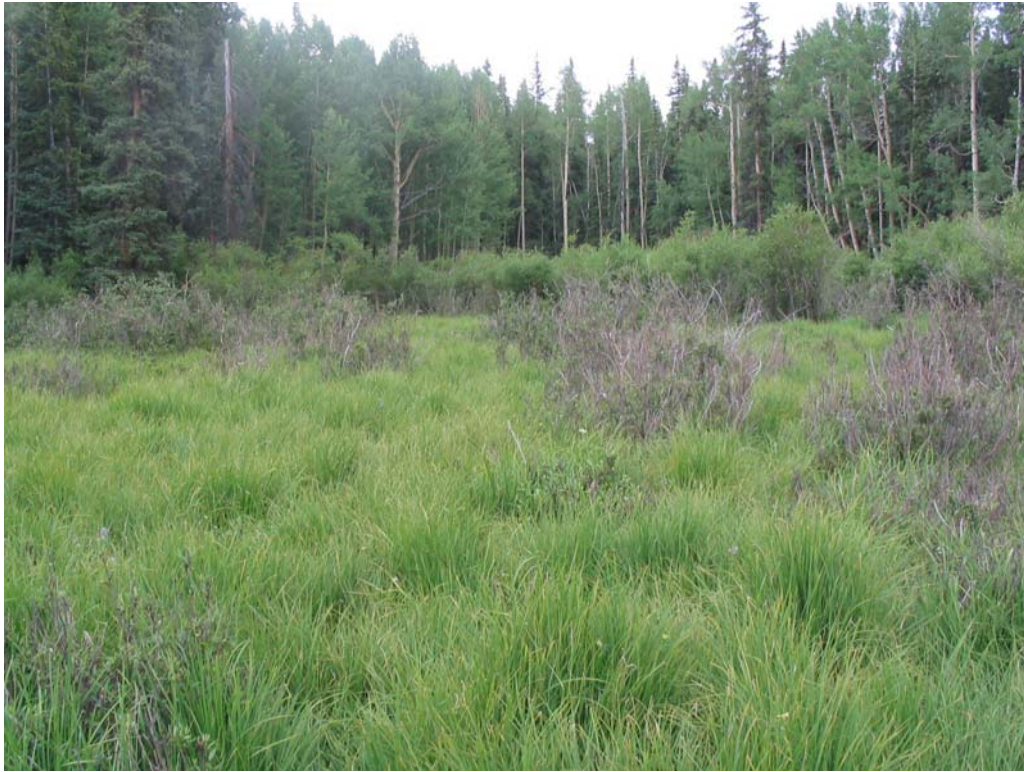
**Schafer Gulch
Standard Checklist
Proper Functioning Condition**

Potential (ecological status that can be attained without above limiting factors or without limiting factors what is the ultimate goal for assessment area) Wetland is functioning at its potential natural community with few current disturbances in the drainage. Drying appears to be natural and not from disturbance. Disturbances in the area including sheep grazing and recreational uses do not appear to be affecting the wetland.

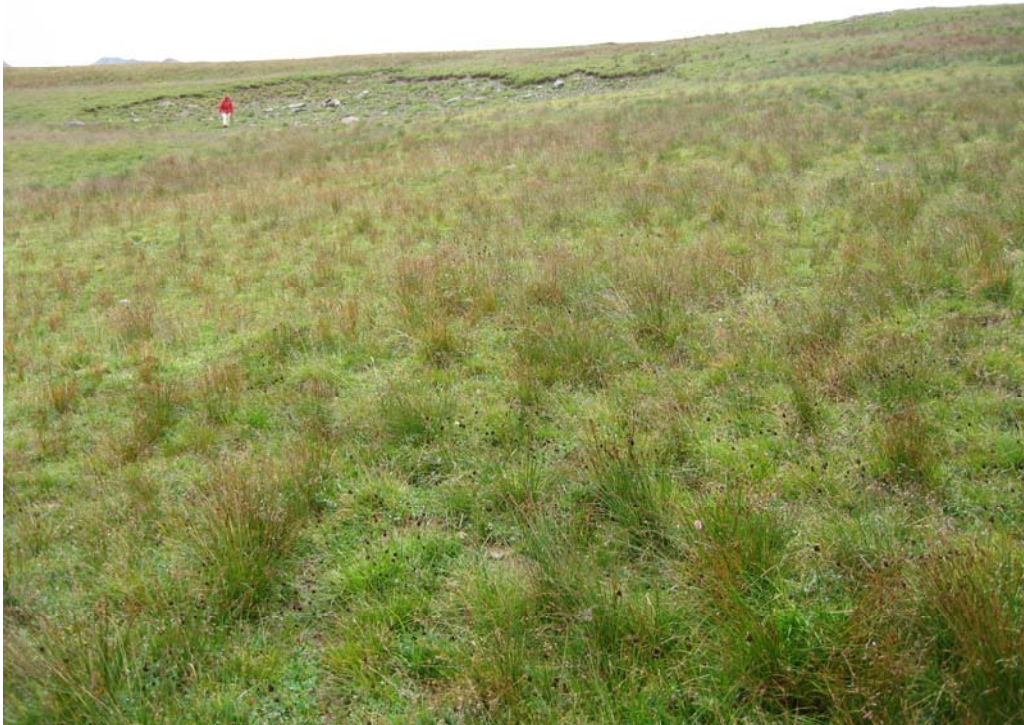
**American Flats
Standard Checklist
Non-Functional**

Potential (ecological status that can be attained without above limiting factors or without limiting factors what is the ultimate goal for assessment area) Site indicated by the BLM seeps and springs map is not a functioning wetland. Area does not exhibit signs of consistent hydrology, supports few wetland indicator species, and no soils indicative of wetland hydrology. Site occurs in a small contour and may hold water in wet years and during spring snowmelt.

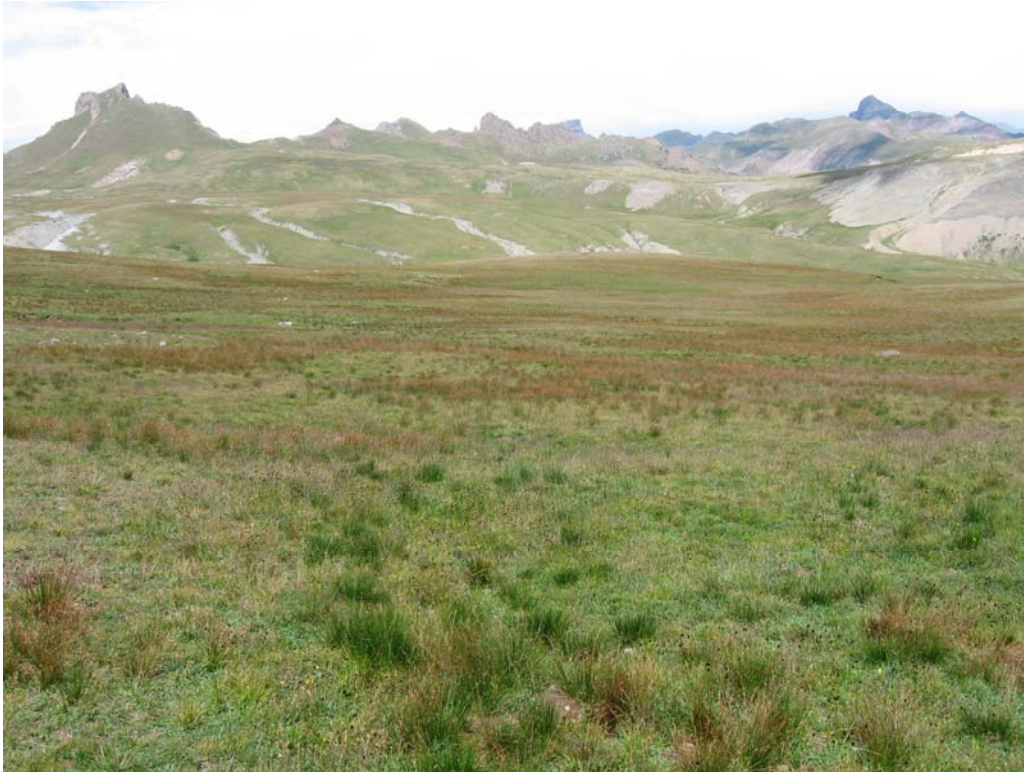
**American Flats
Standard Checklist
Non-Functional**

Potential (ecological status that can be attained without above limiting factors or without limiting factors what is the ultimate goal for assessment area) Site indicated by the BLM seeps and springs map is not a functioning wetland. Area does not exhibit signs of consistent hydrology, supports few wetland indicator species, and no soils indicative of wetland hydrology.

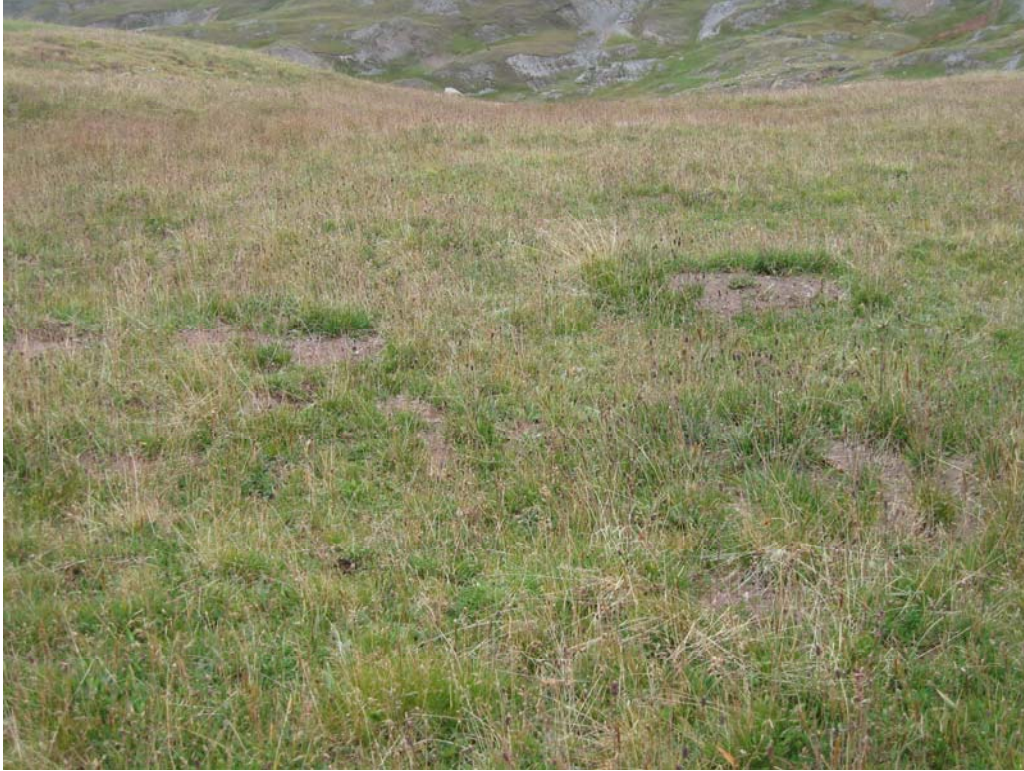
**Spring Creek Seeps
Lentic Standard Checklist
Functioning Condition**

Potential (ecological status that can be attained without above limiting factors or without limiting factors what is the ultimate goal for assessment area) Wetland is functioning at its potential natural community. The immediate area has few disturbances or conditions creating unacceptable conditions. Livestock use in the area is not extensive and does not appear to affect the wetland.

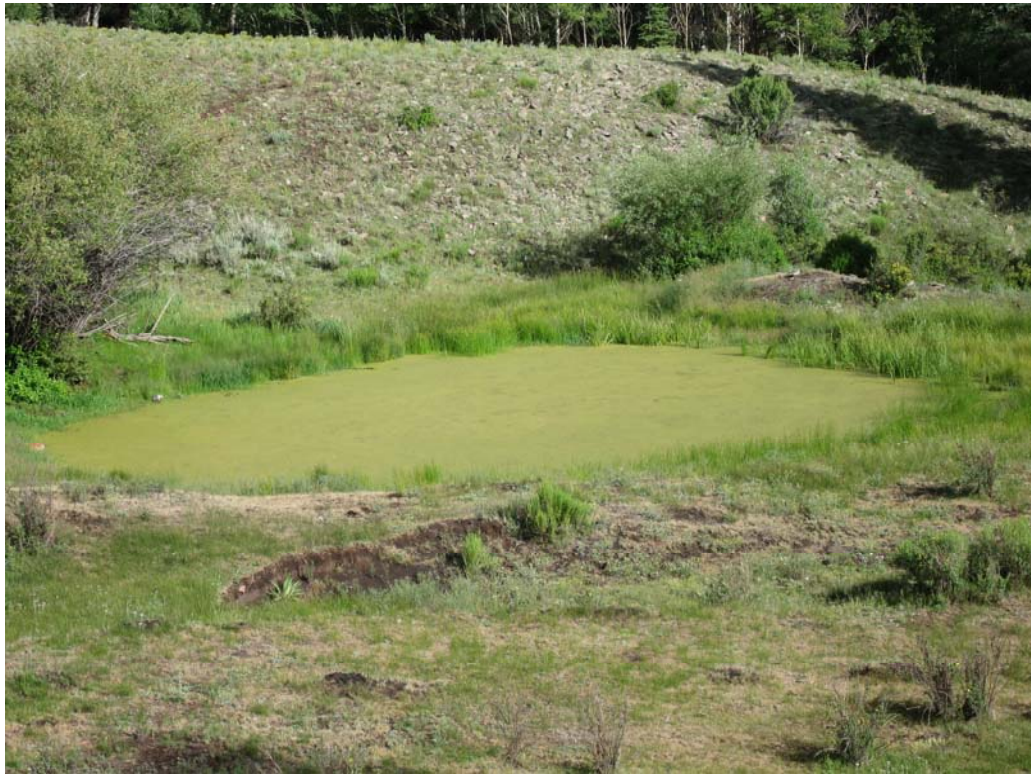
**Powderhorn Lakes Trail
Standard Checklist
Proper Functioning Condition**

Potential (ecological status that can be attained without above limiting factors or without limiting factors what is the ultimate goal for assessment area) Wetland is functioning at its potential natural community with no disturbances leading to unacceptable conditions. Adjacent trail does not appear to currently affect hydrology or species composition at the site.

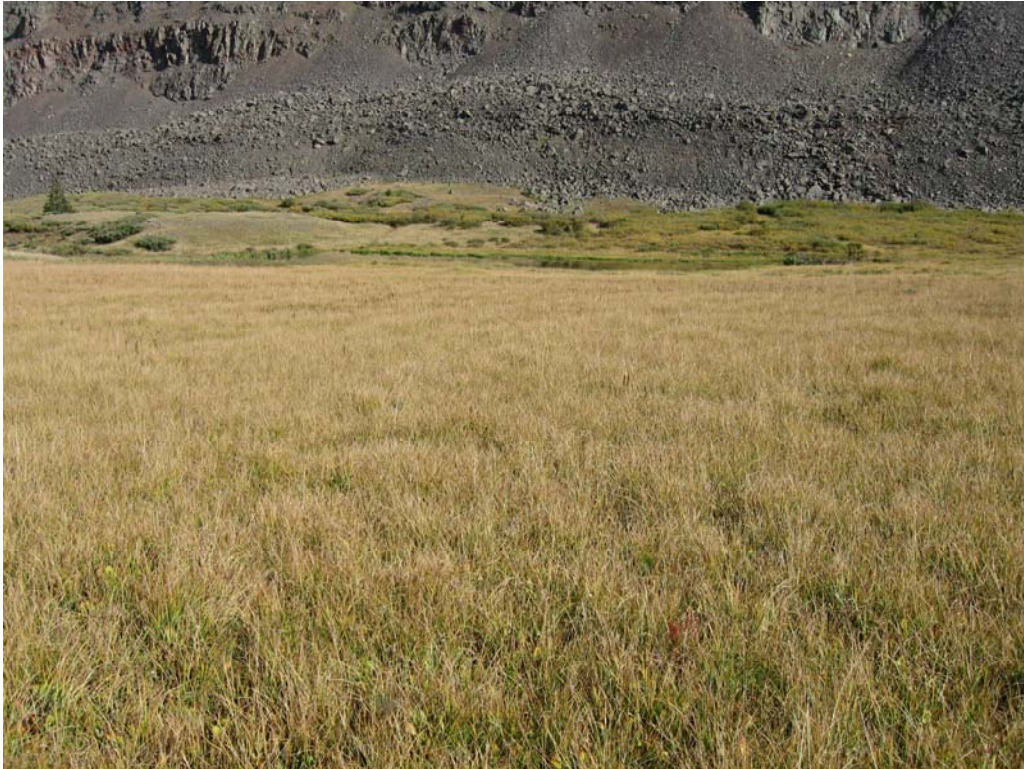
**Engineer Pass – Mine Shaft Seep
Standard Checklist
Proper Functioning Condition**

Potential (ecological status that can be attained without above limiting factors or without limiting factors what is the ultimate goal for assessment area) Wetland is functioning below its potential natural community due to impacts from mine shaft in the center of the wetland. Other disturbances in area do not appear to be impacting the site or influencing hydrology or species composition.

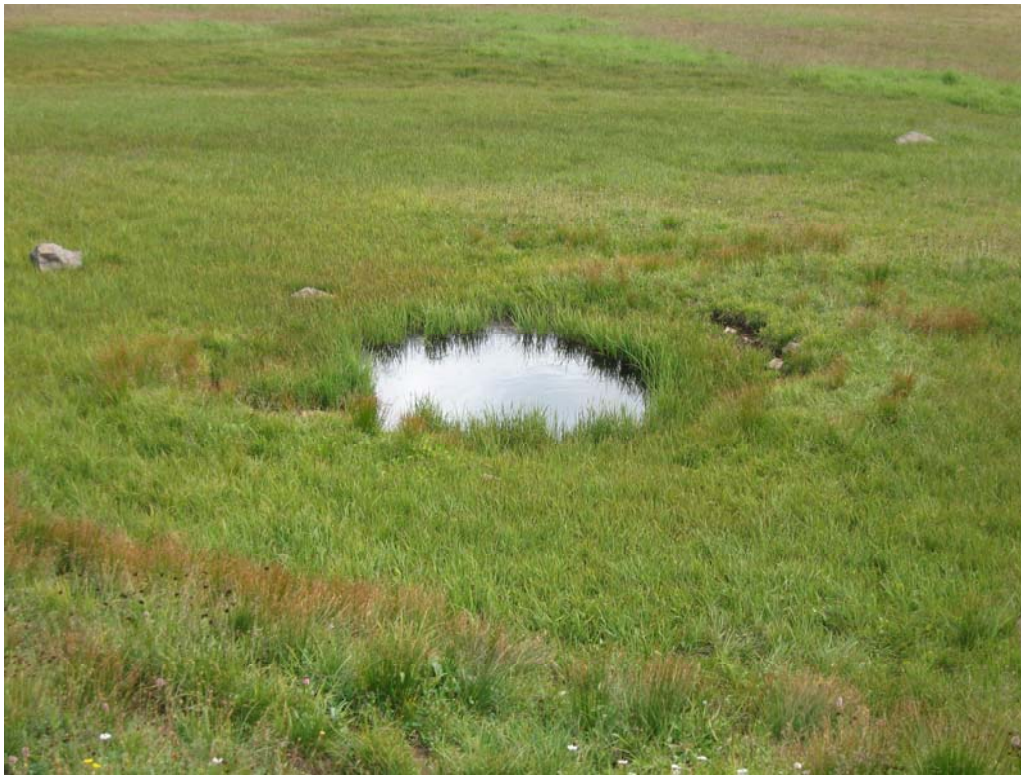
**Palmetto Gulch
Standard Checklist
Functional – At Risk**

Yes	No	N/A	HYDROLOGY
X			1) Floodplain above bankfull is inundated in “relatively frequent” events
		X	2) Where beaver dams are present they are active and stable
X			3) Sinuosity, width/depth ratio, and gradient are in balance with the landscape setting (i.e., landform, geology, and bioclimatic region)
X			4) Riparian-wetland area is widening or has achieved potential extent
	X		5) Upland watershed is not contributing to riparian-wetland degradation – Wetland located just below draining adit, white precipitates present along streambed

Plants: Vegetation is dominated by a short shrubland of *Salix planifolia* (35-45%) with mesic graminoids. Shrubs are stunted which may be due to high mineral content of hydrology, saturation cycles, alpine elevation. Understory is dominated by a mix of mesic herbaceous species including *Carex aquatilis*, *Carex scopulorum*, *Podistera eastwoodiae*, and *Calamagrostis canadensis* all in low to moderate cover (5-15%). Other species present (<5%) include *Rhodiola rhodantha*, *Juncus drummondii*, and *Deschampsia caespitosa*. Surrounding uplands are dominated by xeric to mesic alpine meadow vegetation.

Potential (ecological status that can be attained without above limiting factors or without limiting factors what is the ultimate goal for assessment area) Site is functioning below its potential natural community due to impacts from adjacent mining activities including draining adit, adjacent road, and reclamation efforts. These activities have likely diminished water quality and altered the hydrologic regime. Wetland is functioning despite these impacts.

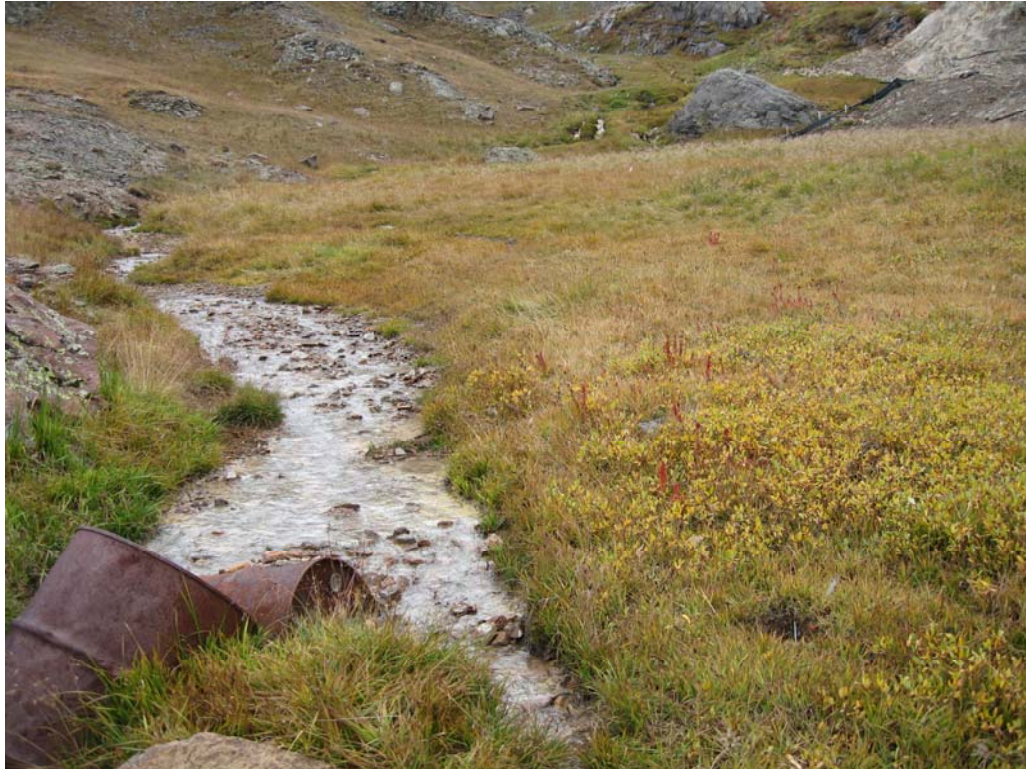
**Palmetto Gulch Mine Wash
Standard Checklist
Functional – At Risk**

Other (specify e.g., grazing, irrigation, agriculture activities) Drying may be due to drought conditions of recent years, it is not apparent why site is drying.

Potential (ecological status that can be attained without above limiting factors or without limiting factors what is the ultimate goal for assessment area) Site is functioning below its potential natural community due to anthropogenic disturbances in the including past mining, sheep grazing, and recreational use. Drying in the area appears to be natural and not caused by disturbance. Natural disturbances in the area include avalanche activity and spring flooding.

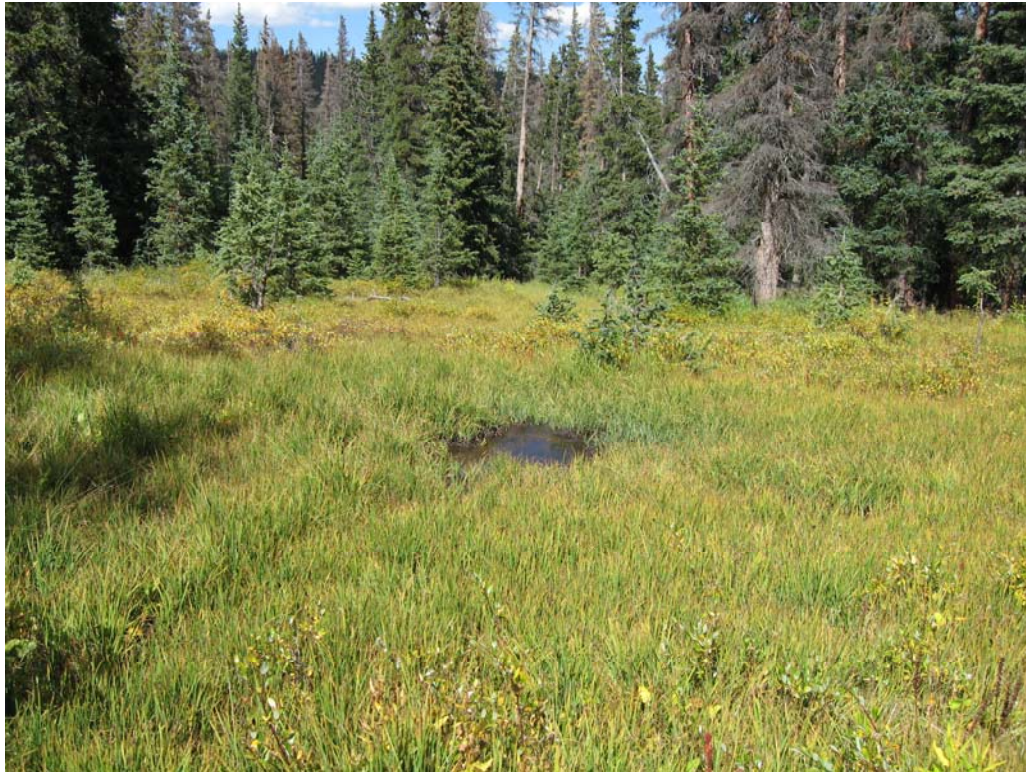
Upper Palmetto Gulch Standard Checklist Functional - At Risk

Yes	No	N/A	HYDROLOGY
X			1) Floodplain above bankfull is inundated in "relatively frequent" events
		X	2) Where beaver dams are present they are active and stable
X			3) Sinuosity, width/depth ratio, and gradient are in balance with the landscape setting (i.e., landform, geology, and bioclimatic region)
X			4) Riparian-wetland area is widening or has achieved potential extent
	X		5) Upland watershed is not contributing to riparian-wetland degradation – Extensive mining in surrounding watershed may be contributing to wetland degradation

Dewatering Mining activities Watershed condition
 Dredging activities Road encroachment Land ownership
Other (specify e.g., grazing, irrigation, agriculture activities) Erosion may be due to past use or current grazing regime. It is not apparent exactly what disturbances are causing unacceptable conditions and area may need to be monitored to fully understand the cause for bare areas and erosion.

Potential (ecological status that can be attained without above limiting factors or without limiting factors what is the ultimate goal for assessment area) Wetland is functioning below its potential natural community due to disturbances in the area. Evidence of disturbance can be seen along banks of channel in the form of soil wasting and bare areas. Vegetation appears to be vigorous and hydrology intact despite disturbed soils.

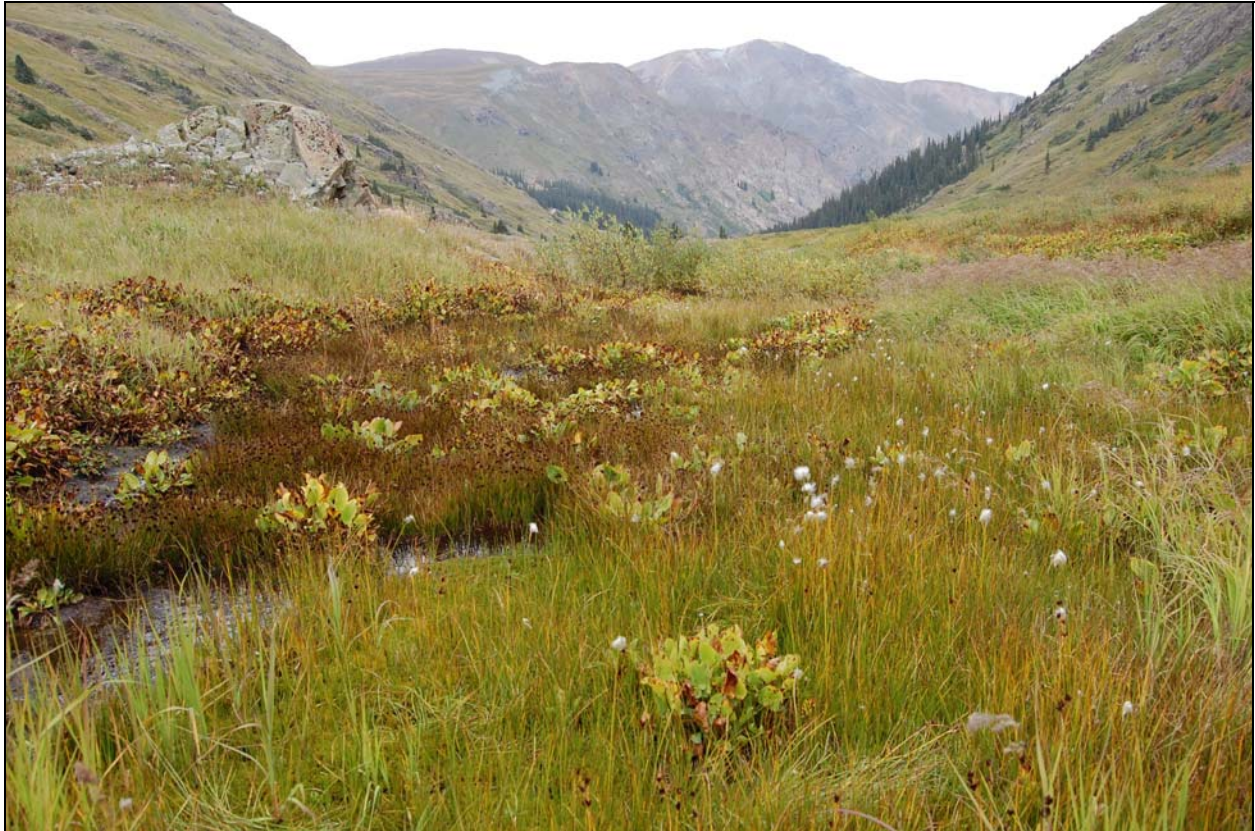
Lentic Checklist			
Name of Riparian-Wetland Area		Gnome Mine Wetland-S	
Date:	10/4/2007	Segment/Reach ID	2199-S
ID Team Observers:		Malone

Site is a wetland at the base of an abandoned mine dump. Site is not at potential. Mining activities have degraded the upland watershed and altered surface groundwater flow pattern. Excess sediment from the mine dump is carried into the wetland with precipitation and snowmelt.
