Survey of Seeps and Springs on Bureau of Land Management lands in northern Hinsdale County 2006-2007

**Prepared for:
Bureau of Land Management, Gunnison Field Office
216 N. Colorado
Gunnison, Colorado 81230**

**Prepared by:
Stephanie Neid, Delia Malone, and Jennifer Jones**

March 1, 2008

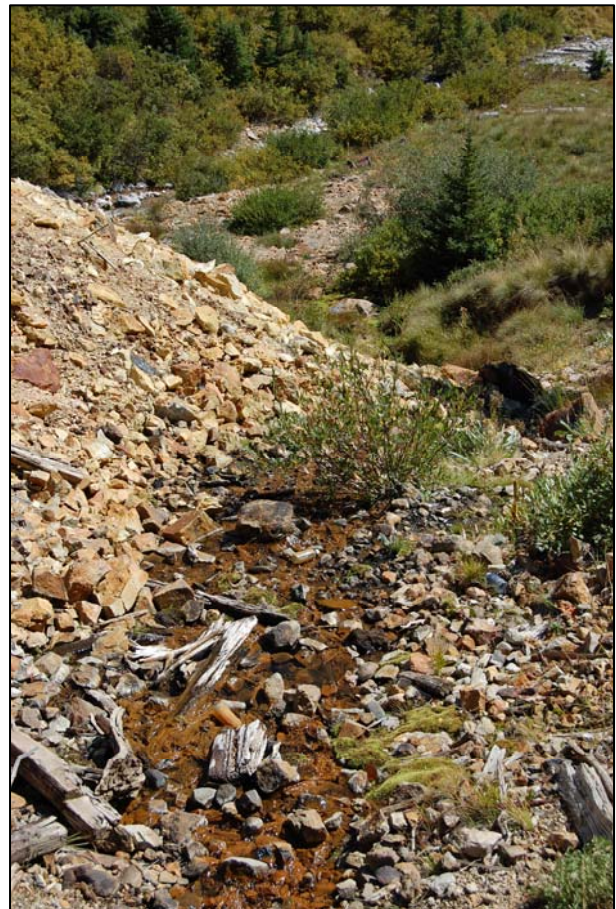
Name of Riparian-Wetland Area:	Boulder Gulch		
Date:	9/1/2007	Segment/Reach ID:	AM- 2229
ID Team Observers:	Malone

A mine dump and shaft (Morrow Tunnel) are located on a steep southwest-facing slope. The base of the dump borders on riparian vegetation and the floodplain of the stream that drains Boulder Gulch. Riparian vegetation along the stream is in good condition; cover is high, diversity is appropriately high, all age-classes are well represented and vigor is good. Riparian zone vegetated width is appropriate to the landscape and likely mitigates any mine dump impacts.

<input checked="" type="checkbox"/> Proper Functioning Condition <input type="checkbox"/> Functional - At Risk <input type="checkbox"/> Nonfunctional <input type="checkbox"/> Unknown		<p>Are factors contributing to unacceptable conditions outside the control of the manager? Yes/No: <u> </u> No</p> <p>If yes, what are those factors?</p> <input type="checkbox"/> Flow Regulations <input type="checkbox"/> Mining Activities <input type="checkbox"/> Upstream Chan Conditions <input type="checkbox"/> Channelization <input type="checkbox"/> Road Encroachment <input type="checkbox"/> Oil Field Water Discharge <input type="checkbox"/> Augmented Flows <input type="checkbox"/> Other (specify)
<p>Trend for Functional - At Risk:</p> <input type="checkbox"/> Upward <input type="checkbox"/> Downward <input type="checkbox"/> Not Apparent

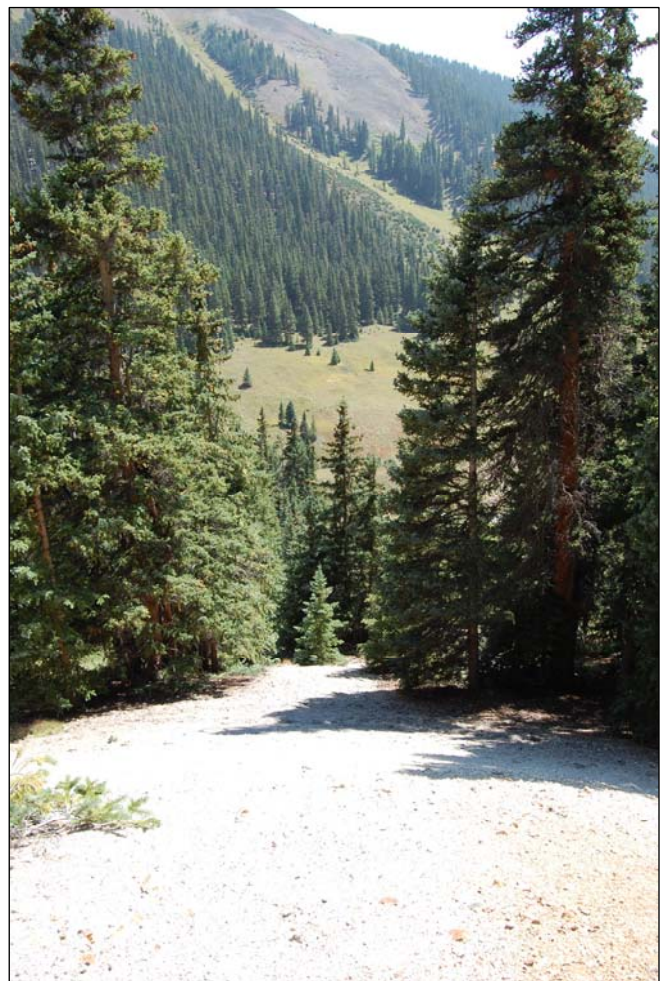
Name of Riparian-Wetland Area:		Alpine Gulch	
Date:	8/13/2007	Segment/Reach ID:	AM-2235
ID Team Observers:		Malone

General Description: A mine adit and dump are located adjacent to a high gradient stream that flows east to Alpine Gulch. Stream gradient decreases above and west of a recreational trail. Decreased gradient results in overbanking flows and groundwater discharge which has created a wide slope wetland. Above and below the trail vegetative characteristics including cover, richness and structure indicate functional wetland habitat. However, the trail interrupts surface groundwater flow and trampling degrades vegetation on 1 to 2 m on each side of the trail. Although the stream briefly flows through mining waste rock and a strong sulfur odor emits from the nearby adit riparian vegetation appears to have restored and is sustainable.

<input type="checkbox"/> Proper Functioning Condition <input checked="" type="checkbox"/> Functional - At Risk <input type="checkbox"/> Nonfunctional <input type="checkbox"/> Unknown		<p>Are factors contributing to unacceptable conditions outside the control of the manager?</p>
<p>Trend for Functional - At Risk:</p> <input type="checkbox"/> Upward <input checked="" type="checkbox"/> Downward <input type="checkbox"/> Not Apparent		<p>Yes/No: <u> </u> No</p> <p>If yes, what are those factors?</p> <input type="checkbox"/> Flow Regulations <input type="checkbox"/> Mining Activities <input type="checkbox"/> Upstream Chan Conditions <input type="checkbox"/> Channelization <input type="checkbox"/> Road Encroachment <input type="checkbox"/> Oil Field Water Discharge <input type="checkbox"/> Augmented Flows <input type="checkbox"/> Other (specify)

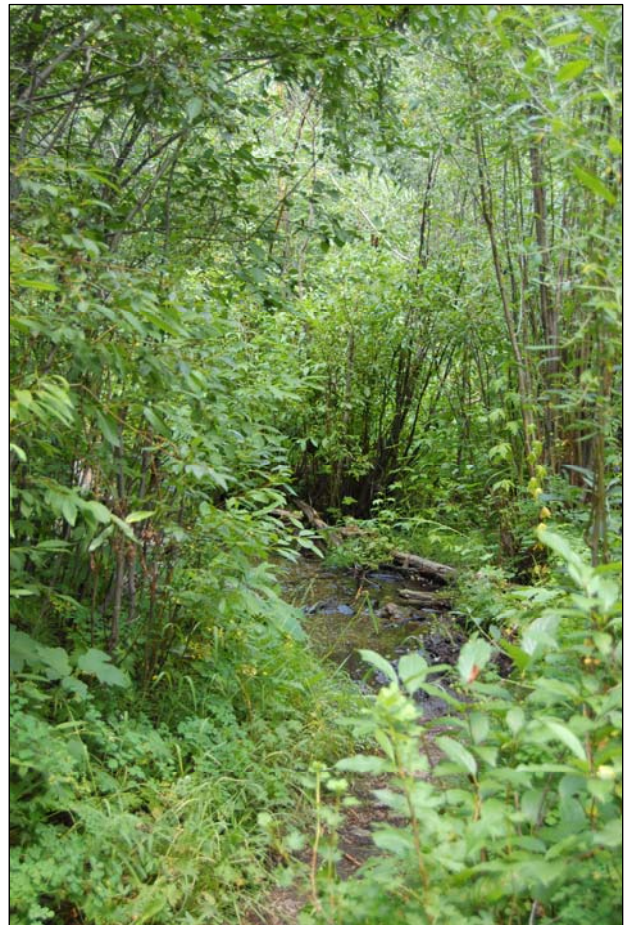
Name of Riparian-Wetland Area:	Henson Creek		
Date:	8/24/2007	Segment/Reach ID:	AM-2252
ID Team Observers:	Malone

General Description: Site is a mine dump and adit located on a steep north-facing slope 20m uphill and southwest of MD-57. Upland habitat surrounding the mine dump is characterized by *Picea engelmannii* with the shrub layer dominated by *Paxistima myrsinites* and *Ribes coloradense* and the herbaceous layer by *Arctostaphylos uva-ursi*, *Vaccinium myrtillus* and *Geranium richardsonii* and with *Populus tremuloides* communities dominating in moister ravines.

Tree cover (dump): <5% including *Pinus contorta* and *Picea engelmannii*.
 Shrub cover(dump):<5% including *Juniperus communis* and *Ribes coloradense*.
 Herbaceous cover(dump):<5% including *Bromus ciliatus*.
 Weed cover(dump):none observed.

<input type="checkbox"/> Proper Functioning Condition <input type="checkbox"/> Functional - At Risk <input checked="" type="checkbox"/> Nonfunctional <input type="checkbox"/> Unknown		<p>Are factors contributing to unacceptable conditions outside the control of the manager? Yes/No: <u> </u> <u>No</u></p> <p>If yes, what are those factors?</p> <input type="checkbox"/> Flow Regulations <input type="checkbox"/> Mining Activities <input type="checkbox"/> Upstream Chan Conditions <input type="checkbox"/> Channelization <input type="checkbox"/> Road Encroachment <input type="checkbox"/> Oil Field Water Discharge <input type="checkbox"/> Augmented Flows <input type="checkbox"/> Other (specify)
<p>Trend for Functional - At Risk:</p> <input type="checkbox"/> Upward <input type="checkbox"/> Downward <input type="checkbox"/> Not Apparent

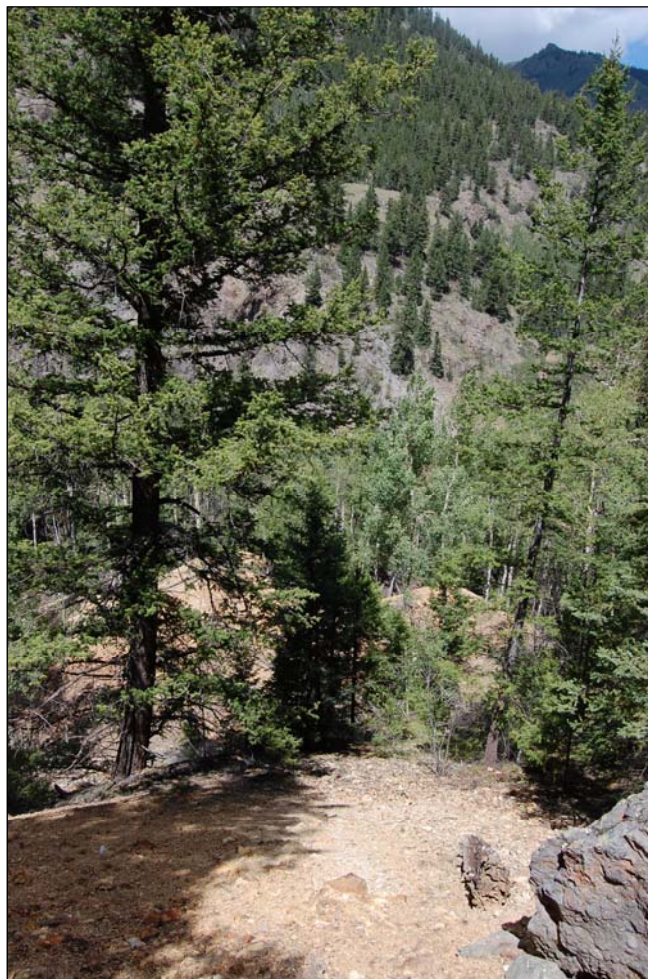
Name of Riparian-Wetland Area:	Deadman Gulch		
Date:	8/11/2007	Segment/Reach ID:	AM-2303
ID Team Observers:	Malone

<input type="checkbox"/> Proper Functioning Condition <input type="checkbox"/> Functional - At Risk <input checked="" type="checkbox"/> Nonfunctional <input type="checkbox"/> Unknown		<p>Are factors contributing to unacceptable conditions outside the control of the manager? Yes/No: <u> </u> No</p> <p>If yes, what are those factors?</p> <input type="checkbox"/> Flow Regulations <input type="checkbox"/> Mining Activities <input type="checkbox"/> Upstream Chan Conditions <input type="checkbox"/> Channelization <input type="checkbox"/> Road Encroachment <input type="checkbox"/> Oil Field Water Discharge <input type="checkbox"/> Augmented Flows <input type="checkbox"/> Other (specify)
<p>Trend for Functional - At Risk:</p> <input type="checkbox"/> Upward <input type="checkbox"/> Downward <input type="checkbox"/> Not Apparent

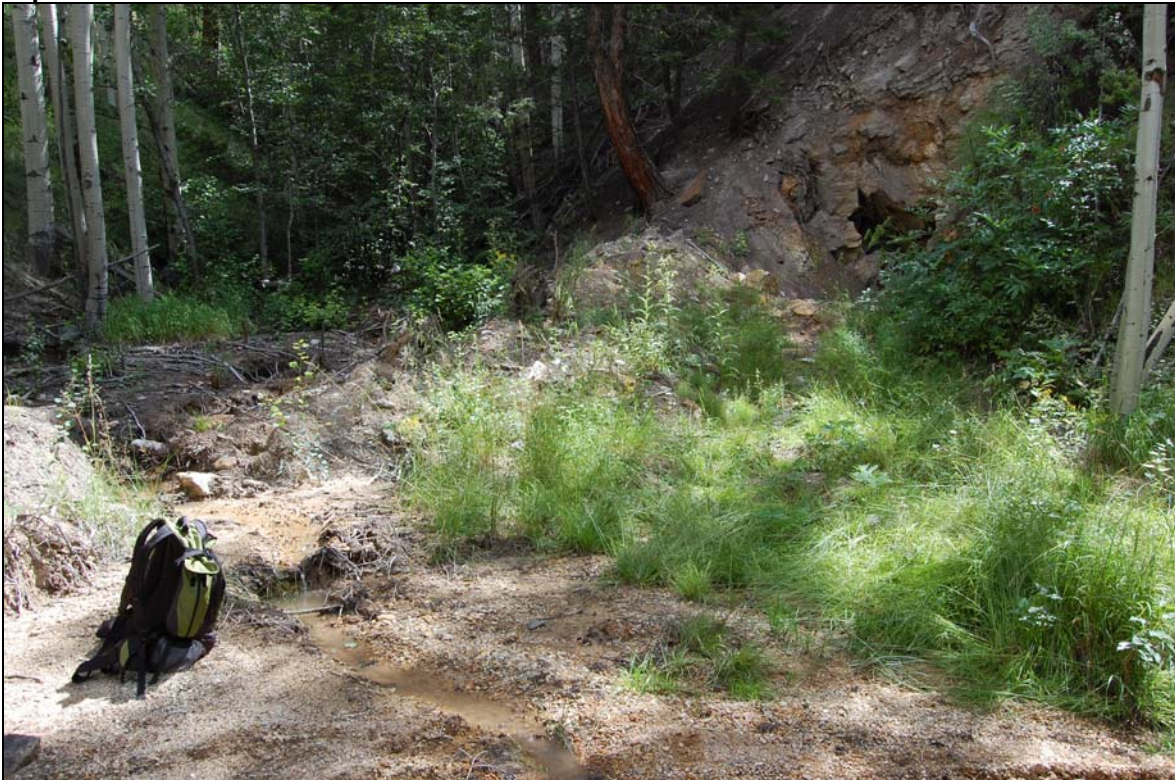
Name of Riparian-Wetland Area:	Henson Creek		
Date:	8/24/2007	Segment/Reach ID:	AM-2316
ID Team Observers:	Malone

General Description: Site is a mine dump located on an east-facing slope. Hillslope vegetation is characterized by *Pseudotsuga menziesii* with the shrub layer dominated by *Symphoricarpos oreophilus*, *Juniperus communis* and *Amelanchier alnifolia* and the herbaceous layer by *Carex pensylvanica*, *Mahonia repens*, *Heterotheca villosa*, *Artemisia frigida* and with *Populus tremuloides* communities in moister ravines.

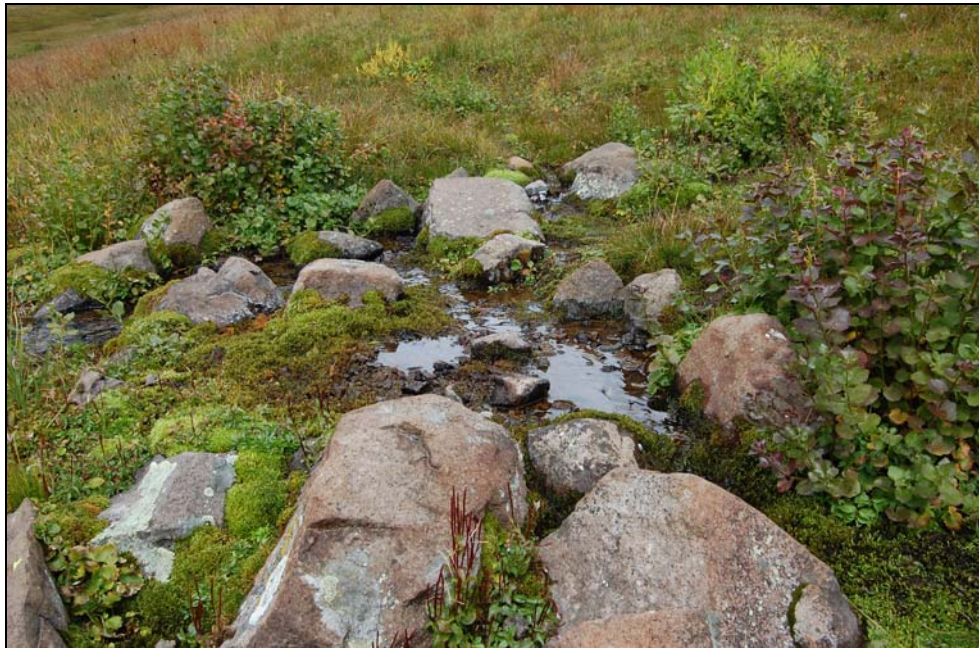
Name of Riparian-Wetland Area:	Boulder Gulch		
Date:	9/5/2007	Segment/Reach ID:	D-467
ID Team Observers:	Malone

Spring daylight at the base of a northeast facing slope in an alpine turf meadow, flows 10m east to where flows coalesce with the main channel. Upland and riparian habitat are in good condition and sustainable. Riparian plant community is characterized by the classification Cardamine cordifolia-Mertensia ciliata-Senecio triangularis herbaceous vegetation but only C. cordifolia is present. The plant community is rich in other forb, sedge and rush species. Wildlife use is moderate here but in nearby willow carrs elk use is very high. Observations of the elk herd and browse indicate that this area provides important summer and autumn elk habitat.

<input checked="" type="checkbox"/> Proper Functioning Condition <input type="checkbox"/> Functional - At Risk <input type="checkbox"/> Nonfunctional <input type="checkbox"/> Unknown Trend for Functional - At Risk: <input type="checkbox"/> Upward <input type="checkbox"/> Downward <input type="checkbox"/> Not Apparent		<p>Are factors contributing to unacceptable conditions outside the control of the manager? Yes/No: <u> </u> No</p> <p>If yes, what are those factors?</p> <input type="checkbox"/> Flow Regulations <input type="checkbox"/> Mining Activities <input type="checkbox"/> Upstream Chan Conditions <input type="checkbox"/> Channelization <input type="checkbox"/> Road Encroachment <input type="checkbox"/> Oil Field Water Discharge <input type="checkbox"/> Augmented Flows <input type="checkbox"/> Other (specify)
--	--	---

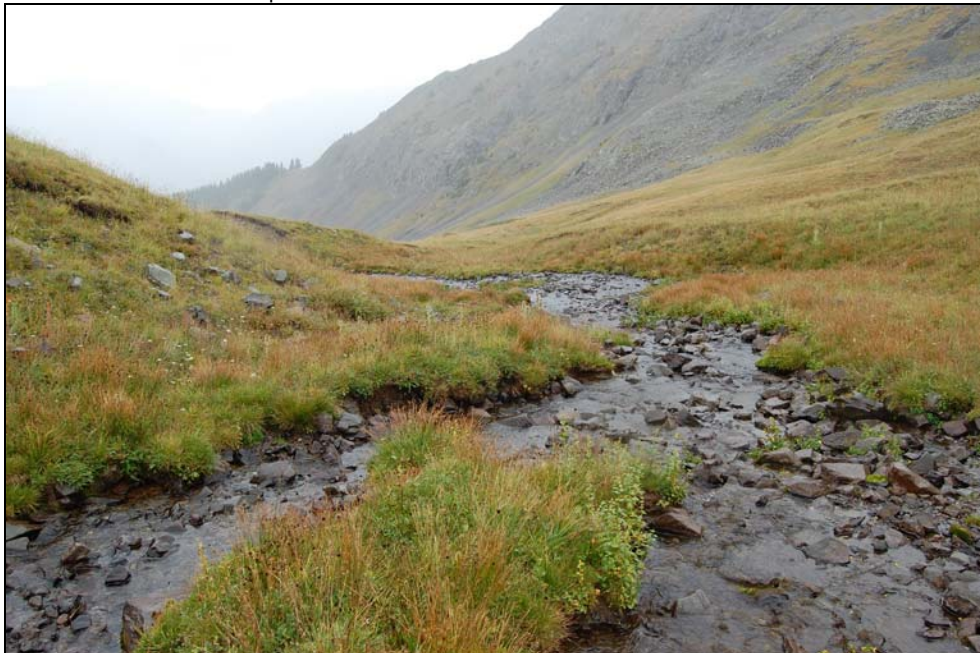
Name of Riparian-Wetland Area:	Deadman Gulch		
Date:	8/10/2007	Segment/Reach ID:	F-276
ID Team Observers:	Malone

<input type="checkbox"/> Proper Functioning Condition <input type="checkbox"/> Functional - At Risk <input checked="" type="checkbox"/> Nonfunctional <input type="checkbox"/> Unknown		<p>Are factors contributing to unacceptable conditions outside the control of the manager?</p>
<p>Trend for Functional - At Risk:</p> <input type="checkbox"/> Upward <input type="checkbox"/> Downward <input type="checkbox"/> Not Apparent	<p>Yes/No: <u> </u> No</p>	<p>If yes, what are those factors?</p> <input type="checkbox"/> Flow Regulations <input type="checkbox"/> Mining Activities <input type="checkbox"/> Upstream Chan Conditions <input type="checkbox"/> Channelization <input type="checkbox"/> Road Encroachment <input type="checkbox"/> Oil Field Water Discharge <input type="checkbox"/> Augmented Flows <input type="checkbox"/> Other (specify)

However, sediment barriers installed to mitigate sedimentation were ineffective and a retention pond below the mine dump was leaking. Additionally domestic sheep grazing is high and likely impacts vigor of wetland vegetation.

Wetland potential is degraded by ineffective mitigation strategies and by excessively high levels of grazing: stubble height of palatable grasses and forbs is <10% of potential height and vigor is impacted.

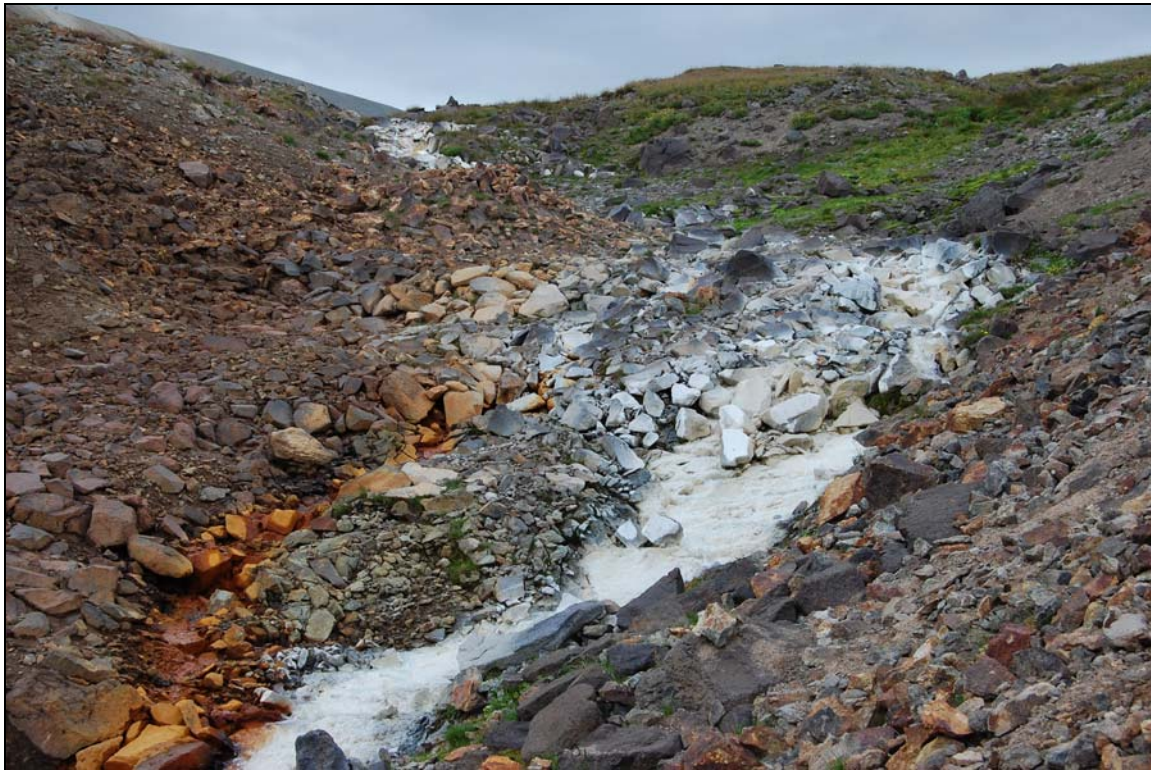
Name of Riparian-Wetland Area:	Palmetto Gulch wetland		
Date:	9/2/2007	Segment/Reach ID:	MD-13
ID Team Observers:	Malone

Wetlands are degraded by waste rock from the dump which is carried downslope with precipitation and is smothering wetland vegetation. Domestic sheep grazing is heavy. Browse on willows is moderate to high, 25-50% of 2nd year and older stems are browsed, and likely impacts vigor.

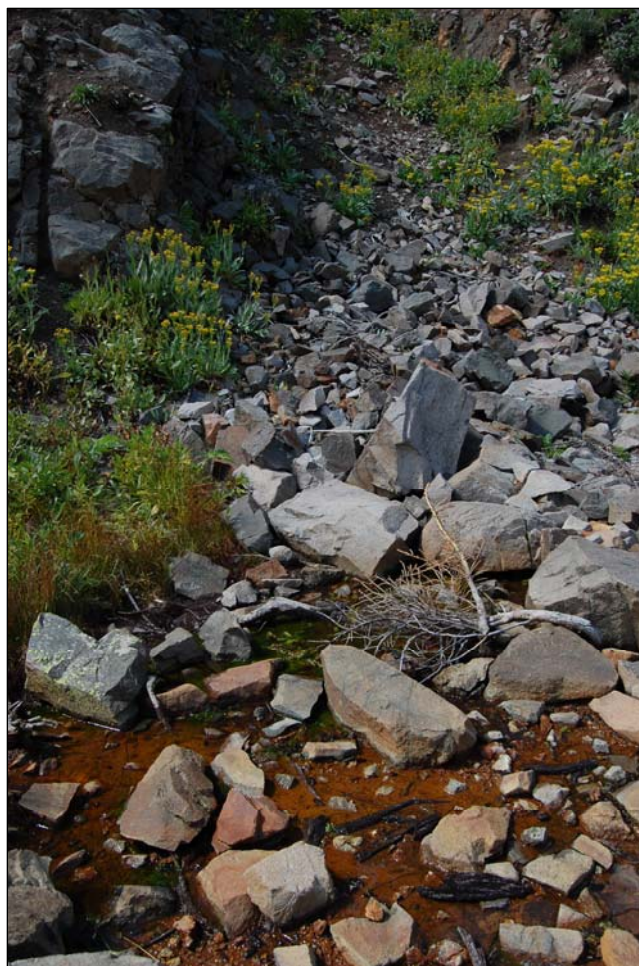
Name of Riparian-Wetland Area:	North Fork Henson Ck		
Date:	8/26/2007	Segment/Reach ID:	MD-48
ID Team Observers:	Malone

<input type="checkbox"/> Proper Functioning Condition <input type="checkbox"/> Functional - At Risk <input checked="" type="checkbox"/> Nonfunctional <input type="checkbox"/> Unknown
