# COLORADO STATE CAPITOL

## HISTORIC STRUCTURE ASSESSMENT

STATE HISTORICAL FUND PROJECT NUMBER  
SHF-2006-T1-001

**December 15, 2006**

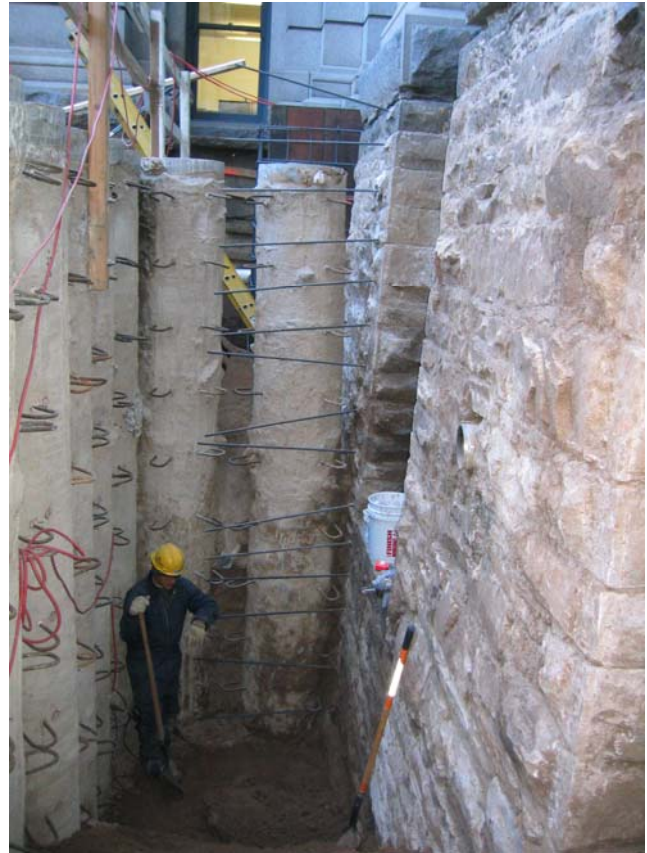
Excavation at northwest foundation wall for new exit stair

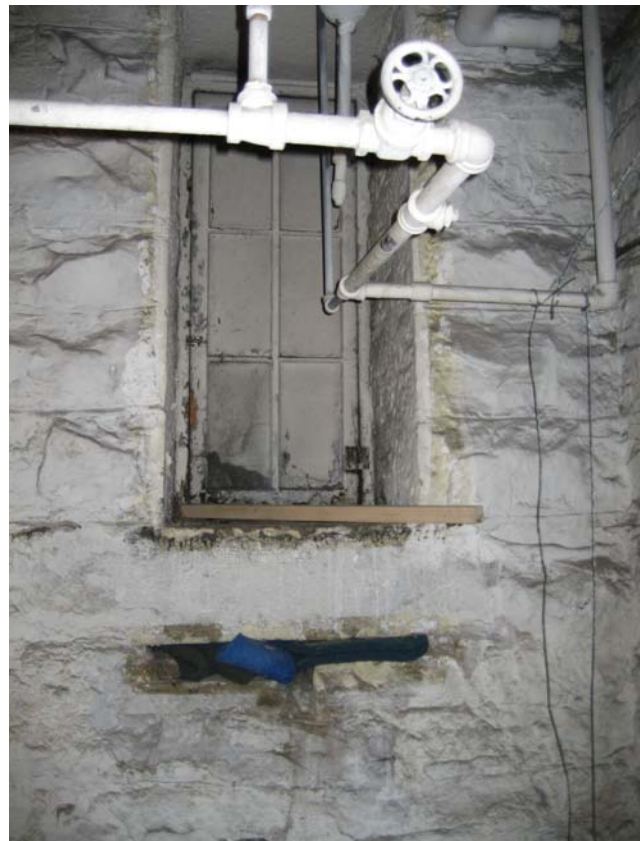
Failed mortar joint at Sub-Basement

Evaluate extent and cause of water infiltration that is damaging foundation walls. Immediate resolution is recommended to prevent further erosion and possible structural failure. Repair mortar joints and replace destroyed finish plaster. A re-grade of the grounds is required to establish positive drainage from the building. Refer to Section 5.3 Estimate of Probable Cost of Construction.

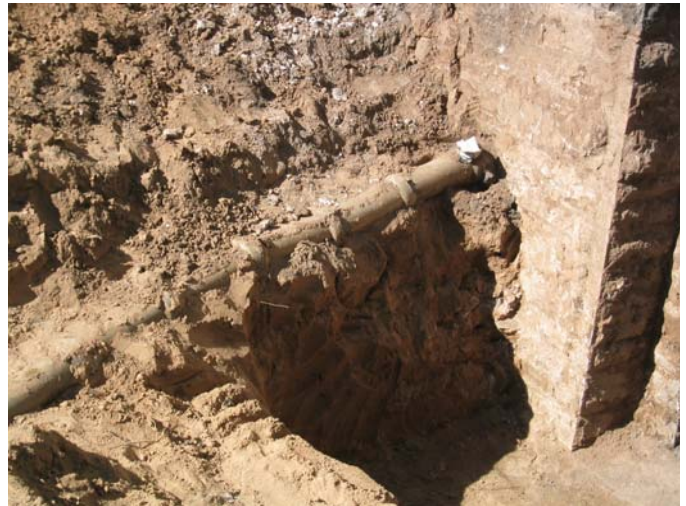
Excavation of drain leader at north east area well location. This pipe section

Tear out the circle drive and restore grade level drainage away from the building. Installation of new curbs, gutters, sidewalks and sprinkler systems, as well as a repair of the asphalt at removed curbs, should be done as indicated in Section 5.3 Estimate of Probable Cost of Construction.

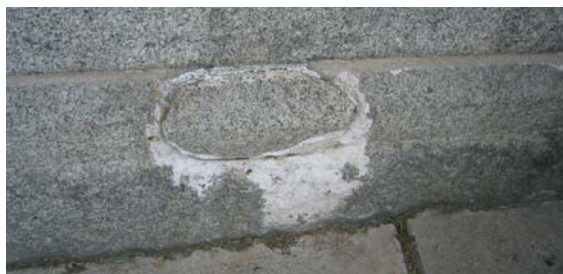
Most of the granite is in good condition with the exception of some broken fragments from impacts or water damage and spalling. The broken fragments have in most cases been incorrectly repaired. There is a significant amount of spalling caused by water penetrating small cracks and the repeated freeze thaw condition. Spalled areas have not been addressed. Damage of these types is found along the bottom third of the building elevations. In contrast to the good condition of the granite, fifty to sixty percent of the stone joints around the building have failed. In some cases, the failed areas have been patched with inappropriate materials including incorrect mortar and synthetic caulk. Even though the building exterior has been cleaned several times, lime staining and mold growth are evident along and under all ledges of the building. (In addition, a brownish-black stain is apparent on many of the facades. As observed from the roof, many of the horizontal granite surfaces are covered with a liquid roofing material. This may be the cause of the brownish-black staining.

A poorly executed patch

The entire exterior façade should be evaluated and a repair program undertaken as soon as possible. A complete understanding of the scope of the problems, as well as the causes, is critical prior to undertaking any repairs. It is important to make repairs in a historically sensitive manner using appropriate methods and materials.

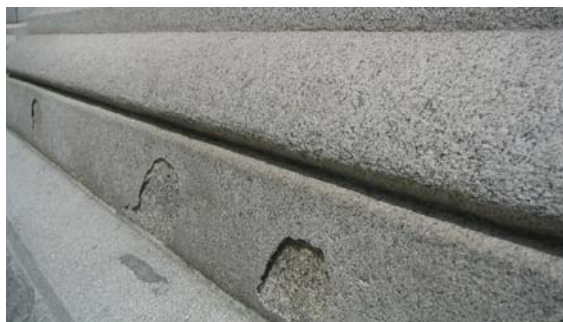
Example of spalling

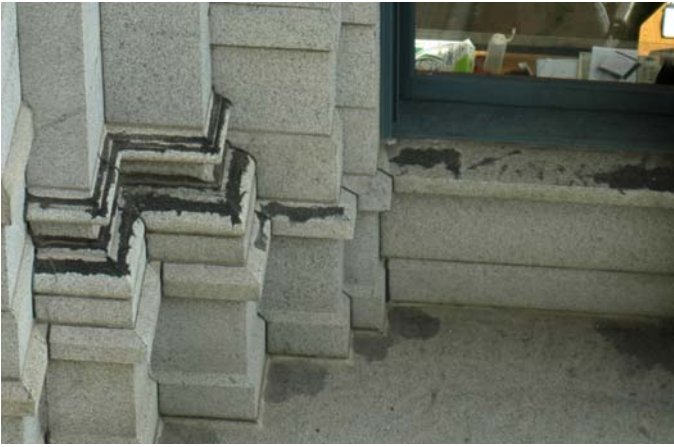
Dark colored roofing sealer

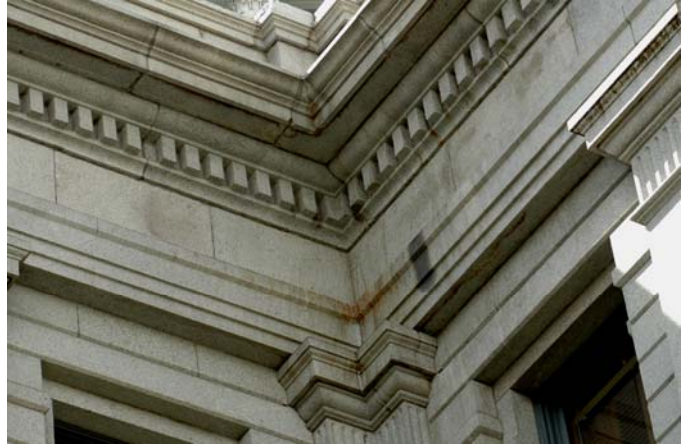
Staining and failed joints

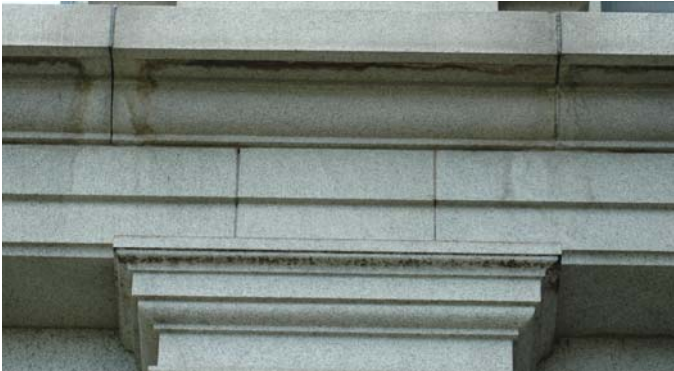
Lime staining at failed joints

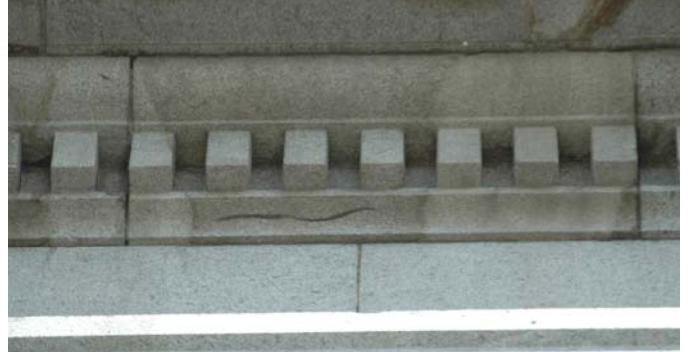
Horizontal crack in carved granite

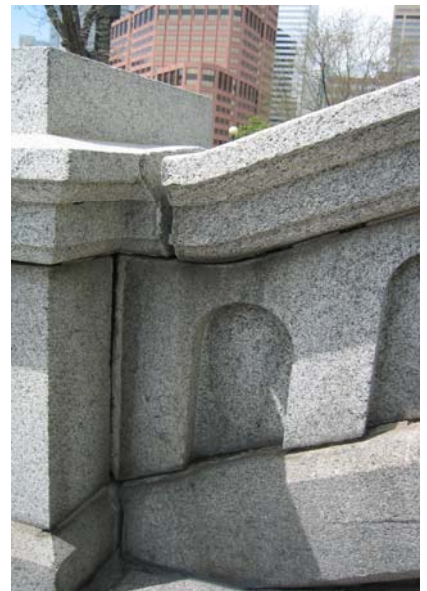
Pediment carvings are in good condition but the joints between the carved panels have failed. Evidence of failed joints and staining are visible. The granite steps and rails are settling and the joints are open to the weather. Some inappropriate patches have been made with synthetic caulk that is also failing. The multi-chambered area below the Steps is damp year round. The brick vault is showing signs of decay due to the moisture and water seeping through joints in the steps above.

West Steps open joint resulting from settling

The West Portico and Steps should be evaluated and a repair program undertaken as soon as possible. A complete understanding of the scope of the problems as well as the causes is critical prior to undertaking any repairs. It is important to make the repairs in a historically sensitive manner using appropriate methods and materials. The West Steps should be given immediate attention due to the open joints and settling. Refer to Section 5.3 Estimate of Probable Cost of Construction.

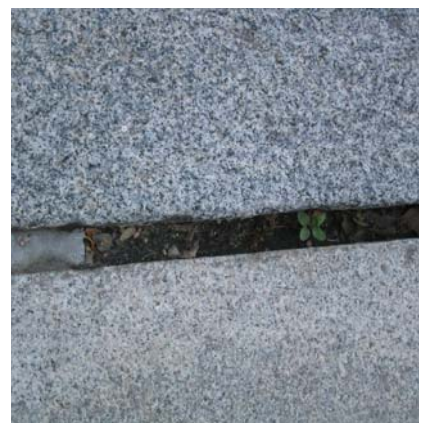
West Steps open joints

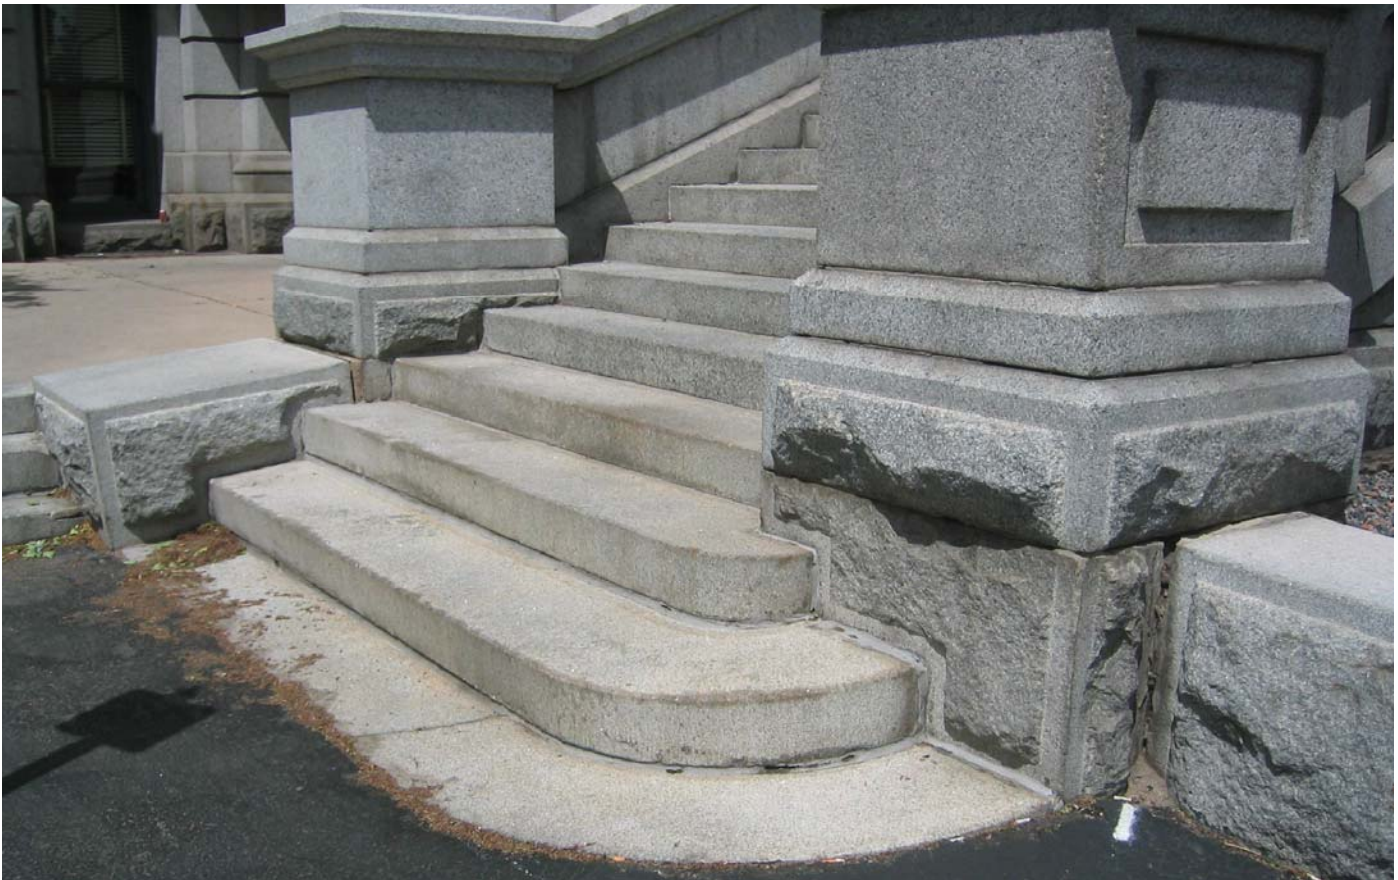
Settling at South Steps and features, caulked joints

The South Portico and Steps should be evaluated and a repair program undertaken as soon as possible. The South Steps should be given immediate attention due to the spalling, open joints, and settling. Refer to Section 5.3 Estimate of Probable Cost of Construction.

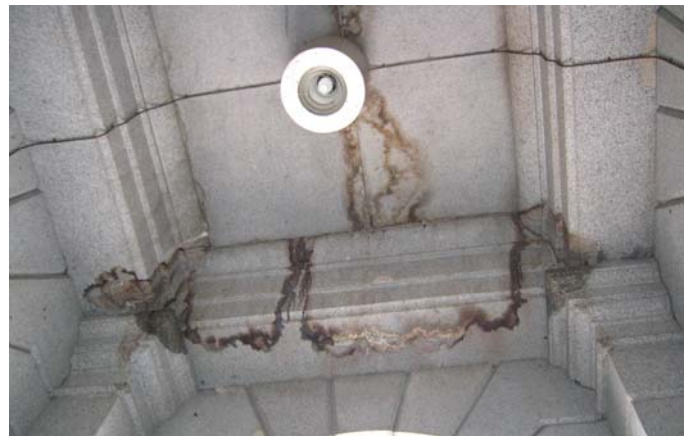
Stains at East Portico from water collecting on the porch above

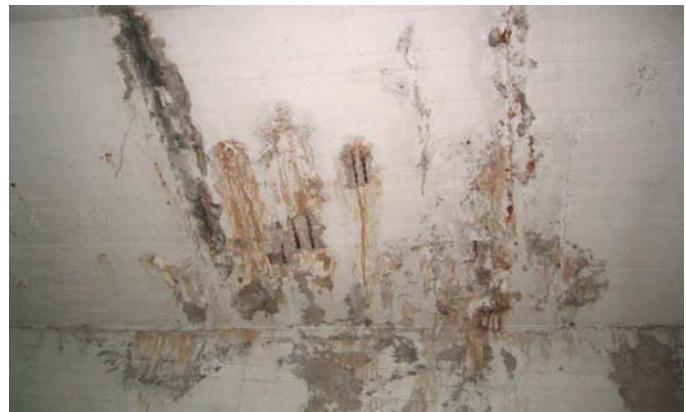
Decaying concrete and reinforcing below the East Steps

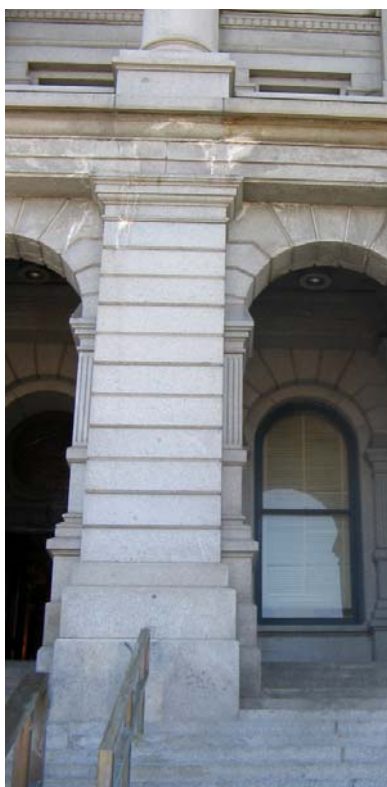
Lime stains at porch

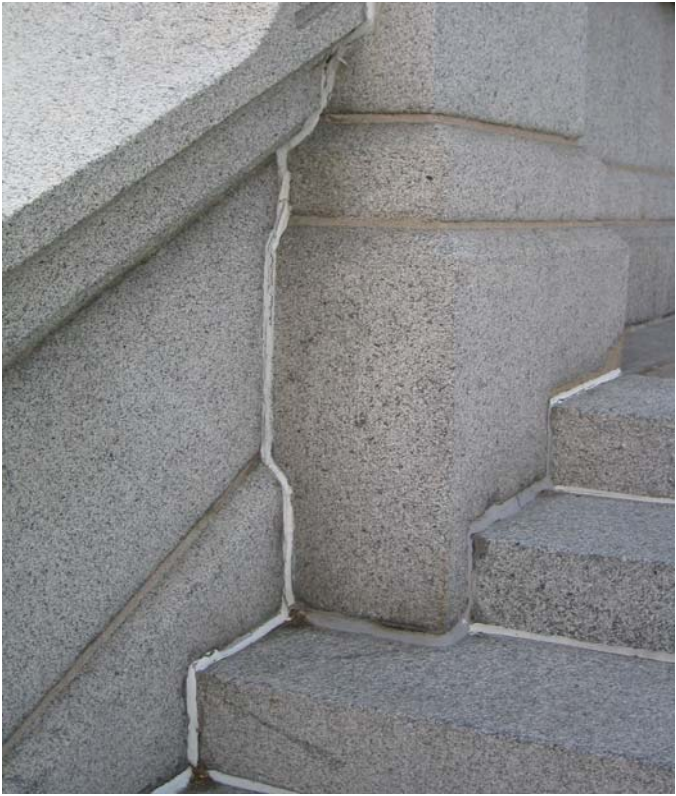
Incorrect caulk joints at steps

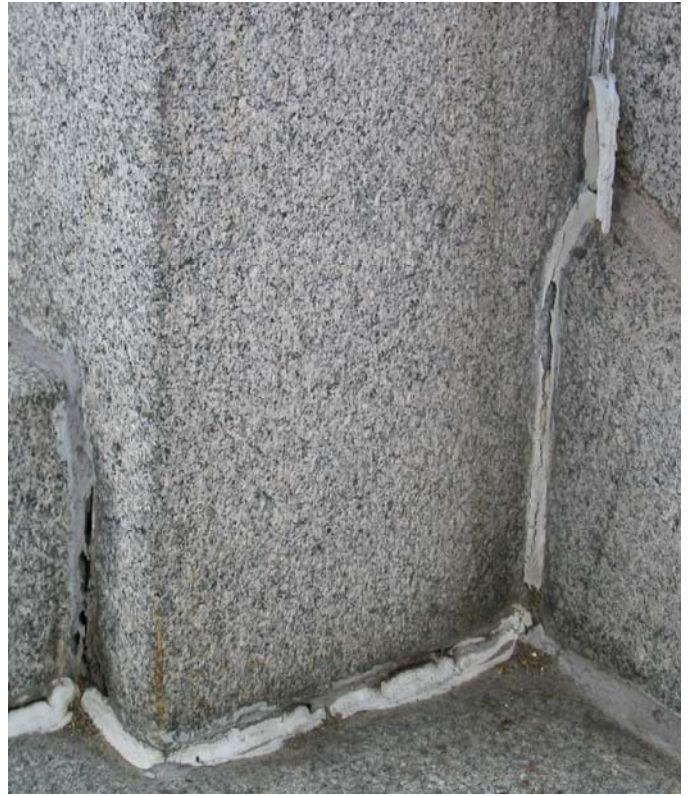
Failing caulk joints

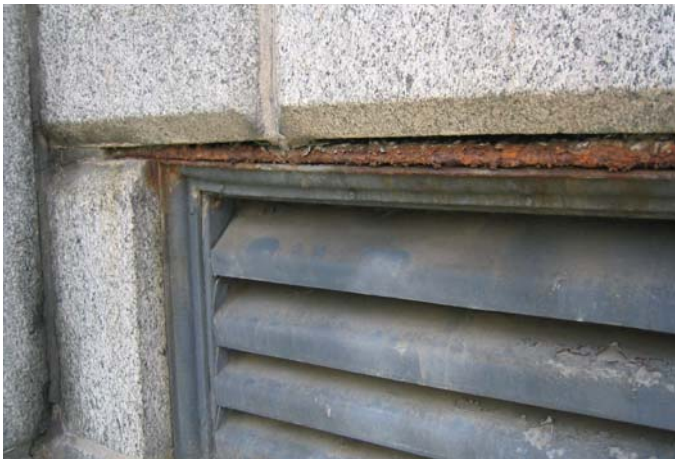
Rusting mechanical vent

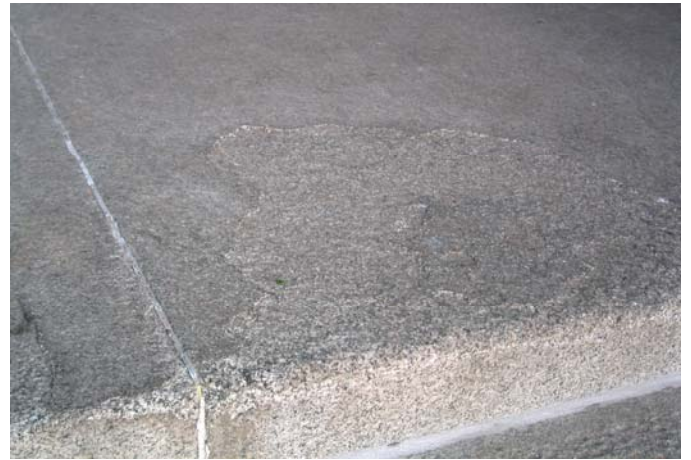
Granite spalling at East entry

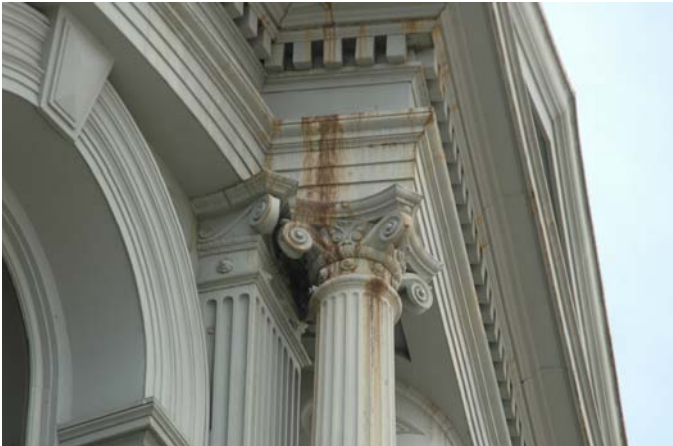
Corrosion at column capitol

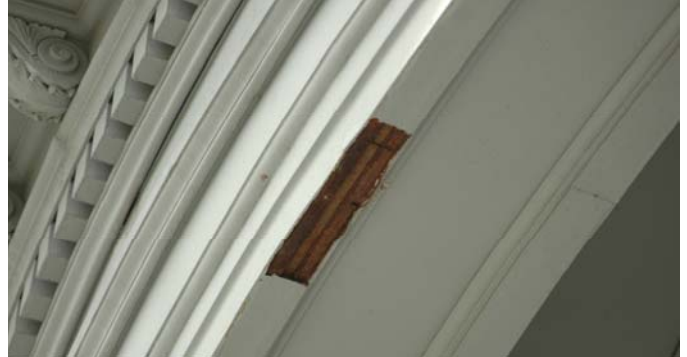
Cast Iron façade damage from winter 2005

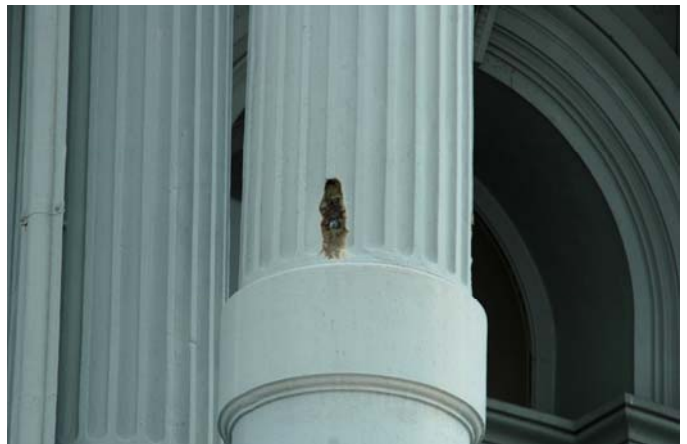
Rusting from within at column

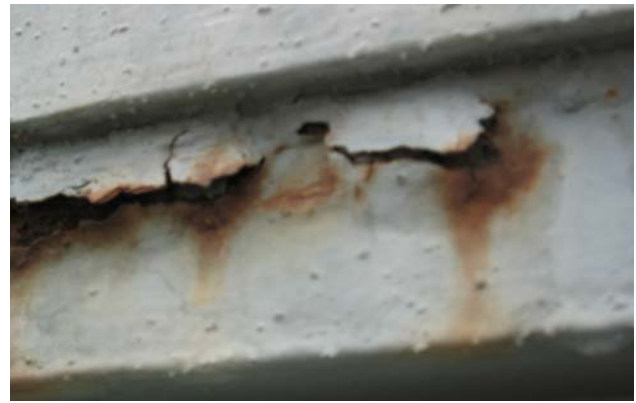
There is evidence of corrosion and decay on almost every feature of the Dome. See section 3.6 for information on the windows. Rust is visible from the window lintels on the Dome all the way down to the drum at the roof level. In many instances, freeze/ thaw action has broken off pieces of cast iron. The round columns appear to be rusting from the inside out, an indication that they are filled with water, and pieces of the flutes have broken off. Although severely dimpled from past hail storms, the gilded portion of the Dome is largely intact.

Corrosion above the drum

The entire Dome will require extensive work to repair current damage and preserve the feature for future generations. This work is time sensitive because the rate of decay is increasing with the passing of each winter.

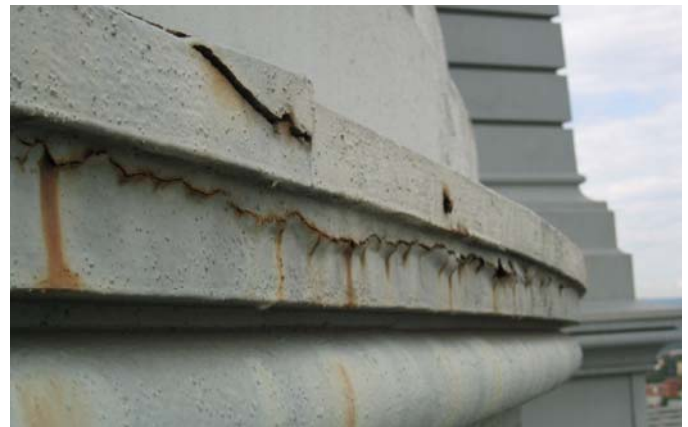
Broken and corroded cast iron

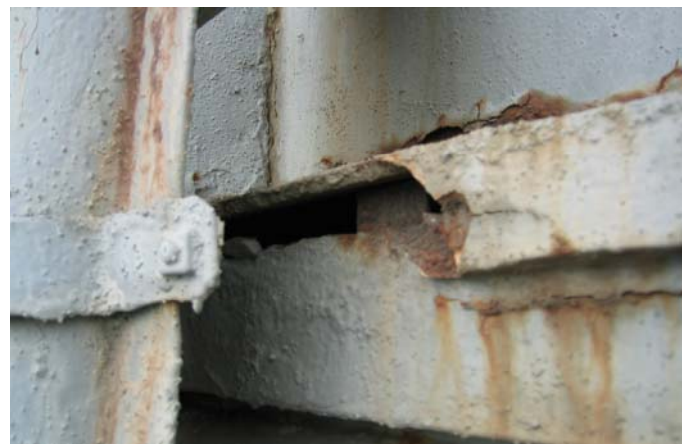
There is some staining beneath the windows that appears to be from corrosion around the windows. All downspouts show signs of having been frozen which would indicate a blockage. Some have expanded enough to burst the seams and all are in need of suitable replacement.

Broken cast iron behind downspout

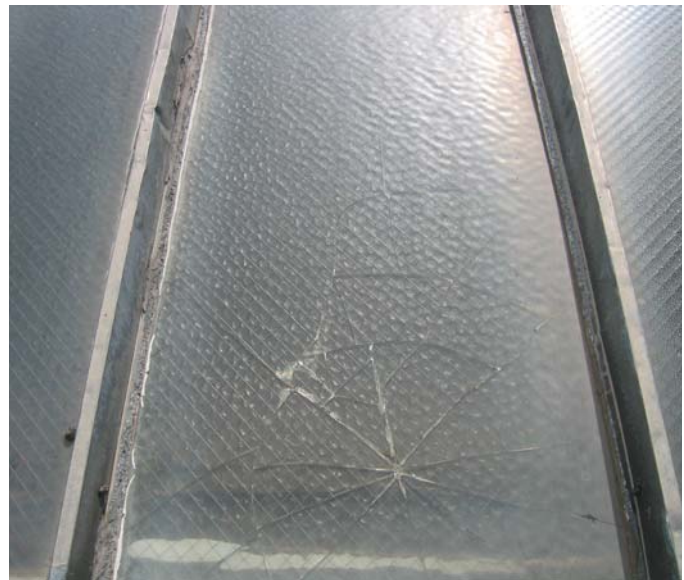
Broken pieces of glass were replaced in 2003, however the North Skylight has recent damage resulting in cracked lights and there are still broken tiles on the west gabled section. The South Skylight is also leaking.

Cracked skylight glazing

Replace two cracked skylight panes and repair leak at South Skylight. Refer to Section 5.3 Estimate of Probable Cost of Construction for repair costs.

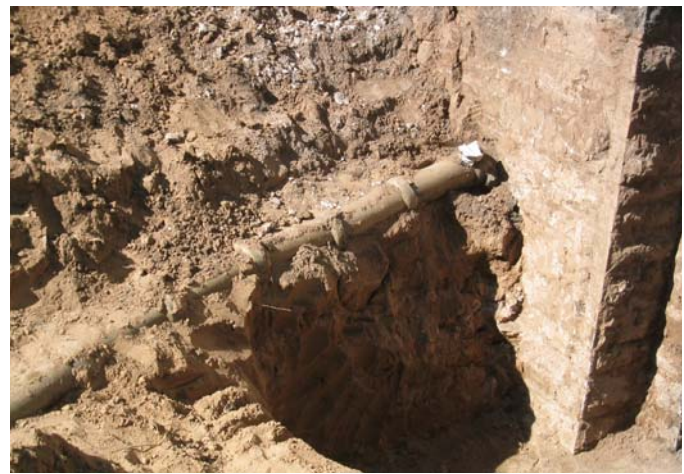
Excavation of a drain leader at north east area well. This pipe was replaced, but the condition is typical of drain leaders around the building

The downspouts are in poor condition due to internal oxidation and breaks caused by freezing water. Internal investigation of the drain leaders revealed numerous blockages by roof debris in areas where settlement has resulted in constricted flow. It is not uncommon for the slow draining pipes to backup and standing water to be present in the gutter. Excavations for the Life Safety Project have provided an opportunity to address the conditions described. Where work has been performed, impacted piping has been replaced with new PVC piping and slope issues have been corrected when possible.

The immediate repair and cleaning of downspouts, gutters and drain leaders (includes some excavation) is crucial to prevent further damage.

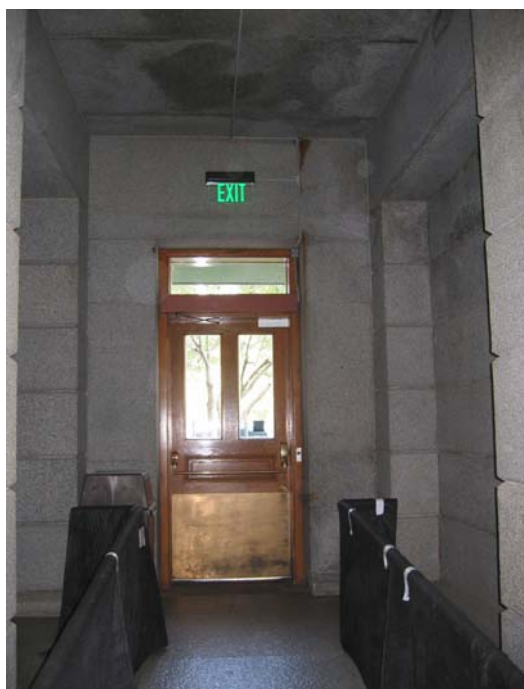
The paint on the east Basement door may contain hazardous materials.

Basement exterior doors

For the Basement doors, evaluate the potential hazardous material at the east Basement door. Repair the finish on all doors to prevent deterioration from weather.

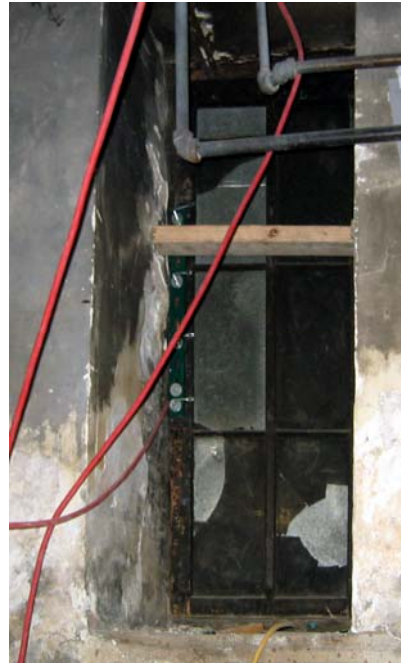
The wood is generally intact, however, there is some damage from the annual window AC unit installation, and some have weathered significantly. The paint is crazed, cracked, and peeling, and the underlying wood is exposed and weathering. There is no evidence in the peeled areas of the use of a primer. The number of paint layers is relatively few. Restored windows are in much better condition overall than the balance of the windows. Remaining windows are in various states of disrepair. There are no drains in the area wells, so water pools and evaporates. The extent of damage is directly related to the previously described site drainage issues. Those subject to the most amount of water collection, have sustained the most damage, including missing paint and accelerated weathering, cracking, shrinkage, staining, and mold.

Sub-Basement exterior window

Continued exposure to the elements threaten the long term functionality of the existing windows above and below grade. Repair, strip and refinish all exterior windows. Replace any windows that are beyond repair. Correct site drainage issues to protect current and future Sub-Basement windows. Refer to Section 5.3 Estimate of Probable Cost of Construction for repair costs.

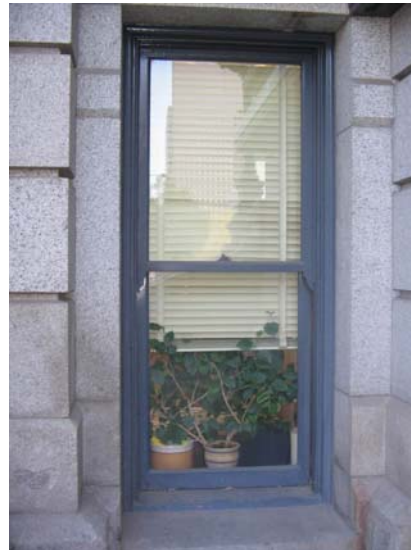
Basement exterior window

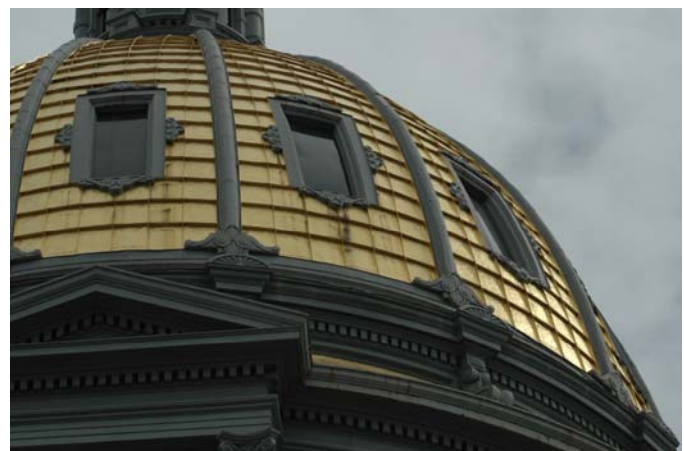
Dome painted steel exterior windows

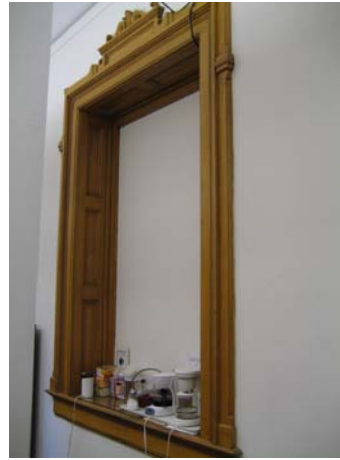
Original interior window, now within office space

Prevent use of stains or paint on original trim. Perform regular maintenance and refinish only with multiple light coats of clear varnish.

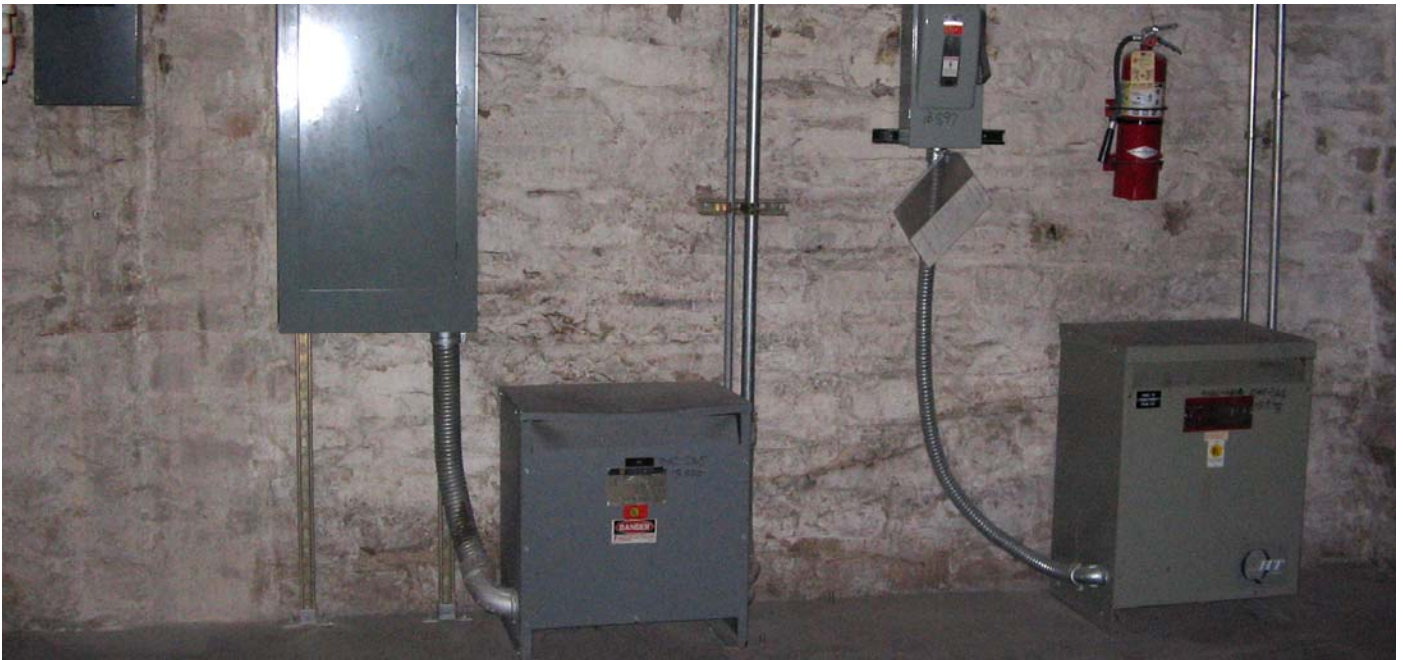
Transformers in Sub-Basement

Provisions need to be made for electrical demand in the future.

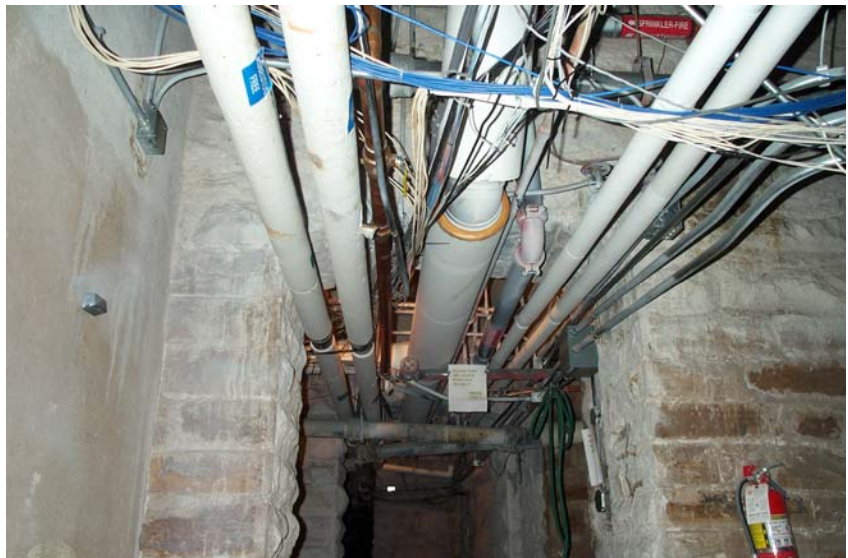
Mechanical and electrical systems being run overhead in the Sub-Basement

Check grounding of small transformers in the Sub-Basement. Correct loose, hanging wire in elevator shaft. Develop and maintain a complete and accurate as-built drawing for the entire capitol electrical distribution system. Relocate overlooked/hidden panels in back rooms of the Attic. Remove abandoned electrical wiring. Review and correct grounding deficiencies of all home run wiring. Review and address code deficiencies in the existing electrical distribution. Relieve overloaded junction boxes. Rewire fixtures and panels that use the original DC wiring for AC circuits. Replace sub 12-gauge wiring used for 20 amp circuits. Address conditions inside electrical rooms such as 137 and 275.

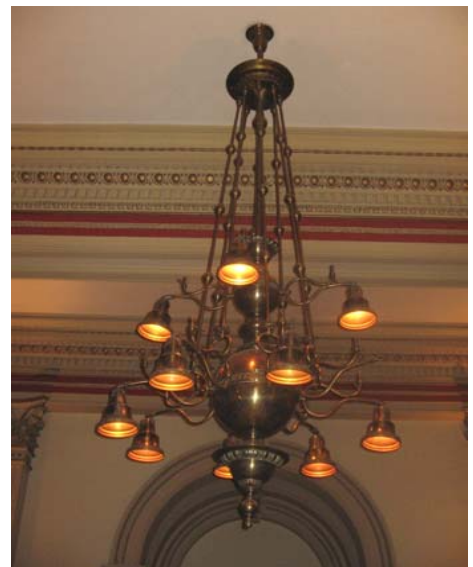
First Floor Elevator Vestibule

Found in the First Floor Elevator Vestibule, this chandelier, original to the building, matches the one in the same location on the Second Floor. This fixture has undergone the following changes: the frosted shades around the electric lamps along with the original glass ball shades around the gas outlets have been removed; the gas outlets have been plugged; the tubing has been altered; and the entire fixture has been rewired. Additionally, brass trumpet shades have been added, eliminating the up lighting component of the fixture.

**Functional Condition: Good**

Repairs should consider impact on fixture restoration.

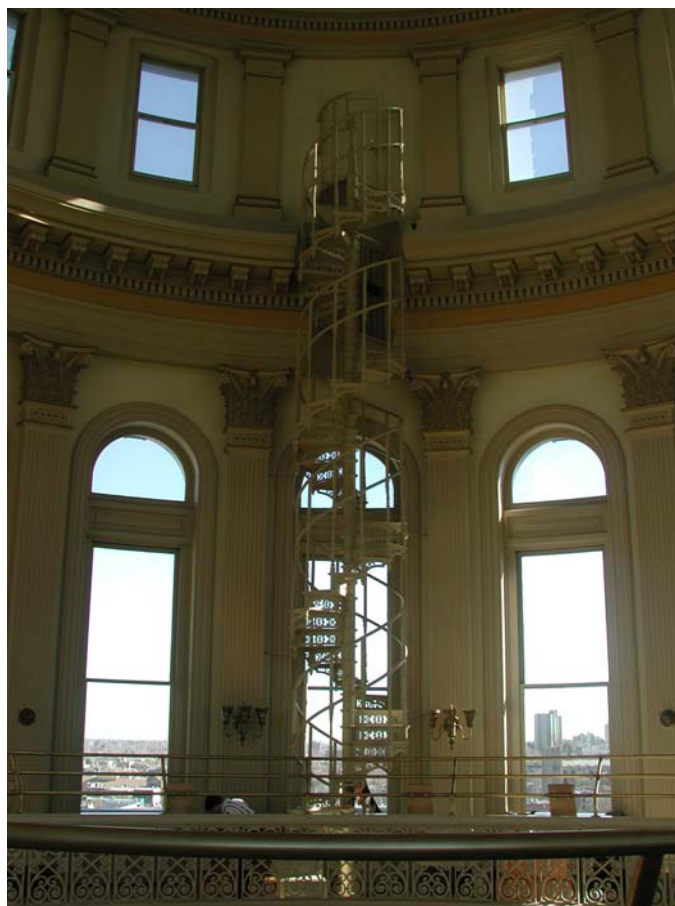
The interior space is in good condition. The exterior space is in poor condition. Exposure to water and freeze-thaw cycles have resulted in oxidation, staining and cracking. In one location, directly overhead of where occupants would normally view the city skyline, a piece of iron fell off in late 2005. The windows are in fair condition.

Dome: ornamental spiral staircase leading to the Upper Dome

Refurbish and maintain operable windows. Evaluate, repair and refinish exterior iron façade.

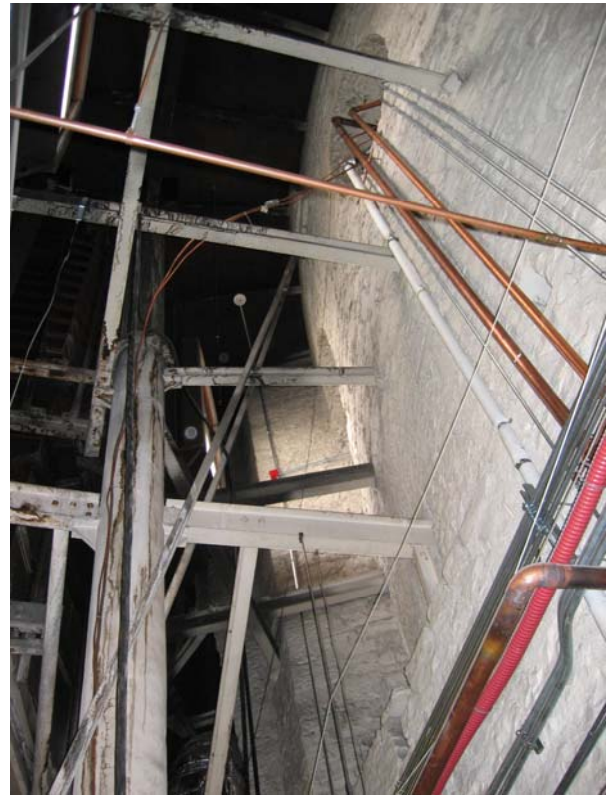
This space is in good condition except for the increasing presence of water infiltrating the façade. Cast iron is very susceptible to oxidation in the presence of water. Once started it becomes very difficult to stop. For this reason the superstructure condition is seen as poor.

Dome Interstitial: Dome superstructure

Correct the façade and drainage problems to eliminate water from getting onto the Dome superstructure. Inspect oxidized portions of the superstructure to determine the extent of damage.

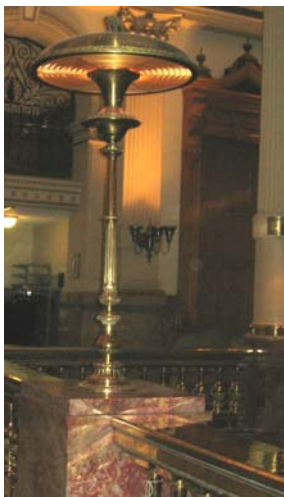
Non-original light fixture, brass balustrade

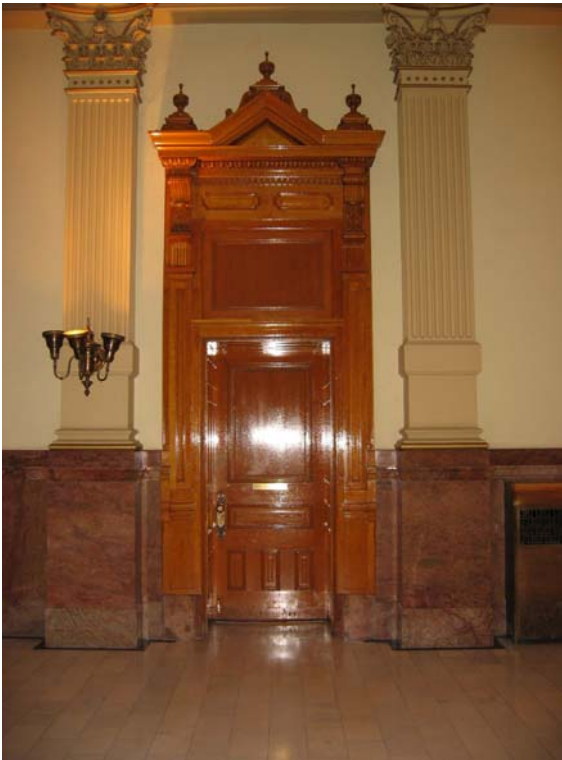
Public corridor door showing typical trim type T5 with non-original wood panel at door and transom

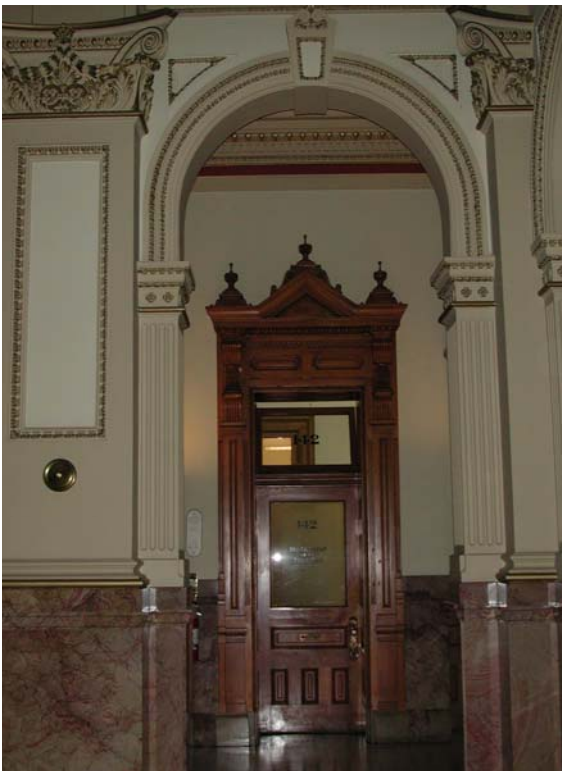
Public corridor door showing typical trim type T5 with original door glazing and non-original clear transom glazing

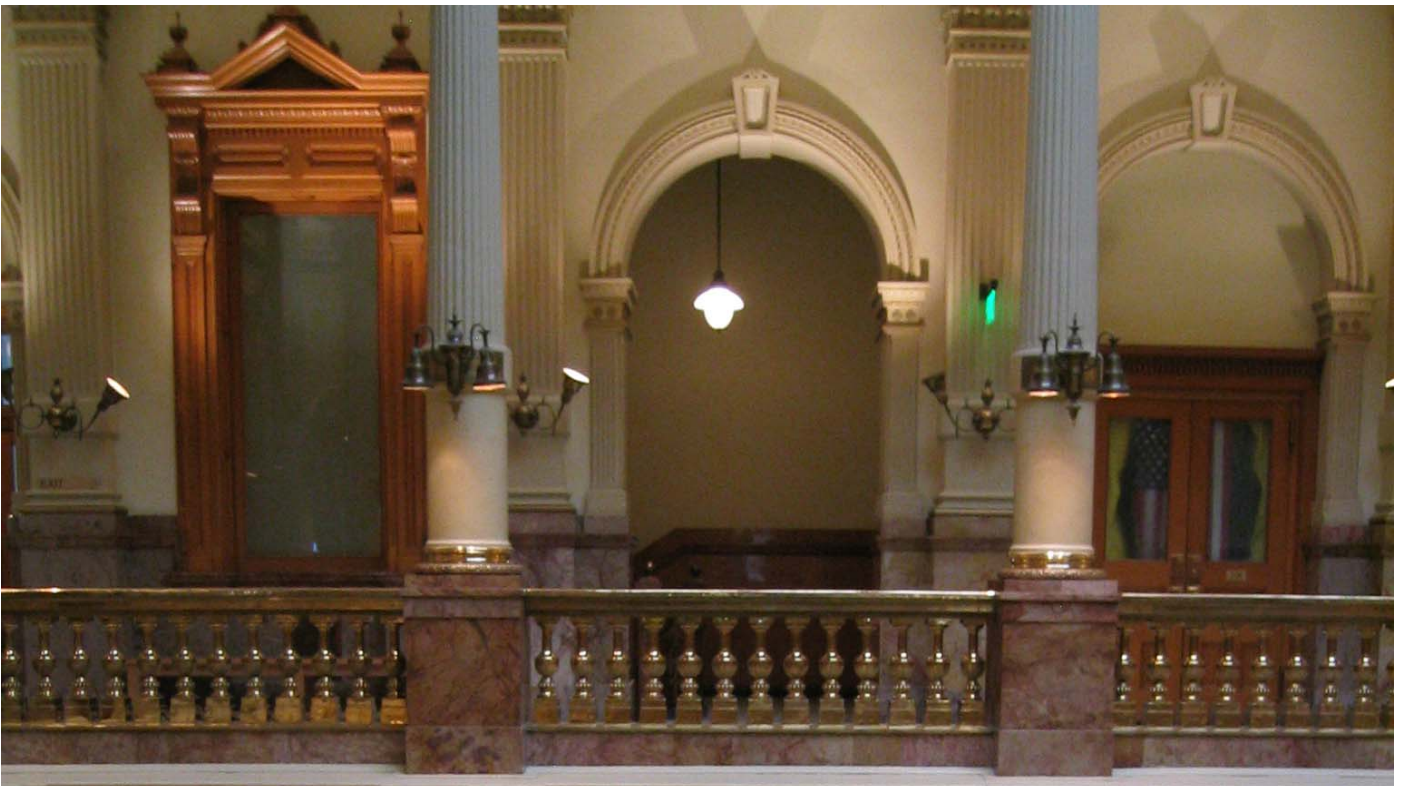
Overall view of the Third Floor Arcade, north side, showing in filled arched opening with relocated original doors

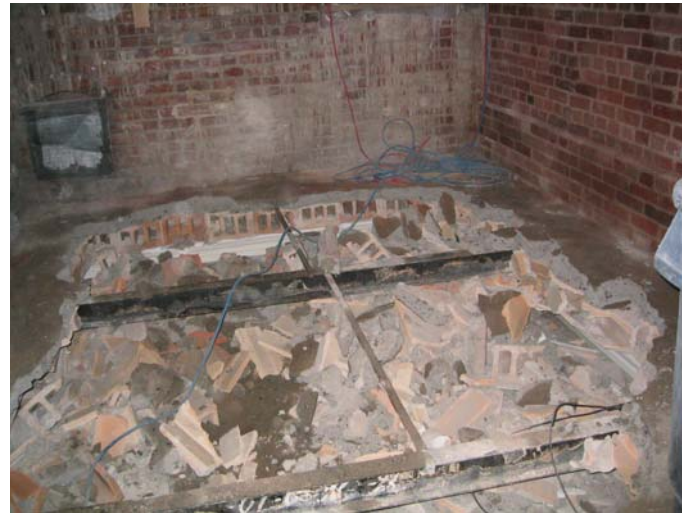
Removal of attic floor for extension of Northwest Stair

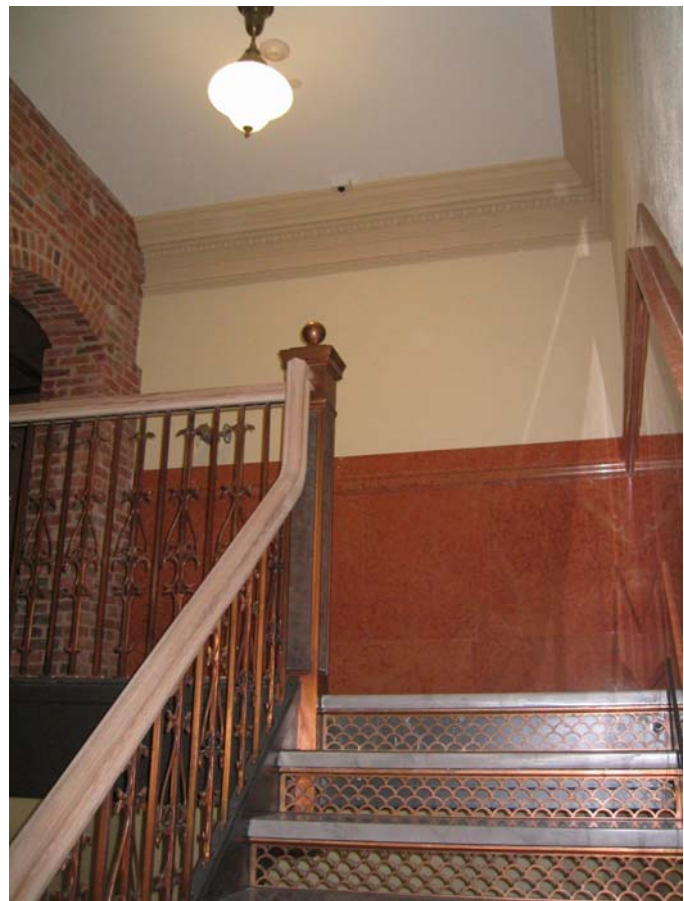
New landing at Attic looking south, prior to finish being applied to handrail

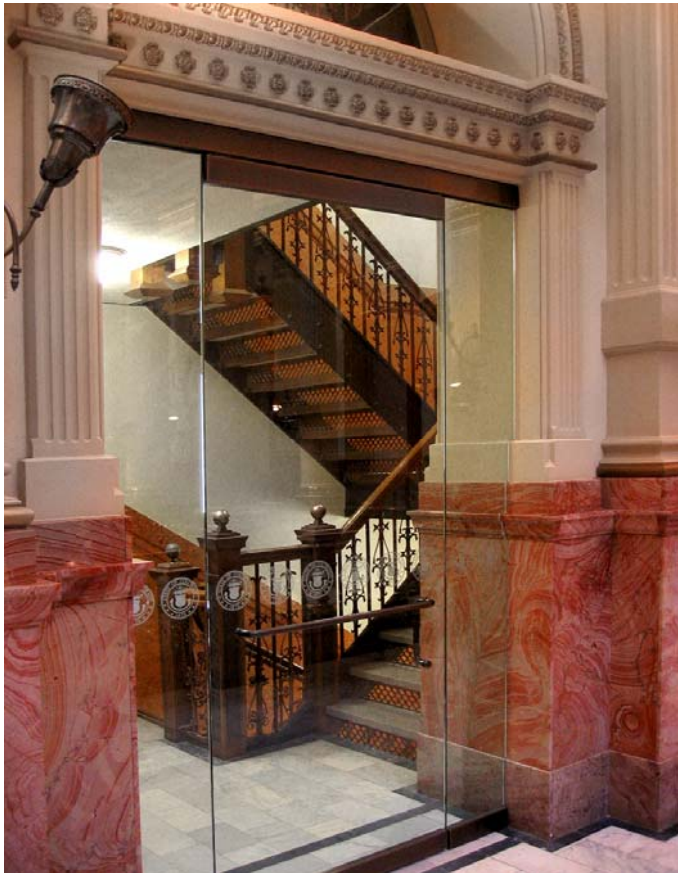
New header and glass door with side lights at Third Floor

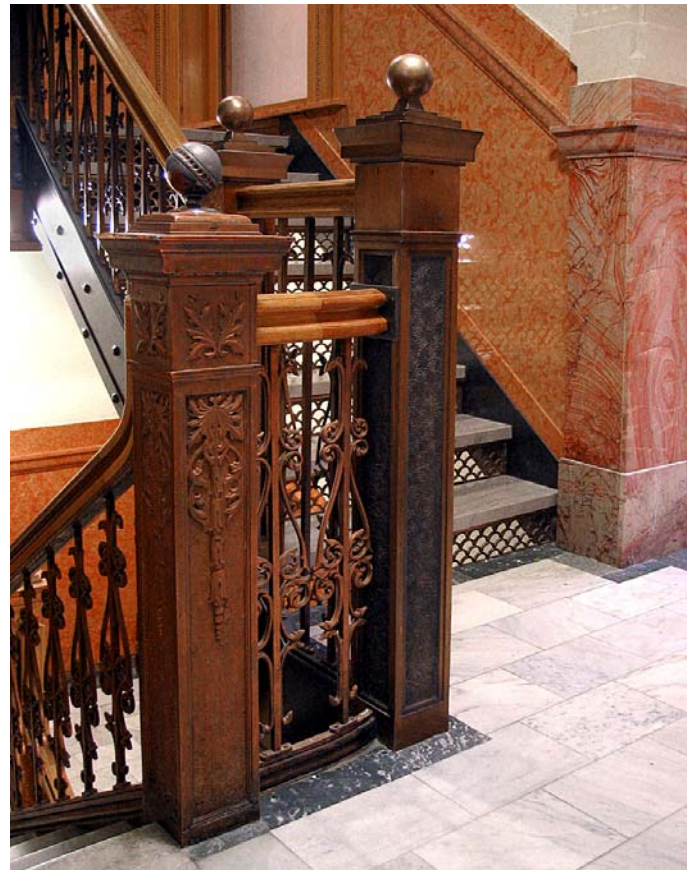
Stair transition at Third Floor landing with original newel post on left and new newel post on right

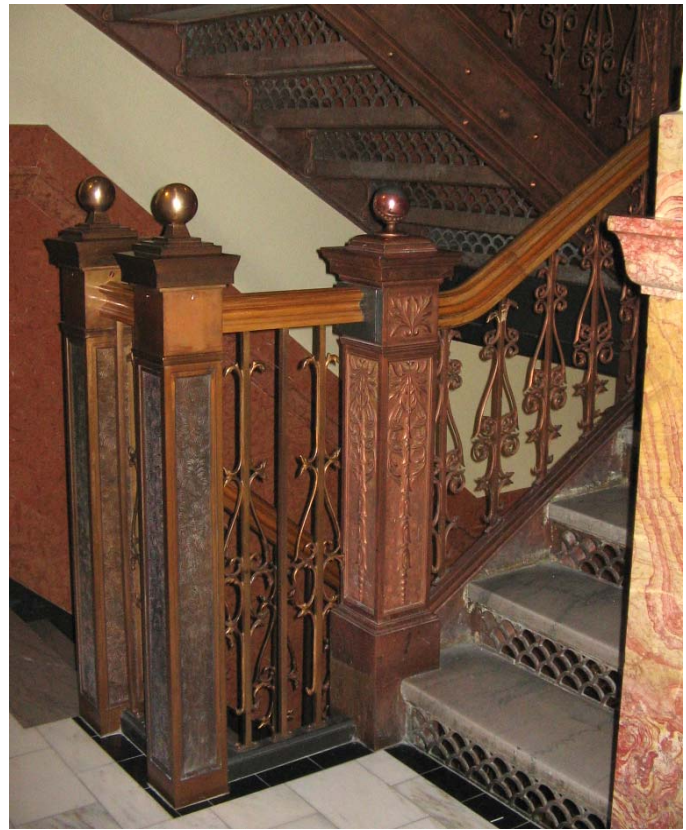
Transition of Northwest Stair from existing to new at the Second Floor

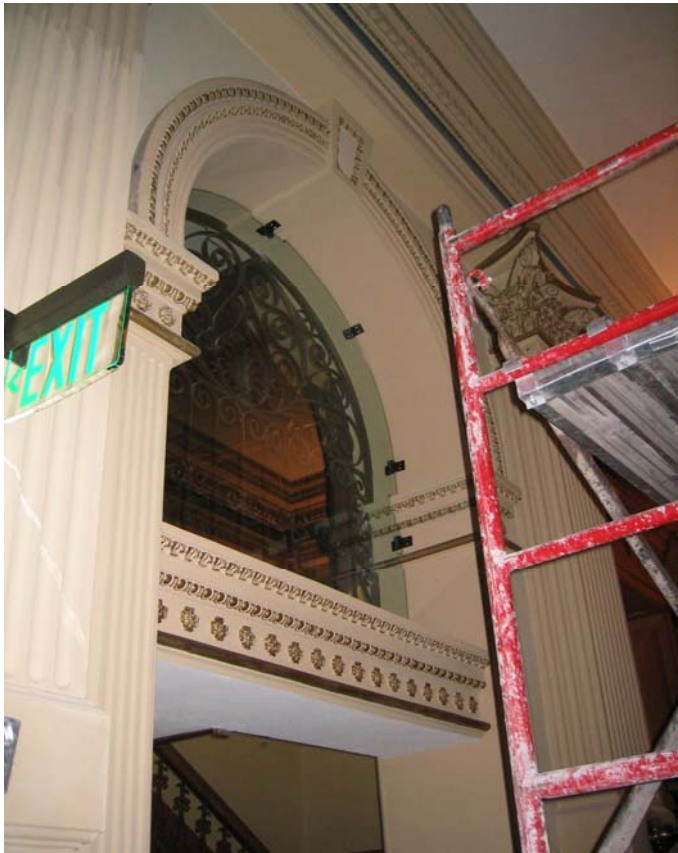
Glass installed above Second Floor Northwest Stair entry

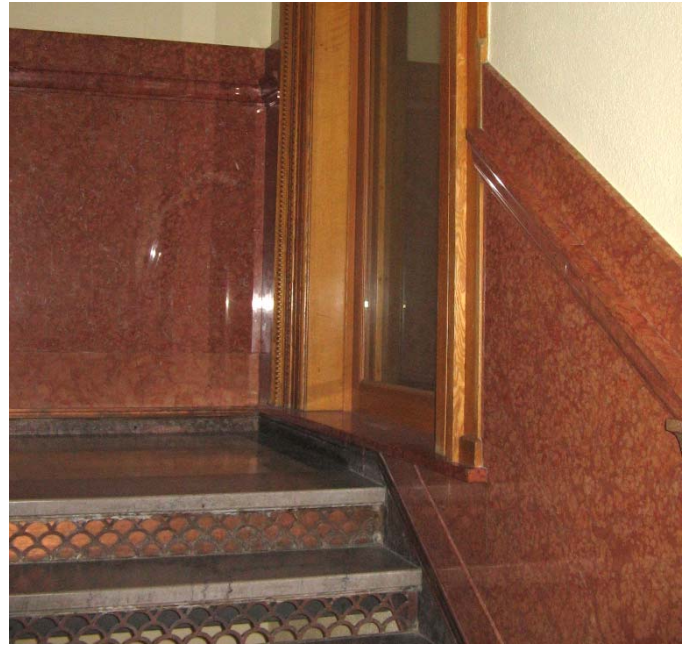
New stone sill and wainscot at Second Floor Northwest Stair
