# COLORADO STATE CAPITOL

## HISTORIC STRUCTURE ASSESSMENT

STATE HISTORICAL FUND PROJECT NUMBER  
SHF-2006-T1-001

**December 15, 2006**

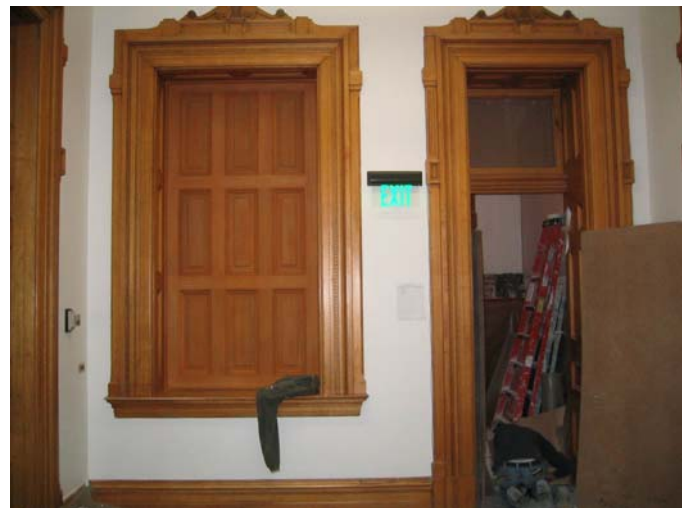
Remodeled window at First Floor Northwest Stair during construction

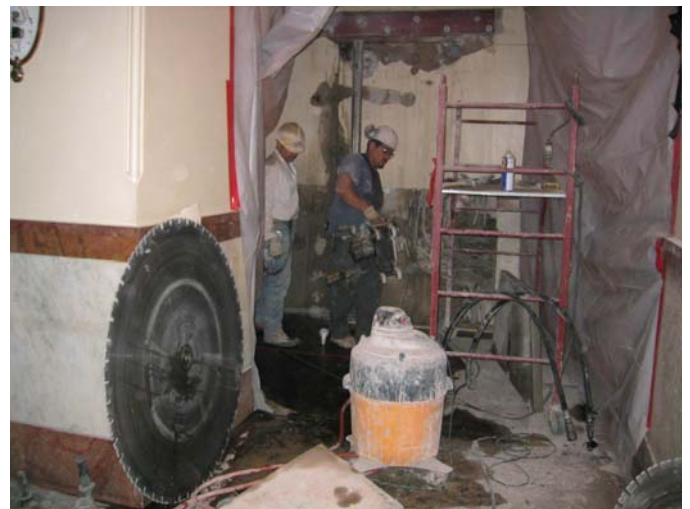
Cutting opening in Basement masonry wall for Northwest Stair

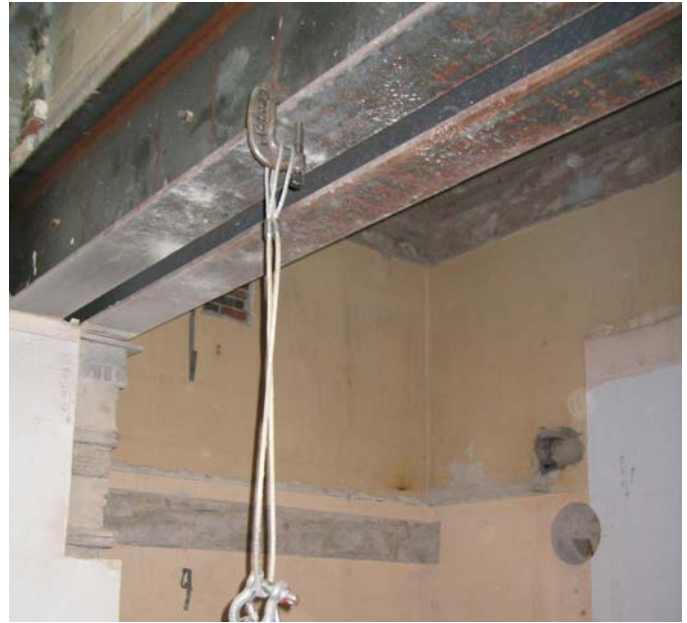
Steel beams where wall was removed with work for new Basement Northwest Stair in background

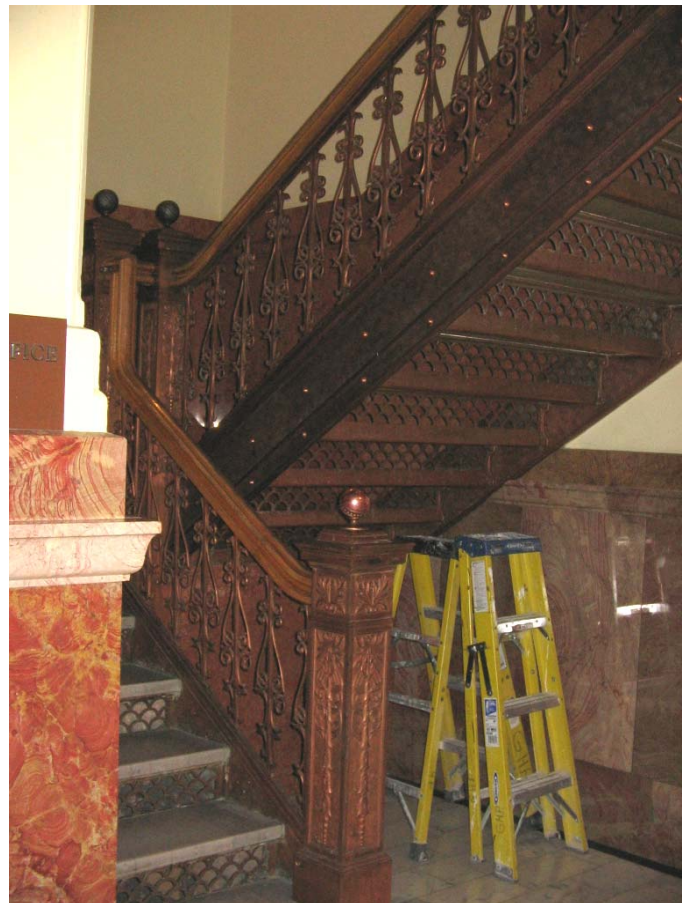
Existing stair and landing at Second Floor; bottom landing will be partially

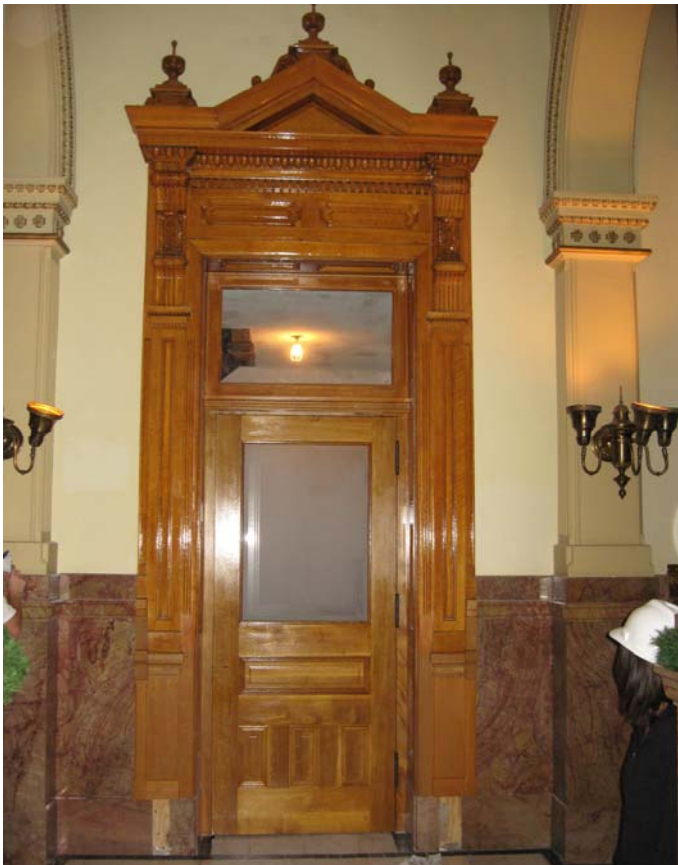
First Floor Northeast Stair after converting window opening into doorway

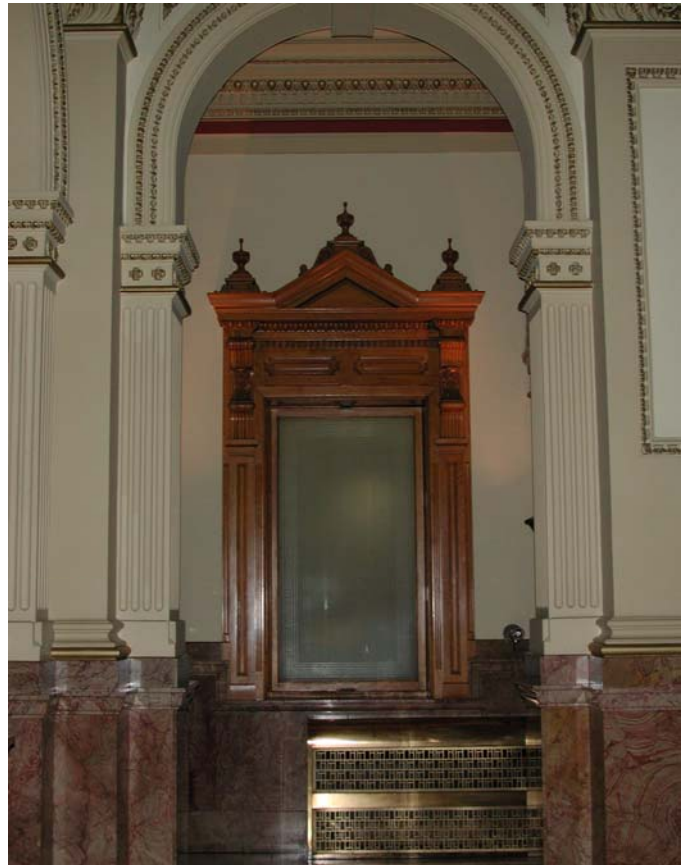
Existing window and radiator enclosure, prior to removal at First Floor Northeast Stair

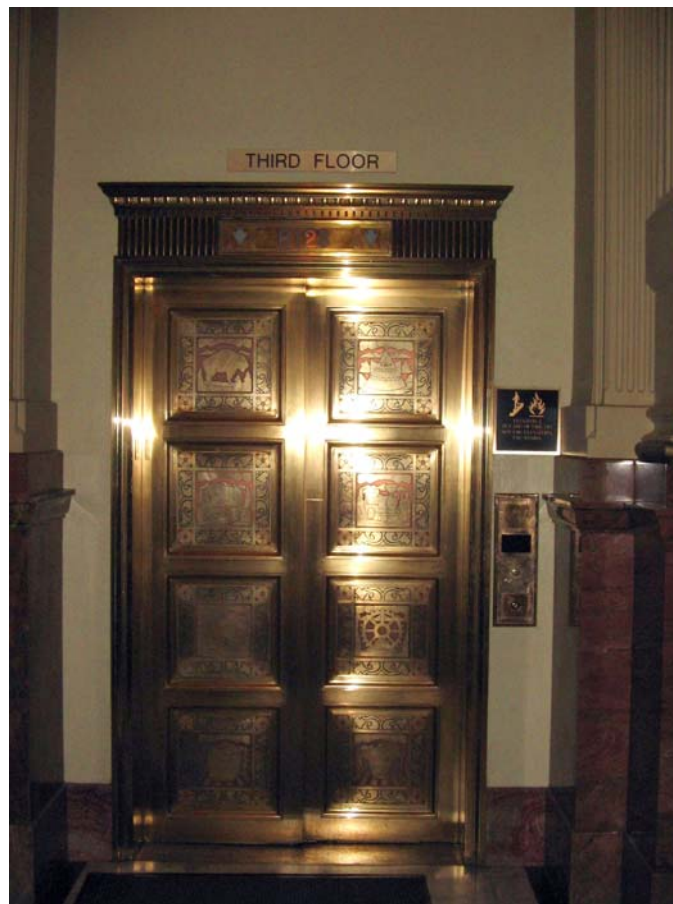
Elevator door, typical all floors

Review elevator equipment and repair or replace as necessary.

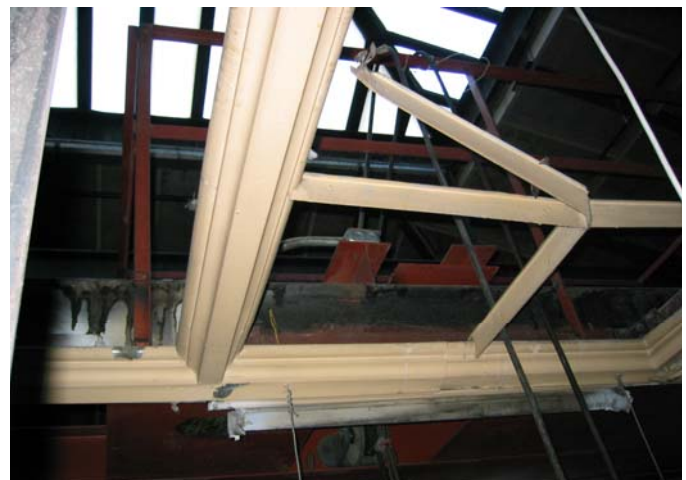
Existing coffer detail above non-original House Chamber ceiling

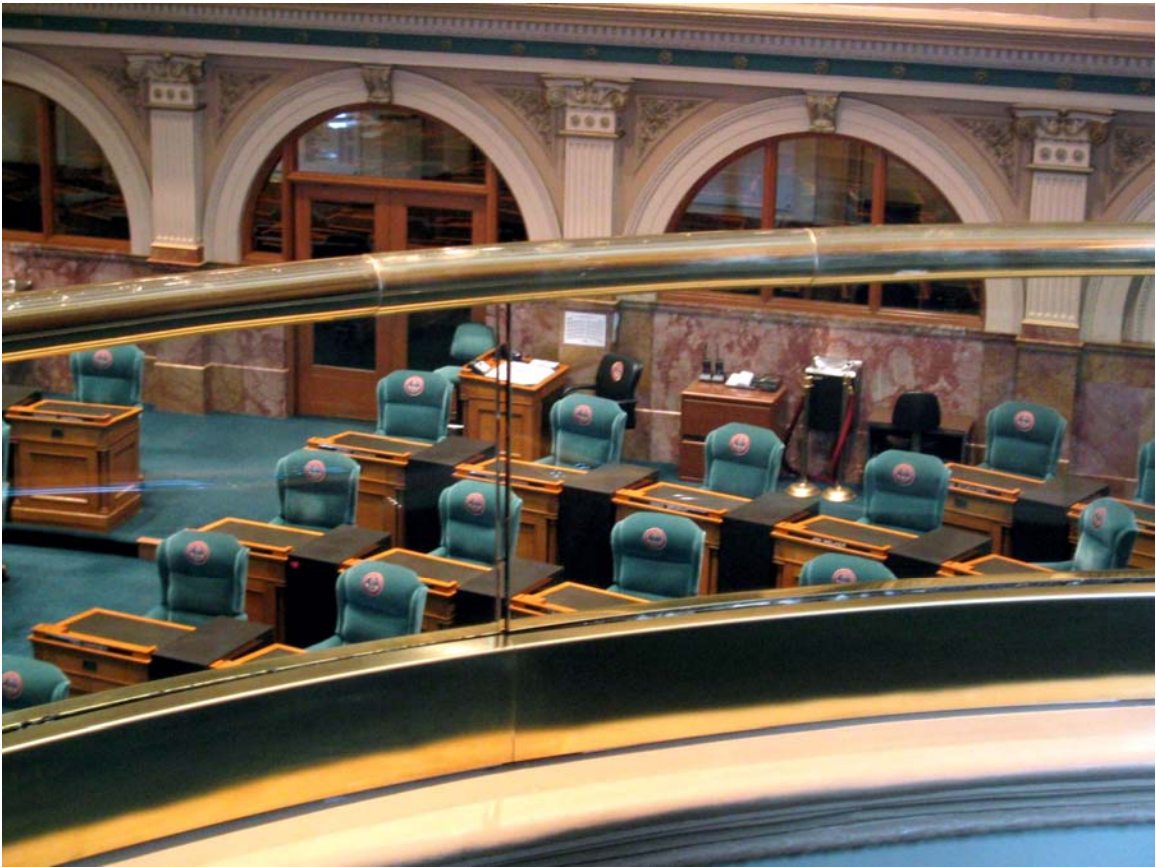
House Chamber view of entry from Gallery showing new brass and glass rail extension

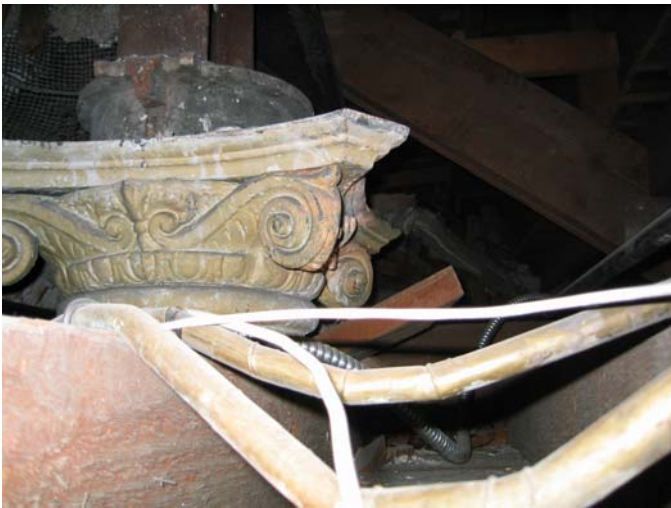
Iron column capital concealed above the House Vestibule ceiling

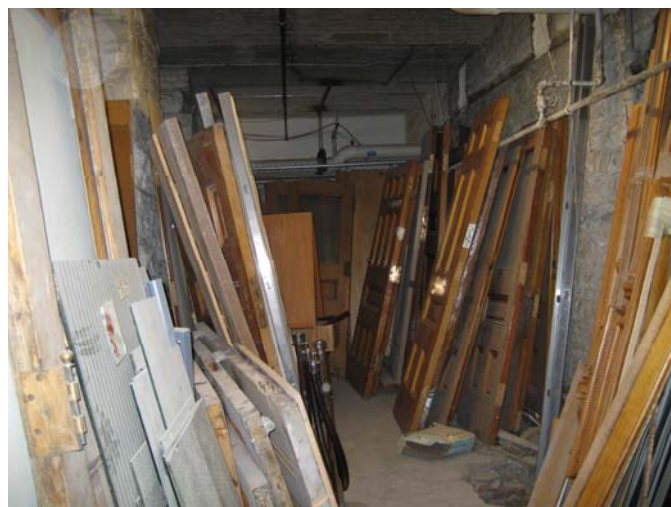
The entire Sub-Basement has some degree of damage or modification to the walls and ceilings. Only the columns seem to have aged without harm. Quantification of these hazards is beyond the scope of this report, but the items described below are abundant: (1) Water due to site drainage or leaky drain leaders is coming back into the building resulting in decay of the existing Sub-Basement windows, and more significantly, eroding the foundation wall. Due to the severity of the consequences of prolonged erosion the perimeter walls are considered to be in poor condition. (2) Numerous un-reinforced penetrations have pierced the ceiling structure of the Sub-Basement. The fact that the floor assembly remains intact is evidence that the practice has worked thus far, but if the practice continues unchecked the result may be partial or total loss of existing original assemblies, and may be harmful to occupants. The ceiling condition ranges from good to poor. (3) Due to the consequences of both conditions above, the plaster wall finish is considered to be in good to poor condition. Where site drainage continues to be a problem, the walls will continue to erode and create a potential for mold to form, an example of this situation is room V-5.

Sub-Basement room of removed trim and doors

Resolve drainage issues. Repair damaged foundation walls. Remove abandoned wiring and piping, and provide coordinated oversight of future work on building systems.

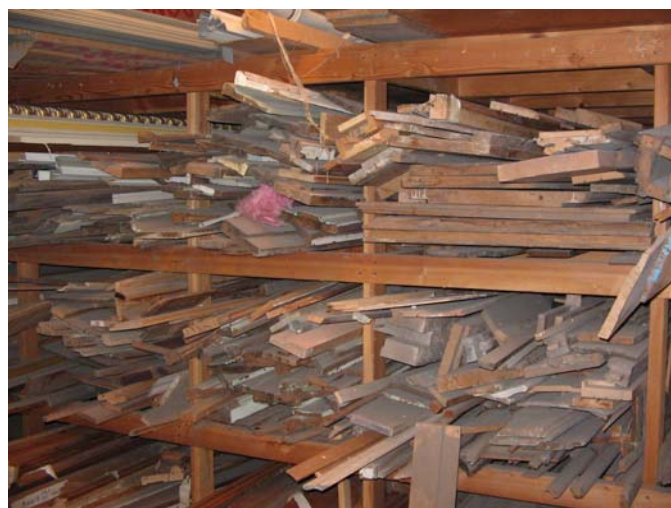
Sub-Basement storage room of removed original trim

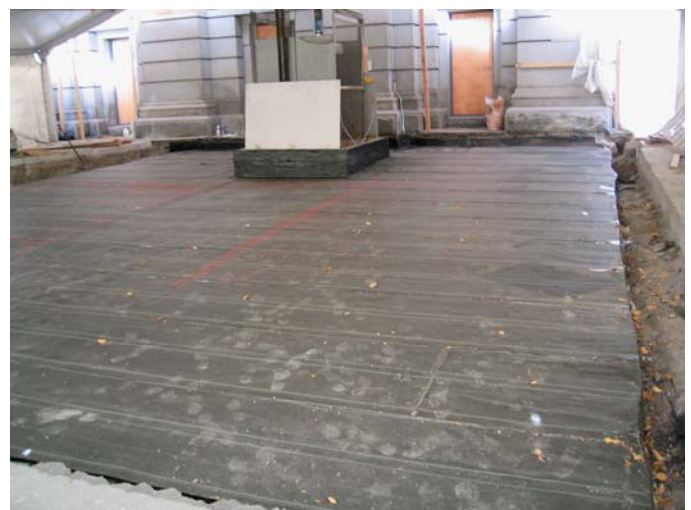
A chamber located further south in the tunnel under 14th Street where the domestic water supply enters the building is in very poor condition and should be repaired.

New tunnel lid under construction in 2005 as viewed from street level

Replace lid in southern tunnel chamber to protect power, water, and communication lines to the Capitol.

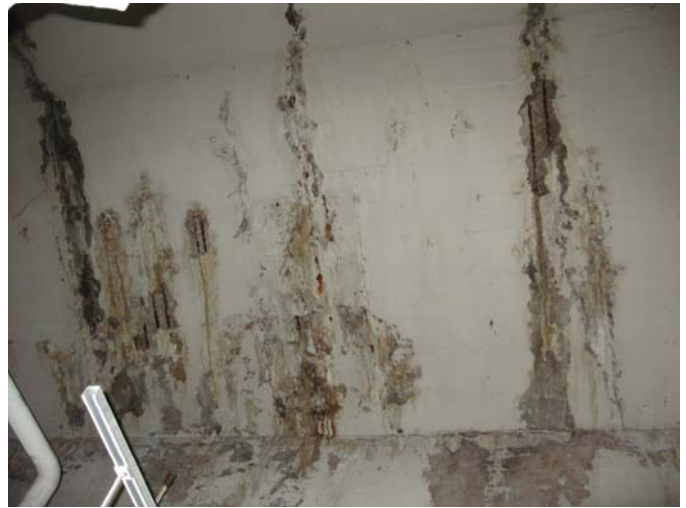
The tunnel is in good condition except for the portion beneath the East Stairs where evidence of water damage and decay is apparent. Refer to Section 3.4 for more information.

East Tunnel decaying ceiling structure

Repair or replace East Stair structure.

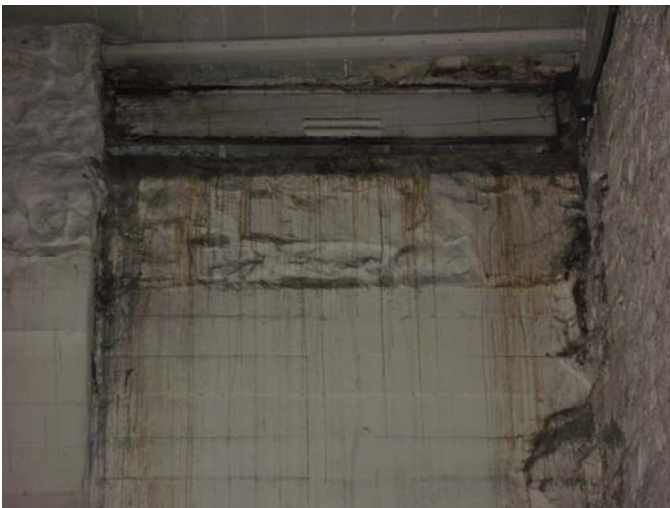
East Tunnel water damage and decaying ceiling structure

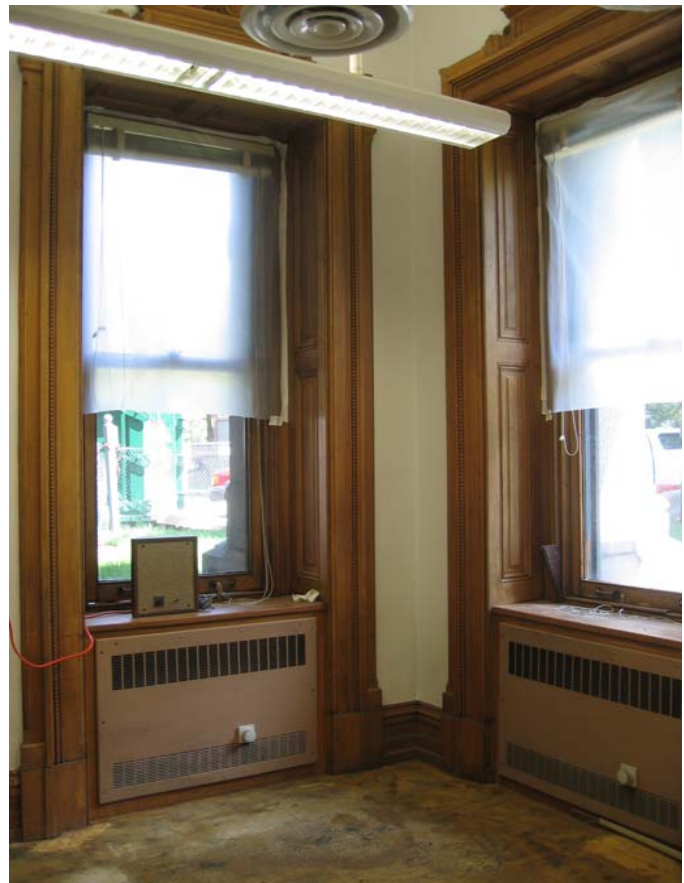
Carpet over 9" tile; over original wood; 9" tile over original wood floor could contain hazardous material.

001 View of north east corner while carpet was removed

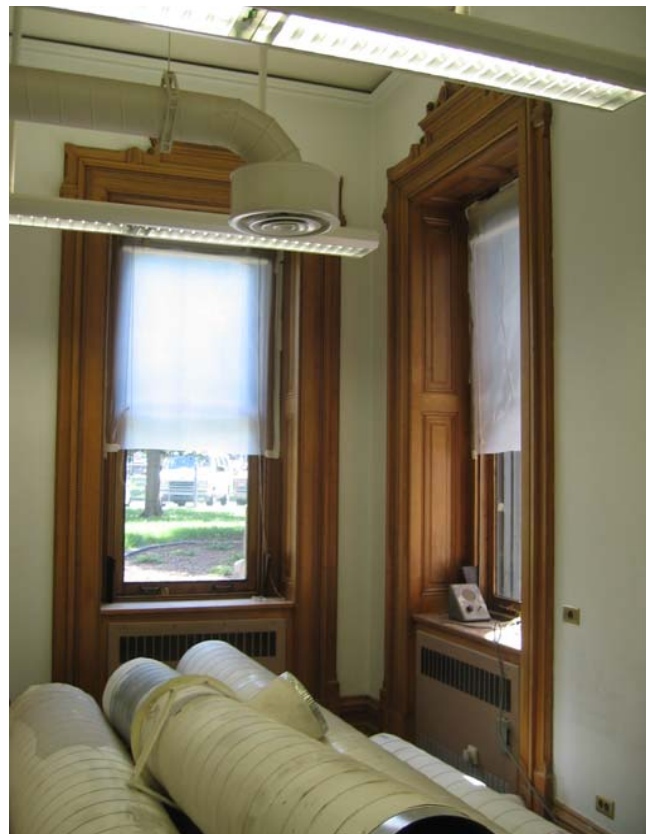
The space is in good condition and consistent with the current use; walls show signs of patching; plaster is cracking and delaminating in some areas

Repair the delaminating plaster

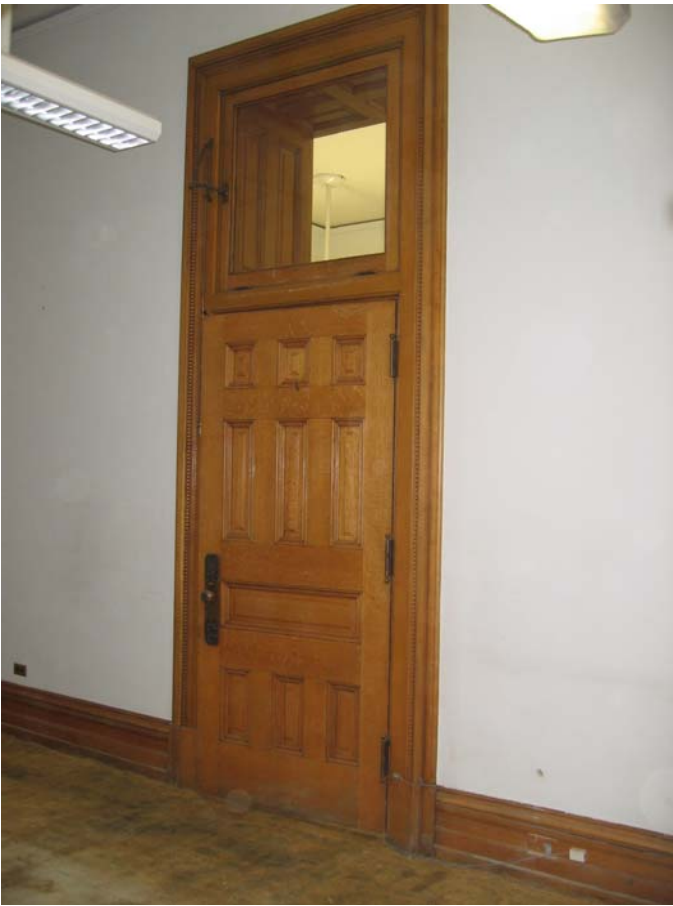
003 West wall looking into room 005

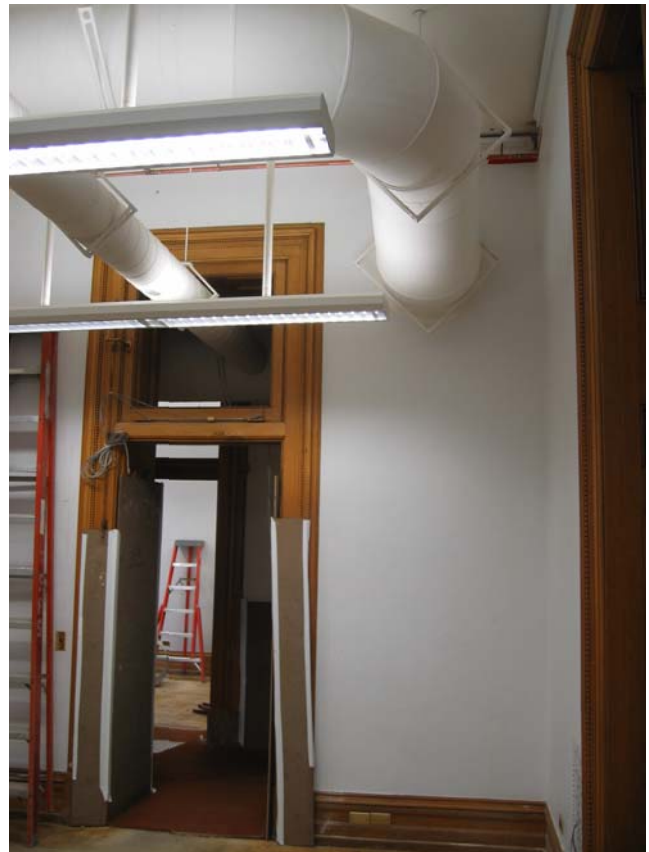
Door from Hallway 007: original frame, casing and trim; door is missing for construction; transom glazing has been removed to allow for ductwork; outer decorative trim missing; trim type T3 room side; top scroll piece missing on room side

004 Entry door on south wall

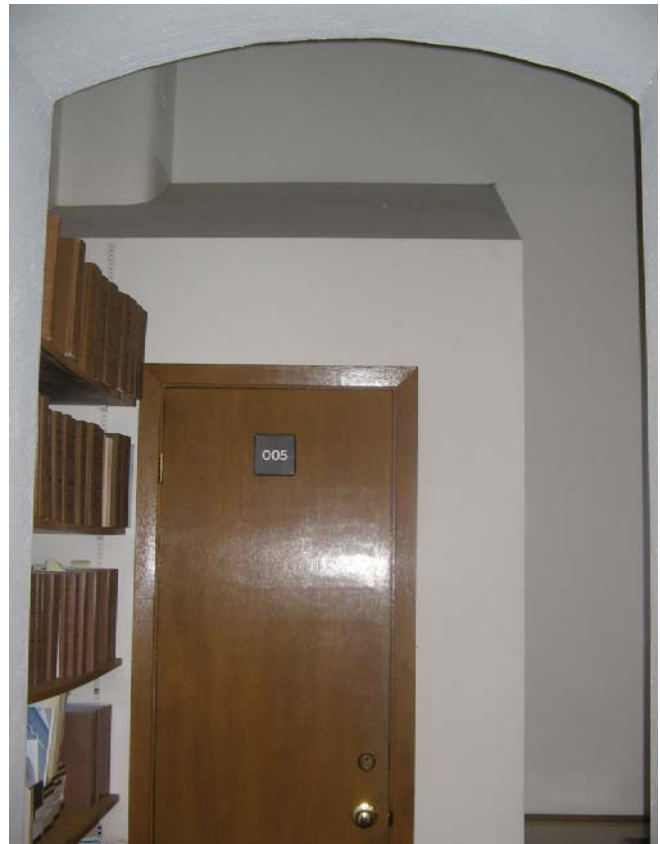
Original vault door has been removed replaced by a gypsum filled arched opening;

005 Built-in closet within original vault area

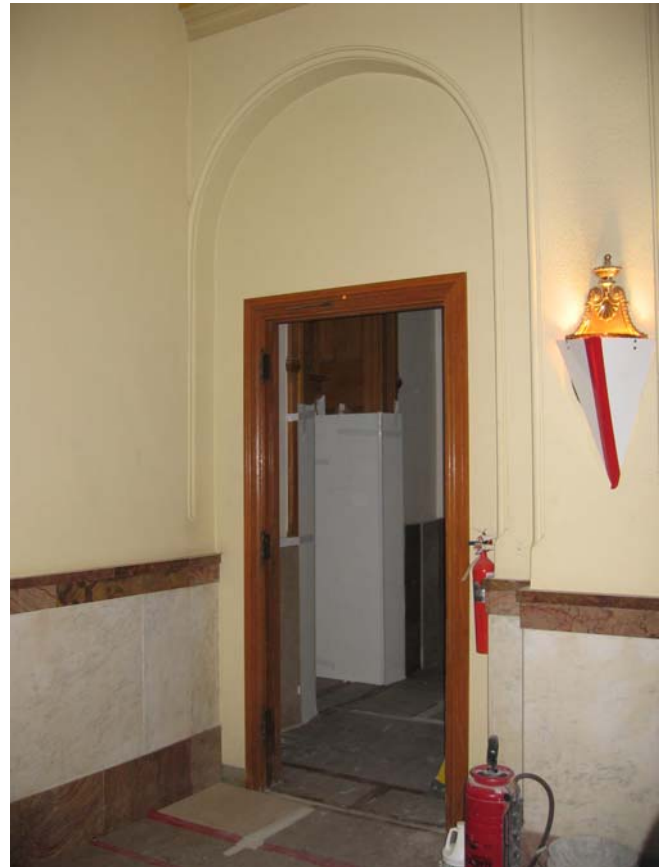
007 In-filled arch looking from Arcade

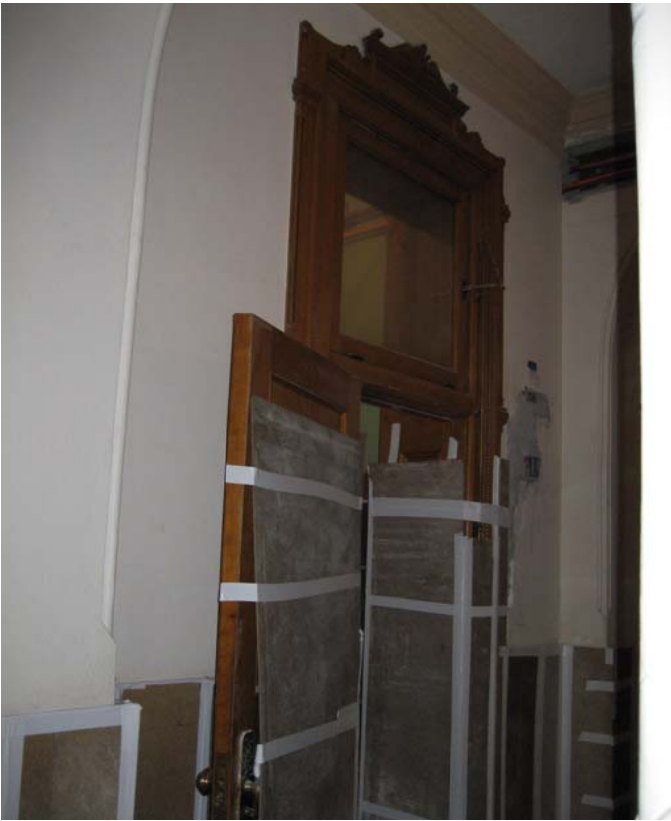
Door to 018: modified original door type D1 in poor condition; door glazing replaced with wood panel; non-original clear transom glazing, stone plinth base on jambs; columbine plate on 018 side; scroll plate on corridor side; large cast knobs; trim type T2 both sides

007 View of door to room 018

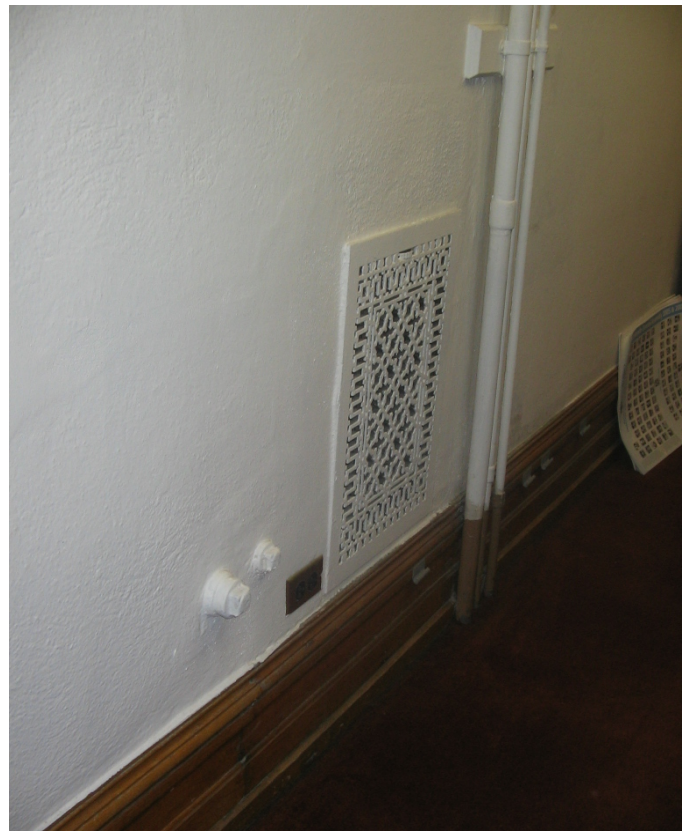
009 conduit and abandoned pipe connections

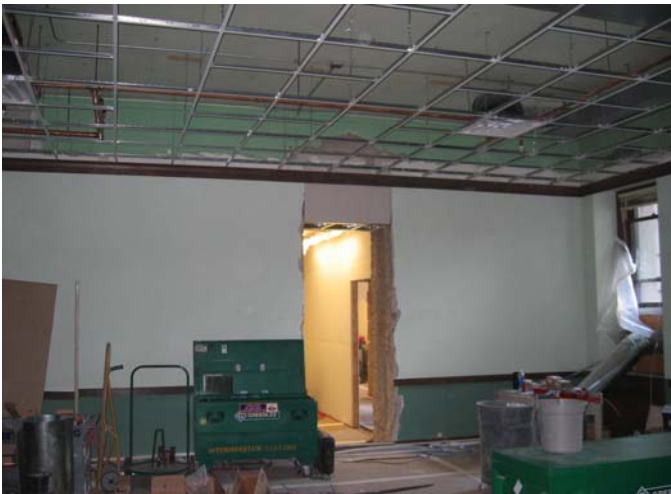
011 North wall showing newly reopened original opening

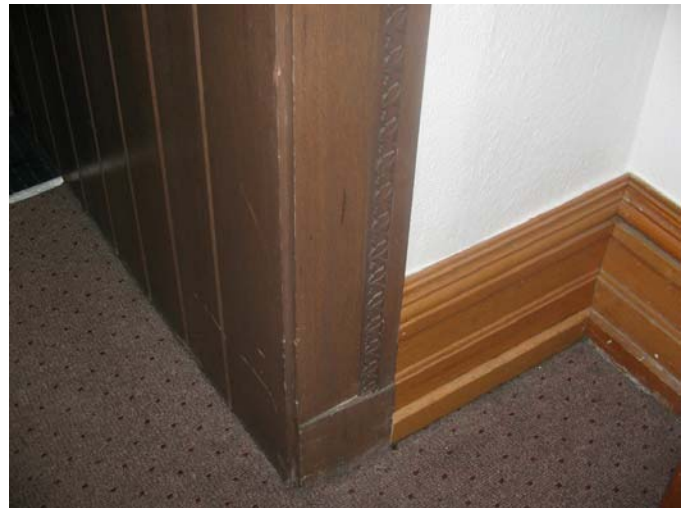
012 Non-original wood door frame and original 12” wood base

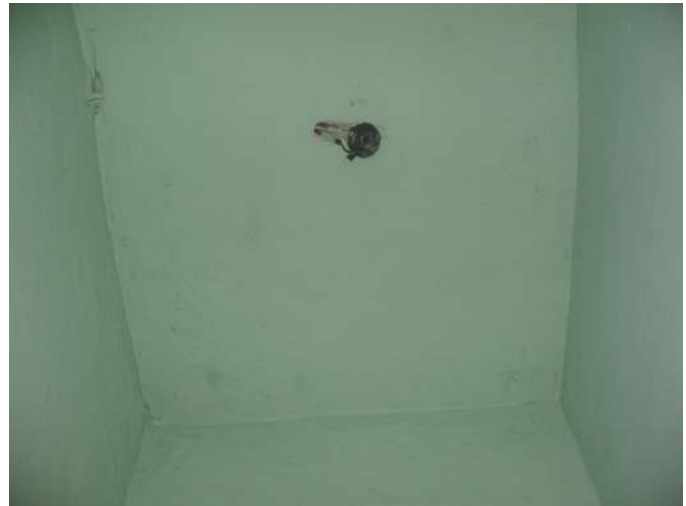
No ceiling fixture present, only exposed wiring

013 Exposed wires and missing light fixture

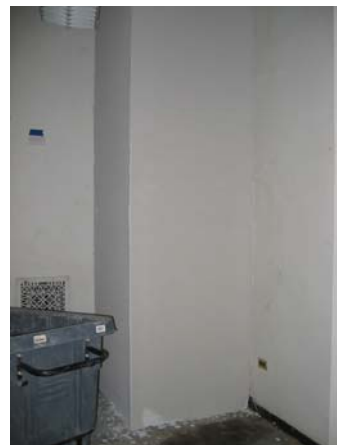
016 Pressurization duct enclosure

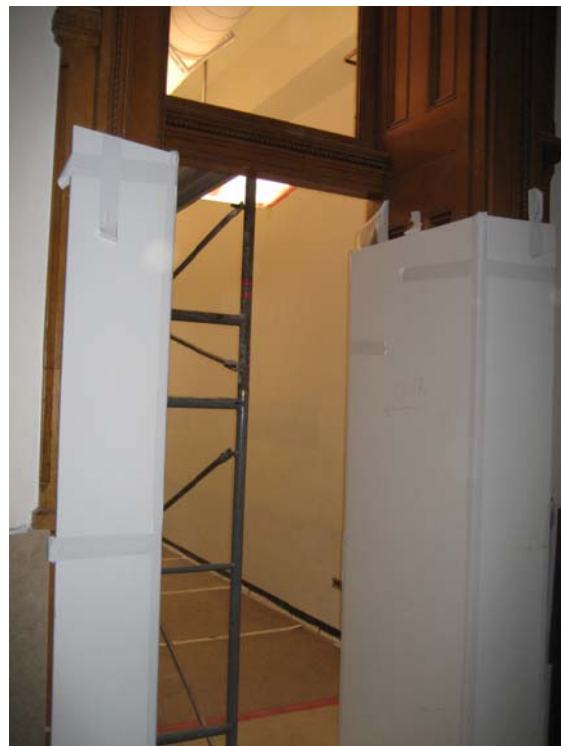
Entry from Hallway 007: original casing, frame and transom; installed in former interior window opening and modified to fit opening; transom glazing removed to allow for ductwork; trim type T3 room 017 side; hardware missing, only latch plates remain; stone plinth base on jambs; trim type T2 on corridor side

017 View of entry door from hallway 007

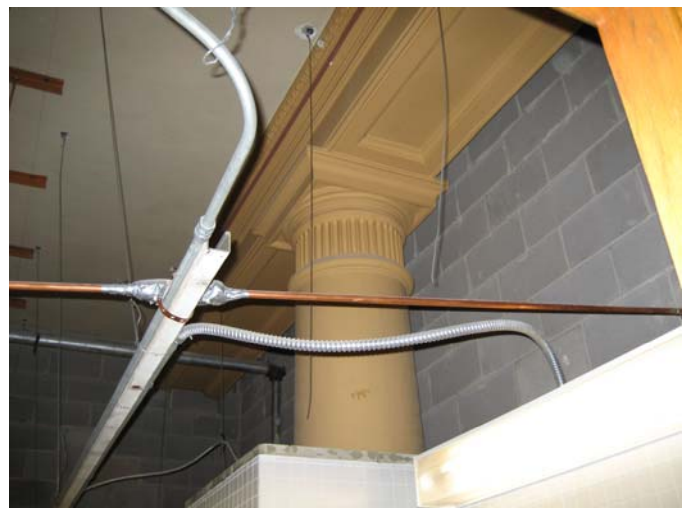
020 Original columns and cornice above the current restroom ceiling

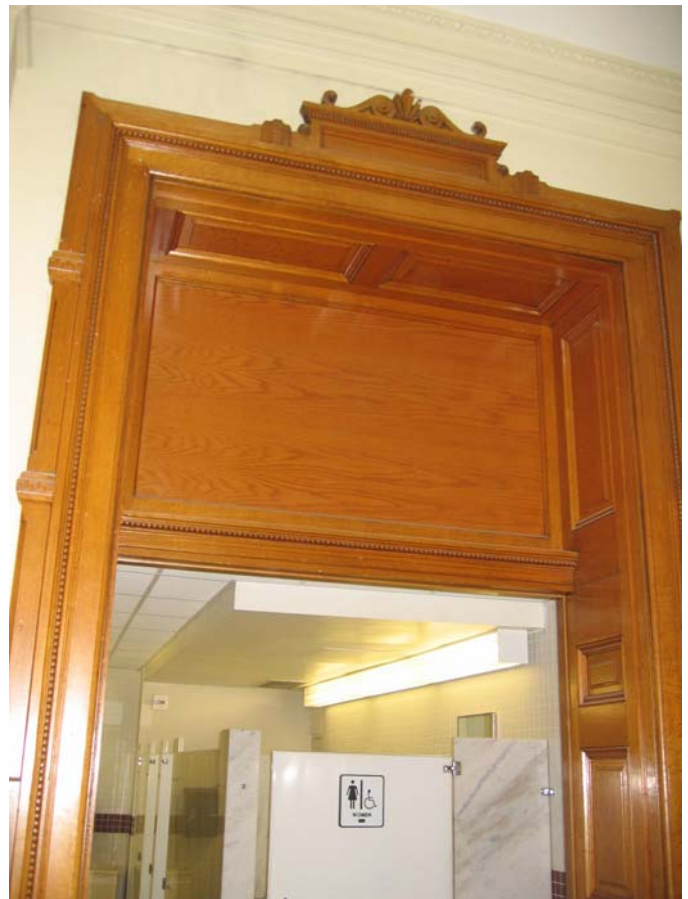
Entry to 021A: modified original frame and casing; doors removed and transom glass replaced with wood panel; trim type T2

021 Original vestibule door casing

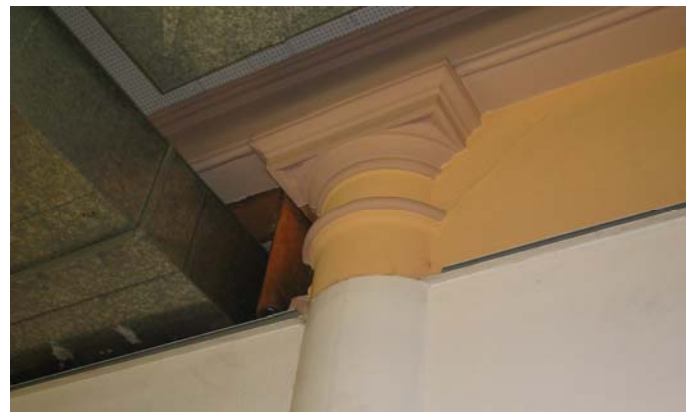
027 Free standing column now engage in non-original wall

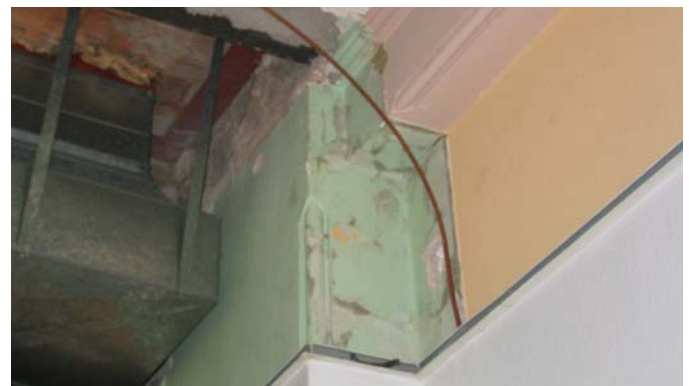
027 Patched-in opening above ceiling in southeast corner

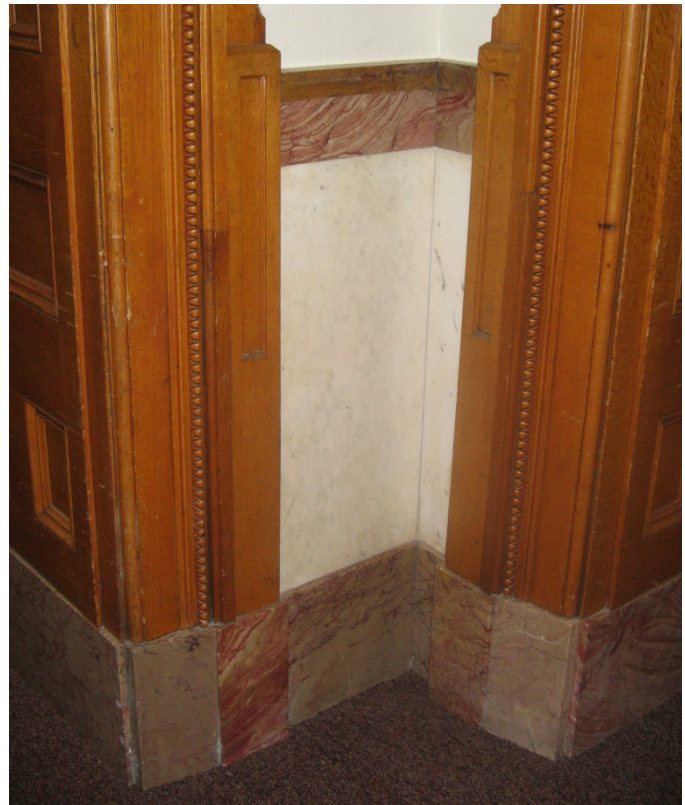
029A Stone wainscot and plinth base at door frames

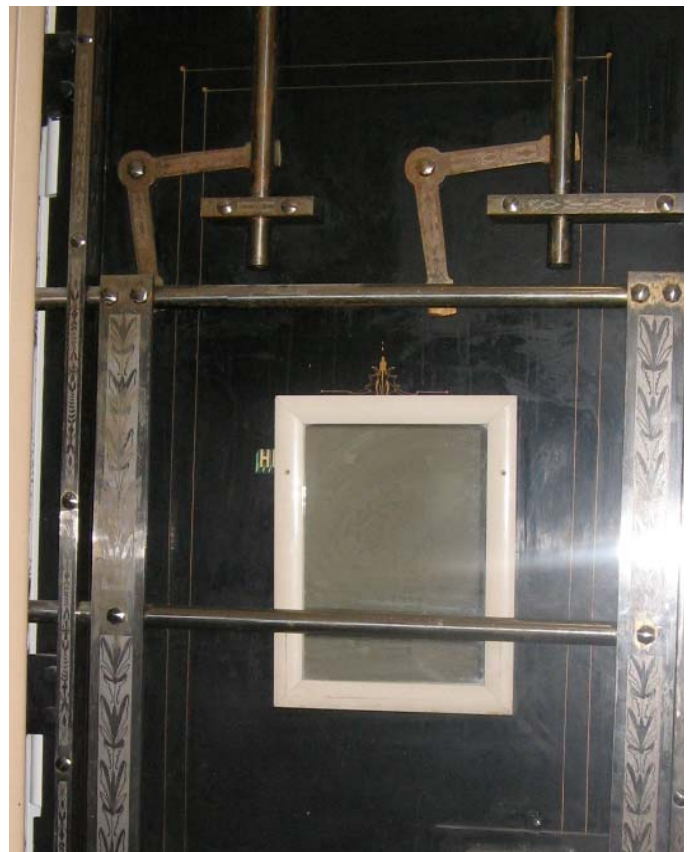
031 Vault door detail

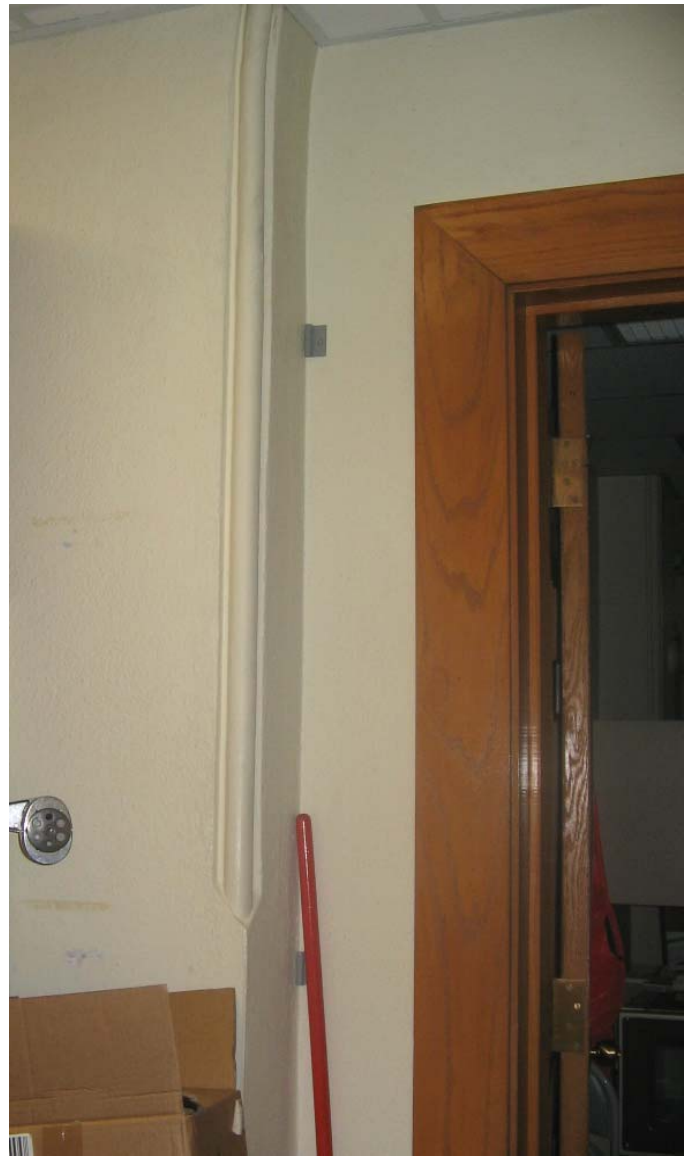
043 Arch with original wainscot removed

Finishes are in fair condition; some damage to the plaster walls is present

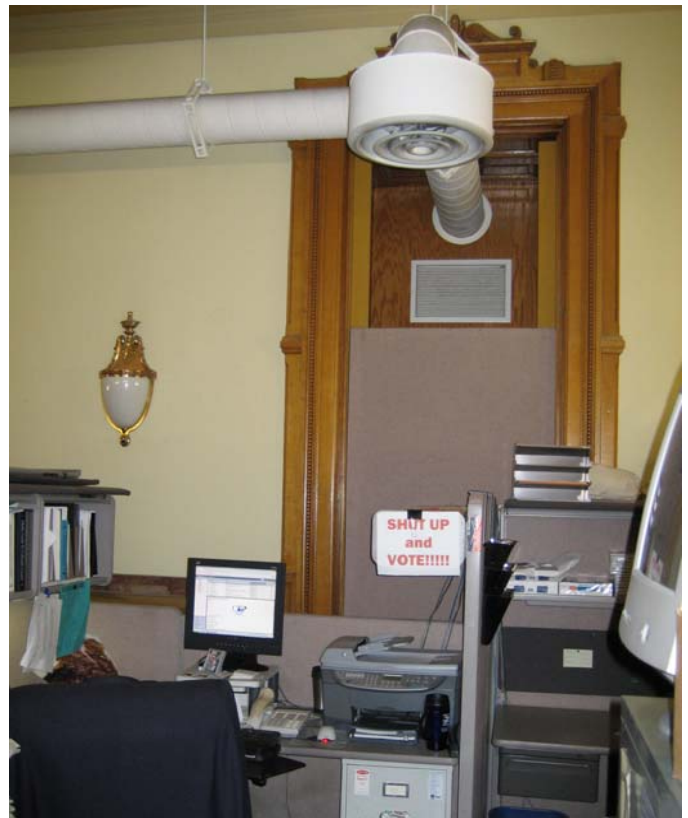
The space is in fair condition; walls show signs of wear; one of the original wall sconces is damaged; needs repainting

044 West wall; modified original interior window and wall sconce from original Arcade wall

No preservation work required

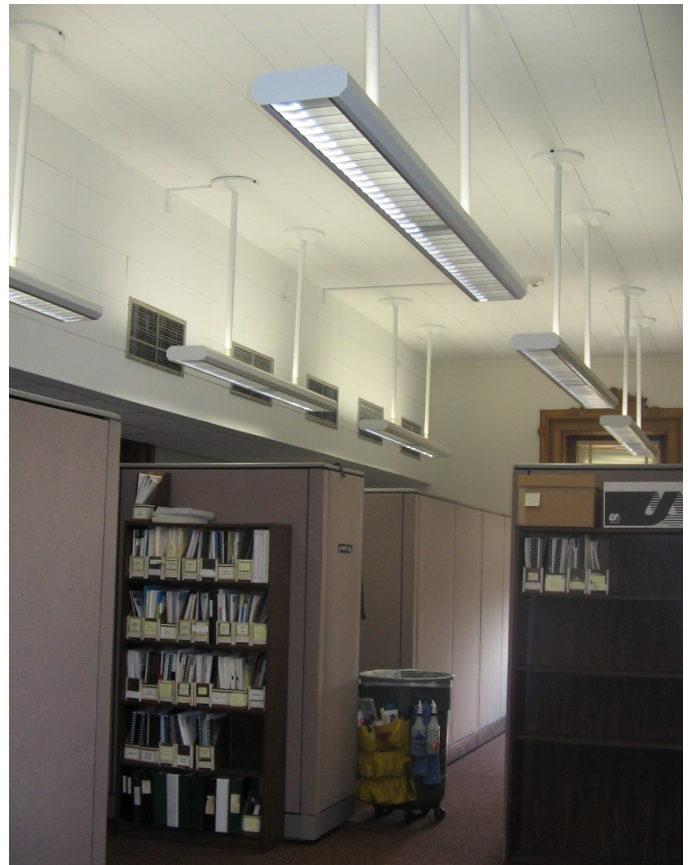
045 Added HVAC soffit to the left

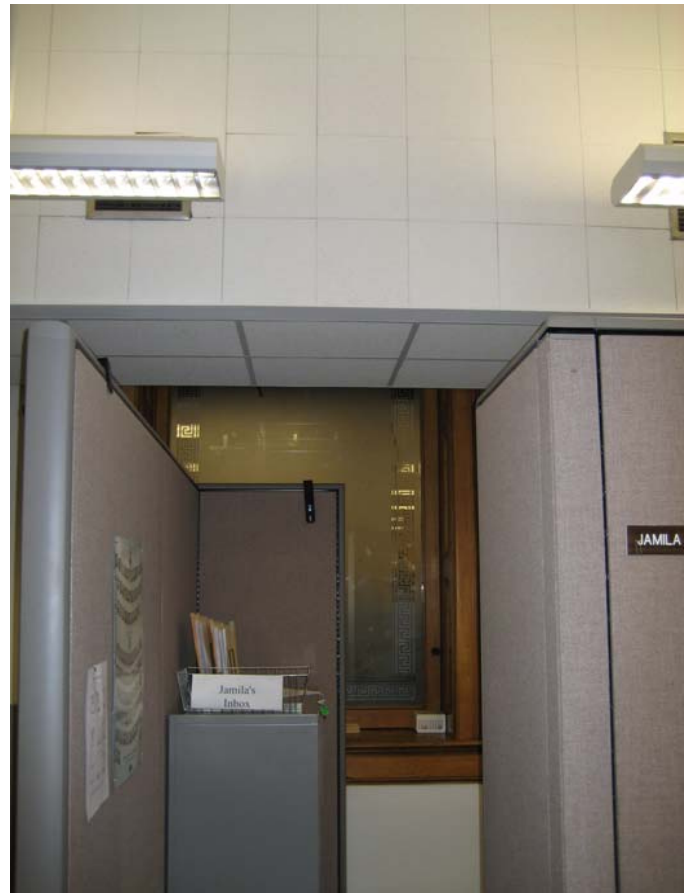
Original wood; trim type T2; interior windows in very poor condition with original trim hidden above mechanical soffit and etched glass with Greek key border; non-original, large soffit along south wall for mechanical ductwork

045 Original internal window on south wall

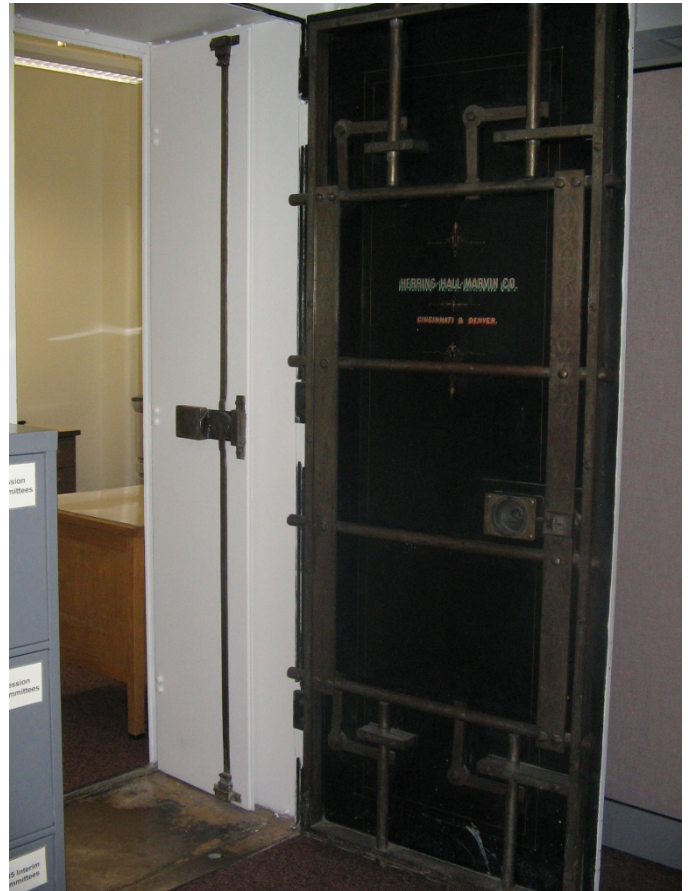
045A Vault door

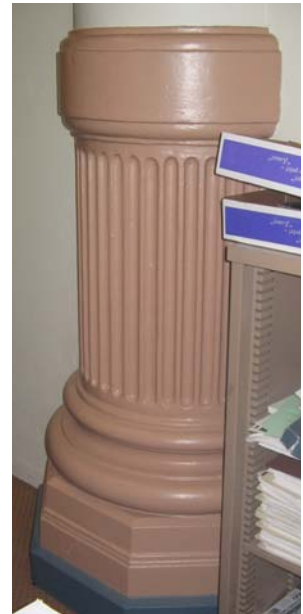
048 Cast iron column base

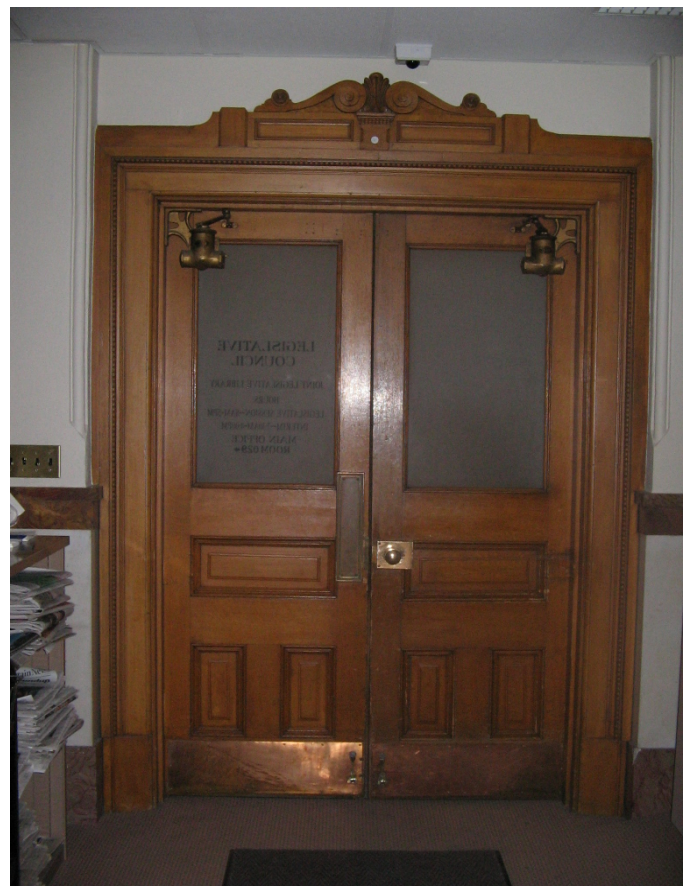
048 Relocated door in Rotunda archway

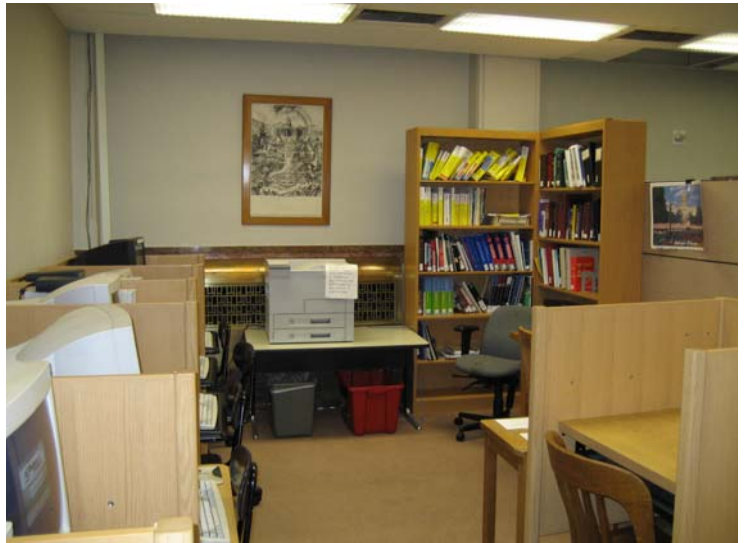
048 View north with original radiator cover

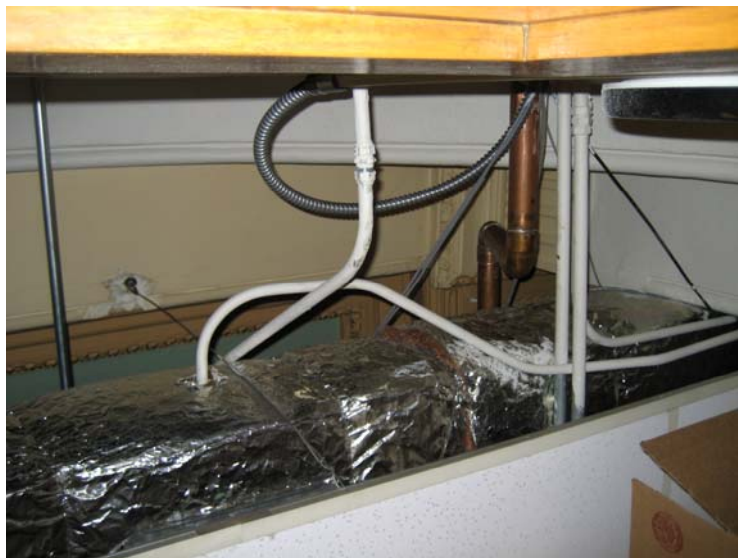
048 View above ceiling showing original ornate ceiling and pilaster capitol

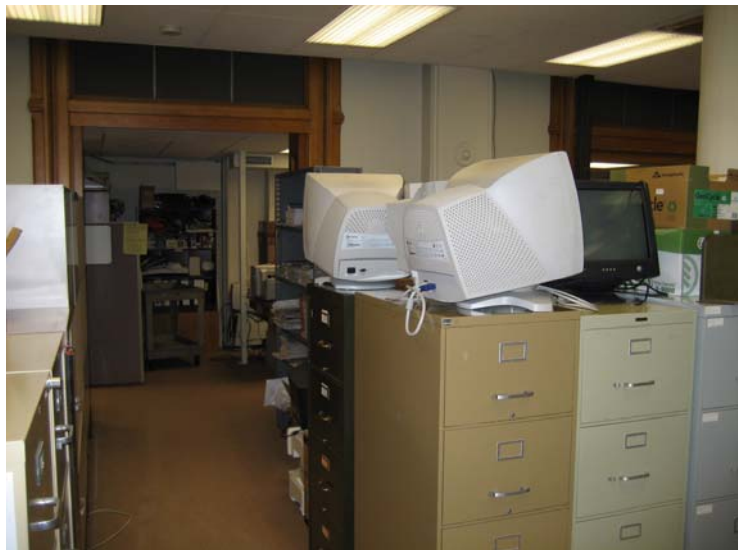
049 View of original vestibule door opening in west wall

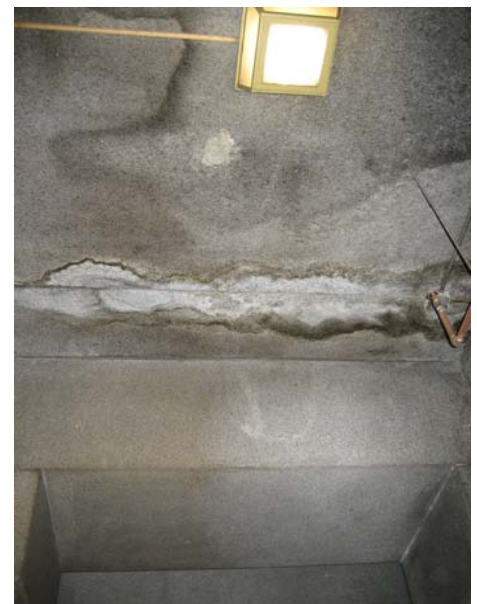
051 Water damage on ceiling

Granite; signs of water infiltration from west steps above

The space is in fair condition; water infiltration from the west steps above

Repair water infiltration to prevent further damage
