# COLORADO STATE CAPITOL

## HISTORIC STRUCTURE ASSESSMENT

STATE HISTORICAL FUND PROJECT NUMBER  
SHF-2006-T1-001

**December 15, 2006**

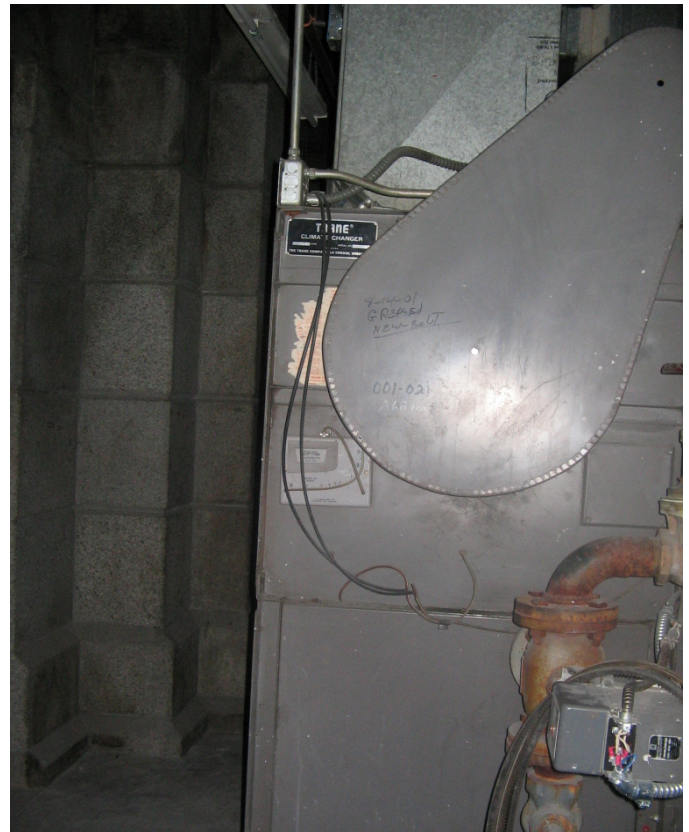
Identified as part of the former west entry vestibule on the original plans, this space now serves as a mechanical room. This space is located under the West Steps and this stair structure is currently in poor condition, allowing water to infiltrate the room.

Space in fair condition; water infiltration from steps above

052 AHU in former breezeway

Correct water damage from West Steps in order to prevent further damage in this area

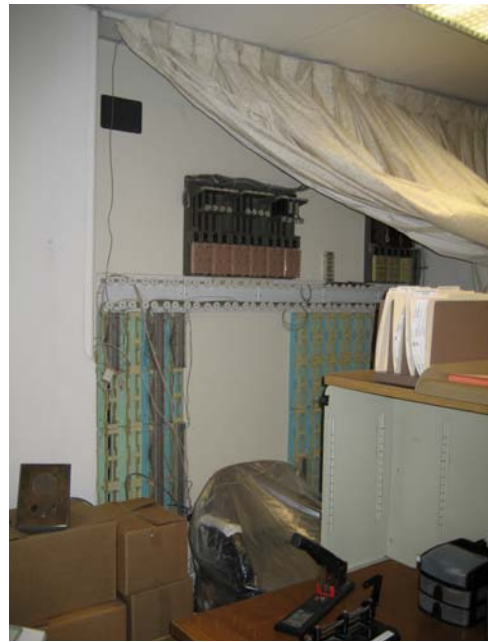
054 Existing telecom board

Finishes in good condition, except as noted; telecomm board on east wall needs to be properly housed

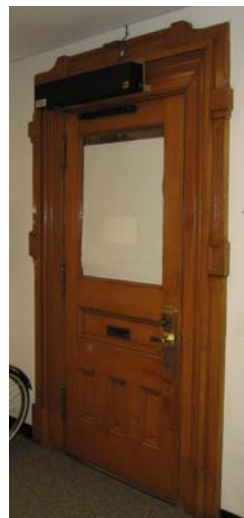
054 Interior of entry door

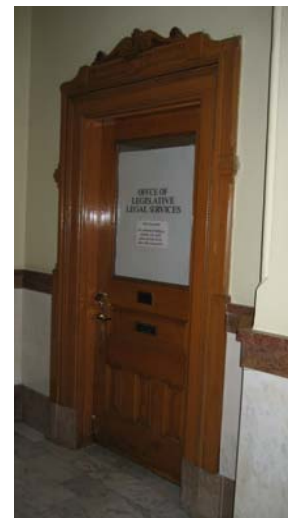
Door from Arcade: relocated original frame, casing and door type D1; non-original clear wired door glazing; non-original hardware; trim type T2 both sides; top scroll missing on room side; push button combination lock; lever function opener

054 Entry door Arcade side

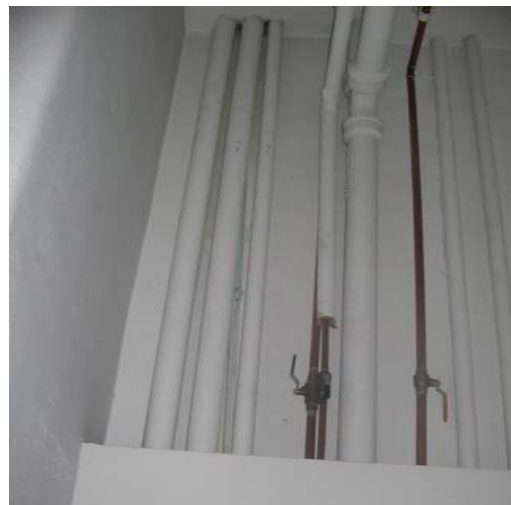
055 Exposed piping on north wall

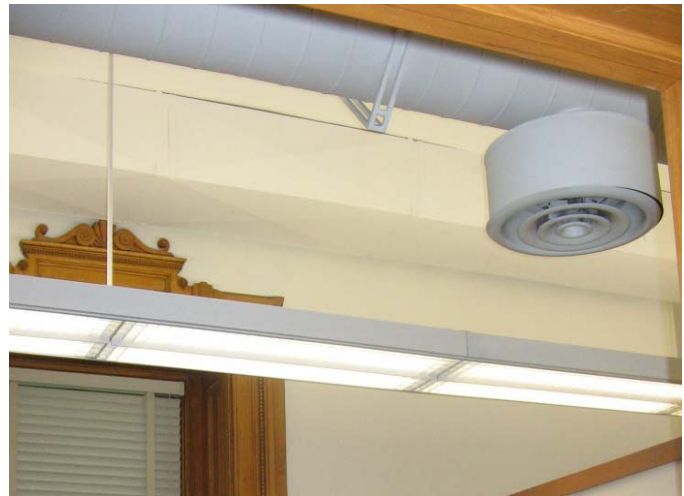
056 Exposed ductwork and partial height wall

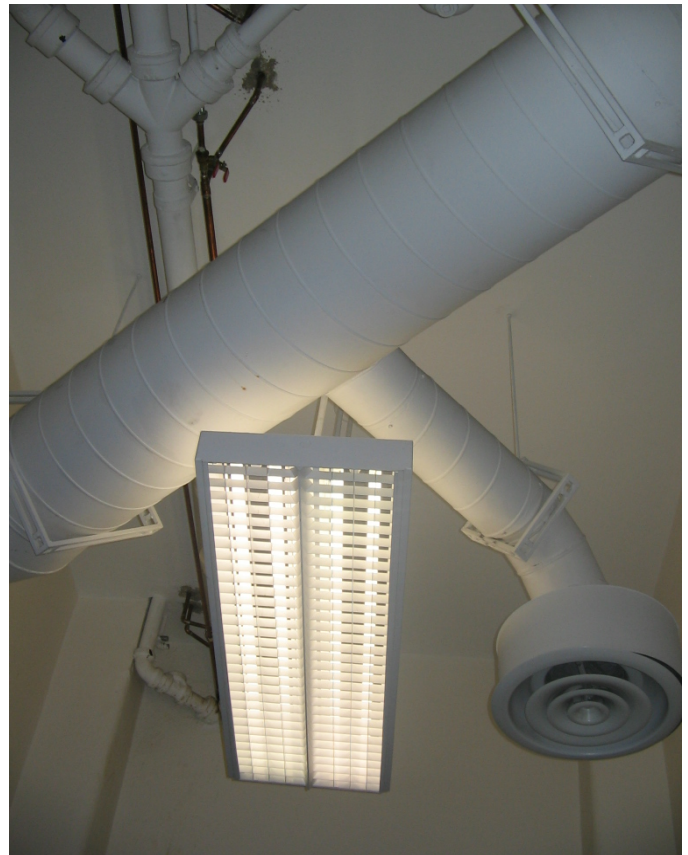
060 Exposed MEP over-head

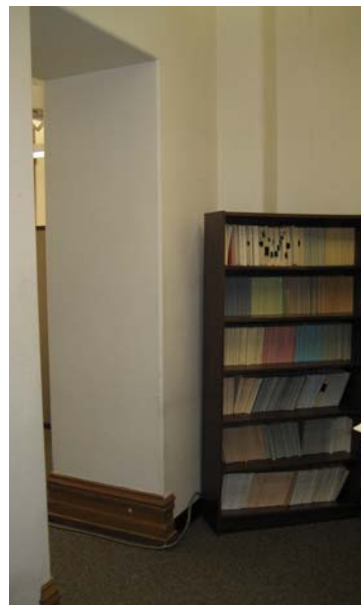
Original vault door is missing

060 Opening at former vault door

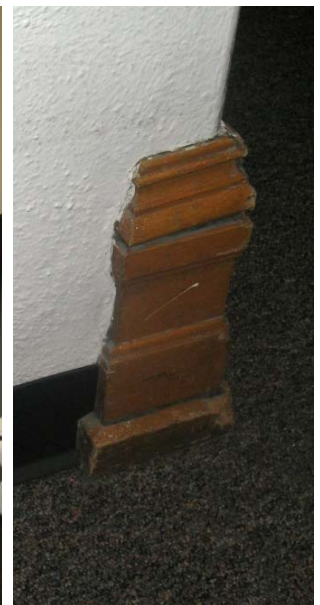
060 Base transition and at former vault door

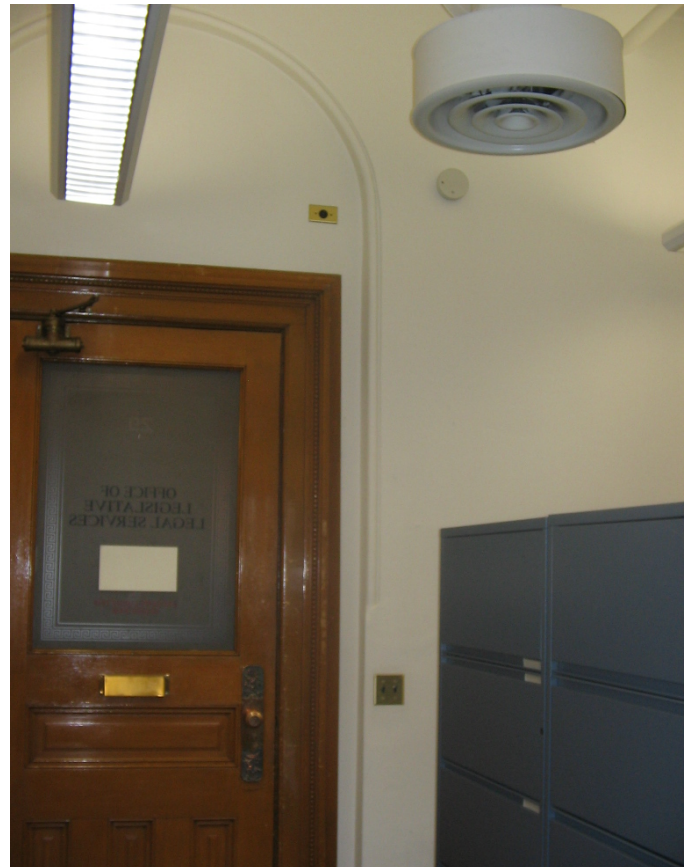
065 Archway in-fill with relocated door

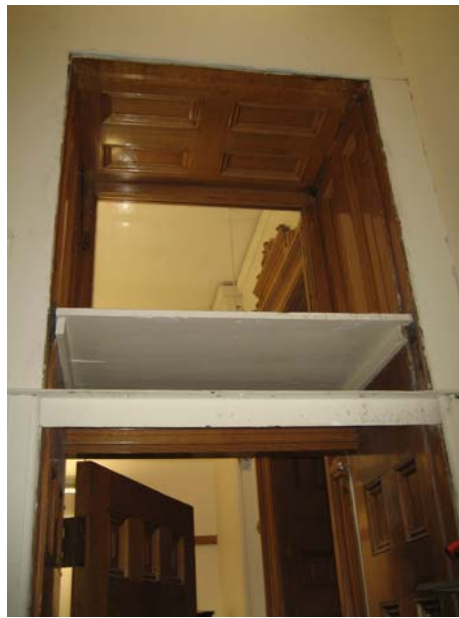
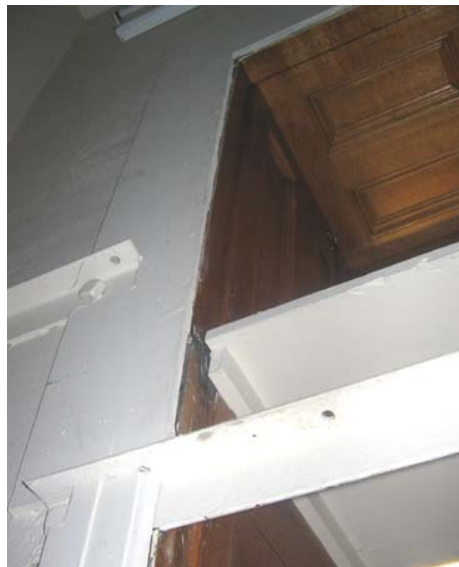
074 Remnants of original stair

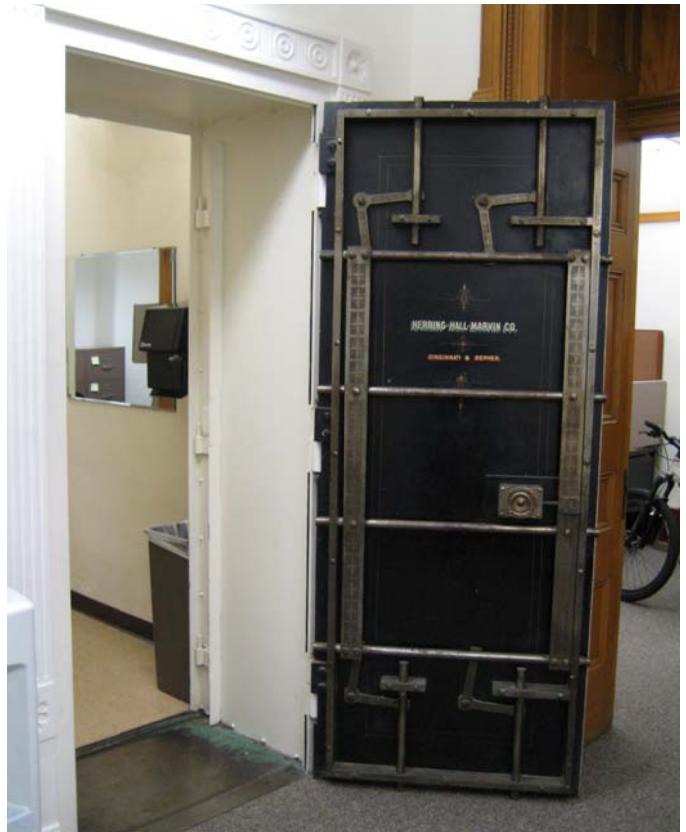
076A Vault door to 075

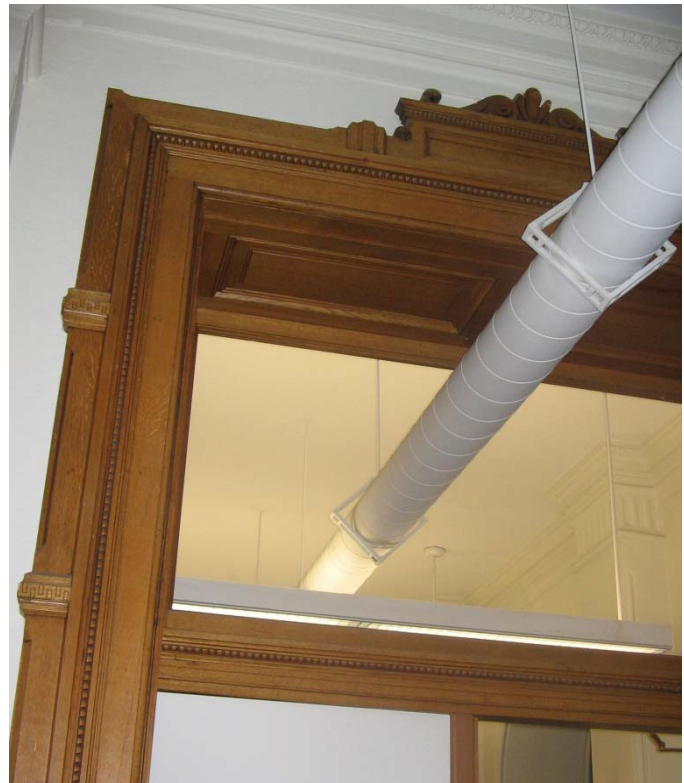
Door from 091: original double doors type D1 of former entry vestibule; original frame and casing; transom glazing removed to accommodate ductwork; west door leaf replaced with partition in-fill and pass through window; non-original clear door glazing in east door; original push plates; trim type T2 on outside; inner trim modified for partition and window

083 Exposed duct and missing transom glass

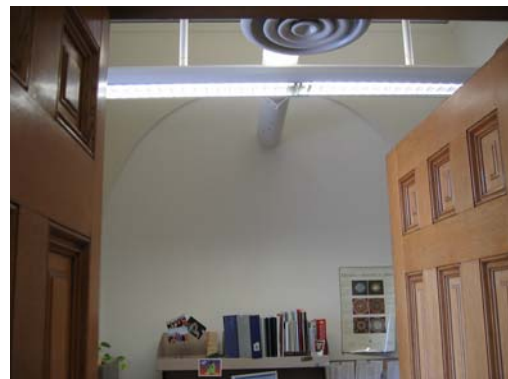
085A View of in-filled archway on west wall

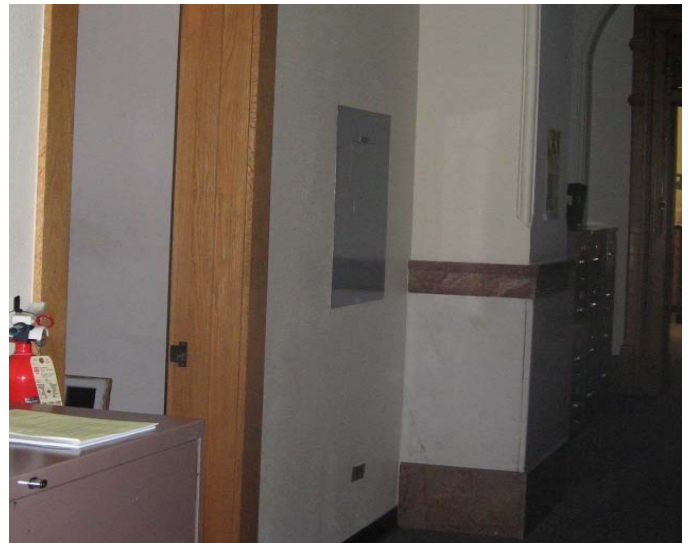
088 Wainscot discontinues after wall intersection

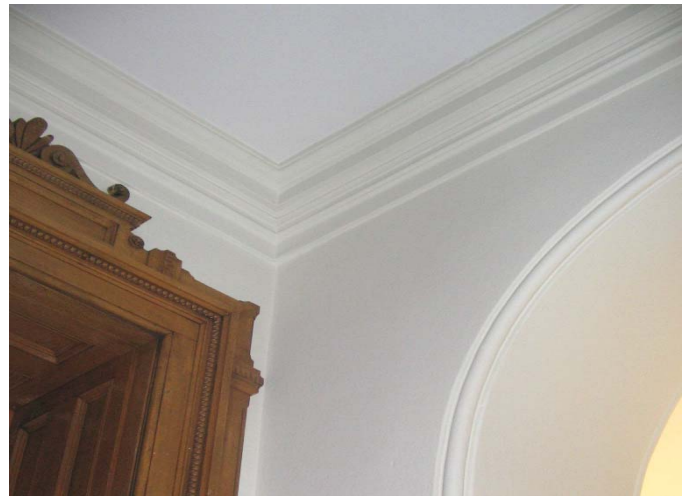
090 Existing conditions at southwest corner

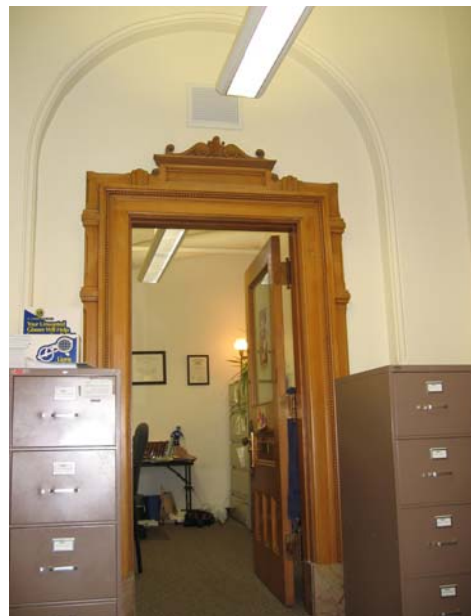
090 Looking north at former archway into 092

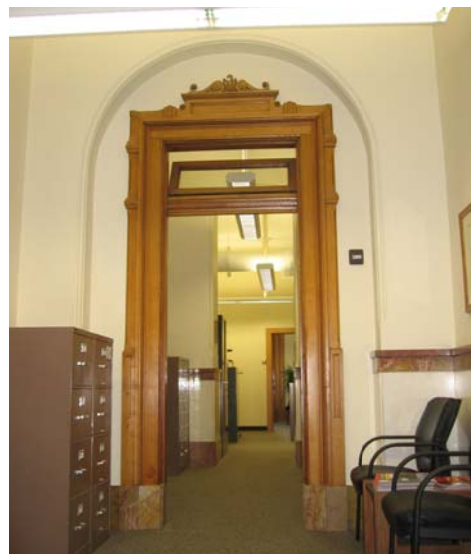
090 Looking east through doorway and former arch into 089

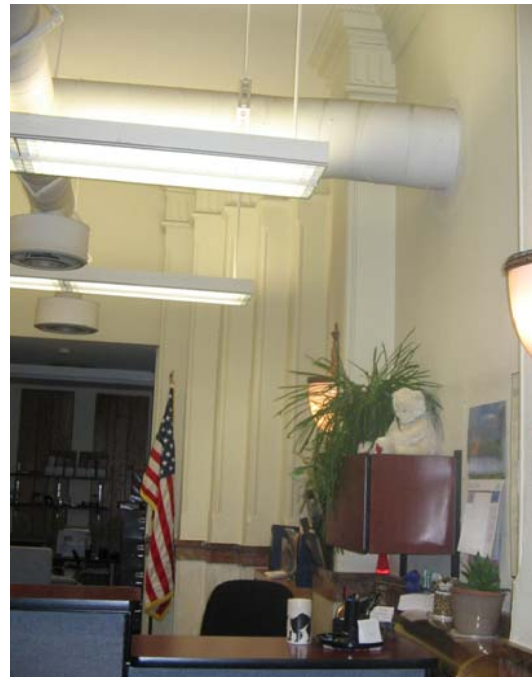
091 View looking north with corded plaster pilaster and stone wainscot of the former public corridor

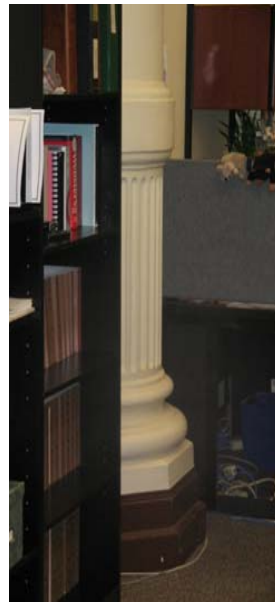
091 Cast iron column of former public corridor

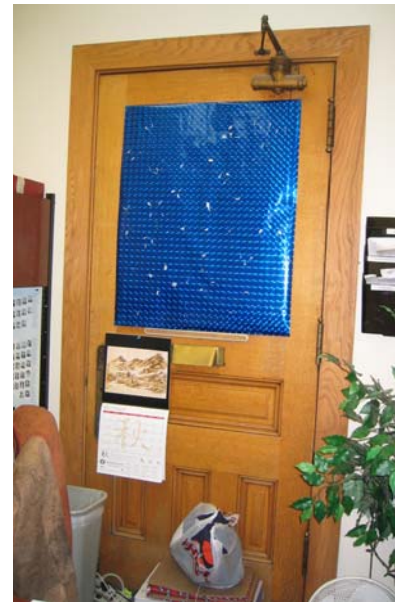
091 Secondary door to public corridor

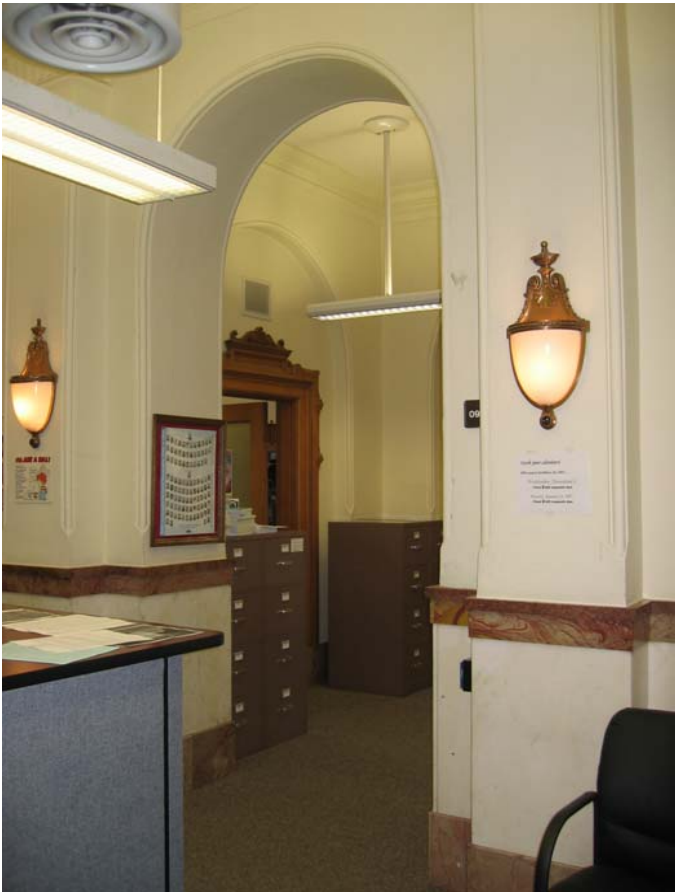
091 Looking northeast at original archway to Hallway 090

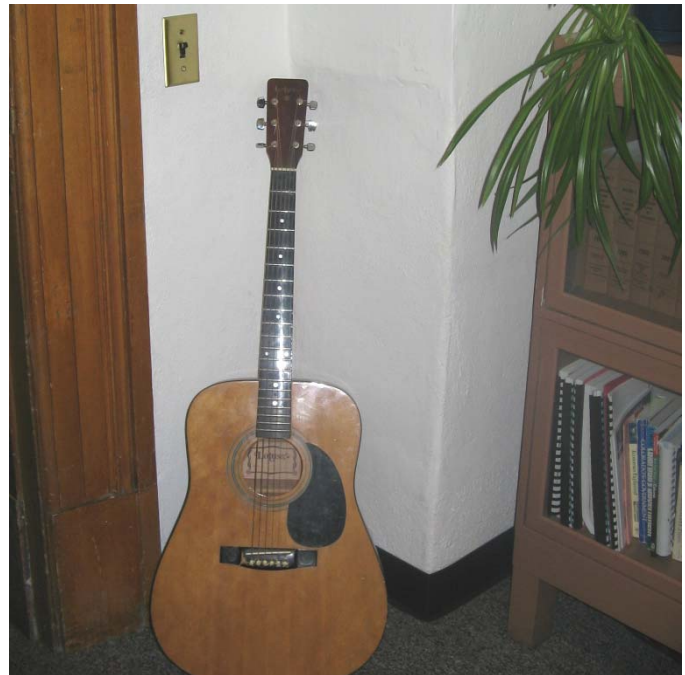
092 Stone wainscot missing

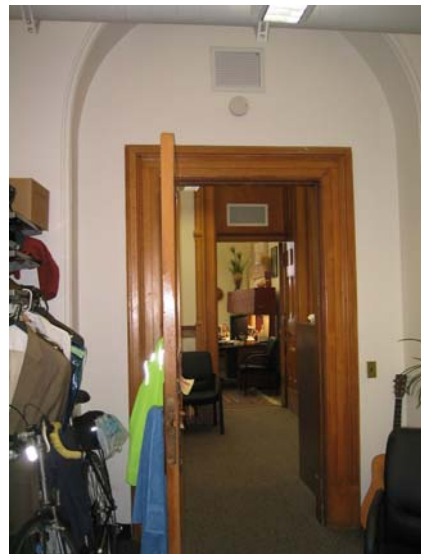
092 In-filled arch looking to 090

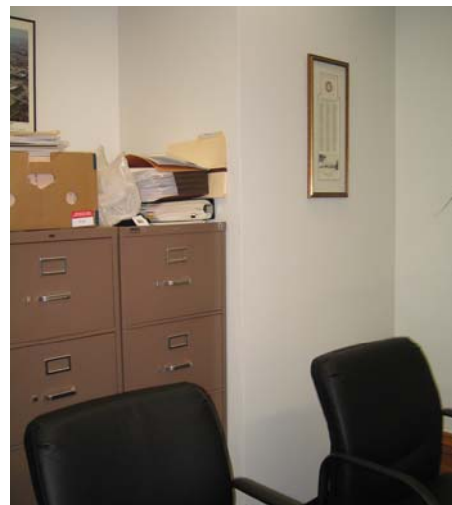
095 Chase in northwest corner

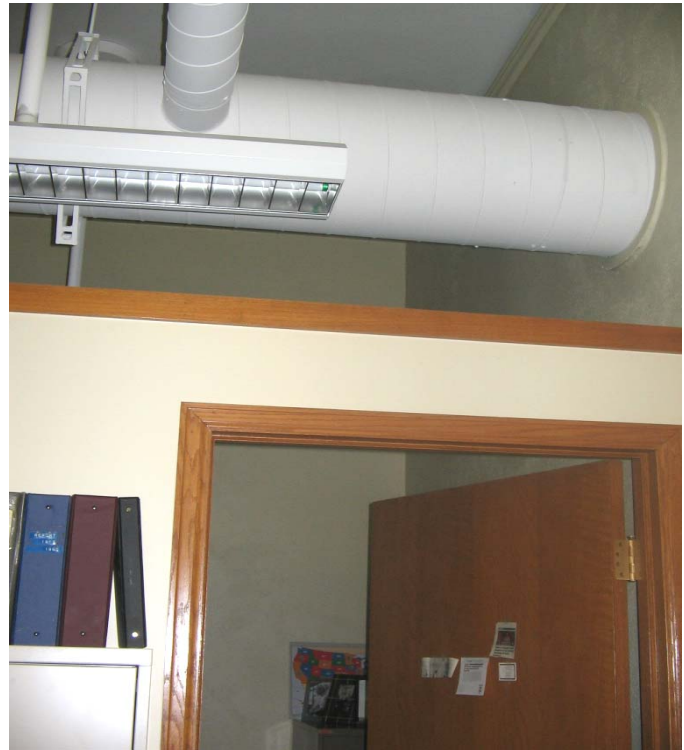
096 Partial height walls and exposed ductwork

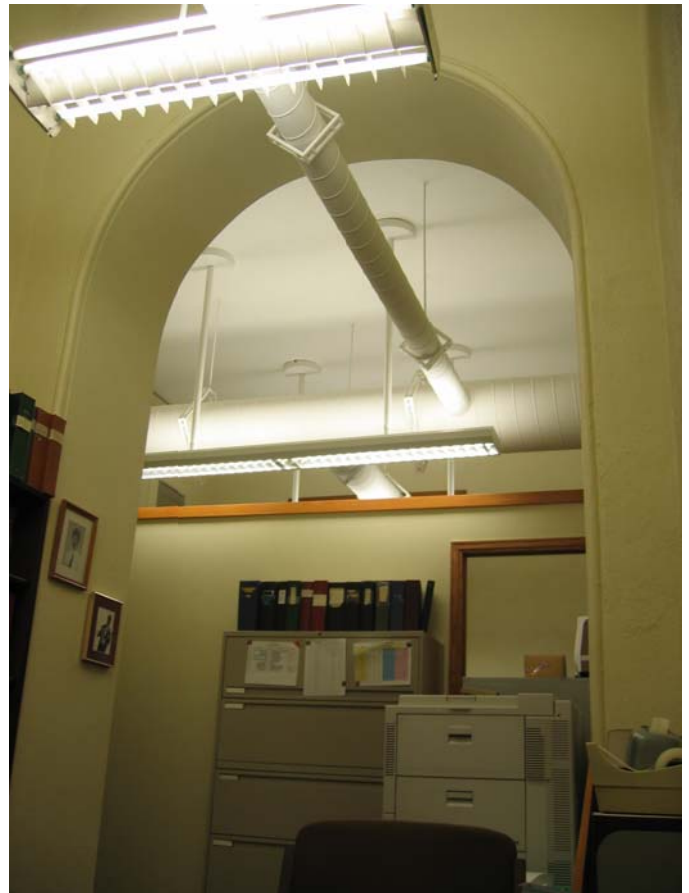
097 Looking east; original corded archway

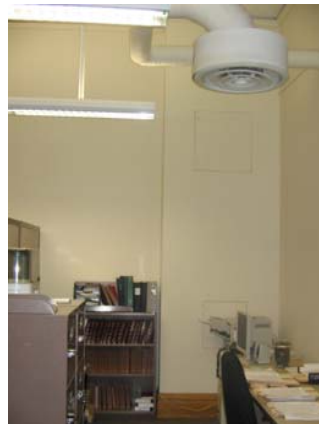
0102 Standpipe chase in southwest corner

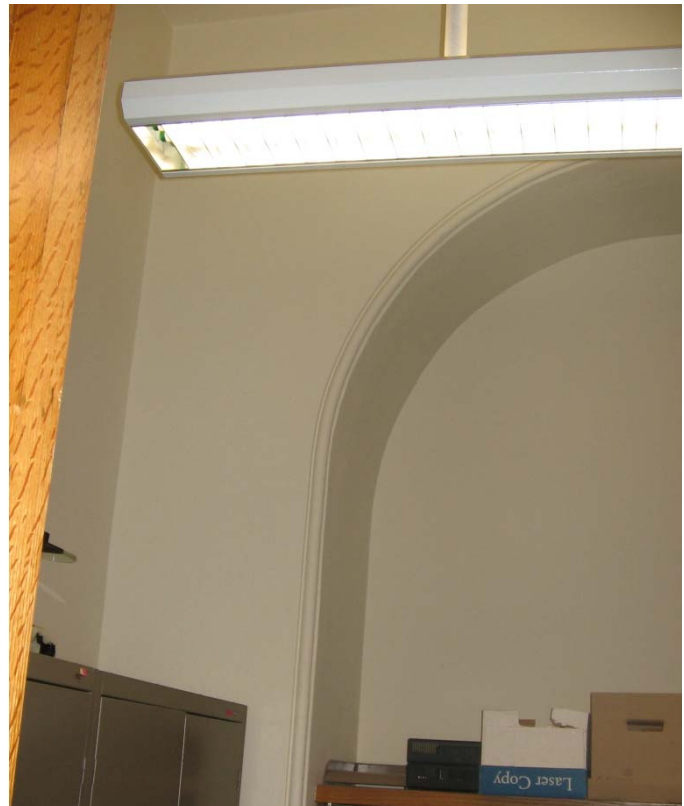
0105 In-filled arch opening in east wall

No preservation work required

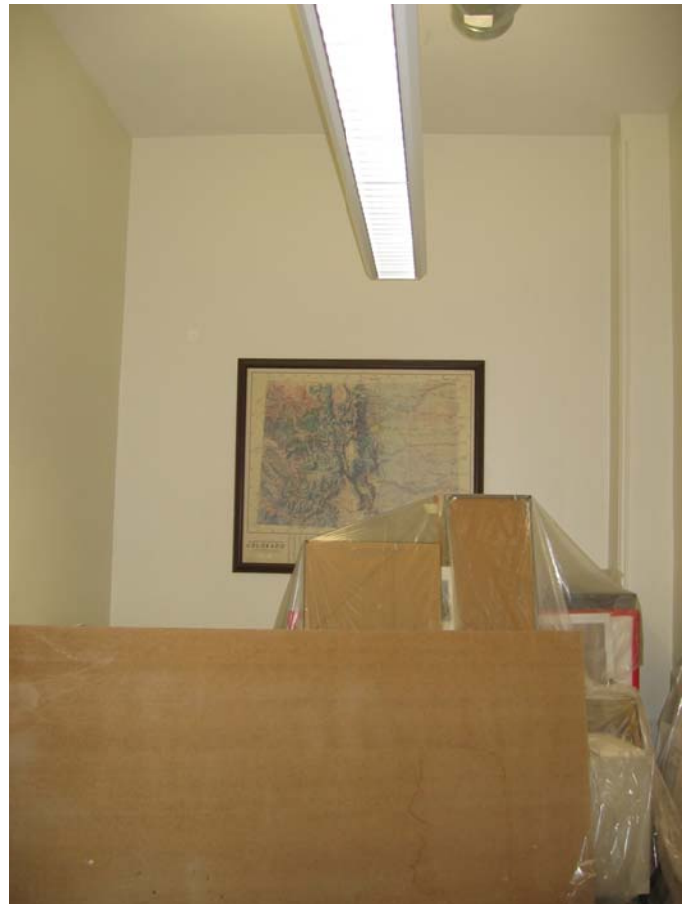
0106 View of south wall and original archway

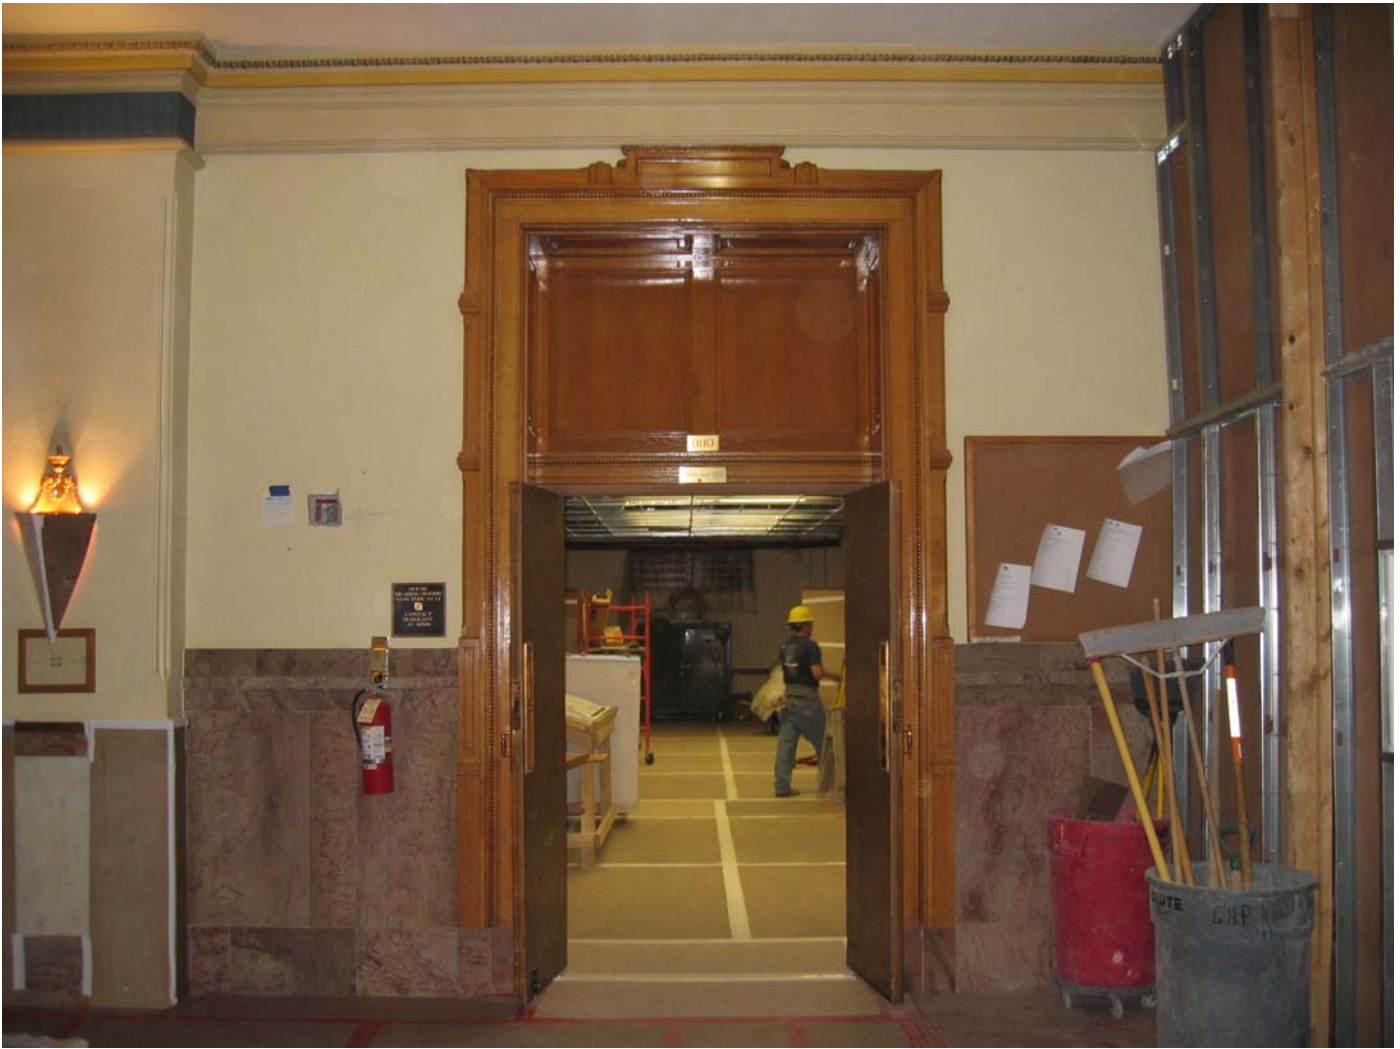
Entry door from 0124: modified, relocated original double frame, casing and transom; non-original wood slab doors; transom glazing replaced with wood panel; modified top trim; hardware removed for construction; added to separate room 0110 from 0124

0124 Entry door to Hallway 0110

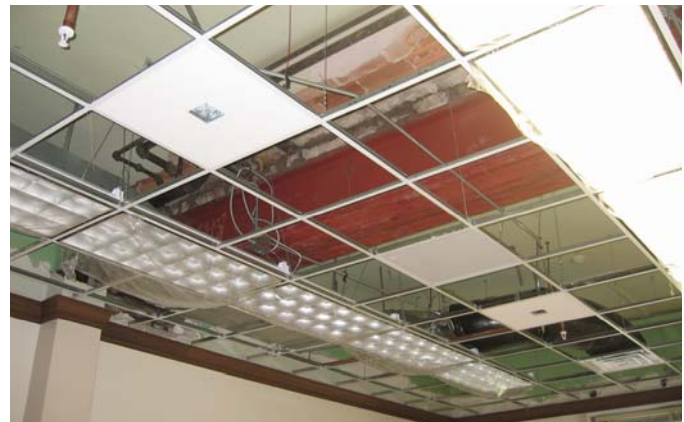
0111 View above ceiling at steel beam added when masonry wall was removed during 1968 remodel

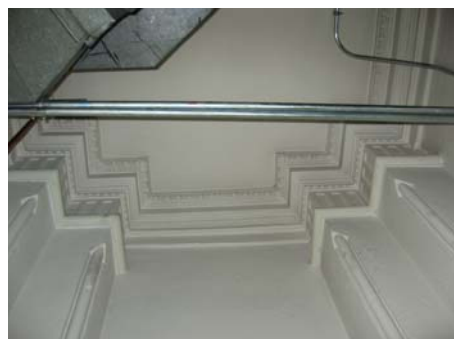
This space is in poor condition. Although it functions adequately as a mechanical room, the original finishes of the former entry vestibule are damaged beyond repair.

No preservation work required

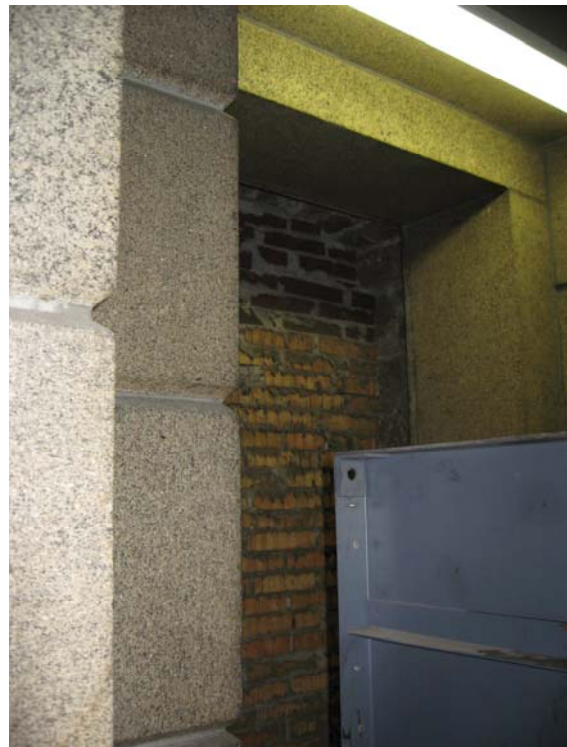
0116 Brick in-fill of original interior window

No preservation work required

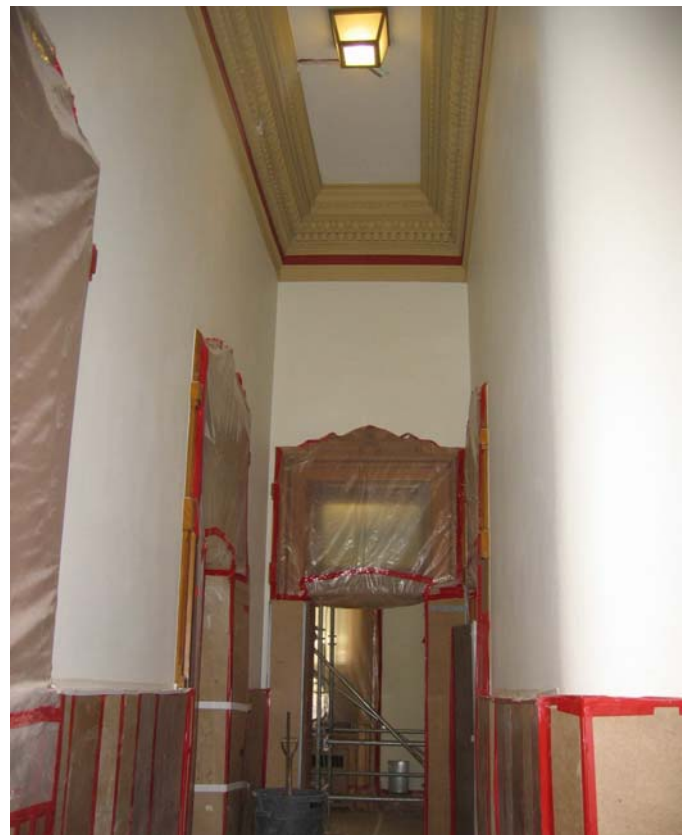
100A Looking east to room 104

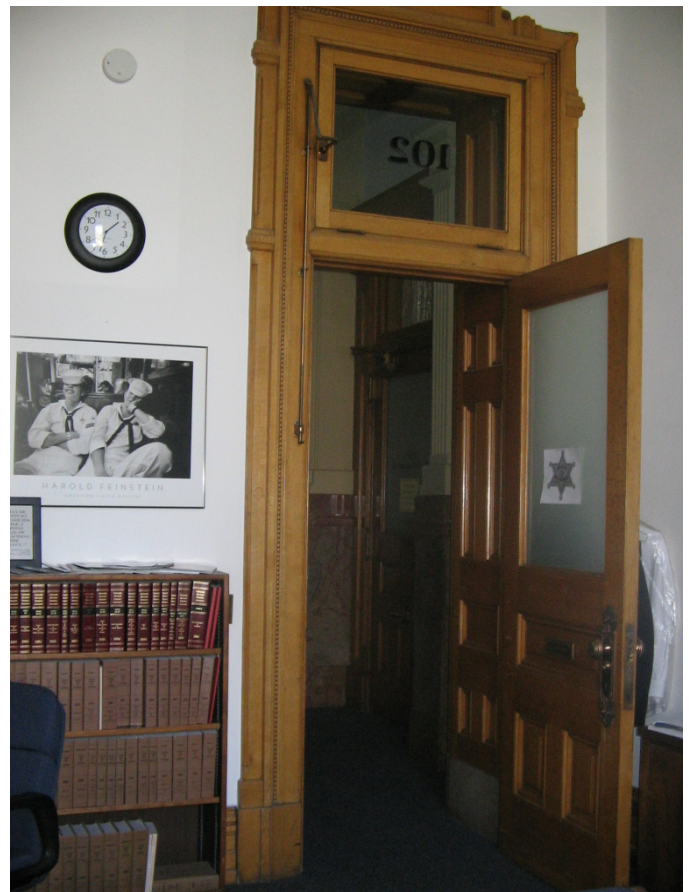
102 Entry door to Room 100B

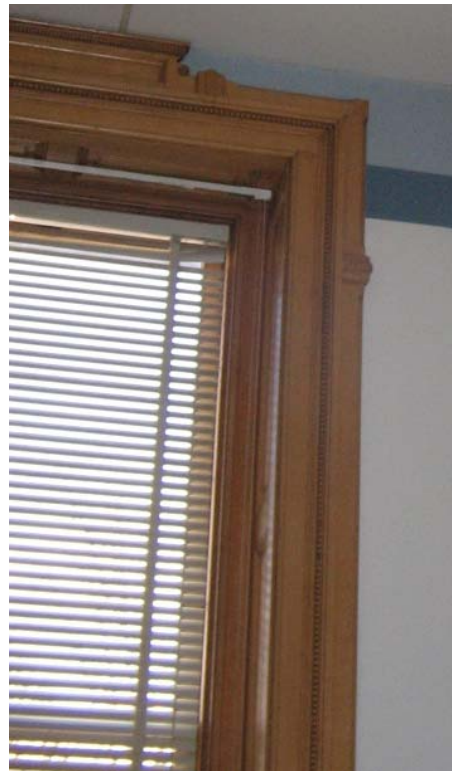
103 Window trim on north wall

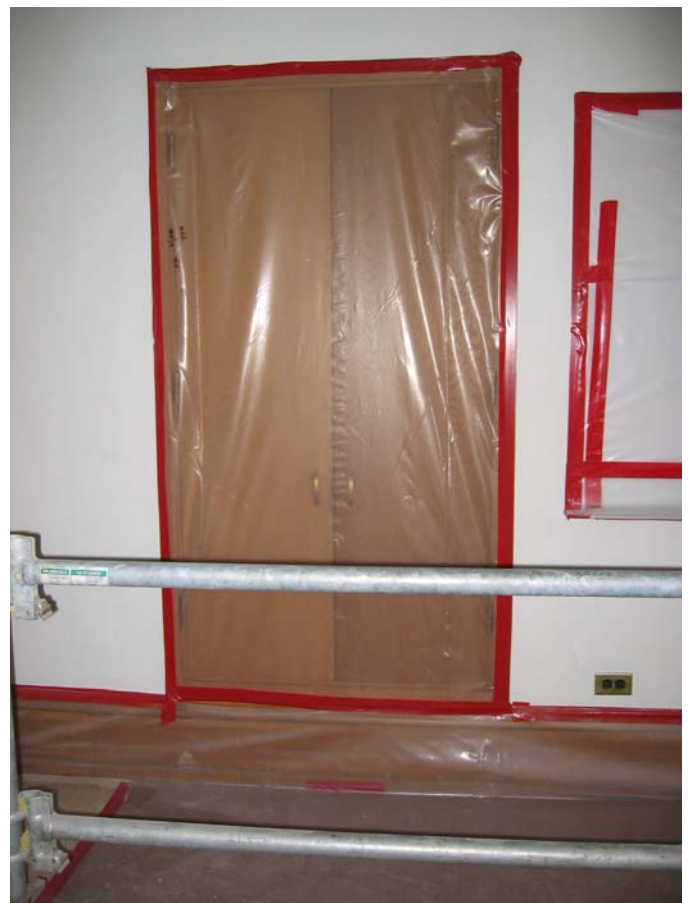
103 Cabinet on west wall protected during phase 3 of the 2006 Life Safety Project

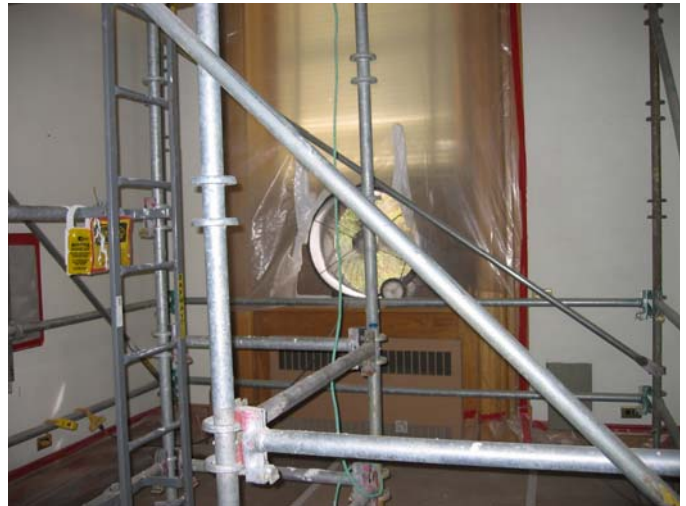
104 East window protected during construction of the Life Safety Project

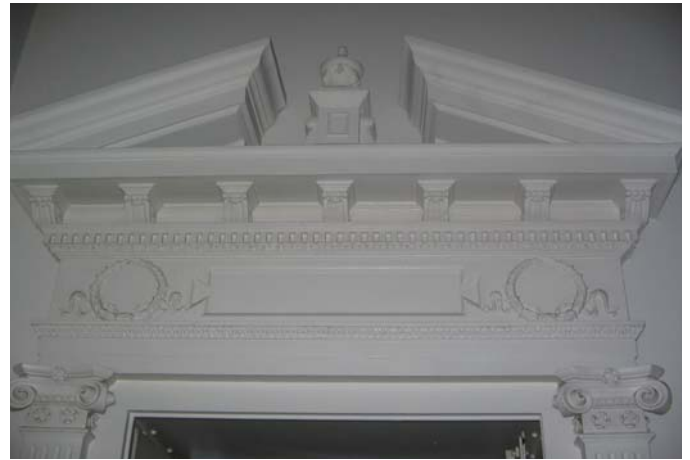
105A Original vault finishes have been painted over

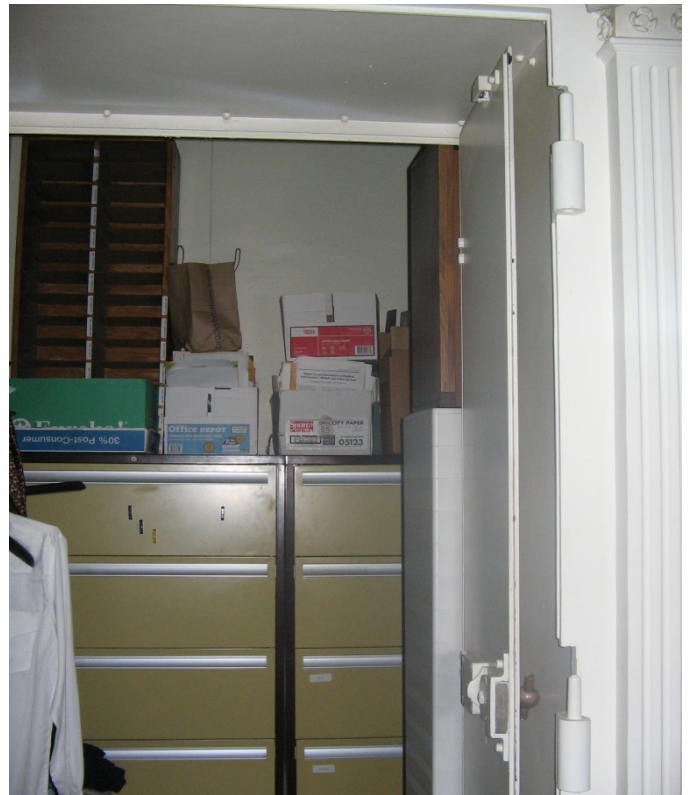
105A Hinge pins for missing vault door

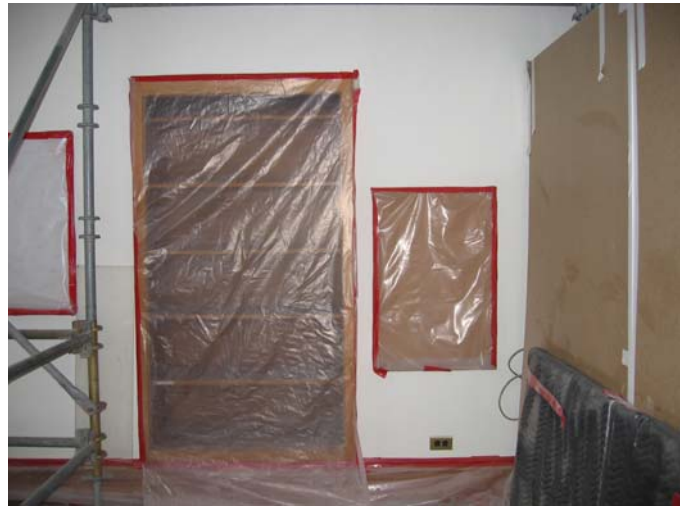
106 Bookcase on south wall infilling opening

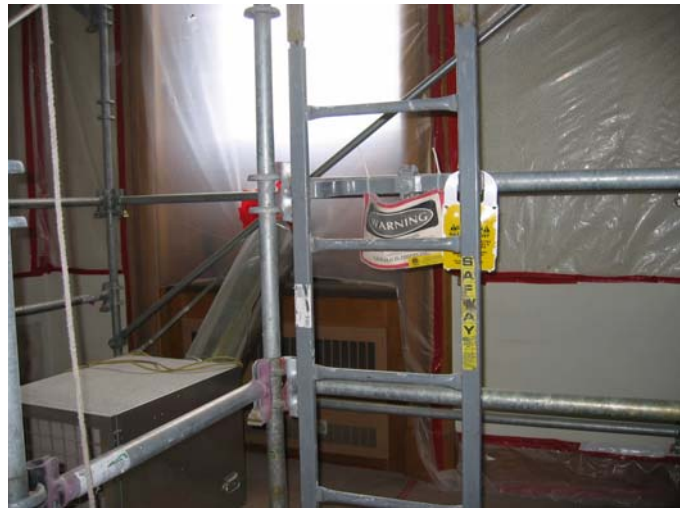
110 View towards exterior window protected during the Life Safety Project

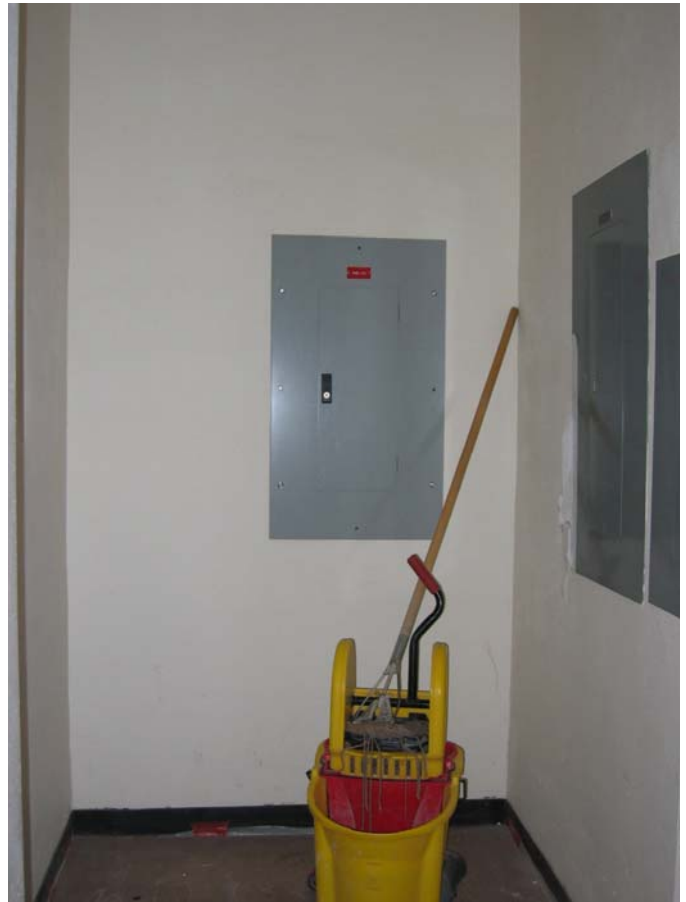
110A South wall view of electrical panels

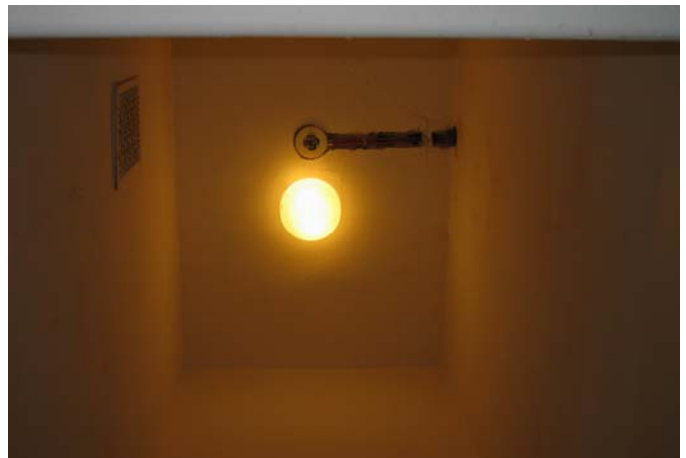
110A Ceiling showing lighting and smoke detection channeling as part of the Life Safety Project

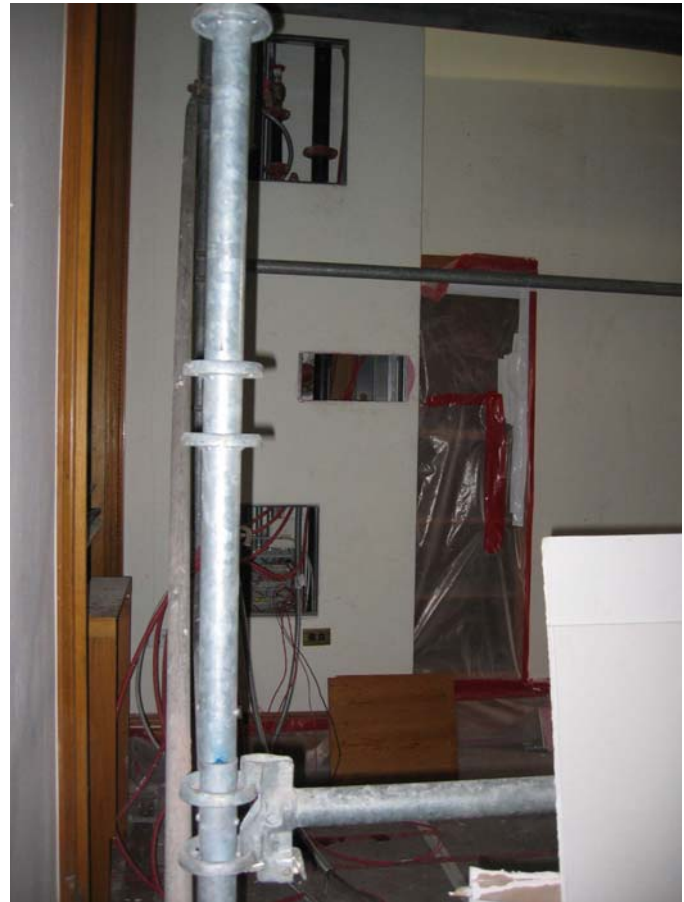
111 shaft in northwest corner

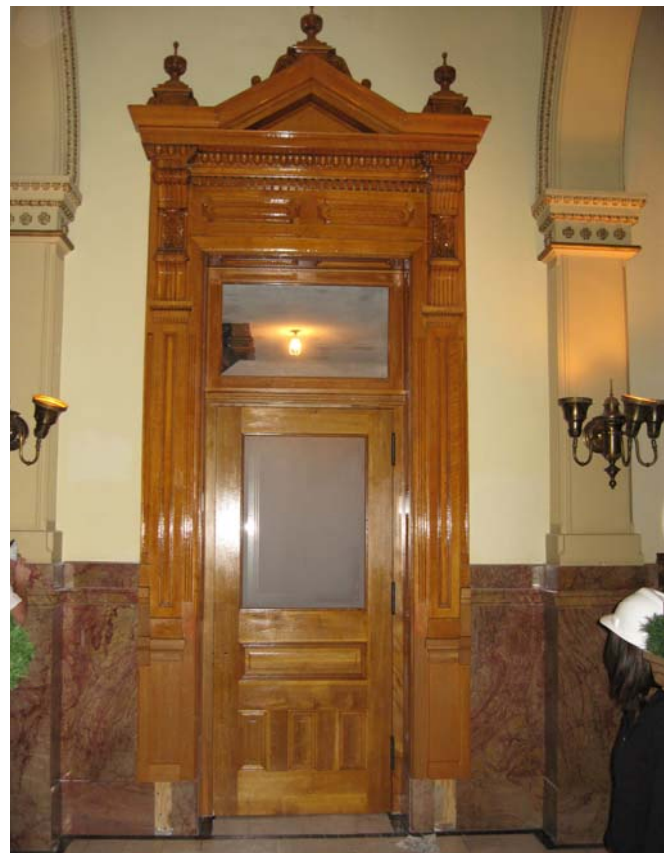
113 New doorway to stair

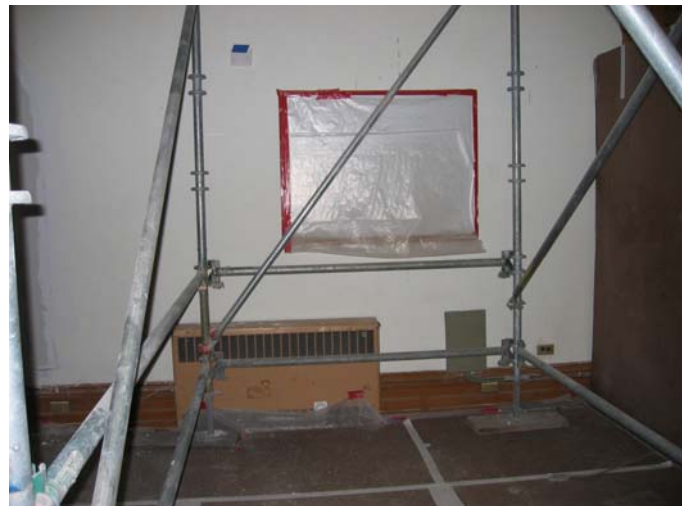
115B Non-original radiator at south wall

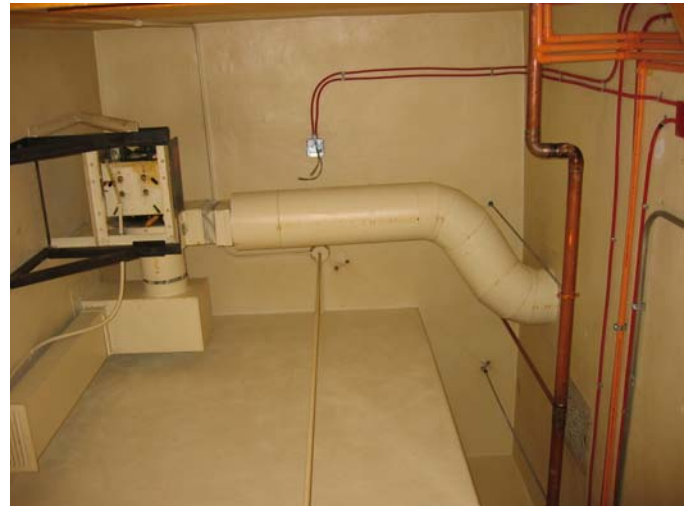
Smooth plaster in good condition; exposed MEP systems

116 Ceiling with exposed MEP systems

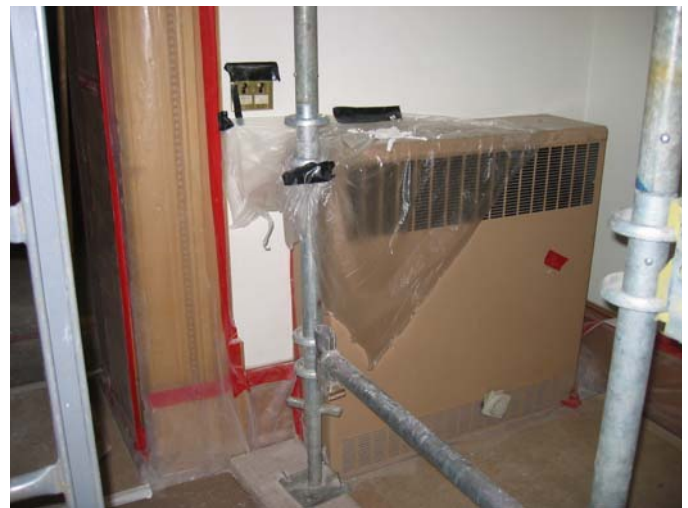
116B Freestanding non-original radiator in the southwest corner

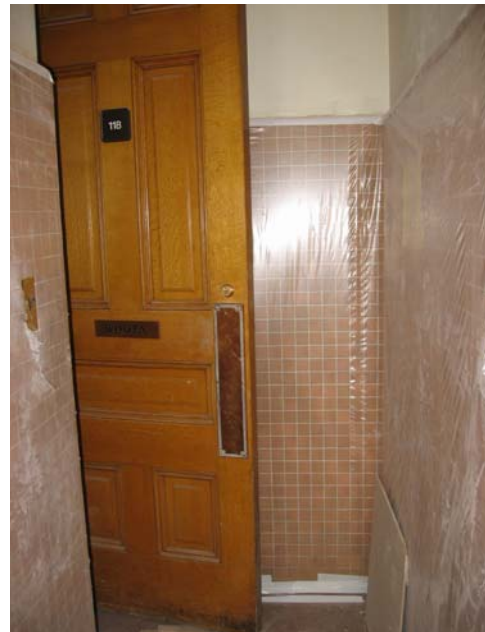
118 Entry door with push plate on corridor side

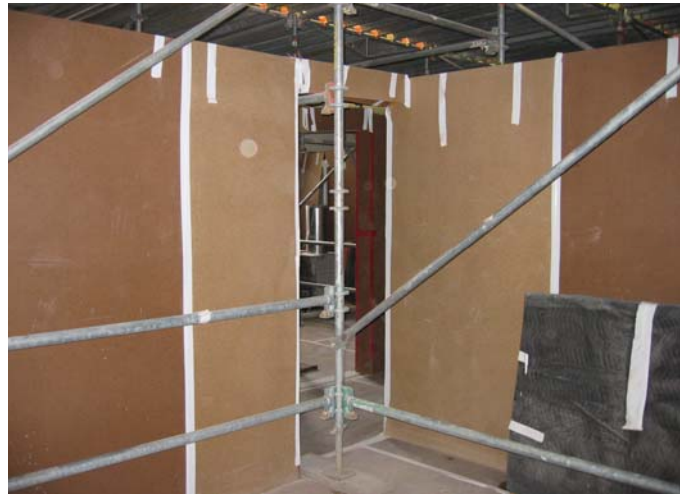
119 Southwest corner protected during construction for the Life Safety Project

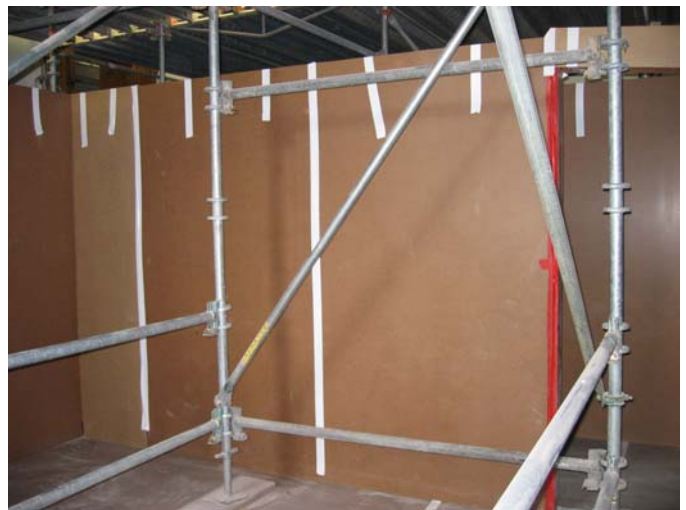
119 South wall protected during construction for the Life Safety Project
