# COLORADO STATE CAPITOL

## HISTORIC STRUCTURE ASSESSMENT

STATE HISTORICAL FUND PROJECT NUMBER  
SHF-2006-T1-001

**December 15, 2006**

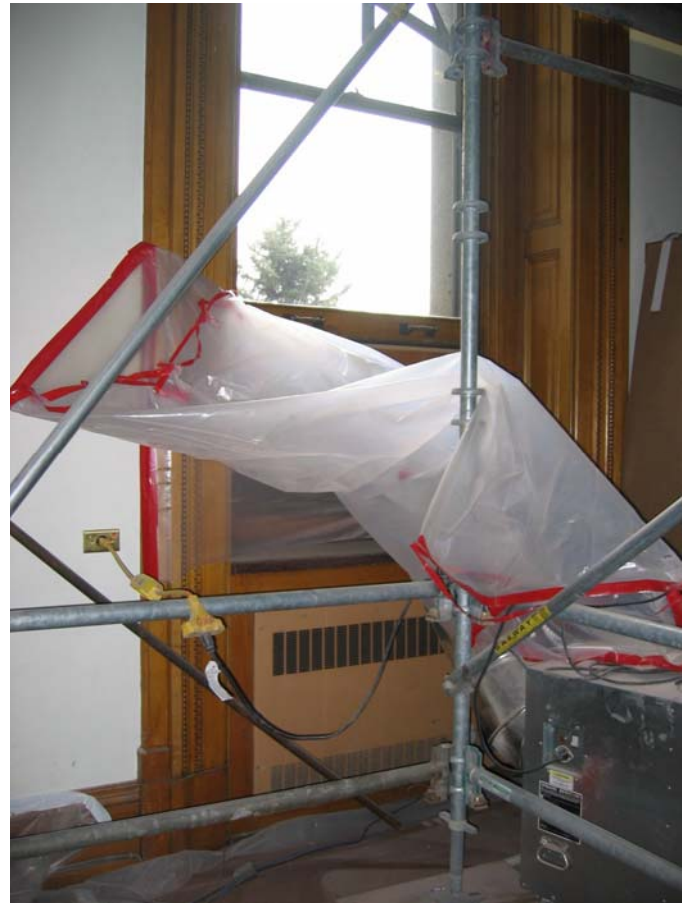
119A Window with non-original radiator

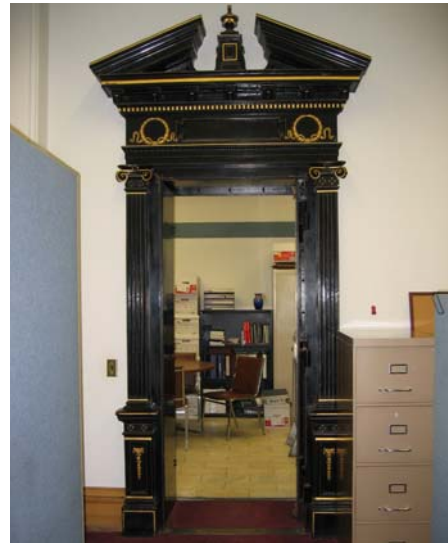
Original vault door missing; original vault door frame

121B Ornate vault door frame.

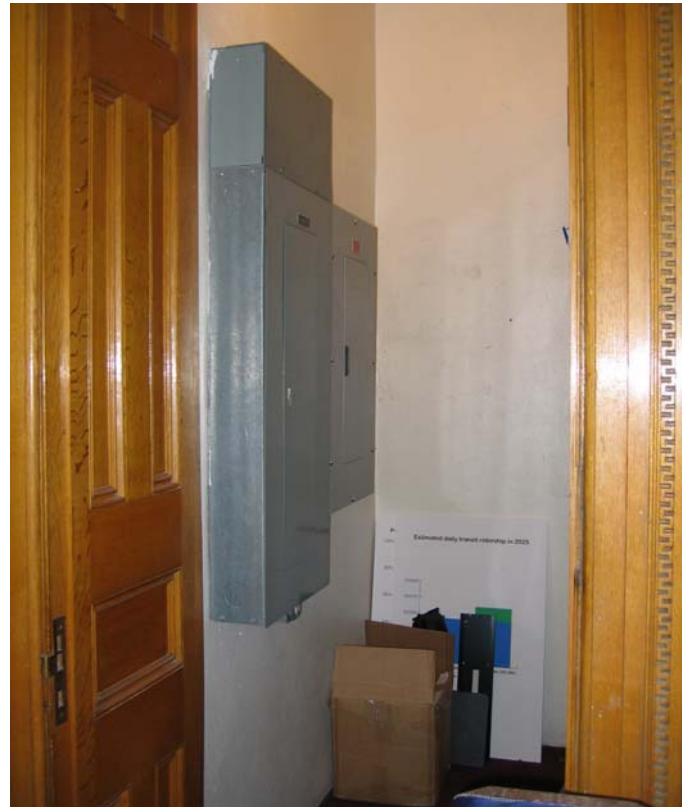
124A West wall with view of electrical panels

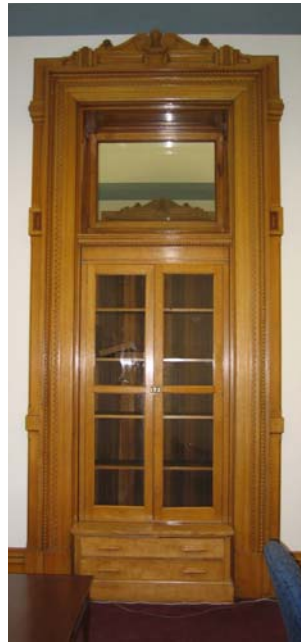
Painted plaster with sand-textured finish, requires repair; non-original book cabinet installed in south wall doorway; non-original radiator

125 South wall cabinet in door opening

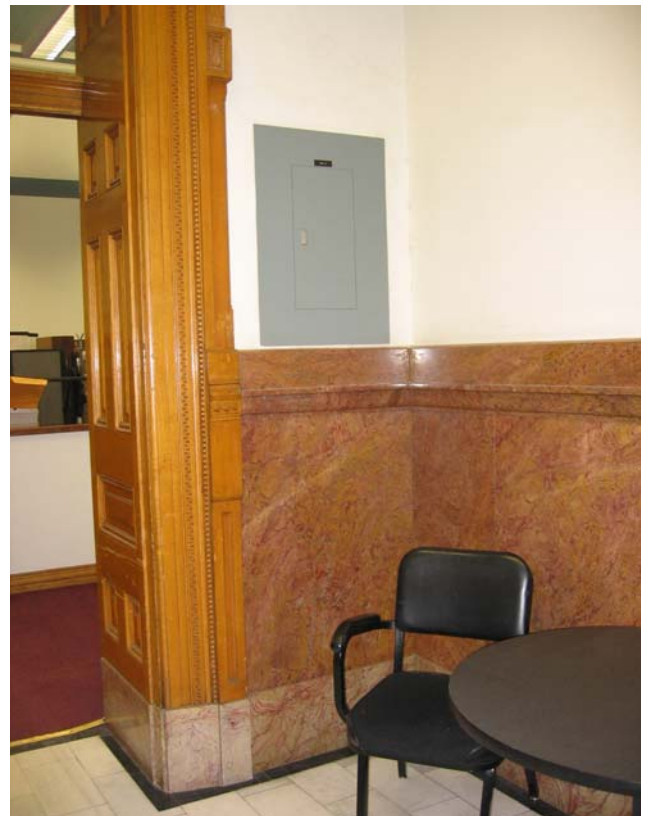
127 Electrical panel in south east corner

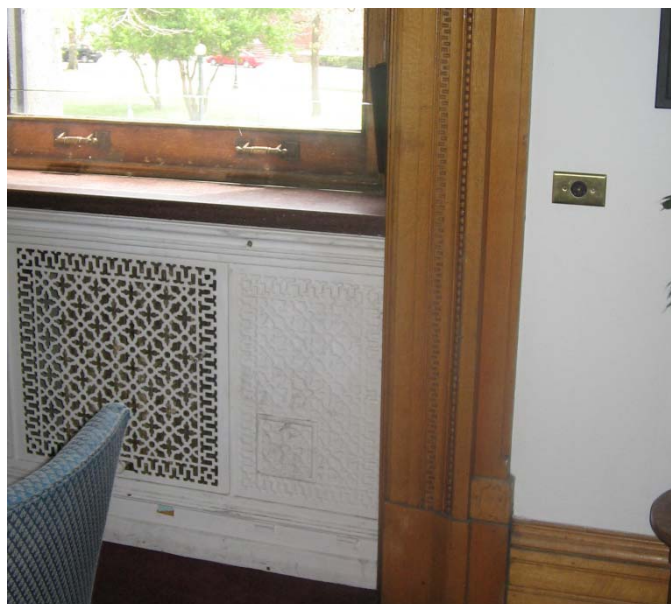
127A Radiator at exterior window with Cedar marble sill

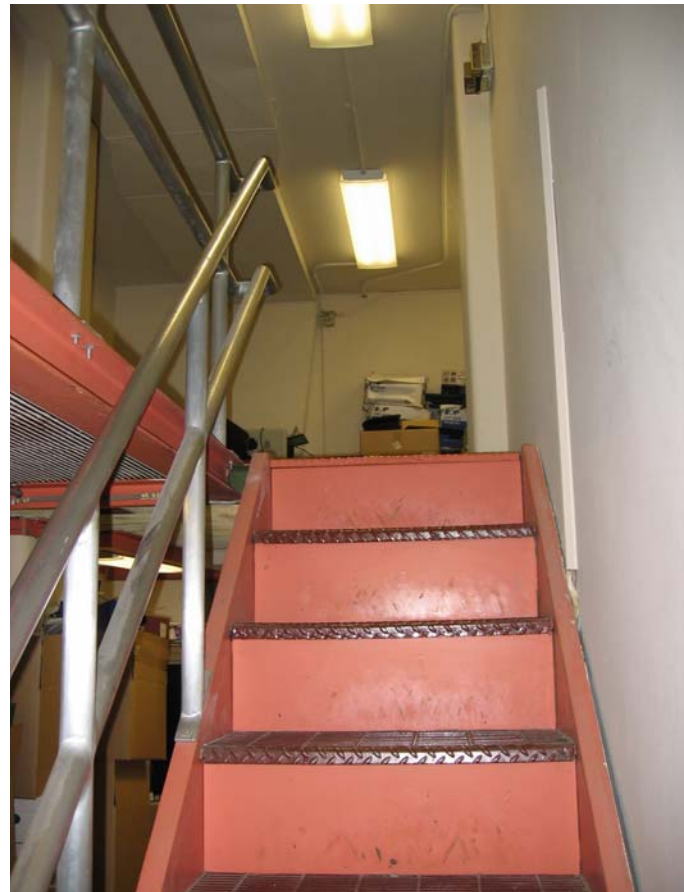
128 Stair to vault floor above

#### **Functional Condition: Fair**

Finishes in fair condition; walls show signs of patching and normal wear.

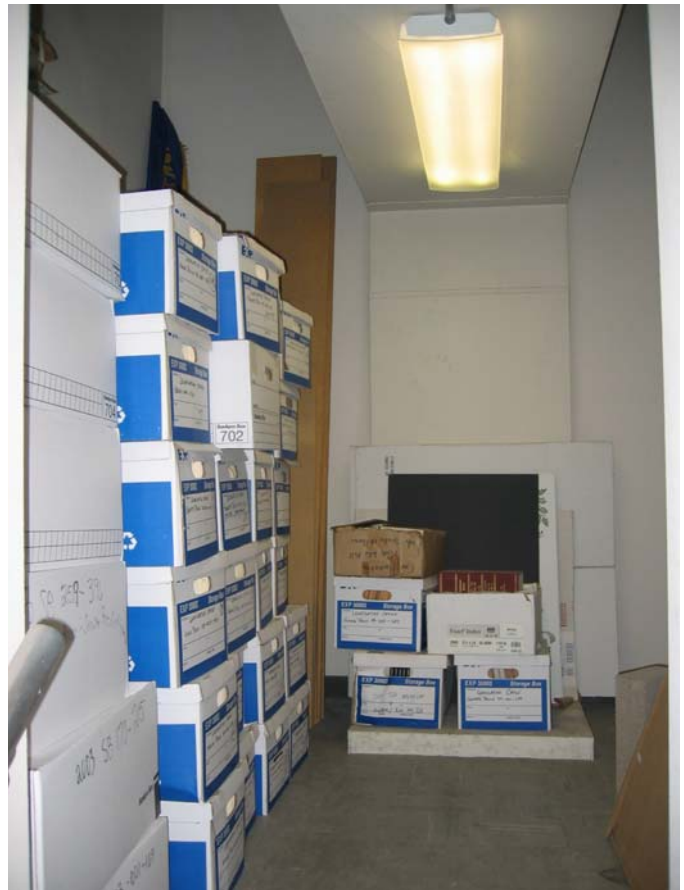
128B Duct along north wall with surface mounted light fixture

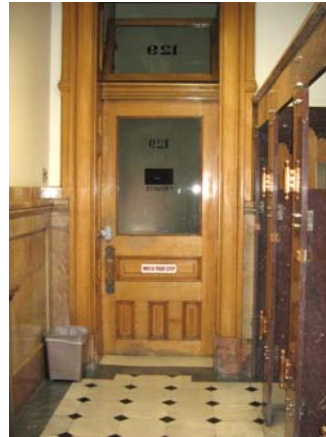
Door from Lobby 129A: original door type D1; original etched door glazing with Greek key border; non-original clear transom glazing with number "129"; columbine plates on both sides; knob missing from Restroom side; small knob on Lobby side; original operational transom hardware; trim type T2 on room side; trim type T1 on Lobby side  
Stall doors: original quarter-sawn oak with scroll top; original frosted glass panels (one panel missing); original hardware

129 Entry door from lobby 129A

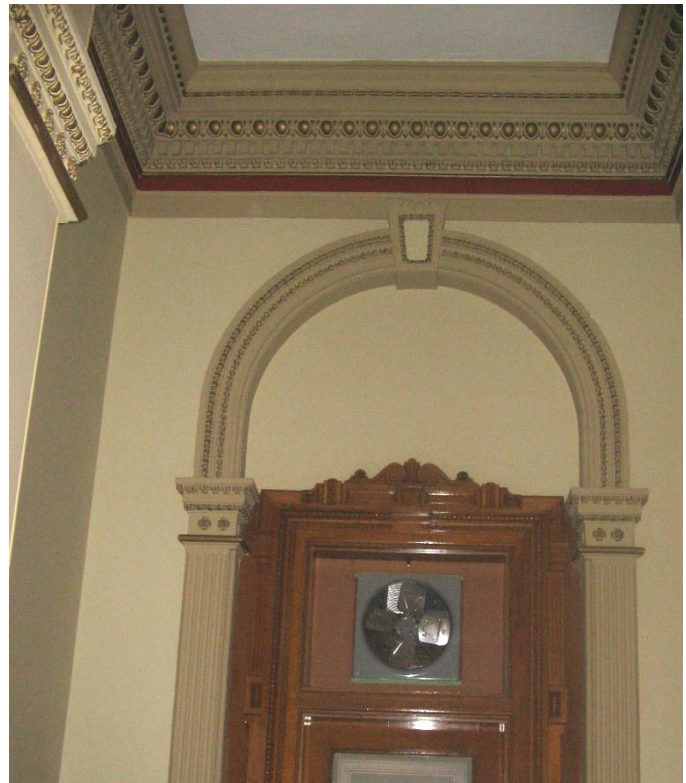
Door to Hallway 127: relocated original door type D1; original etched door glazing with Greek key border; located in former arched opening; transom glazing replaced with wood panel with an exhaust fan installed; columbine plate 127 side, scroll plate 129A side; large cast knobs; trim type T1  
Door to 129: original door type D1; original etched door glazing with Greek key border; non-original clear transom glazing; columbine plates on both sides; knob missing from Restroom side; small knob on Lobby side; original transom hardware, still operational; trim type T2 on Restroom side; T1 on Lobby side

129A In-filled arched opening with relocated door

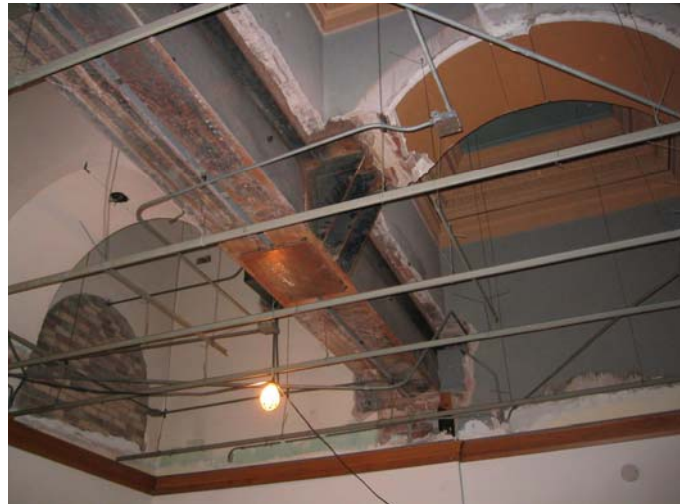
130 Steel shoring at removed column.

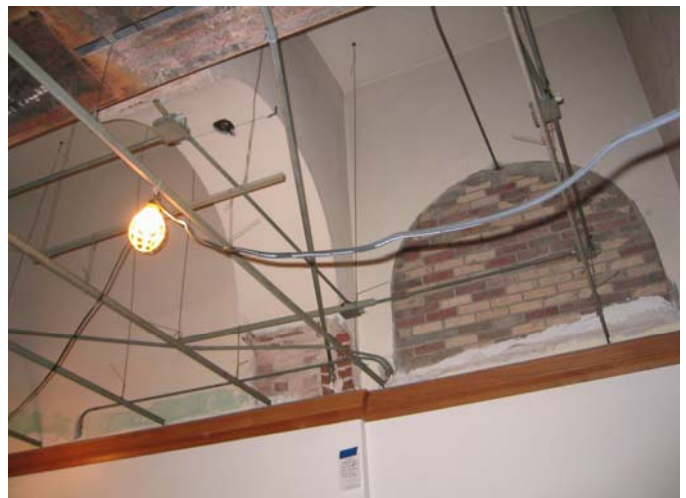
130 In-filled opening at south wall, part of a former vault.

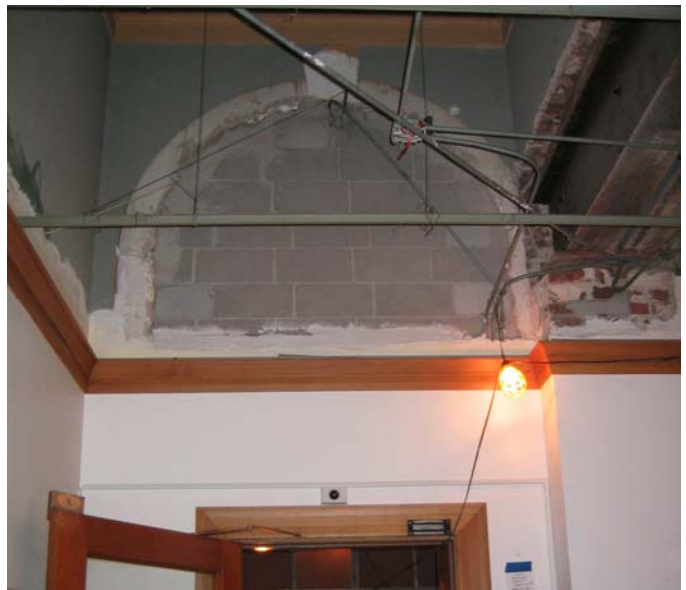
130 In-filled opening into First Floor Arcade.

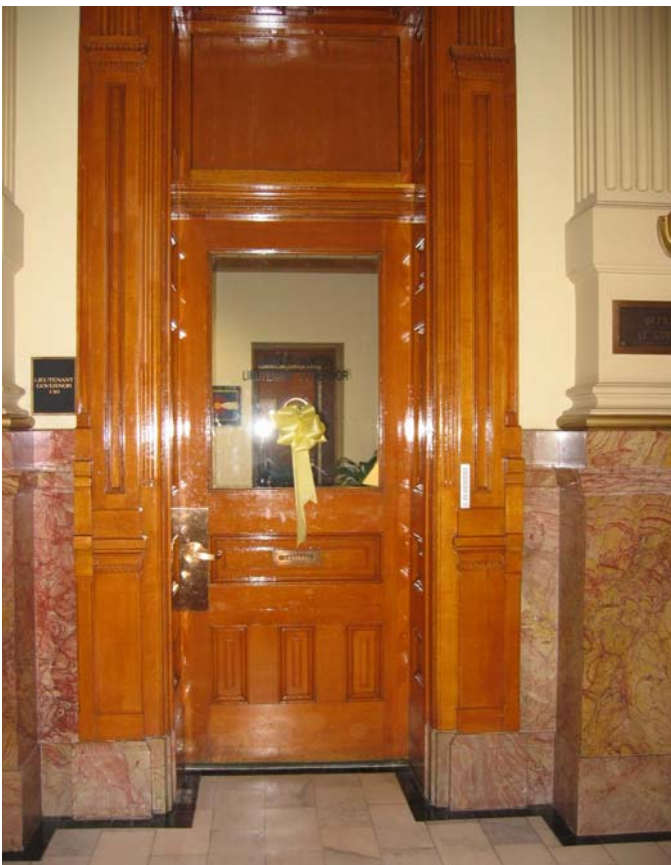
Door from Arcade: relocated original door type D1; door, casing and frame is completely altered on room side; non-original clear door glazing; original transom glazing replaced with wood panel; non-original door hardware; original trim type T5 on Arcade side; non-original trim on room side  
Door to 130A: non-original wood slab panel; non-original hardware; non-original trim with gold band  
Door to 132: an original door opening, only the opening remains; no door or trim present

Door to Room 130 from Arcade

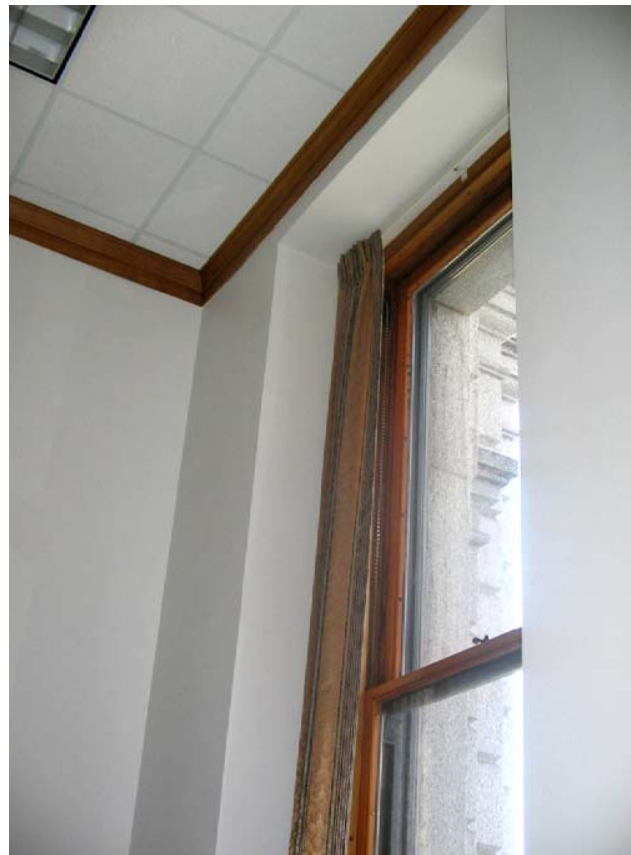
132 Plaster return and non-original window frame detail

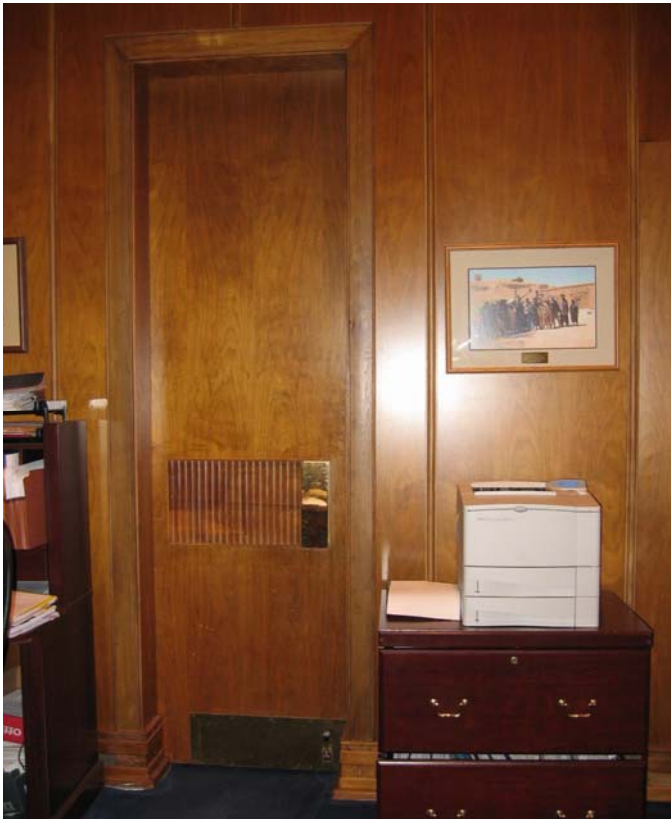
East wall at door to Room 136D

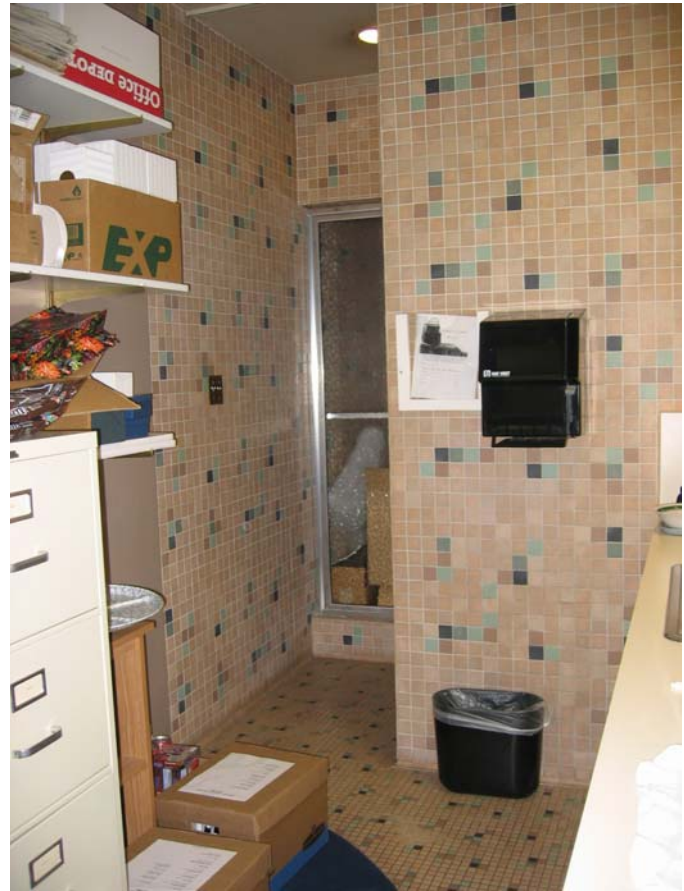
Kitchen style cabinets with a stainless steel sink; large mirror; plastic laminate cabinets with paneling on the north and east walls; open shelving on east wall; 2x2 ceramic tile on remaining walls; shower not in use; original wall removed between former Vault and former Wardrobe

136D Tile walls

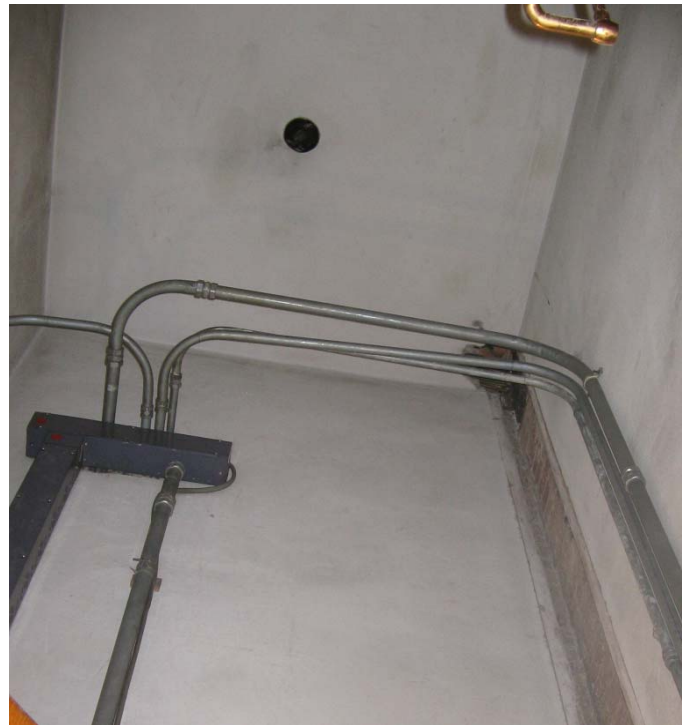
This room is in poor condition; inconsistent with current use, improper clearances and construction for electrical equipment; walls show signs of patching and heavy wear

137 View of ceiling

Relocate electrical equipment out of room; refinish floors

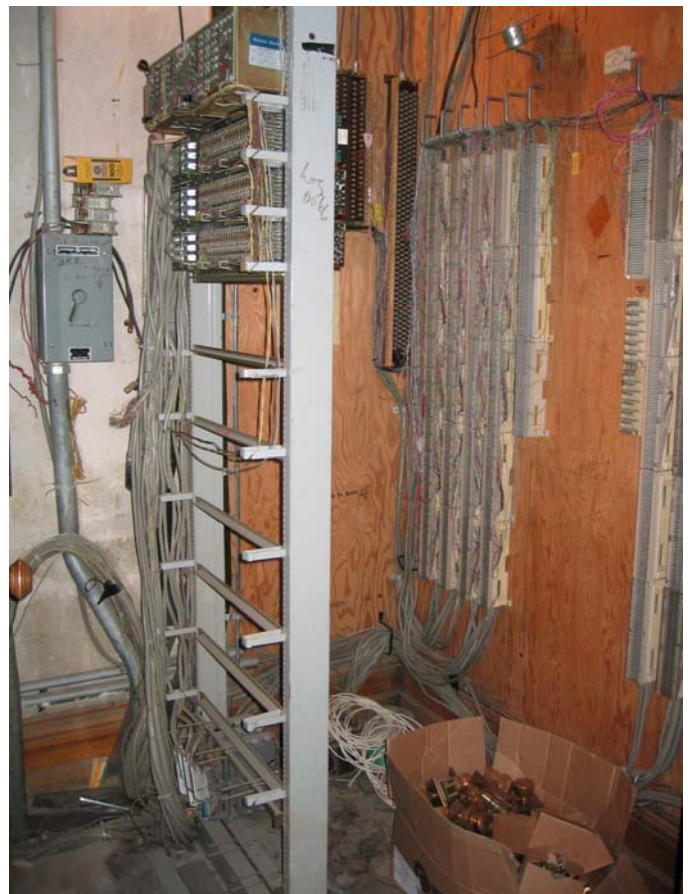
137 Existing electrical panels and telecomm equipment

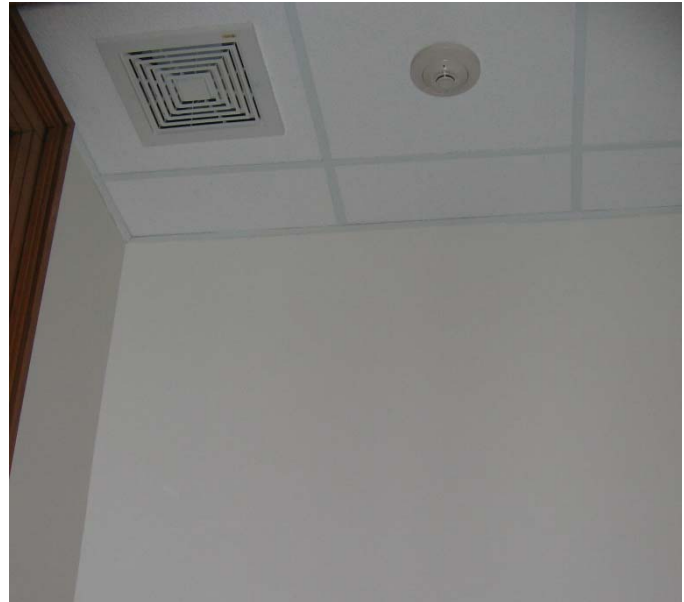
Finishes in good condition, except as noted; walls show signs of patching and normal wear

138 Existing ceiling conditions

No preservation work required

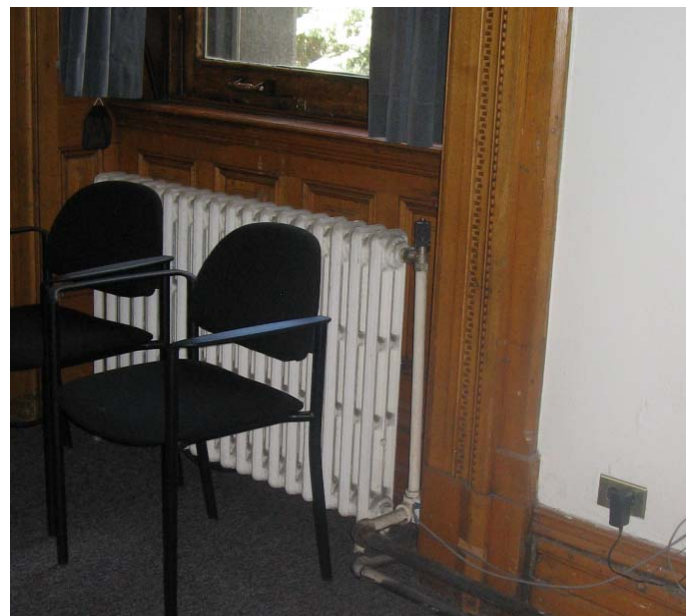
140 Existing original radiator at north wall

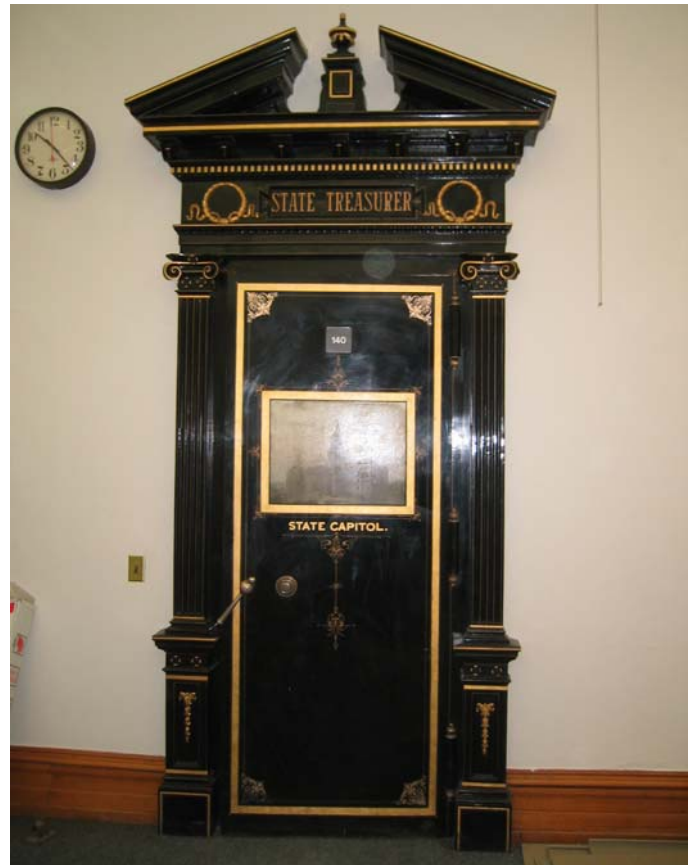
140A Original vault door

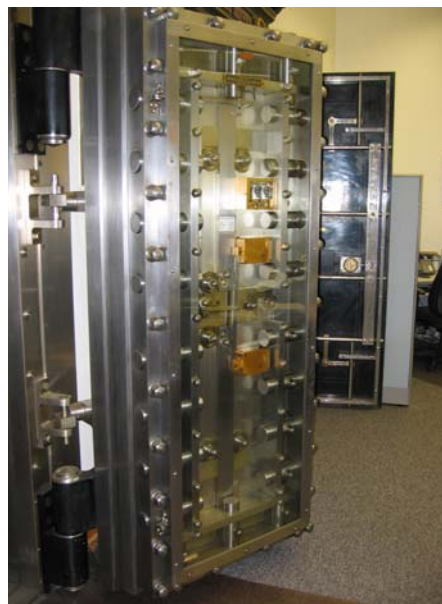
140B Non-original vault door

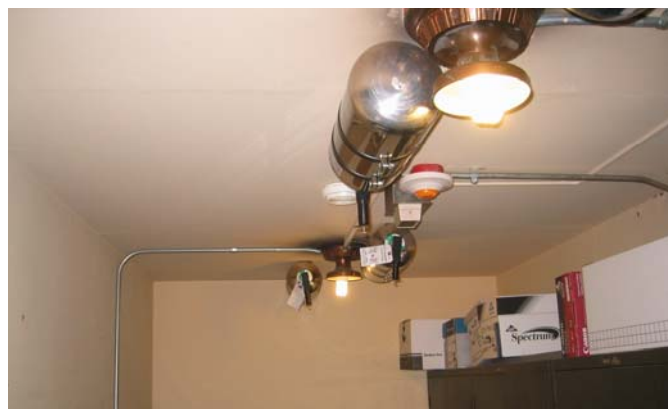
140B FM200 Fire extinguishing system inside modified vault 140B

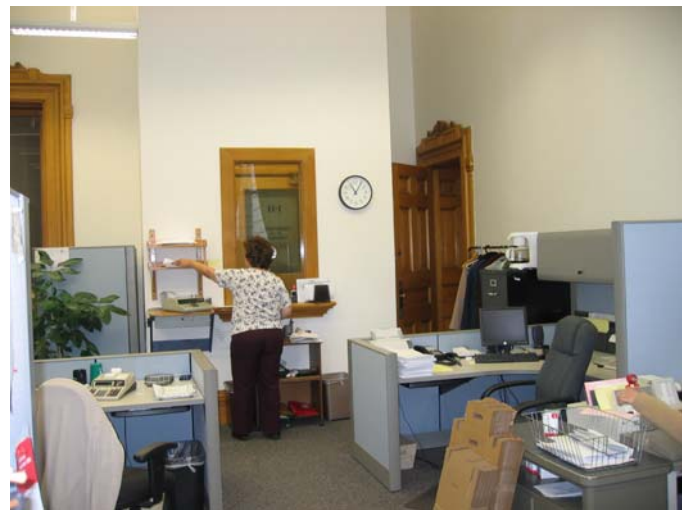
141 View of non-original transaction window on east wall

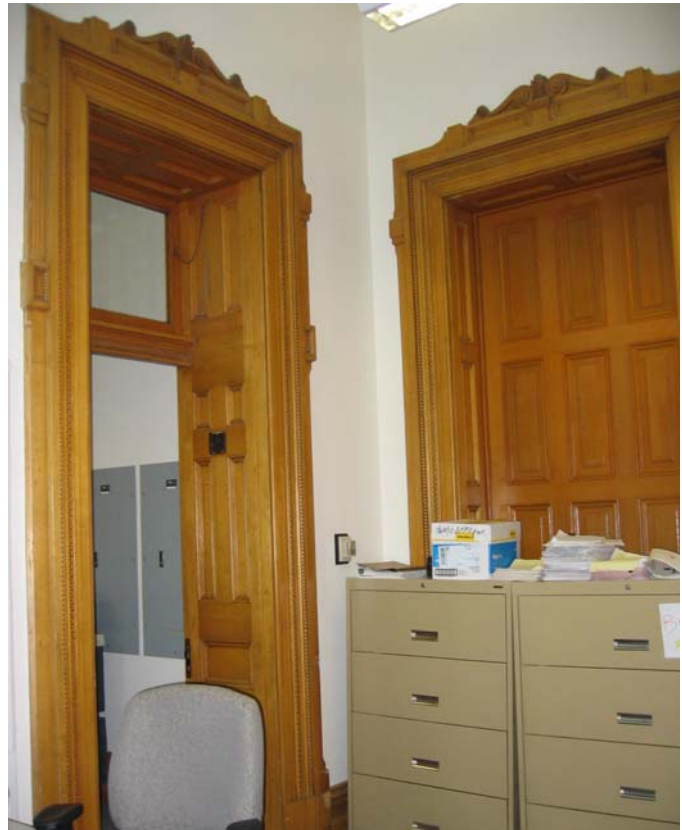
Door to 145: Original frame and casing; door is missing; non-original clear transom glazing; trim type T1

144 Interior window on east wall and door to 145 on the north wall

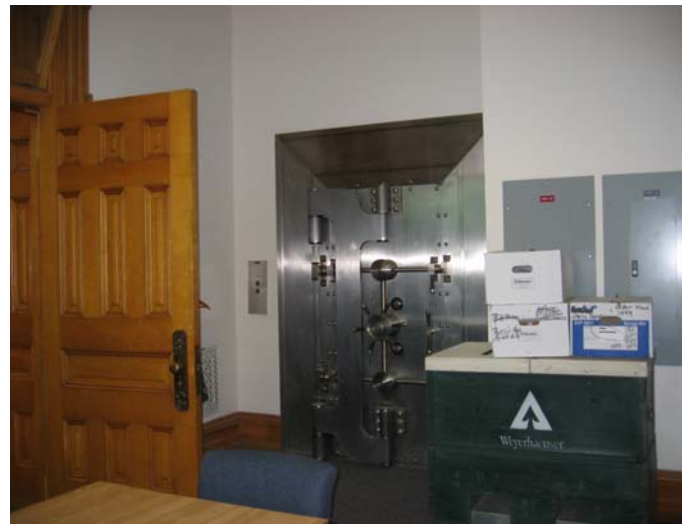
145 East wall with vault door and door to Room 146

Finishes in good condition; walls show signs of normal wear

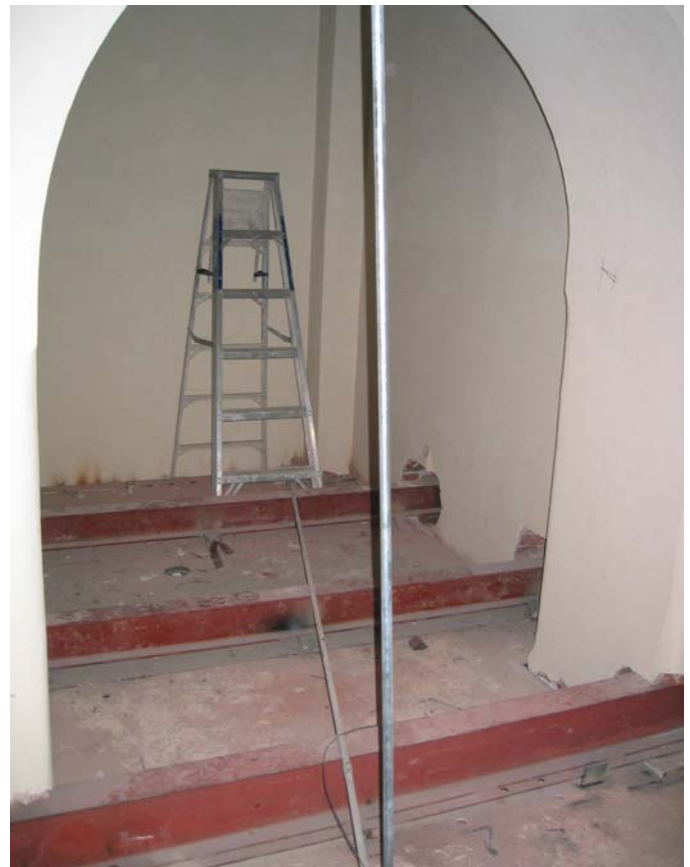
145A Space above the vault.

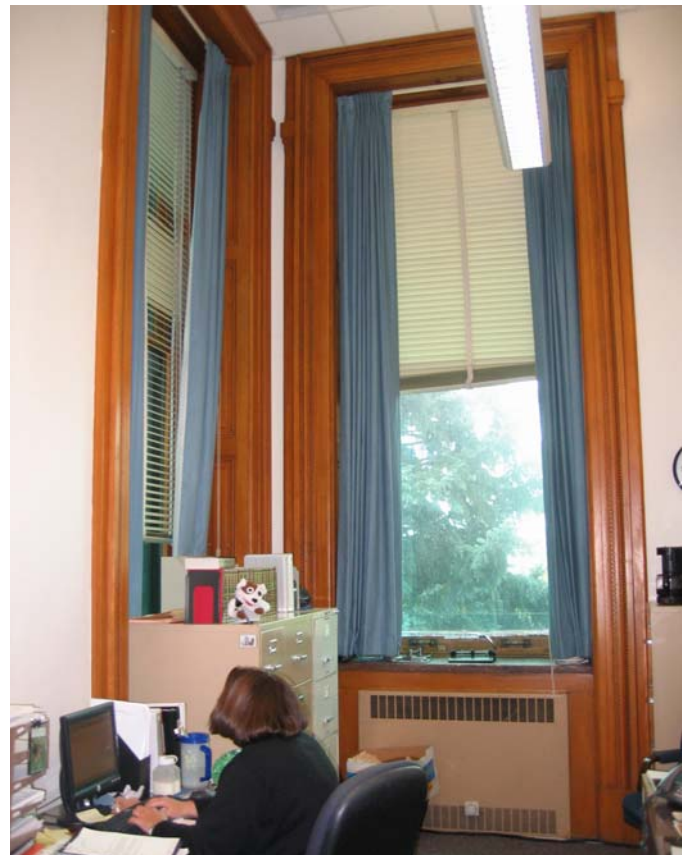
Finishes are in good condition and consistent with use; walls show signs of patching and normal wear

146 Exterior windows at southwest corner

No preservation work required

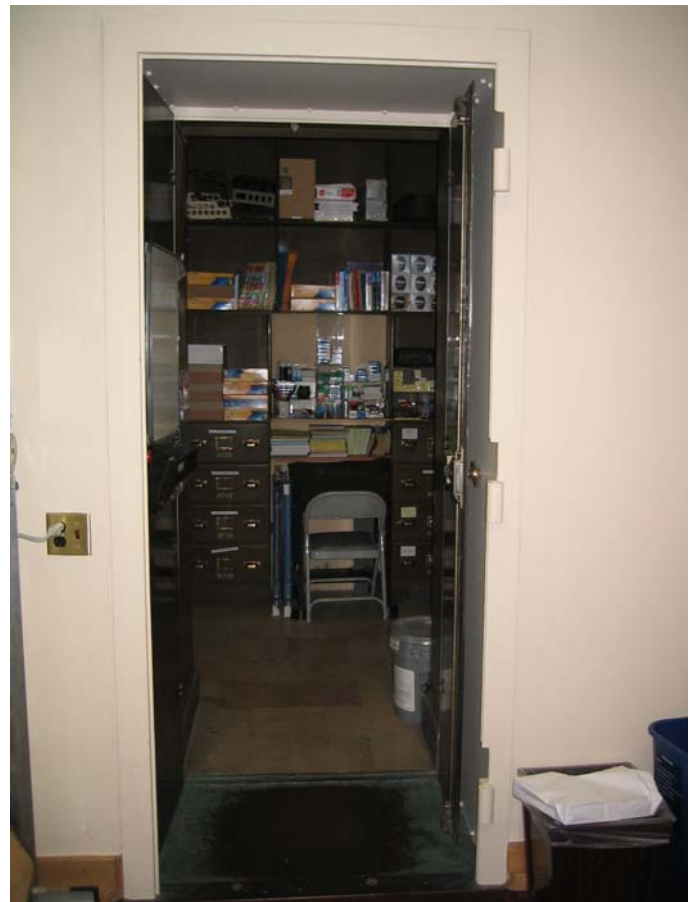
Original inner vault door; outer vault door missing

154 Vault with metal shelving

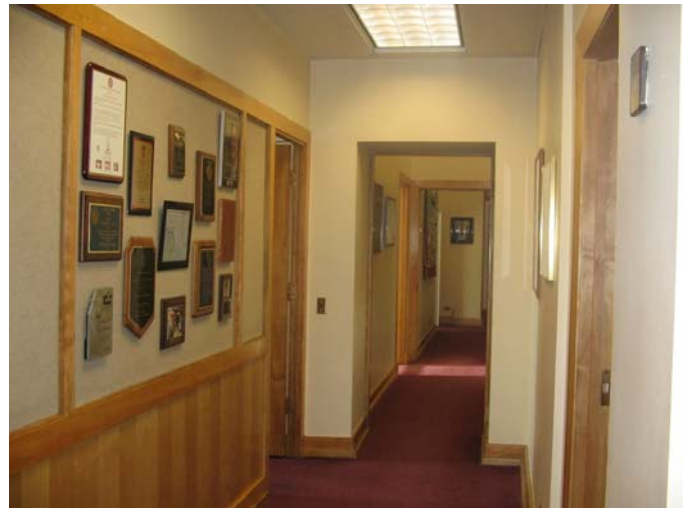
160 View looking north at wood in-fill panel

Finishes in good condition, except as noted; ceiling panels need cleaning

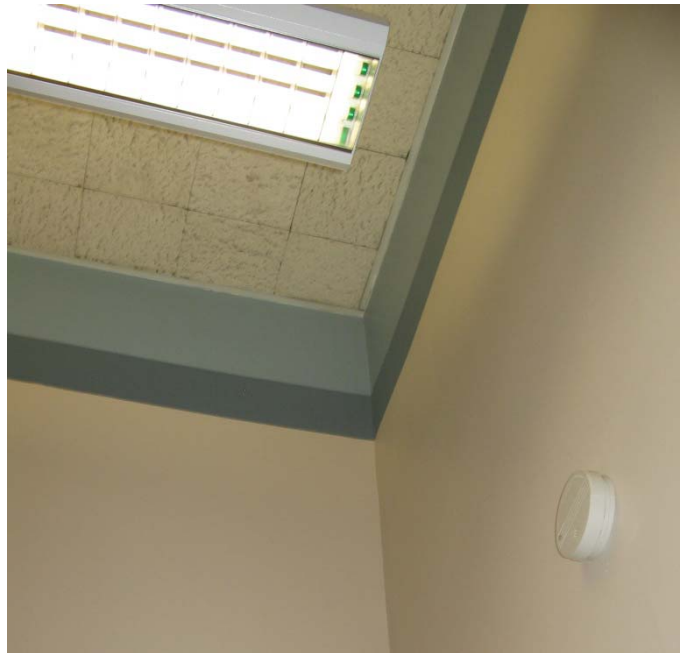
161 Existing ceiling conditions

No preservation work required

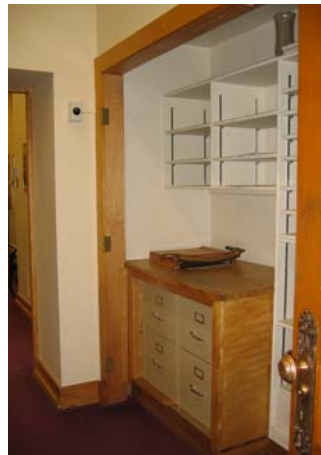
Original walls painted plaster with smooth finish; non-original walls painted gypsum board with smooth finish; two non-original closets installed on north wall, doors missing on larger closet; no stone wainscot as suggested walls are by original drawings

161 Closets on north wall

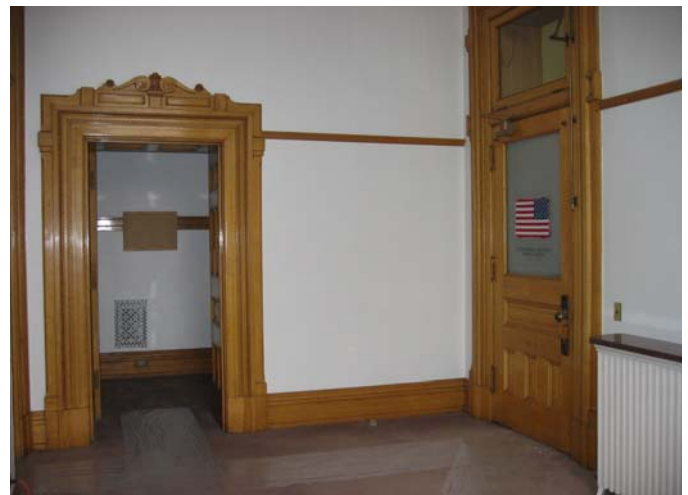
Finishes are in good condition and consistent with current use; walls show signs of patching and normal wear

201 Corner window and crown molding detail

201 Original radiator housing with Cedar marble top

201 Northwest corner looking at Room 204 and door to corridor

No preservation work required

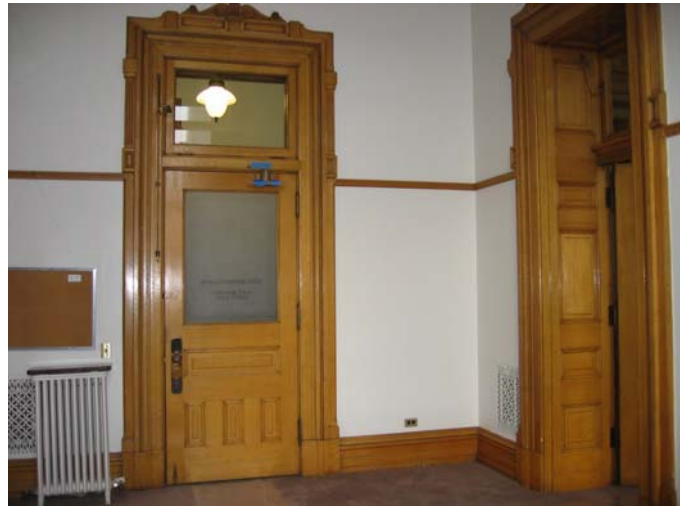
Finishes are in good condition and consistent with current use

202 Door to corridor

202 Southeast corner

No preservation work required

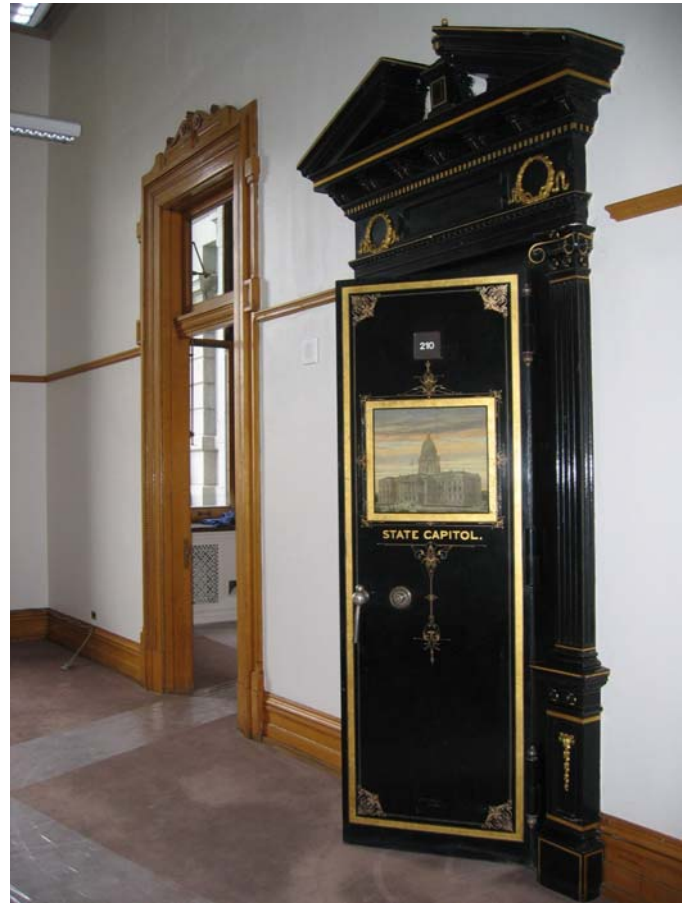
Finishes are in good condition

210 View of original vault door

210 Metal filing system

No preservation work required

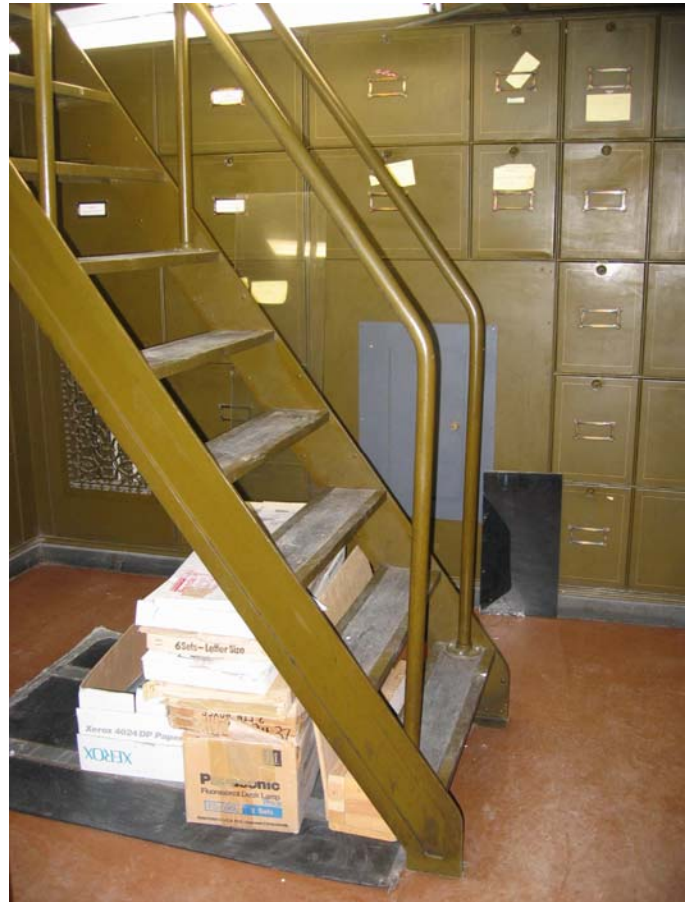
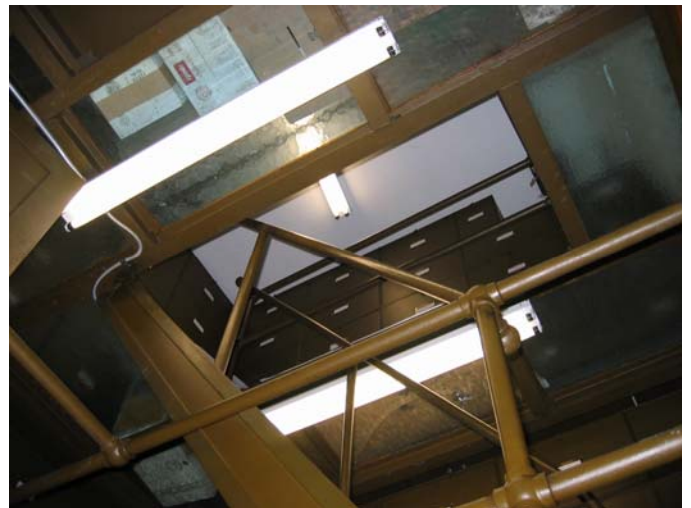
Finishes are in good condition

211 Bottom of internal stair

211 View up through internal stair

No preservation work required

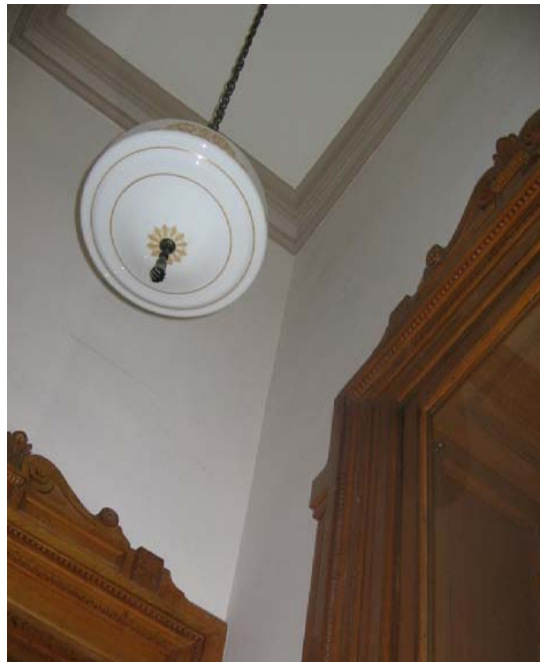
Finishes are in good condition, except as noted, and consistent with current use; walls show signs of patching and normal wear

212 View looking south

212 Lighting and trim detail

No preservation work required

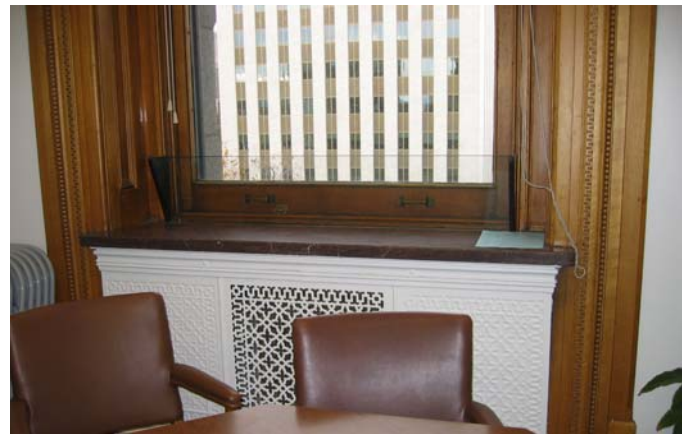
Finishes are in good condition and consistent with current use; walls show signs of normal wear.

221 Corner chase

221 original cast iron radiator front at north window

221 west door to 222

No preservation work required

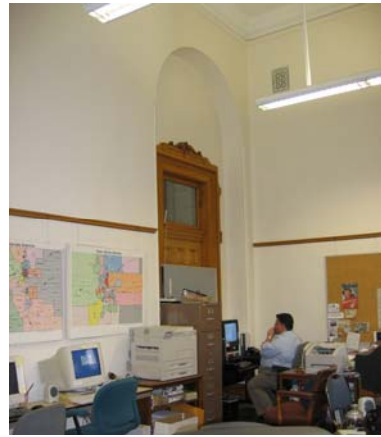
222 Wood trim and plinth

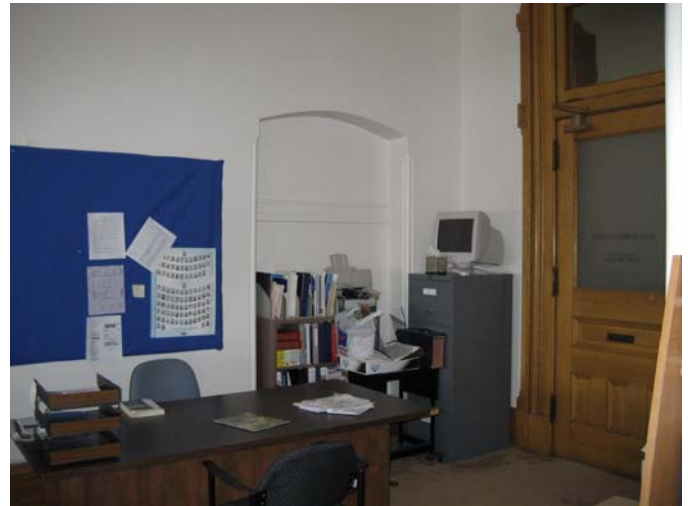
223 View of northeast corner and in-filled arch

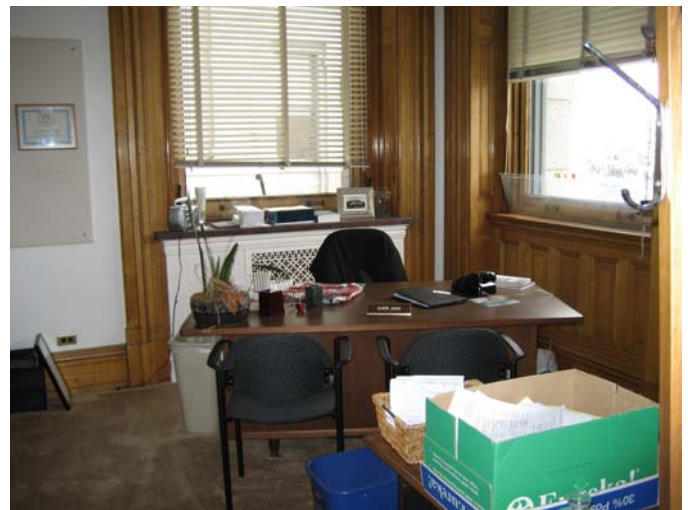
223 View to southwest corner of room

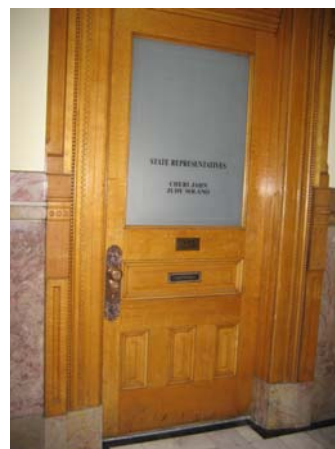
223 Entry from Arcade side

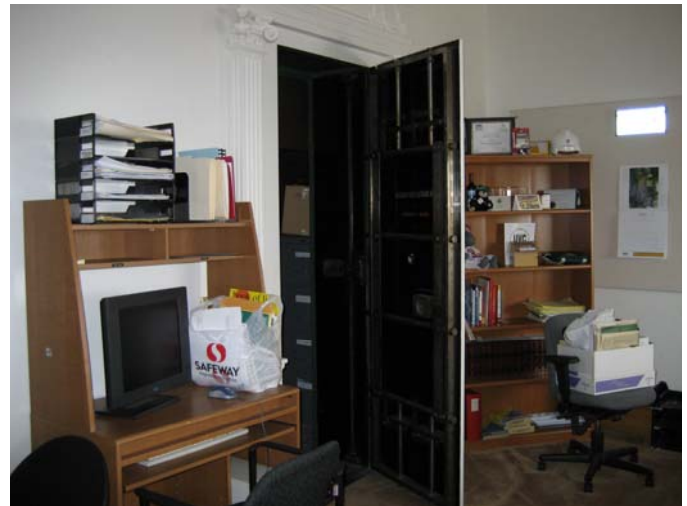
224 Original vault door from Room 223

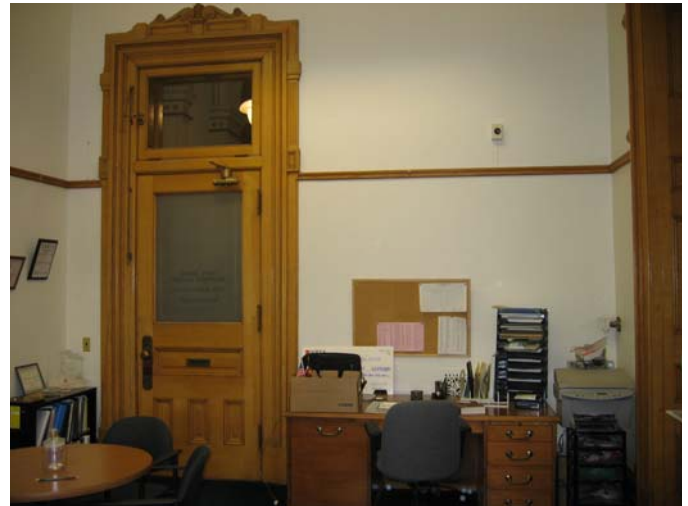
227 East wall and door

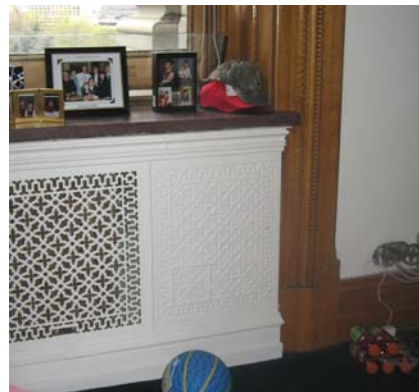
227 Original radiator with cedar marble sill

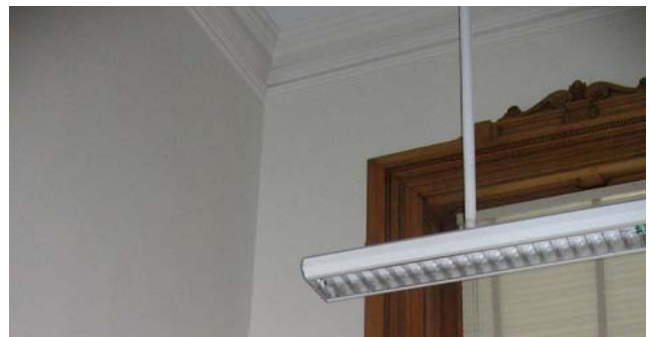
227 Wall, window and cornice detail

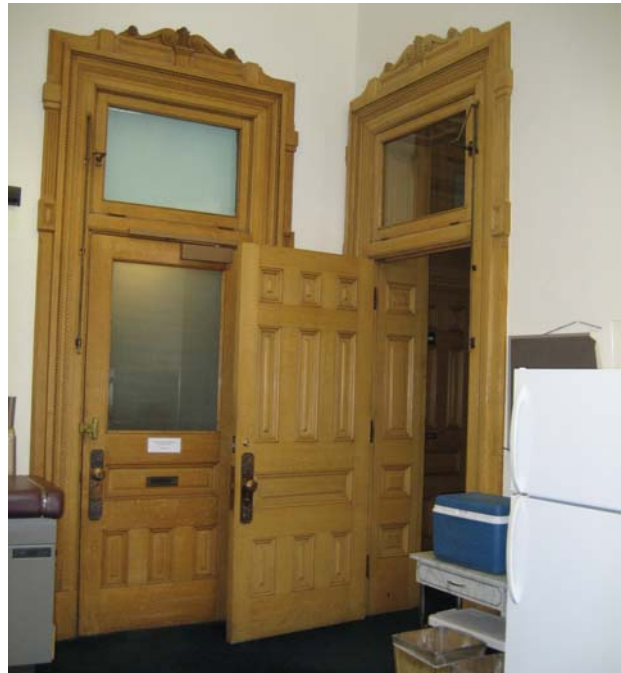
229 Southeast corner and doors to stairwell 228 and hallway 231

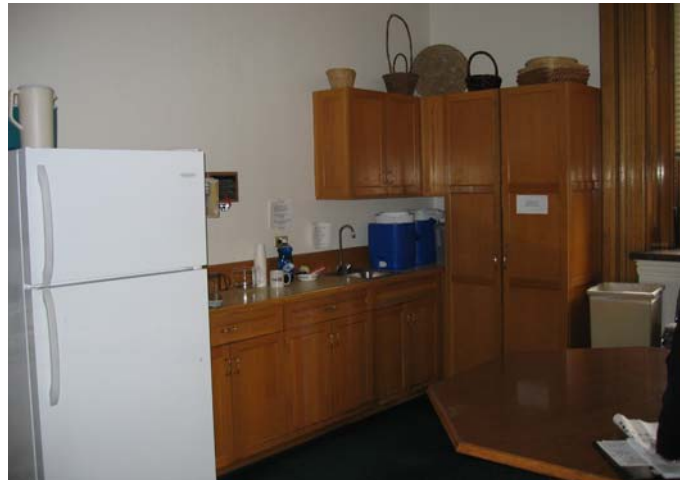
229 Non-original cabinetry in the southwest corner

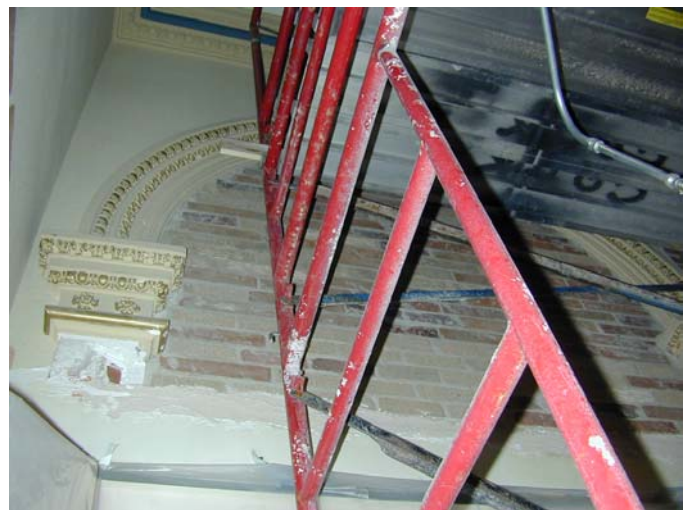
230 Remnants of former arched opening above ceiling
