# COLORADO STATE CAPITOL

## HISTORIC STRUCTURE ASSESSMENT

STATE HISTORICAL FUND PROJECT NUMBER  
SHF-2006-T1-001

**December 15, 2006**

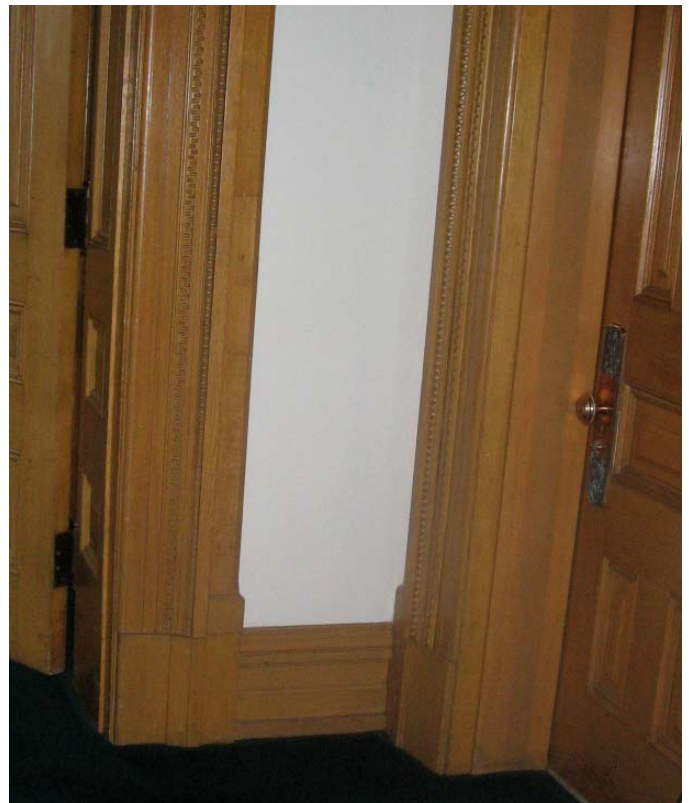
231 Door to Room 229 detail

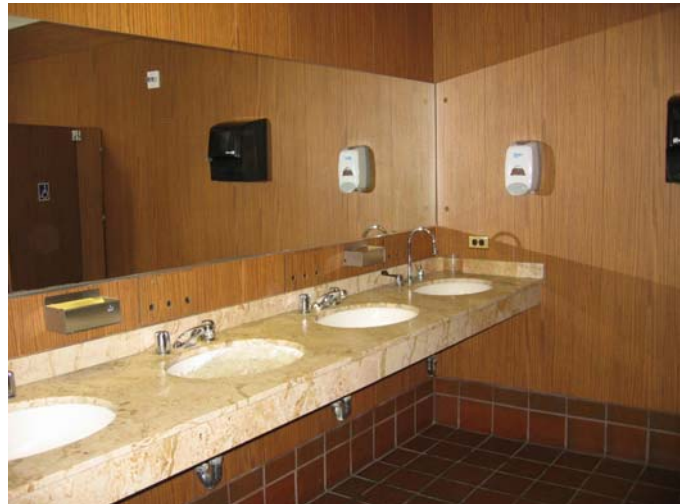
232 View of sink area

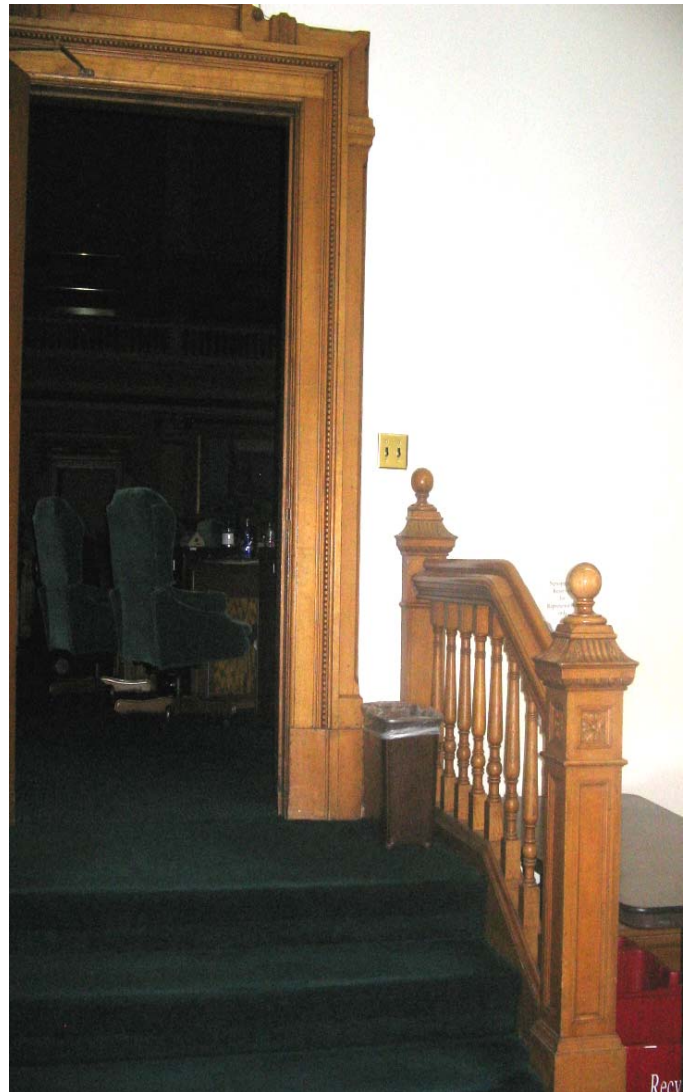
234 Steps to House Chamber

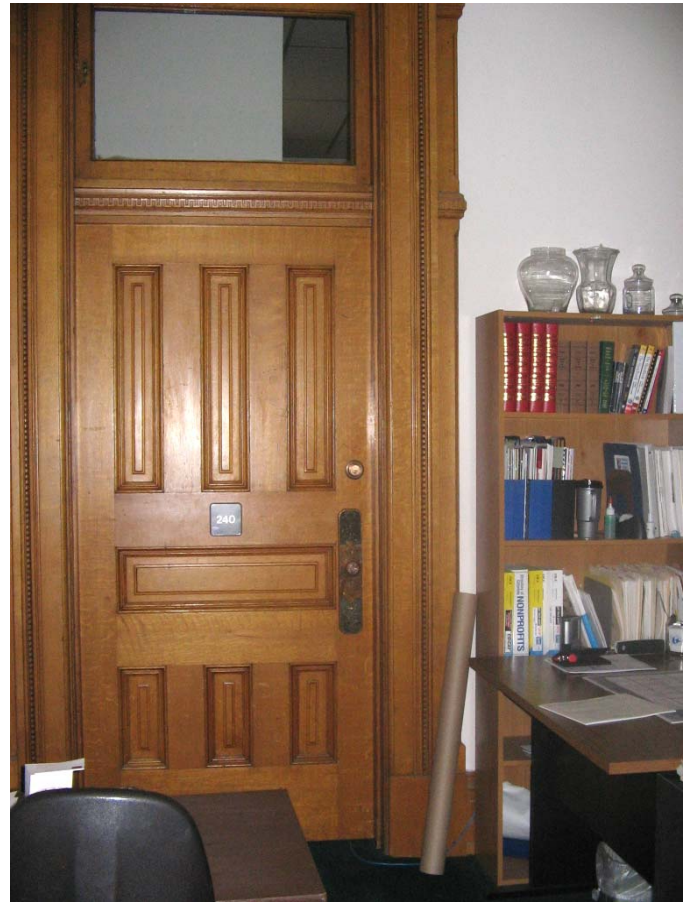
239 Door to Room 240

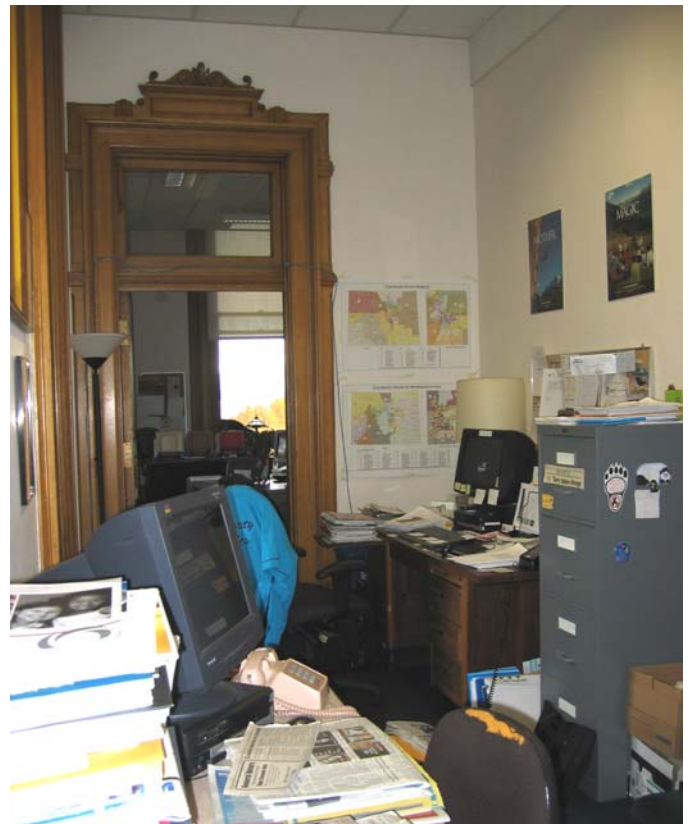
240 Looking west towards Room 241

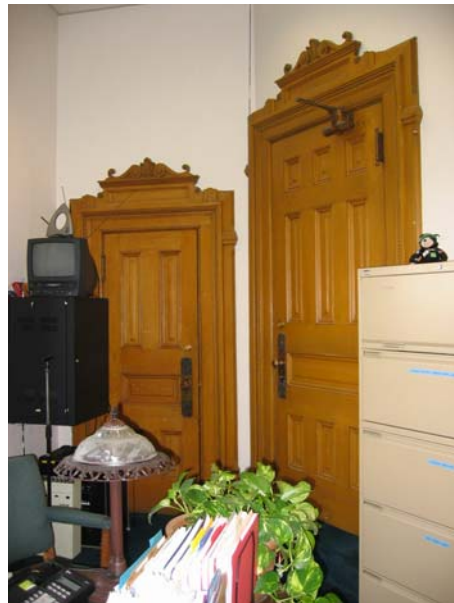
241 Northwest corner at server closet and door to House Chamber

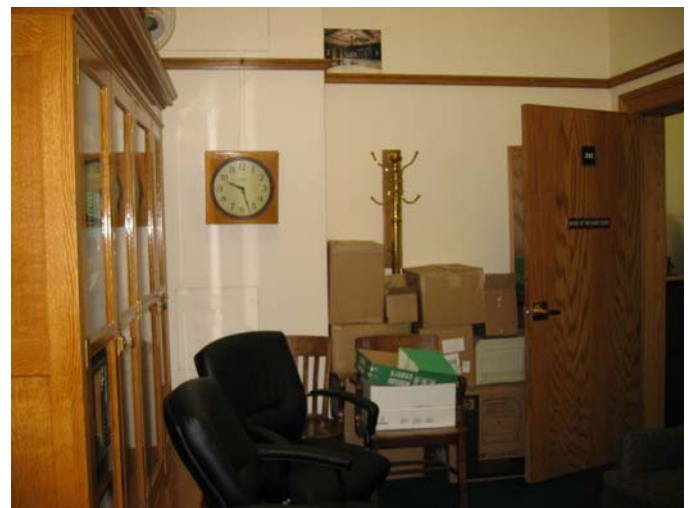
242 Picture rail and standpipe chase on the south wall

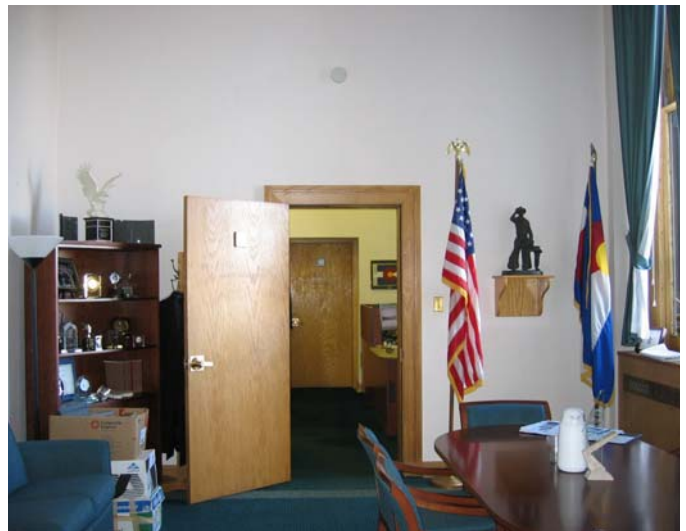
244 Non-original slab door and trim work on the south wall

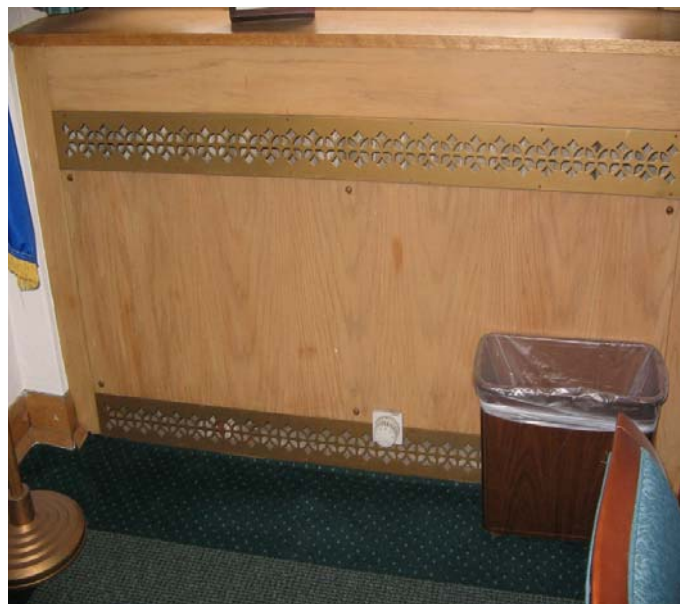
244 Non-original radiator housing detail

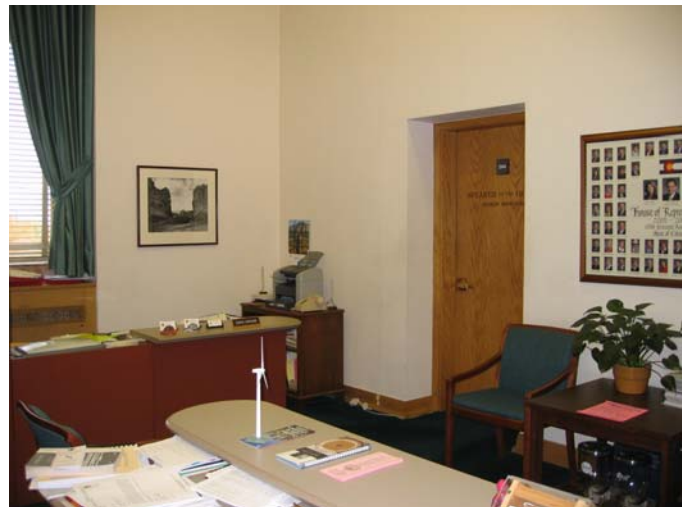
246 Non-original door and trim to Room 244

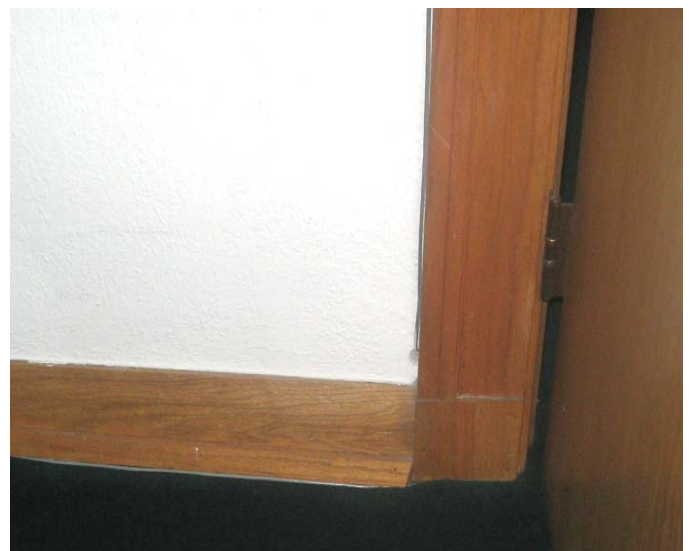
247 Non-original wood trim and base detail

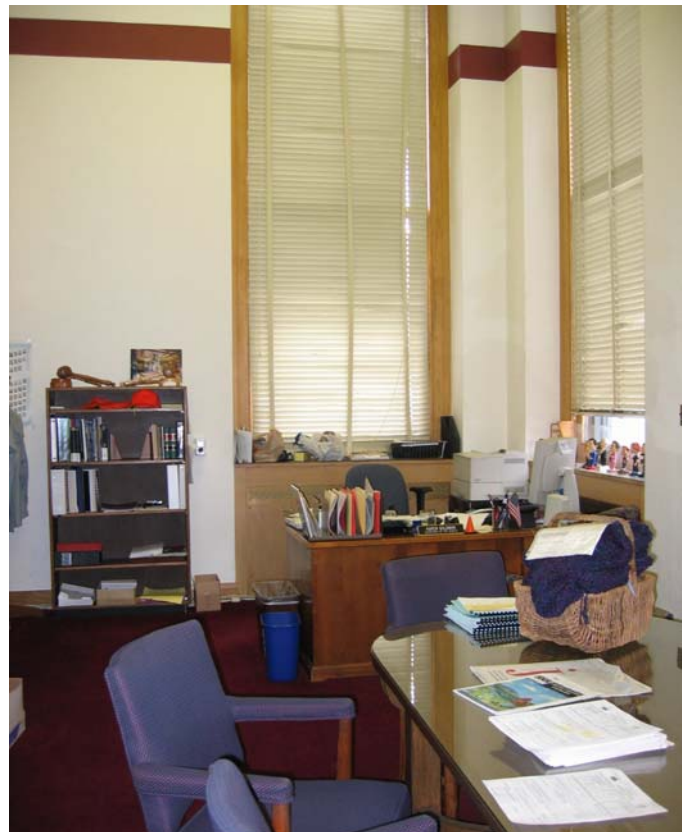
250 Windows in southwest corner with original trim removed

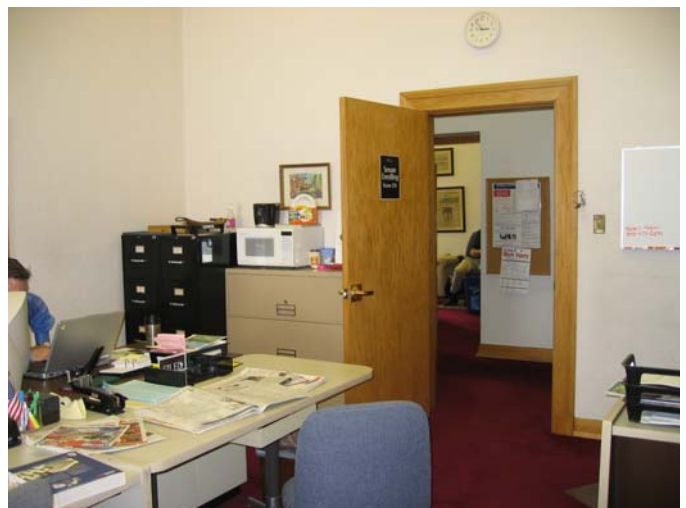
251 Non-original door on north wall

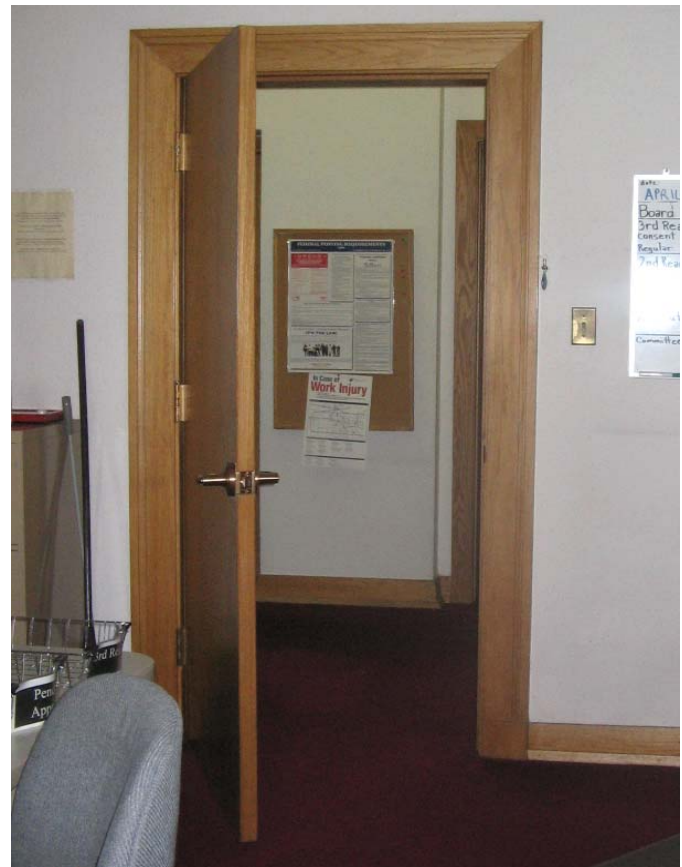
252 Non-original door on north wall

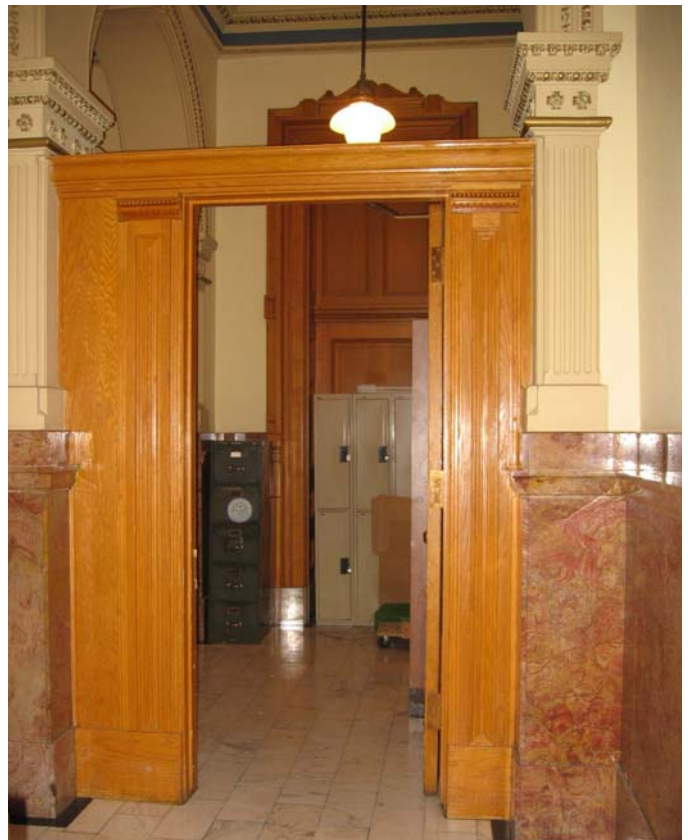
253 Looking west at in-filled door to Room 247

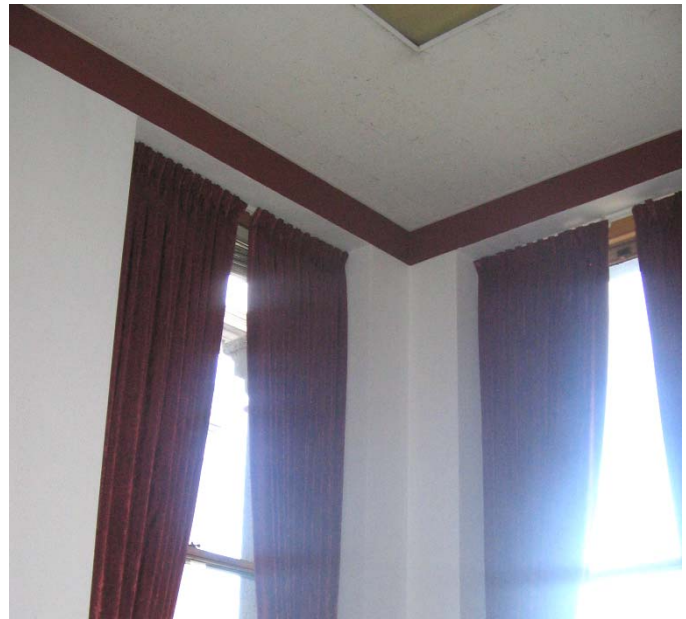
259 Original wood window trim has been removed

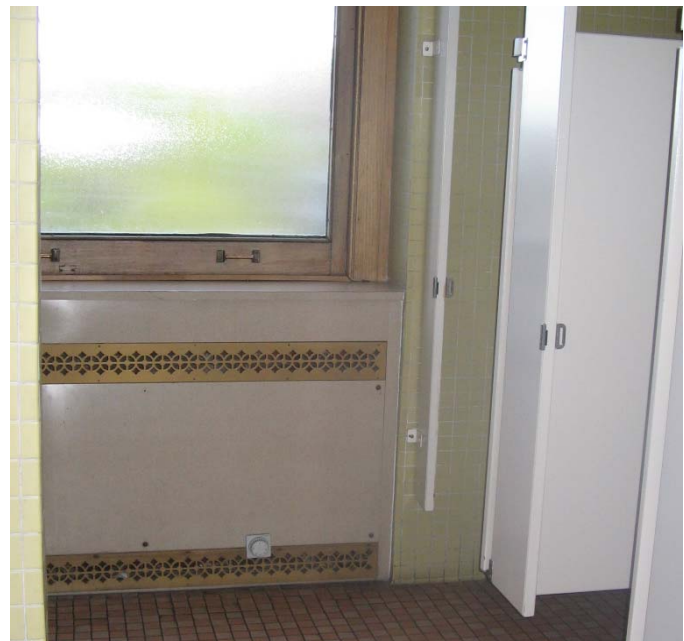
262 Window modifications and non-original metal partitions

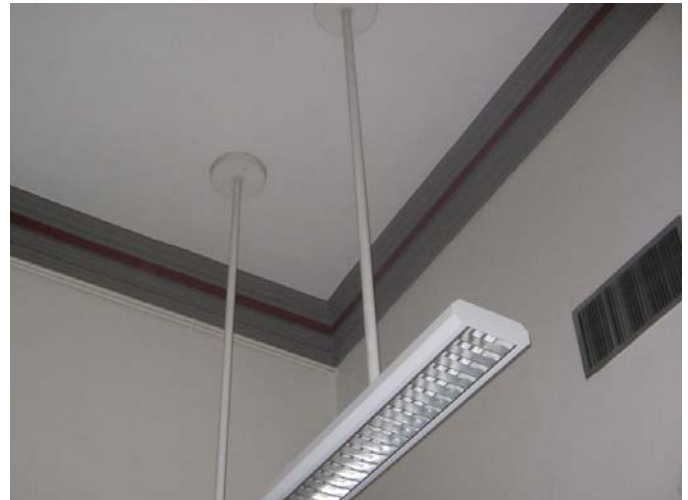
Smooth plaster, in fair condition; original plaster cornice; exposed conduit on ceiling

263 Existing cornice detail

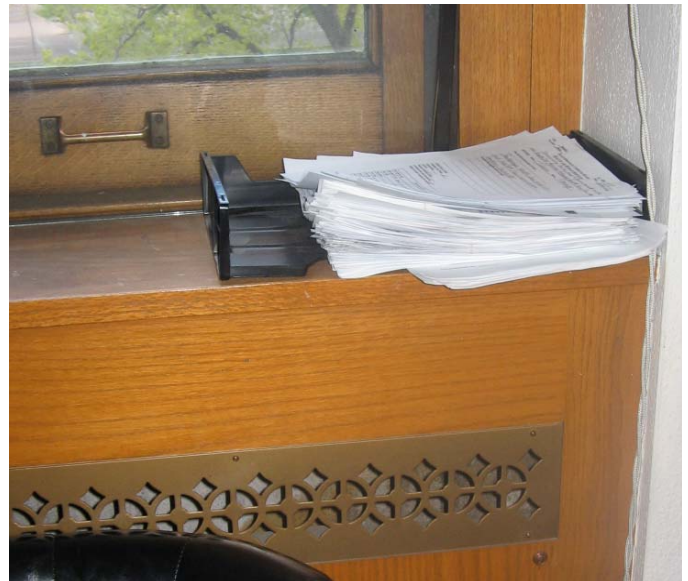
263 Modified window trim and non-original radiator panel detail

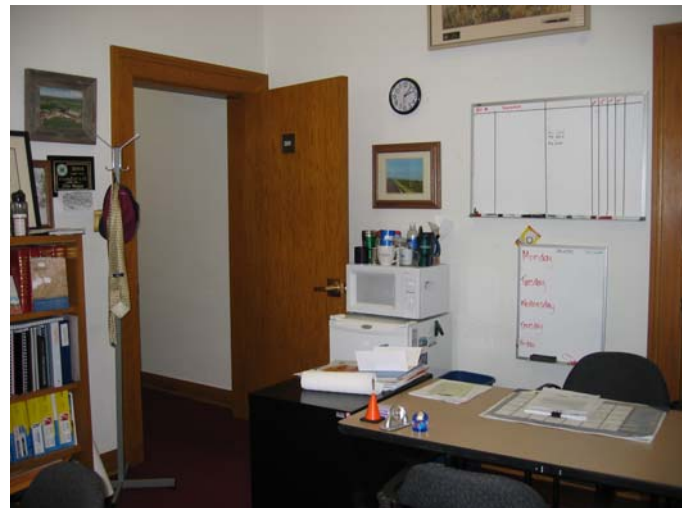
269 non-original slab door on the south wall

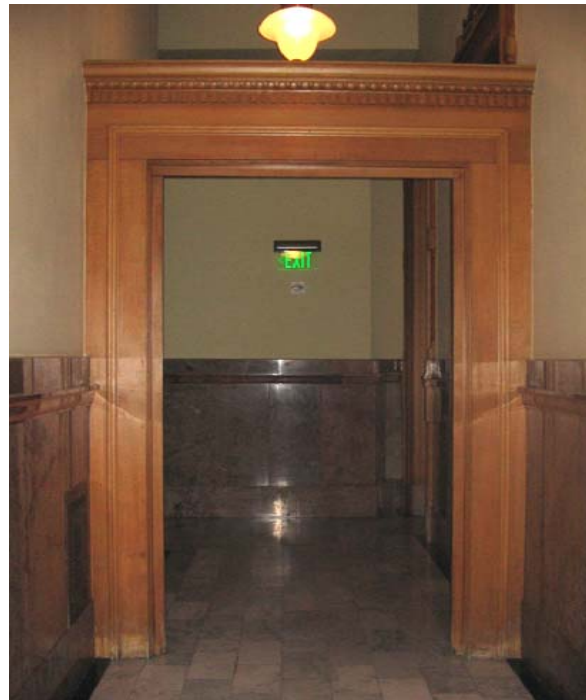
303 Non-original cased opening looking west

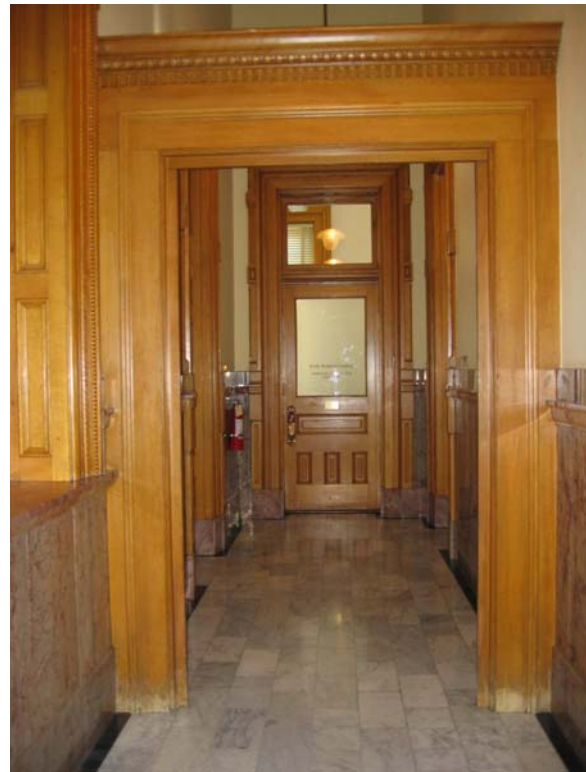
303 Non-original cased opening looking east

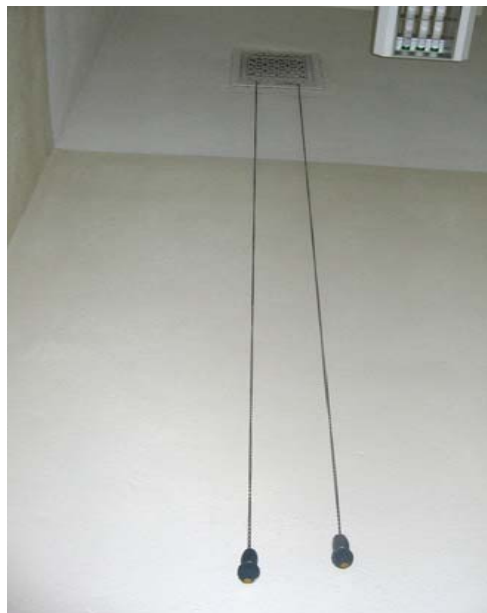
304 Original damper operator in place

The space is in good condition and consistent with current use, walls show signs of patching and normal wear

No preservation work required

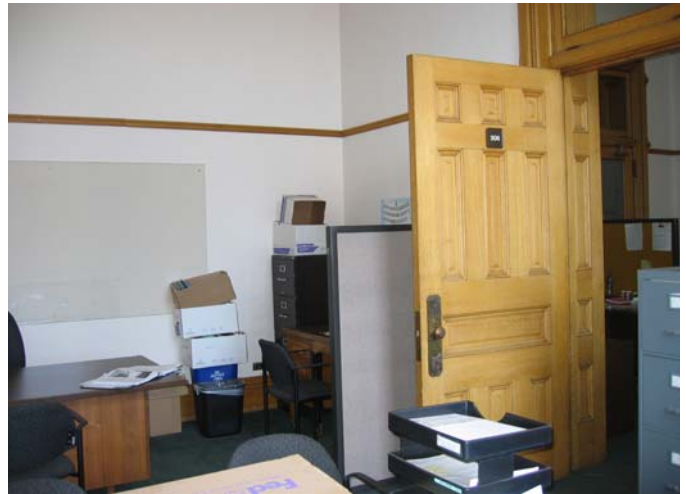
306 Interconnecting door to Room 305 at northwest corner

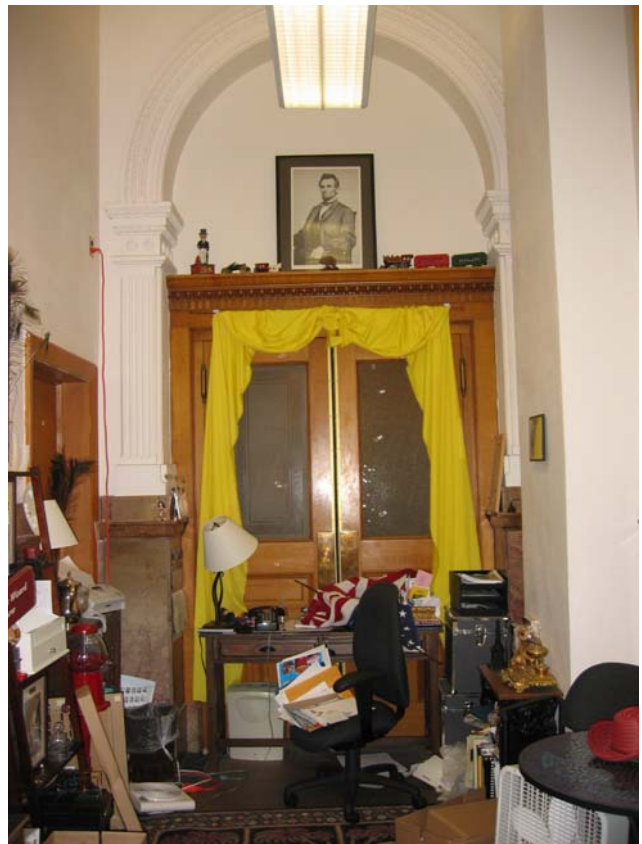
308 Non-original header and door location, west wall

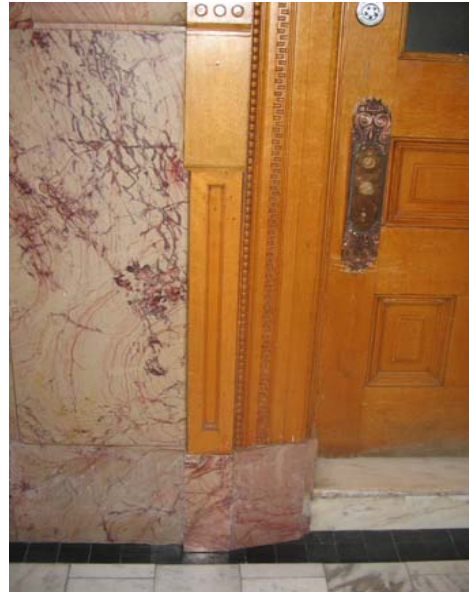
311A Existing original detailing at restroom door

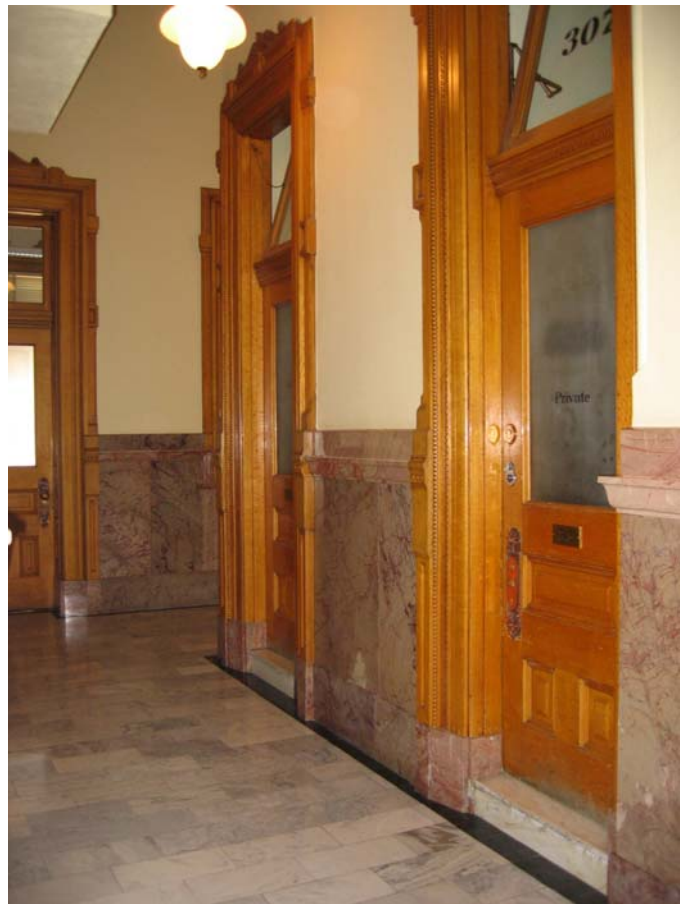
Exterior doors to 312 and 313

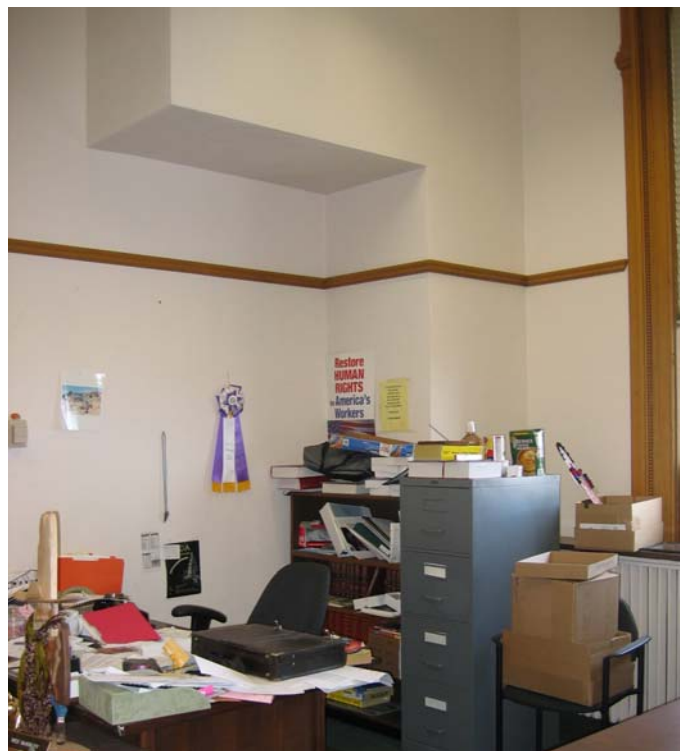
314 Mechanical Chase in northwest Corner

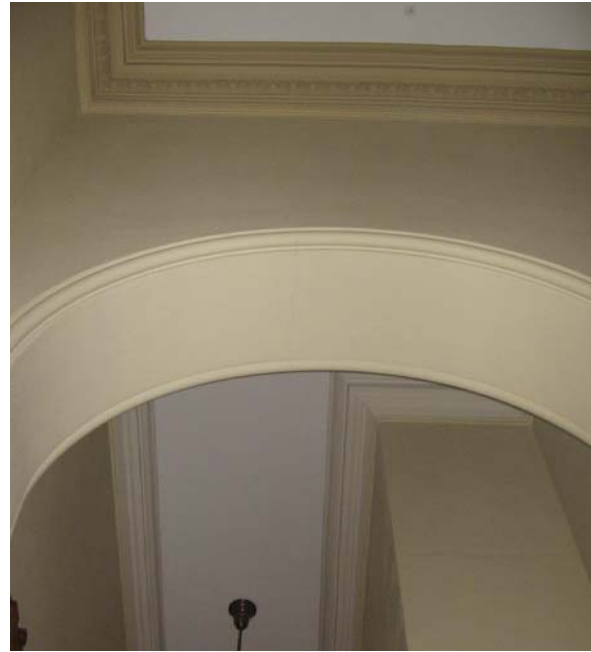
315 Corridor ceiling and corded arch detail

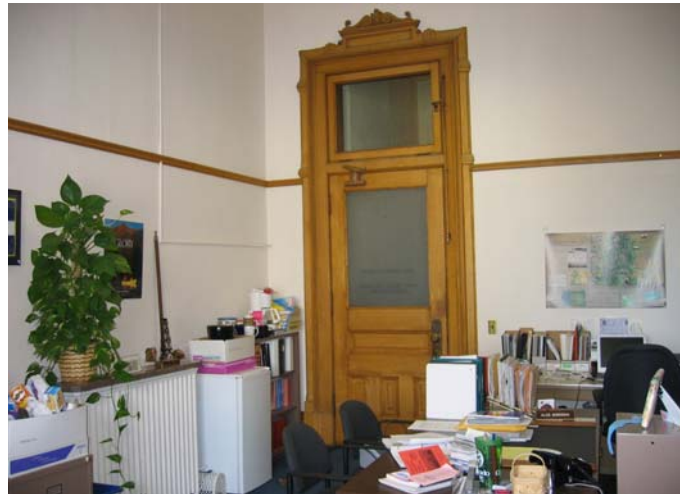
316 Main door to Hallway 315

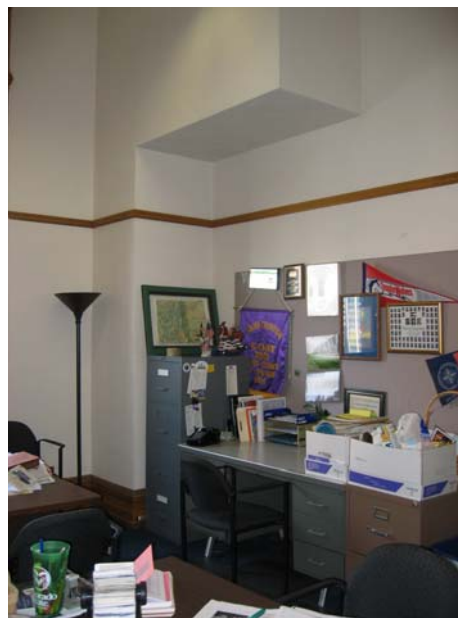
316 Mechanical chase, northeast corner

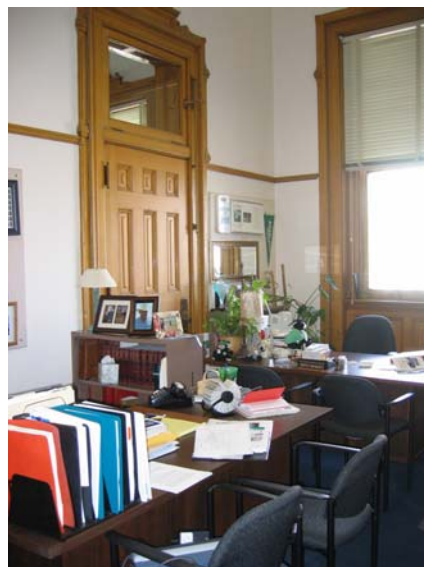
316 Interconnecting door to Room 317, west wall

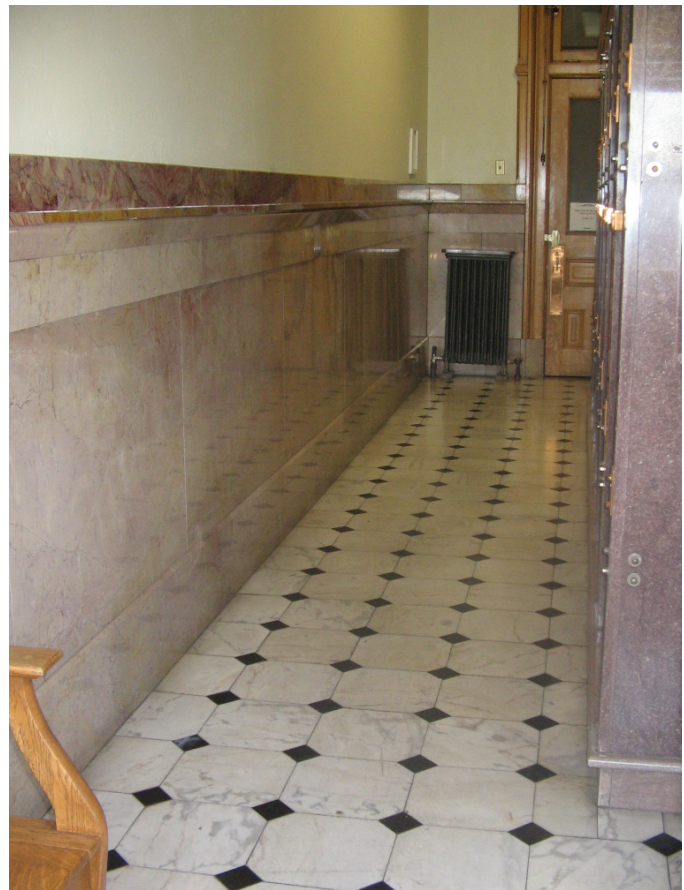
319 Original restroom finishes with radiator on east wall

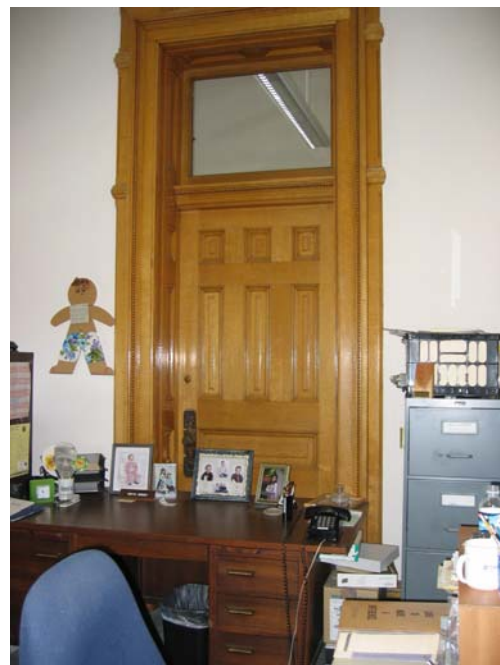
320 Interconnecting door to Room 322; inoperable

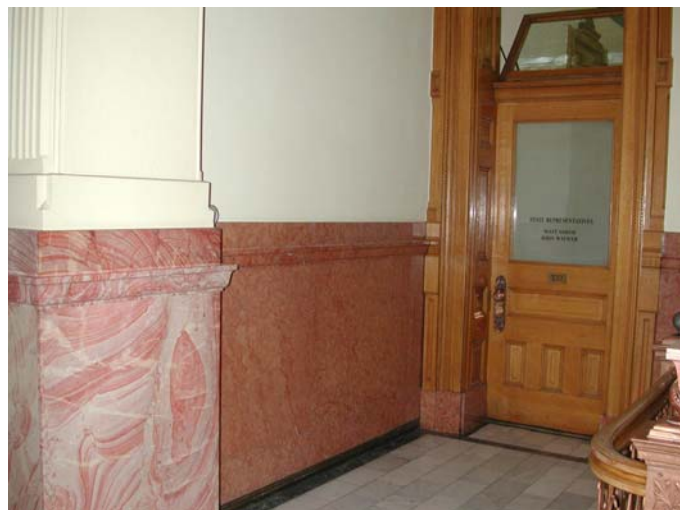
322 Door to Room 332 from Stairwell 337

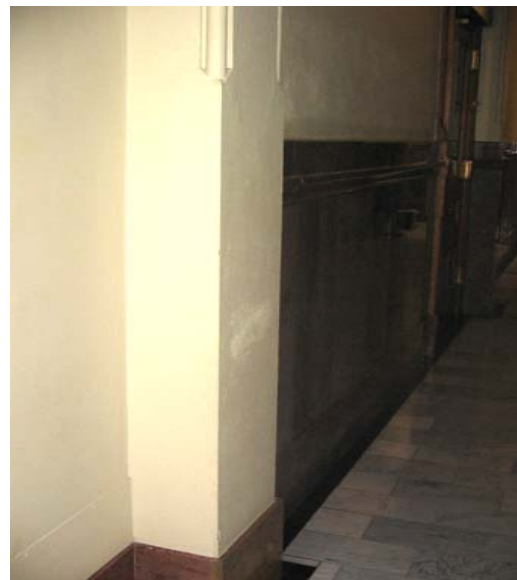
328 Missing wainscot at east wall archway

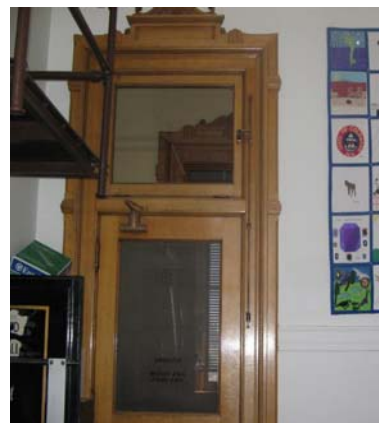
337 Entry door from Hallway 344A

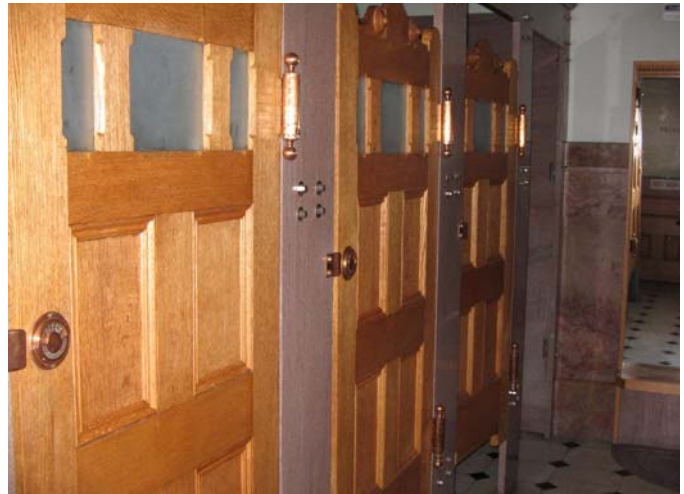
Original wood stall doors with frosted glass panel insets; original hardware

340 Original Cedar marble partitions and oak stall doors

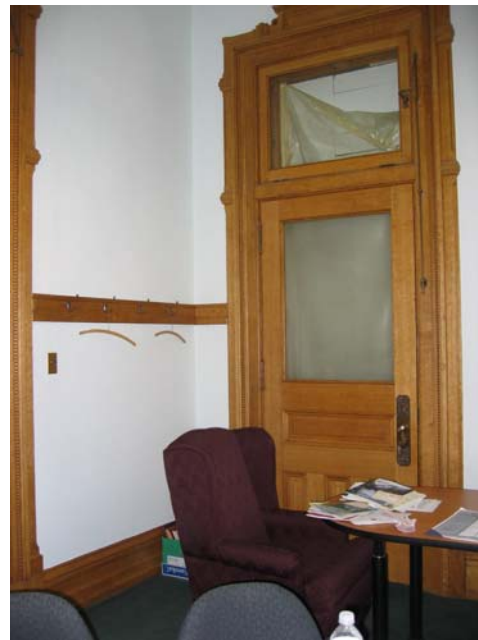
Door to 342: relocated original type D1; inoperable; original etched door glazing with Greek key border; non-original clear transom glazing; columbine plates both sides; knobs missing; wrapped panel over entire door and transom on room 342 side; trim type T2

341 Northwest corner with inoperable door to Room 342

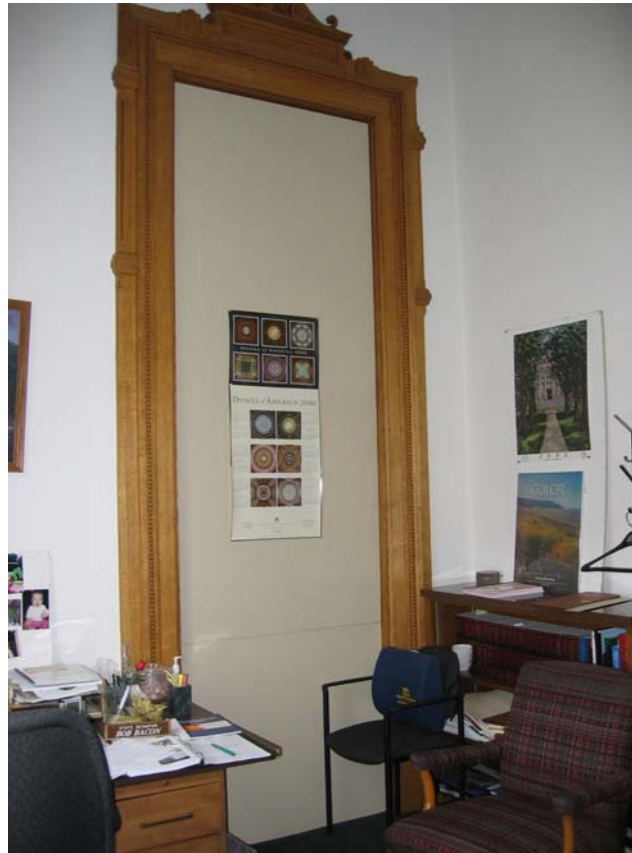
Door to 341: relocated original type D1; inoperable; original etched door glazing with Greek key border; non-original clear transom glazing; columbine plates both sides; knobs missing; wrapped panel over entire door and transom on room 342 side; trim type T2

342 In-filled fabric wrapped panel on south wall door to Room 341

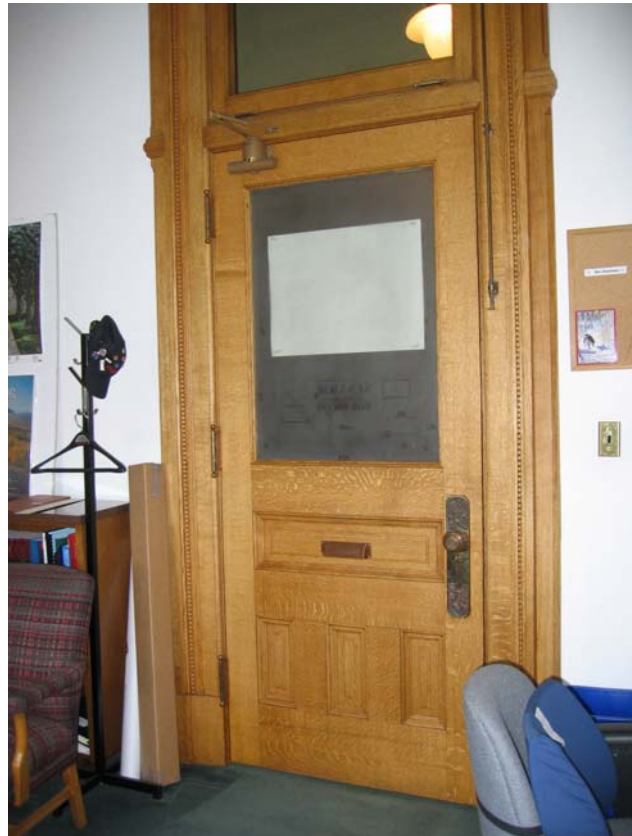
342 Door from corridor

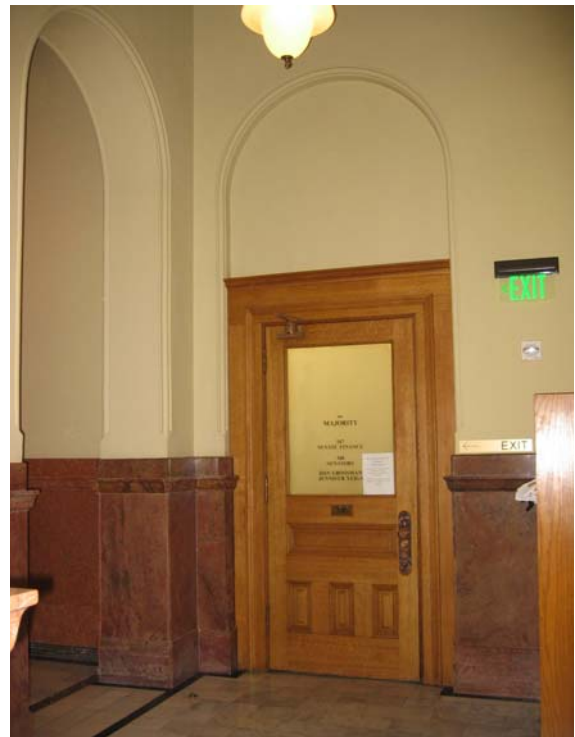
344A Northwest corner to Room 346

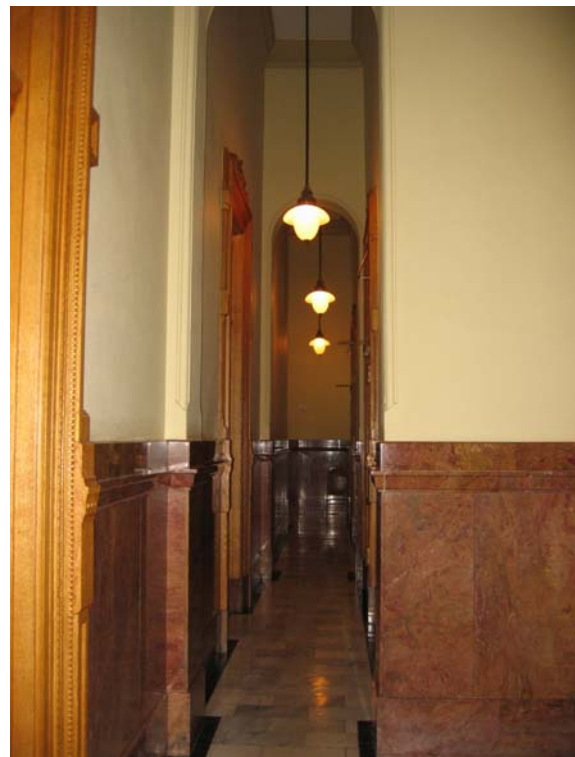
344A View looking to Hallway 344

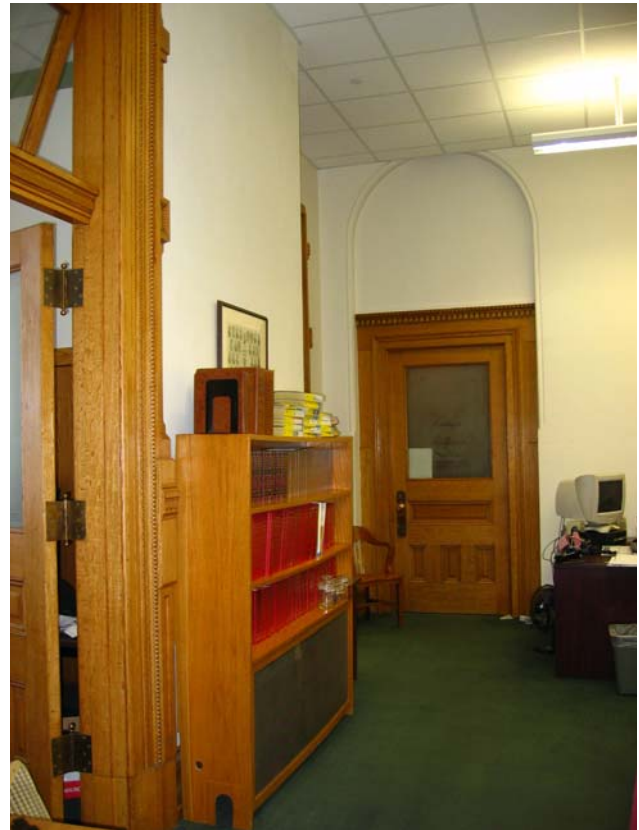
346 In-filled archway with missing wainscot

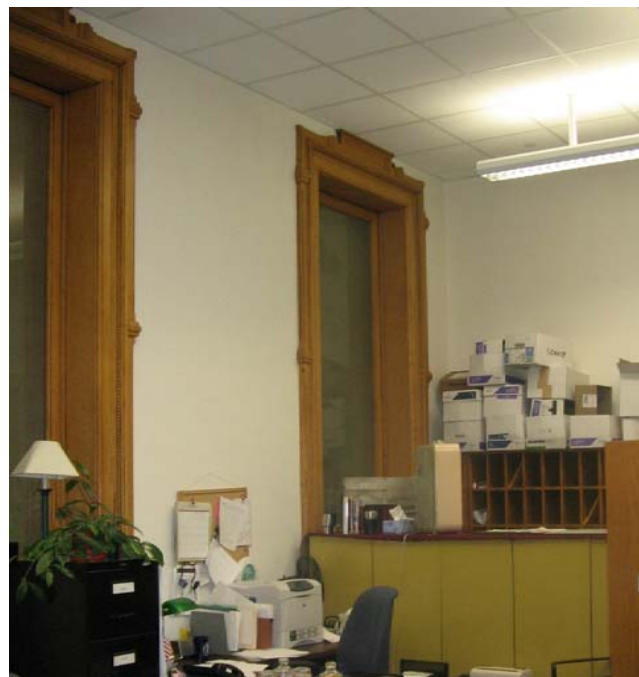
346 View of west wall

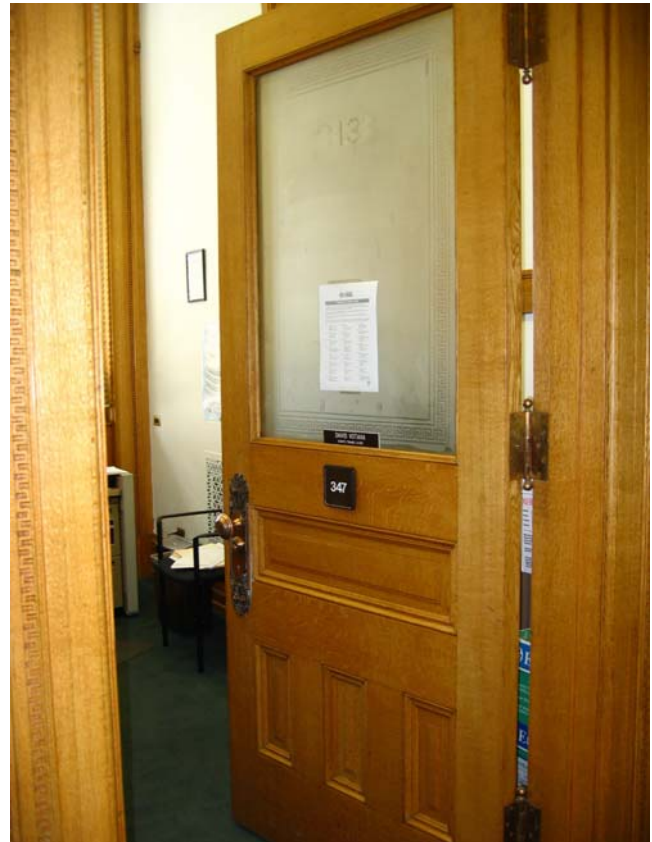
347 Entry door from Room 346

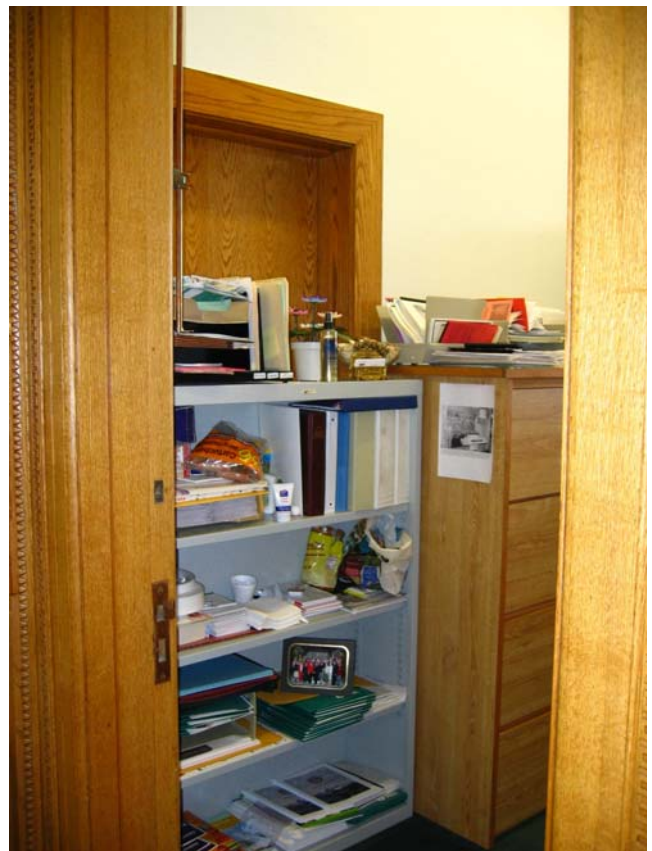
347 View of inoperable connecting door to Room 348

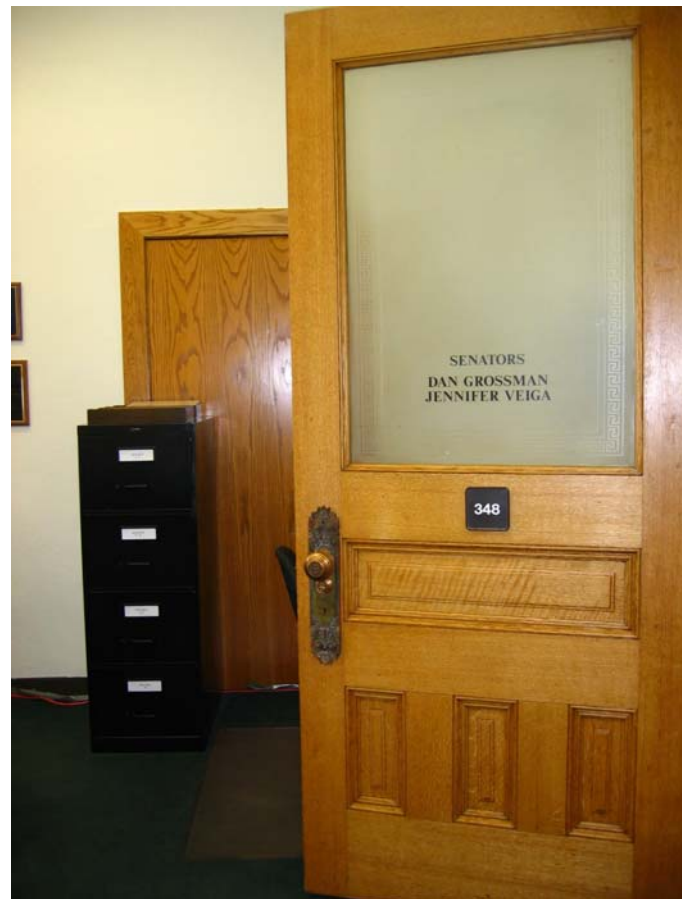
348 Entry door looking south to Room 347

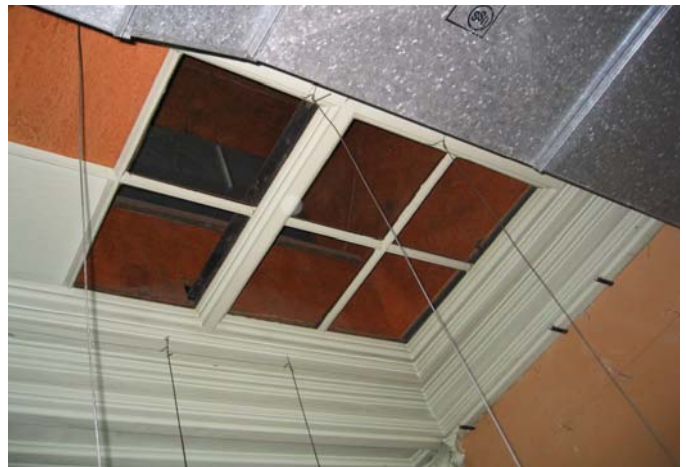
351 Original skylight above suspended ceiling.

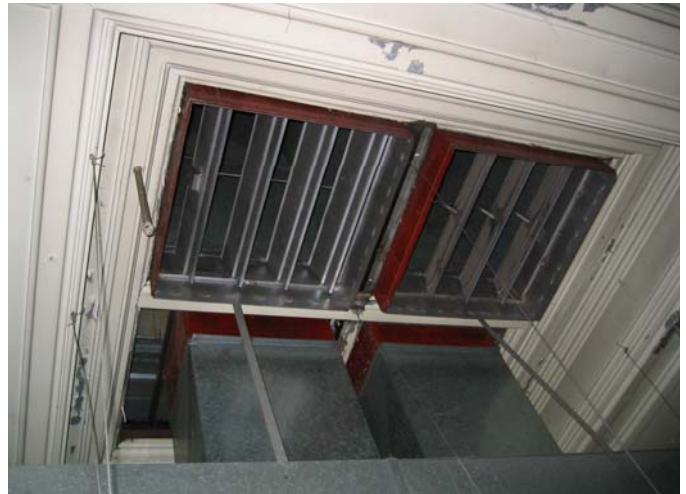
357 Former skylight now serving mechanical functions

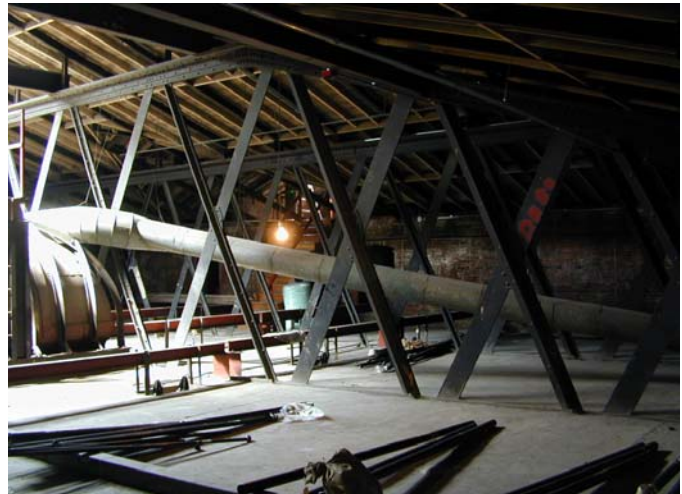
Attic: Iron trusses

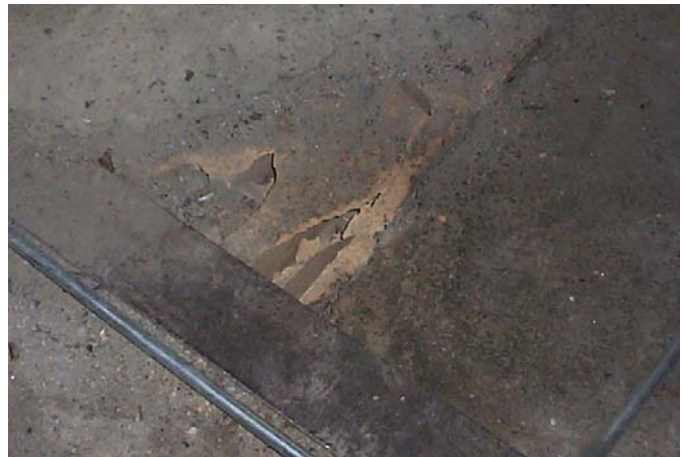
The floor of the Attic is un-reinforced concrete on flat terracotta arches. The finish on the concrete topping slab is of poor quality and was not intended to withstand heavy use. Consequently the floor has fractured and potholed in places. In addition, floor is covered with a numerous trip hazards both original and non-original. The hazards include structural members, uneven concrete, conduit and recently installed sprinkler lines that serve the Third Floor below. As a result step-over and ramps have been installed on the main circulation routes.

Attic: Chipped concrete floor exposing broken terracotta structure

The Attic is in good condition except the floor. Care should be taken so that it is not damaged further. The most deteriorated sections of the floor are located beneath the new gallery space and are no longer at risk.
