# COLORADO STATE CAPITOL

## HISTORIC STRUCTURE ASSESSMENT

STATE HISTORICAL FUND PROJECT NUMBER  
SHF-2006-T1-001

**December 15, 2006**

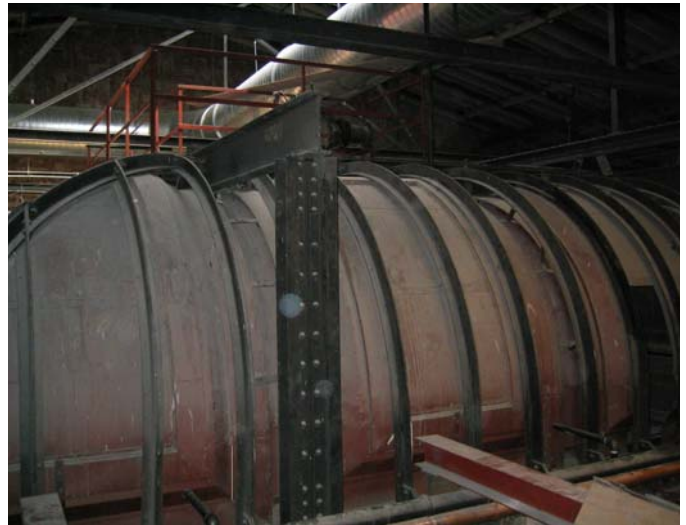
Of the six interior skylights, only the two Atria skylights are performing their intended function. The House and Senate Chambers skylights have been abandoned and obscured from view from below. These skylights are comprised of pressed tin panels with decorative tin drop pendants. The glass (now missing) was held in place by a steel framework similar to the Atrium skylights. The tin panels are painted in a light burgundy color and covered with hand painted patterns recalling the design of the stair pickets. The majority of the drop pendants are missing but a few still remain over the Senate Chambers. Platforms have been erected on the top of these skylights and winches installed to raise and lower the chandeliers in the Chambers below. This and numerous other alterations have caused severe damage to the skylights including the tin panels.

Attic: Senate Chamber interior skylight

Remove abandoned wiring and piping. Provide coordinated oversight of future work on building systems. Prevent further damage to skylights and original ornamental metalwork.

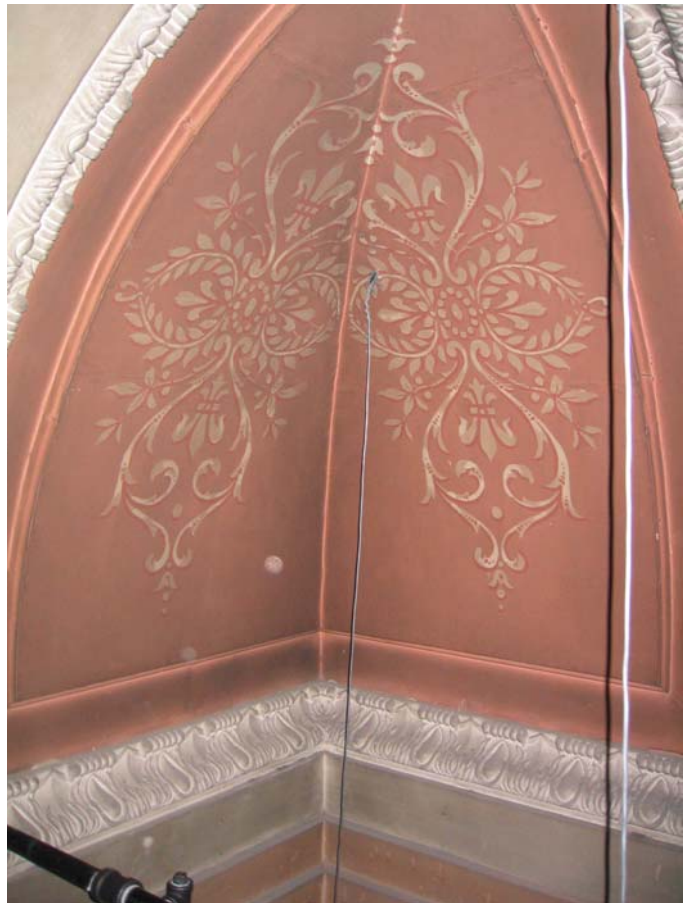
Attic: Senate Chamber interior skylight, hand painted pressed tin panels

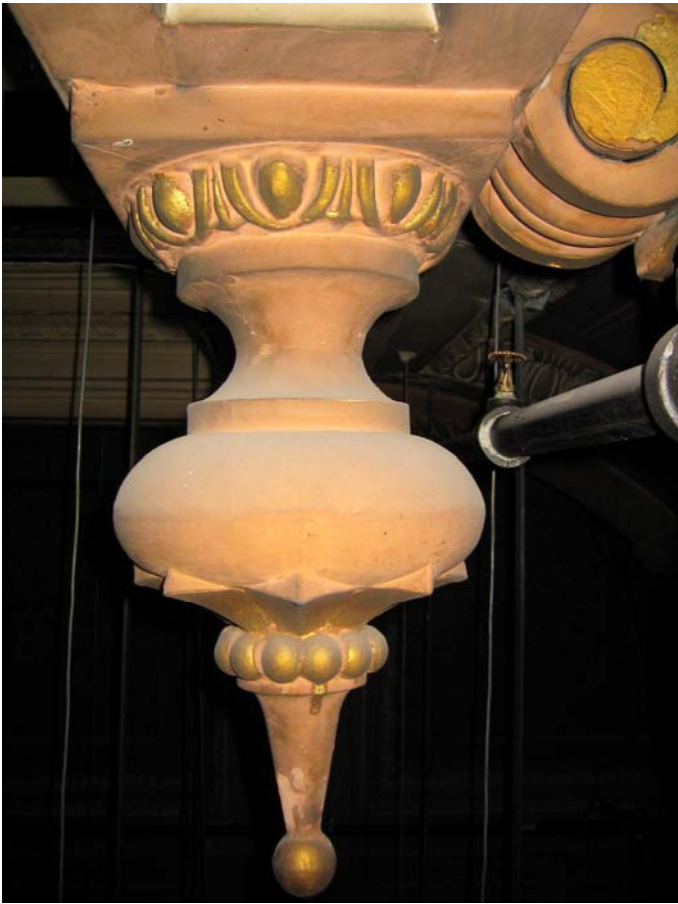
Attic: Senate Chambers Skylight, surviving drop pendant

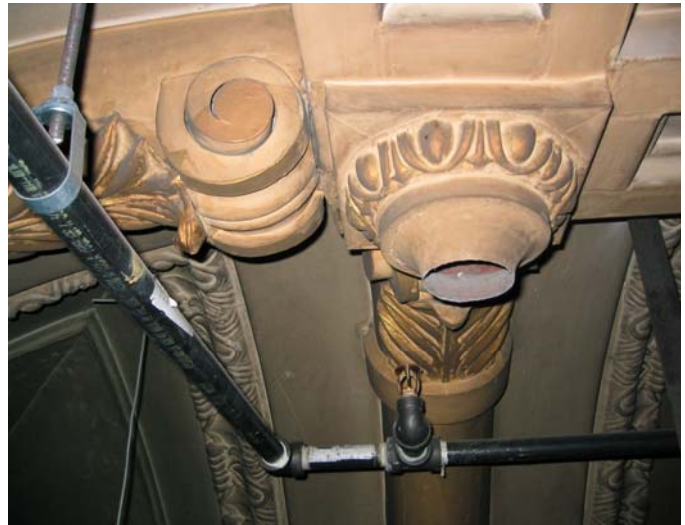
Attic: Senate Chamber skylight missing pendant

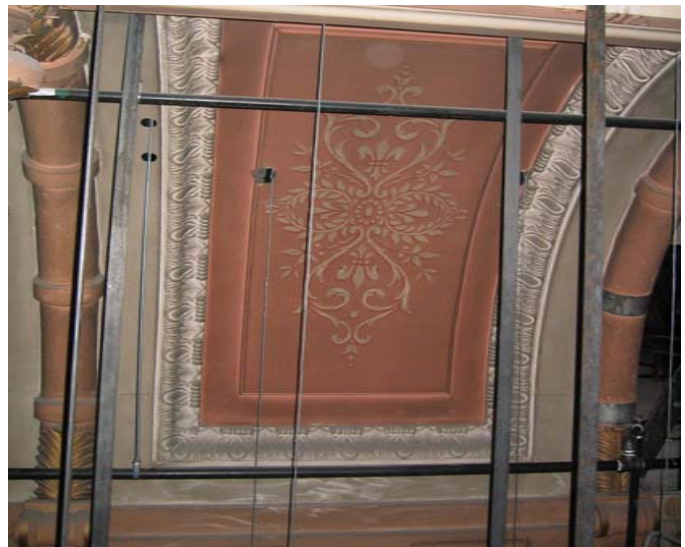
Attic: Senate Chamber Skylight, hand painted panel

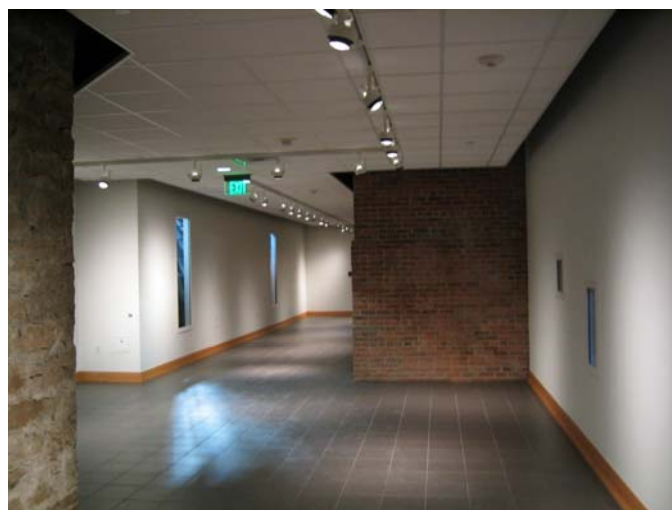
Attic Gallery: New construction with masonry cleaning complete
