Report No. CDOT-DTD-R-96-10

Long-Term Performance of Accelerated Rigid Pavements, Project CXMP 13-0006-07

Final Report
October, 1996

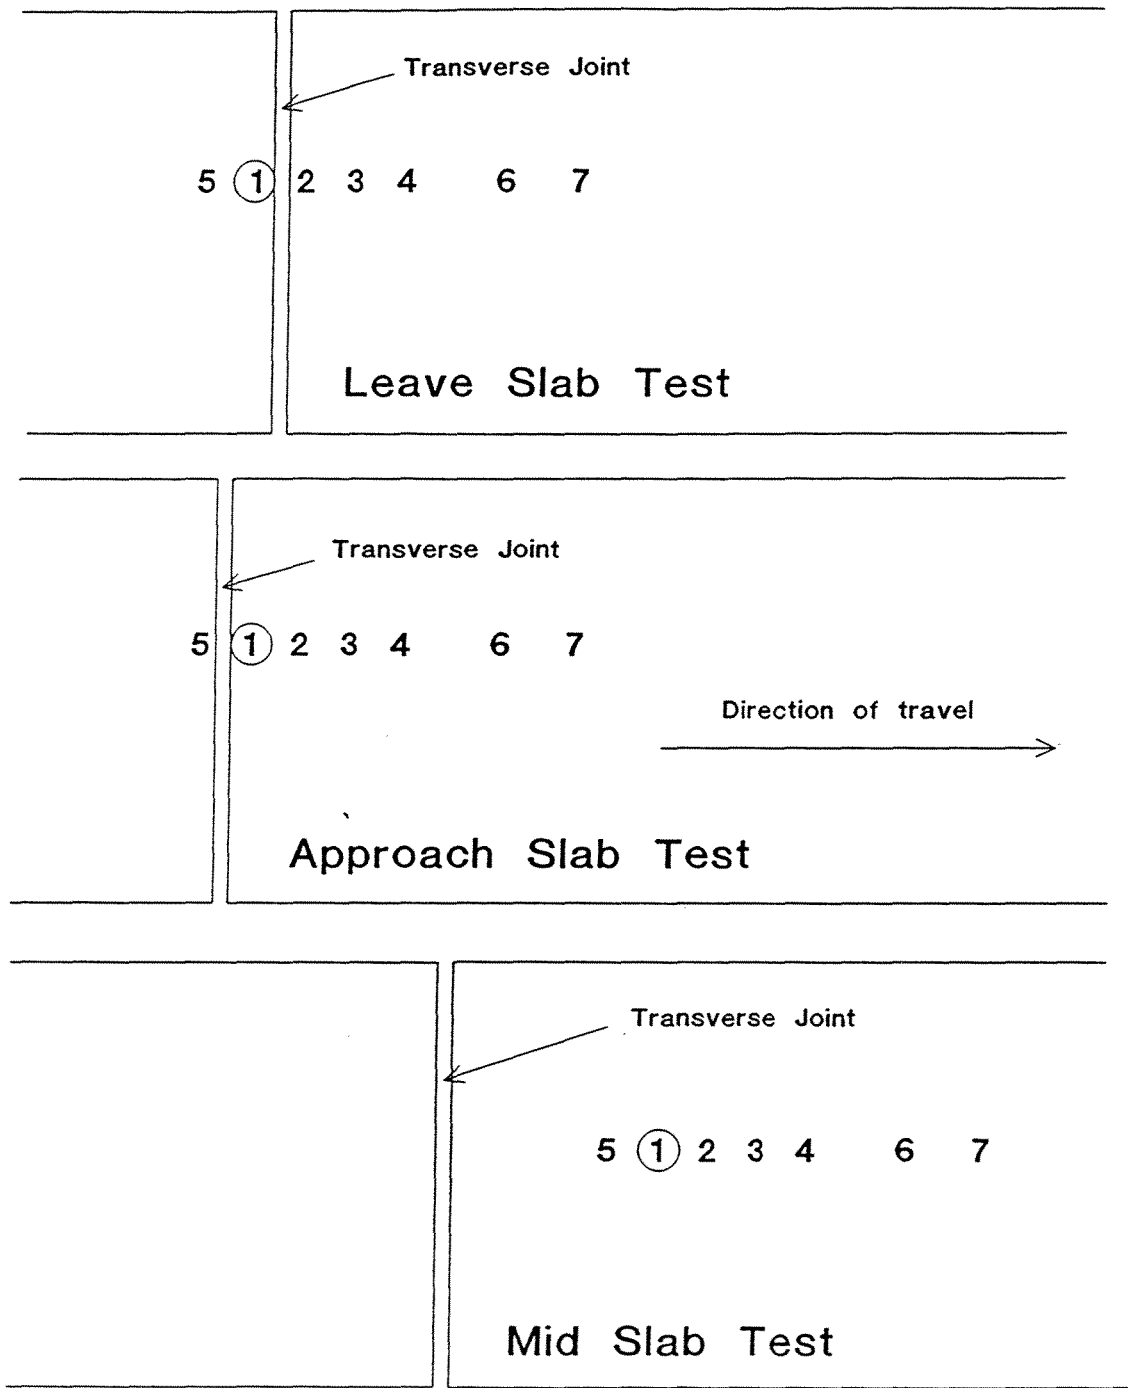
Figure 1

To assess the structural response and the load transfer efficiency across the joints, deflection measurements were acquired using a falling weight deflectometer (FWD) at the leave-slab, approach-slab and at the mid-slab (Figure 1).
