# Colorado Underground Coal Mine Fires 2018 Inventory Report

August 2019

**Tetra Tech**  
350 Indiana Street, #500  
Golden, Colorado 80401

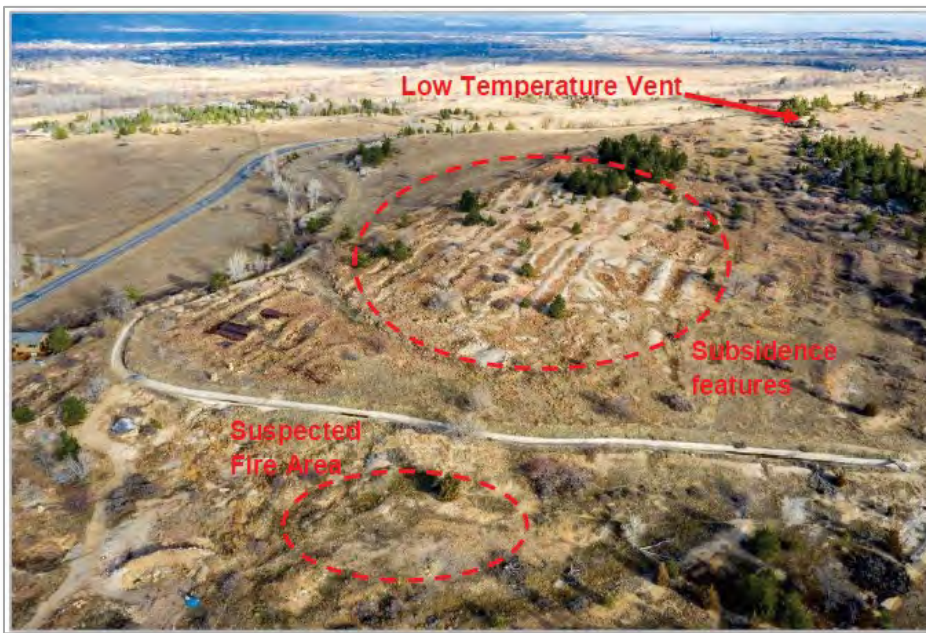
Figure 4-1 – Lewis Mine Fire Looking North

The fire was visited on February 8, 2018 to collect aerial orthophotography and thermal images, 3D surface mapping, and analyze potential fire risks. No venting or elevated surface temperatures were observed at this time. Aerial thermal images showed substantial subsidence has occurred around and under a concrete aqueduct. A cavity approximately 3ft tall, 10ft wide, and 30ft long has developed underneath the concrete aqueduct (Figure 4-1). This is not believed to be related to the fire.

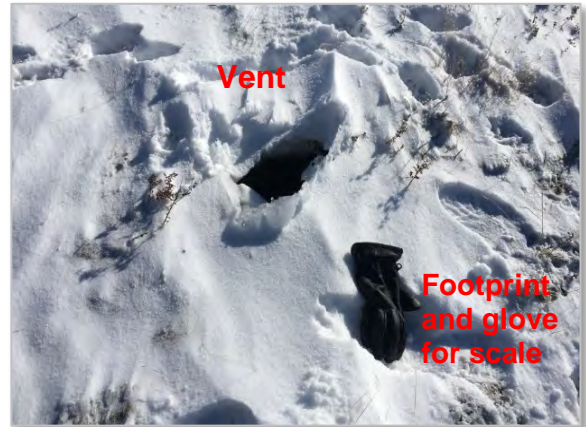
Figure 4-2 – Lewis Mine Fire Vent

On February 12, 2018, the site was revisited to collect snowmelt pictures. One vent (Figure 4-2) was found at 39° 57' 31.93", 105° 13' 10.49". The gas temperature was slightly above ambient. The landowner mentioned that he has observed steam and snowmelt in the winter time in an area south of the lined irrigation ditch, but that area was not active at the time of this inventory.

The fire's activity is very low and thus presents little public safety risk or potential to start a surface fire. While part of the fire is on City of Boulder Open Space, the parcel sees limited activity in the vicinity of the fire. No fire abatement work is recommended for the Lewis fire because of this low potential risk.

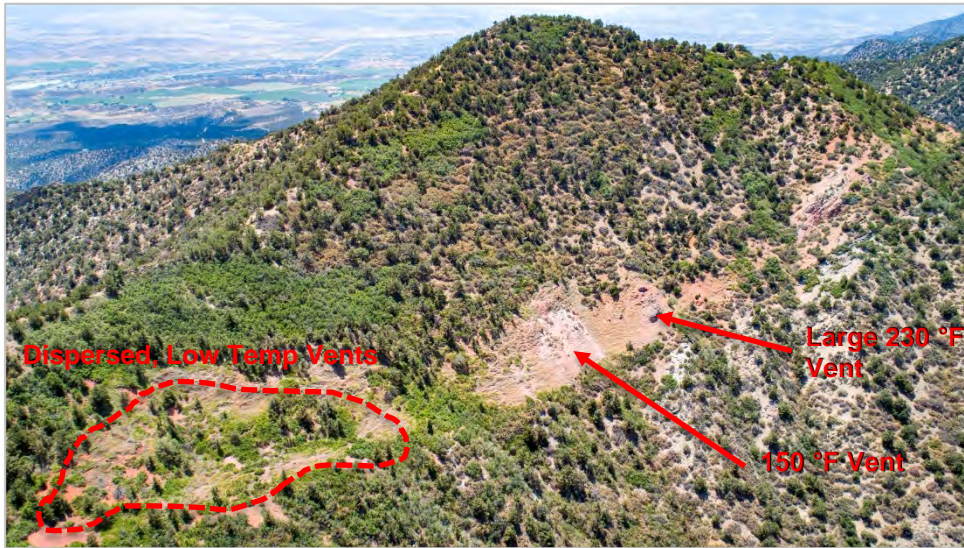
Figure 4-39 – Morgan Mine Fire Looking Southwest

The fire is moderately active, with vent temperatures around 230°F. Ground heat has kept most vegetation from growing near the vents, reducing the potential for wildfire. The fire expressions are well defined and free of major vegetation. There is moderate risk of wildfire because of the fire's moderate activity. Although the fire is on public land, there is no easy access to the site, so the risk to public safety is low.

Currently, no abatement actions are recommended at the site.

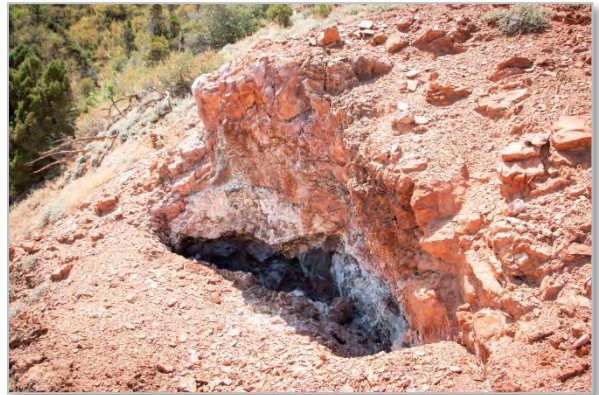
Figure 4-41 – Large 230 °F Vent Looking Southeast

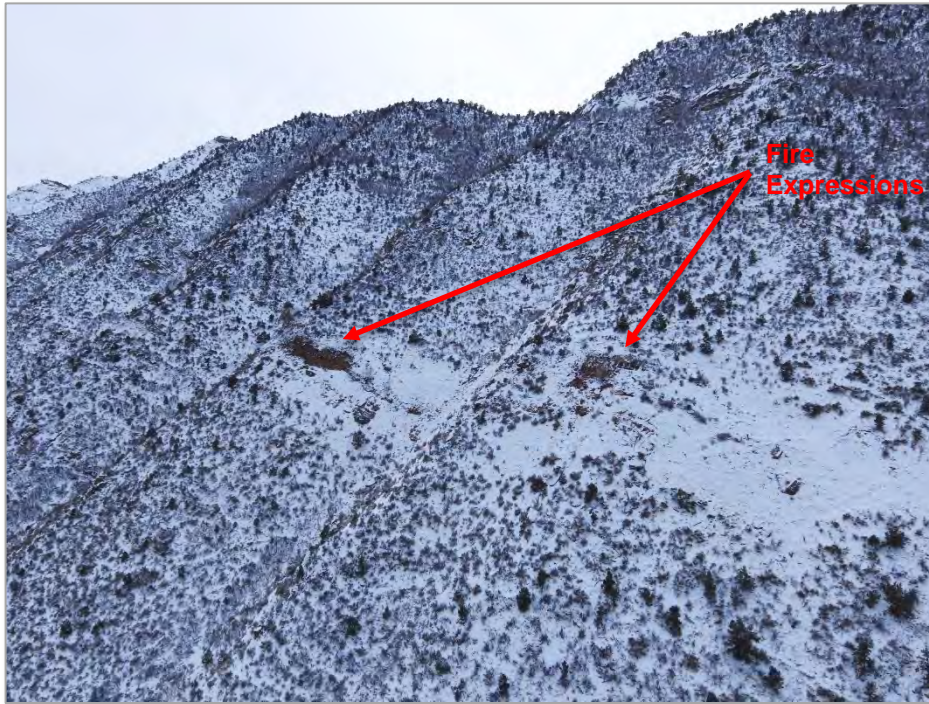
Figure 4-43 – New Castle No. 1 Mine Fire Looking Southeast

The New Castle No. 1 Mine fire does not present a substantial risk to public health or potential to start a wildfire because it lacks high-temperature surface expressions, subsidence features, noxious gases, and is on private property and in steep terrain.

No work is recommended on the New Castle No. 1 Mine Fire at this time.

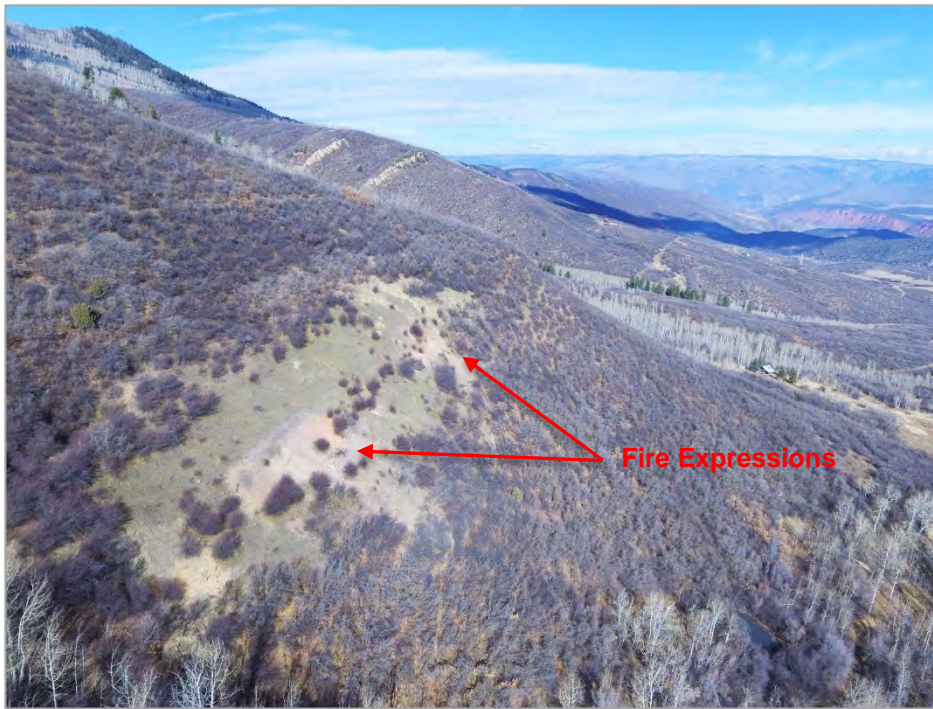
Figure 4-50 – Pocahontas Mine Fire Looking North

The fire was visited in May and November 2017 to gather surface data and analyze potential fire risks. No venting or elevated surface temperatures were observed. There were no signs of newly stressed vegetation, but bare spots were still present at previous fire expressions (Figure 4-50). No odor or recent subsidence was observed during these site visits.

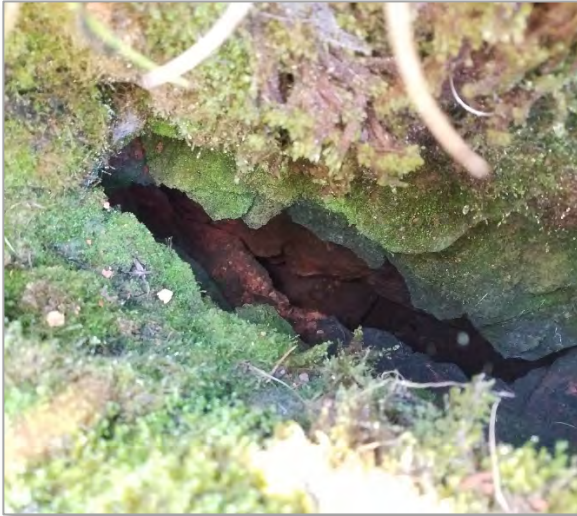
Figure 4-75 – Venting Fracture w/ Moss

The fire was visited on July 2, 2018. The pit was thoroughly inspected for evidence of fire activity. Substantial amounts of clinker that litter the site demonstrate the scale of this once highly active coal fire. The features mentioned in previous inventory reports were found on the eastern edge of the pit. The eastern rim of the pit is characterized by terraces created during the 1974 surface seal with intermixed large subsidence features and fractures. The previously active northernmost vents in this area were found to be dormant and infilled with loose material. Ground temperatures around the vents were not elevated, and vegetation was noticeably denser than in pictures from the 2005 inventory report. A series of moss-lined vents along a fracture 100 ft south of the dormant vents were venting at 58°F, 12°F over ambient ground temperatures (Figure 4-75). No sulfurous odor was observed emitting from these vents.

The fire's activity is low, with few low-temperature vents along one fracture. The potential risk of this fire starting a surface fire is low because of this low activity. The public safety risk to trespassers is low because of the remote location of the site, lack of major surface features and low vent temperatures.

No abatement activities are recommended for this site. A snowmelt or thermal drone flight would help determine the extent of the fire and is recommended for the next inventory.

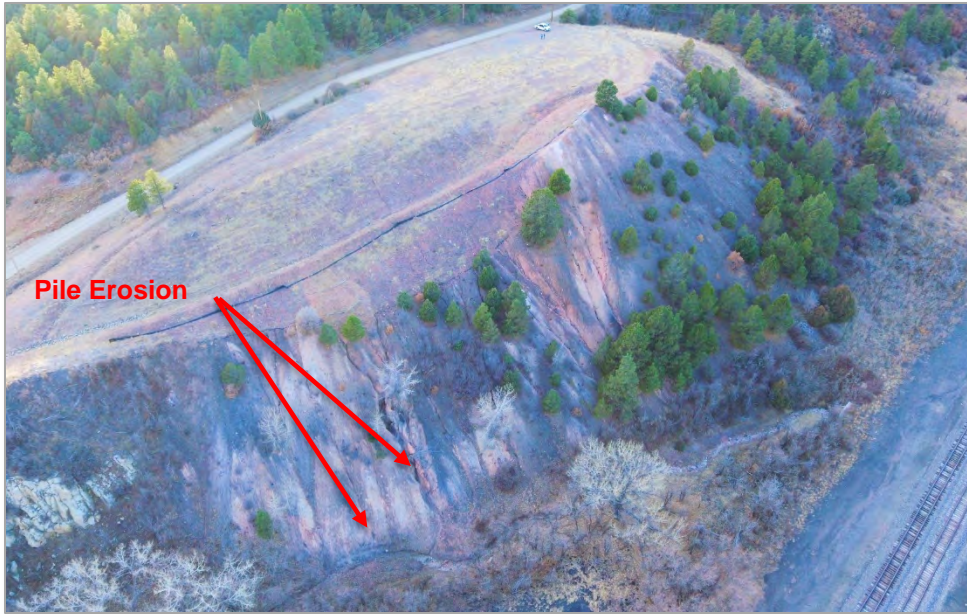
Figure 4-77 – Morley Coal Refuse Pile Looking West

No work is needed to reduce the risk associated with the fire. Revegetation performed during the abatement has established well. Areas of the refuse pile that were not excavated or reclaimed—primarily the northeast slope of the pile—show signs of erosion due to the 1.4:1 slope and little vegetation. It is recommended that the erosion control BMPs be implemented on the northeast slope to lessen the water-quality impacts associated with the refuse pile on Raton Creek (Figure 4-77).

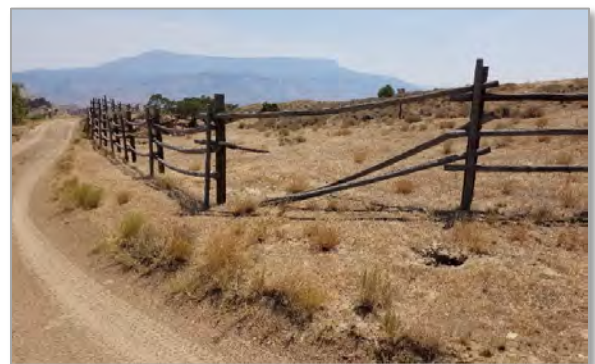
Figure 4-93 – Fence Damage and Subsidence

The fire was visited by Tetra Tech on July 30, 2018 to collect aerial photogrammetry and thermal imagery, 3D surface mapping, and analyze potential fire risks on site. No venting or elevated surface temperatures were observed at the time of the site visit. Aerial thermal images showed no elevated temperatures, and the shaded fracture zones were cooler than ambient surface temperatures (Figure 4-94). There was no evidence of the recent fire activity, and all subsidence features appeared to be the results of the earlier fire. Several subsidence features were noted onsite, aligning parallel to the main surface fractures near the south rim of the cliff. A small section of fence has some damage or is starting to deteriorate due to age (Figure 4-93).

The fire activity at the Garfield Mine Fire site is very low and poses limited risk of wildfire. The subsidence and unstable ground combined with the proximity to the cliff face present the greatest risk to the public. It is recommended that the fence on top of the mesa be fixed and maintained to limit access and signage be placed to inform potential trespassers of the dangers.

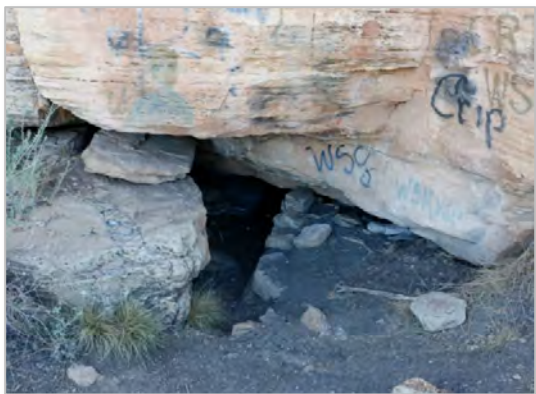
Figure 4-105 – Former McElmo Entry

The fire was visited by Tetra Tech on September 11, 2018 to collect aerial imagery and photogrammetry, conduct 3D surface mapping, and inspect the site for signs of fire activity. The west and south sides of the outcrop were thoroughly inspected, and no evidence of active fire was encountered. Remnants of a mine entry were found and appear to have recently been used as transient shelter (Figure 4-105). No active or dormant vents were discovered, and no coal combustion or oxidation odors were noticed. Minimal deformation related to fire activity was discovered during the site visit.

The fire's activity is very low and could be considered dormant if confirmed by a drilling investigation and a winter thermal drone flight. If indeed dormant, this fire does not present risk of wildfire. There is, however, considerable risk to trespassers because of the opening into the coal seam. People entering the confined space—possibly into old workings—could face hazardous mine atmosphere conditions and rock fall. There is also the potential of people unintentionally starting or reigniting a coal fire with a camp fire, since the opening shows signs of repeated overnight use. It is recommended that the mine entry be sealed off.

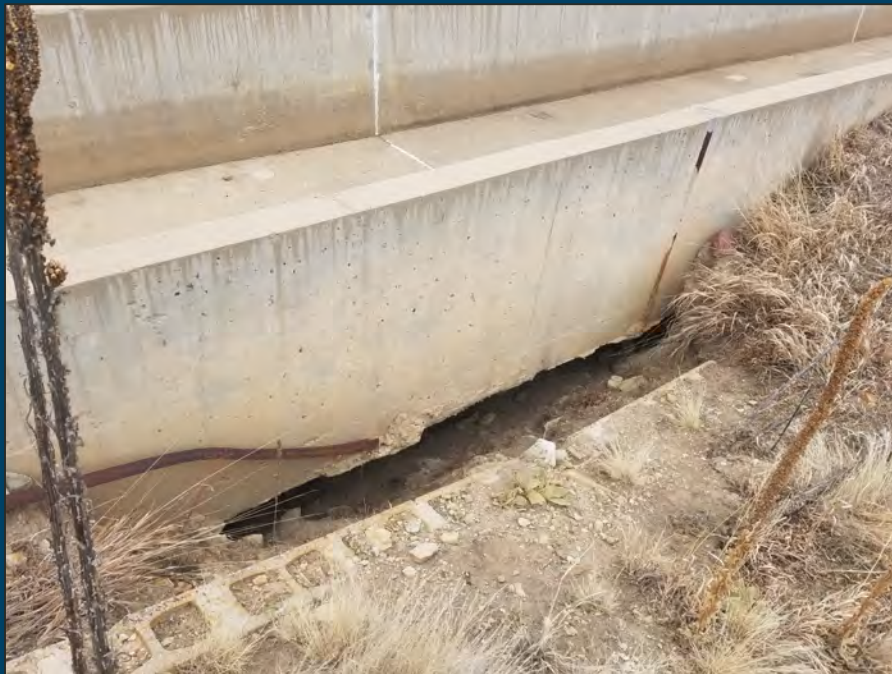
Subsidence under aqueduct

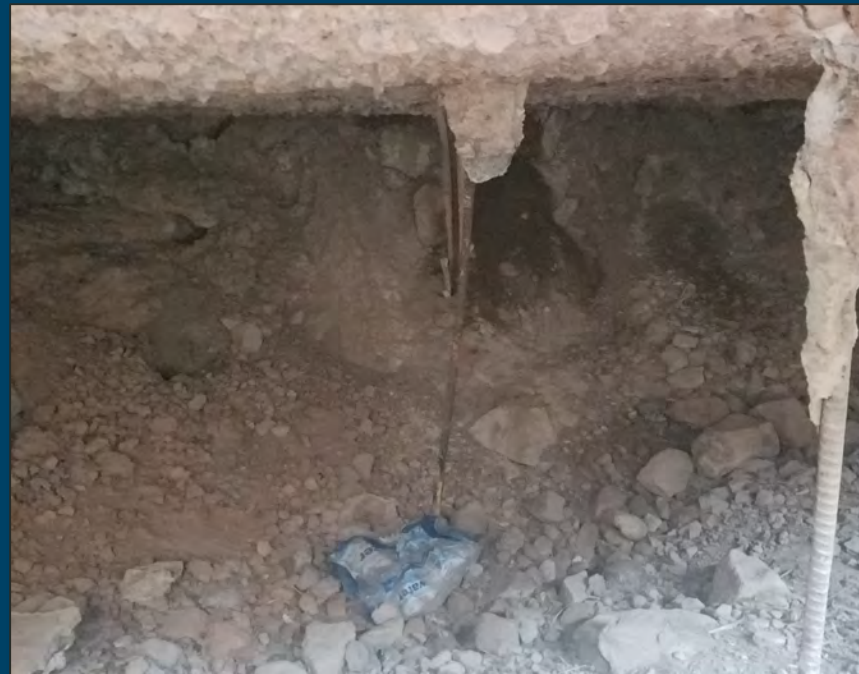
Subsidence under aqueduct

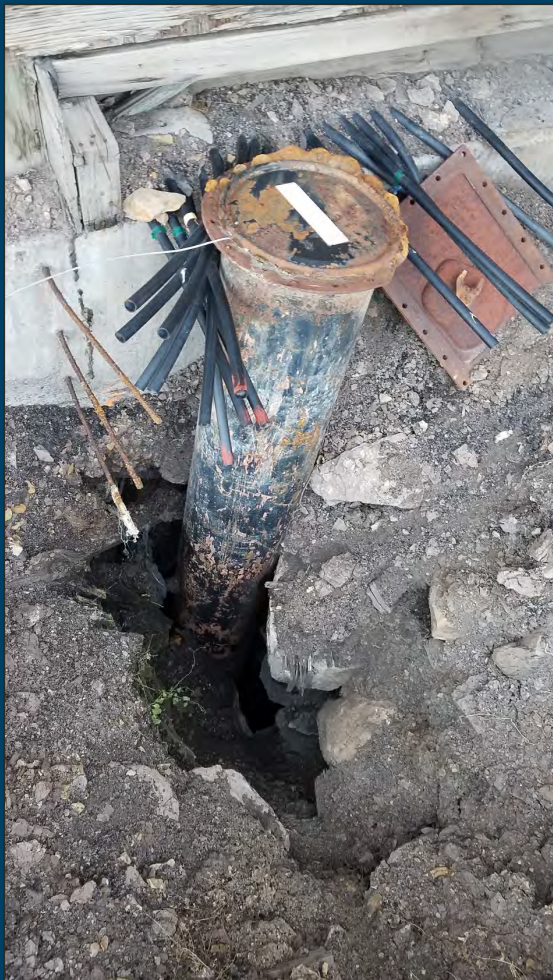
Vent pipe with opening into mine workings

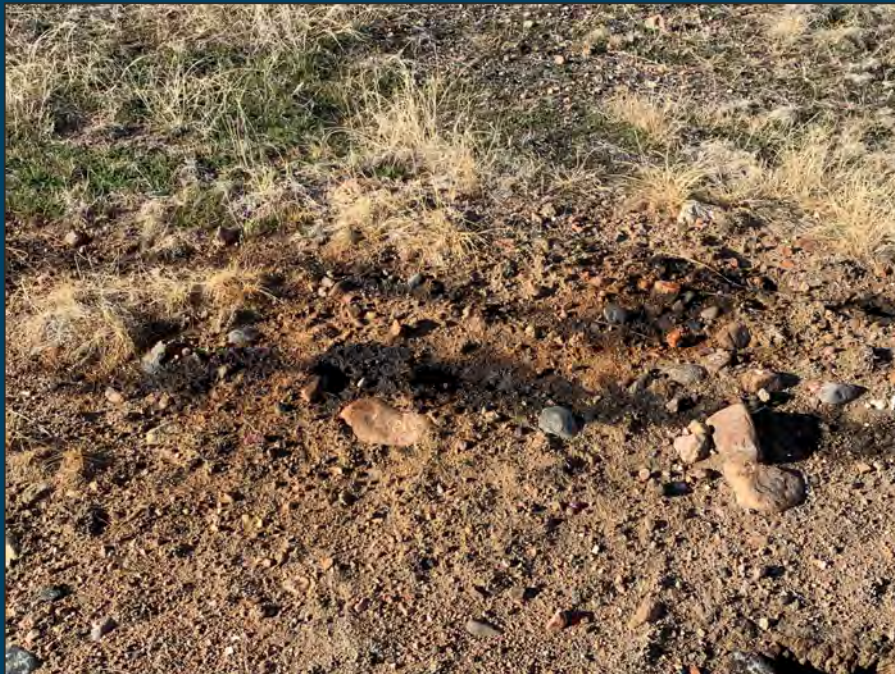
Vents with creosote

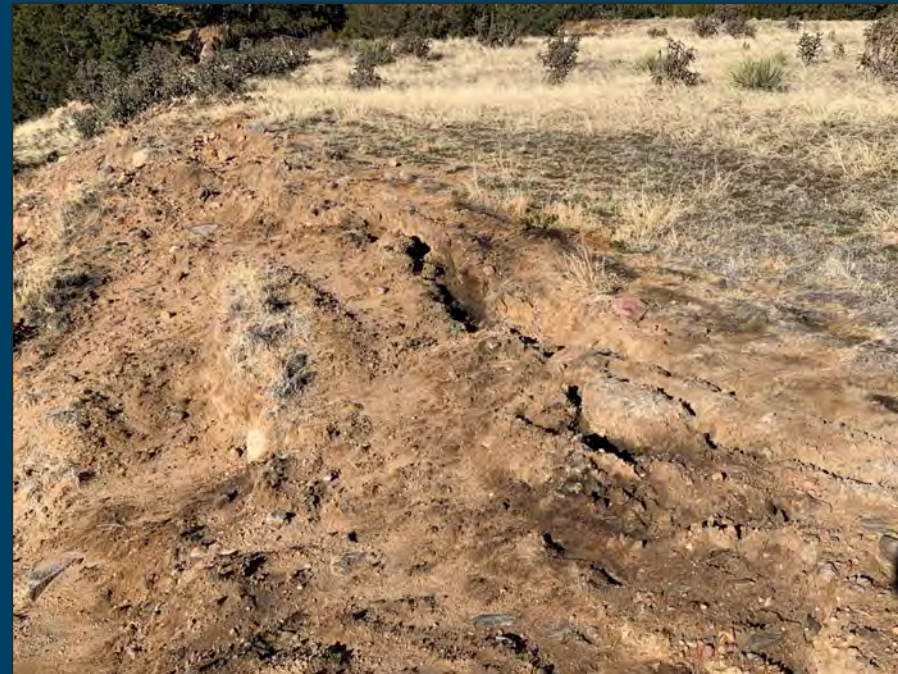
Slumping near vents

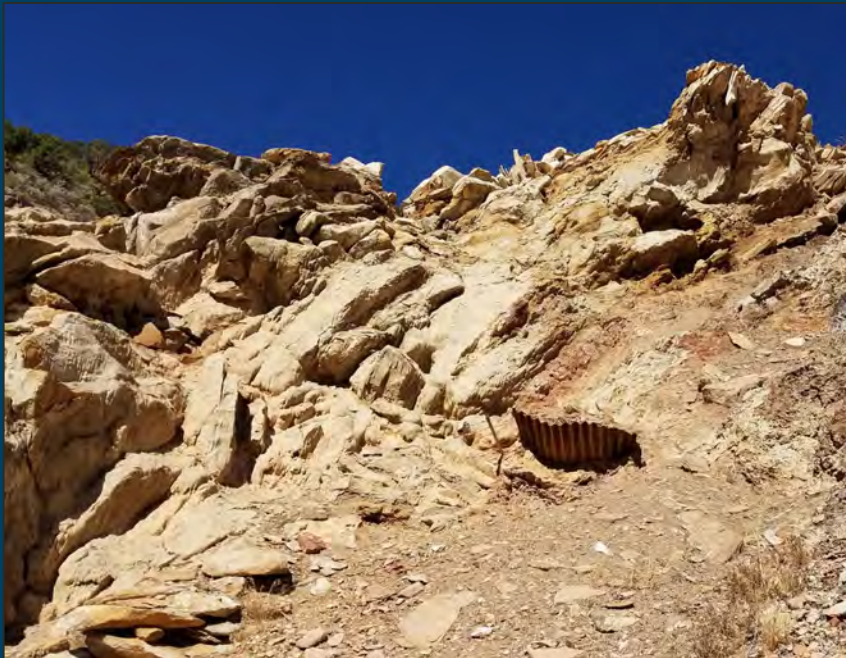
300 °F vents with grout looking West

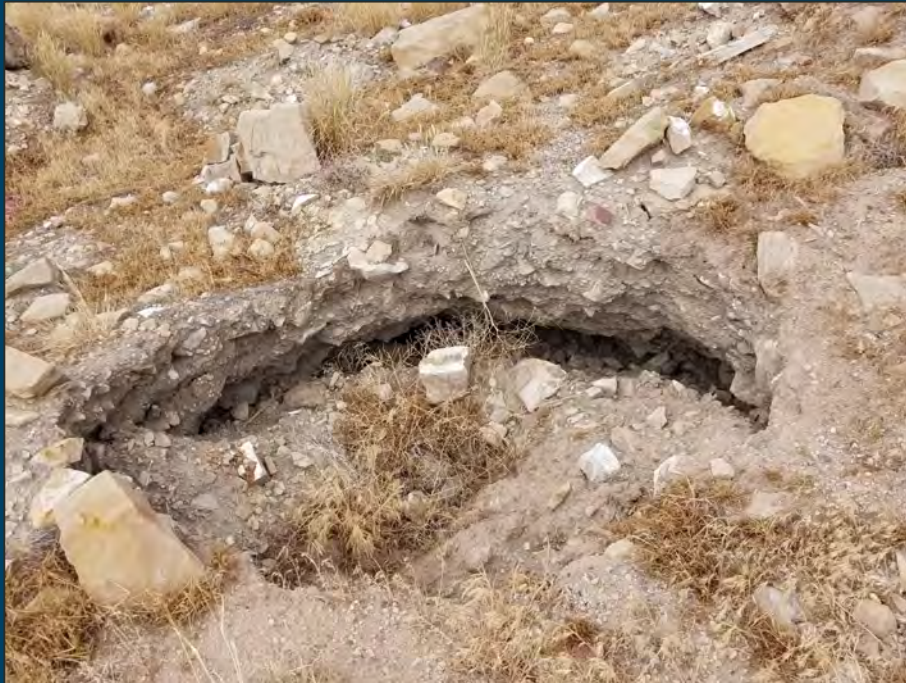
6 ft by 5 ft subsidence feature

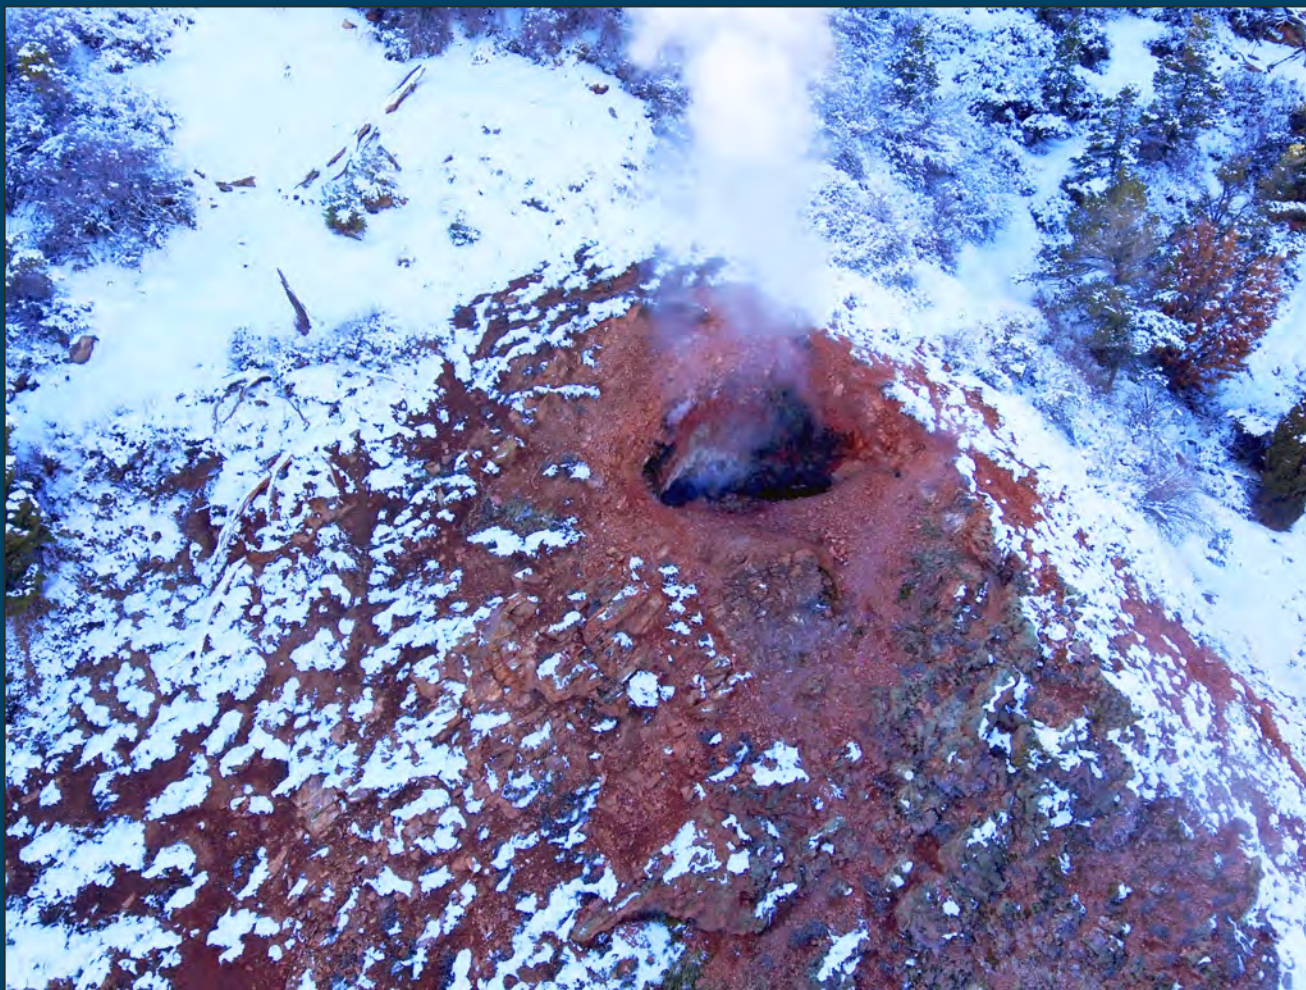
230 °F large vent looking South

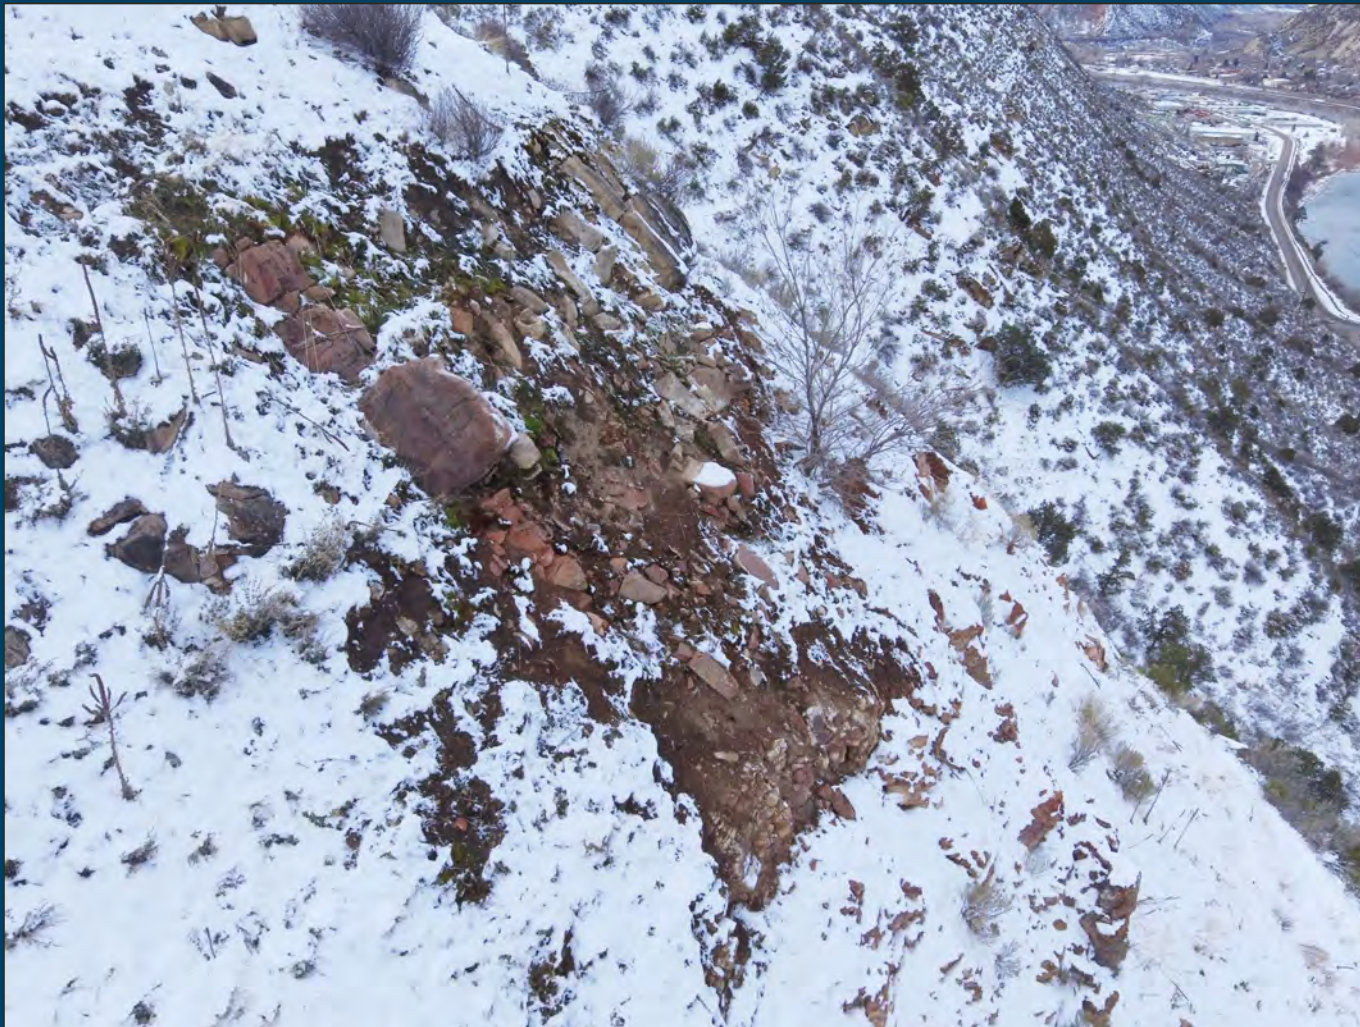
Fire expression looking West

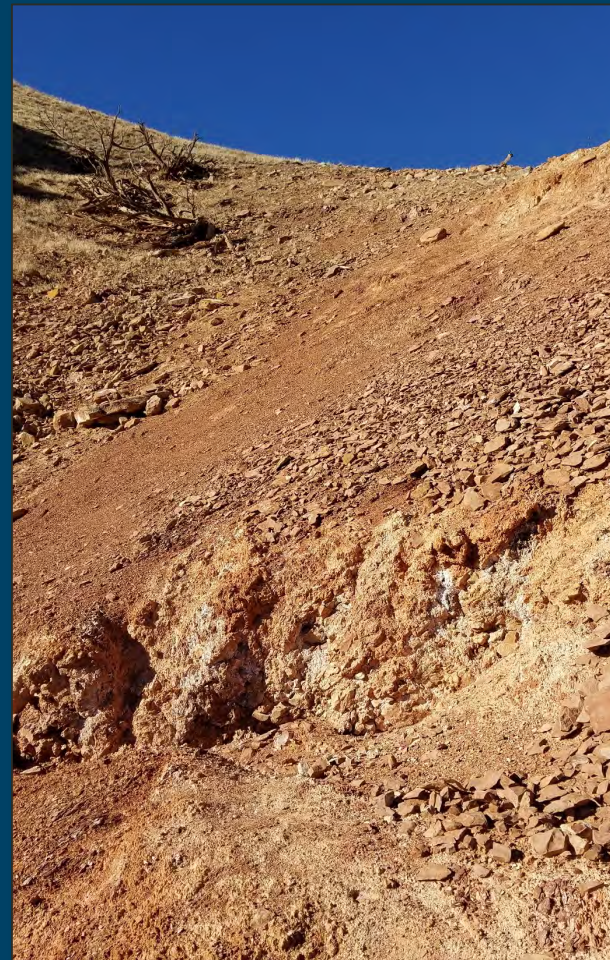
Large subsidence feature

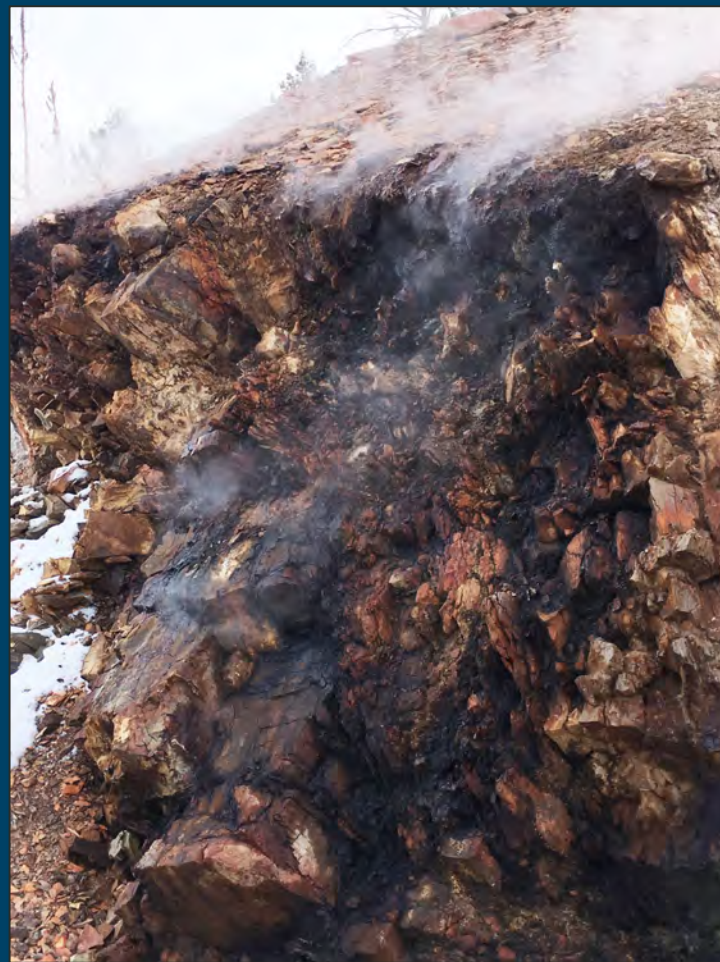
Upper road cut vents with creosote

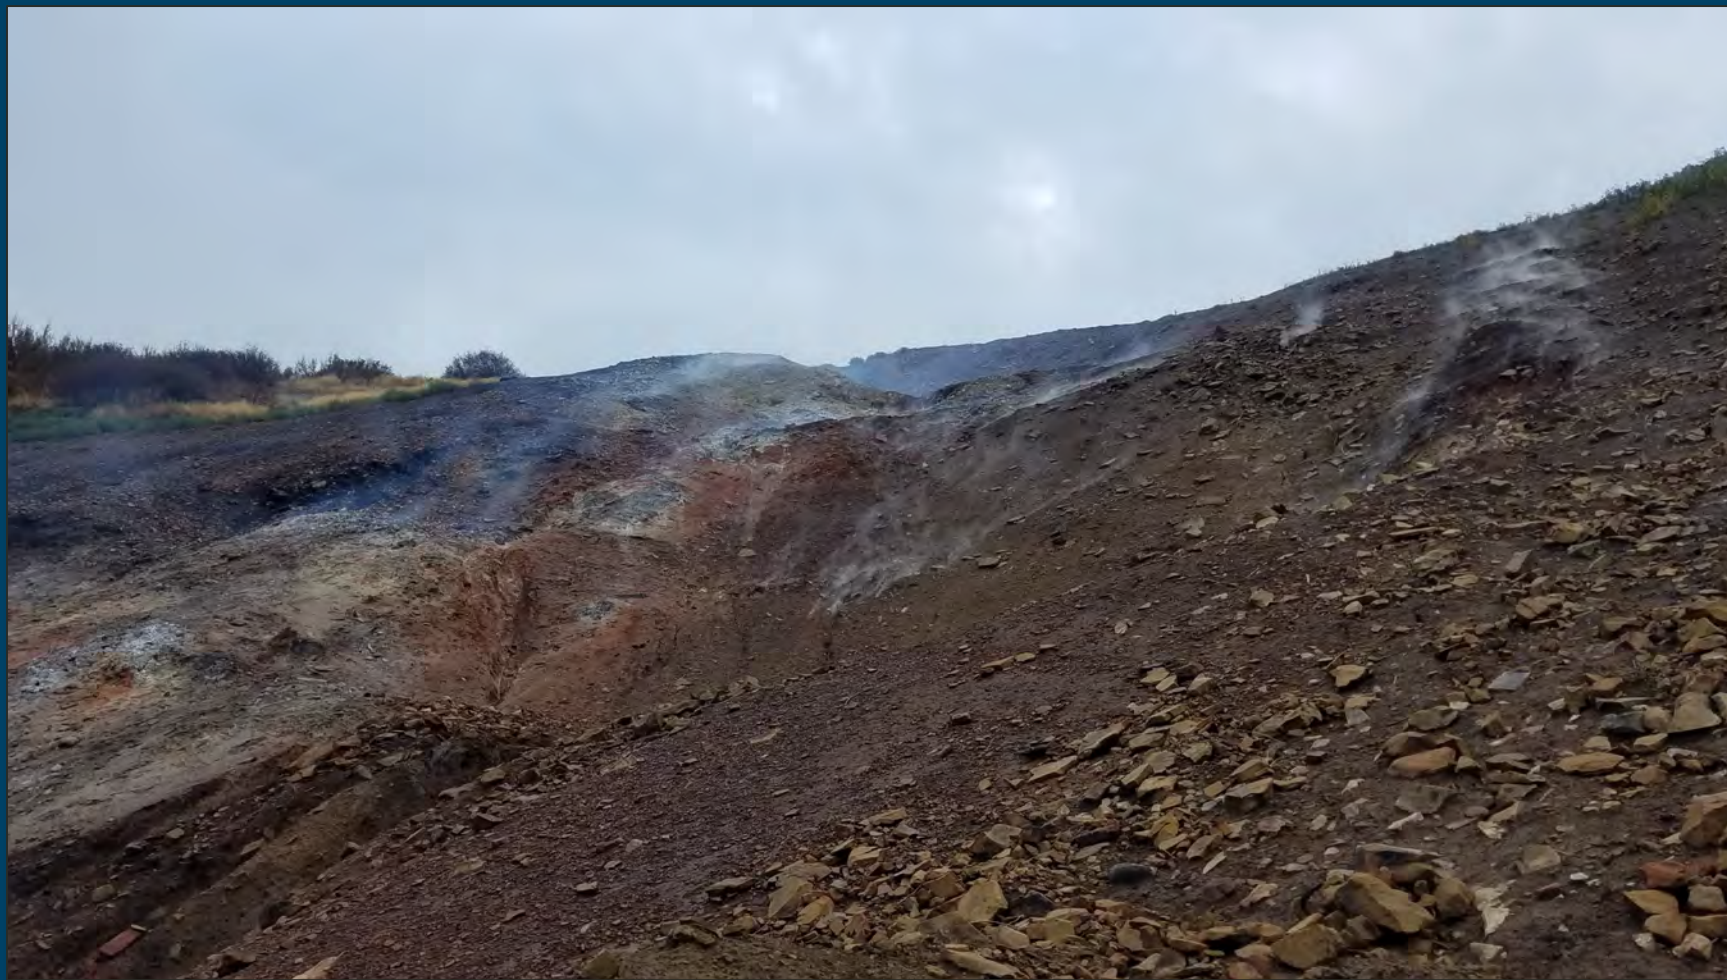
Main fire expression looking Northeast

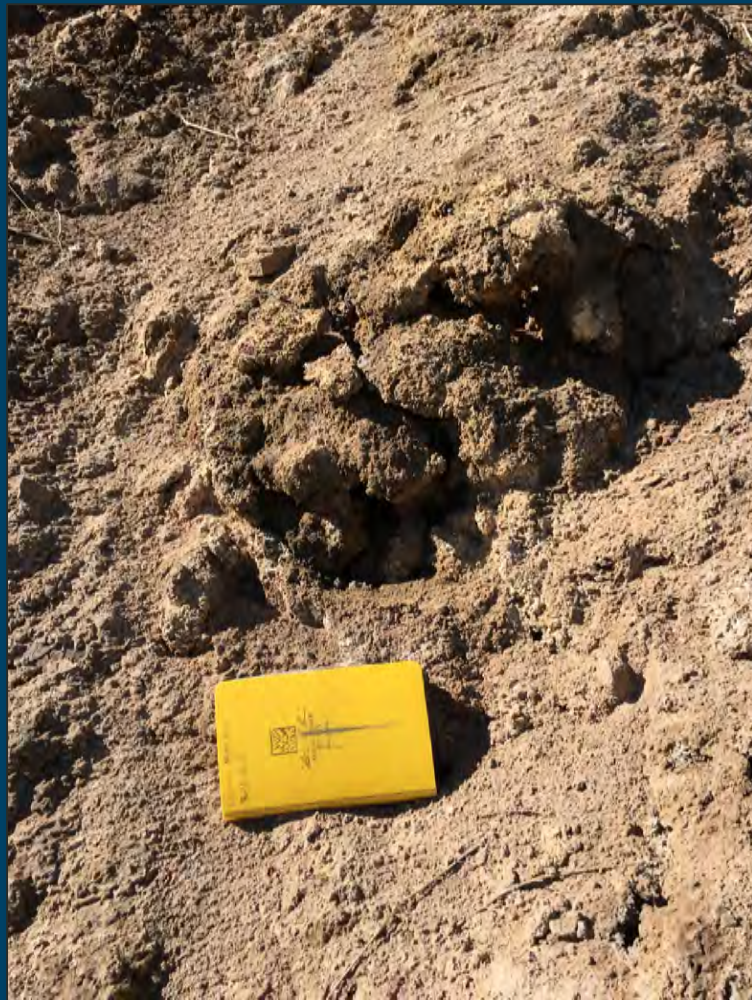
Lower area vents

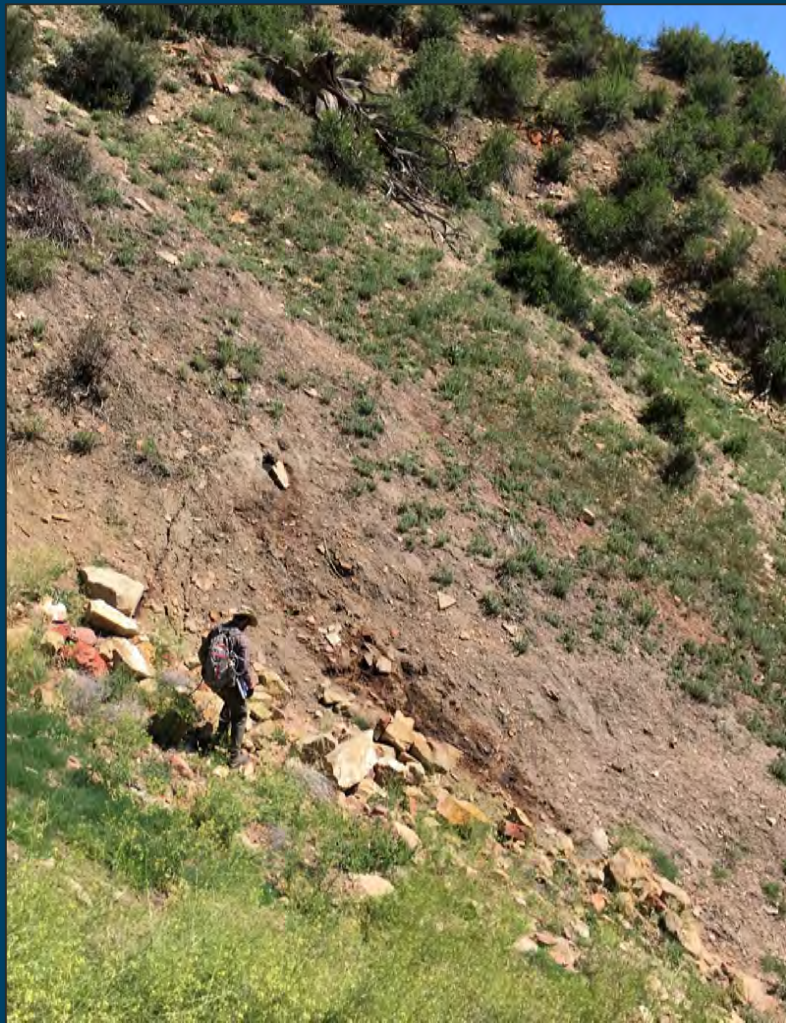
New vent May 24, 2017

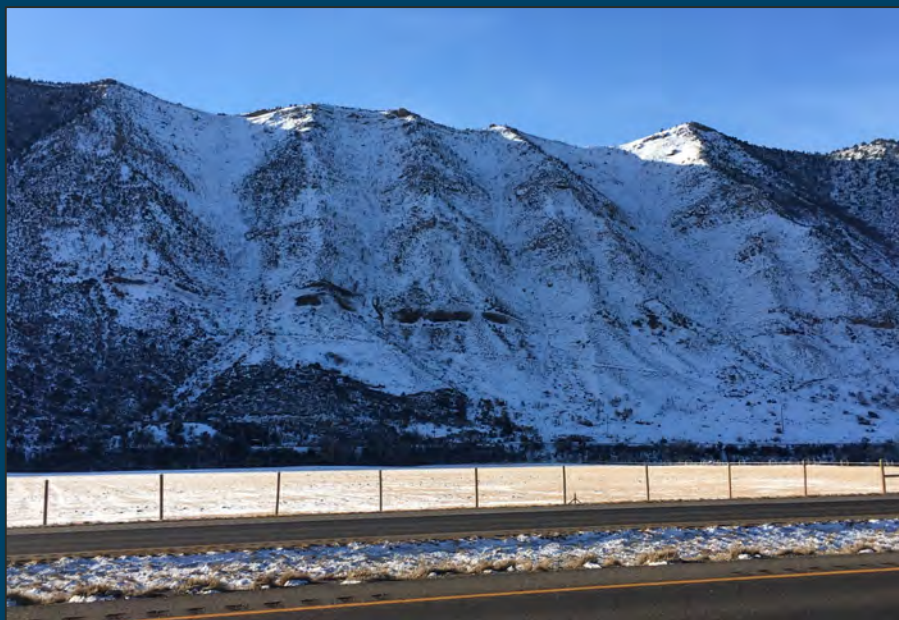
Snowmelt from Interstate 70 January, 24, 2018

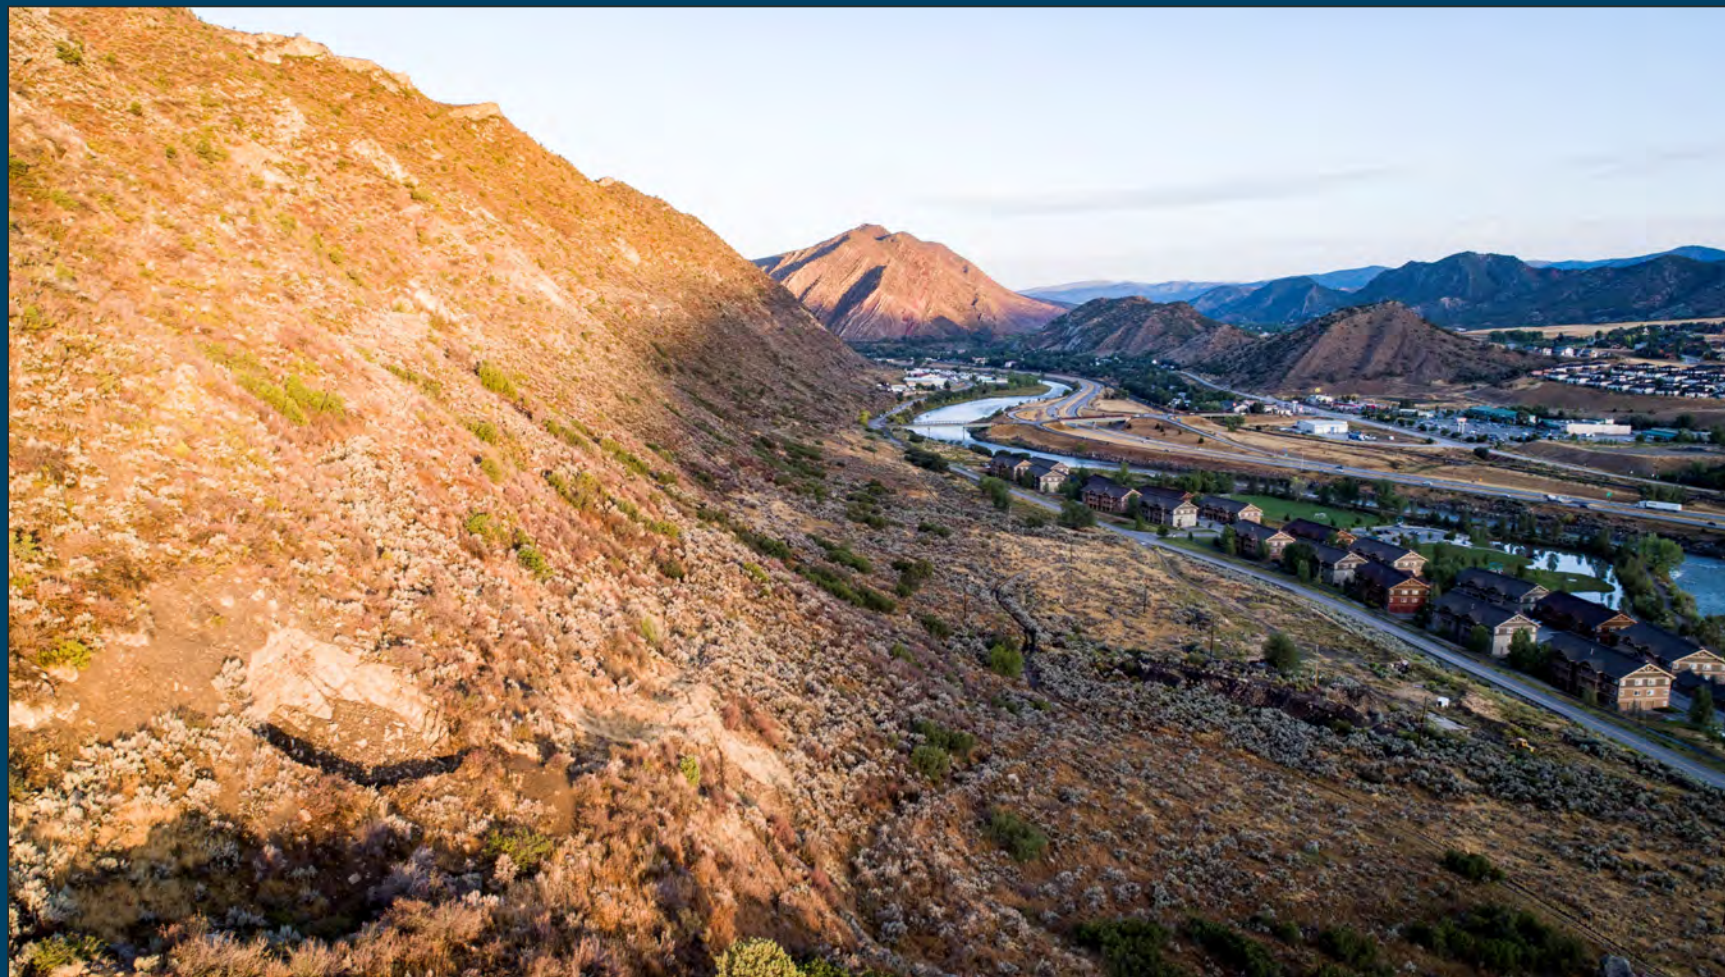
45 ft diameter subsidence feature looking West

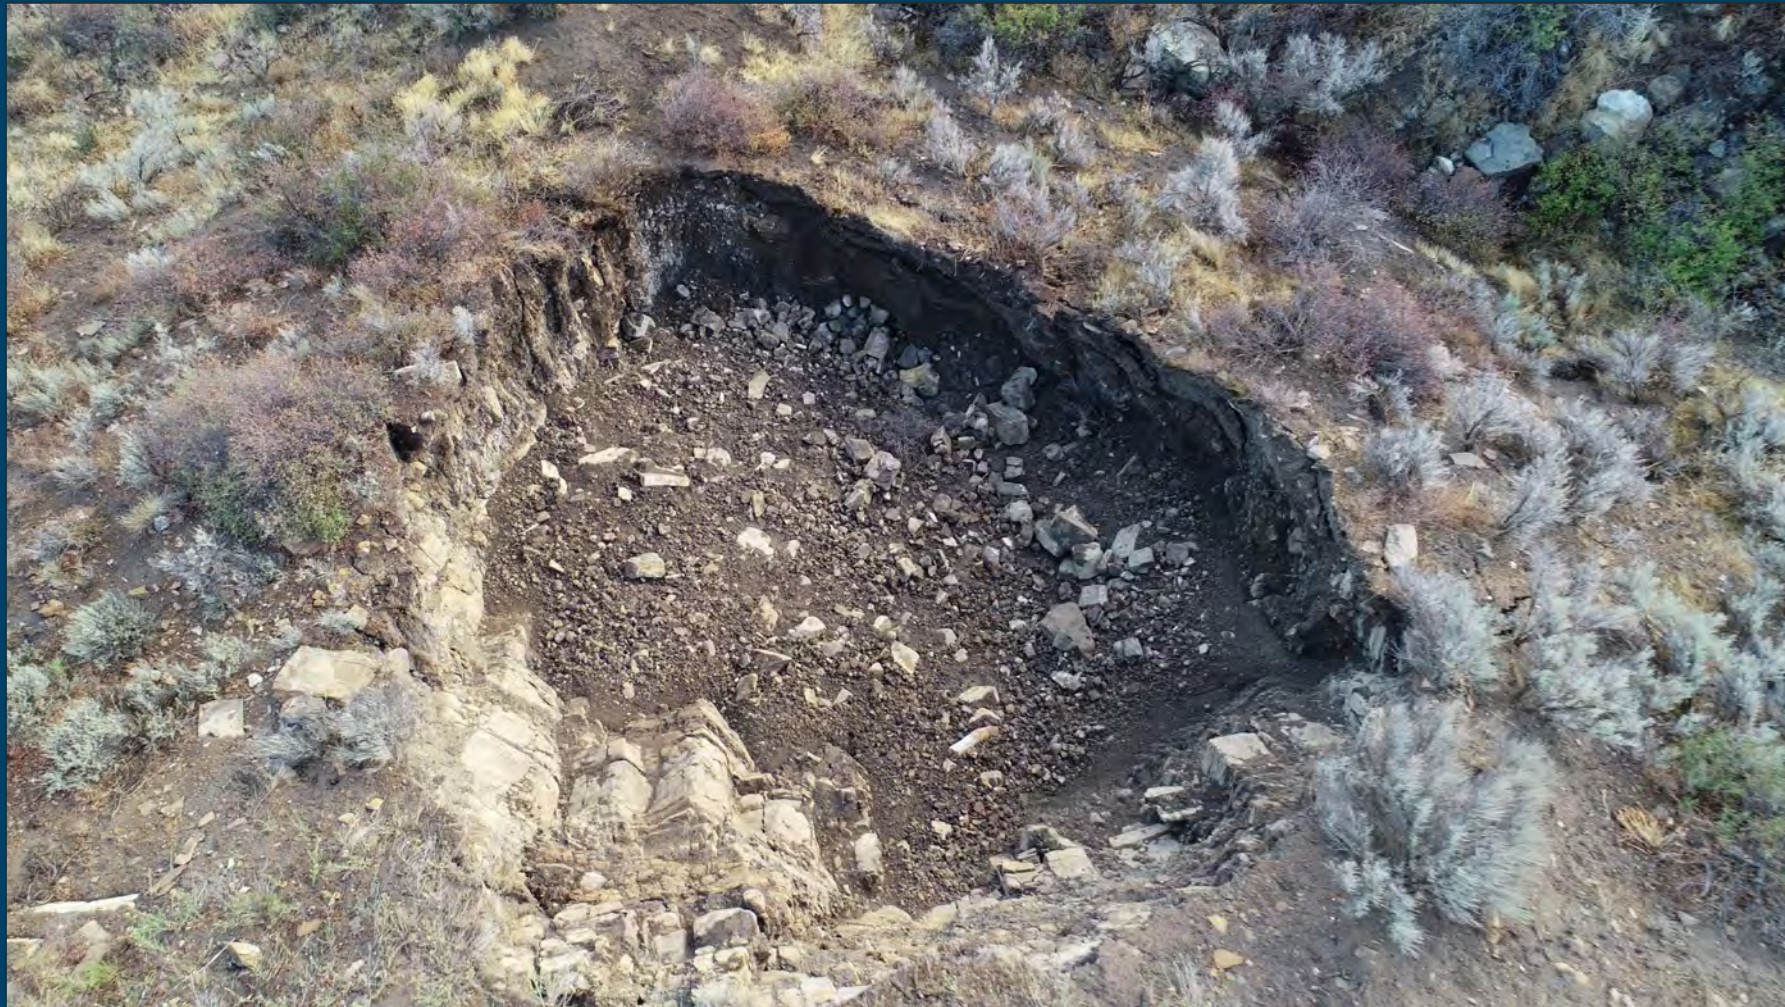
45ft diameter subsidence feature looking down

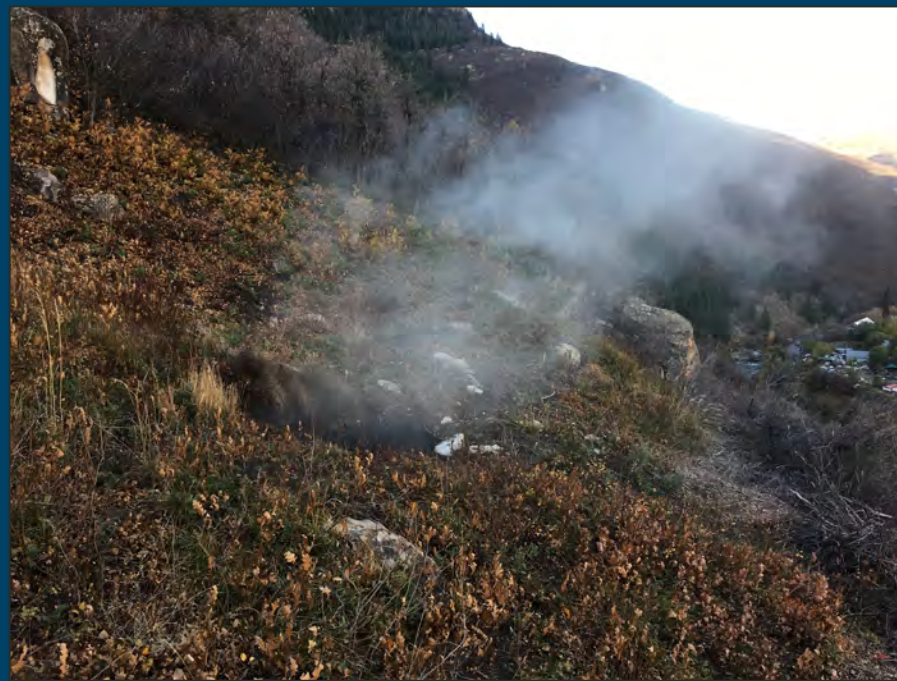
Main vent looking West

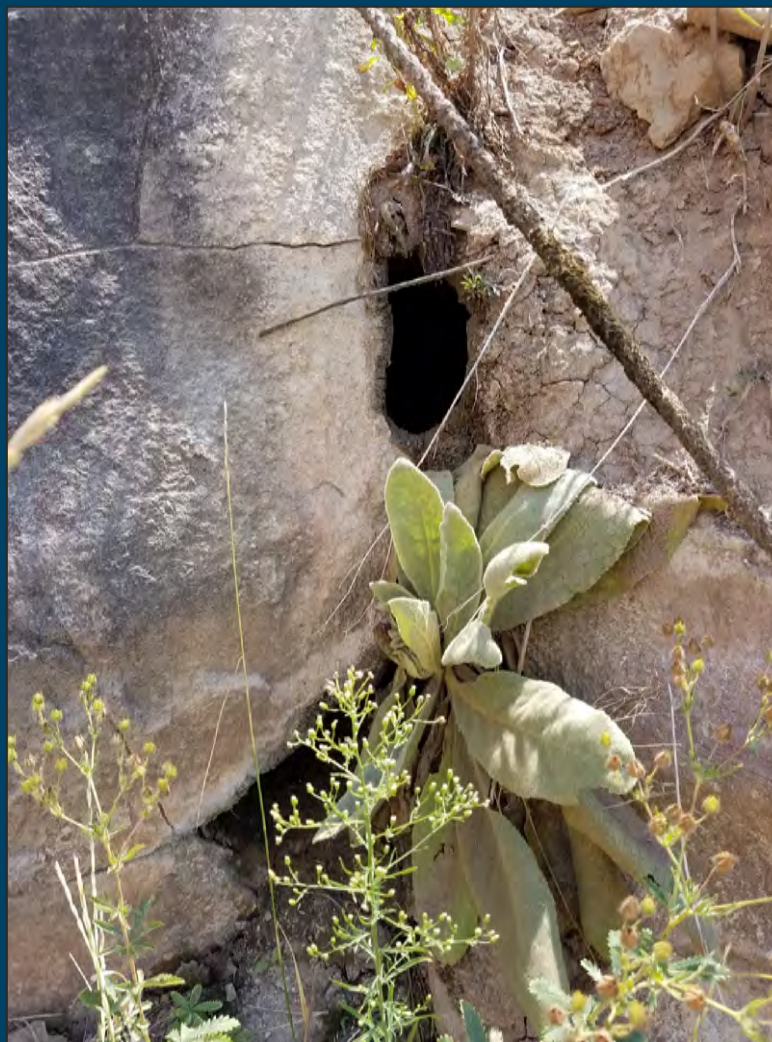
# Oliver Mine

93 °F vents with elevated methane
