# Colorado Underground Coal Mine Fires 2018 Inventory Report

August 2019

**Tetra Tech**  
350 Indiana Street, #500  
Golden, Colorado 80401

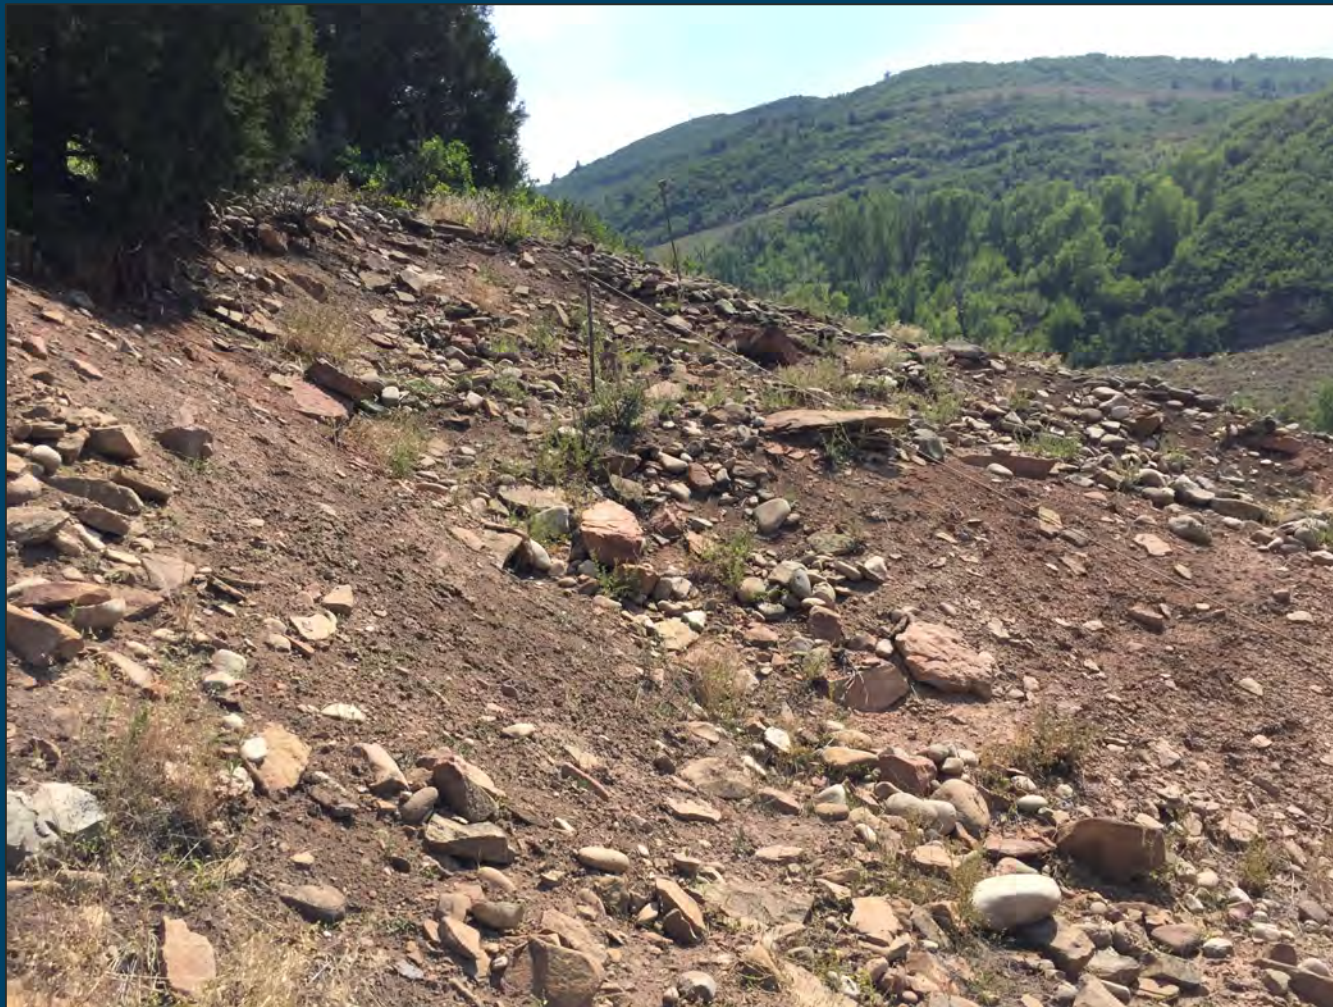
# Jackson County

Subsidence area over adit with monitoring monuments

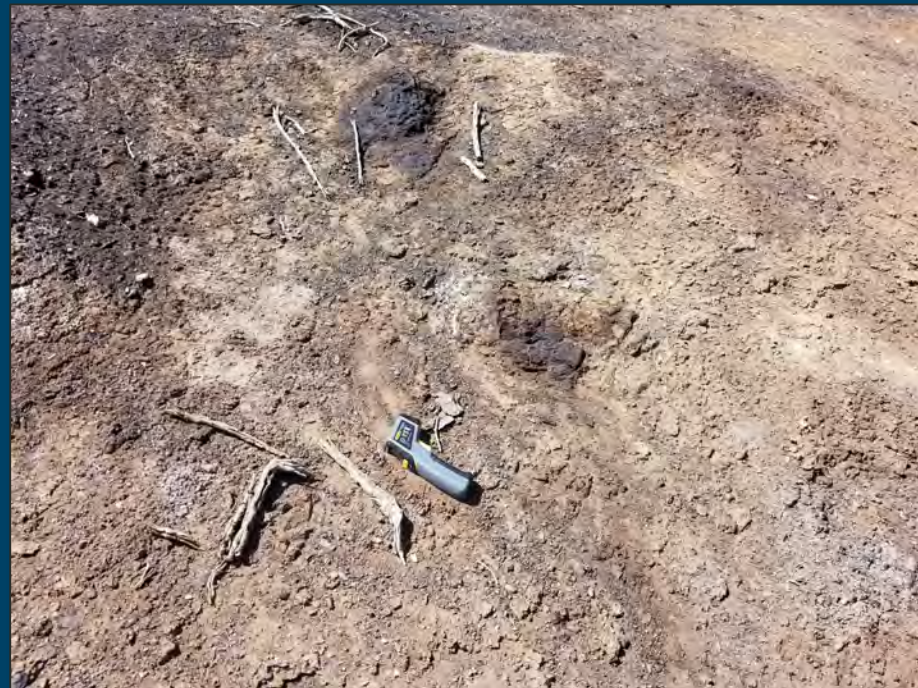
Coal oxidation in refuse pile

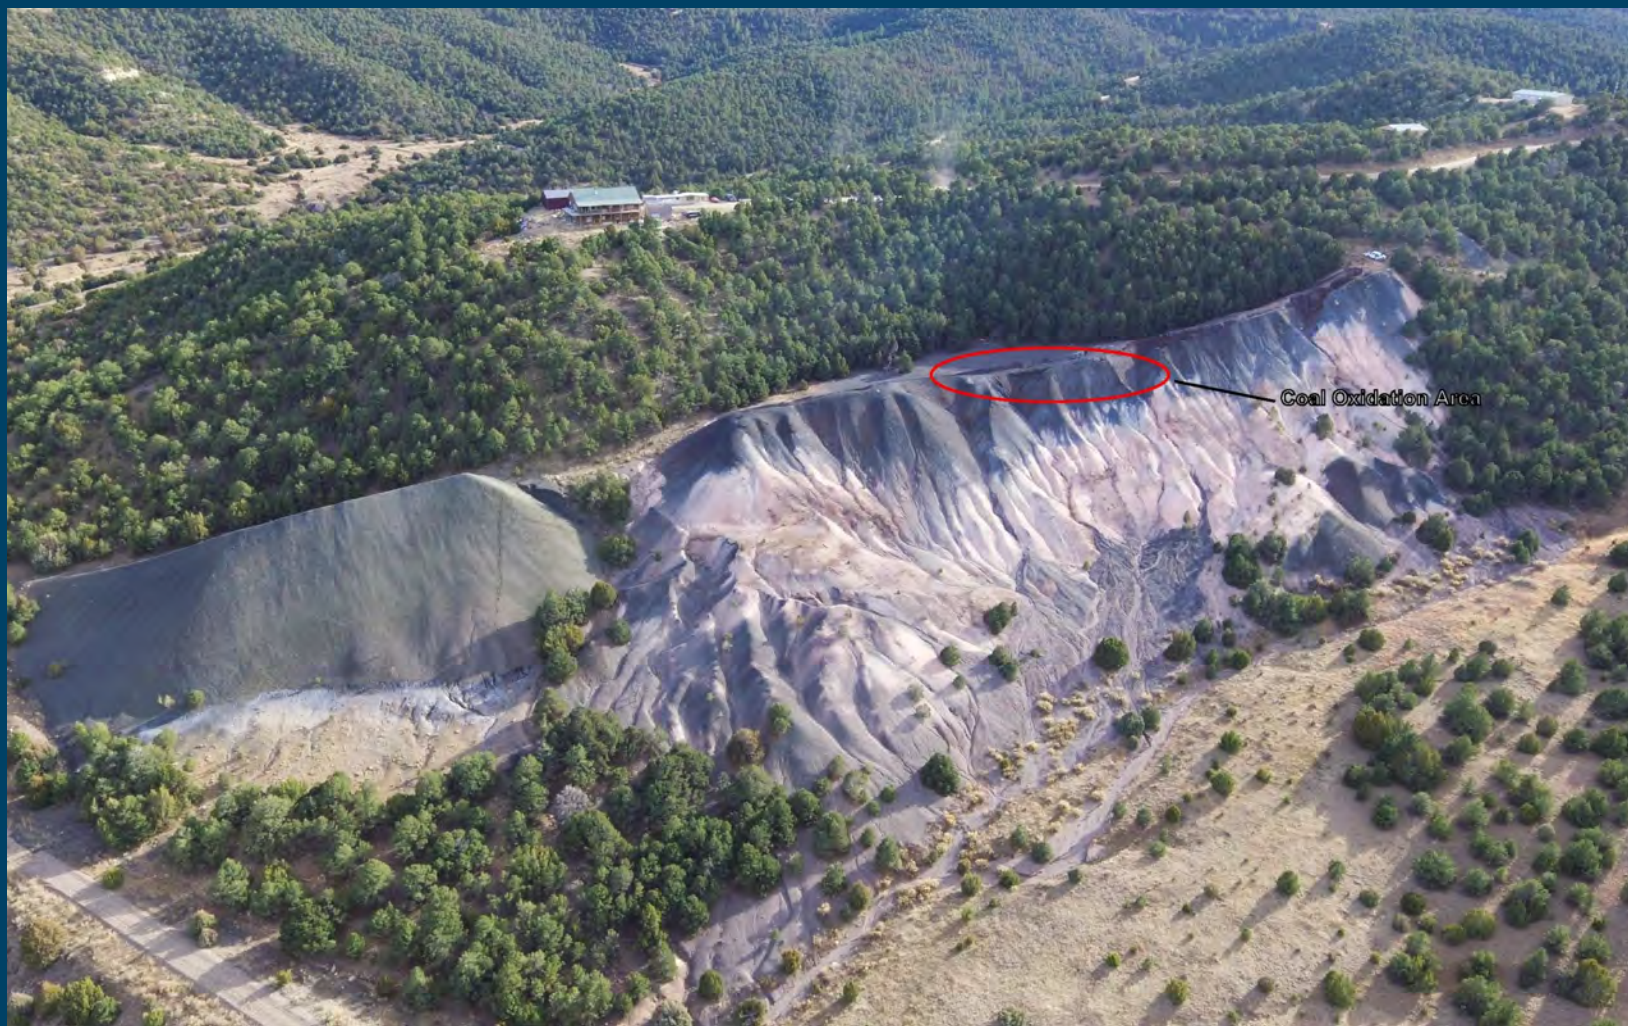
# West Sopris Coal Refuse Pile

West Sopris coal refuse pile fire looking Southeast

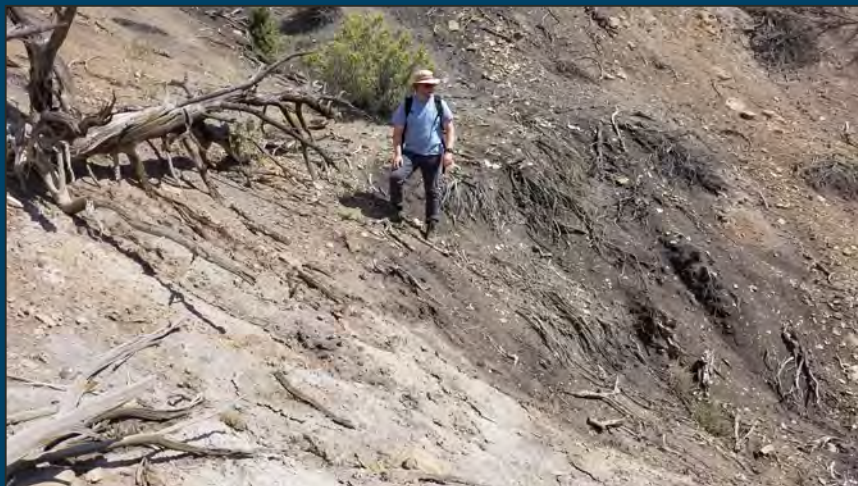
Area of low heat/oxidation looking East

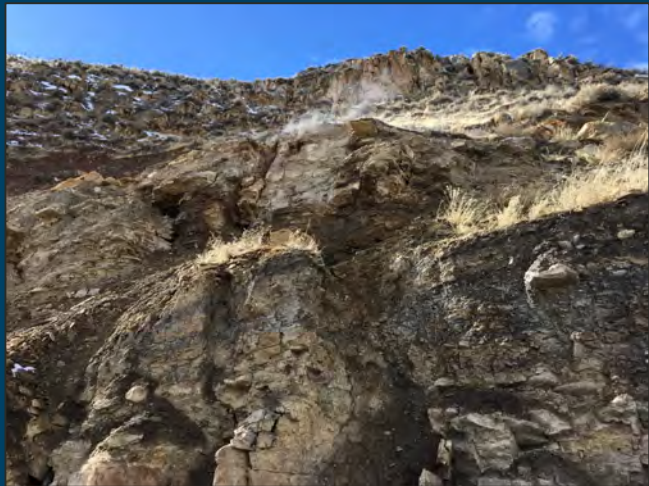
Vents in east-facing outcrop

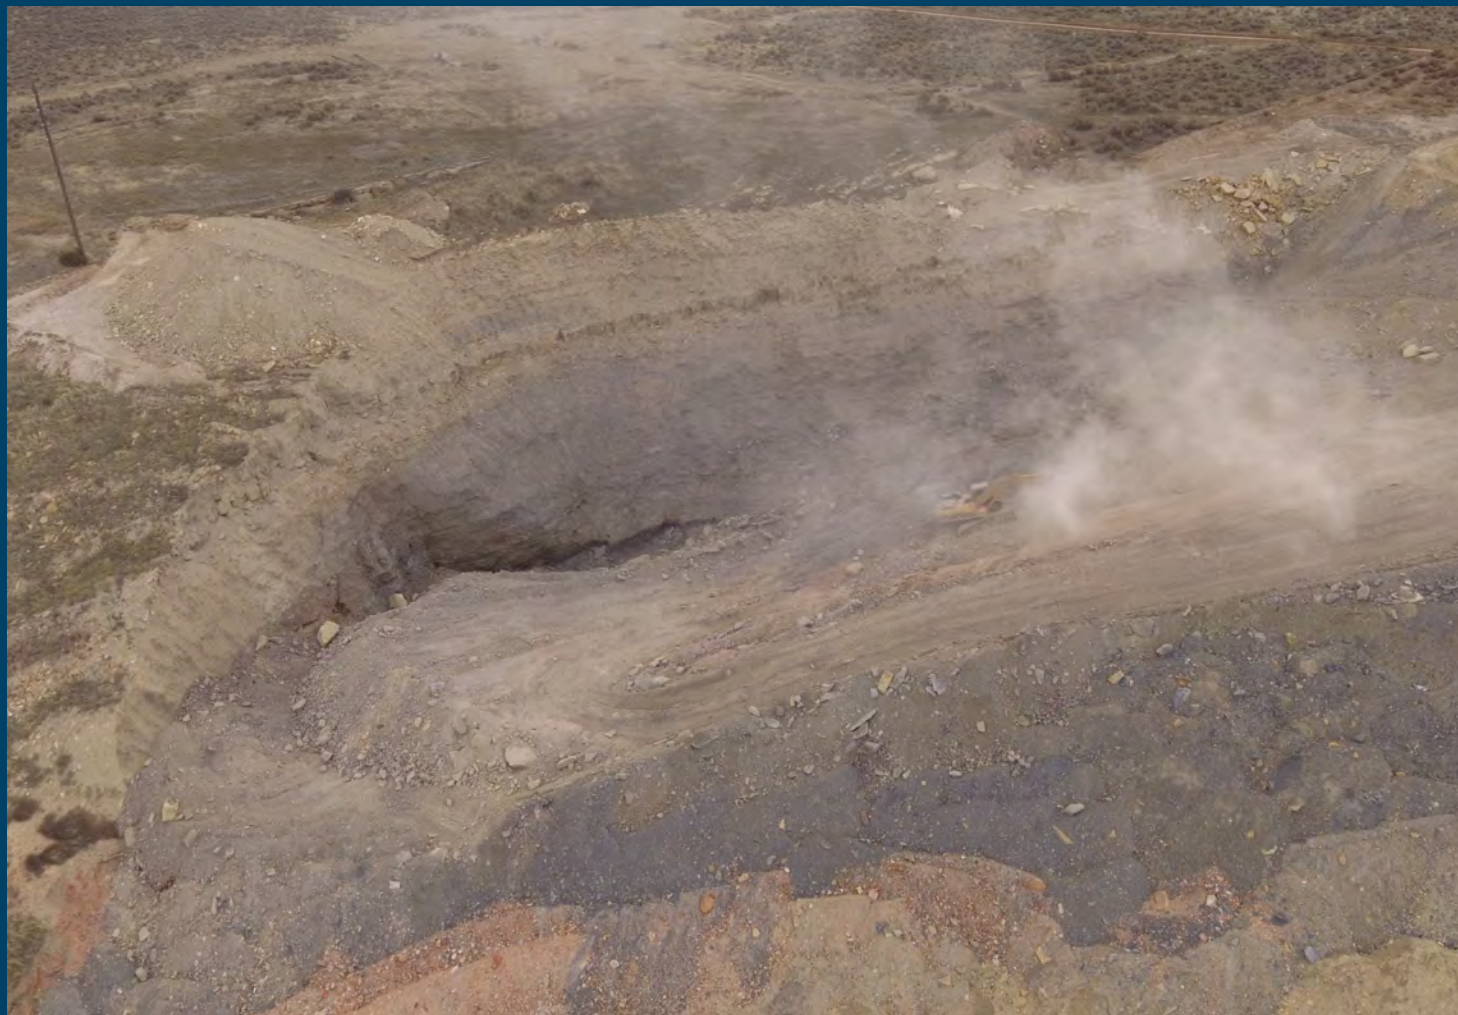
North abatement area with open seam looking Southeast (November 2, 2017)

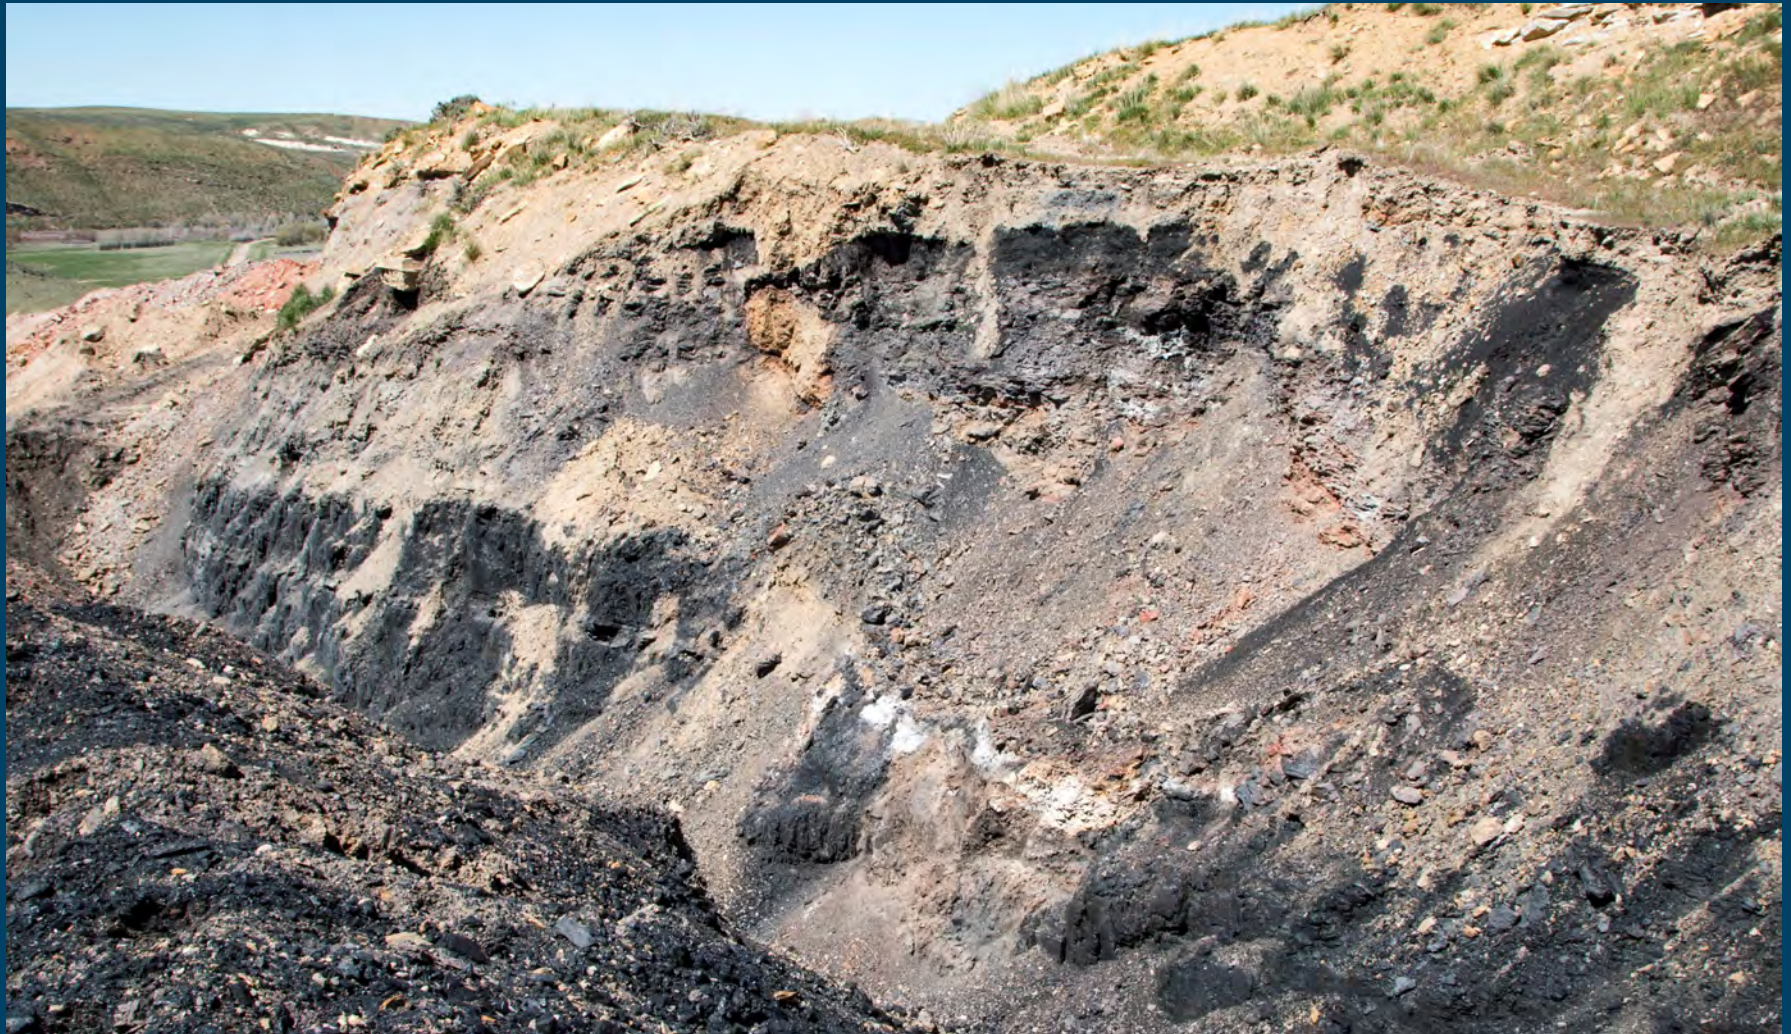
Southern abatement area looking North at excavated coal seam (May 8, 2018)

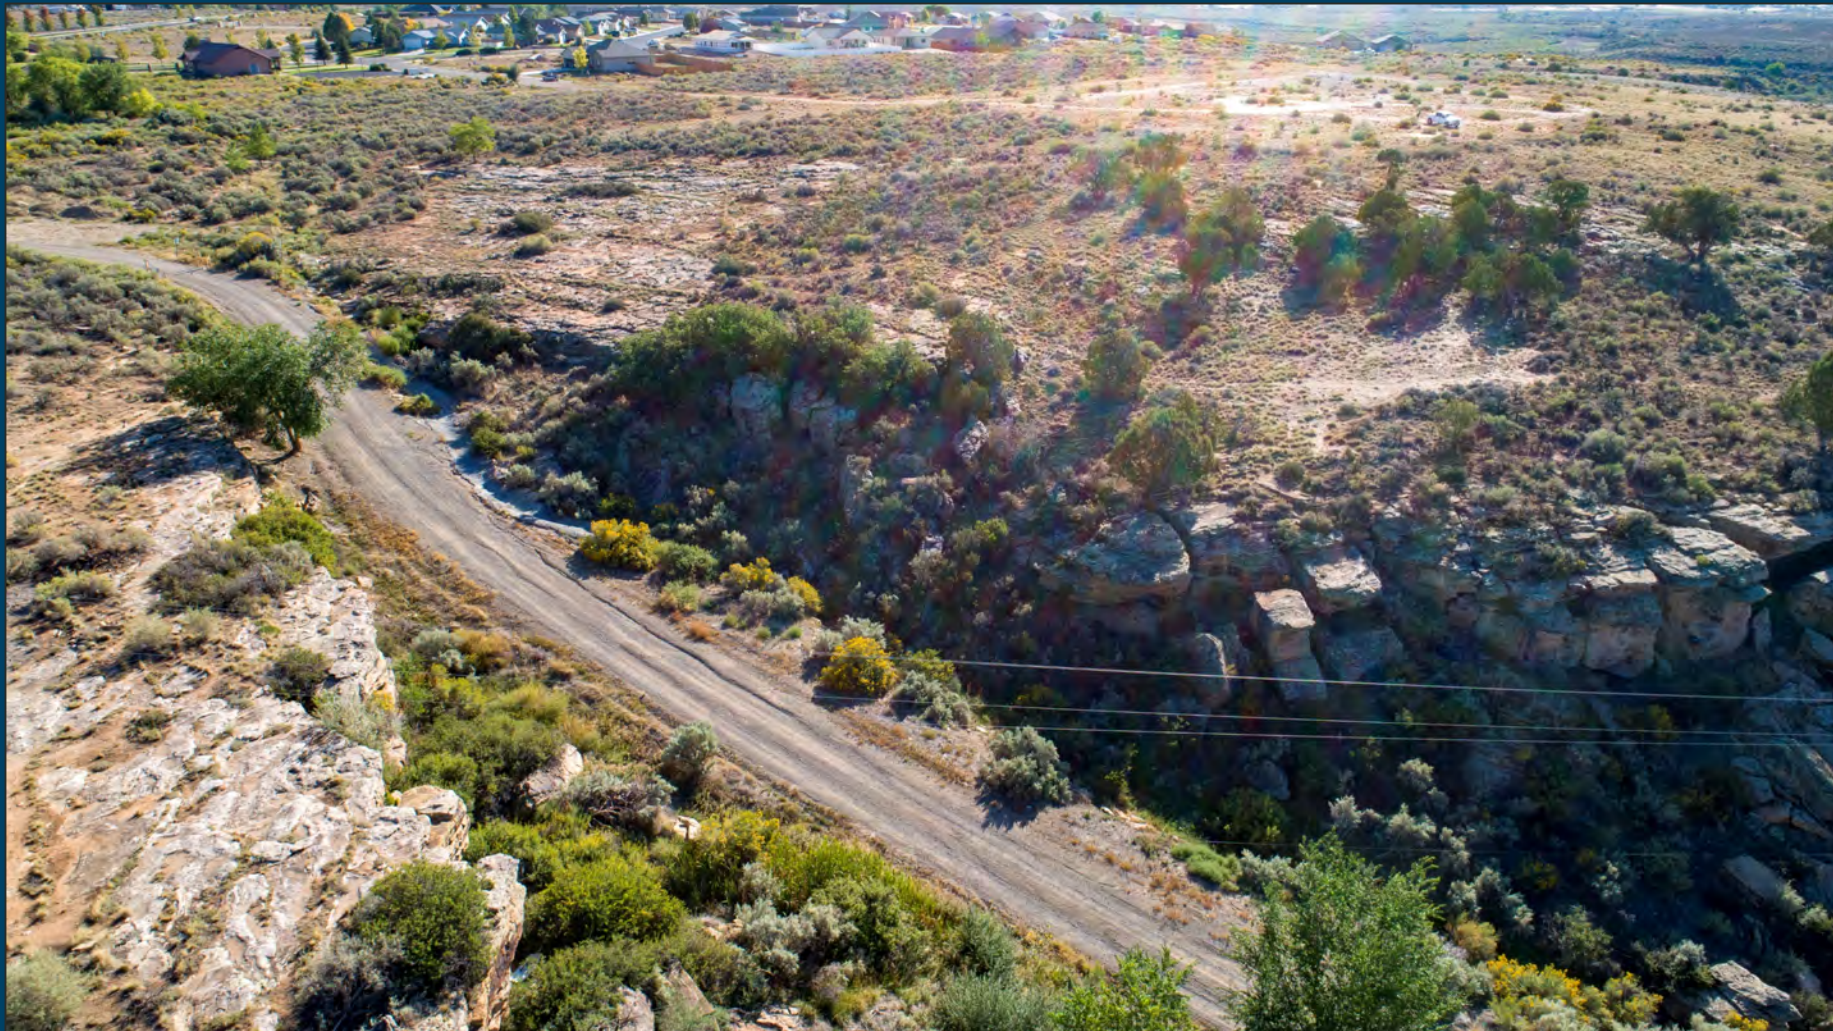
Fire area looking East

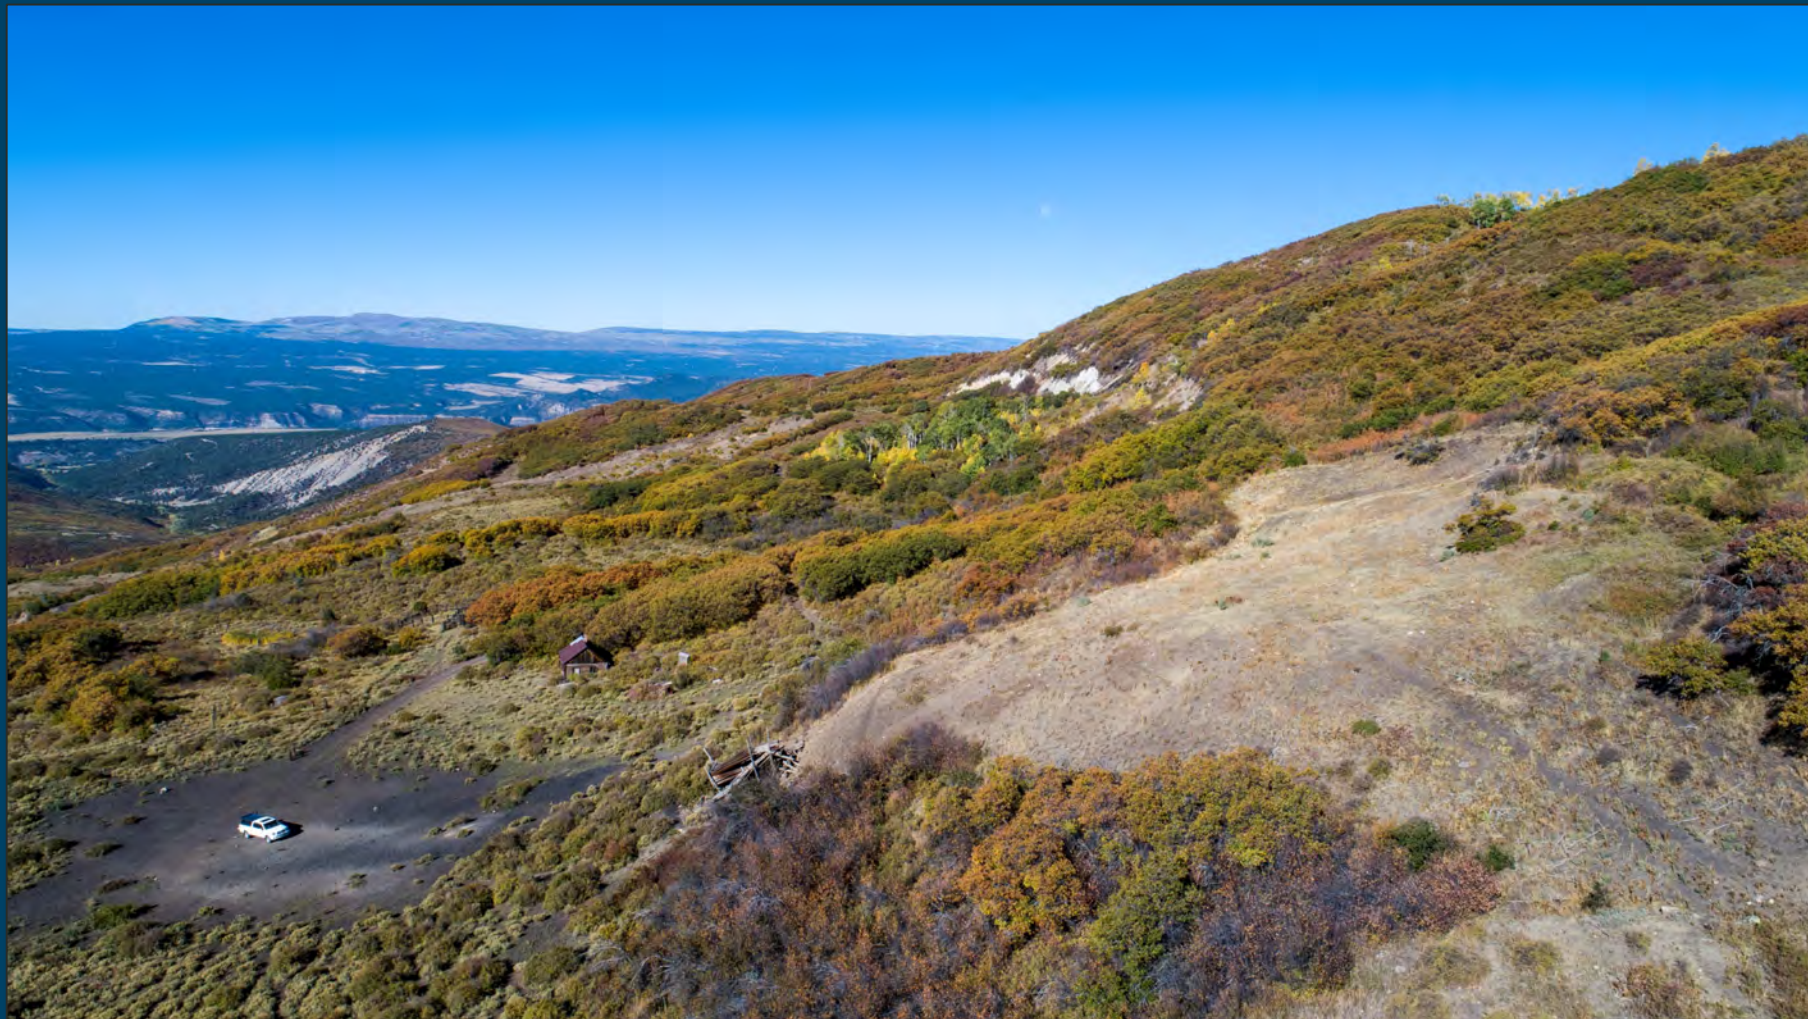
Surface seal looking West

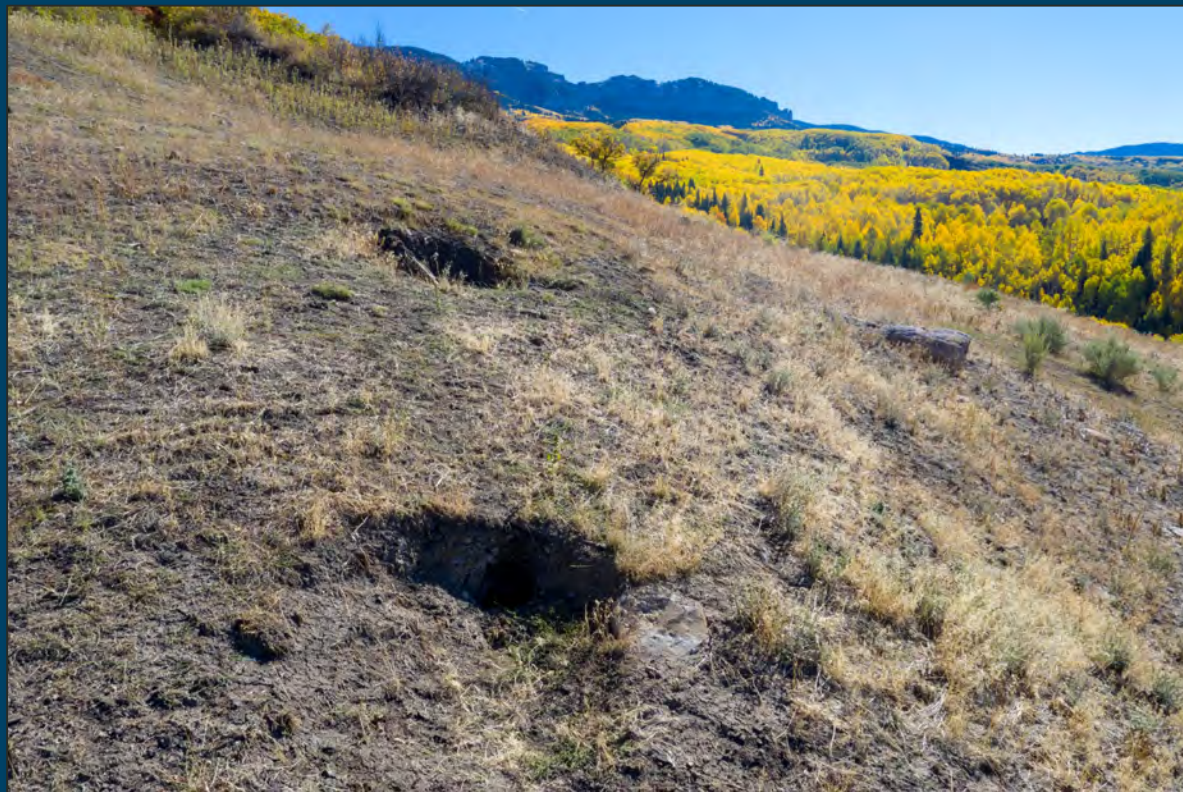
110 °F vent (foreground), subsidence (background)

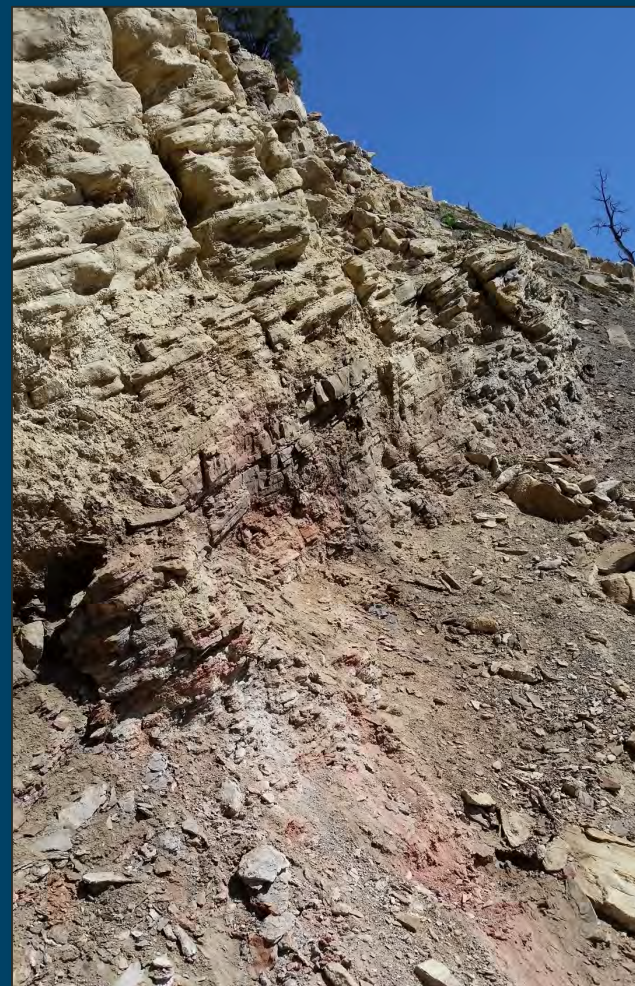
Vents along cliff base

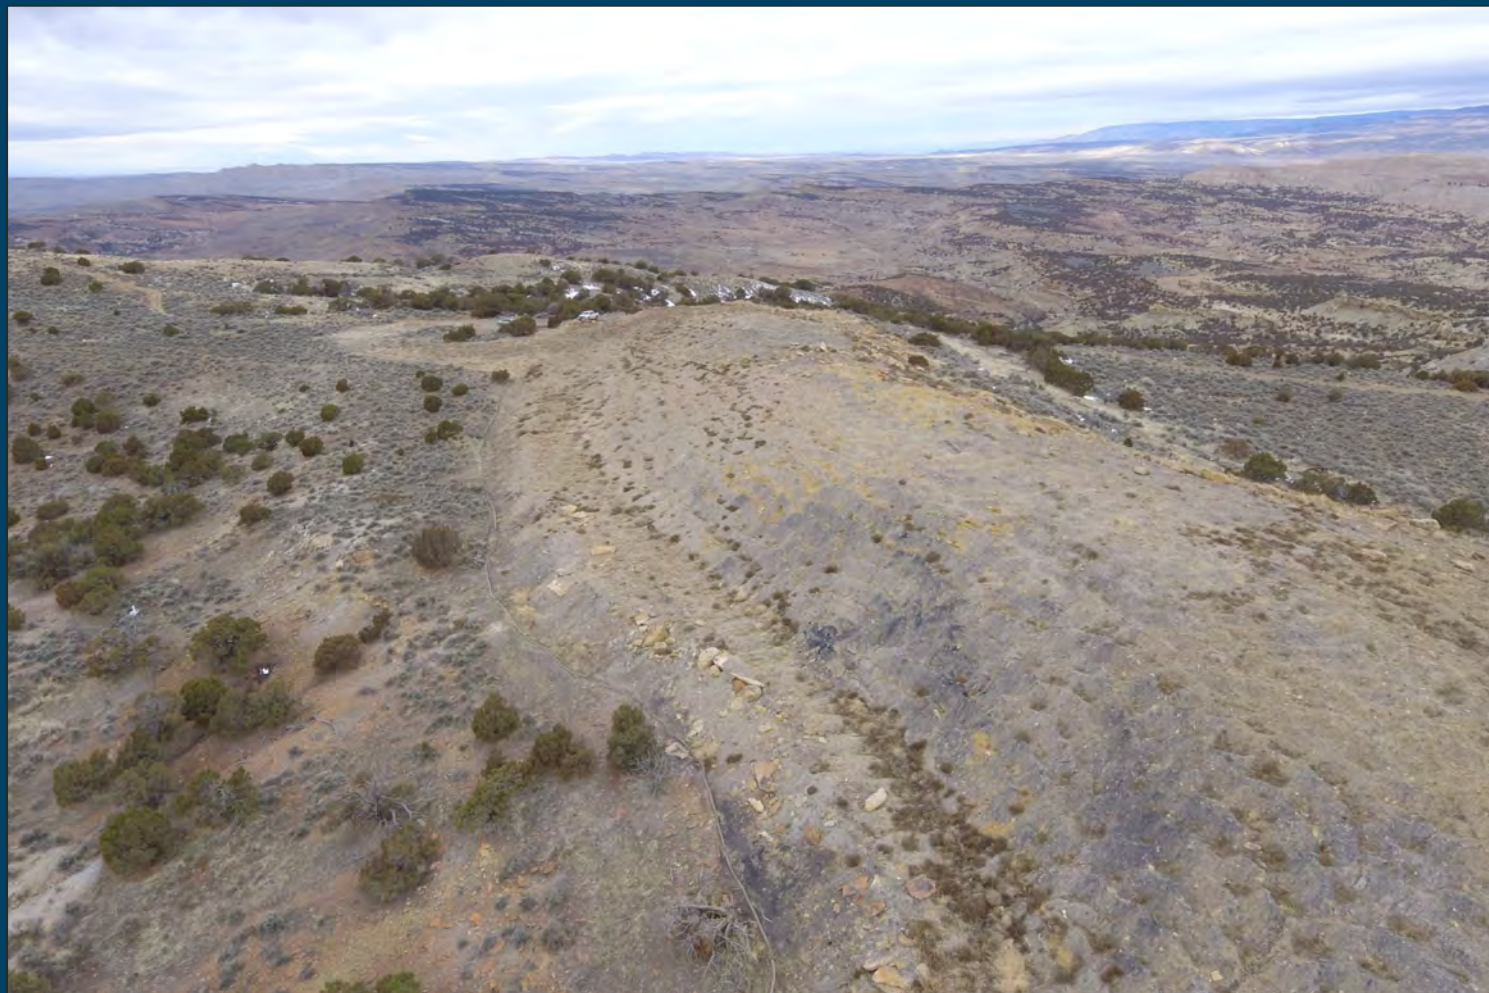
Fire abatement looking West

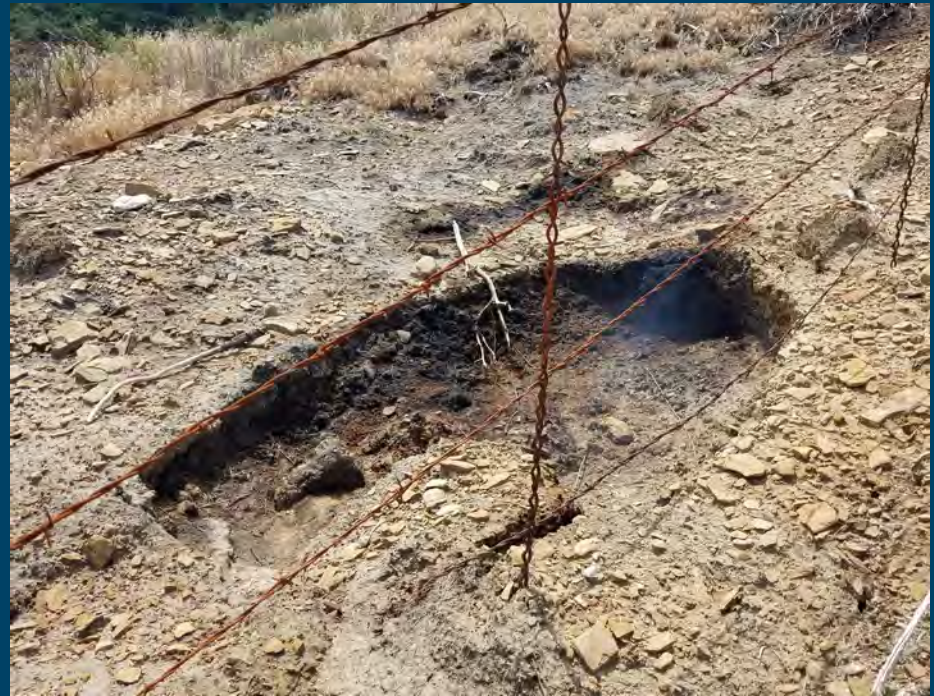
The fire was visited on July 2, 2018. The mine fire has 2 active fire expression areas that both correlate with the subsidence “Feature 2”, discussed by Renner in the 2005 report. “Feature 1” from the 2005 report is currently not active. At the upper fire expression, hot and dry mine fire emissions are venting at multiple locations along the upper coal seam. Similar emissions are found on the east side of a 25 ft long, 3-inch-wide fracture running perpendicular to the stratigraphy. Vents along the west side of this fracture have more creosote buildup around them, indicating the fire in this area is in an earlier stage of its combustion cycle. This fracture extends west towards what appears to be a new area of fire in an underlying coal seam outside of the current fire perimeter fence. The surface of this new fire area is defined by a few dry and dead bush trunks, creosote staining in the soil,

Smoking subsidence feature

It is recommended that vegetation be removed from around the new fire expression area. It is also recommended that the fire perimeter fence be moved to include the new fire expression area. A snowmelt or thermal drone flight would help determine
