Summary Report

Coal Basin Mine Reclamation Projects

August 24, 2007

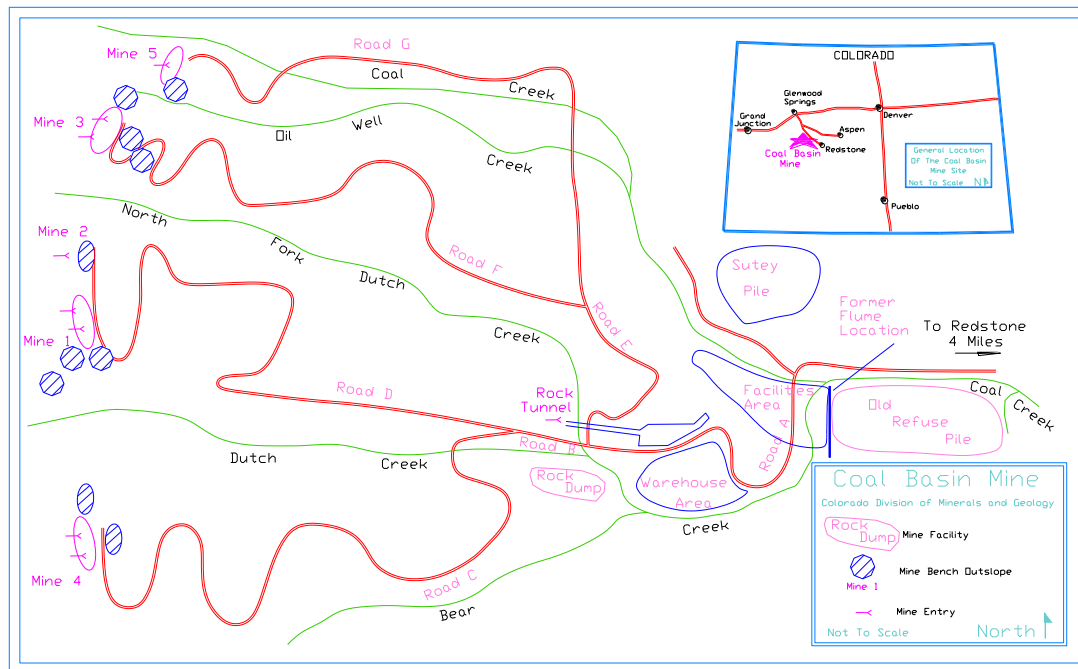
Coal Basin Mine
 Colorado Division of Minerals and Geology

- Rock Dump Mine Facility
- Mine 1 Mine Bench Outslope
- ← Mine Entry
