State of Colorado Streambank Erosion Study

Elk River
Routt County, Colorado
for the
Colorado State Soil Conservation Board
Colorado Association of Soil Conservation Districts
Routt County Soil Conservation District

Soil Conservation Service Denver, Colorado

November 1988

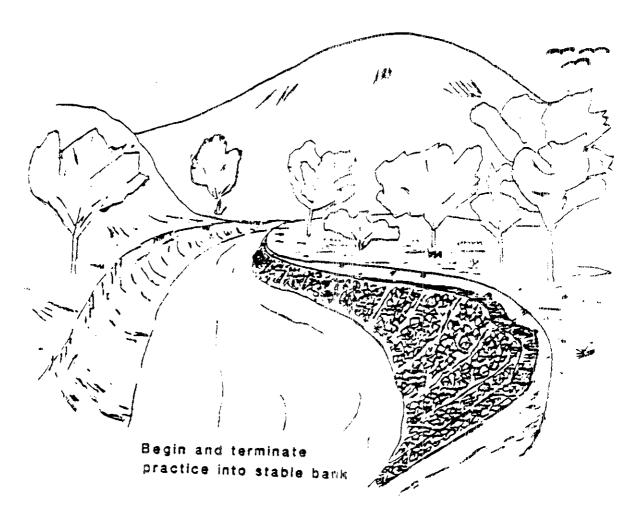
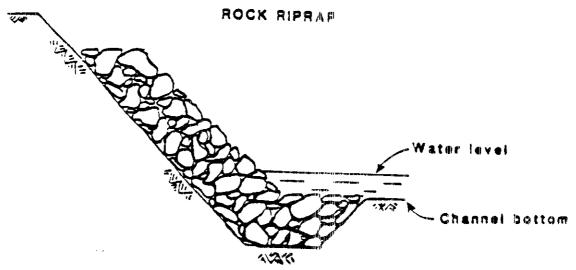
ROCK RIPRAP

A variation of this practice is to use wire-bound rock. The cross section would be similar to the rock riprap cross section. However, since the rock is held in place with anchored, wire-fencing material, the rock can be a smaller size. This will allow the thickness of the blanket to be reduced. Wire-bound rock is not recommended on channels with high banks or streams with a high flow velocity.

Maintenance requirements for a riprap blanket include replacing or repositioning rock if it is displaced by high flows. The upstream and downstream ends of the blanket should be checked to make sure erosion is not occurring. If scour holes have developed, the eroded areas should be filled and protected with additional riprap.

TYPICAL RIPRAP SECTION

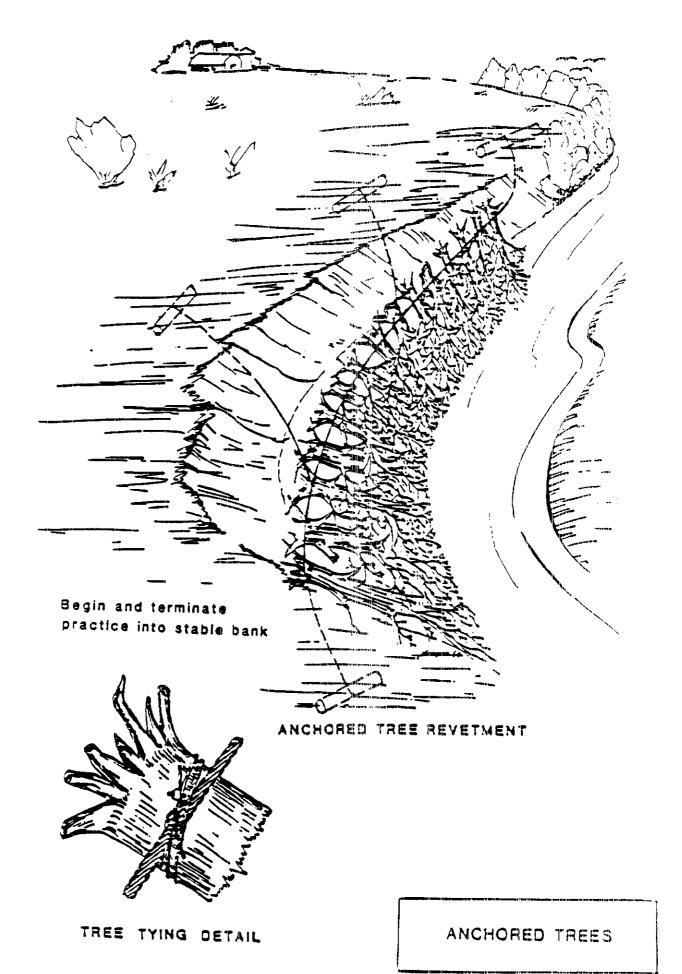
Anchored trees can be used as an effective method of stream bank protection on most streams. They can be used on streams with any degree of meandering. The trees can be placed perpendicular or parallel to the bank. The trees should be as bushy as possible. Juniper and brushy willow work well. The trees are placed with the butt end of the tree against the bank and/or upstream. The trees are anchored with cable and deadmen to hold them in place. The anchors are located on the bank at least 10 feet from the edge of the bank. The area behind the trees is sometimes filled with gravel or other material. This helps hold the trees in place and also provides a surface which can be seeded. Even when the area behind the trees is not backfilled, some type of vegetation should be established. The upstream and downstream end of the reach must be protected to minimize the chance of water getting behind the trees and causing erosion. The most effective long-term result from this practice occurs when vegetation has been established along the entire reach.

Maintenance requirements for this practice include repairing damaged cable or anchors. Disturbed spots or scour holes behind the trees or on the ends should be repaired and protected.

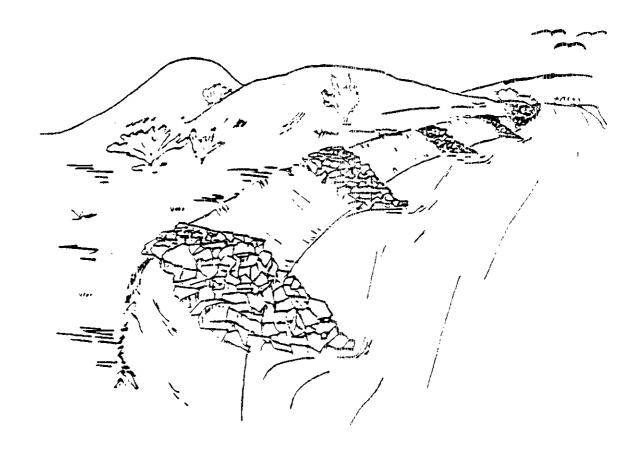
JETTIES

Jetties are an effective method of controlling stream bank erosion on slight to moderately meandering curves. Jetties typically are not feasible on sharp curves. Jetties function by deflecting the flow from the stream away from the stream bank. Jetties can be constructed completely from rock or they can have a dirt, sand or gravel core with rock on the surface for erosion protection. Rock must be large enough to withstand the force of the water without being displaced. The size and spacing of the jetties depends on the physical characteristics of the stream; for example, the channel width and the sharpness of the curve. A jetty should not extend into the stream from the bank more than 20 percent of the channel width. The design of jetties requires an evaluation of the downstream channel and bank conditions to avoid causing erosion and other problems.

Jetties can be used to protect a stream bank without using any other practices. However, it is generally recommended to shape and seed the bank reaches between jetties.

Maintenance requirements for this practice include replacing or repositioning any rock which has been displaced. Over a period of a few years, sediment bars may develop near the downstream end of the jetty. These gravel bars should be removed to keep the jetty system functioning properly. A maintenance inspection should include a look at the downstream bank to check for erosion which could have been caused as a result of the jetties.

JETTY STREAMBANK EROSION CONTROL

TYPICAL JETTY SECTION

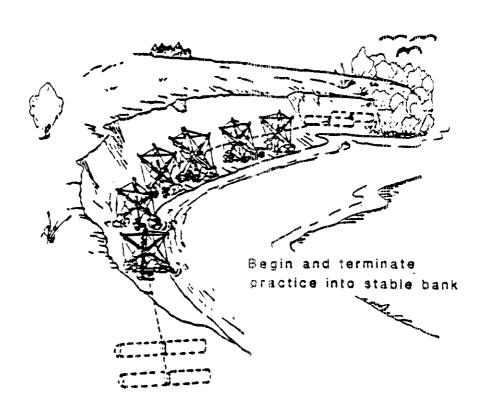
Jacks can be used to stabilize most eroding banks. Jacks are especially useful in streams which have wide sections due to stream bank meandering. The jacks can be located to allow eroded areas to silt in behind the row of jacks. On smaller streams and streams with fairly low flow velocities, a single row of jacks is all that would be required. The jacks can be fabricated from wood, concrete or metal. Individual jacks are fabricated by tying three posts or beams in a cross shape with wire. The jacks are placed along the toe of the bank. Rock is placed on and around the base of wood jacks to keep them from floating. The jacks are anchored to the bank with cable and deadman anchors. Vegetation should be established in the area behind the jacks.

Maintenance requirements for this practice include inspecting the jacks and repairing any loose or broken wires. Any movement of the jacks or rock should be corrected by returning it to its original location. Any scour holes or other erosion which has occurred behind the jacks should be reshaped and revegetated.

STREAMBANK EROSION CONTROL WITH JACKS

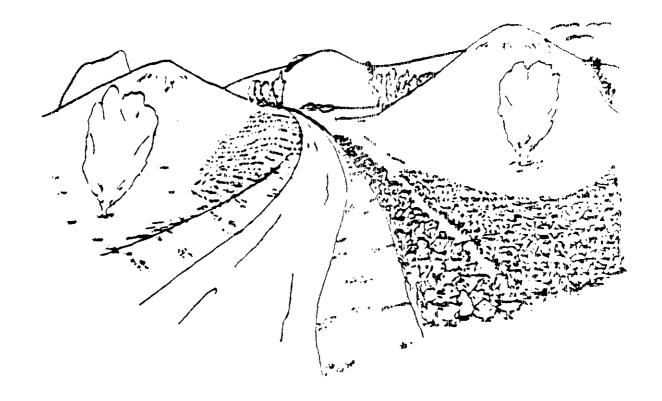
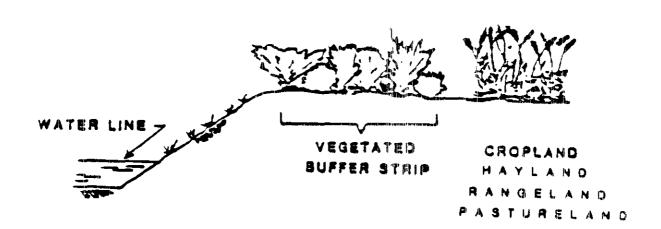
This practice would leave at least a 50 foot, and preferably a 100 foot wide, strip on each side of the stream channel. This would effectively create a buffer strip for trapping sediment coming from off channel sites and reduce erosion along the stream bank. In no case should overstory brush and tree vegetation along or within 50 feet of the stream channel be eliminated to increase crop or livestock forage production.

Maintenance requirements for this practice include brush removal in channel and periodic checks of vegetation to ensure understory vegetation is perennial. If understory vegetation is annual species, the area should be farmed and reseeded to adapted perennial species.

VEGETATED BUFFER STRIP BANK PROTECTION

VEGETATED BUFFER STRIP

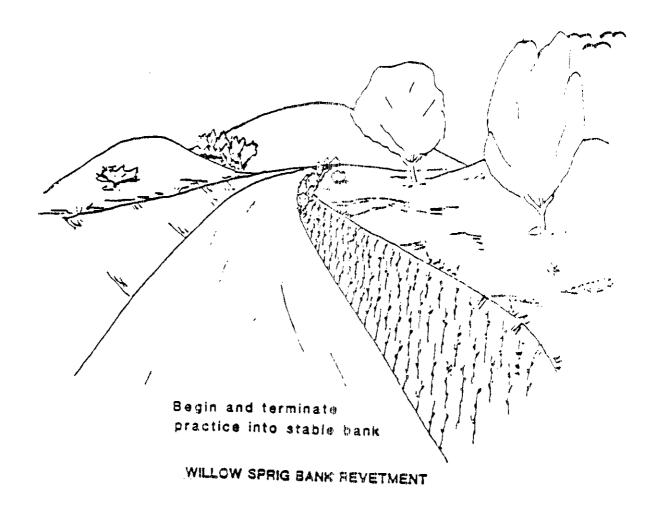
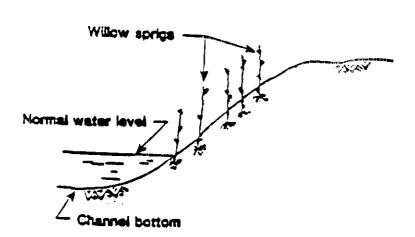
WILLOW SPRIGS

Willow/Alder/Dogwood Sprigs Revetment

Stream bank vegetation is one of the most effective methods of controlling stream bank erosion under natural conditions. It is also the least costly method available when maintained in good condition. Then streams begin to meander, bank erosion can occur if the vegetative protection is not in proper condition.

When this occurs, sprigs of adapted woody species such as willows, alders, and dogwood can be used in the wetter zone of the stream bank. This method works best on the straight stream sections where water pressure is not attempting to scour the banks. A critical requirement of this method is to sprig the cuttings deep enough or close enough to ground water to ensure moisture for at least 60 days. If water levels decrease too fast for the cuttings to root and follow the declining water table, they will die. The stream banks above the sprigged cuttings should be seeded to grass and banks may require shaping to at least 1.5 to 1 slope.

Maintenance for this practice will require replacement of dead sprigs and reshaping and seeding banks which develop scour holes.

TYPICAL BANK SECTION

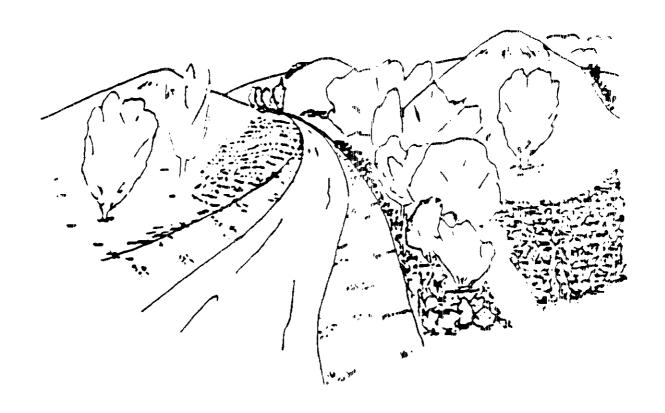
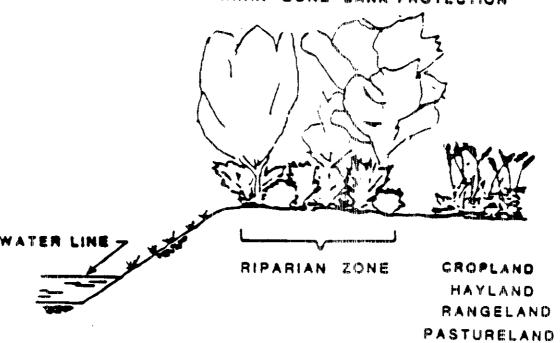
Dedication of riparian zones along the river banks will reduce much of the damage associated with streambank erosion. Riparian zones will provide protection from the lower frequency flows. However, large flows can produce bank erosion. Structural practices may be needed in some locations.

Maintenance requirements for this practice include tree and brush removal that can block channel and cause additional bank cutting. Fencing to keep livestock out of the riparian areas during certain times of plant growth.

RIPARIAN ZONE BANK PROTECTION

RIPARIAN ZONE

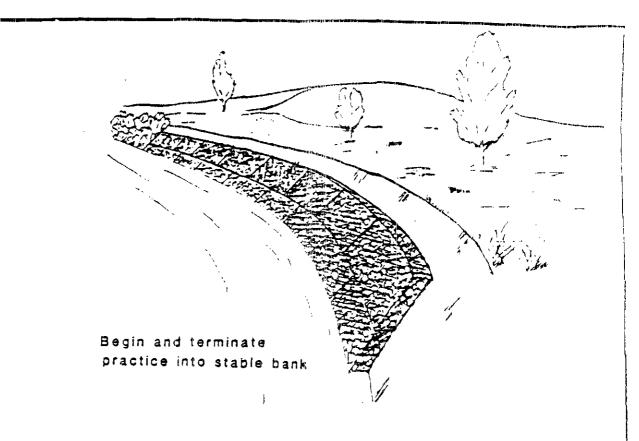
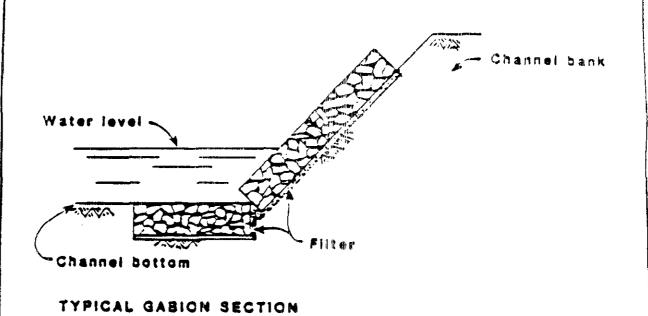
Gabion Revetment

Gabions can be used to stabilize stream banks in nearly every situation. Gabions consist of wire baskets filled with rock. Bank protection using gabions can be constructed using either a mattress revetment or a retaining wall. The installation of gabions must consider the potential scour depth in the channel. The gabion baskets usually require a filter between the baskets and the base material. The filter can be either a sand or gravel filter or a filter fabric. If a mattress revetment is used, the banks should be shaped to a slope no steeper than I horizonal to I vertical prior to placing the gabions. If a retaining wall is used, the banks may be vertical.

Maintenance requirements for this practice include inspecting the gabion baskets and repairing any broken wires.

GABION REVETMENT

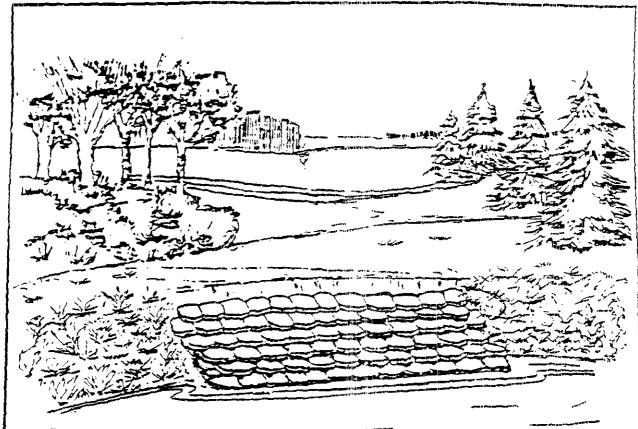
Sack concrete revenuents can be used to control bank erosion in nearly every situation. The stream bank should be shaped to a slope no steeper than I horizontal to I vertical. Burlap or plastic sacks are filled with soil-cement or sand-cement mixtures. The sacks are then stacked along the bank. The toe for the sacks should be placed below the channel bottom to prevent any undercutting of the sacks. After the sacks have been placed, they can be hosed down to get a quick set or they can be left to harden from natural precipitation. The durability of this practice will depend on the quality and proportions of the mixture in the sacks. The sacks should extend up the bank to at least one foot above the high waterline. If the sacks do not extend to the top of the bank, the bank should be shaped and seeded.

This practice should be maintained by inspecting for broken-up concrete and erosion at the ends of the revetment. Any broken-up concrete should be patched. Scoured areas at either end of the revetment should be shaped and protected.

Begin and terminate practice into stable bank

SACK CONGRETE REVETMENT

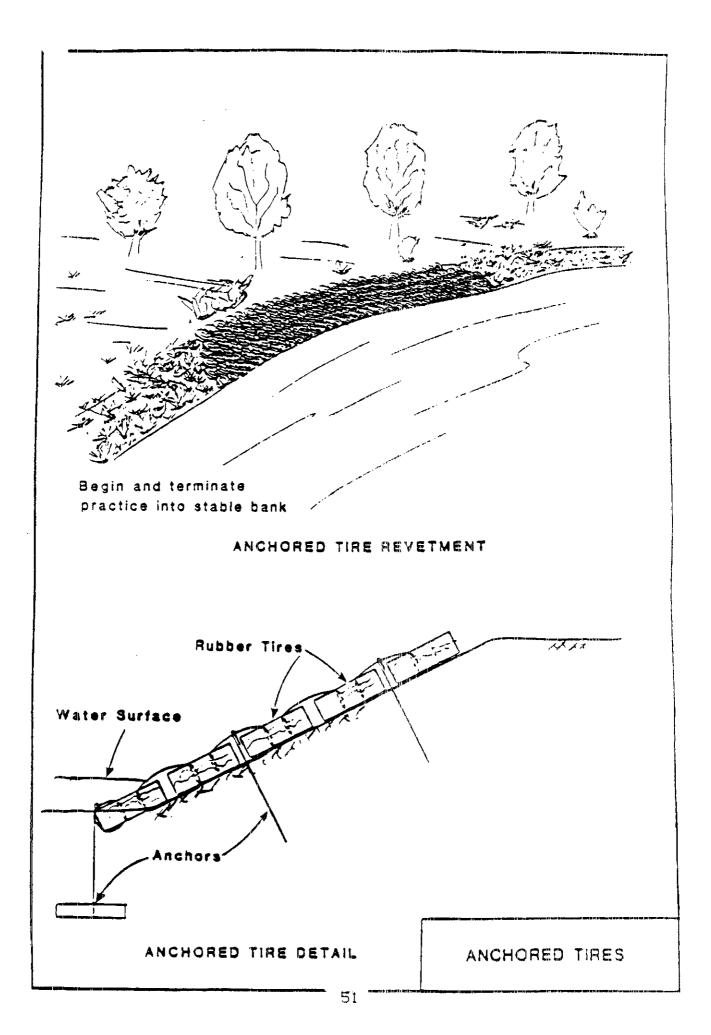
Anchored tires can be used to control bank erosion in streams which do not have high flow velocities. High flow velocities make it difficult to get vegetation established. High velocities also increase the chance of erosion occurring around the tires. The stream banks are shaped to a slope no steeper than 2 horizontal to 1 vertical. Tires are then tied together and placed on the slope. They should extend up the bank to a height of one foot above the high water elevation. The area above the tires should be shaped and seeded to appropriate vegetation. The mat of tires is anchored to the slope to keep it from floating when it is submerged. The toe of the tire mat should be protected with rock to prevent the stream from undercutting the tires. Vegetation should be established over the tire mat.

Maintenance requirements for this practice include replacement or repair of broken tire wires or anchors. Vegetation which has been damaged due to high flows should be reestablished.

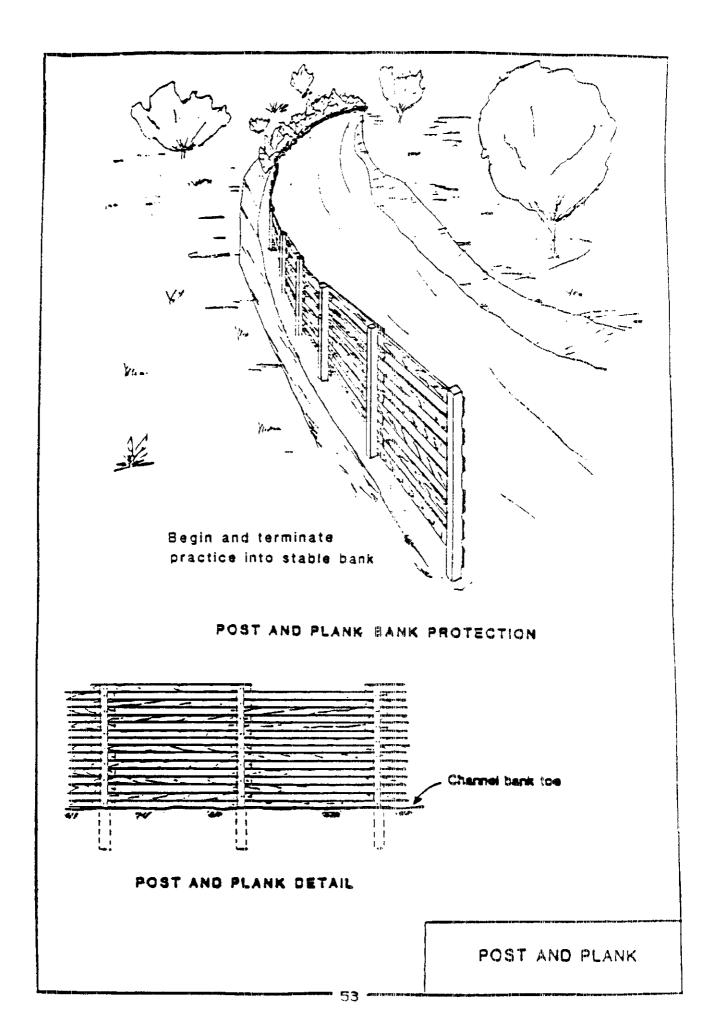
Posts and Planks Bank Protection

This practice consists of building a post and plank or pole barrier along the toe of the channel bank. This practice can be used on most streams with moderate to low flow velocities. It is especially useful in streams which have wide sections due to stream bank meandering. The post and plank or pole barriers can be located to allow eroded areas to silt in behind the barrier. Posts are placed at approximately a 12 foot spacing. Three-inch thick planks are bolted to the channel side of the posts. The bank behind the barrier should be shaped to a slope no steeper than 1.5 horizontal to 1 vertical and then seeded.

This practice is maintained by repairing or replacing any broken or loose planks. Eroded areas or scour holes should be reshaped and seeded.

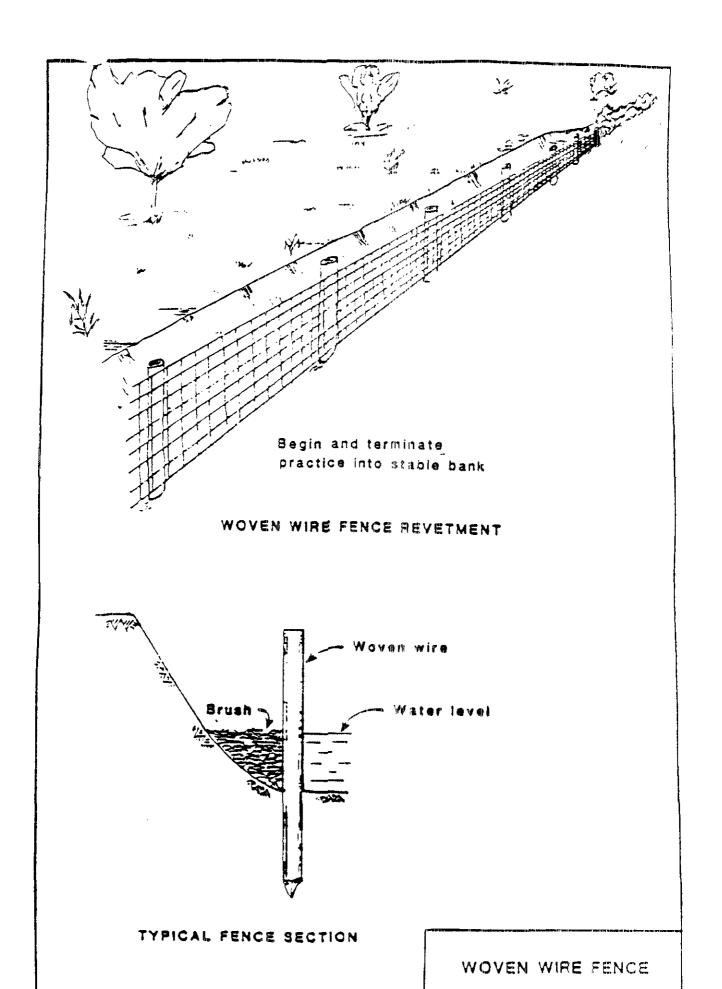
Woven Wire Fence Revetment

Woven wire fence can be used to stabilize stream banks with relatively low velocities. Posts are driven into the channel along the toe of the bank at six to eight feet spacings. Woven wire-fencing material is attached to the posts on the channel side of the posts. The bank behind the fencing should be shaped to a slope no steeper than 1.5 horizontal to 1 vertical and then seeded. This practice has achieved its intended results when the bank behind the fence has been completely stabilized with vegetation.

Another variation to this practice is to use live willow posts. These posts should be three to five inches diameter and spaced on a four foot spacing. Fiber netting is tied to the posts to provide protection at the toe until the willows get established. The bank behind the willow posts should be shaped and seeded.

Maintenance on these practices includes inspecting the fencing and vegetation. Any loose or broken wires should be repaired. Any seeded areas which have been eroded should be reshaped and seeded.

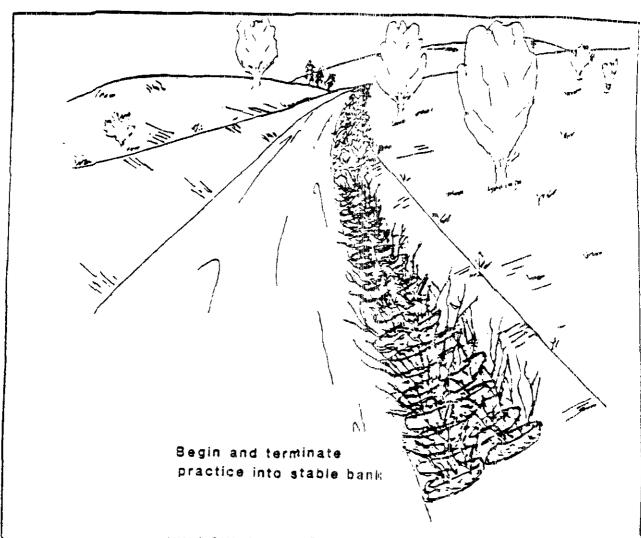
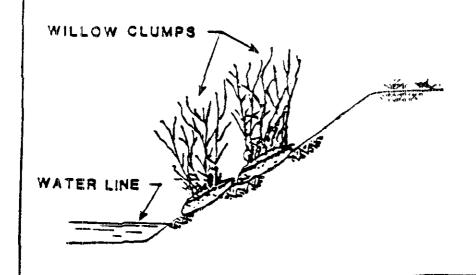
Willow Clump Revetment

When meander erosion is occurring, clumps of live willows can be relocated from local areas which have excess willows to protect either straight or meander type erosion.

The clumps can be dug and transported using a front end loader or backhoe tractor and placed directly into the stream bottom against the bank. Willows should normally be placed in locations where they receive perennial water/moisture.

The clumps should be placed so stream flow can not get behind or between clumps. On meanders, clump protection such as steel posts with woven wire fence should be installed to ensure the clumps stay in place until well rooted (one year's protection is adequate). This protection may also be necessary on straight channel sections if stream flows are high enough to endanger washing out of freshly placed clumps. The woven wire should be installed high enough up bank on the ends to ensure the clumps and fence are not washed out the first season. The banks can then be sloped to 1.5 to 1 or greater slope and seeded with an adapted grass or local clumps of sod to speed up the total bank rehabilitation. This may not be necessary as the clump protected banks will slough and revegetate naturally, but will help in weed control.

WILLOW CLUMP BANK REVETMENT

WILLOW CLUMPS

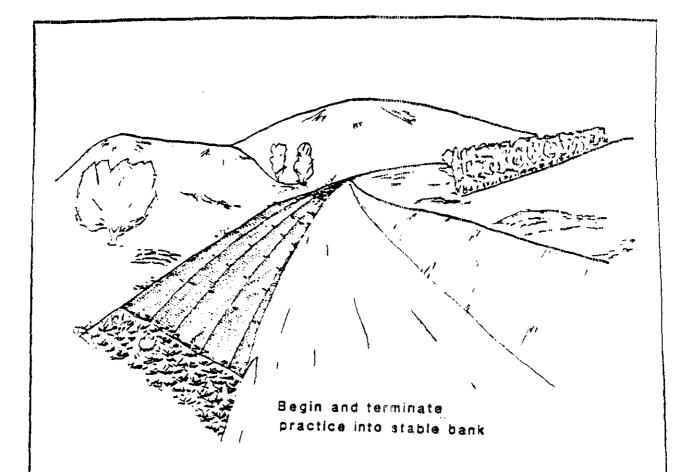
Seeding With Fabric Mat Revetment

Stream banks should be shaped to a 3:1 slope or greater and seeded with a mix of adapted grasses. The mix should include species capable of withstanding excessive moisture to species which are quite drought tolerant (i.e. canary-grass/creeping foxtail - brome - wheatgrasses). The seeded section should then be covered with erosion control revegetation mat and staked down to stabilize the section until sod is established. This practice can be used below the temporary high water line, but not normally where perennial flows occur.

Maintenance requirements for this practice include periodic checks to ensure fabric mat is adequately staked and additional seeding if necessary.

FABRIC MAT WITH SEEDING BANK REVETMENT

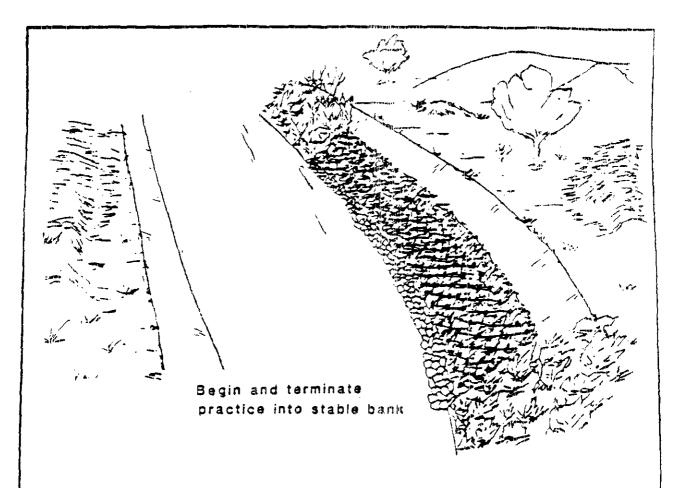
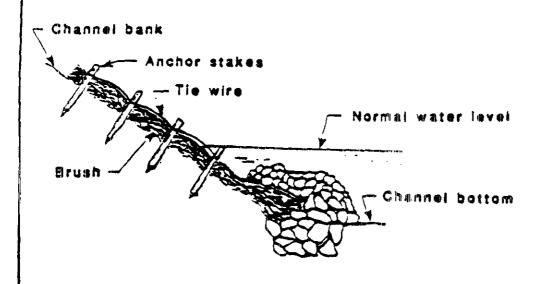
Rock and brush mat revetments can be used to control stream bank erosion in most areas where rock riprap can be used. There are two conditions when this practice would not be recommended. The first is on a sharp curve. The second is on reaches with large flows and a high velocity. The bank is sloped back to a slope not steeper than 1.5 horizontal to 1 vertical. A rock toe is placed at the bottom of the slope to protect the bank from undercutting. Brush is then laid with the butt ends up the slope and transverse to the stream bank. The brush is anchored in place with wire and stakes. If the mat does not extend to the top of the bank, the unprotected area should be seeded.

A variation to this practice is to use all bundled brush or willows. This would not be recommended on channels with high flow velocities. The brush would replace the rock in the toe and bottom part of the slope.

It is recommended to use live brush for the above practices. If live brush is used, loose dirt should be placed over or around the bundled brush. This will enable more of the brush to sprout faster and form vegetative protection for the bank.

These practices should be maintained by inspecting the wire anchors and the rock toe. Any wires which have been pulled loose should be repaired. Brush or rock which has been dislodged should be replaced.

BRUSH AND ROCK BANK REVETMENT

TYPICAL REVETMENT SECTION
