# JOINT-USE RESERVOIR AND GREEN MOUNTAIN EXCHANGE PROJECTS

Prepared For The  
**Colorado Water Resources  
and Power Development Authority**

By  
**Boyle Engineering Corporation**  
April 1987

**APPENDIX A**  
**HYDROLOGIC ANALYSIS**

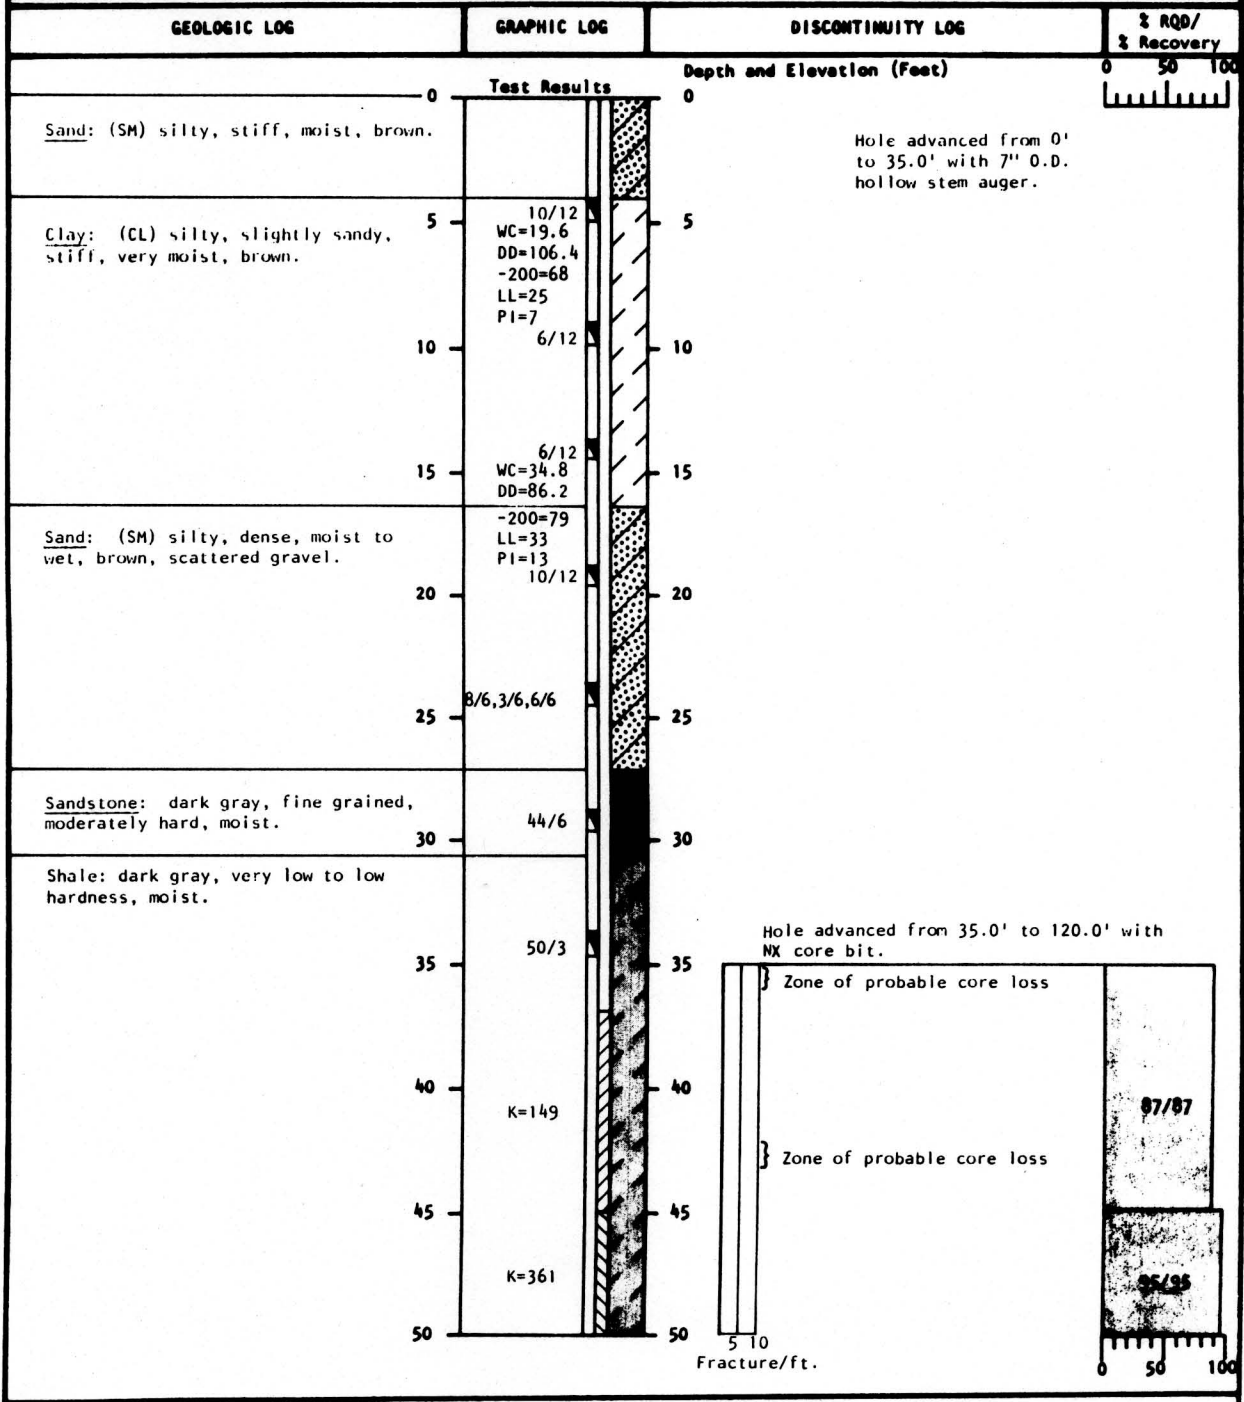
**FIGURE C.2.4a**

Angle from Horizontal -90° Bearing of Angle Hole \_\_\_\_\_ Depth of Water 8.0' Begun 8/22/86

Finished 8/22/86

Standard penetration test.
  Core sample tested

Packer permeability test section  
 K in ft/yr

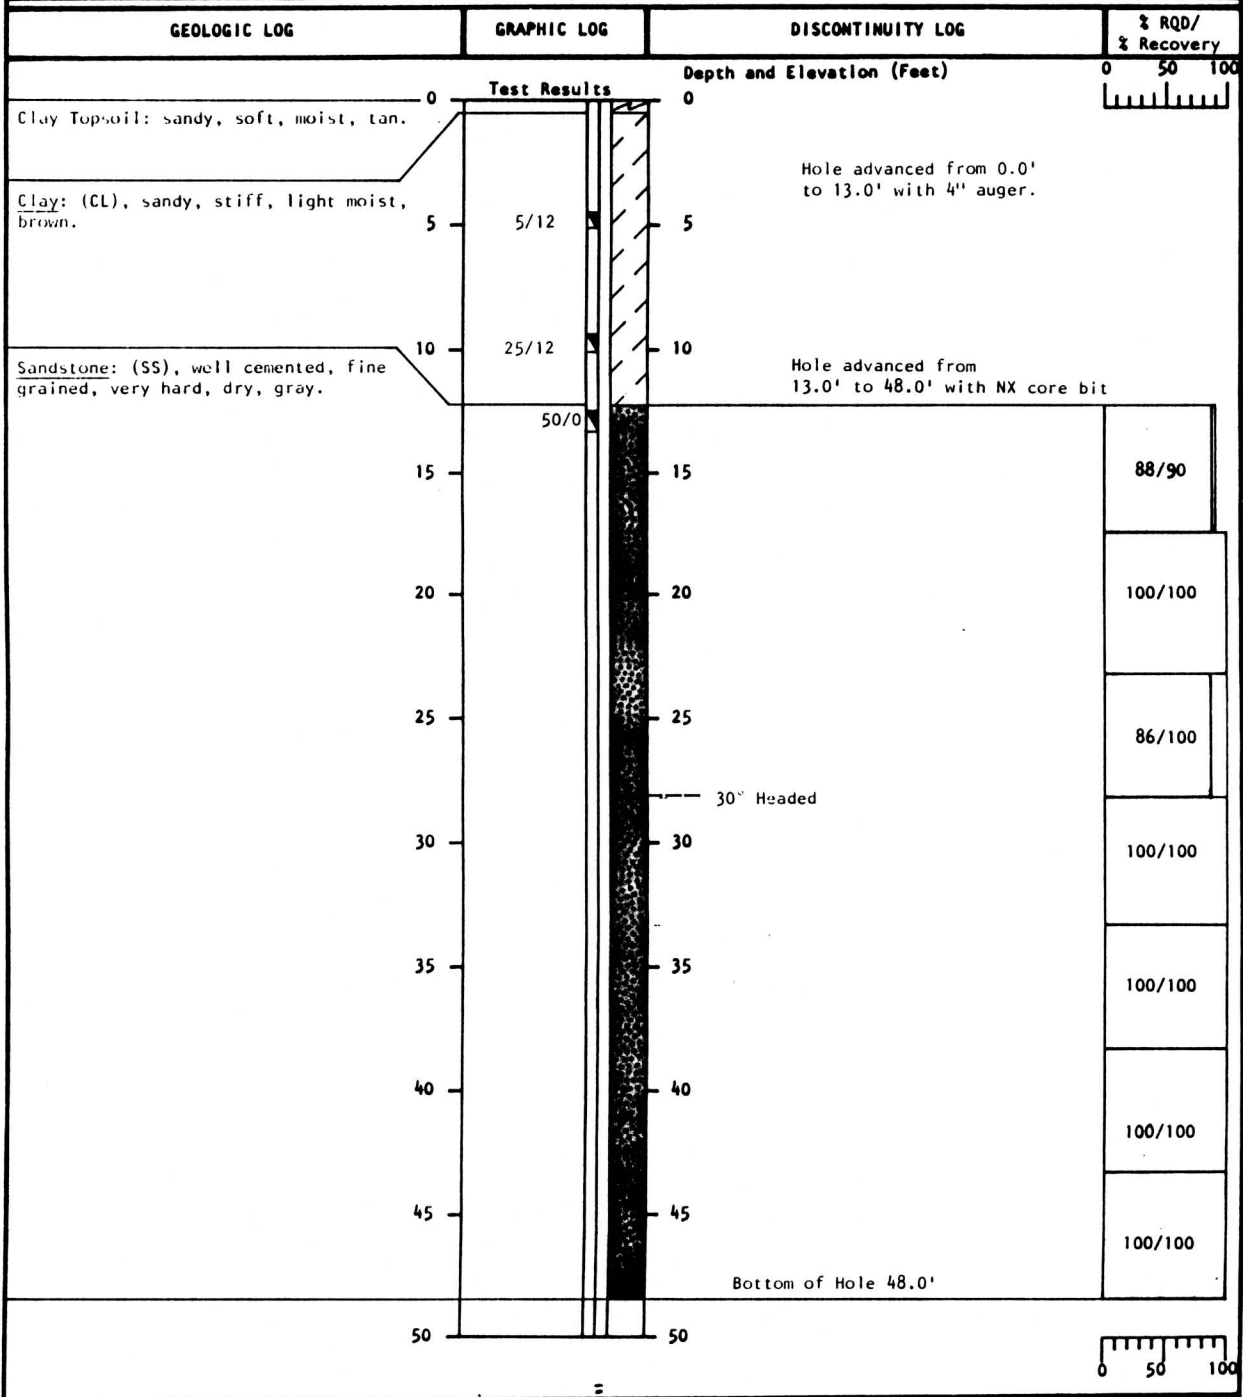
LOG OF HOLE 4

Hole 4 Ground Elevation 7440' Total Depth 13.0' Depth of Overburden 12.0'

Angle from Horizontal -90° Bearing of Angle Hole -- Depth of Water Not Encountered Begun 9/3/86  
Finished 9/3/86

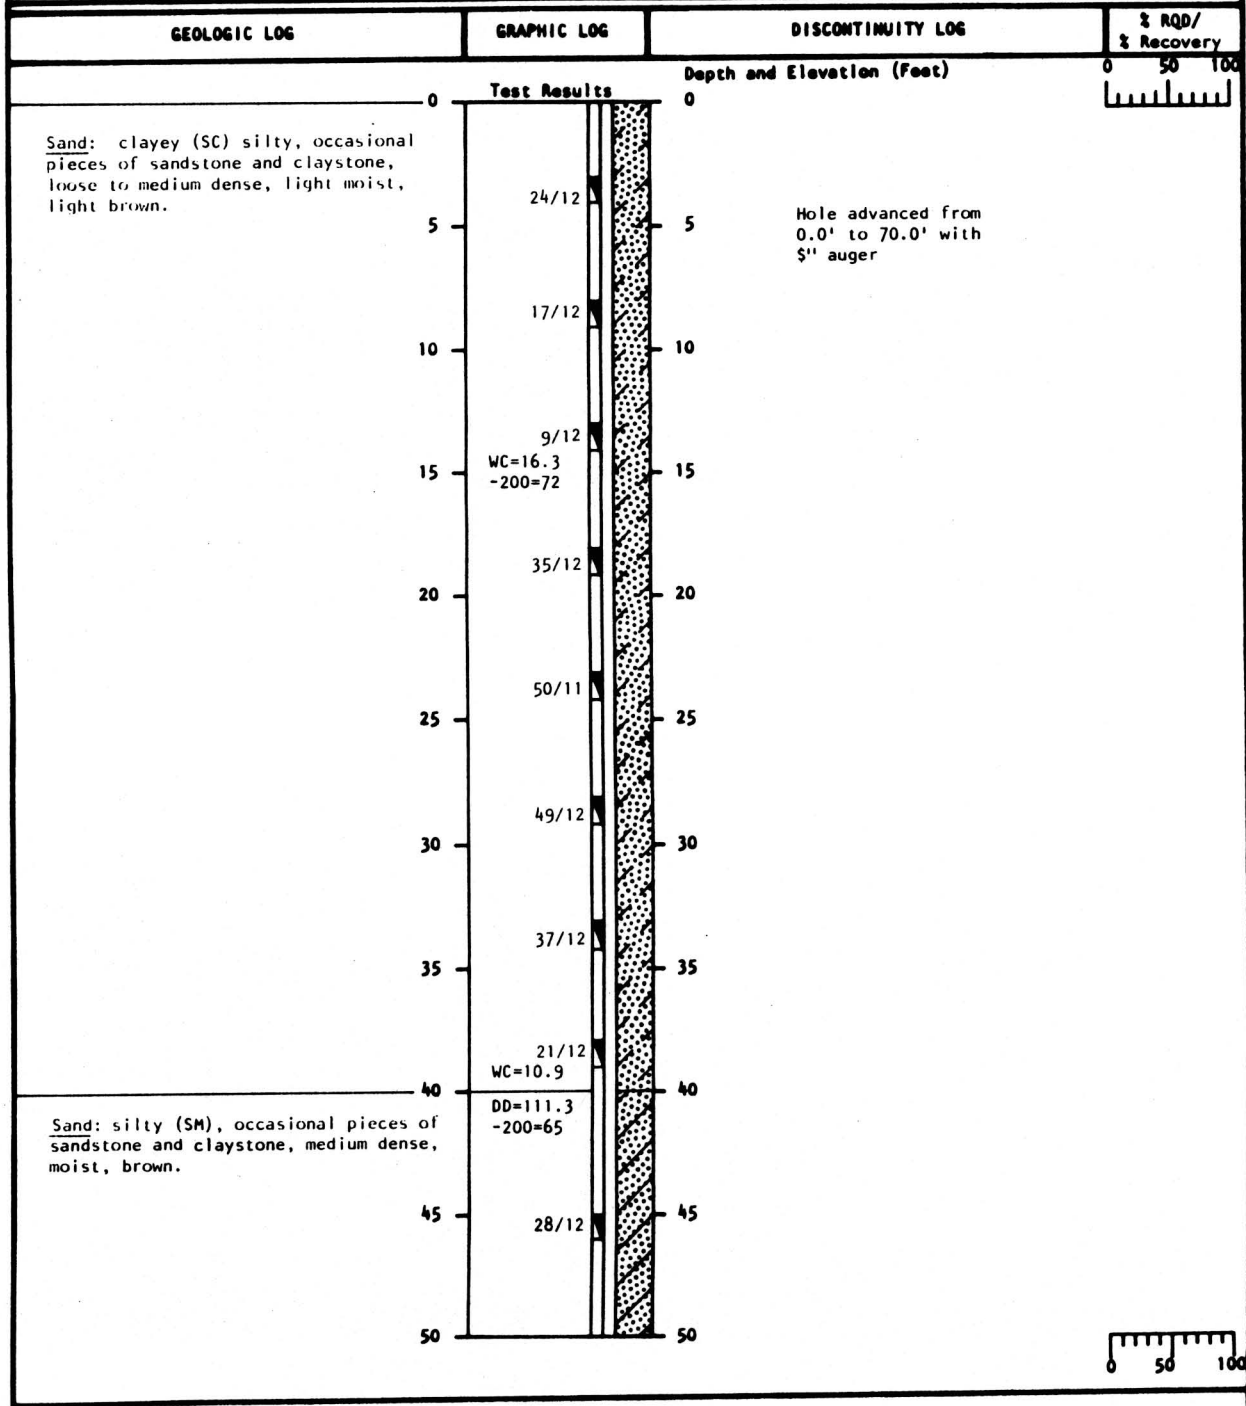
**FIGURE C.2.7a**

Hole 5 Ground Elevation 7430' Total Depth 39.0' Depth of Overburden 39.0'

Angle from Horizontal -90° Bearing of Angle Hole --- Depth of Water not encountered Begun 8/27/86  
Finished 8/27/86

Standard Penetration Test

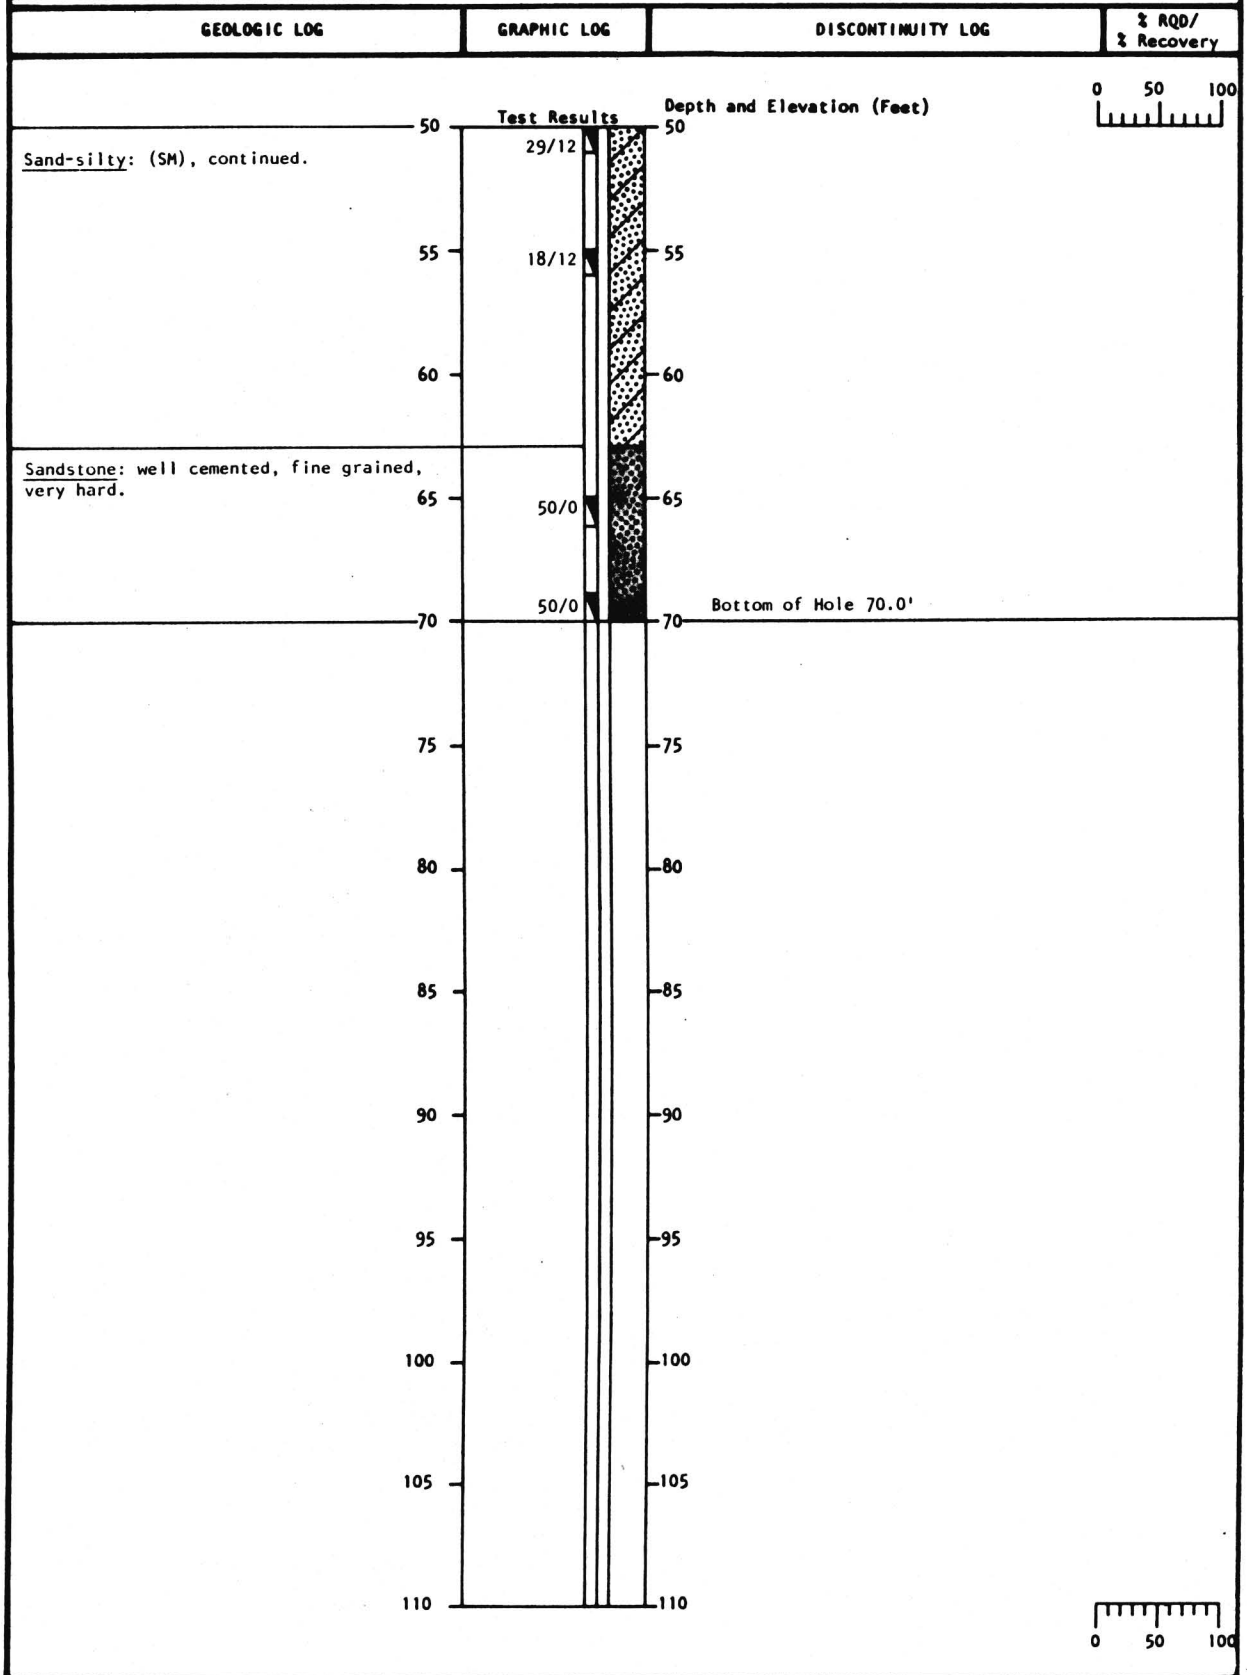
**FIGURE C.2.7b**  
Log of Hole 5  
1 571 86

Hole 5 Continued

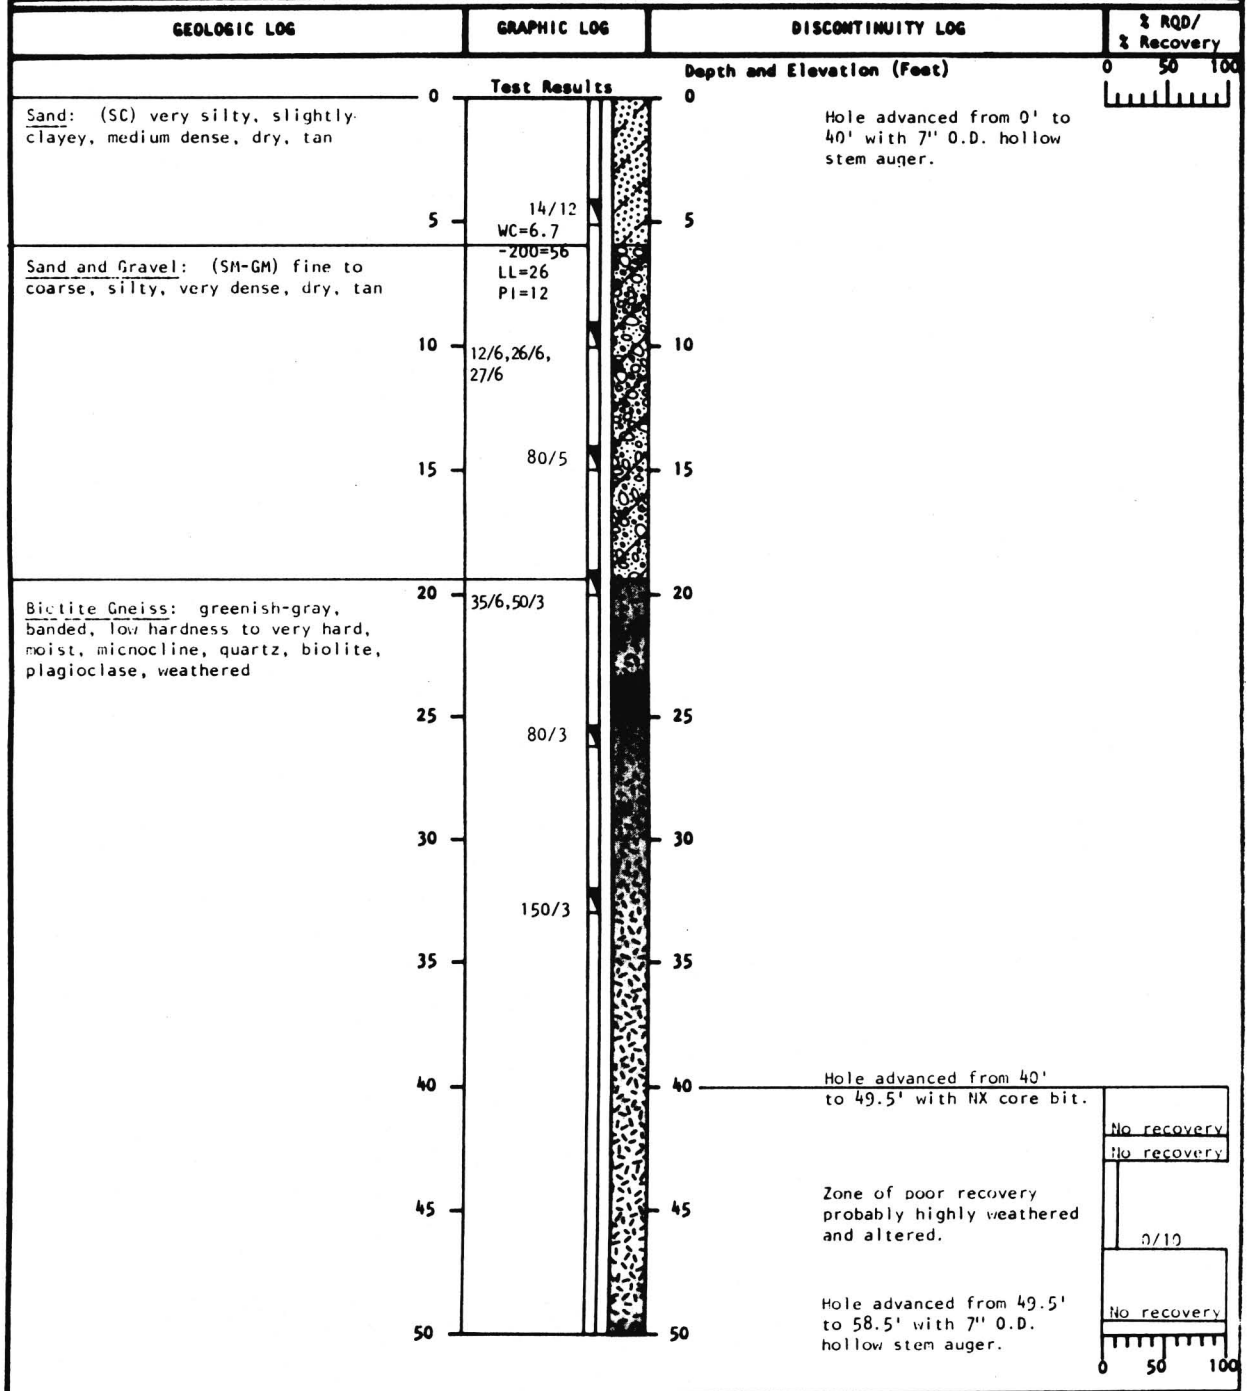
**FIGURE C.3.6a**

Hole 4 Ground Elevation 7384' Total Depth 75.2' Depth of Overburden 19.0'

Angle from Horizontal -90° Bearing of Angle Hole --- Depth of Water - Began 8/18/84  
Finished 8/18/84

- Standard Penetration Test
- Packer permeability test section  
K in ft./yr.
