# Artificial Ground-Water Recharge On The Arikaree River Near Cope, Colorado

# ARTIFICIAL GROUND-WATER RECHARGE ON THE ARIKAREE RIVER NEAR COPE, COLORADO

ROBERT A. LONGENBAUGH<sup>1</sup>

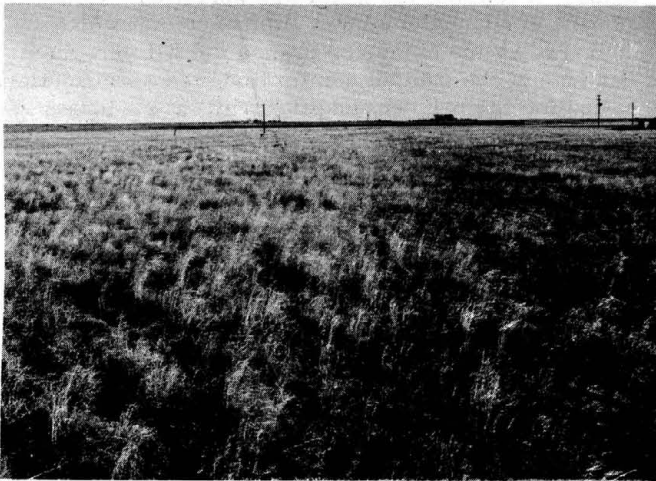
Figure 2. View looking northeast across site No. 1 prior to construction.

approximately 150 acres for location of site No. 2., on Sec. 31 T4S R49W. Landowners at both the sites were enthusiastic about the study and were cooperative. Both sites were located on wide sections in the flood plain corresponding to old stream meanders. Figure 2 shows a northeasterly view across site No. 1, indicating the flat area upon which the water was spread and showing one of the irrigation wells in the upper right hand corner.

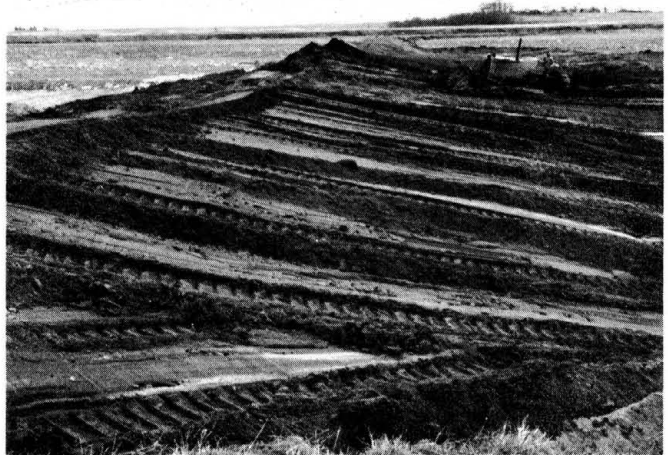
Figure 5. Construction of dam D-2, site No. 1.

During the initial construction, the earth was all pushed from the borrow area immediately upstream of the dam. Figure 5 shows dam D-2 under construction at site No. 1. During reconstruction in the spring of 1966, the material was pushed from borrow areas immediately upstream and downstream from the dam. It was felt that the additional travel on the downstream face of the dam would provide additional compaction and more stability of the fill material. The contractor found that for most cases it was easier and quicker for him to push more fill dirt, resulting in a flatter than three-to-one slope, than it was to try and maintain exact design specifications. This caused him to move some dirt for which he received no pay. Because of the lack of compaction, the contractor was required to add ten per cent to all fills to allow for settling. This proved to be quite satisfactory and the contractor was paid for this additional yardage.

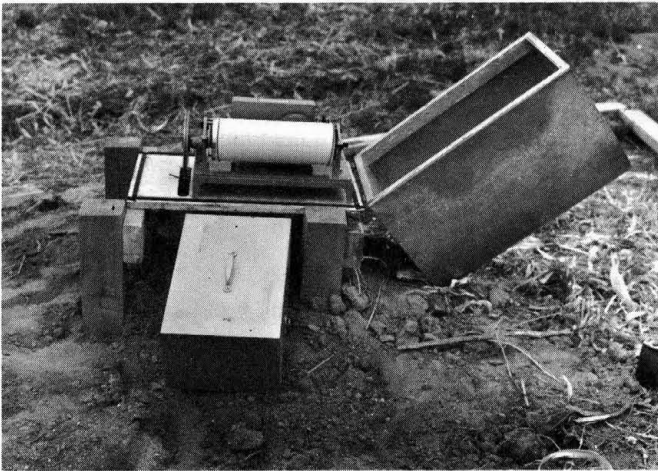
Figure 6. Continuous water level recorder installed on an observation well.

No. 2. Those at site No. 1 include six irrigation wells. The other ten were constructed by drilling a seven-inch hole with a rotary drilling rig and placing either one and one fourth- or five-inch pipe into the hole as casing. Three of the wells are equipped with automatic-continuous recorders as shown in Figure 6. Water levels in all wells were measured periodically with a steel tape and the measurement recorded on field data sheets and the respective recorder charts.

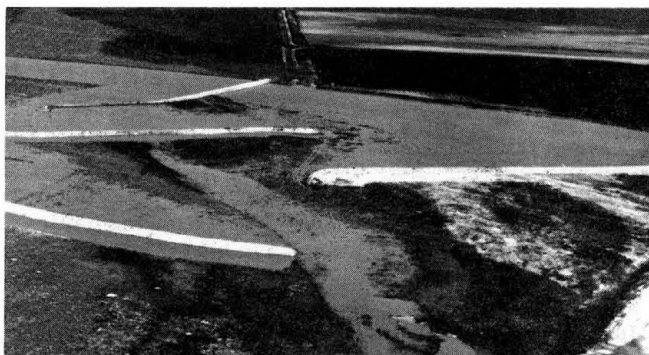
Figure 8. Aerial view of site No. 1 on June 18,

Recharge by structures - Flows during June 1965 did not exceed the design flows for long enough periods to cause much damage to the structures but did provide significant amounts of water for recharge. Figure 8 is an aerial view of site No. 1 on June 18 showing how the water was spread over the entire recharge area. The photo on the cover is also an aerial view on June 18.

In Figure 8 you can see a small erosion channel in the lower part of the photo which later worked its way upstream to the spillway of dam D-3. This caused some lowering of the water behind D-3 and had to be repaired after the June 24 flows.

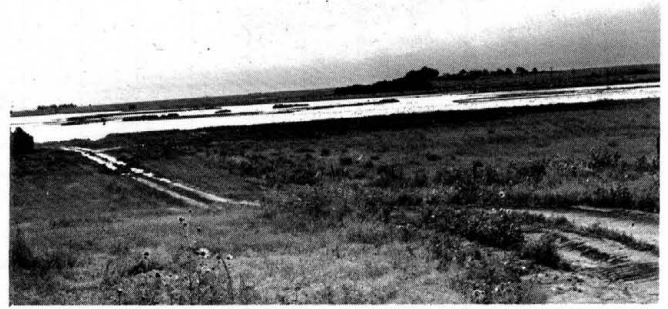
5  
5  
Figure 10. Flood flow destroying structures at site No. 1 on July 24, 1965. do

July 24, a large flow reached site No. 1 at about 5:30 a.m. and destroyed all structures. Figure 10 shows flow across site No. 1 several hours later. Note the breached dikes visible in the center of the photo and the large flow which was still occurring. All structures were overtopped and quickly eroded away as planned. Similar destruction occurred at site No. 2 except for dam D-2 at that site. When dam D-1 at site No. 2 was destroyed the amount of water diverted into the old channel was reduced and dam D-2 held.

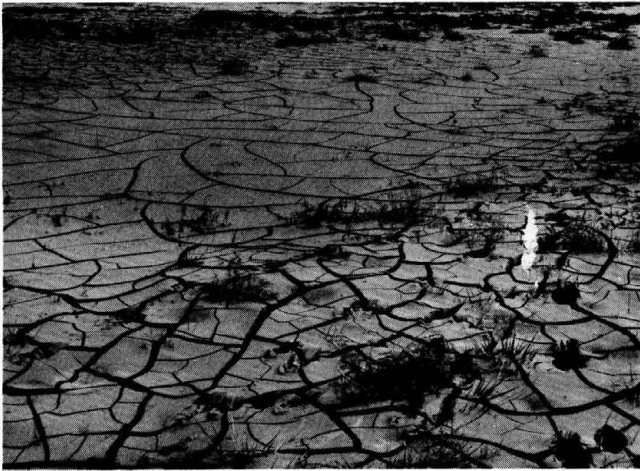
6  
6  
Figure 16. View across site No. 1 showing deposit of fine clay sediment.

**Sediment deposition** - The flood waters contained large volumes of sediment as suspended and bed load. The coarser material was trapped in the first structure but the finer sediments settled out over other parts of the spreading basins, sealing off the coarse material and thus reducing the infiltration or recharge rate. Figure 16 is a photo across a portion of site No. 1 after the June flows showing the deposition of the fine sediments. Figure 17 is a

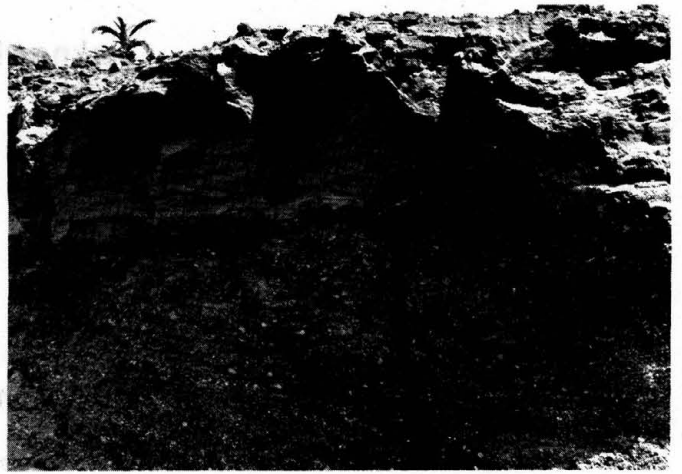
Figure 17. Excavation shows about 6 inches of fine clay deposited on top of original coarse sand.

photo showing approximately six inches of fine silt and clay-sized sediment which was deposited on top of the originally sandy soil. The photo for Figure 17 was taken near dam D-2 at site No. 2 following both the June and July flows.
