# DAM SAFETY MANUAL

*State Engineer's Office  
State of Colorado  
June 1983*

# **STATE OF COLORADO DAM SAFETY MANUAL**

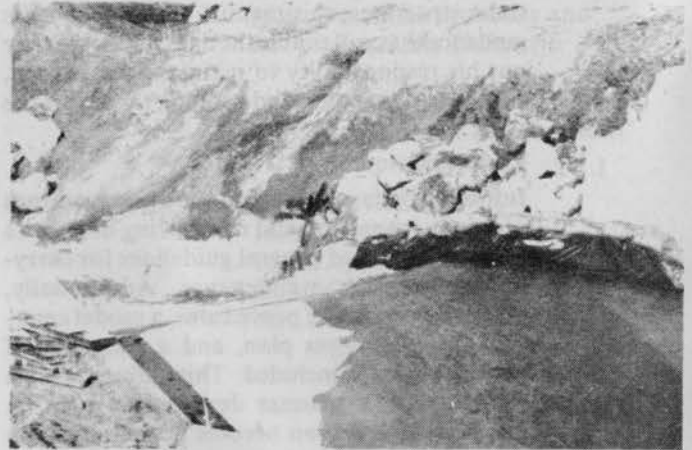
PHOTO 1.4-1  
RUNOFF DAMAGE

FLOWS ERODING UNPROTECTED SPILLWAY CHANNEL. Sandbags and plastic sheet placed on right side to divert flow. Note full outlet discharge to minimize flow through spillway.

When floods caused by severe rainstorms, or excessive snowmelt runoff are predicted, the spillways of all dams should be inspected to detect any areas that will need special protection while passing the flood flows. During the flood and after flows subside, the spillway should be inspected to identify any damage needing repair.

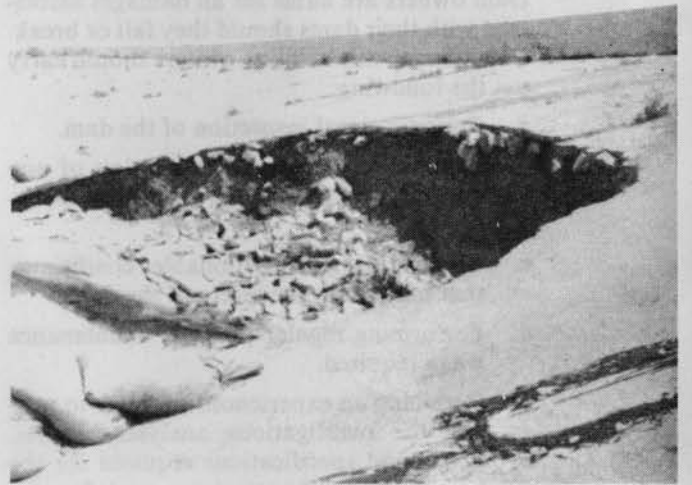
PHOTO 1.4-2  
WINDSTORM DAMAGE

Large cavern eroded into embankment after wave action destroyed concrete protective coating on the upstream face.

High winds can cause damaging wave action. The upstream slope must be monitored during severe windstorms to allow prompt repair of damaged areas. Thorough inspection when the storm subsides will allow required maintenance to be identified and prompt repairs initiated.

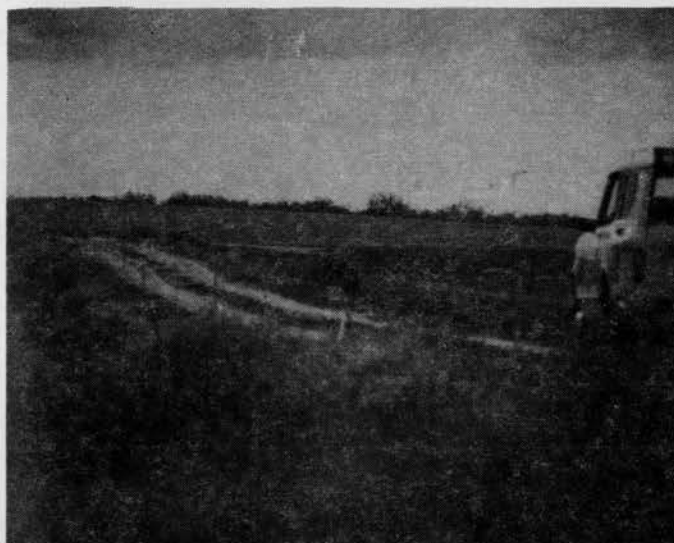
**PHOTO 1.4-3**  
**EARTHQUAKE DAMAGE**

Settlement of 2.5 feet on dam crest first noted about 2 weeks after an earthquake in the area.

If the effects of an earthquake are identified in the area of the dam site or if tremors have been reported, the dam should be thoroughly inspected immediately and at weekly intervals for four to six weeks after the quake. Conditions triggered by an earthquake can often take several weeks to appear.

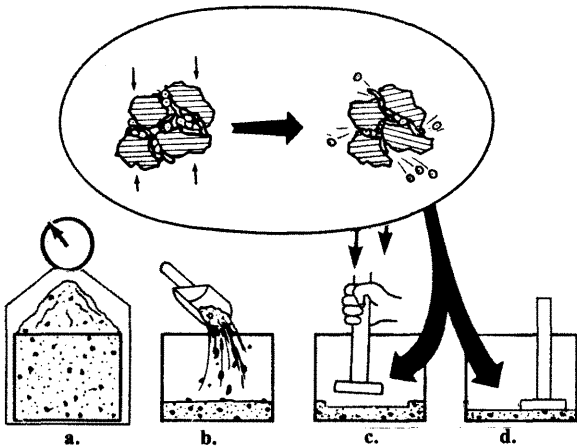
FIGURE 2.5-3 THE COMPACTION PROCESS

Compaction is usually obtained by applying an impact force to the surface of the soil as shown in the example below. The soil used will contain equal parts of sand, silt, and clay.

In Figure 2.5-3 c, a tamping tool is used to pound a 3-inch layer of soil with enough force to create an imprint about 1/2 inch deep. The pounding is continued until the entire surface of the sample has been compacted. (See Figure 2.5-3 d.)

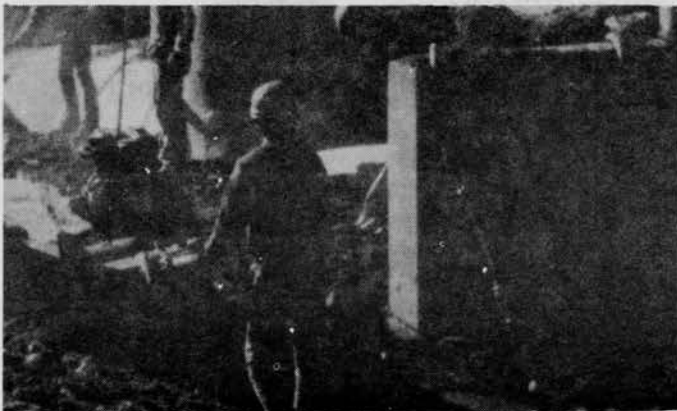
FIGURE 2.5-7 — POGO STICK, SIMILAR TO TAMPING TOOL. — Is used in tight spots not accessible to larger equipment.

As can be seen, the pogo stick and wacker are much smaller and lighter than the sheepsfoot and self-propelled roller. Soils compacted with the lighter equipment must be placed in thin layers not exceeding 4 inches, while soils compacted by the heavier equipment can be placed in layers up to 12 inches.

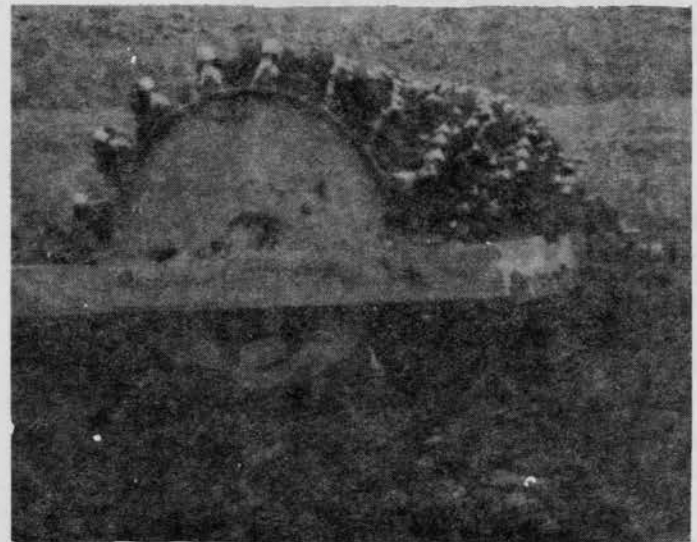
FIGURE 2.5-9 — SHEEPSFOOT ROLLER. — Used in open areas.

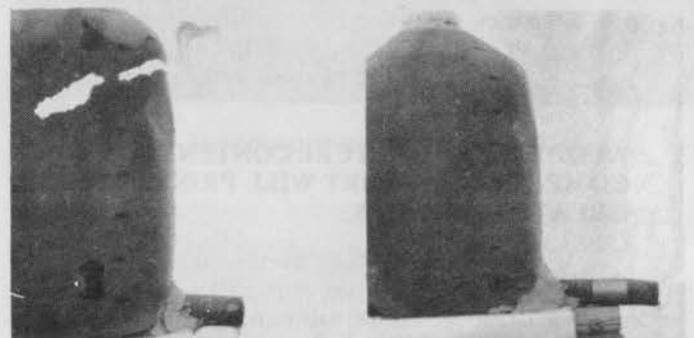
In the experiment shown here the quantity of flow through a compacted sand material contained in a  $\frac{3}{8}$ -inch diameter tube was reduced about  $5\frac{1}{2}\%$  for each 1-inch unit of increased flow path when subjected to a constant water pressure. This illustrates that lengthening of the flow path can help reduce flow through the material.

FIGURE 2.10-1  
REDUCED AMOUNT OF FLOW CAUSED BY LENGTHENING THE FLOW PATH

By increasing the length of the path through the same material, the amount of flow is reduced.

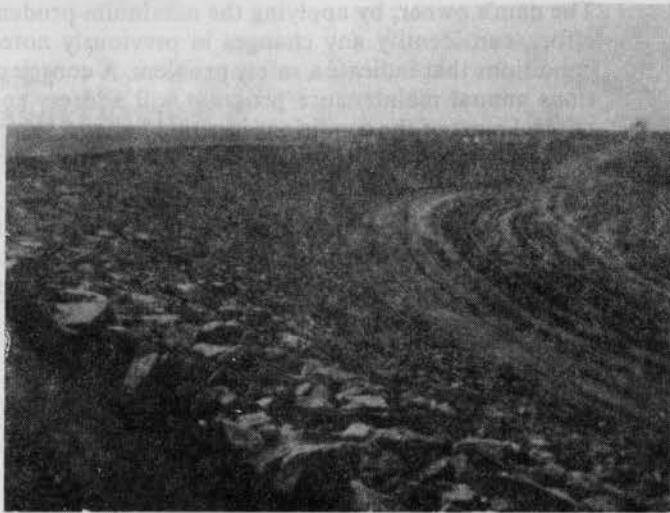
PHOTO 6.1 — EXCELLENT UPSTREAM FACE. Note uniform surface of riprap protection.

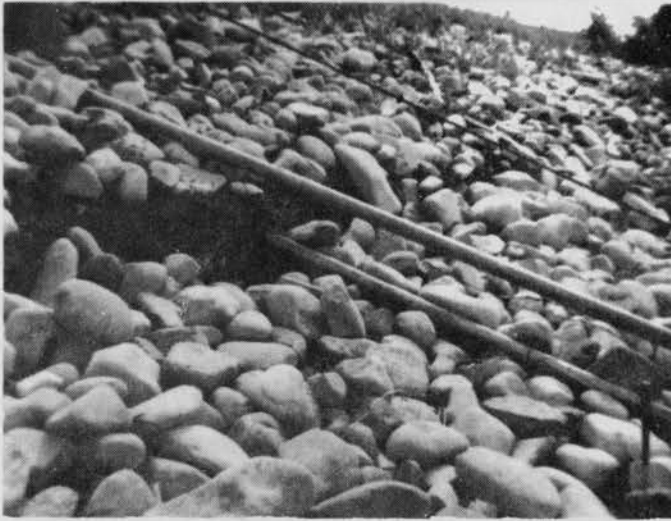
PHOTO 6.5-1 — UNIFORM POORLY SIZED RIPRAP LEADS TO EROSION OF SOIL BEHIND RIPRAP.

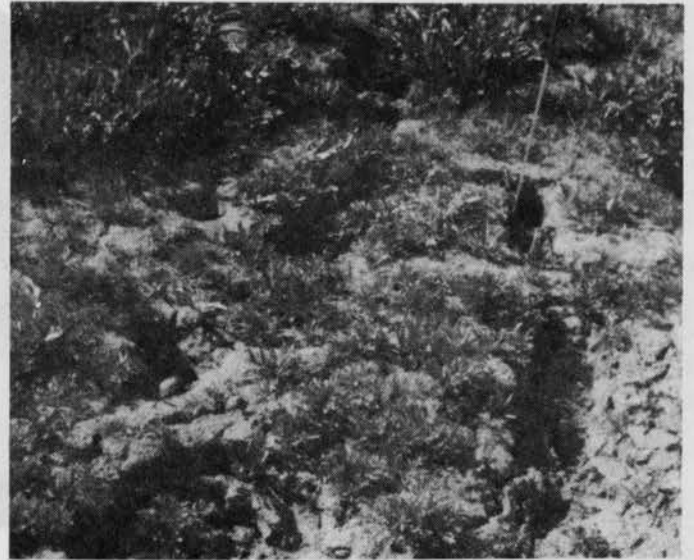
PHOTO 6.5-4 — MUSKRAT DAMAGE

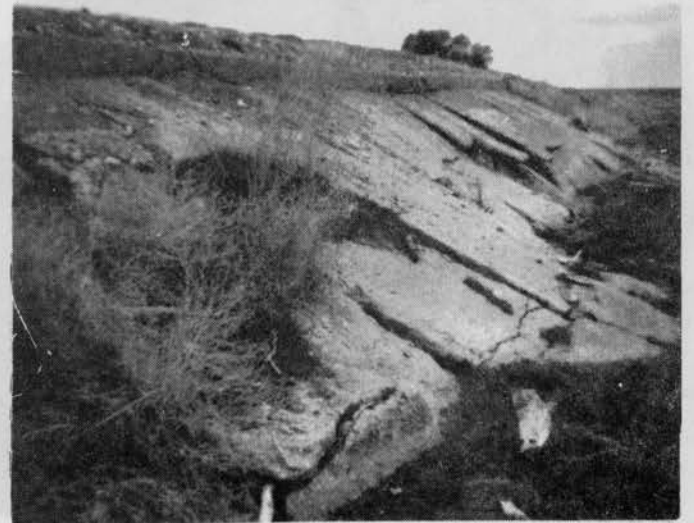
PHOTO 6.5-5 — BADLY DETERIORATED CONCRETE FACE

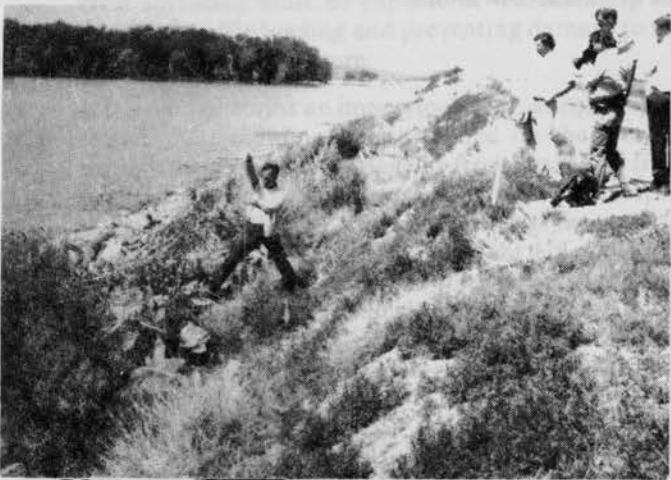
PHOTO 6.5-3 — CRACK IN UPSTREAM SLOPE

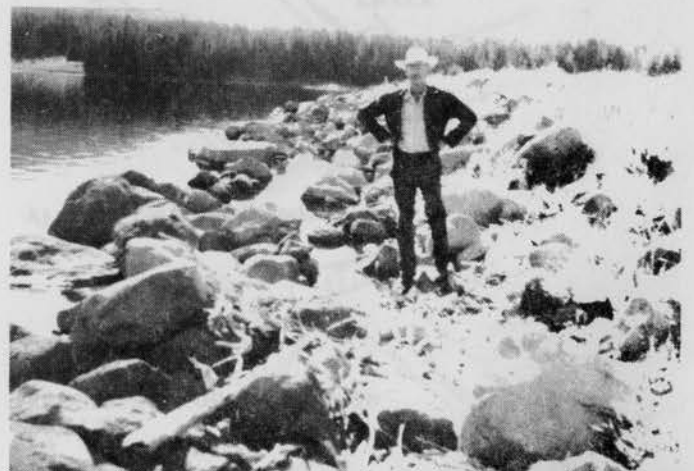
PHOTO 6.5-6 — SLIDE AT UPSTREAM SLOPE. Note water line alignment.

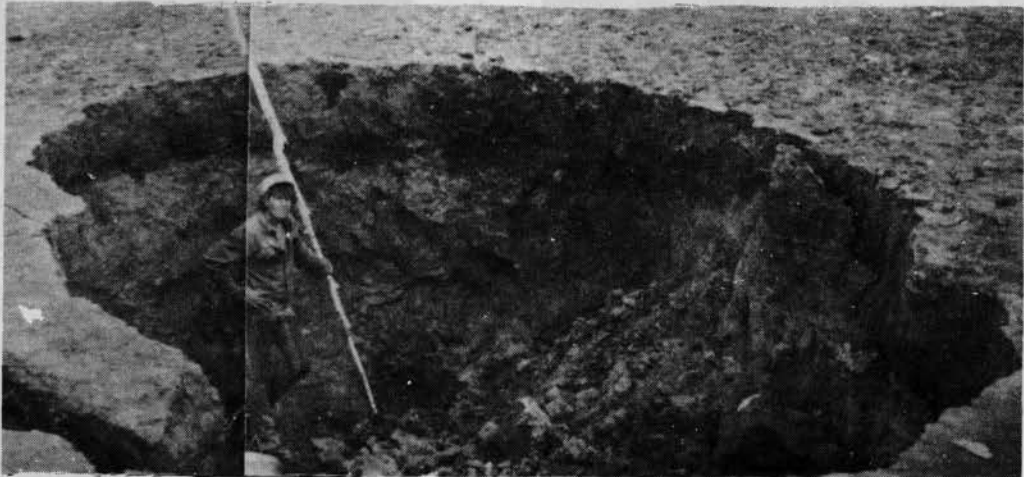
**PHOTO 6.5-8 — 21' x 21' SINK HOLE IN RESERVOIR BASIN**

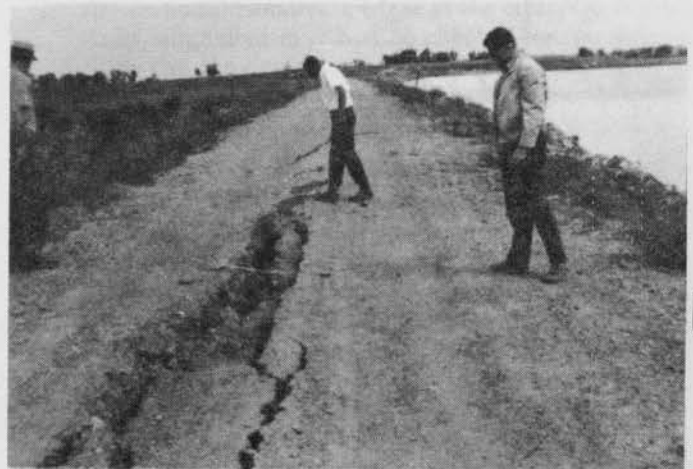
PHOTO 7.3-1 — SEVERE LONGITUDINAL CRACKING. Cracking pattern indicates horizontal movement between adjacent sections of the dam. Note the close parallel cracks.

7.3-1 **LONGITUDINAL CRACKING** can indicate localized instability, differential settlement, and/or movement between adjacent sections of the embankment. Longitudinal cracking is characterized by a single crack or a close, parallel system of cracks along the crest in a direction more or less parallel to the length of the dam.

(See Photo 7.3-1.) These cracks, which are continuous over their length and are usually greater than 1 foot deep, can be differentiated from drying cracks which are usually intermittent, erratic in pattern, shallow, very narrow, and numerous.

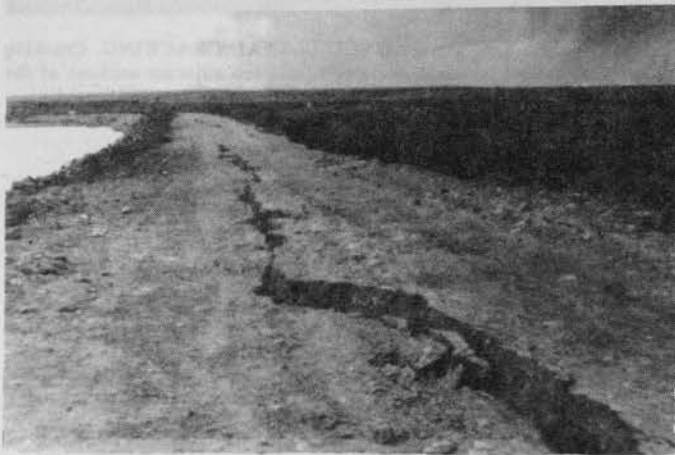
PHOTO 7.3-2 — VERTICAL DISPLACEMENT ON THE CREST OF A DAM. IN ITS INITIAL STAGES, THIS CONDITION WAS DETECTED AS A LONGITUDINAL CRACK.

Longitudinal cracking may precede vertical displacement as the dam attempts to move to a position of greater stability. (See Photo 7.3-2.) Vertical displacements on the crest are usually accompanied by displacements on the upstream or downstream face of the dam. An example of the development of a longitudinal crack into vertical displacement can be seen in Figure 7.3-1.

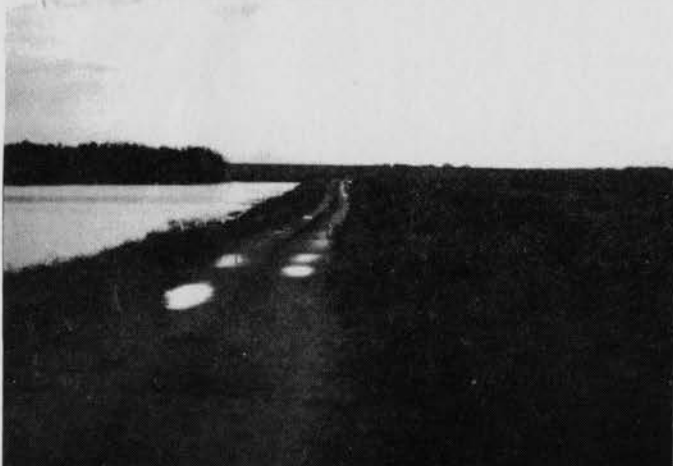
PHOTO 7.3-4 — CREST IN POOR CONDITION SHOWING EVIDENCE OF MISALIGNMENT.

- 7.3-3 **MISALIGNMENT** can indicate relative movement between adjacent portions of the dam in directions perpendicular to the axis of the dam (See Photo 7.3-4).

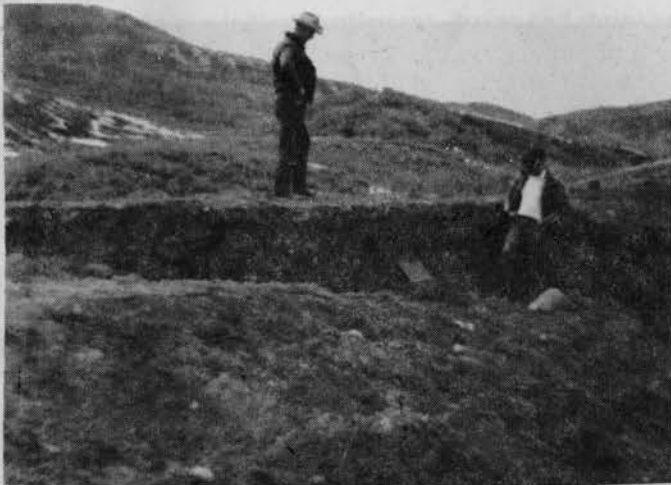
PHOTO 7.5-1.a — VERTICAL DISPLACEMENT ON CREST.

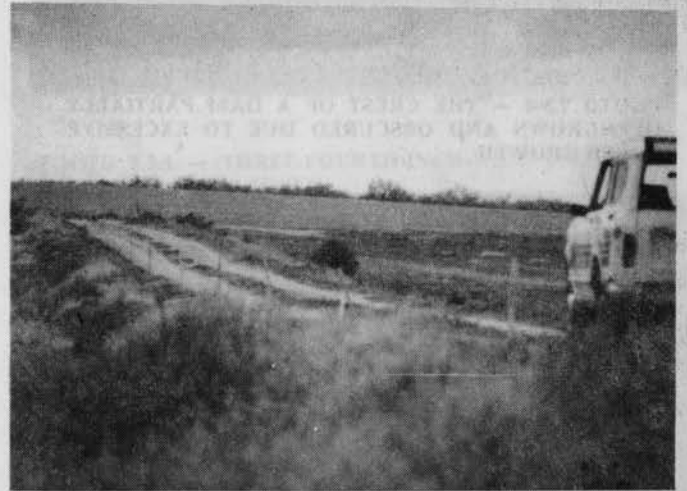
PHOTO 7.5-2 — LOW AREA IN THE CREST OF A DAM, CAUSED BY A FOUNDATION FAILURE.

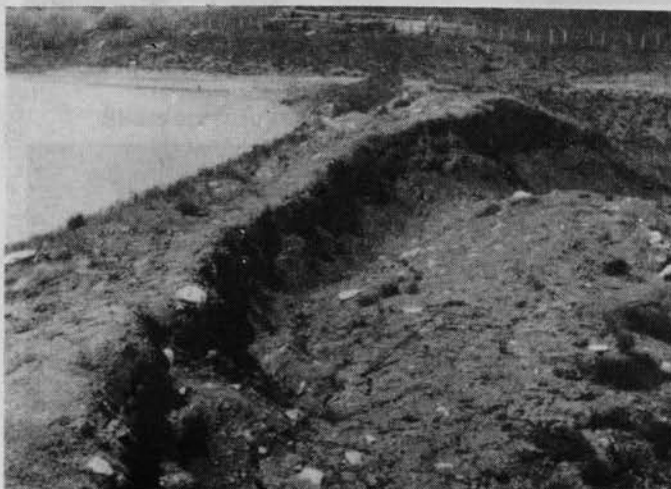
PHOTO 7.5-1.b — VERTICAL DISPLACEMENT ON THE CREST OF A DAM. This vertical movement was associated with a slip on the downstream face.

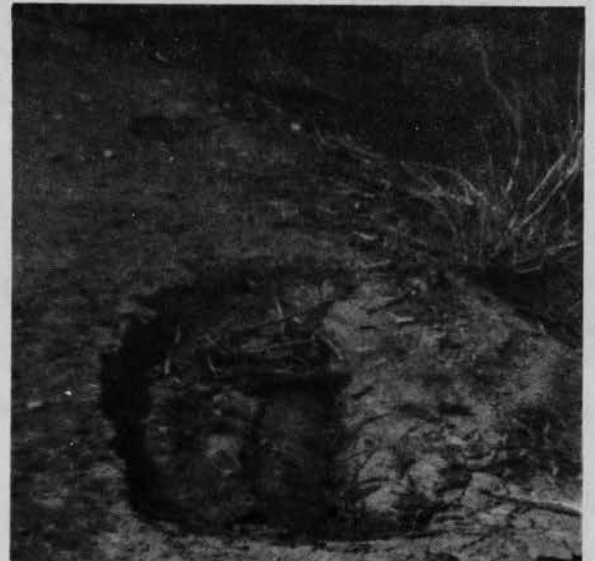
SMALL SINKHOLE

LARGE SINKHOLE

PHOTO 7.5-3 — SINKHOLES IN THE CREST OF A DAM, CAUSED BY CONSOLIDATION OF LOW DENSITY EMBANKMENT MATERIAL.

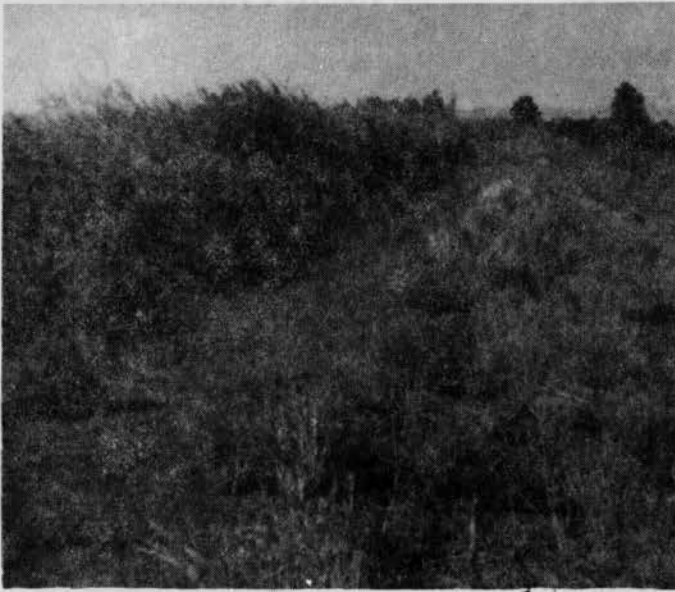
**PHOTO 7.5-4 — THE CREST OF A DAM PARTIALLY OVERGROWN AND OBSCURED DUE TO EXCESSIVE BRUSH GROWTH**

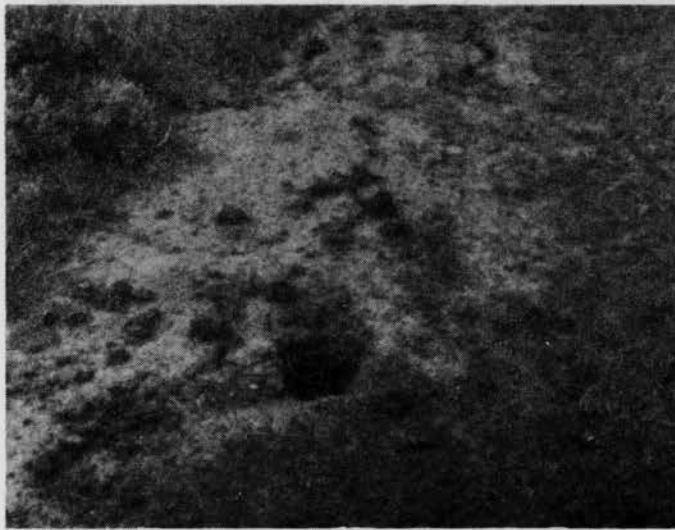
**PHOTO 7.5-5 — RODENT HOLE FOUND ON THE CREST OF A DAM**

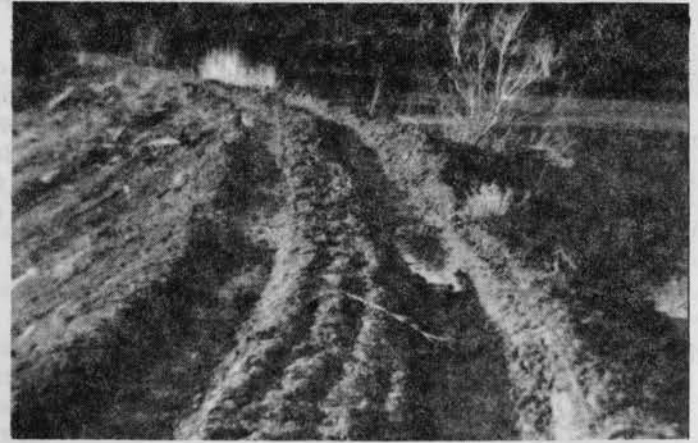
**PHOTO 7.5-7 — RUTS IN THE CREST OF A DAM**

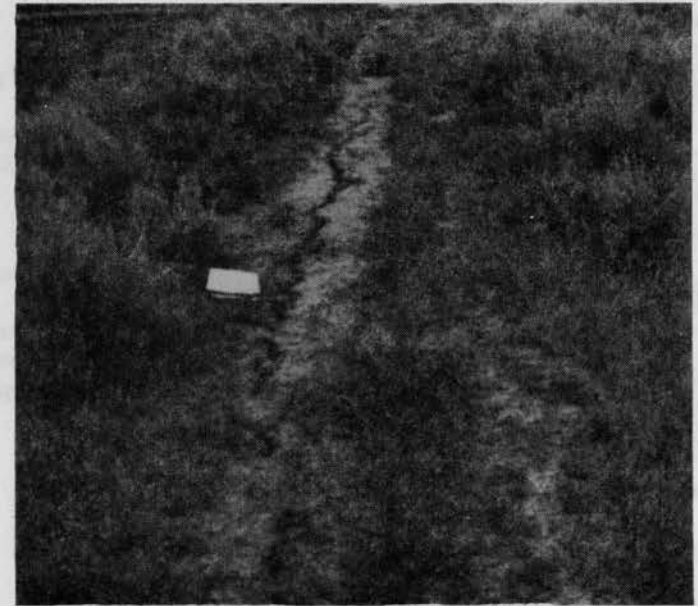
**PHOTO 7.5-8 — LONGITUDINAL DRYING CRACKS ON THE CREST OF A DAM. These cracks are caused by drying of the crest surface and are only 6-8 inches deep.**

Also see Photo 7.5-8.

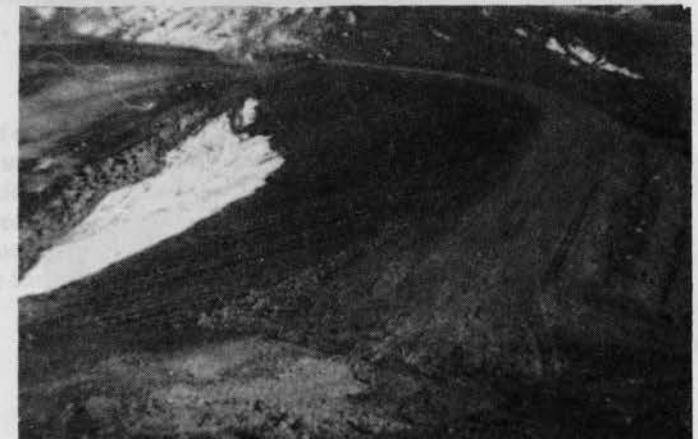
**PHOTO 7.5-9 — CAMBER INCORPORATED INTO CREST DURING CONSTRUCTION. Camber is greatest over highest section of the dam.**

Also see Photo 7.5-9.

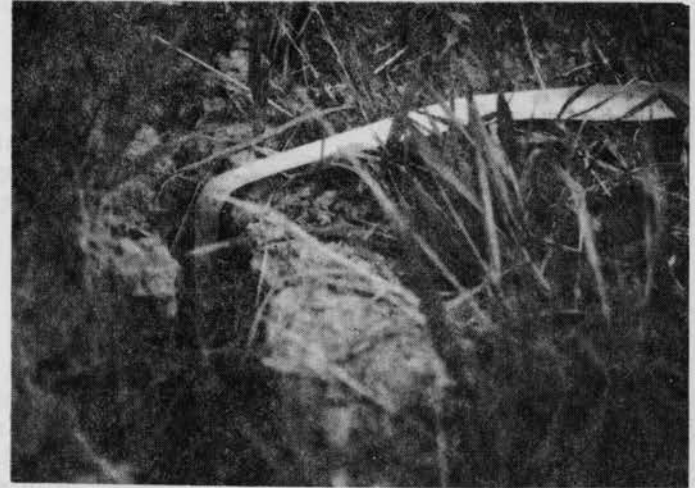
PHOTO 8.3-1 — THREE-FOURTH-INCH-WIDE CRACK, WELL HIDDEN IN GRASS COVER.

area. A crack such as the one shown in the photo below is difficult to locate. To help distinguish drying cracks from other types, the ground surface adjacent to the dam should be examined for similar cracking patterns.

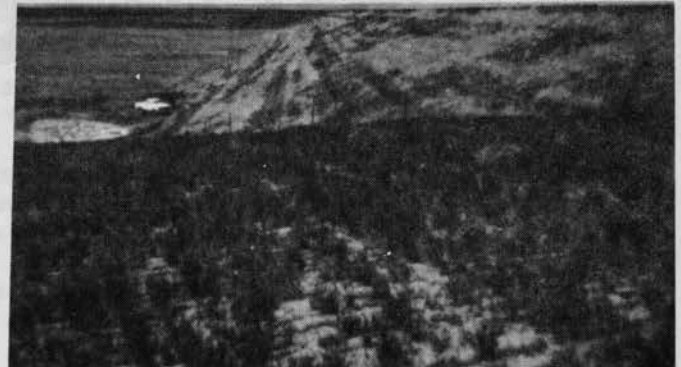
PHOTO 8.4-1 — EARLY STAGE OF GROWTH FOR GRASS SLOPE PROTECTION

**Embankment** or compacted fill is usually covered with grasses to prevent erosion. An example is shown in the photo below.

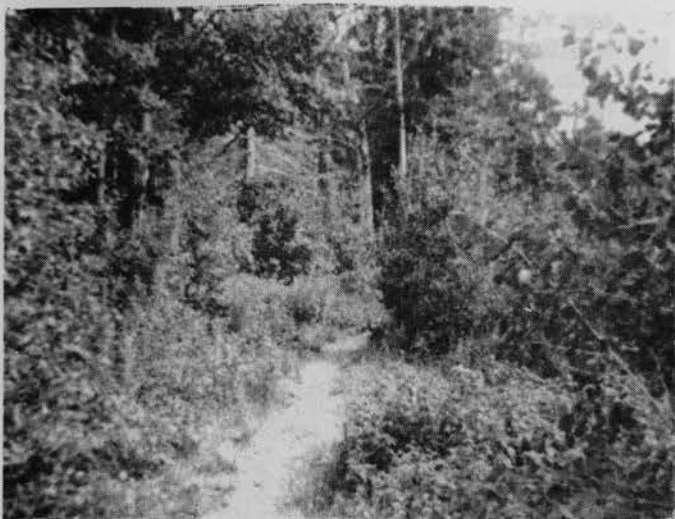
PHOTO 8.4-2 — UNDESIRABLE AMOUNT OF VEGETATION

A thick stand of vegetation such as that shown below is not recommended because it obscures visual inspection of the surface.

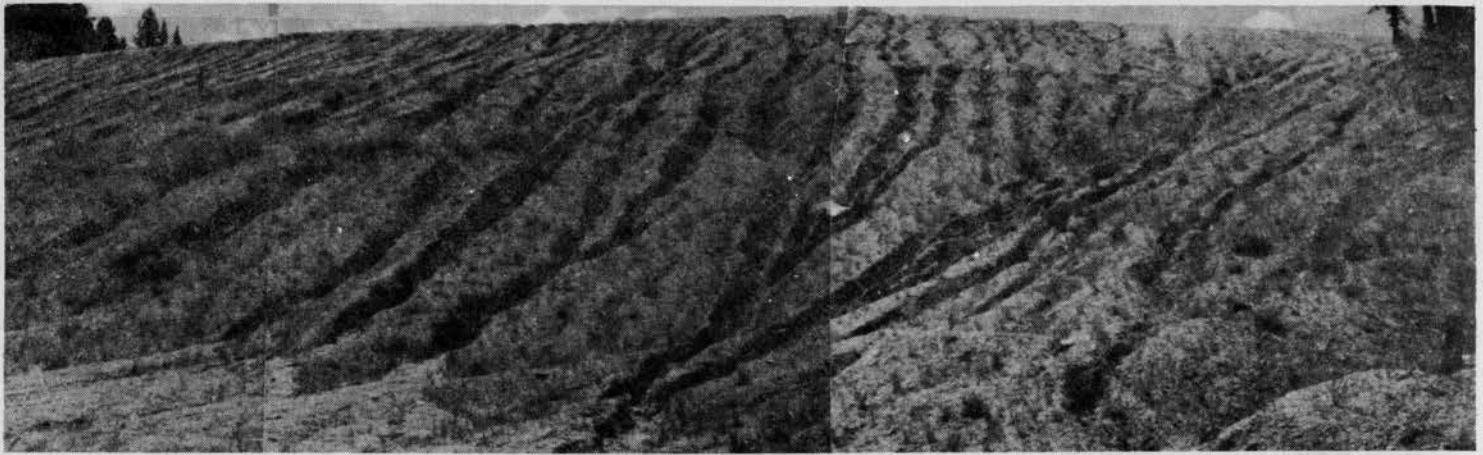
**PHOTO 8.5-1 — EROSION D/S FACE**

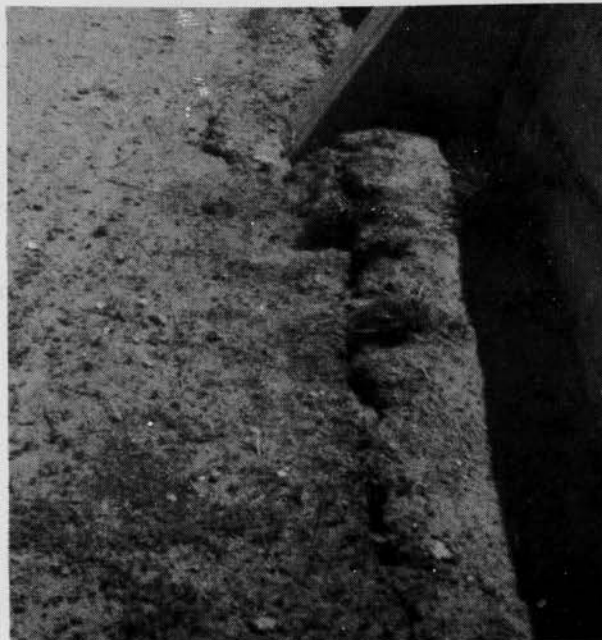
**PHOTO 8.5-3 — LONGITUDINAL CRACKING**

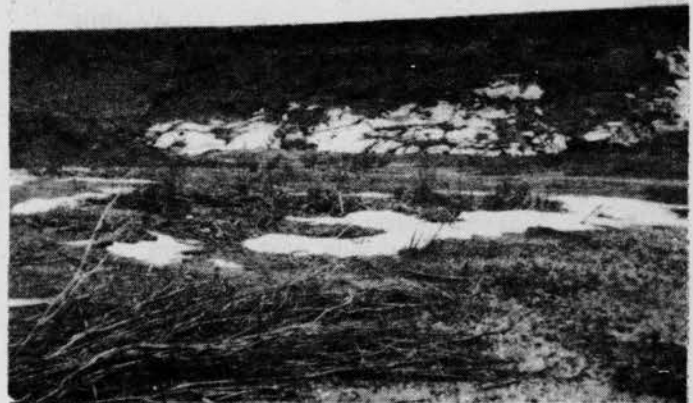
PHOTO 8.5-5 — SLUMP

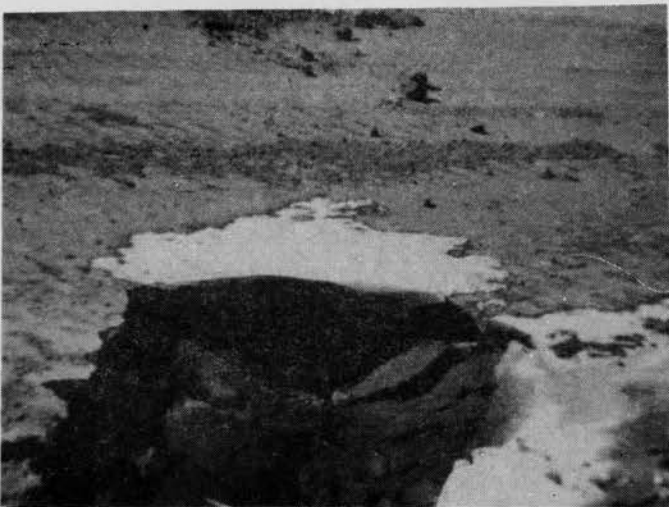
PHOTO 8.5-6 — SINK HOLE/COLLAPSE

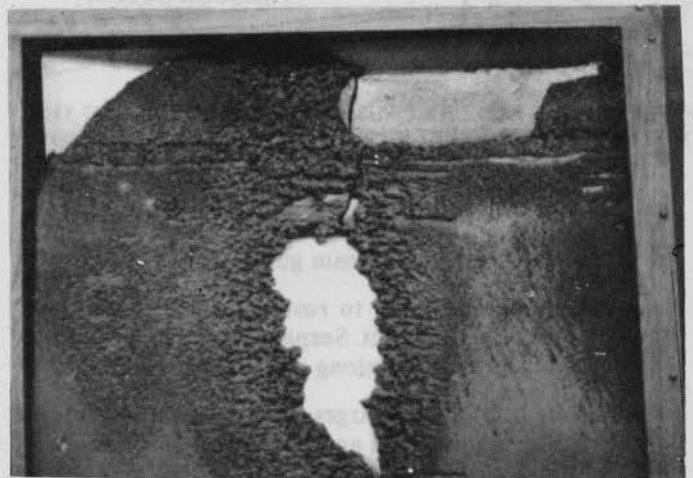
PHOTO 9.3-2 — CAVITATION DAMAGE TO STEEL PIPE LINER. Cavitation has eaten through steel to expose concrete behind liner.

9.3-1 **Cavitation:** When water flows through an outlet system and passes restrictions (e.g., valves), a pressure drop may occur. If localized water pressures drop below the vapor pressure of water, a partial vacuum is created and the water actually boils, causing cavities of water vapor within the flowing water. These cavities later collapse, causing shockwaves, which can damage the outlet pipe or control valve. This process, called cavitation<sup>1</sup>, can be a serious problem for tall dams where discharge velocities are high. Two typical examples of cavitation damage are shown in photos 9.3-1 and 9.3-2 below.

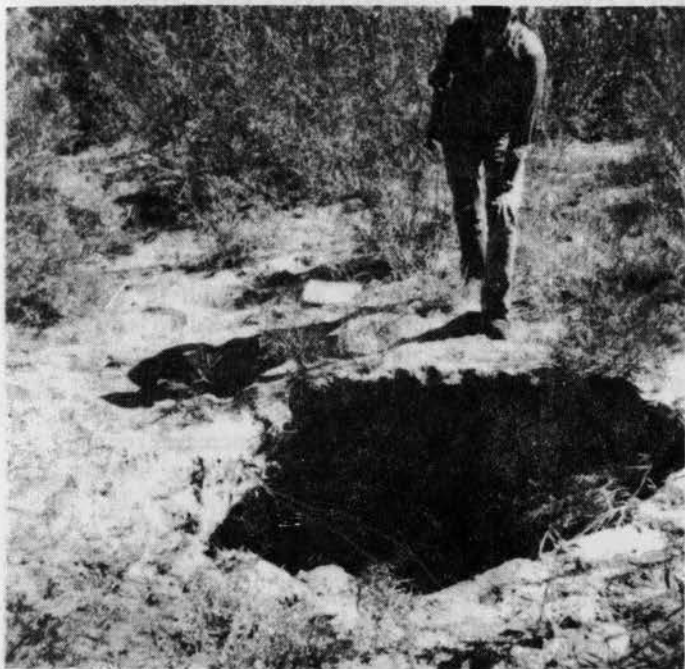
FIGURE 9.4-3 — TURBULENCE AND PRESSURE CREATED BY DEBRIS IN THE PIPE CAUSES SINKHOLE IN THE DOWNSTREAM SLOPE.

Upstream valve. Outlet conduit becomes pressurized because of a buildup of debris in the pipe.

- Hole develops due to rusting, etc. Debris partially blocks conduit, causing water to seep into embankment.
- Hole is enlarged by additional release of water and a cavity develops above pipe. Pumping action of released water slowly erodes embankment.

- c. Cavity collapses, leaving a sinkhole on the downstream slope. Reservoir does **not** evacuate since upstream control valve is undamaged. See Photo 9.4-1.

Figures 9.4-1, 9.4-2, and 9.4-3 show progressive failure of an outlet system by three typical modes. These types of failures are associated with a hole which develops in the conduit, followed by erosion of the surrounding embankment. These conditions require the assistance of an engineer.

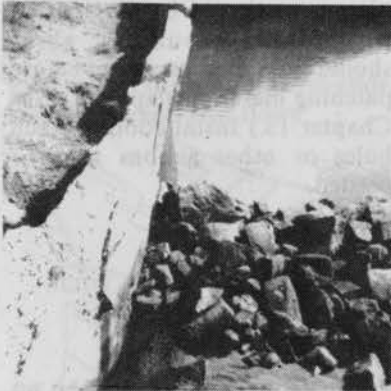
PHOTO 10.5-1 — DETERIORATION OF RIGHT D/S WINGWALL OF SPILLWAY.

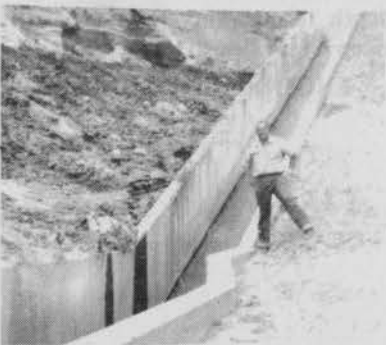
PHOTO 10.5-3 — WATER EXITING AT JOINT OR CRACK BECAUSE OF POOR DRAINAGE.

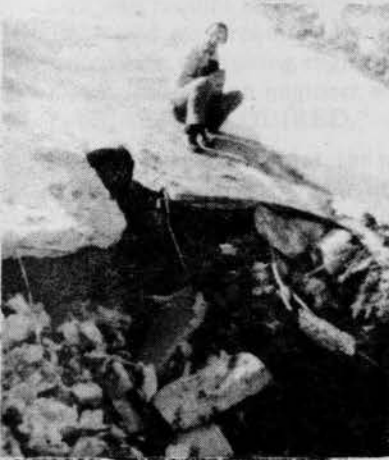
**PHOTO 10.5-4 — FAILED SPILLWAY**  
Fracturing of spillway chute slab

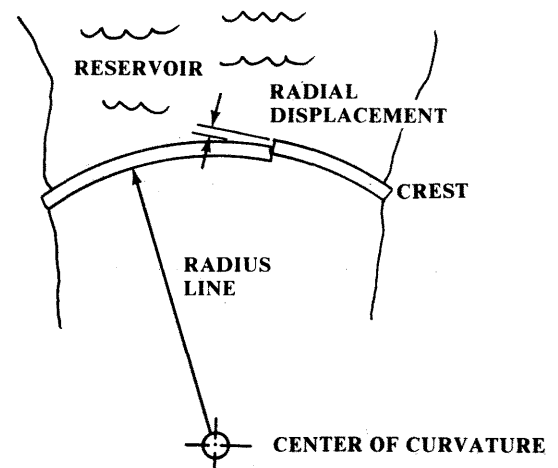
FIGURE 11.1

(B) VIEW LOOKING DOWN ON CONCRETE ARCH DAM. NOTE CRACK WITH RADIAL DISPLACEMENT.

(C) VIEW LOOKING DOWN ON A CONCRETE GRAVITY DAM. NOTE IRREGULAR STRUCTURAL CRACK WITH TRANSVERSE DISPLACEMENT.

(A) VIEW LOOKING UPSTREAM AT A CONCRETE DAM. NOTE IRREGULAR STRUCTURAL CRACK WITH VERTICAL DISPLACEMENT.

These are caused by overstressing of portions of the dam and result because of inadequate design, poor construction technique, or faulty materials. Structural cracks are often irregular, meaning they run at an angle to the major axes of the dam and may exhibit abrupt changes in direction. These cracks also have noticeable radial, transverse, or vertical displacement. (See Figure 11.1.)

Figure 11.1 shows displacement measured at a single location. The amount of displacement often varies along the length of a structural crack. This variation occurs because a portion of the dam has moved in relation to the original alignment. In any case, the presence of structural cracks could be an indication of progressive failure of the abutment, the foundation, or the dam itself. Engineering assistance should be obtained.

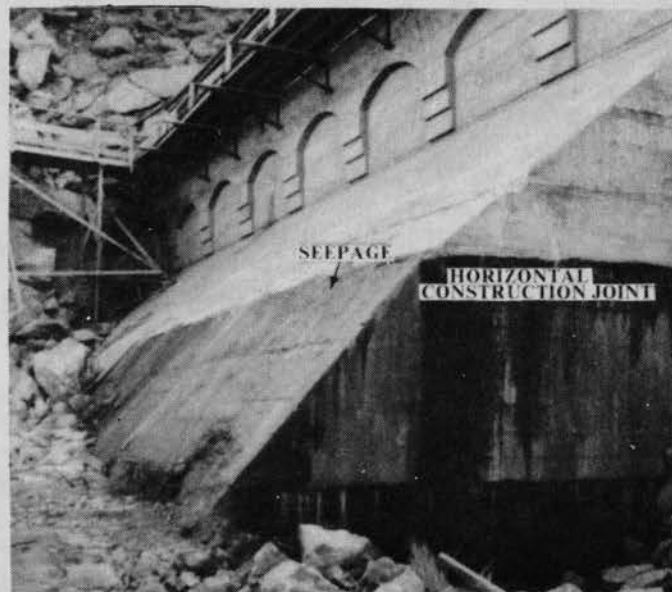
PHOTO 11.4-2  
CRACKS AT HORIZONTAL CONSTRUCTION JOINT. Note evidence of minor leakage.

Construction joints are provided to accommodate volumetric changes which occur in the structure after concrete placement, and are referred to as "designed" cracks. These joints are so constructed that no bond or reinforcing, except non-bonded waterstops and dowels, extend across the joint. (See Section 11.2.a.) Examples of cracking at construction joints are shown in Photographs 11.4-1 and 11.4-2.

Photo 11.4-2 shows an example of typical minor seepage at a construction joint. Refer to Chapter 5 for a general discussion of seepage.

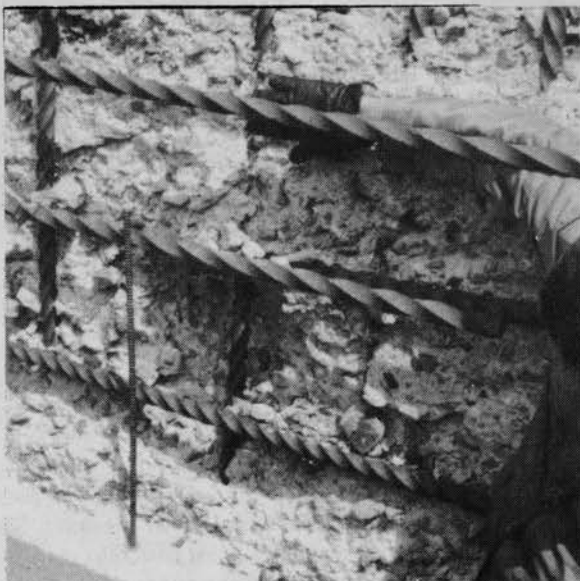
PHOTO 11.4-3 — STRUCTURAL DAMAGE. Spalling has exposed reinforcing.

In severe situations, engineering assistance is required to determine the best method of repair. Photos 11.4-3 and 11.4-4 are examples of damage due to severe spalling.

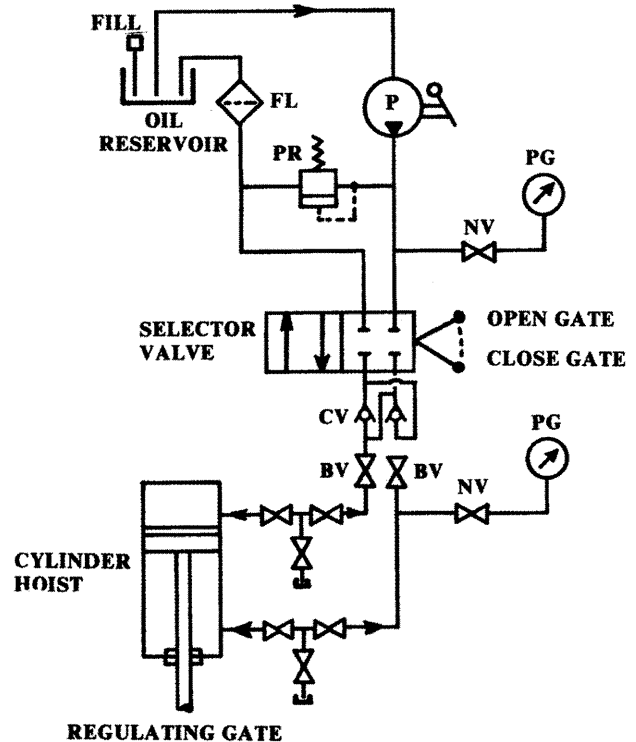
A hydraulic control system is used to open and close the valves or sliding gates of the outlet or intake works. A hydraulic system is especially desirable where the gate or valve requires great force to operate, or the gate or valve is located in an inconvenient place. The following is a schematic drawing of a typical hydraulic system:
