GEOLOGIC CONSTRAINTS--VAIL PASS INTERSTATE 70

Charles S. Robinson

Charles S. Robinson & Associates, Inc.

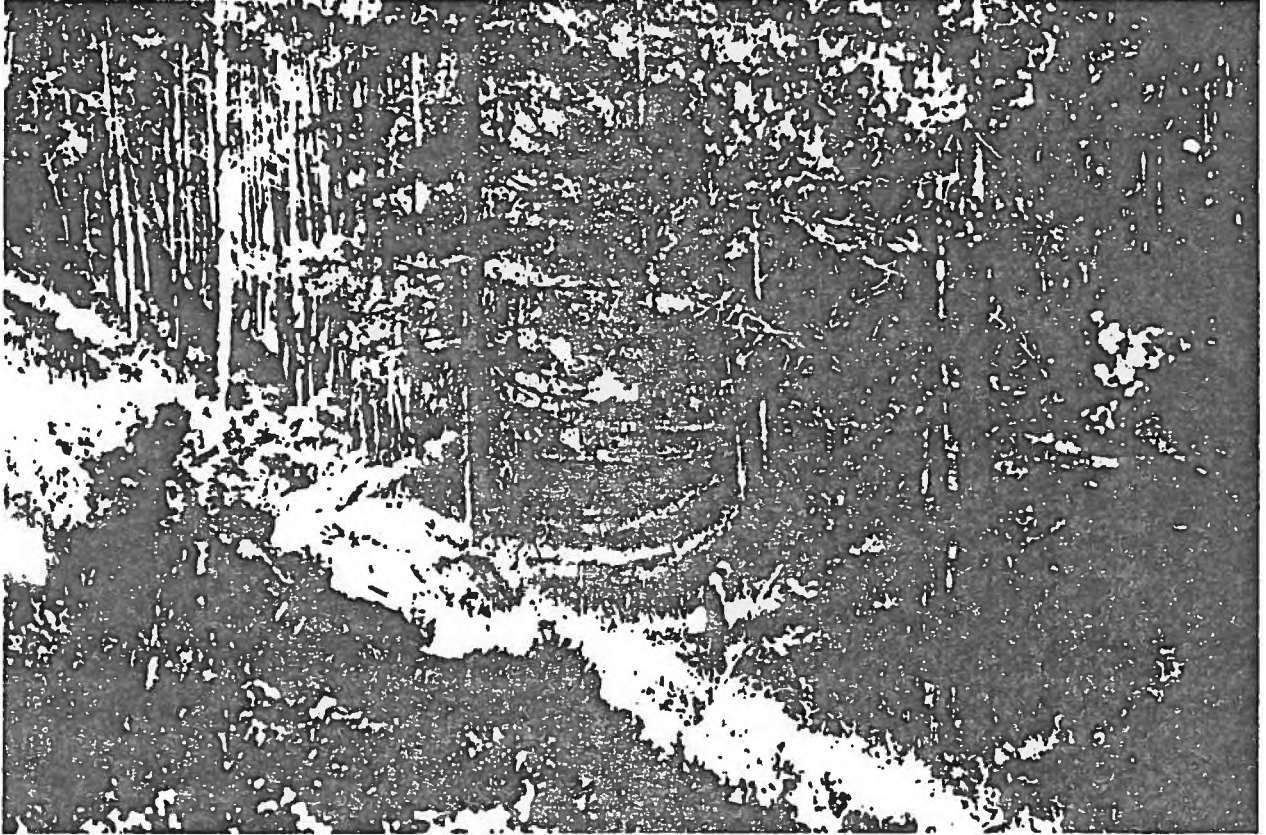
Figure 7.

Photograph of trees growing in landslide scarp depression

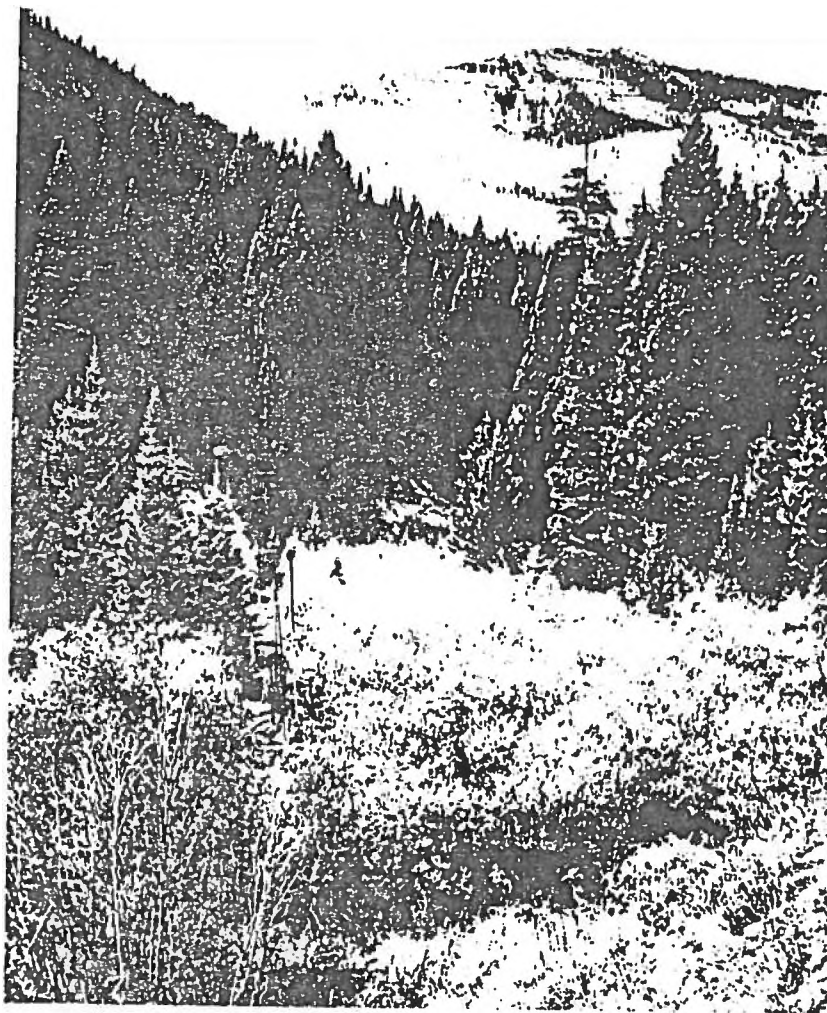
Figure 9.

Alluvial deposits as a result of damming of
stream by landslides

developed. The permeability of the surficial deposits is different in different areas and numerous springs occur throughout the deposits. Much of the year when the surface is not frozen, the deposits are saturated with water. With the spring runoff, there is a period of rapid erosion during the time of maximum saturation. This results in minimum stability for a mass of poorly sorted and unconsolidated material on a steep slope with the lower edge at a stream channel. Along Black Gore Creek, down cutting of the Creek has not been able to keep up with the movement of the landslides into the valley. The gradient of the Creek above the landslides has been lowered and alluvial deposits formed because the landslides have partially dammed the creek (Figure 9).
