Central City Survey Update

Certified Local Government Grant CO-14-014

June 2015

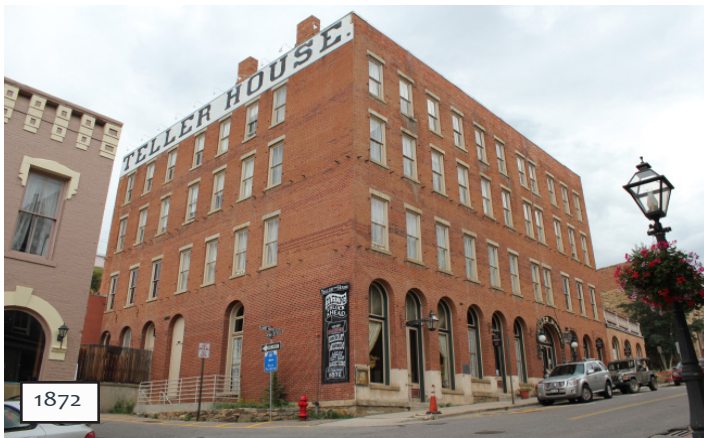
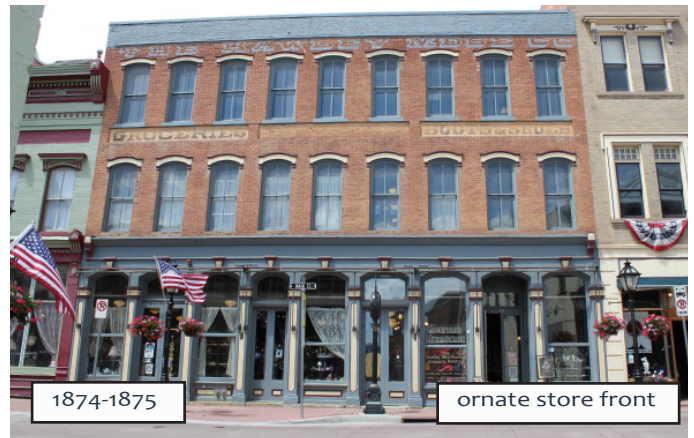
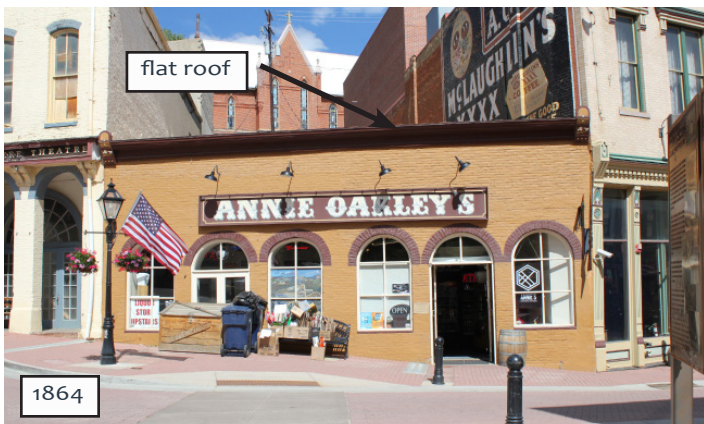
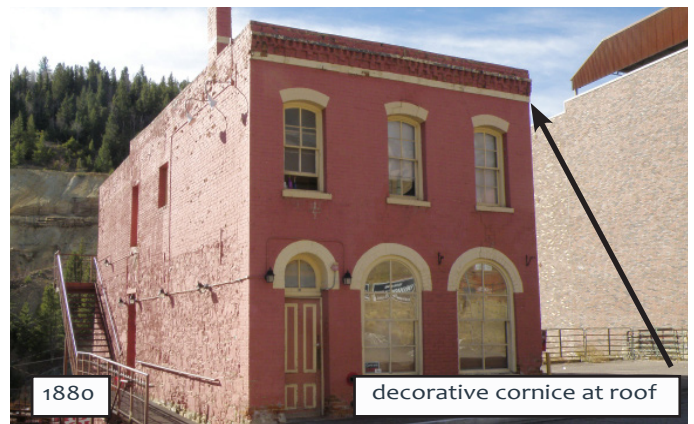
Key Features of a One-Part Block and Two-Part Block

- Rectangular plan with a narrow street frontage
- Flat roof
- Positioned on the lot line with little or no setback from the sidewalk
- Street-level storefronts with large plate glass display windows
- Cornice at the roof line
- Can range from very simple to ornate
- May feature a variety of stylistic influences from Italianate to Art Deco

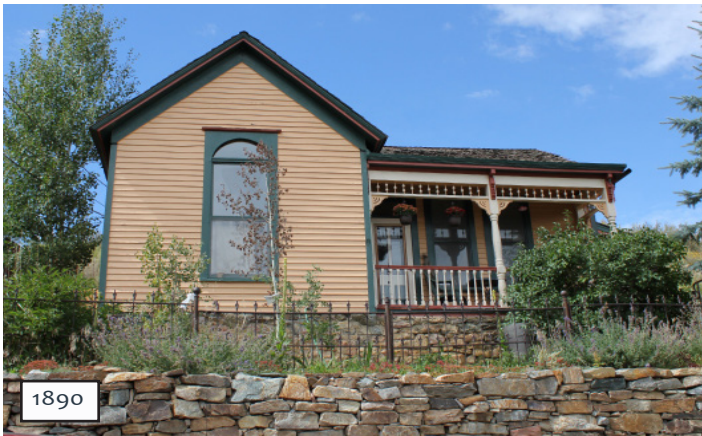
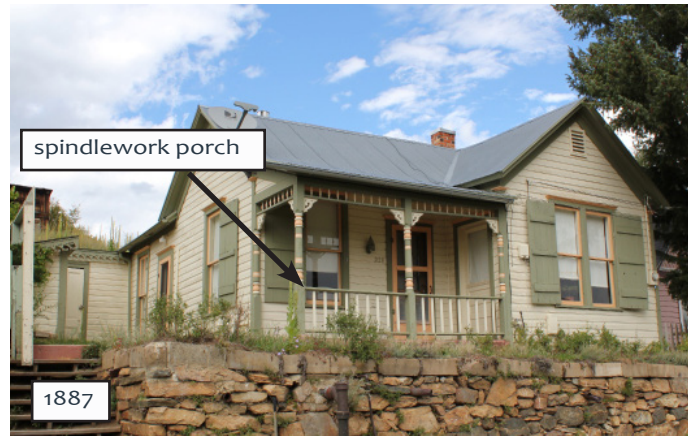
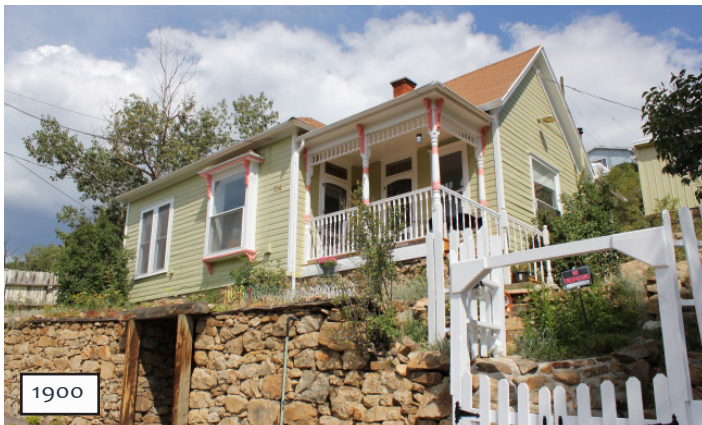
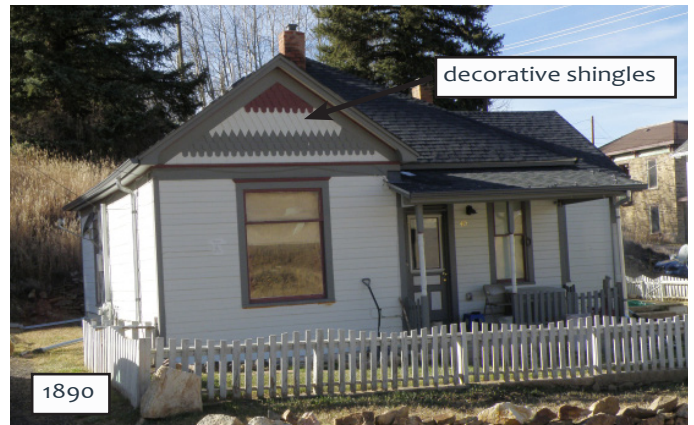
The term Folk Victorian refers to simple vernacular houses (such as Gable Front and Gable Front and Wing) embellished with Victorian Style trim. The Folk Victorian was predominantly a 19th century housing type, but continued into the early 20th century, especially in rural areas. With industrialization and the expansion of the railroad network, decorative details previously available only to those who could afford a skilled carpenter became much more widely available with machine-made building ornaments shipped to lumber yards across the country. Though often inspired by the Queen Anne Style, Folk Victorian houses can be distinguished by their regular plans, absence of varied wall surfaces, and less elaborate decoration.

Key Features of a Folk Victorian

- Frame construction most common
- Boxy shape compared to the curves, towers, and bays of the Queen Anne Style
- Decorative features may include any of the following: Spindework porch detailing, brackets under eaves, gigsaw cut trim, and decorative shingles.

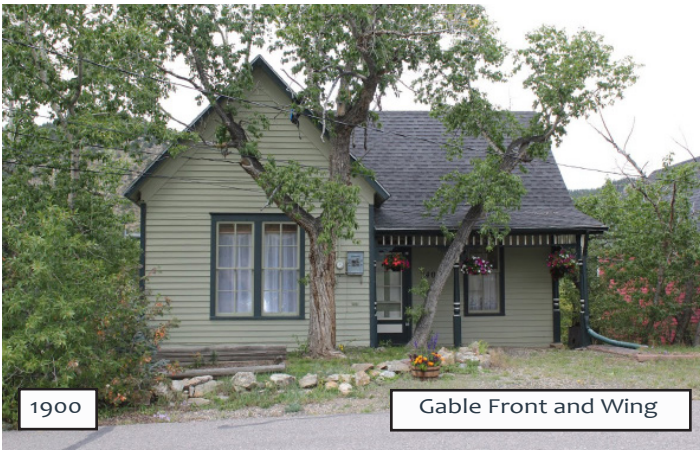
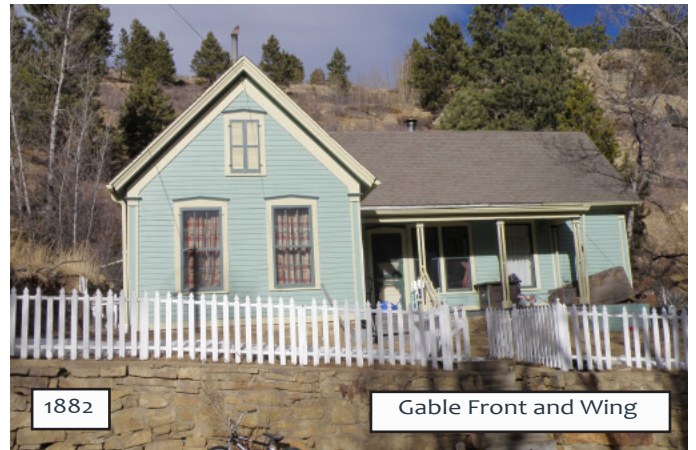
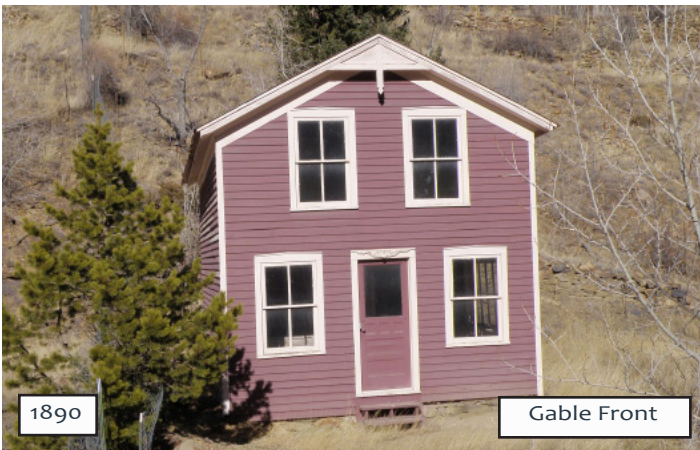
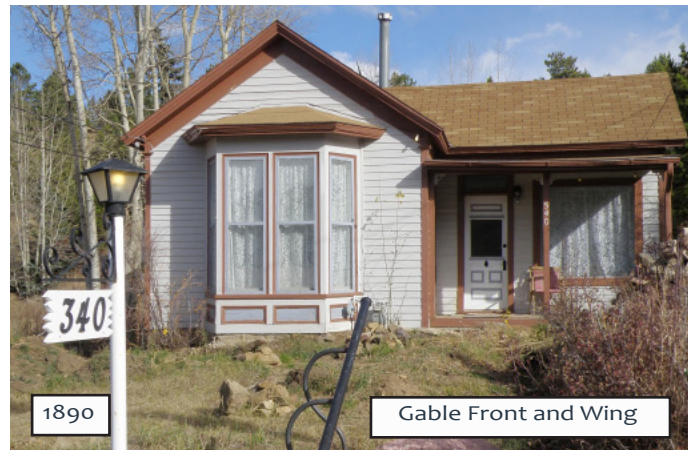
The Gable Front house type is a common vernacular form popular throughout the 19th century and much of the 20th century. Rectangular plan, Gable Front houses are oriented with the primary entrance in the gable end. Orienting the gable end to the street created long, skinny dwellings that were ideal for narrower, less expensive town lots. In the first part of the 19th century, the Gable Front type was often used for Greek Revival houses with the gable end used to echo the Greek temple form. A variation of the Gable Front type is the Gabled Ell, which consists of a side-gable wing placed at a right angle to a Gable Front section, creating an L-plan. The Gabled Ell type was often the result of building expansion, created when an addition was constructed on a Gable Front, but houses were also built in this form originally.

Key Features of a Gable Front/Gabled Ell

- Rectangular plan
- Low-pitch gable front roof
- May have a porch

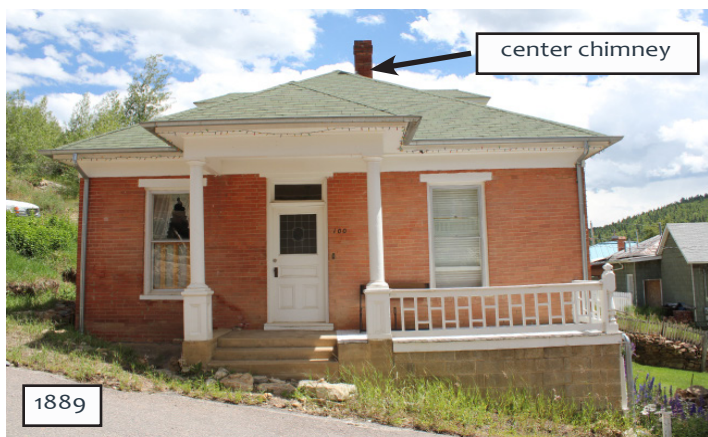
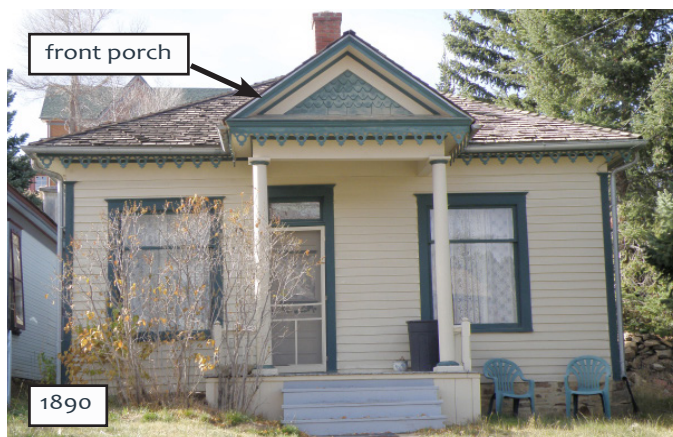
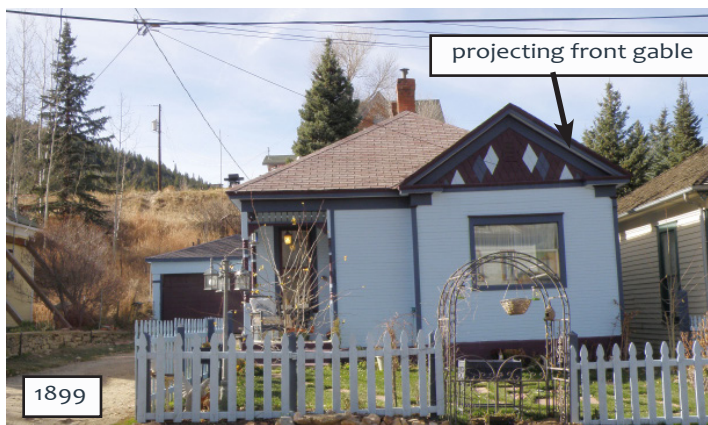
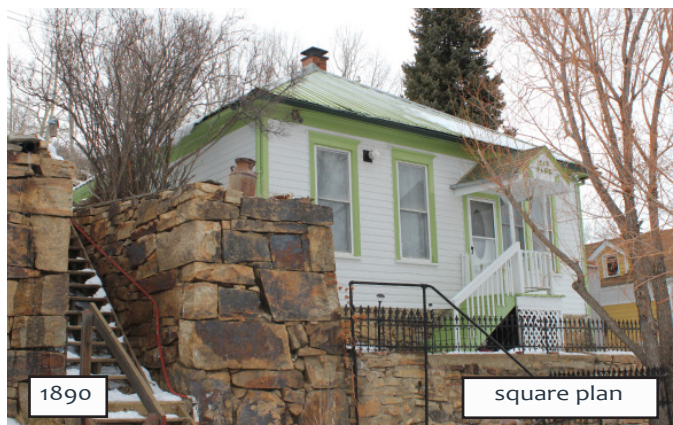
The Hipped-Roof Box (also called a Pyramidal Cottage) is named for its square plan, which generally contained four rooms and was topped by a hipped or pyramidal roof. Popular in the late 19th and early 20th century, this simple and economical form can be found across the Great Plains. It was also common in the mining, lumber, and railroad towns of the West, where it was often built as worker housing. The construction of a pyramidal roof was more complex than a gable roof but required fewer long-spanning rafters, making pyramidal roofs cheaper to construct. Many examples survive, but most have been expanded beyond their original four rooms. A popular variant in Central City is a hipped-roof box with a projecting front gable.

Key Features of a Hipped Box

- Square plan
- Usually constructed of milled lumber
- Often includes a porch, original or a later addition
- Center chimneys are common
- Roof peak may be flattened

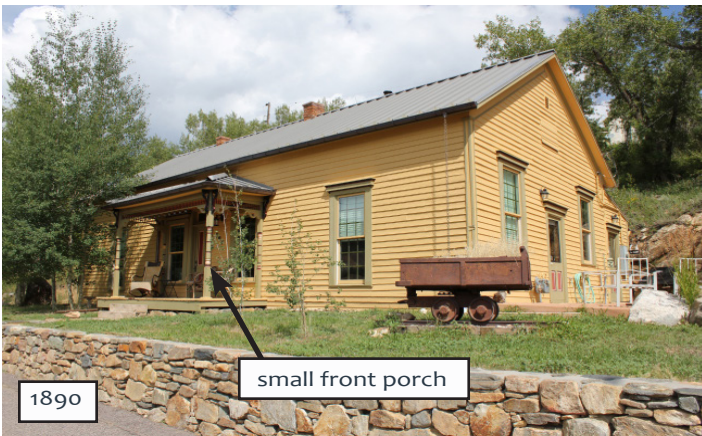
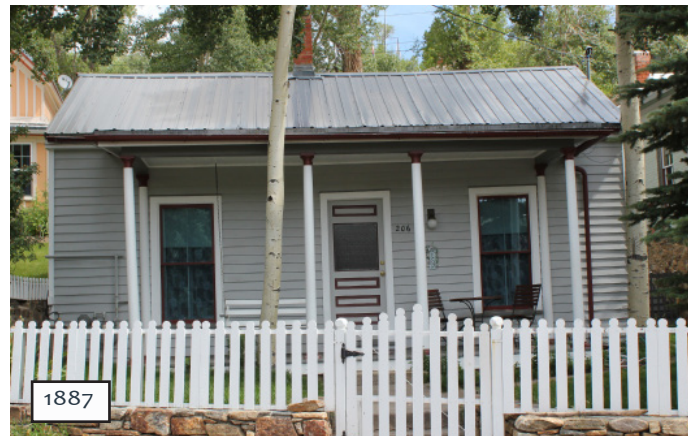
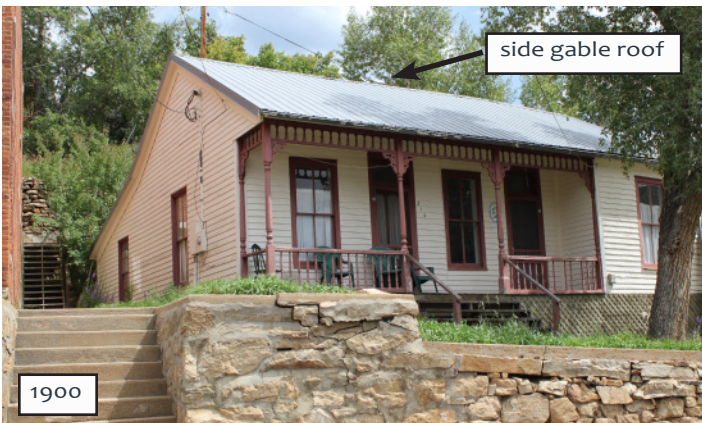
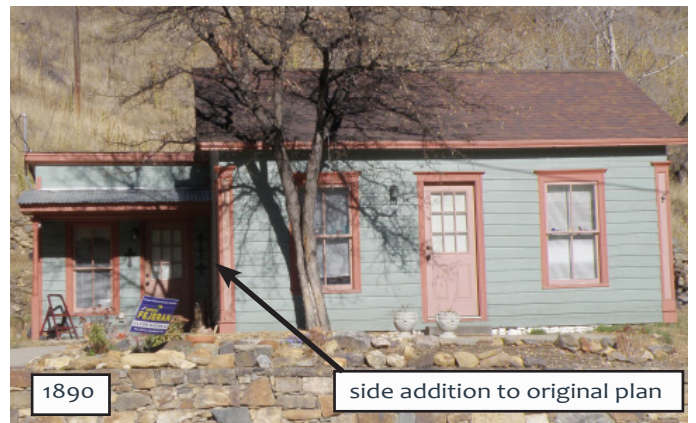
The Massed Plan, Side Gable house was a common vernacular type during the first half of the twentieth century. It is similar to the Hall and Parlor house but larger with a more flexible floor plan. The Massed Plan, Side Gable house is two rooms deep and features a gabled roof that is oriented parallel to the street. The eaves may be closed or open with exposed rafter tails.

Key Features of a Massed Plan

- Side gable roof
- Gable ridge parallel to the street
- Rectangular plan
- May have a small front porch

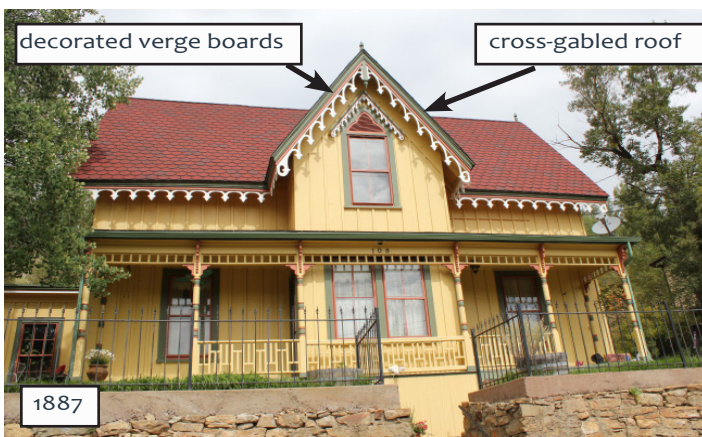
The Gothic Revival style was part of the Picturesque movement, an aesthetic movement that rebelled against architecture's previous strict adherence to classical forms and symmetry. The Picturesque sought to break free from the rigid geometric nature of classicism and to create more naturalistic and romantic buildings and landscapes. The movement also reflected American's desire for greater individuality in building styles, with several architectural styles becoming popular concurrently in the mid-nineteenth century. For the first time it was desirable to have buildings of distinctively different, yet complimentary styles as part of the same streetscape. Inspired by medieval architecture, the Gothic Revival was popular for residential architecture between 1840 and 1860, with the Gothic Revival houses in Central City late examples of the style. Central City's Gothic houses are also atypical for their placement on city lots, since the style's often irregular forms were more popular for larger, rural lots. This period of Gothic Revival is often referred to as Carpenter Gothic for its prominent use of wood decoration. Carpenter Gothic houses commonly feature vertical board and batten wood siding, pointed arch openings, and incised wood trim. The Gothic Revival style remained popular for religious architecture for much longer, continuing well into the twentieth century.

Key Features of a Gothic Revival

- Steeply pitched roof with deep overhanging eaves
- Wall surface extends into gable without break
- Cross-gabled roof
- Decorated verge boards
- Pointed arch windows
- Windows commonly extend into gable ends
- Porches with flattened, Gothic arches
- Tall and slim chimneys, sometimes medieval in character
- Asymmetrical floor plans

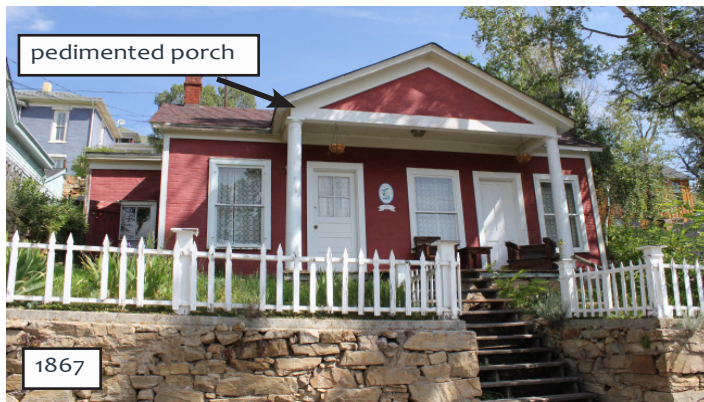
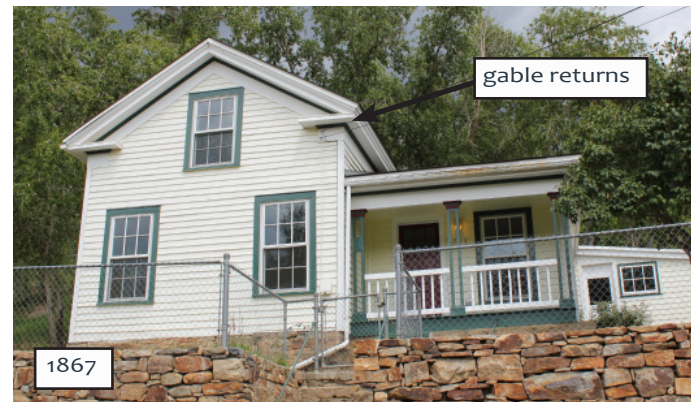
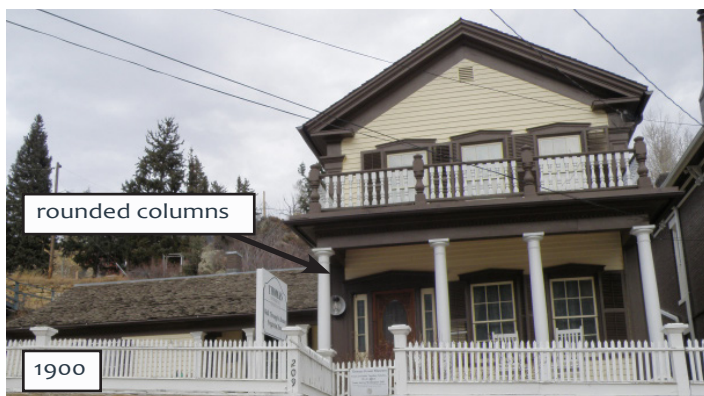
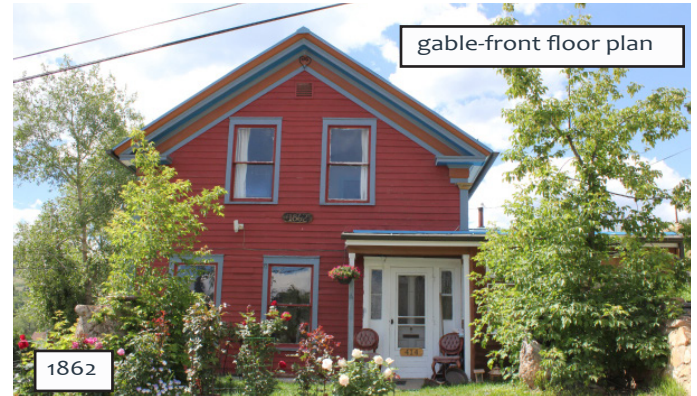
The Greek Revival style developed around 1820, part of a larger interest in Neoclassical architecture. In the early nineteenth century, Americans started to look to Greece rather than Rome for architectural inspiration. Roman architecture was associated with England, and English influenced designs were unpopular after the War of 1812. The American interest in Greece was inspired by sympathy for the Greek War of Independence in the 1820s and new archaeological finds. The Greek Revival became the dominant style in America between 1820 and 1850, often referred to as the national style. The Greek Revival houses in Central City are late example of the style. Promoted by Thomas Jefferson, Greek Revival architecture became a symbol of American democracy. The Greek Revival style was used for all types of building and there was a wide range in the style from elaborate mansions to simple cottages. The primary common feature was an emphasis on the triangular pediment form.

Key Features of a Greek Revival

- Gable or hipped, low-pitch roof
- Porch supported by square or rounded columns
- Often a gable-front floor plan
- Temple-front entryway surrounded by rectangular transom and sidelights
- Generally symmetrical facade, though entry may be to one side
- Gable returns on the gable ends
- Pedimented windows surrounds
- Prominent cornice line

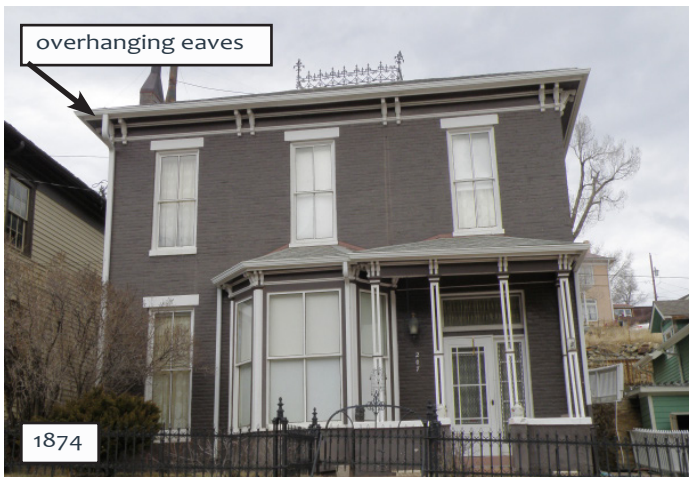
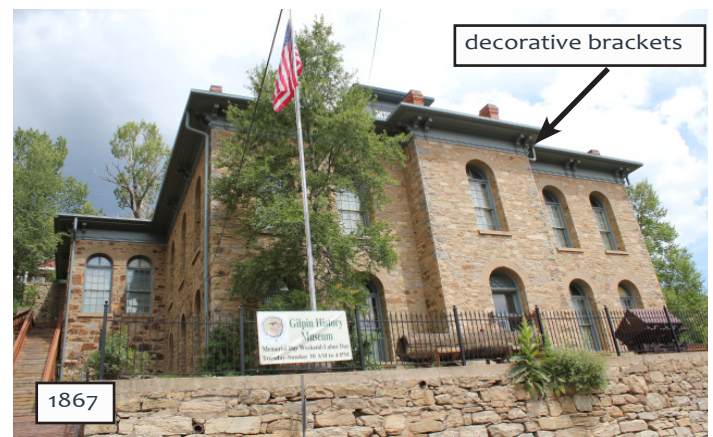
The Italianate style was also associated with the Picturesque Movement. The Italian Villa style first emerged in the 1830s, inspired by rambling medieval Italian farmhouses. It featured an asymmetrical (picturesque) composition, projecting towers, and shallow pitched roofs with deep eaves. The Italianate style followed in the 1840s, featuring the same low pitch roof, generally supported by prominent decorative brackets, and more regular in plan. Italianate residences were popular through the 1870s. Easily adaptable, it also became popular for commercial buildings, where it remained in use until the end of the nineteenth century. The Italianate style came to define the main streets of the new western towns constructed during this period, with commercial streetscapes marked by a continuous line of distinctive bracketed cornices. Some decorative elements were of cast iron, a newly developed technology in this period.

Key Features of a Italianate Residential and Public Buildings

- Typically asymmetrical, two-story L- or T-shaped plans
- Low-pitched roof
- Widely overhanging eaves
- Large eave brackets dominate cornice lines arranged singly or in pairs
- Narrow windows, commonly in arched openings
- Windows frequently embellished with heavy crown molding
- Porches common, centered, or full-width; small entry porches most common
- Wide, overhanging eaves supported by decorative brackets
- Tall, arched windows

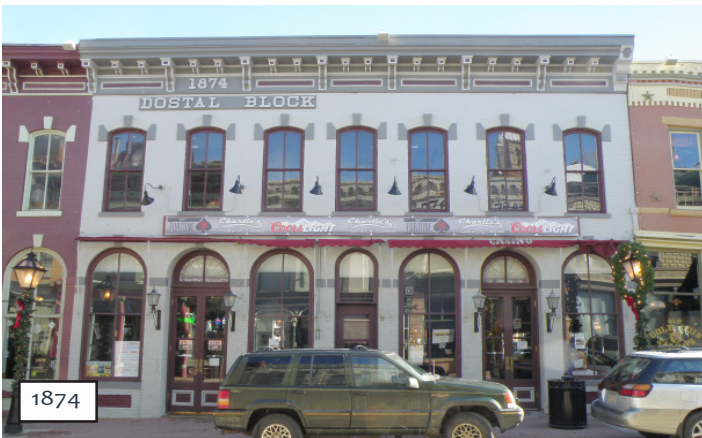
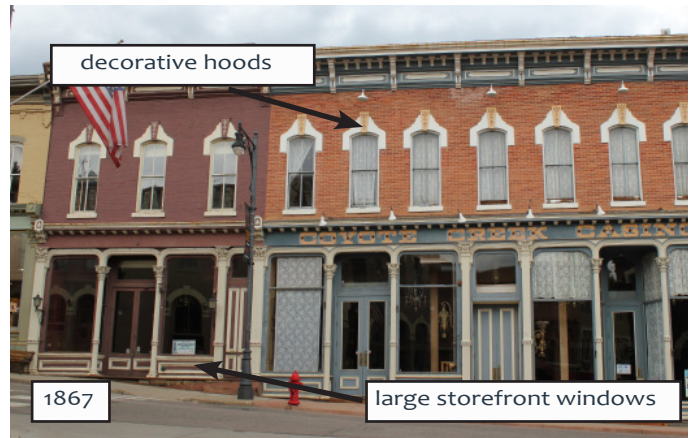
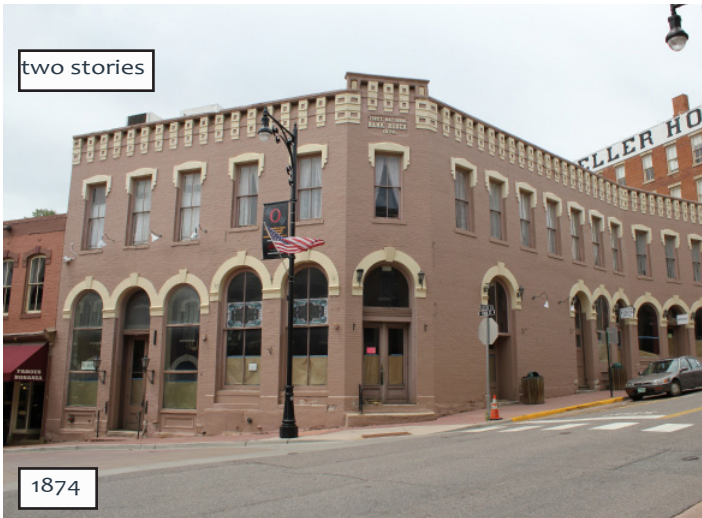
Key Features of Italianate Commercial Buildings

- Brick construction
- Flat roof
- Two to three stories high
- Large storefront windows
- Buildings were constructed side by side often with a shared common wall
- Windows are tall and narrow and evenly spaced on the building with decorative hoods over the top
- Cornice with brackets is the most embellished part of the building
