# **APPENDIX A**

# **ASSESSMENT PROTOCOL**

# **APPENDIX C**

# **SITE DESCRIPTIONS**

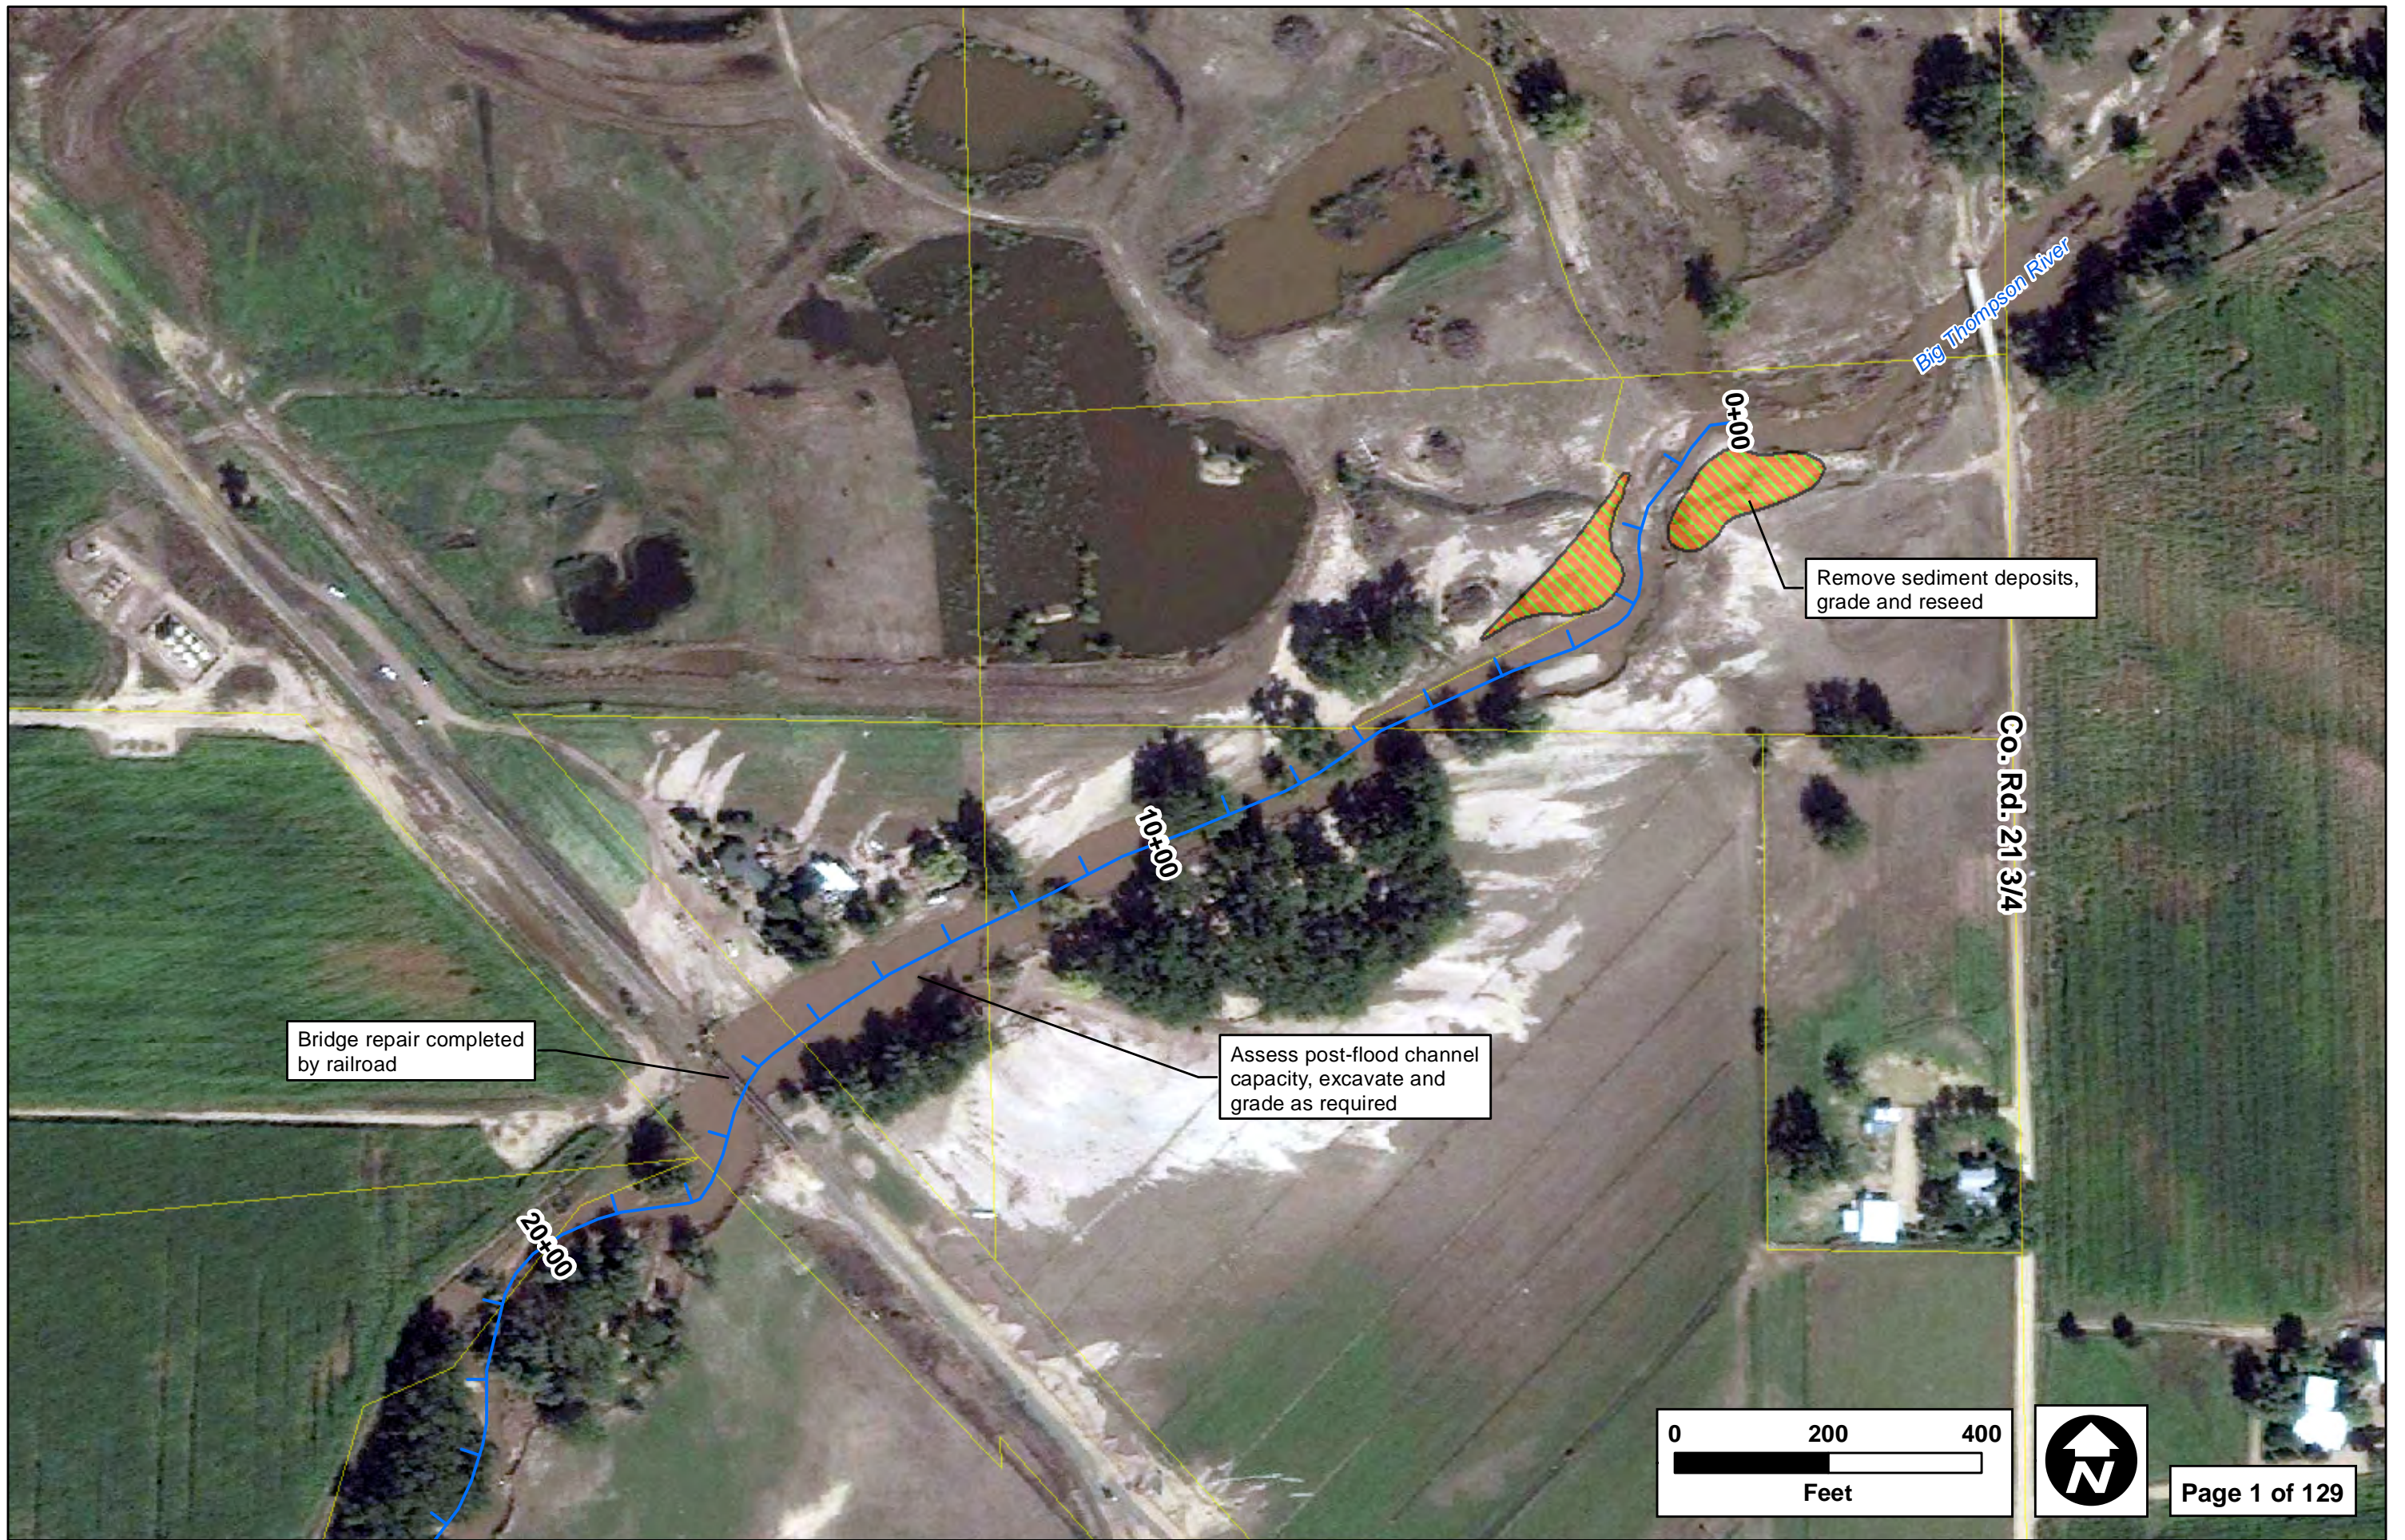
Big Thompson River

Remove sediment deposits,  
grade and reseed

Bridge repair completed  
by railroad

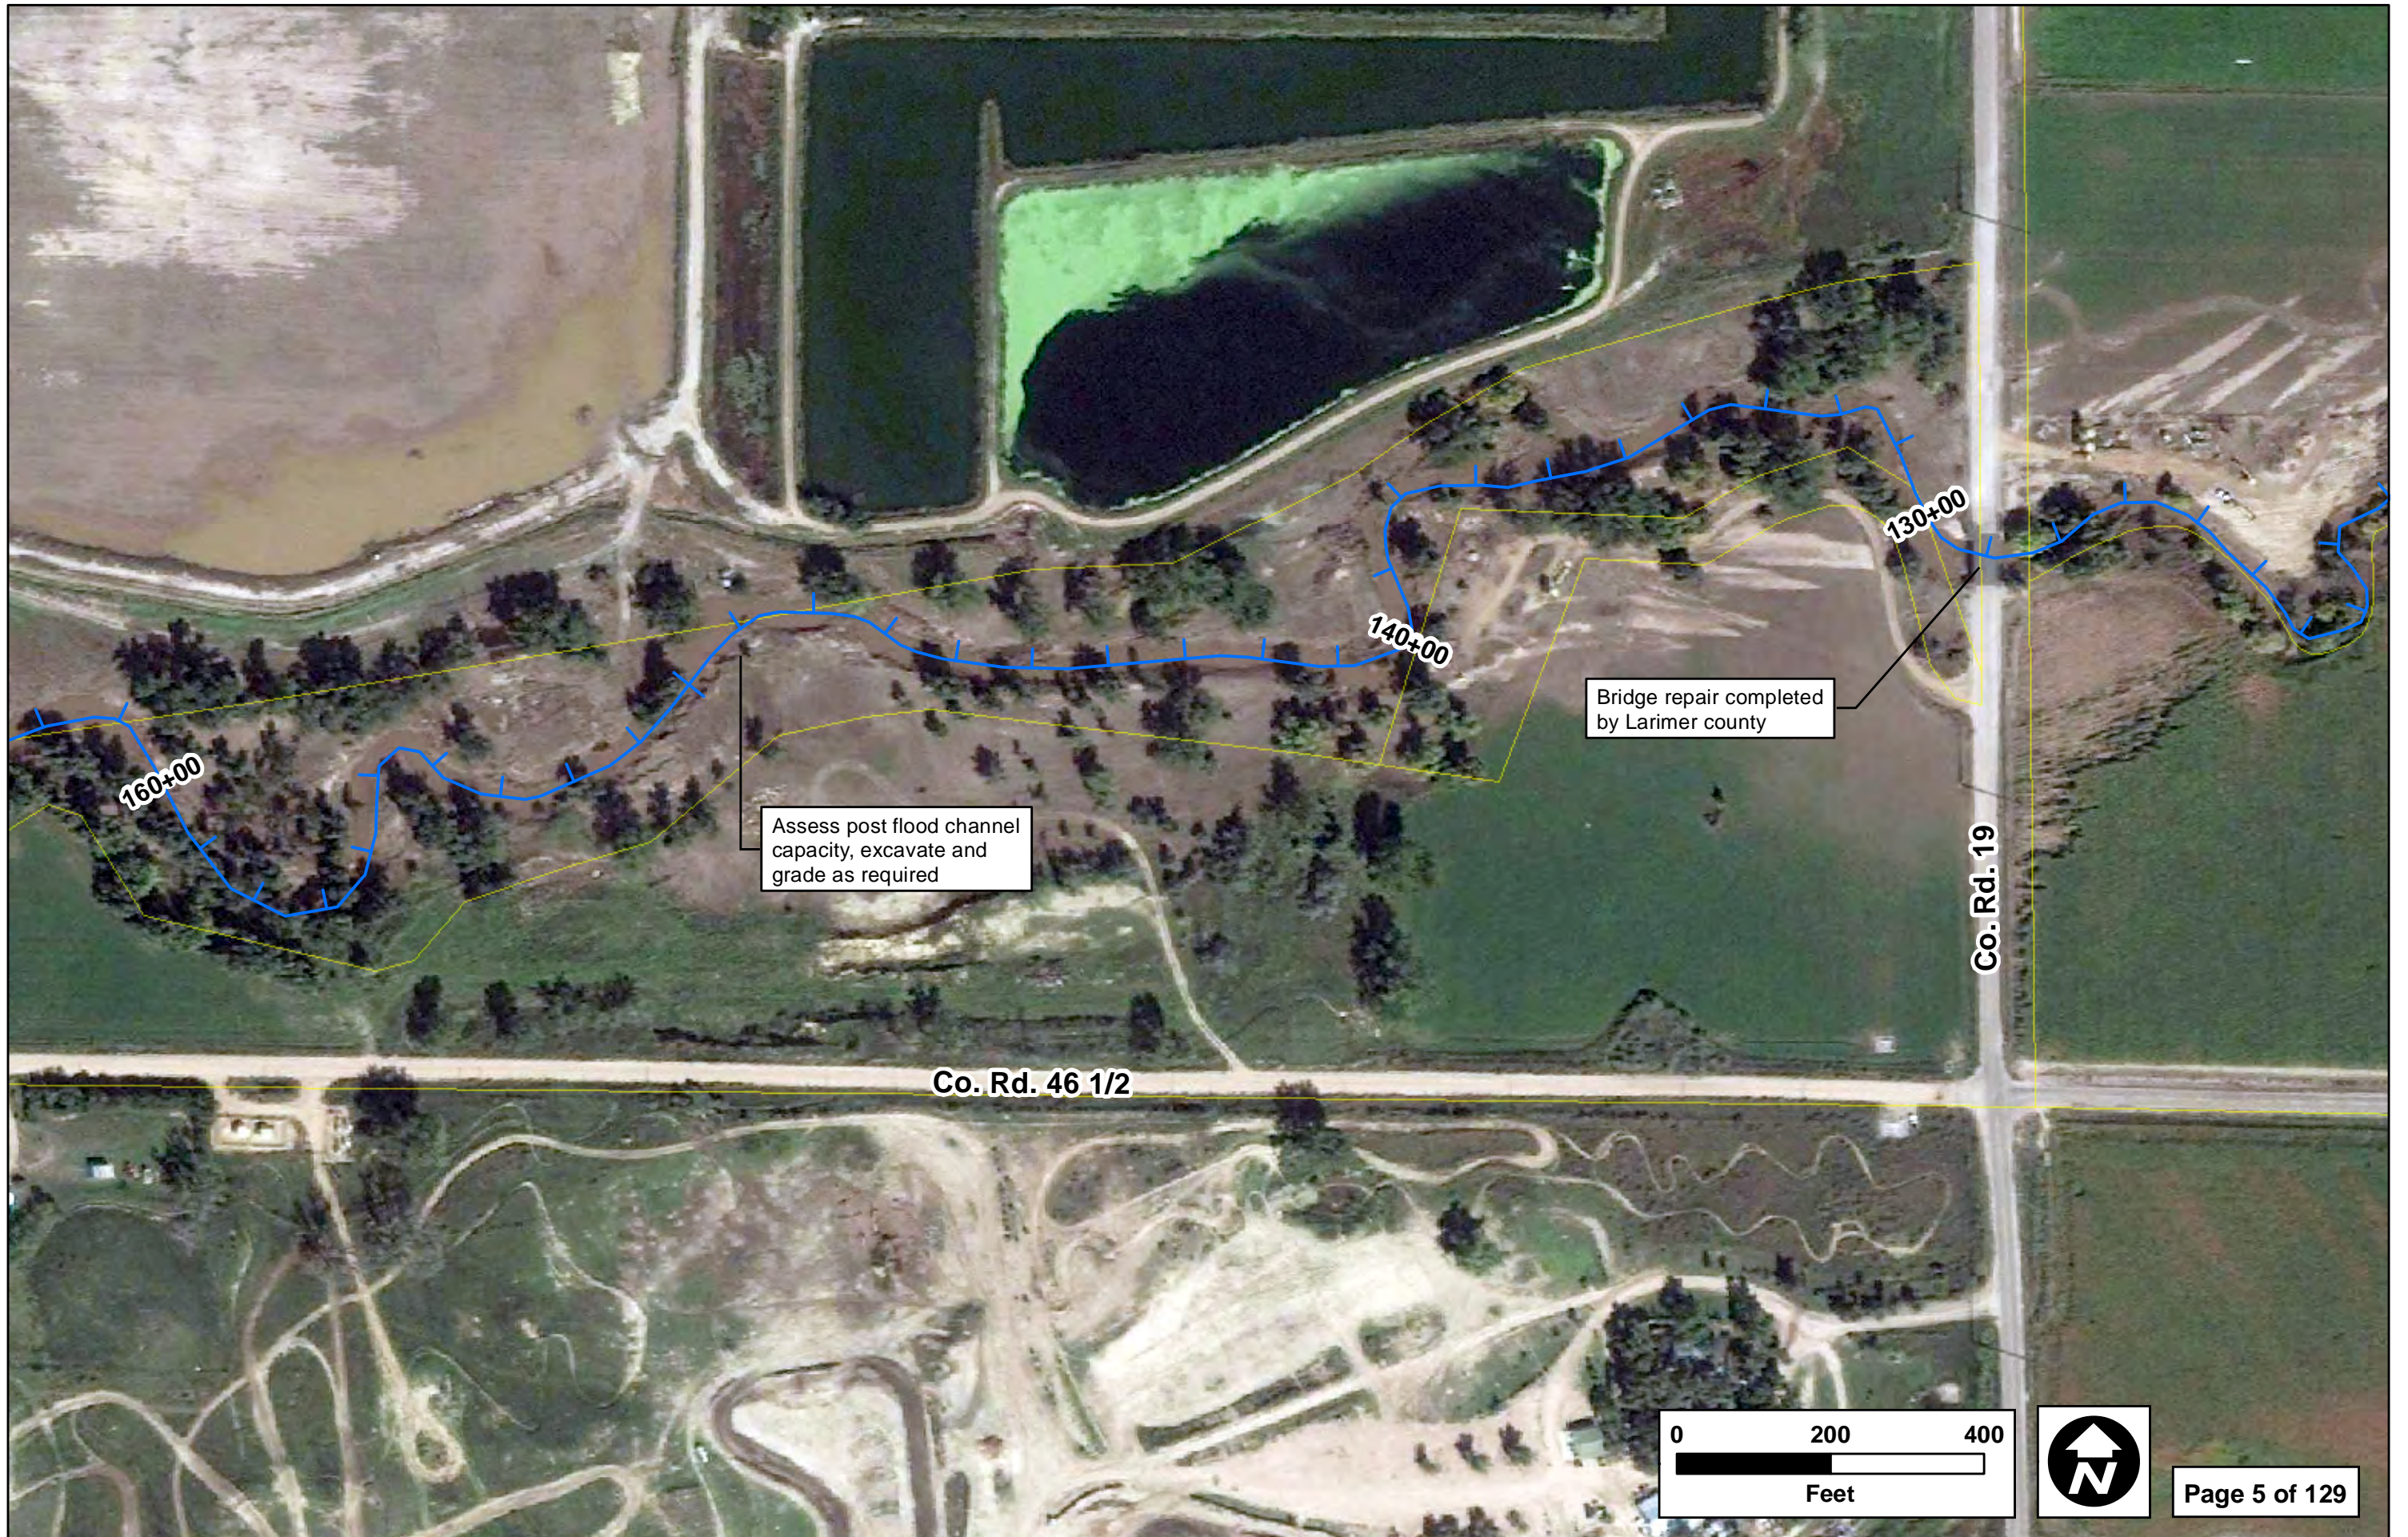
Assess post flood channel capacity, excavate and grade as required

Bridge repair completed by Larimer county

Aerial photos of pre-flood conditions and anecdotal information indicate this reach had a riparian corridor between 50 to 300 feet wide depending on the adjacent land use and encroachments. Adjacent land use includes agriculture, natural gas well pads, rural development and roads, all which control the lateral movement of the river and its planform. Weld County Road 19 crosses the river at Sta 129+00. Damage to this bridge from the 2013 flood event has been repaired by Larimer County.

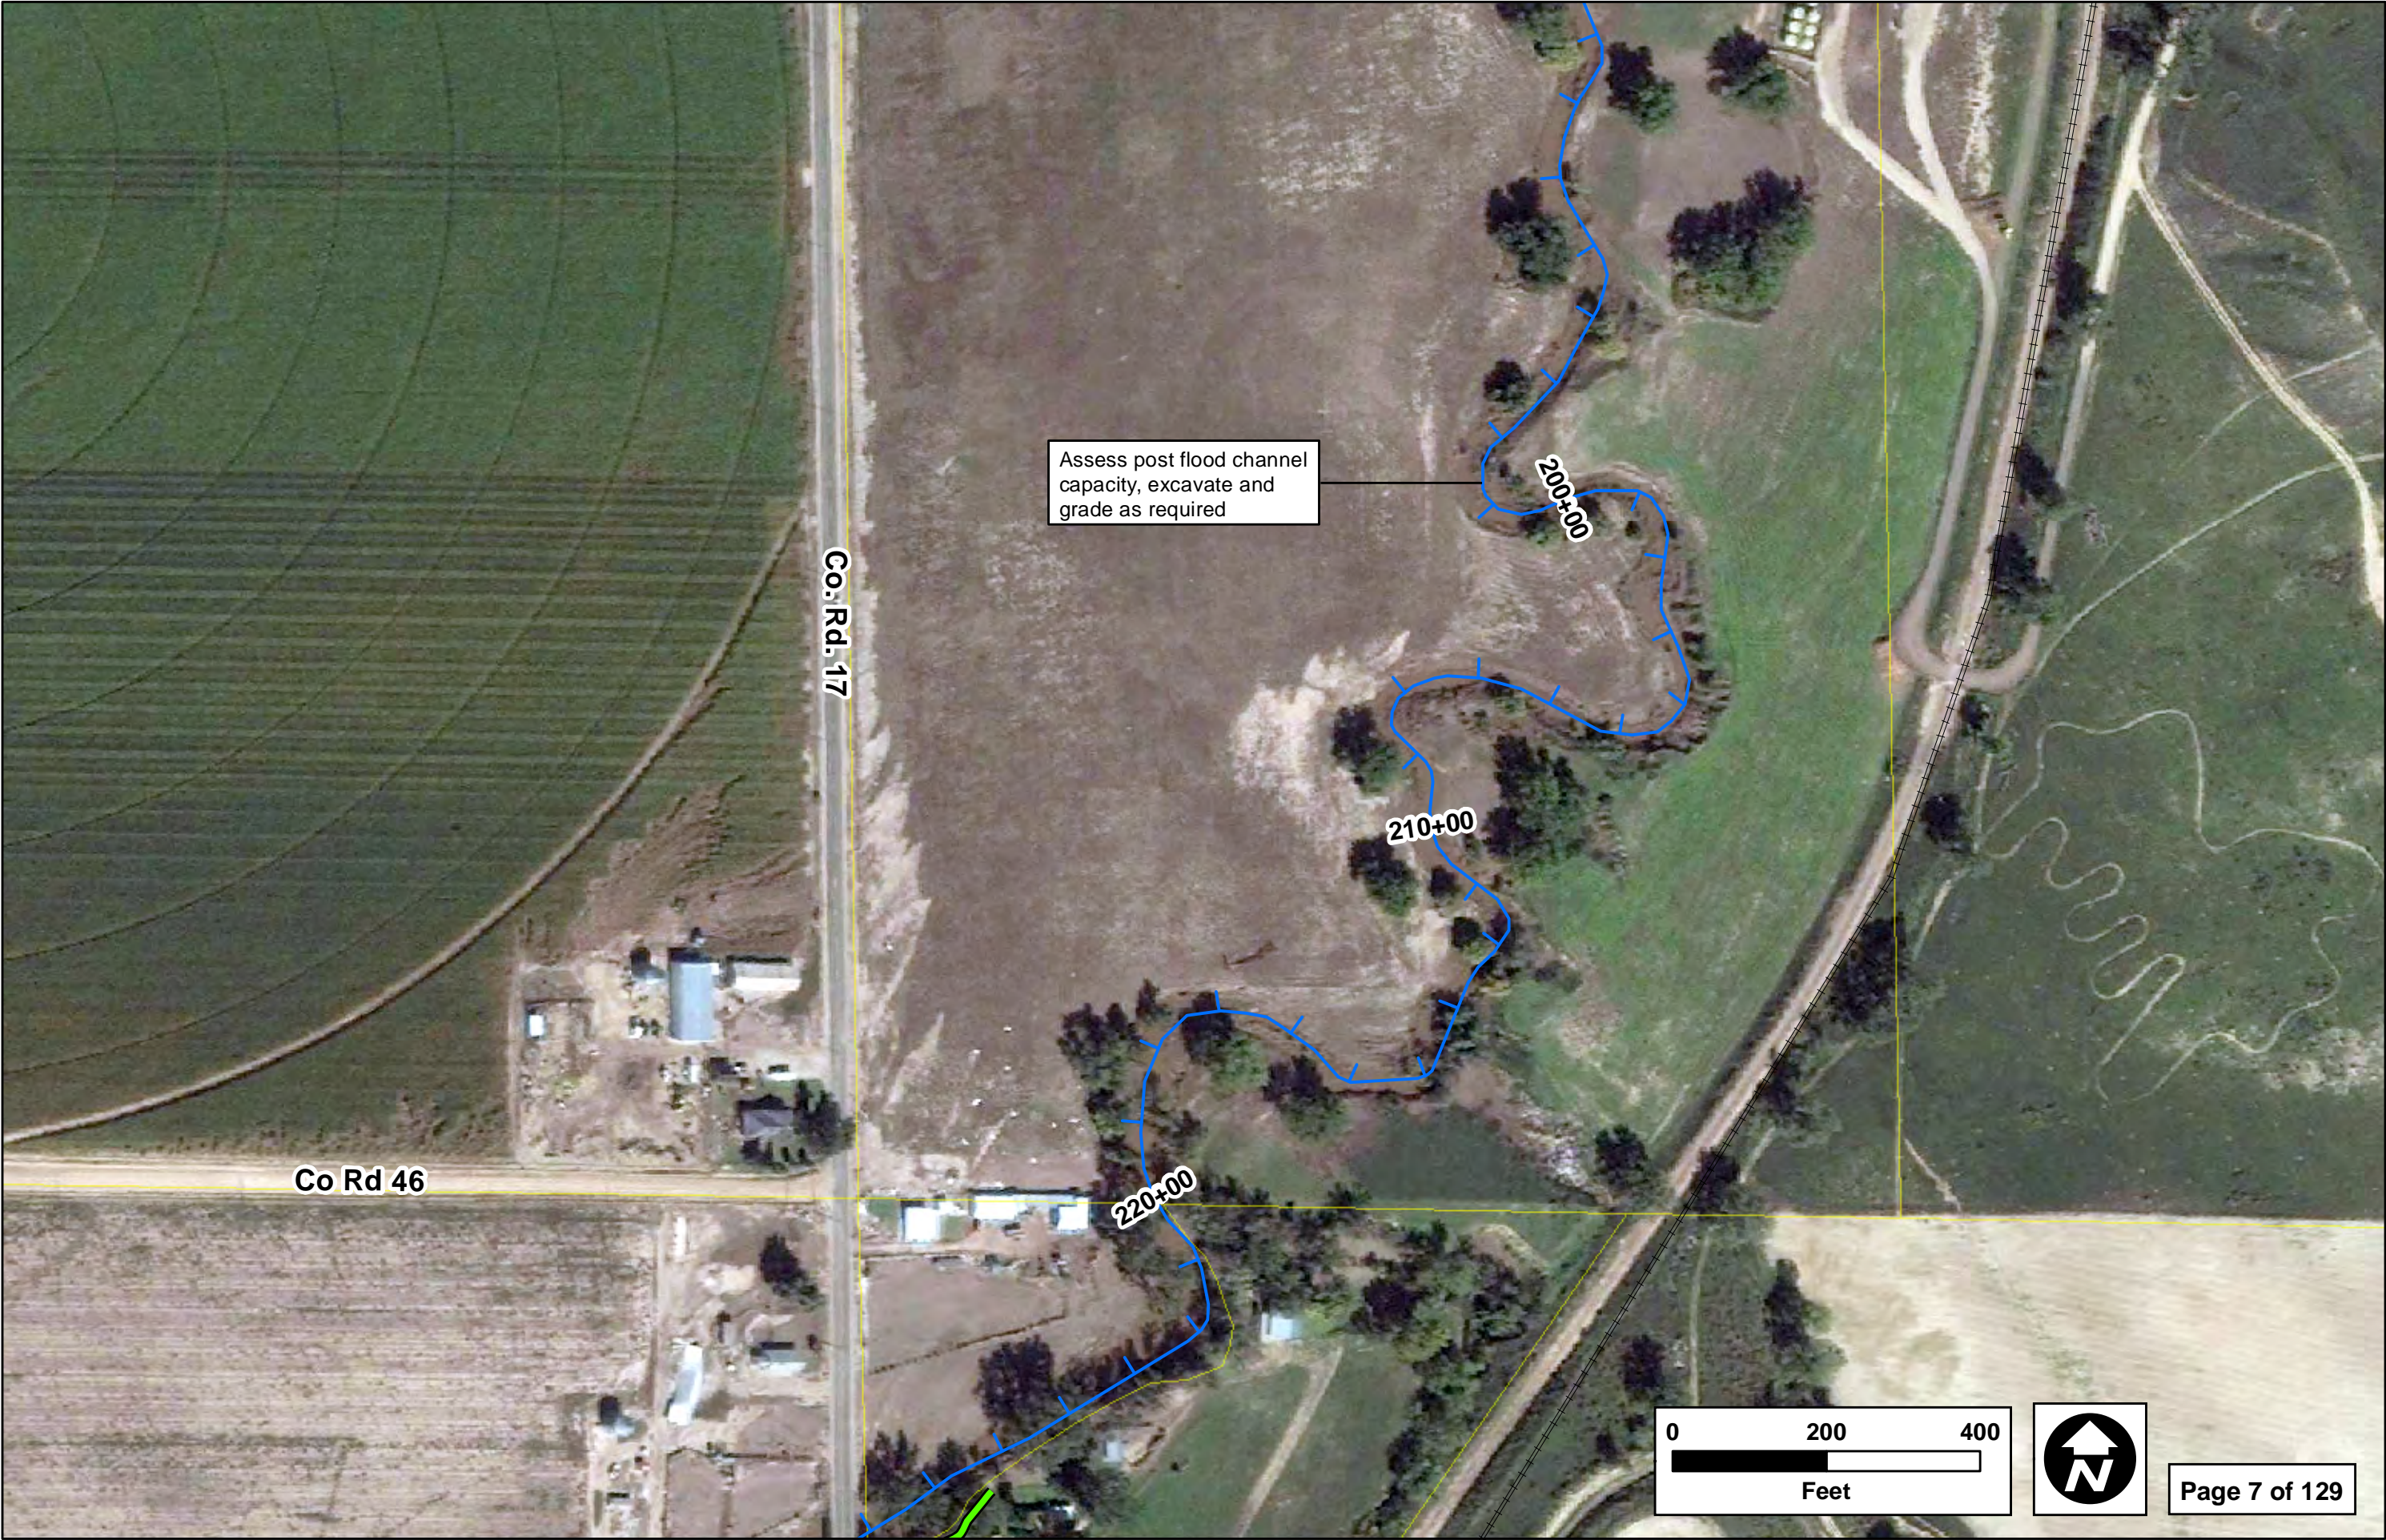
Assess post flood channel capacity, excavate and grade as required

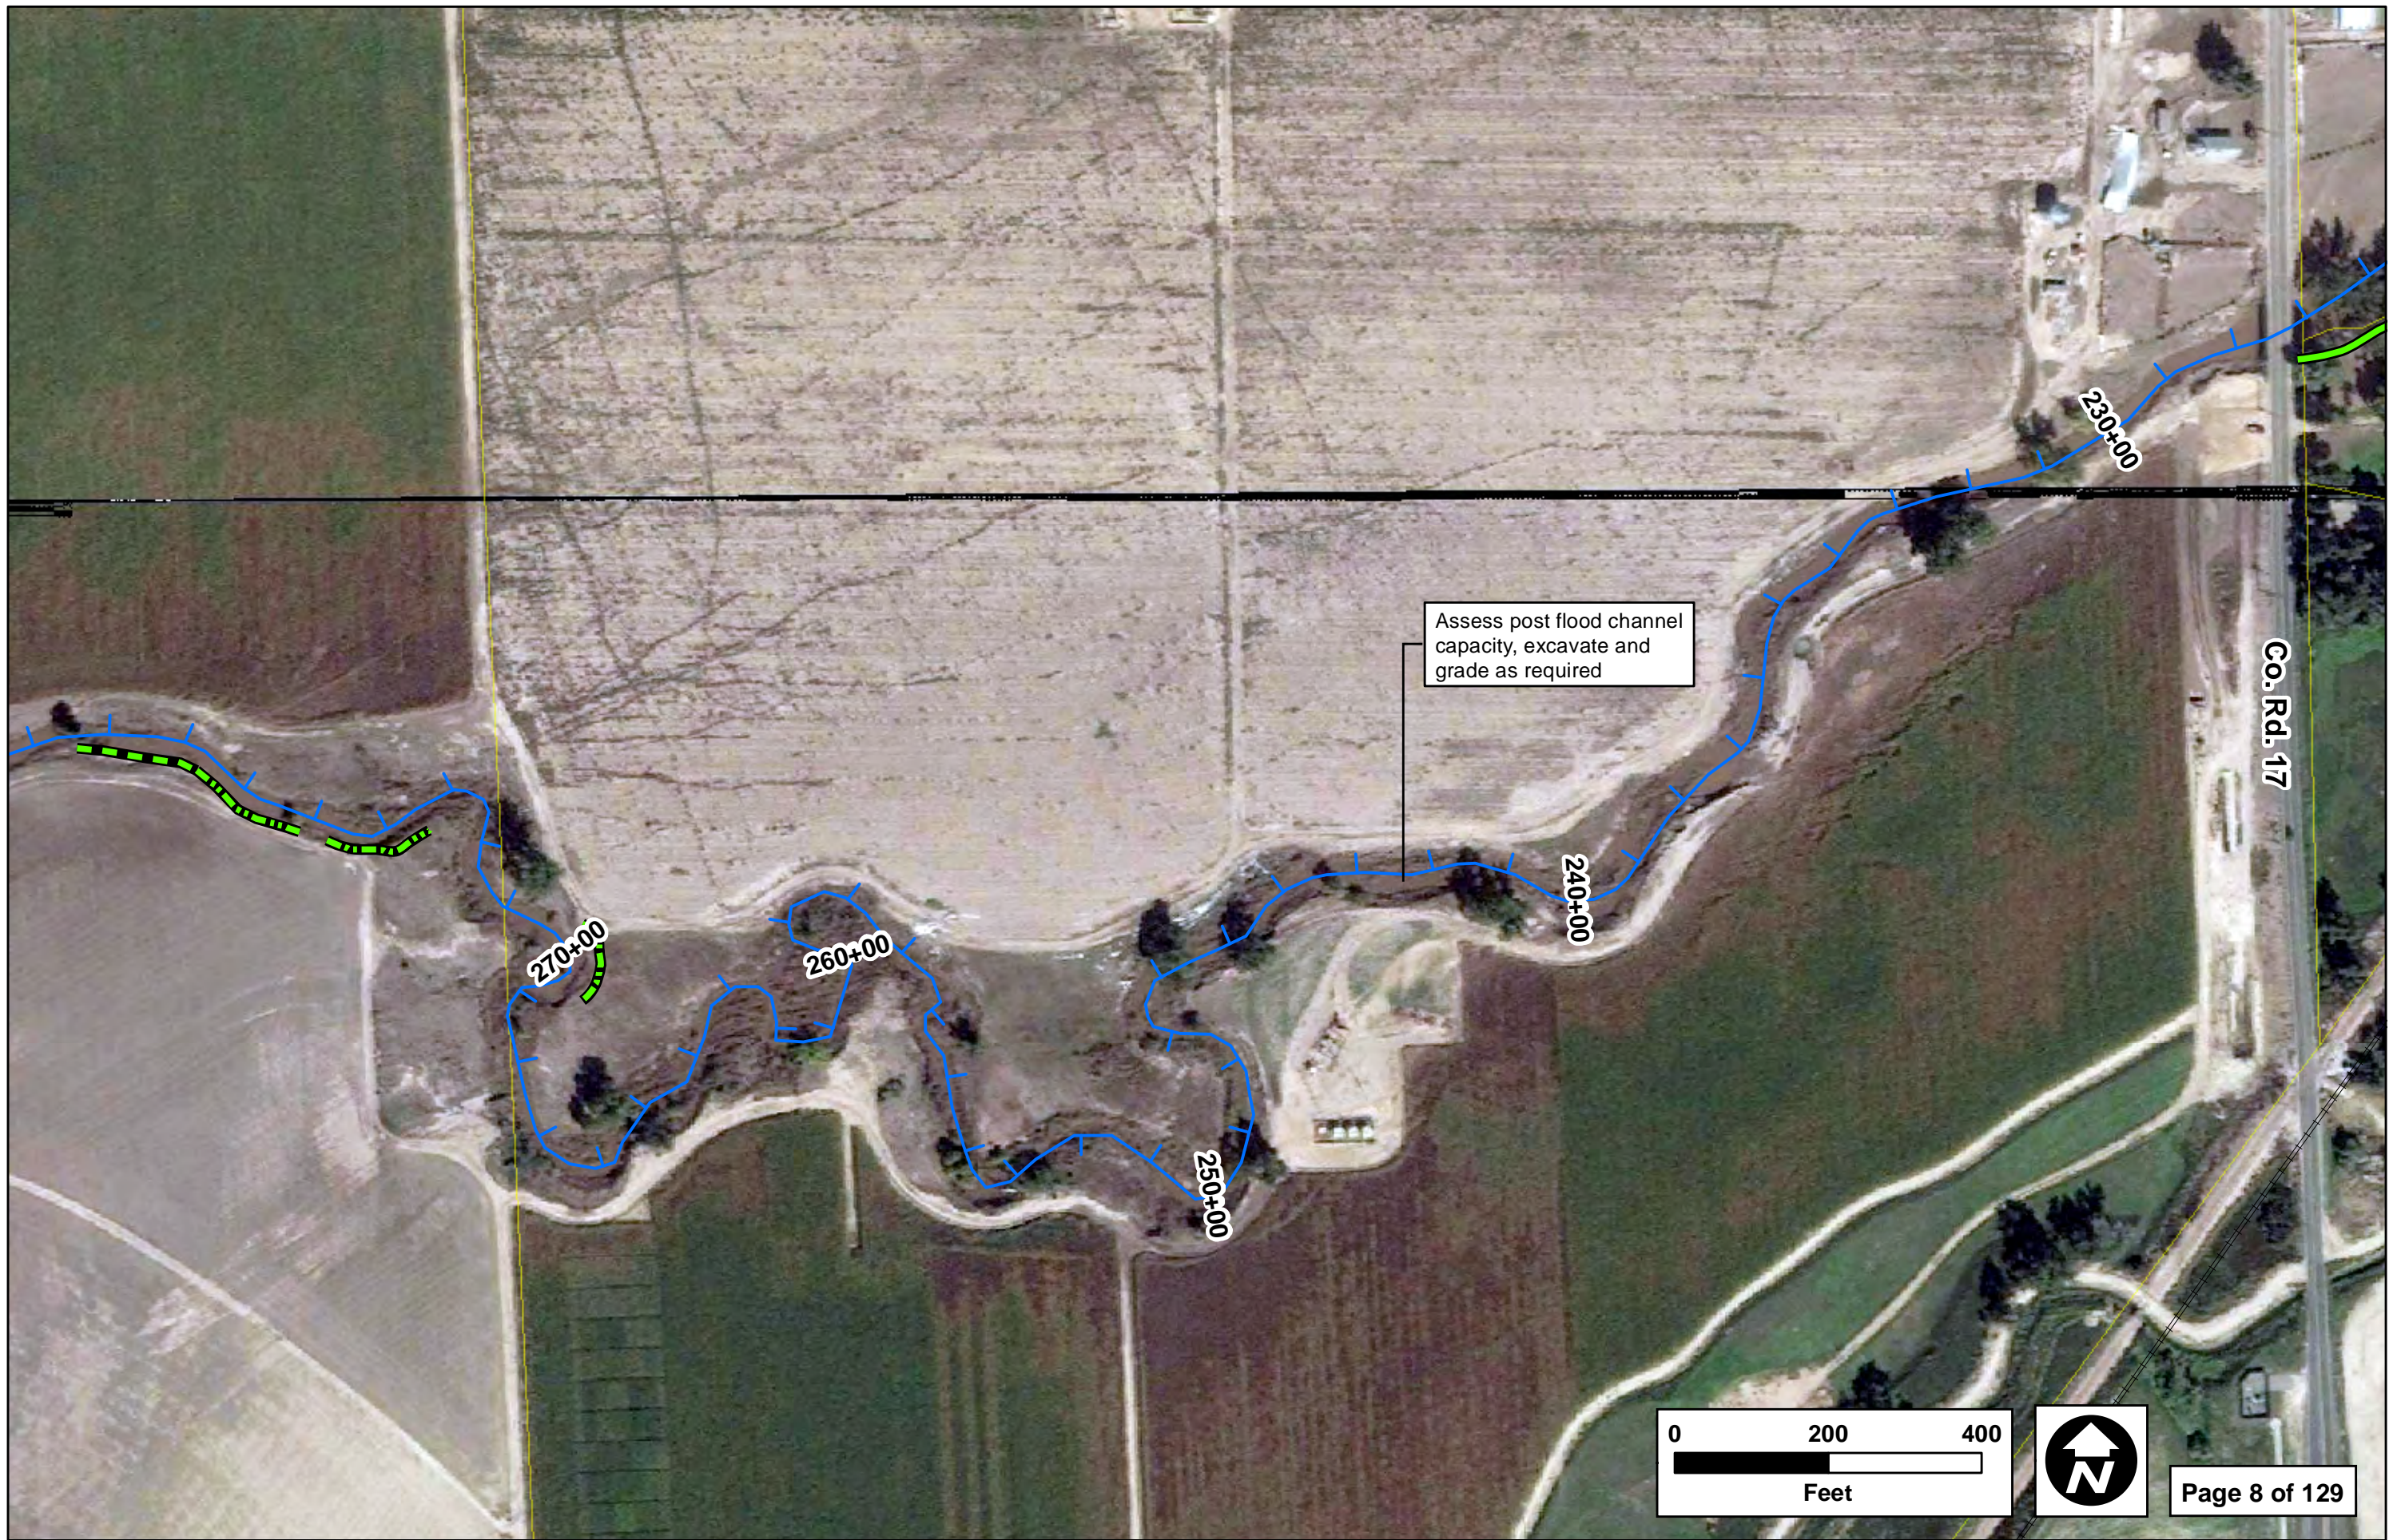
Assess post flood channel capacity, excavate and grade as required

Co. Rd. 17

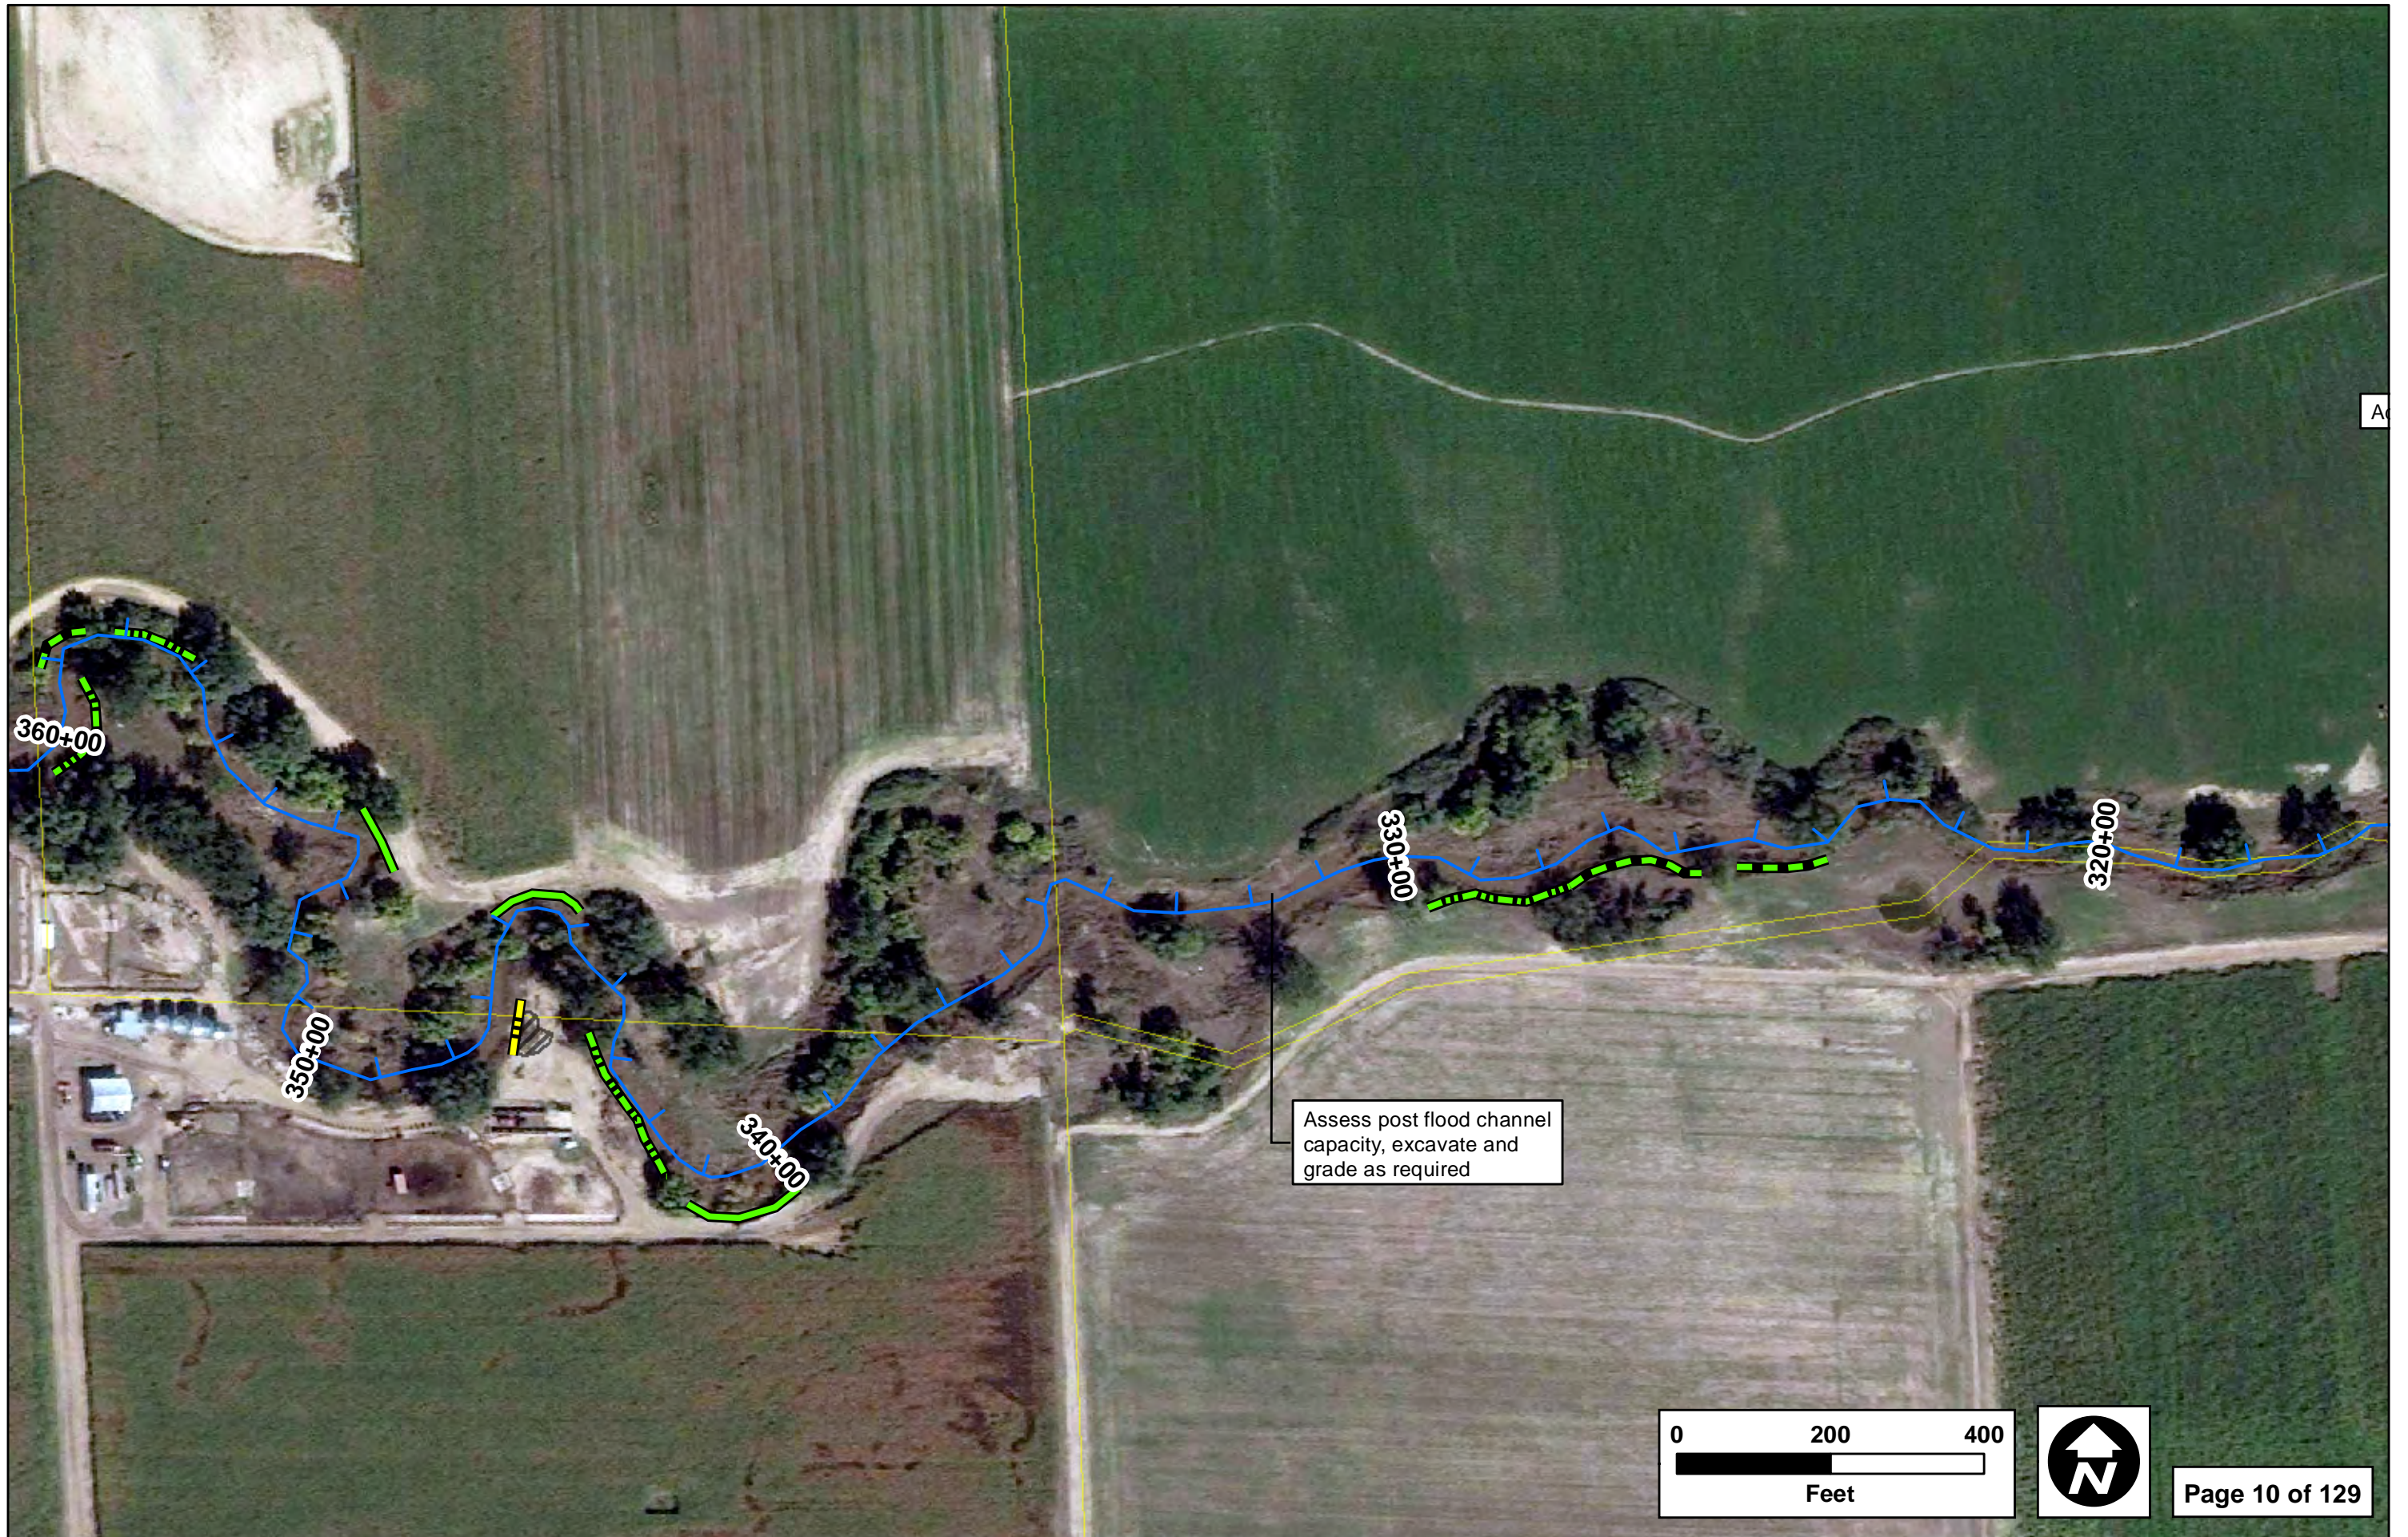
Assess post flood channel capacity, excavate and grade as required

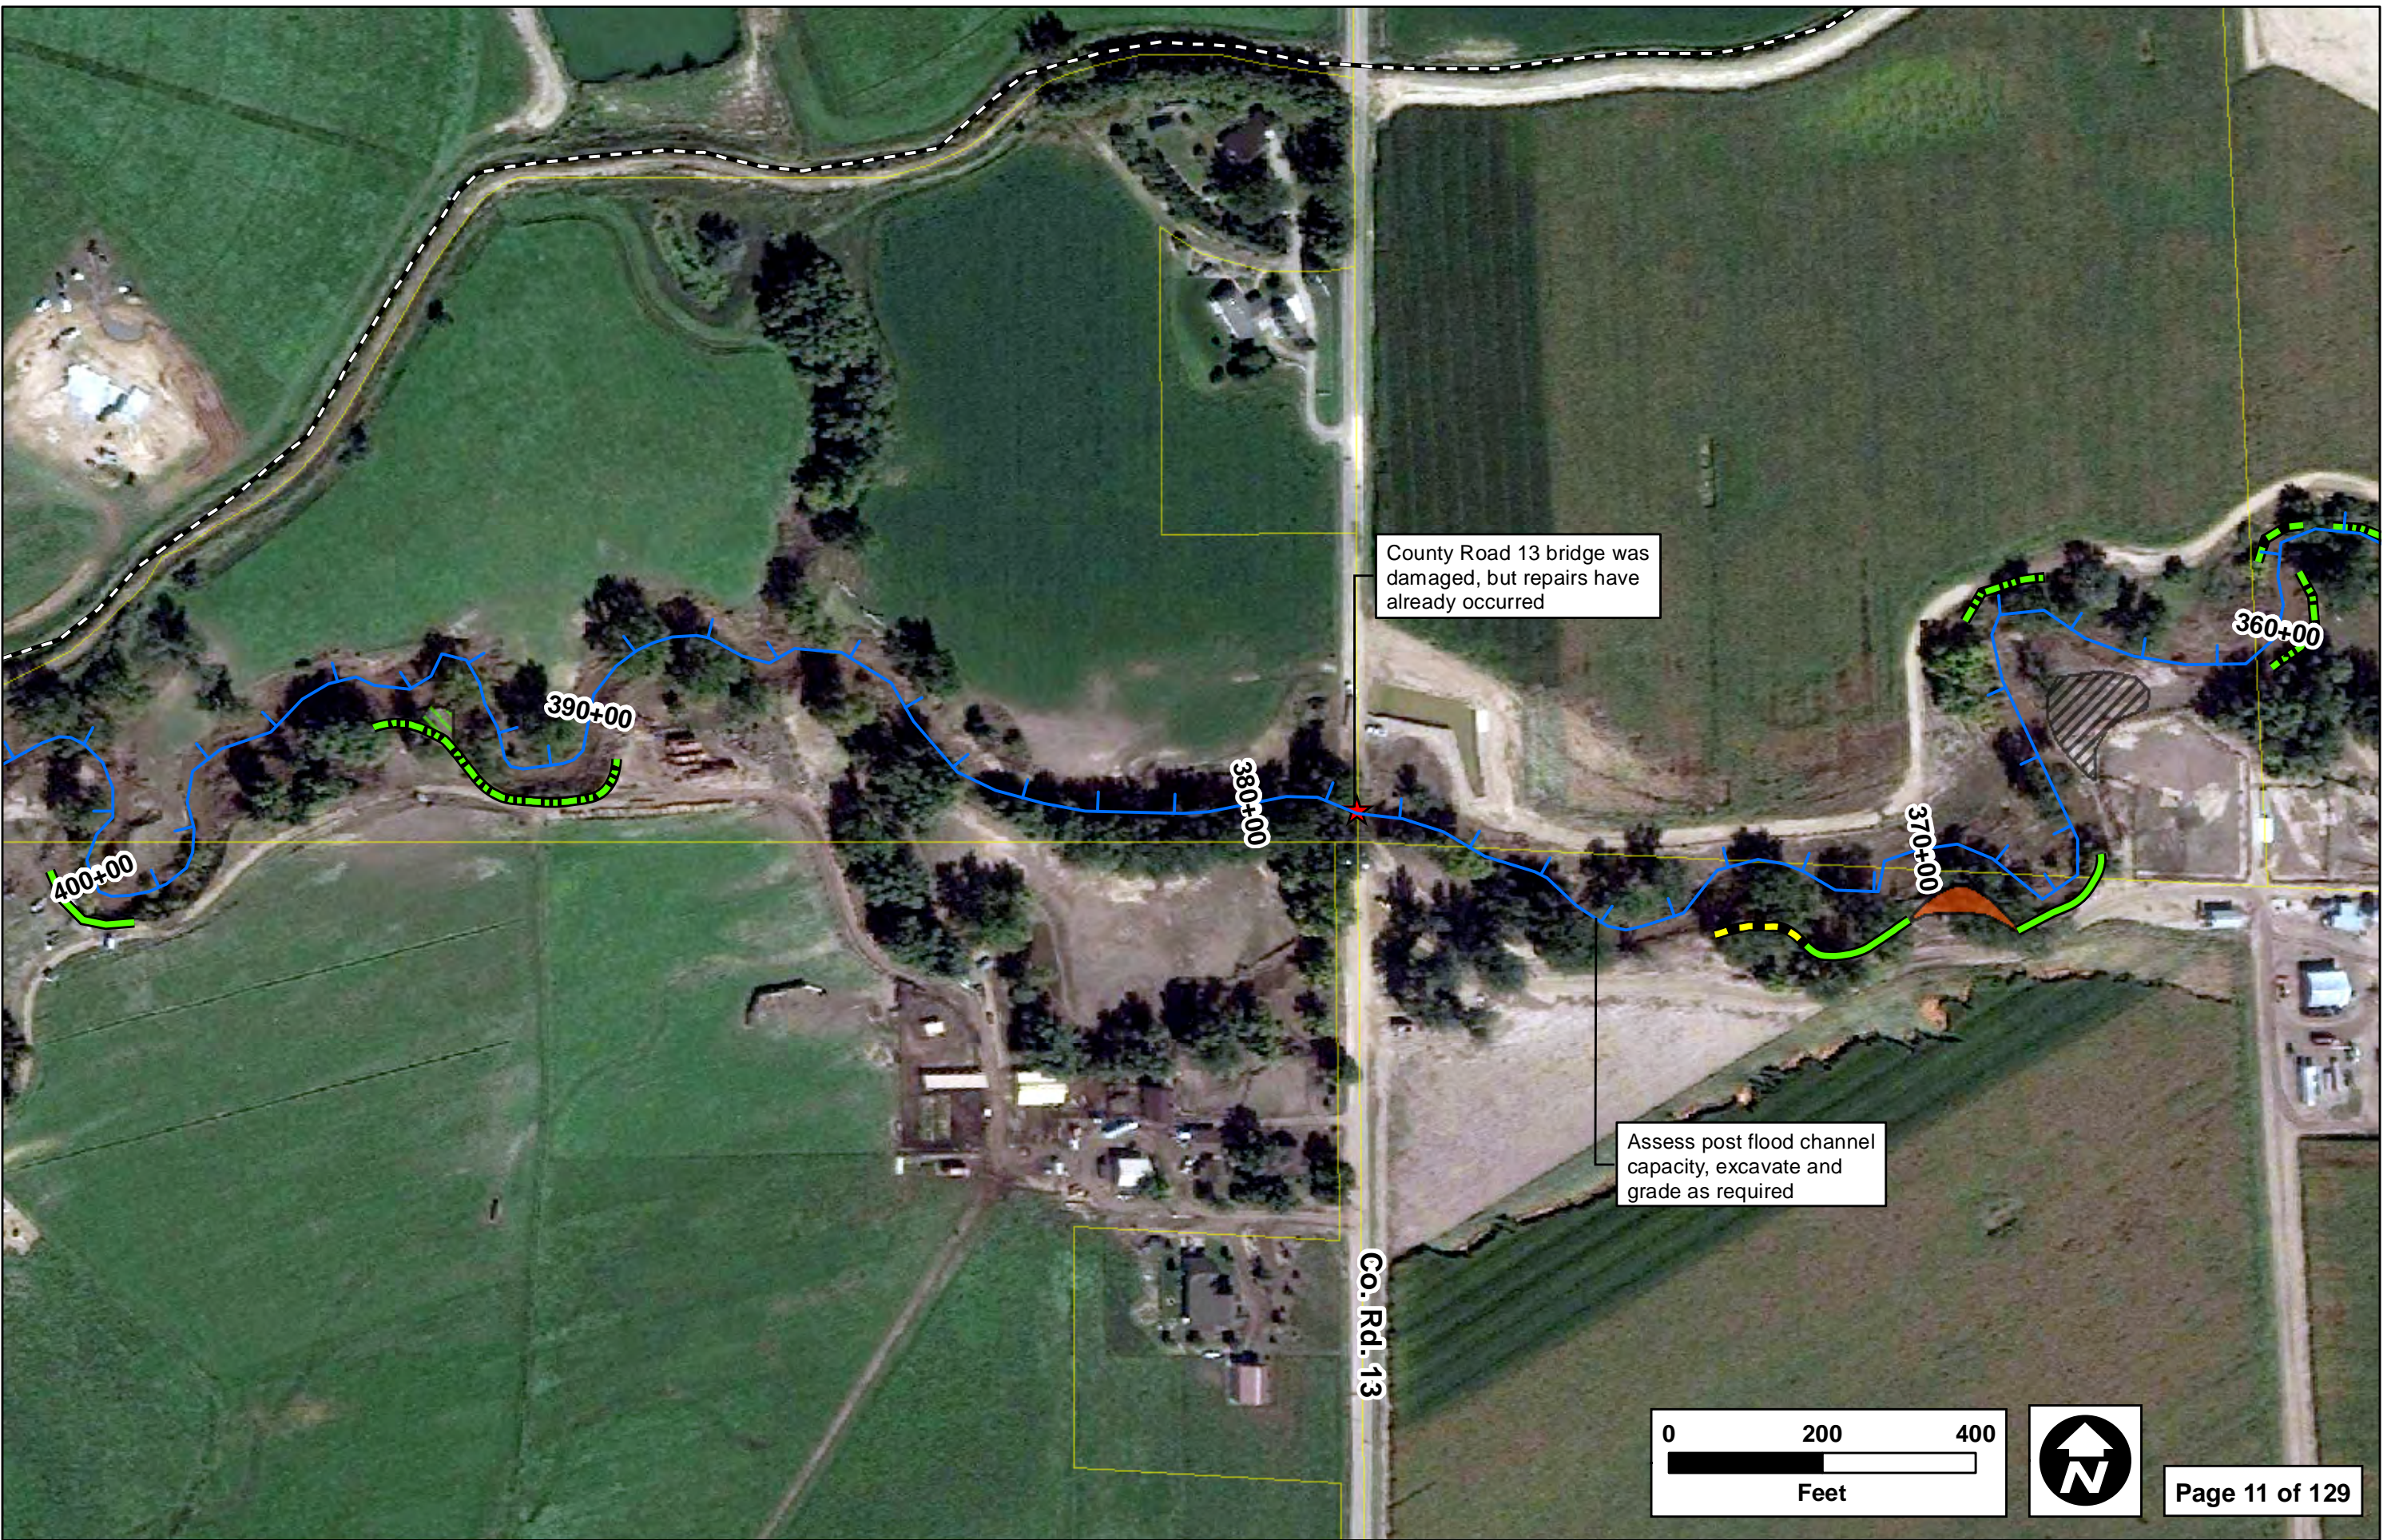
County Road 13 bridge was damaged, but repairs have already occurred

Assess post flood channel capacity, excavate and grade as required

1. Removal of debris is recommended along the channel and overbanks in areas where the debris could affect flood conveyance. Assess the channel elevations and impacts of floodplain elevations and excavate and grade if required to return the channel to pre-flood elevations.
2. Geomorphic functions of this reach are likely sufficient to allow for the natural regeneration of willow, and other riparian species through seeding and cloning without active revegetation.
3. Stabilize left bank near Sta 364+00 to protect access road.
4. Reclaim right overbank near Sta 366+00.
5. Grade floodplain near Sta 370+00 to improve conveyance.
6. Stabilize right bank near Sta 371+00 and Sta 368+00 to protect access road.
7. Stabilize upper bank near Sta 373+00.
8. Stabilize right bank to protect access road near Sta 400+00 and Sta 391+00.
