# **APPENDIX A**

# **ASSESSMENT PROTOCOL**

# **APPENDIX C**

# **SITE DESCRIPTIONS**

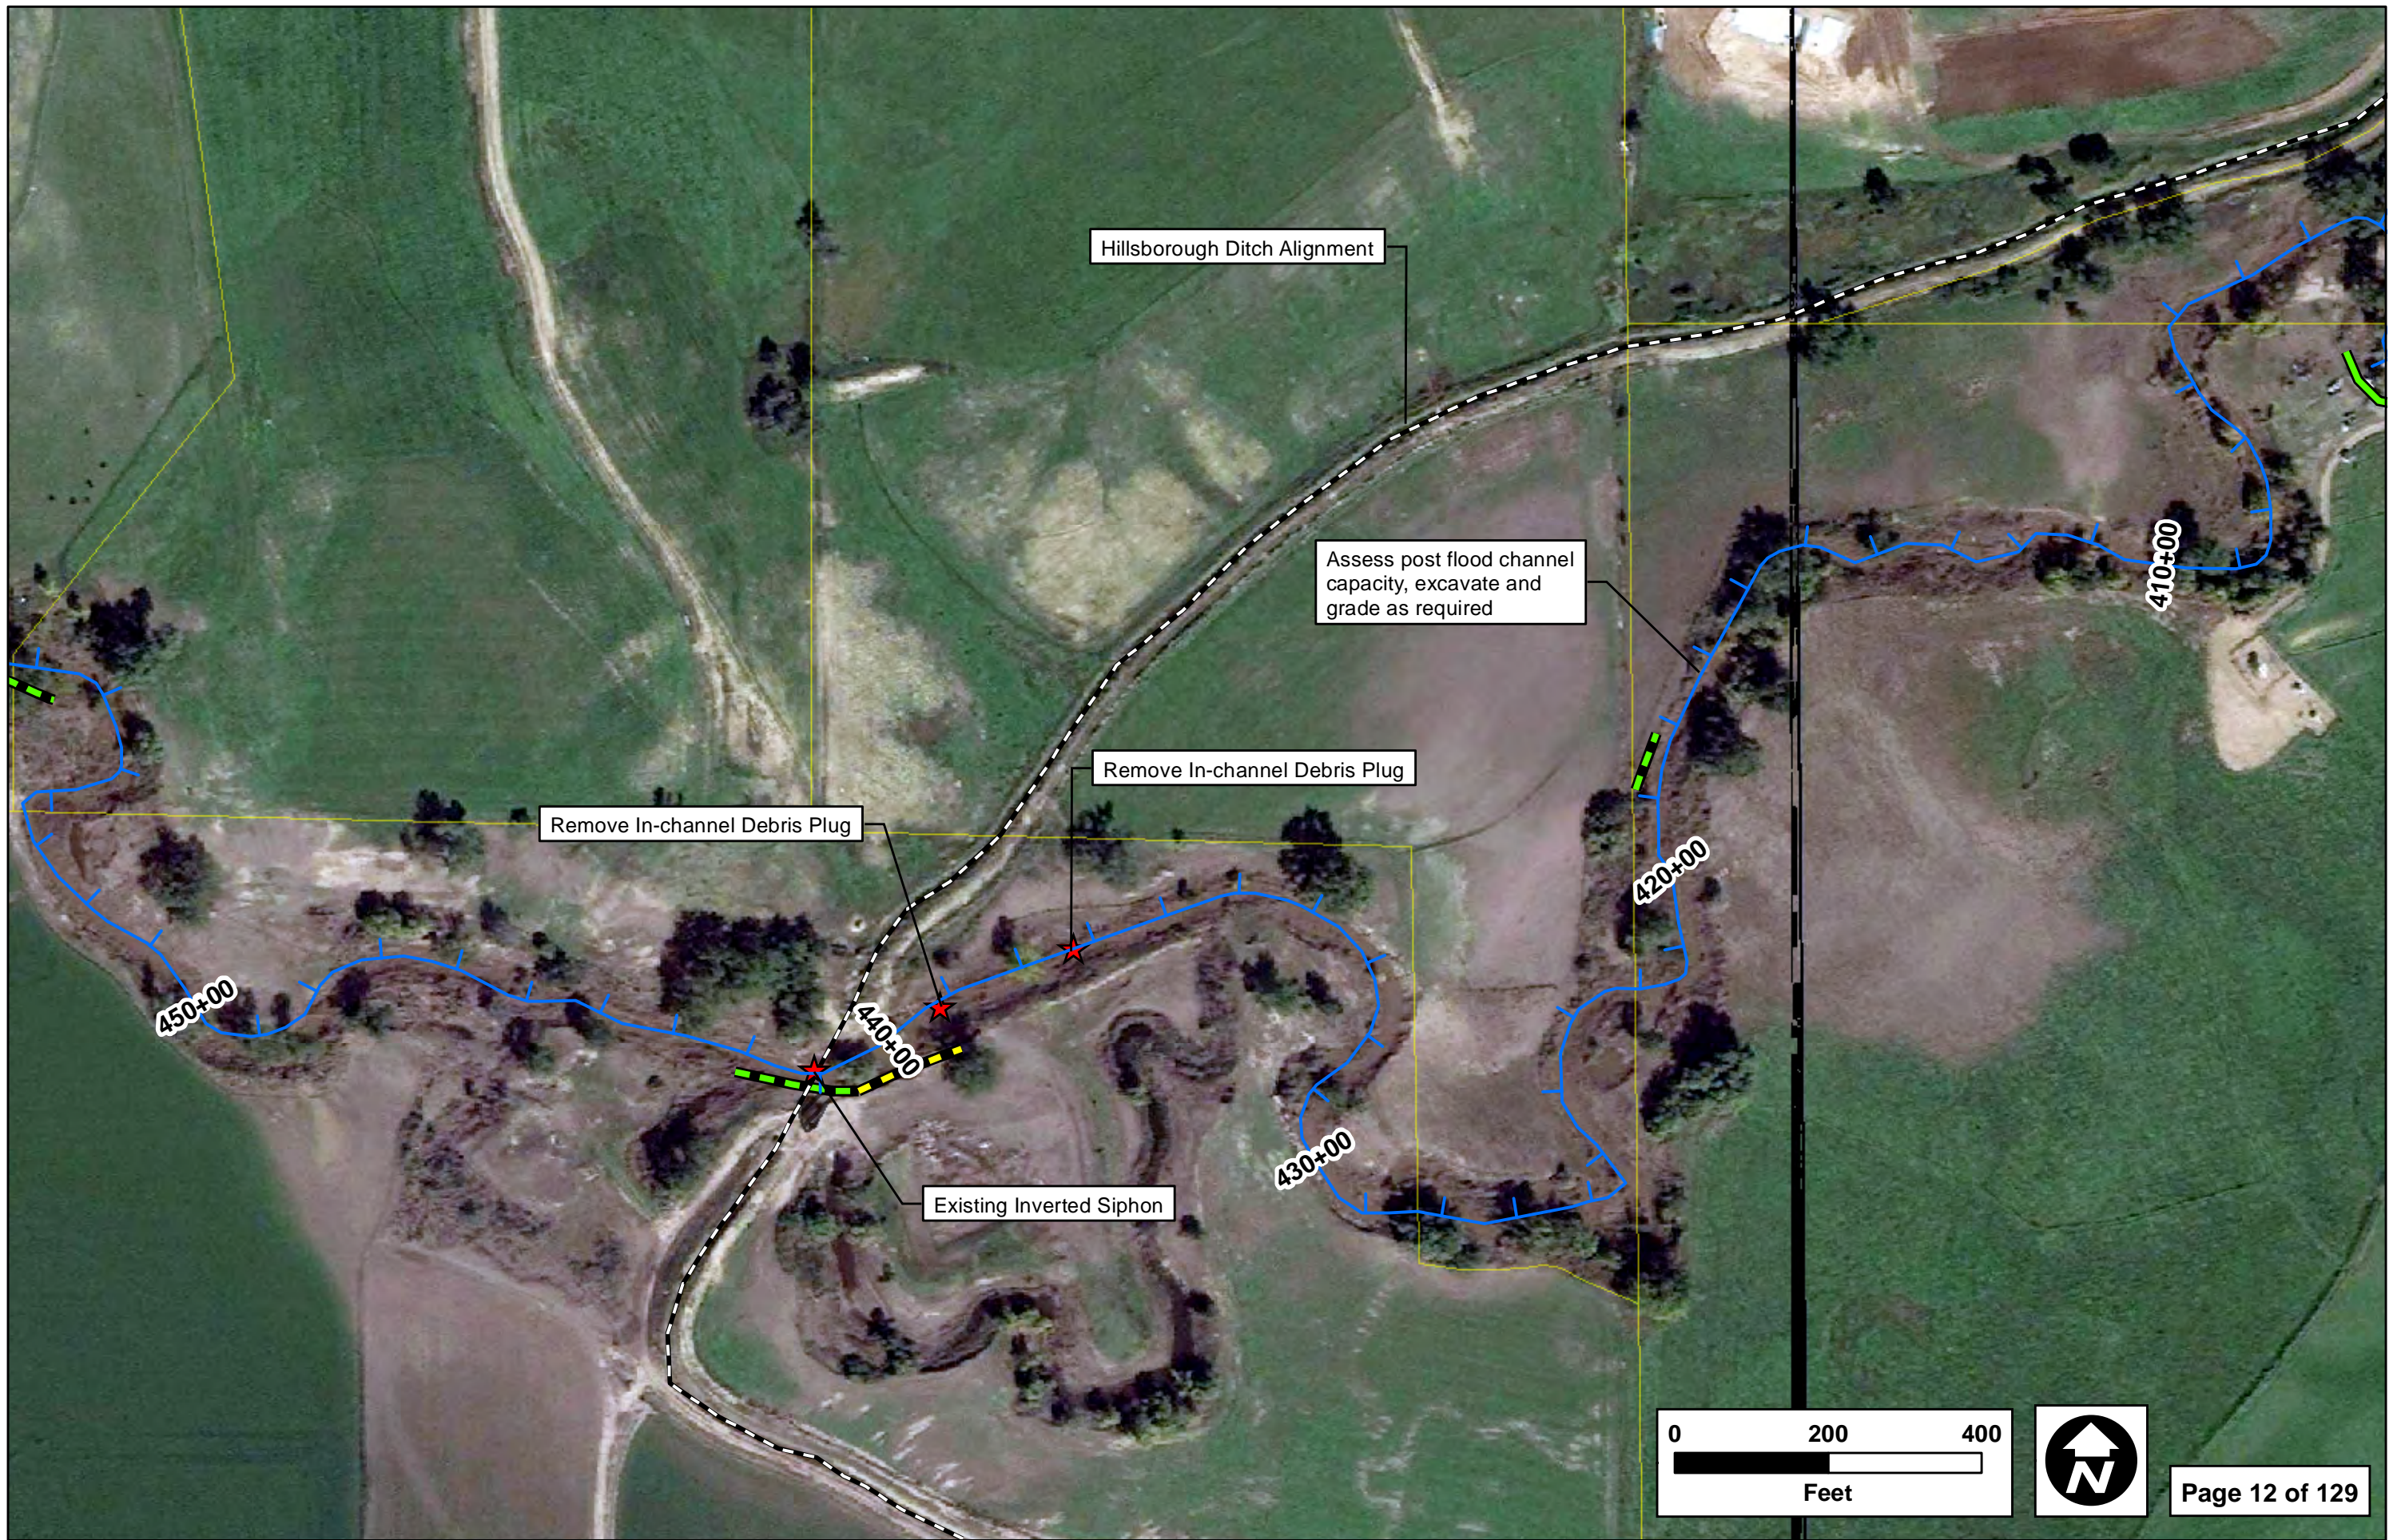
Hillsborough Ditch Alignment

Assess post flood channel capacity, excavate and grade as required

1. Removal of debris is recommended along the channel and overbanks in areas where the debris could affect flood conveyance. Assess the channel elevations and impacts of floodplain elevations and excavate and grade if required to return the channel to pre-flood elevations.
2. Geomorphic functions of this reach are likely sufficient to allow for the natural regeneration of willow, and other riparian species through seeding and cloning without active revegetation.
3. Stabilize left bank near Sta 418+50.
4. Remove substantial in-channel debris plugs near Sta 439+00 and Sta 437+00.
5. Stabilize right bank near Sta 441+00.

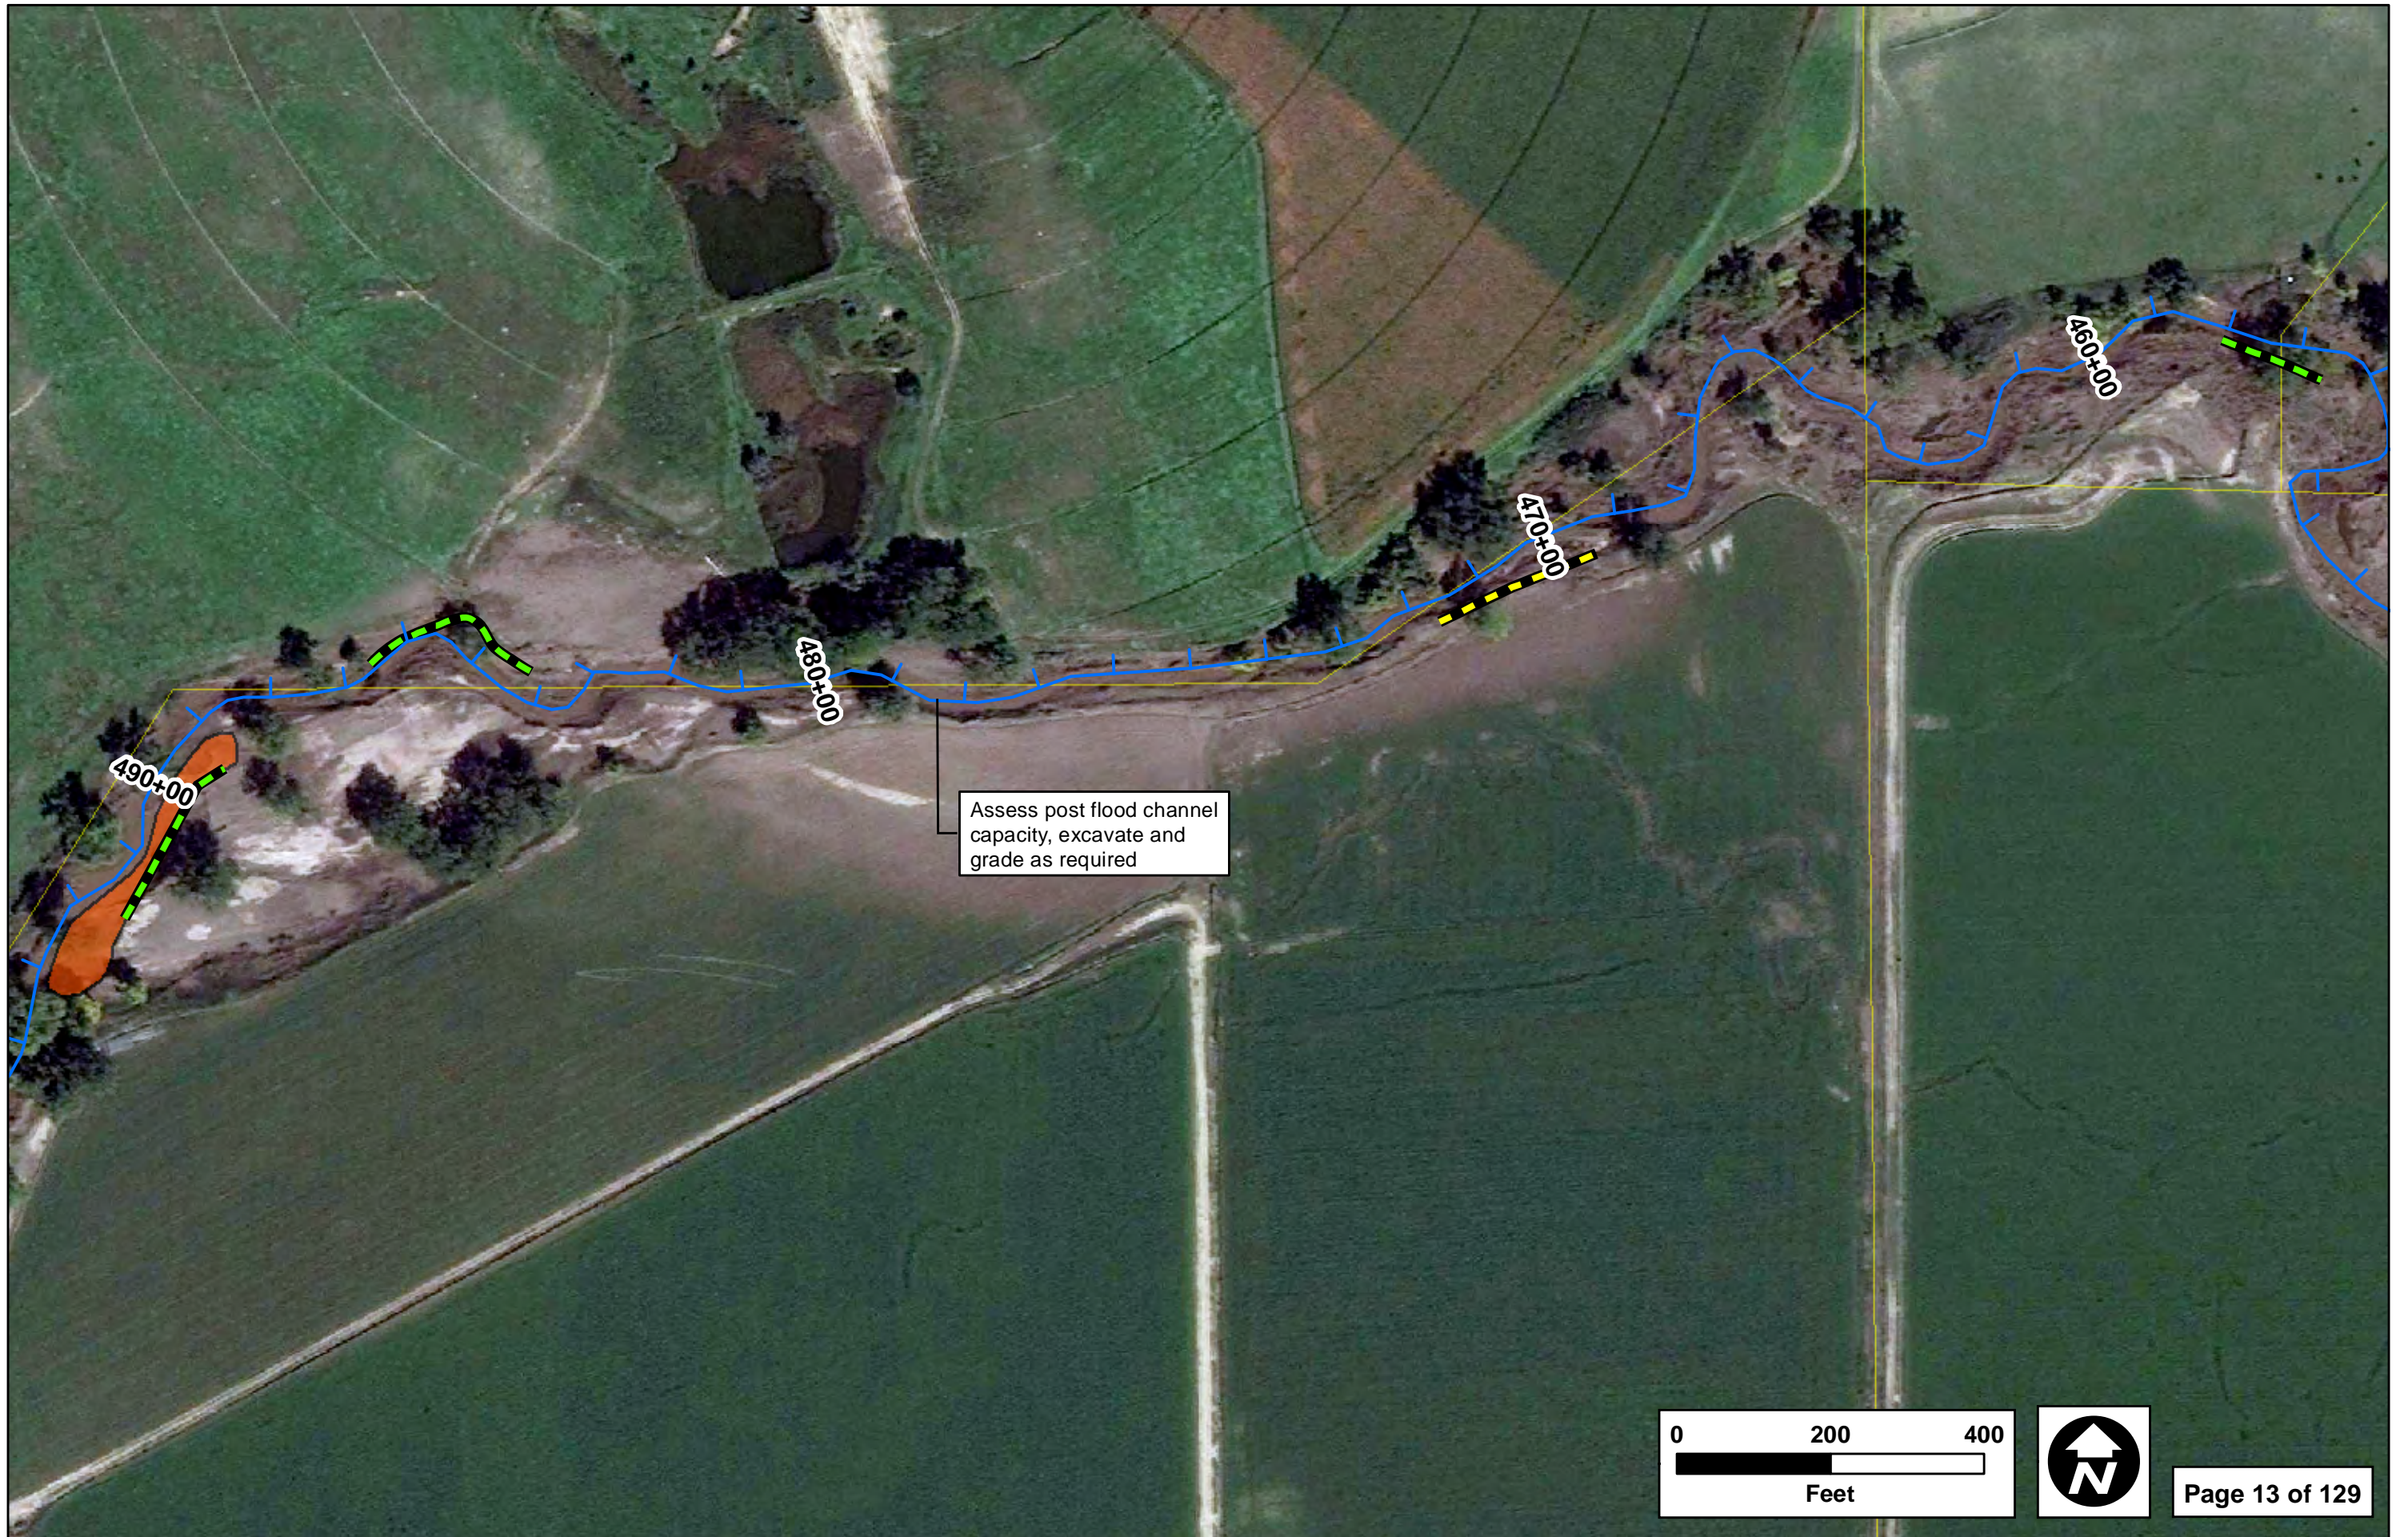
Assess post flood channel capacity, excavate and grade as required

1. Removal of debris is recommended along the channel and overbanks in areas where the debris could affect flood conveyance. Assess the channel elevations and impacts of floodplain elevations and excavate and grade if required to return the channel to pre-flood elevations.
2. Geomorphic functions of this reach are likely sufficient to allow for the natural regeneration of willow, and other riparian species through seeding and cloning without active revegetation.
3. Stabilize right bank near Sta 458+00.
4. Stabilize upper right bank near Sta 471+00.
5. Stabilize left bank near Sta 485+50.
6. Stabilize right channel bank near Sta 491+00.
7. Floodplain grading near Sta 492+00 to improve conveyance and reduce future scour potential.

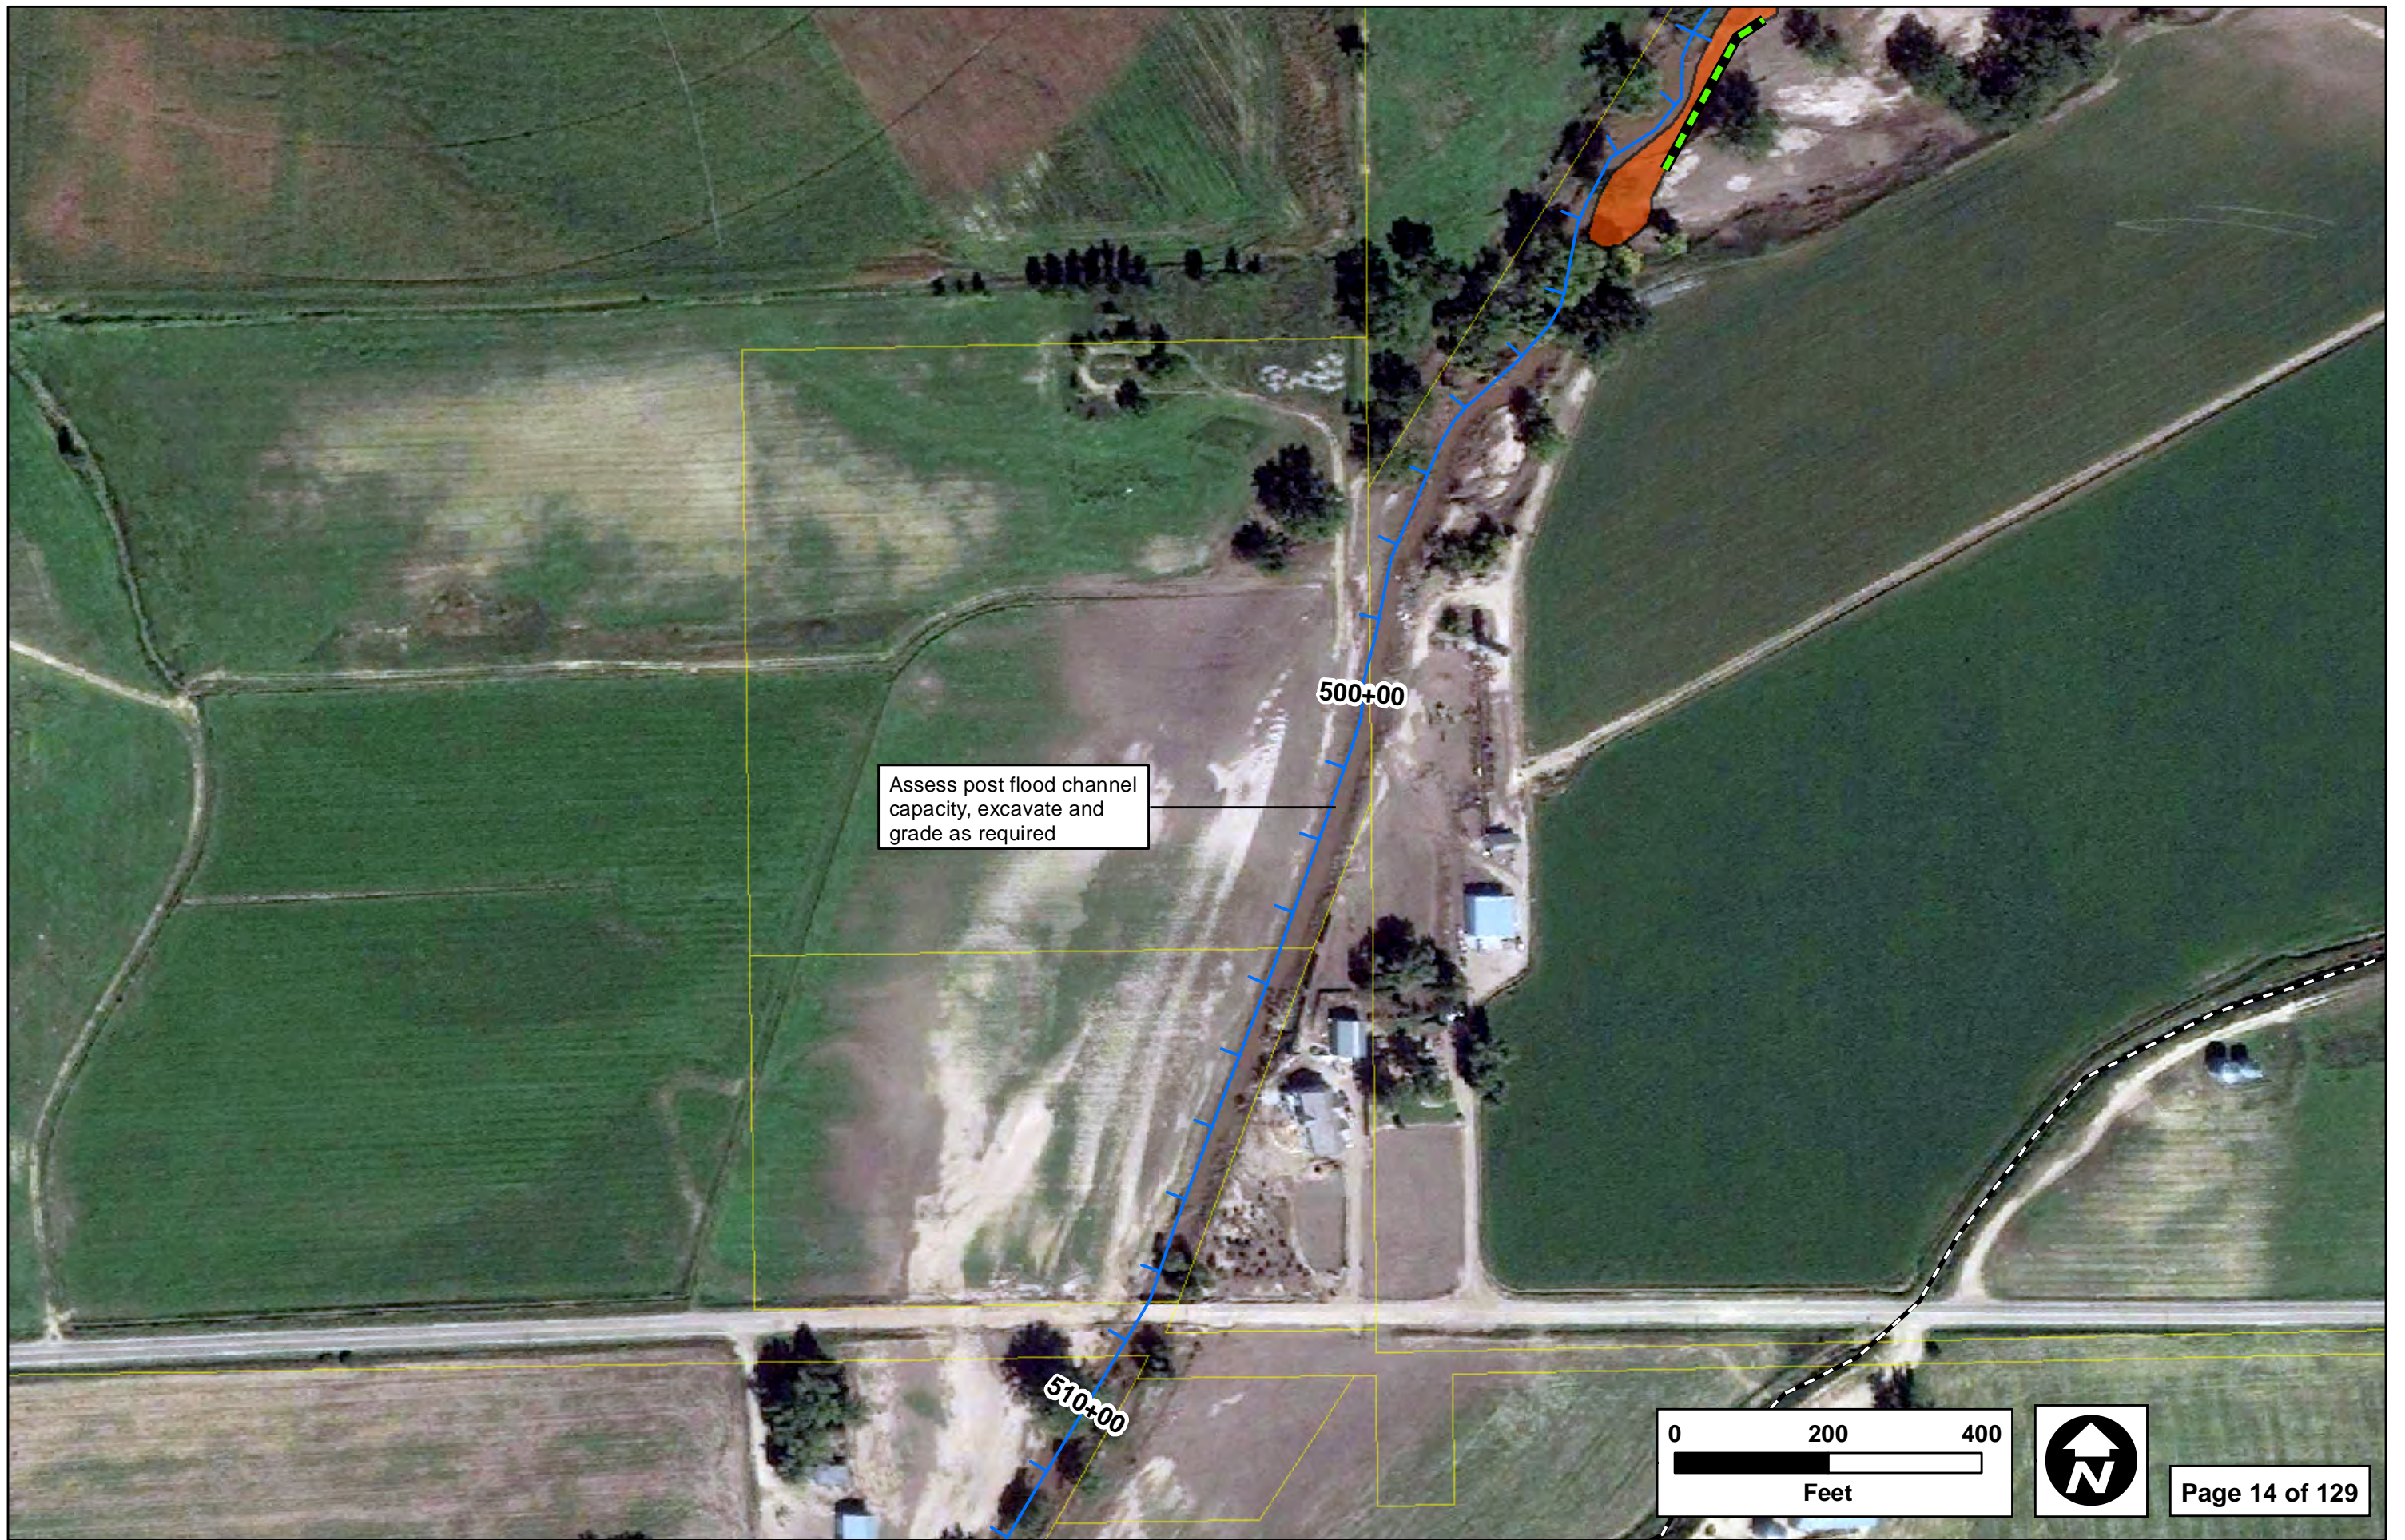
Assess post flood channel capacity, excavate and grade as required

1. Removal of debris is recommended along the channel and overbanks in areas where the debris could affect flood conveyance. Assess the channel elevations and impacts of floodplain elevations and excavate and grade if required to return the channel to pre-flood elevations.
2. Geomorphic functions of this reach are likely sufficient to allow for the natural regeneration of willow, and other riparian species through seeding and cloning without active revegetation.

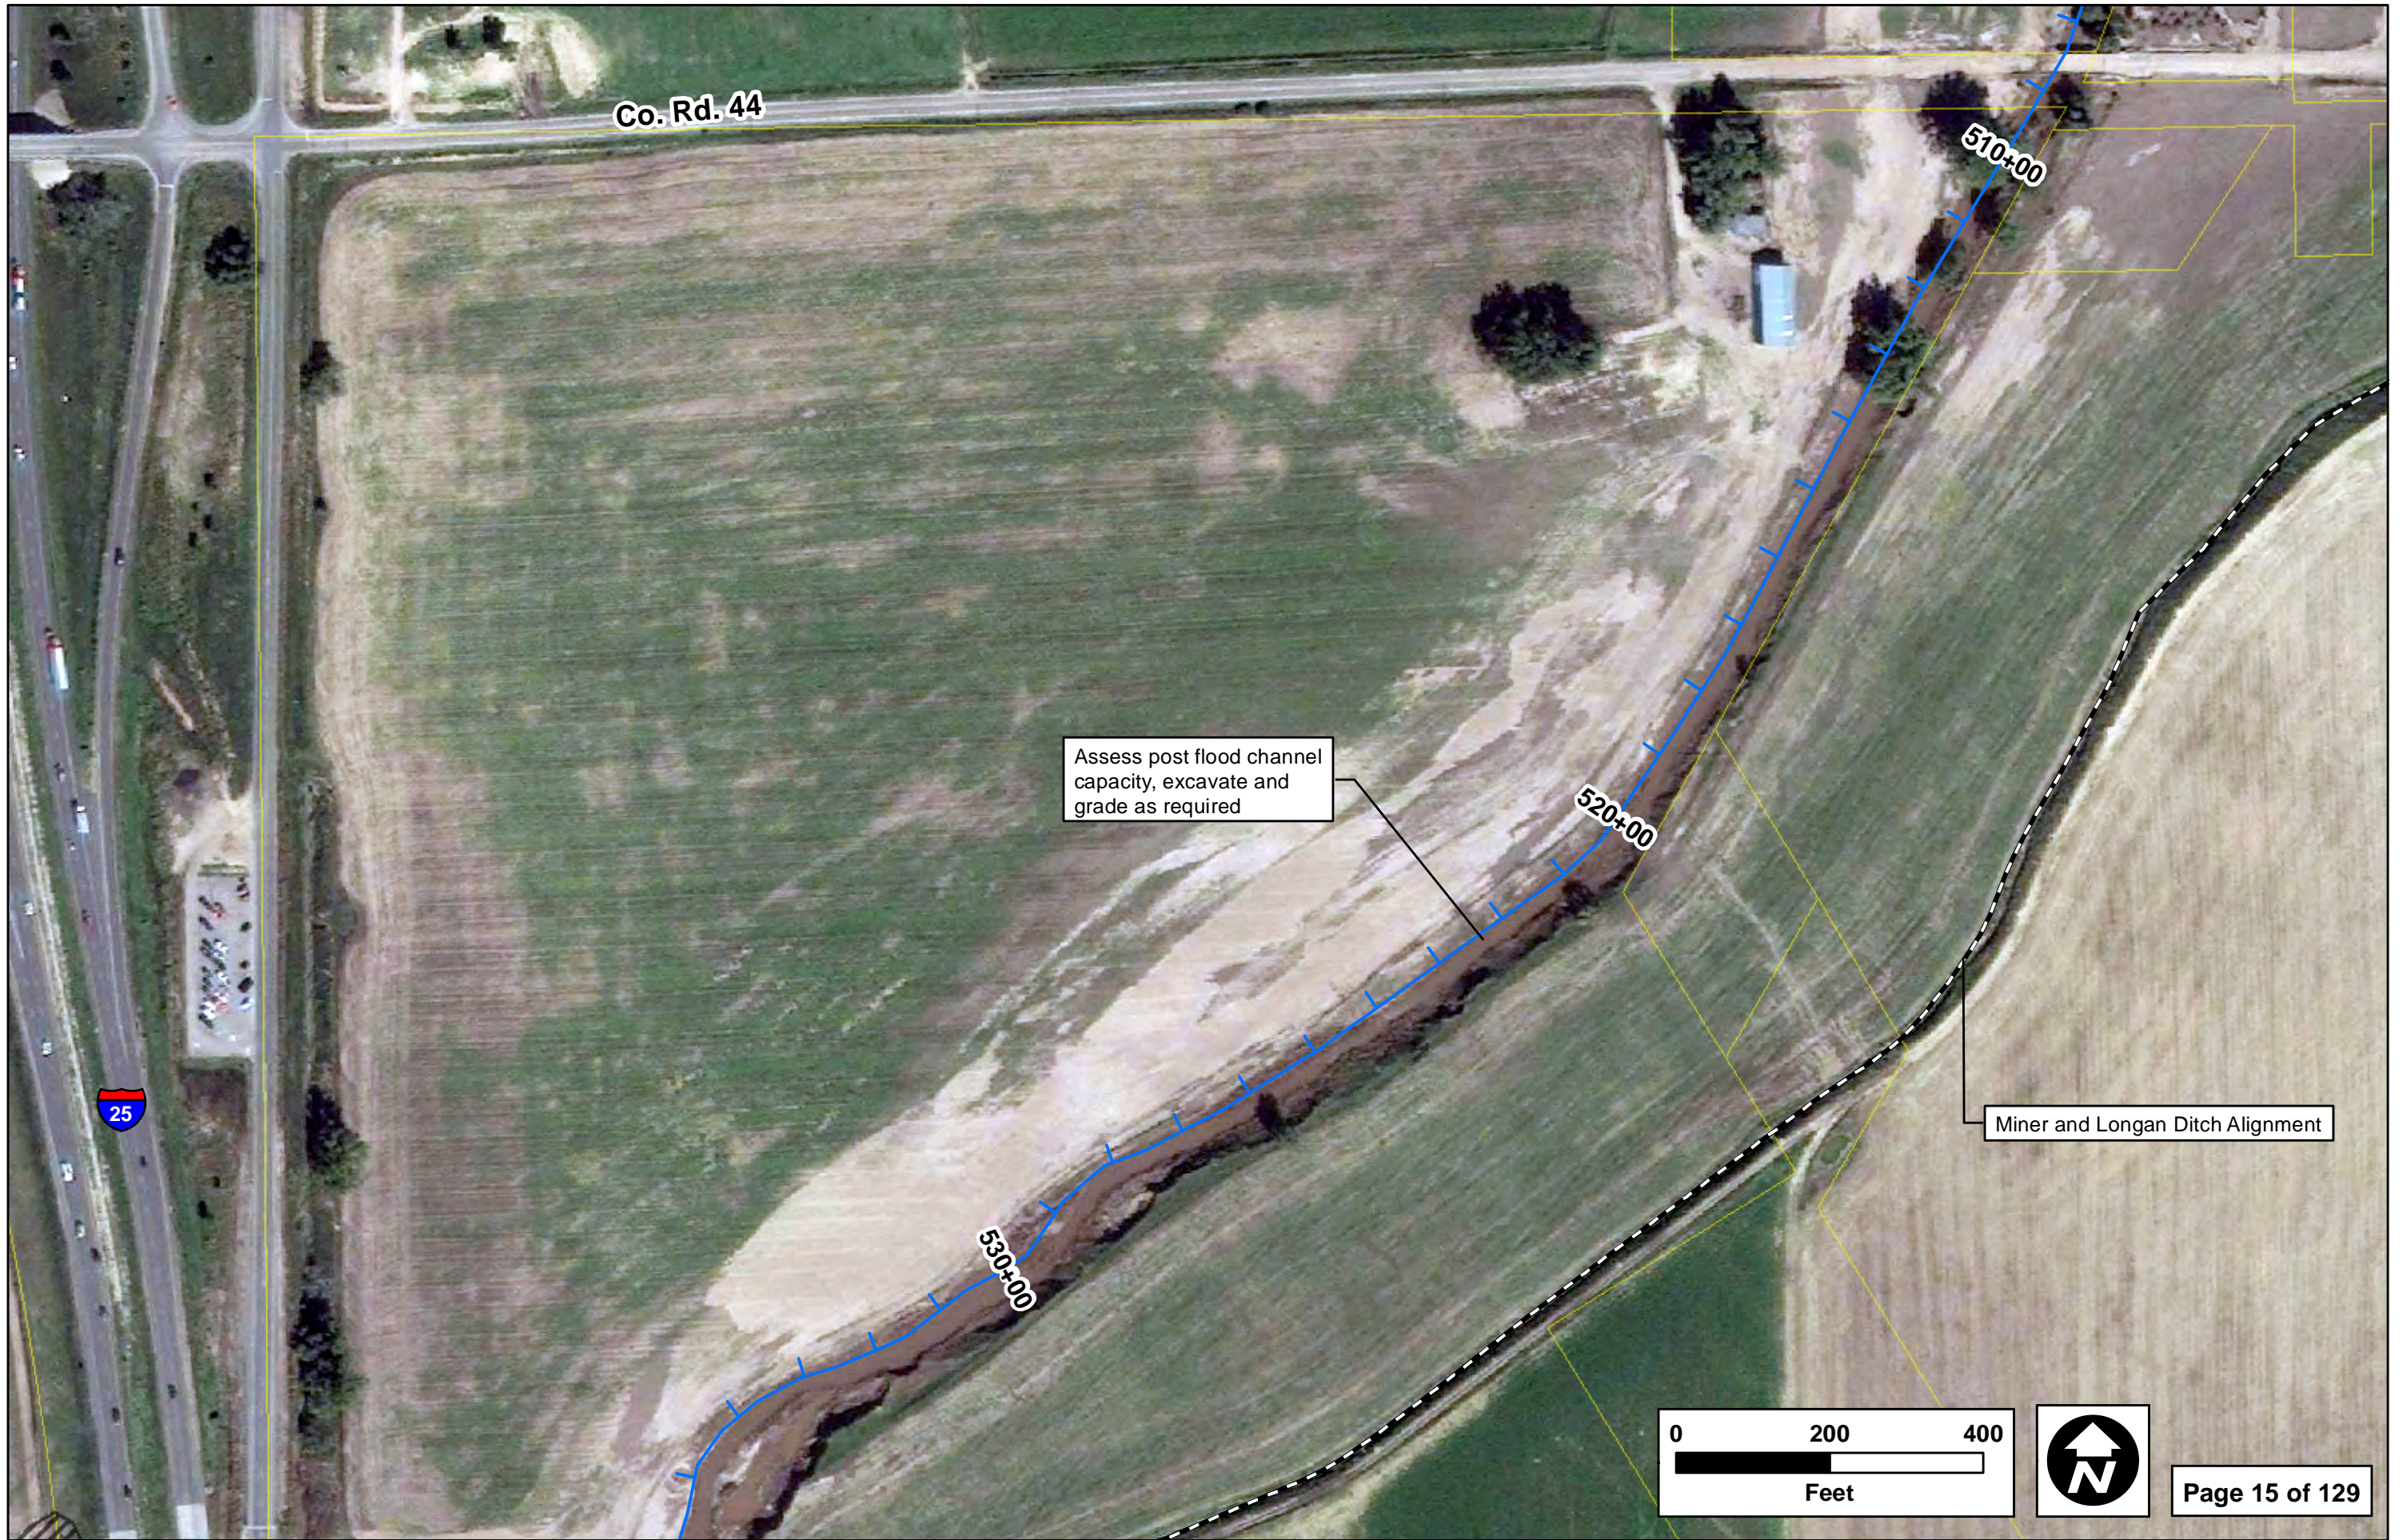
Co. Rd. 44

1. Removal of debris is recommended along the channel and overbanks in areas where the debris could affect flood conveyance. Assess the channel elevations and impacts of floodplain elevations and excavate and grade if required to return the channel to pre-flood elevations.
2. Geomorphic functions of this reach are likely sufficient to allow for the natural regeneration of willow, and other riparian species through seeding and cloning without active revegetation.

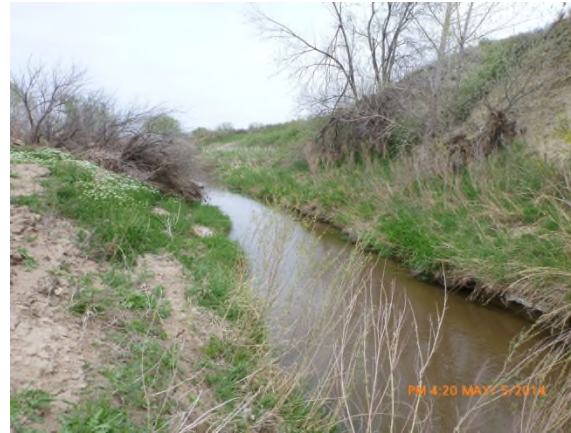
Channel erosion and downcutting did expose many of the pier footings at the I-25 Bridge. Since the time of field assessments, CDOT has reportedly returned to repair and protect footings.

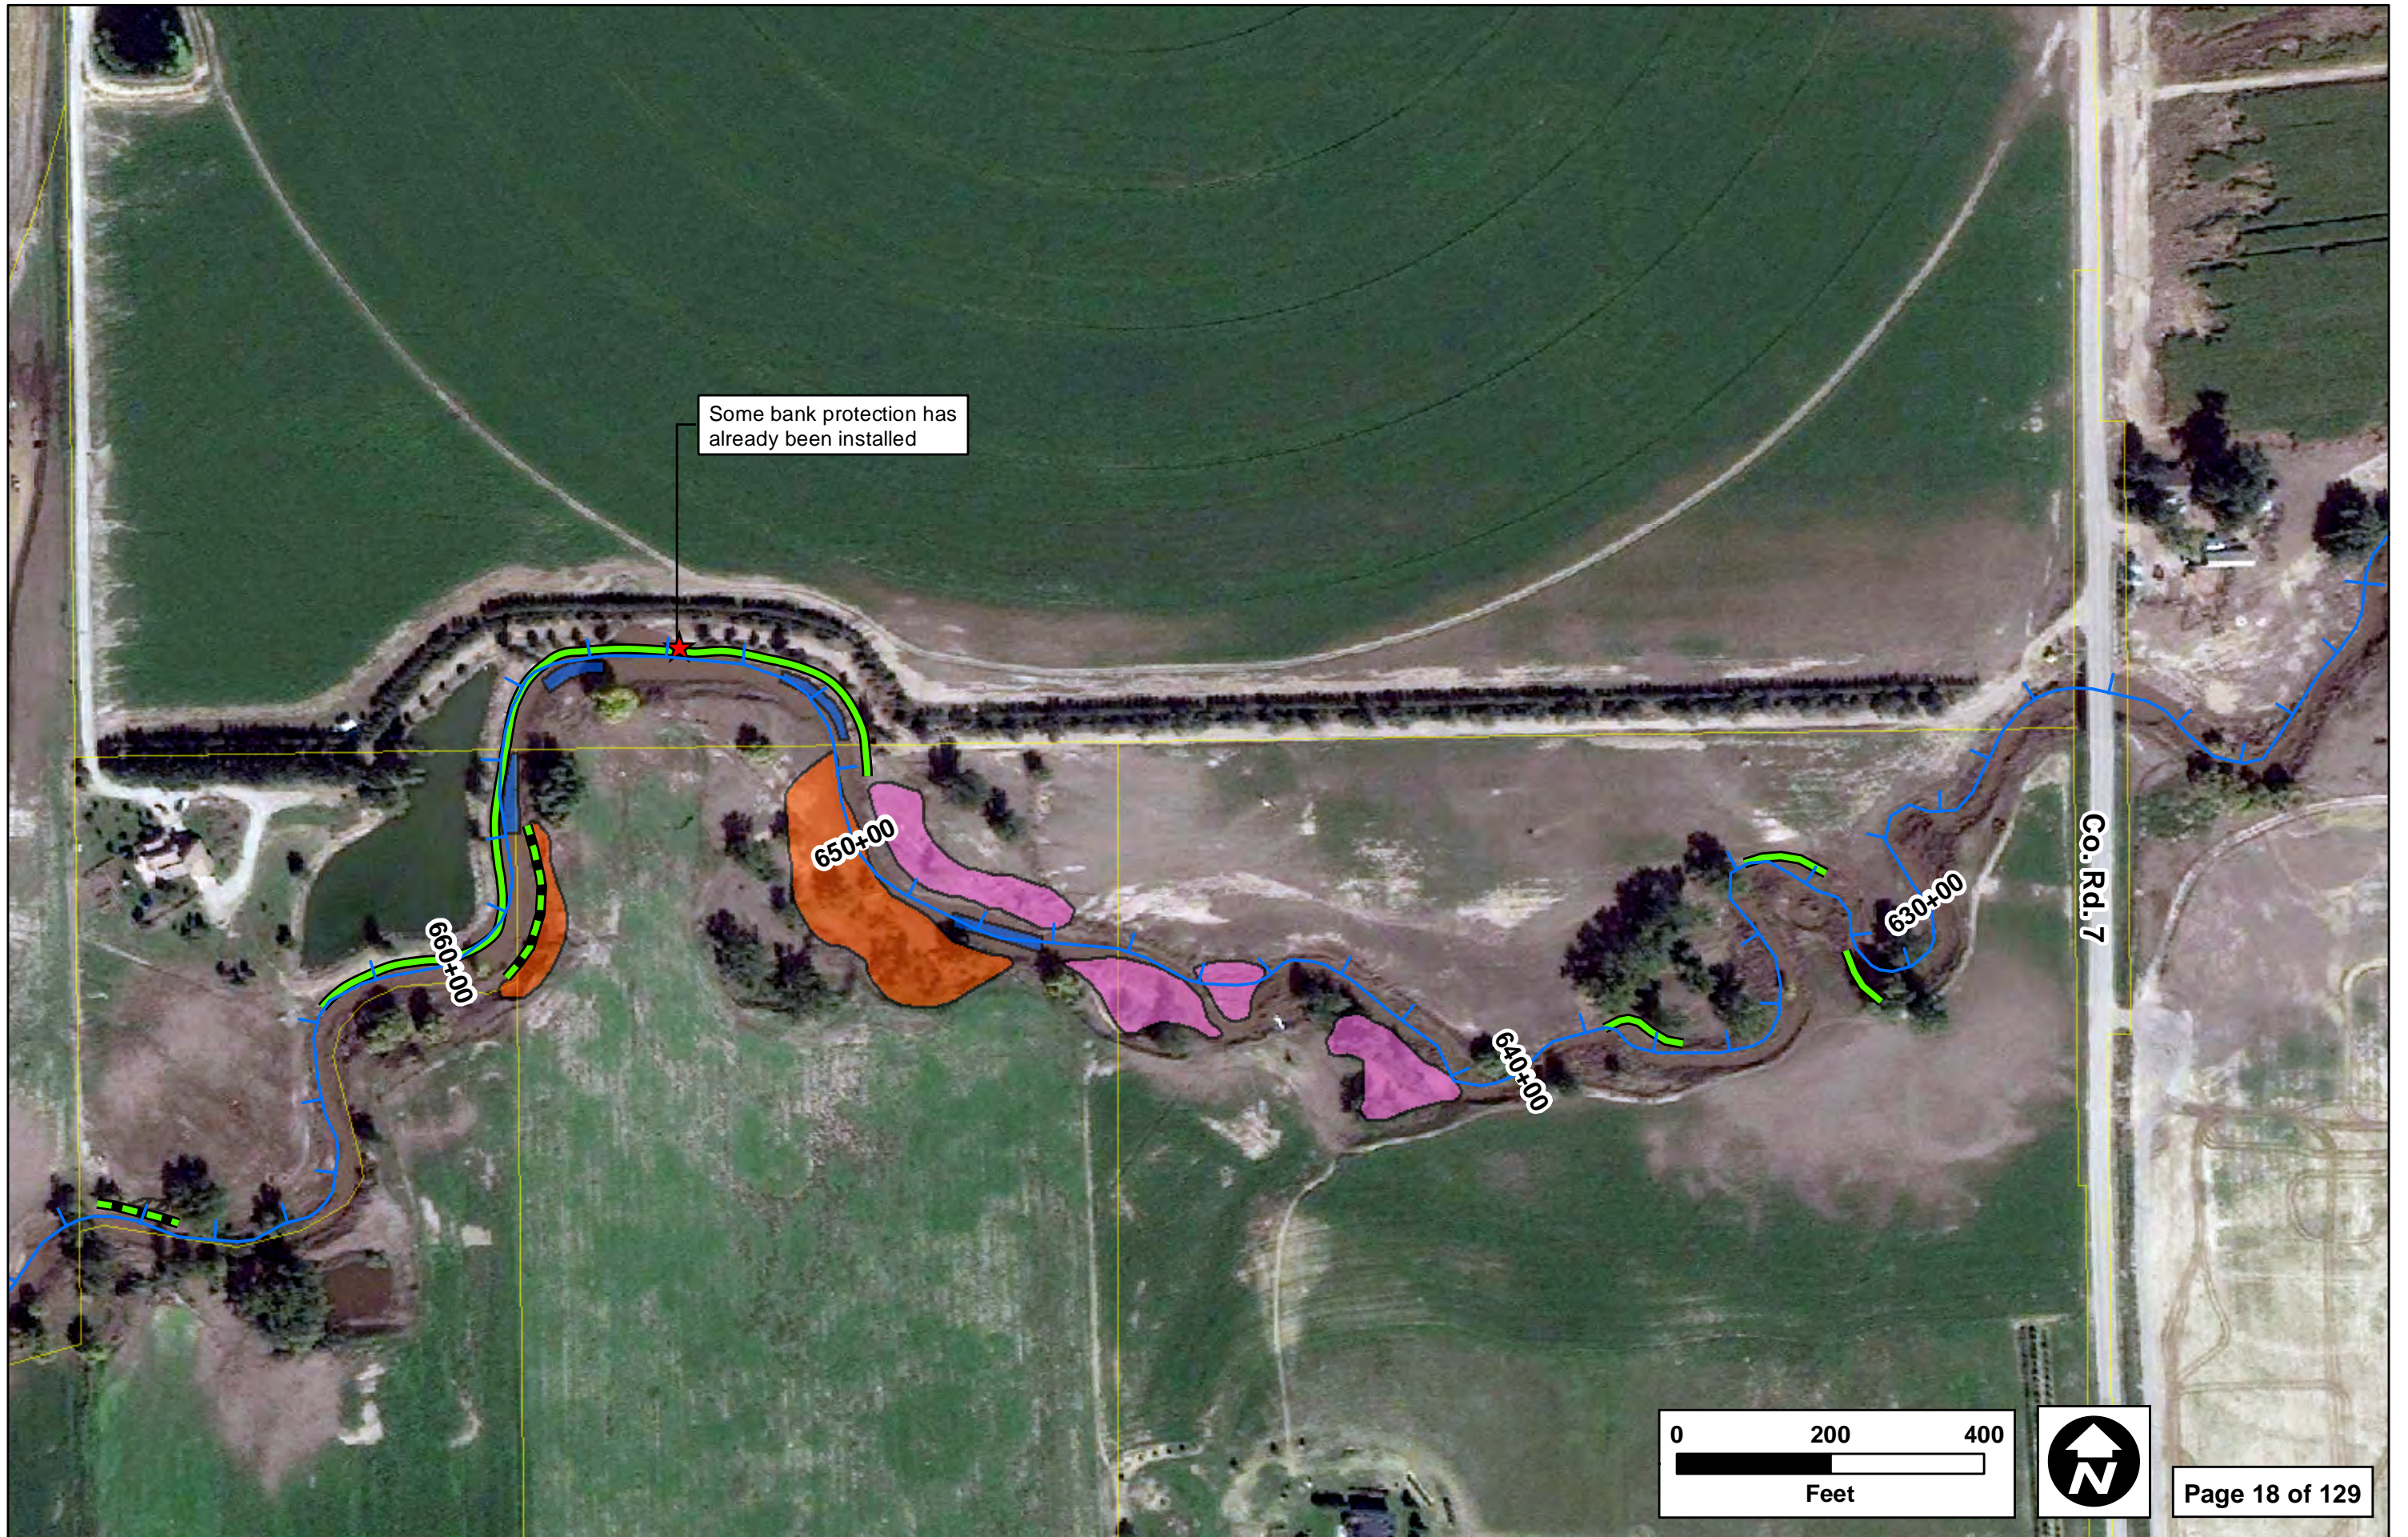
Some bank protection has already been installed

7. Stabilize left bank near Sta 660+00 to protect bank/berm shared by irrigation pond.
8. Stabilize left bank near Sta 668+00.
9. Removal of debris is recommended along the channel and overbanks in areas where the debris could affect flood conveyance. Some of the woody debris could be used as bank and slope stabilization measures where recommended. Removal of the sandy material deposited in the overbanks may also be necessary at a number of locations to reclaim farmland.
