# **APPENDIX A**

# **ASSESSMENT PROTOCOL**

# **APPENDIX C**

# **SITE DESCRIPTIONS**

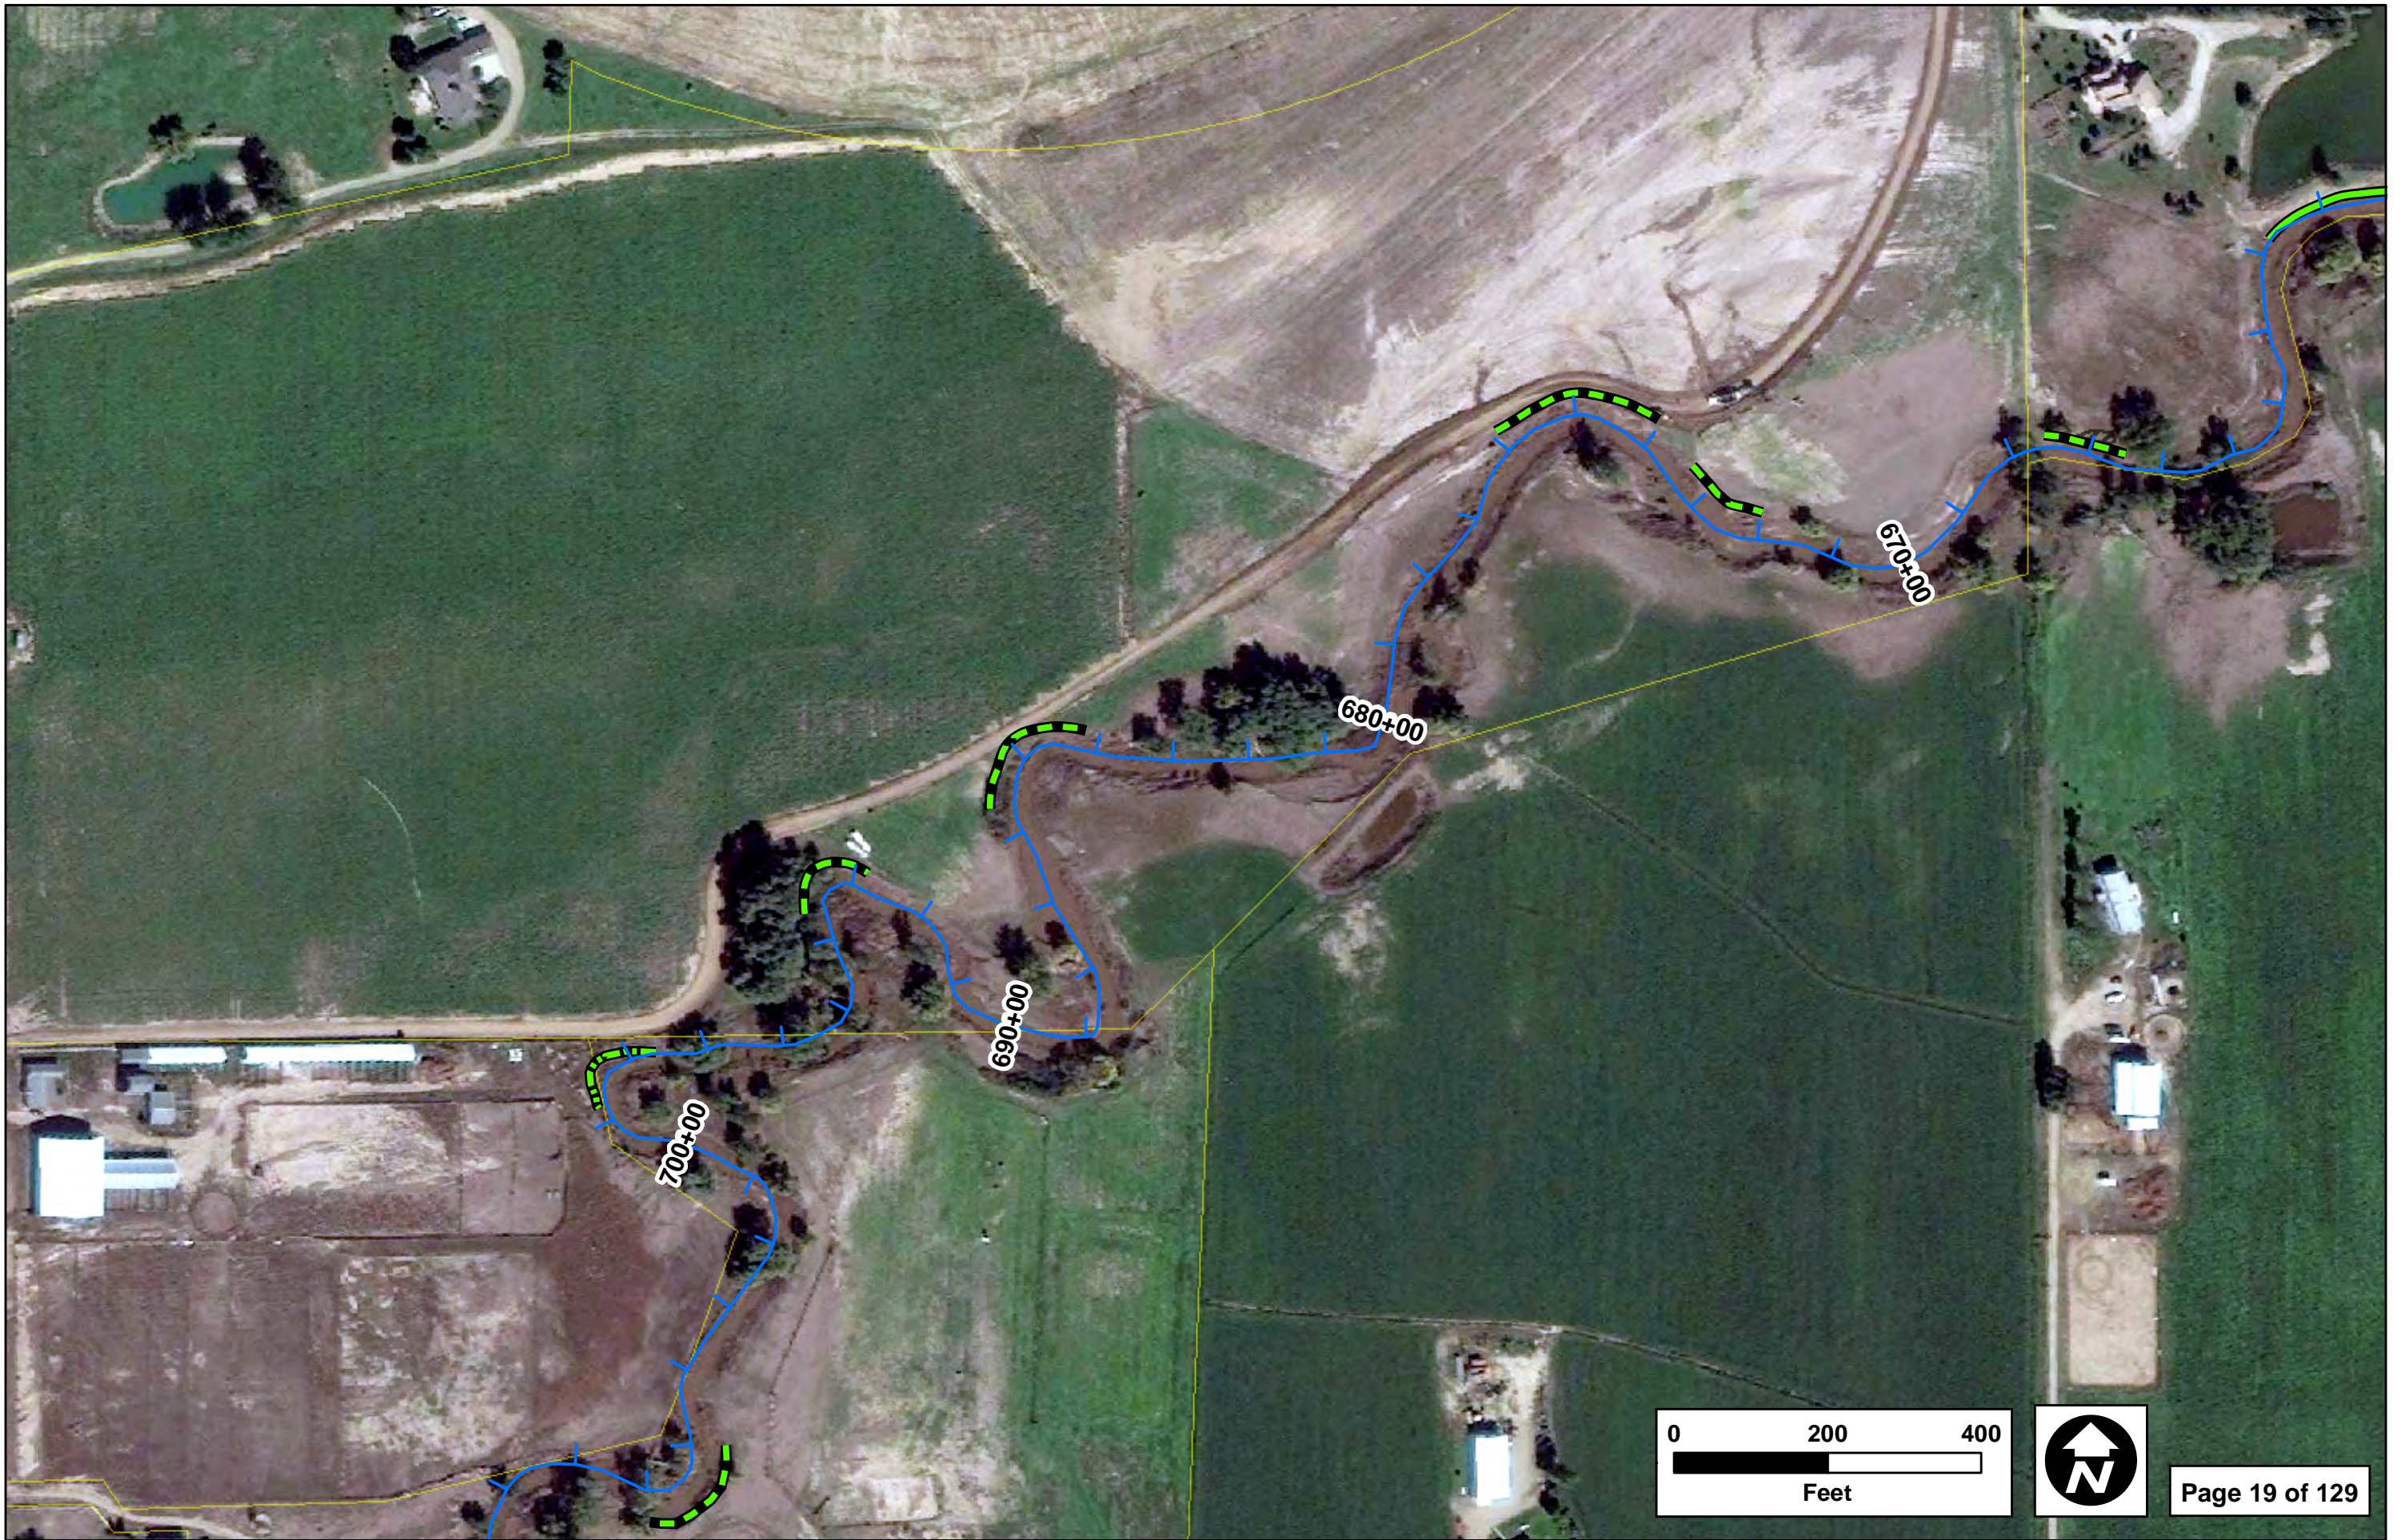
**NEIGHBORHOOD:** Berthoud  
**SHEET:** 19  
**STATION:** 661+00 to 708+00  
**RESTORATION RECOMMENDATIONS:** 671+00 to 700+00

For the most part, the general channel planform was maintained during the 2013 flood event. Lateral migration, significant bank erosion, and channel downcutting are limited, although localized areas showing evidence of each of these items were observed. The most significant and consistent problem through this reach appears to have been aggradation in the main channel, along the channel margins, and in the overbanks, as well as accumulation of debris.

Bank erosion and lateral migration were limited due to the presence of historical bank protection (concrete rubble, automobiles, etc.). Some localized bank erosion that extended from toe to top of bank was observed locally. Upper bank erosion was observed in areas where overbank flows returned to the channel, but the bank toes in these areas appear stable. Downstream from County Road 5, the sharp bends did not erode significantly due to relief provided by flood conveyance over the inside bend, although the more moderate bends experienced some bank erosion that could threaten private drives and access roads.

1. Stabilize left bank near Sta 698+00, Sta 693+00, Sta 685+00, Sta 675+00, Sta 673+00, and Sta 667+00.
2. Stabilize right bank near Sta 705+00.
3. Removal of debris is recommended along the channel and overbanks in areas where the debris could affect flood conveyance. Some of the woody debris could be used as bank and slope stabilization measures where recommended. Removal of the sandy material deposited in the overbanks may also be necessary at a number of locations to reclaim farmland.

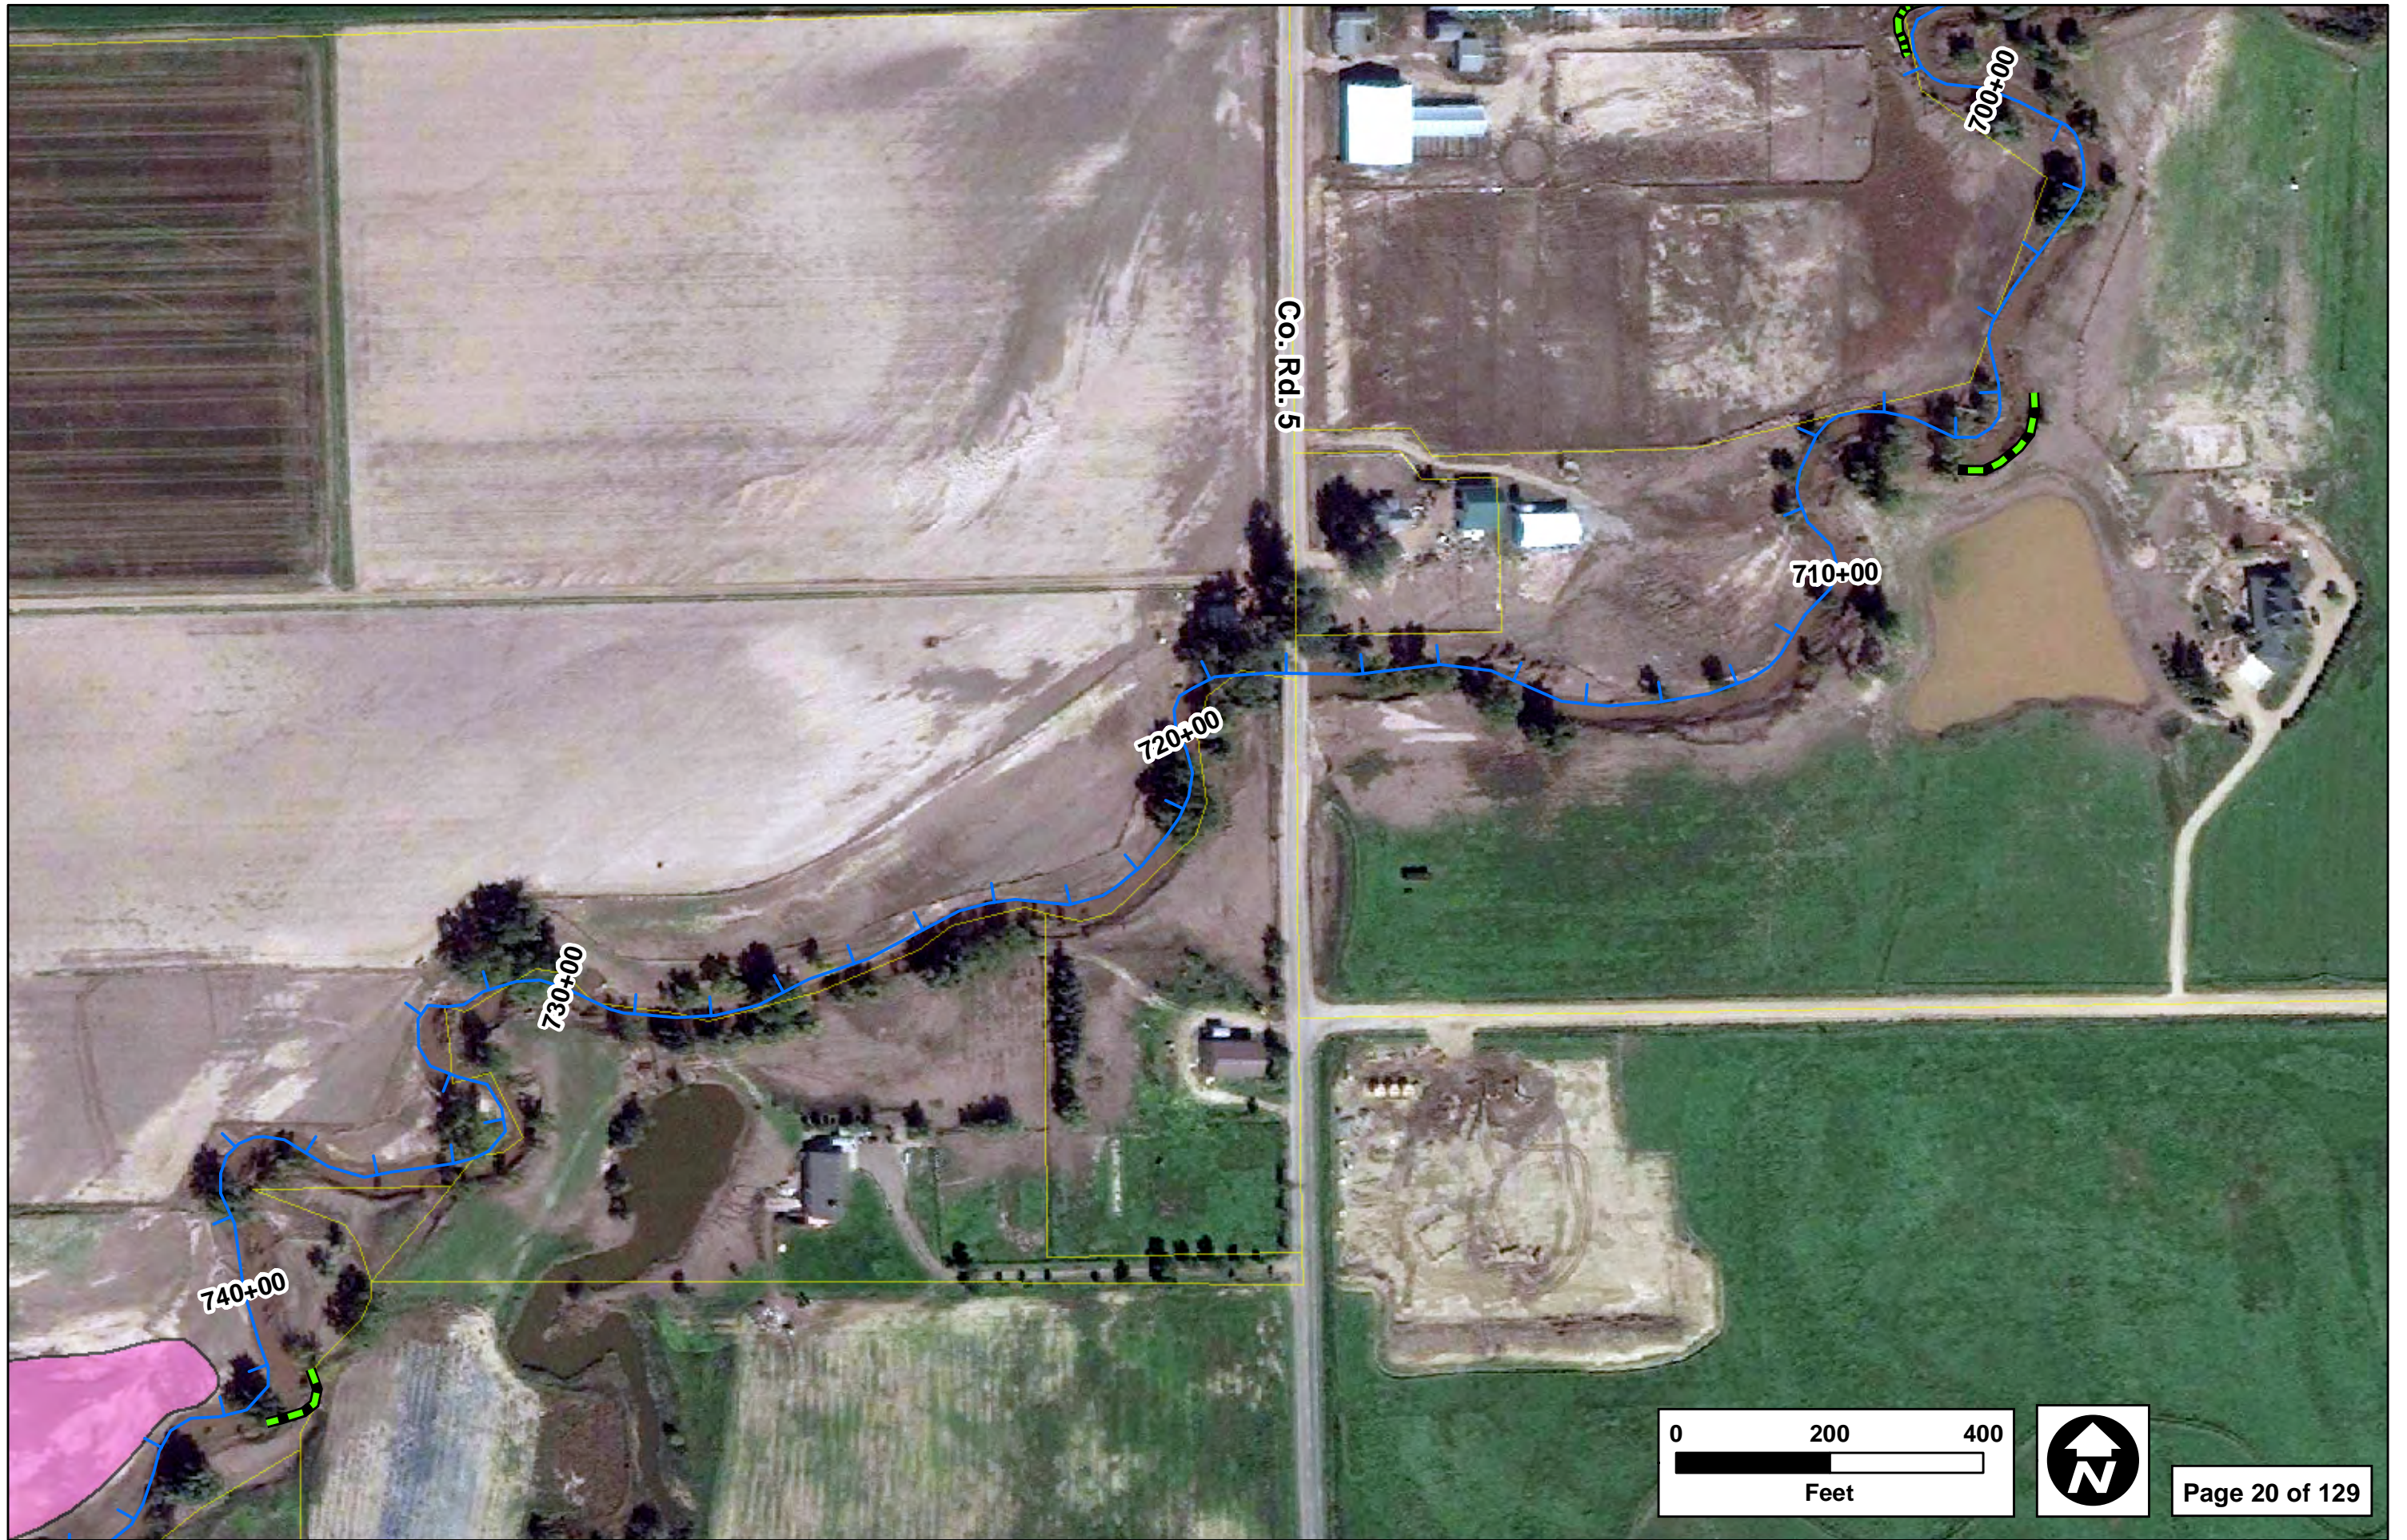
**NEIGHBORHOOD:** Berthoud  
**SHEET:** 20  
**STATION:** 699+00 to 744+00  
**RESTORATION RECOMMENDATIONS:** 704+00 to 742+00

For the most part, the general channel planform was maintained during the 2013 flood event. Lateral migration, significant bank erosion, and channel downcutting are limited, although localized areas showing evidence of each of these items were observed. The most significant and consistent problem through this reach appears to have been aggradation in the main channel, along the channel margins, and in the overbanks, as well as accumulation of debris.

Bank erosion and lateral migration were limited due to the presence of historical bank protection (concrete rubble, automobiles, etc.). Some localized bank erosion that extended from toe to top of bank was observed. Upper bank erosion was observed in areas where overbank flows returned to the channel, but the bank toes in these areas appear stable. Some remedial action has occurred at County Road 5 with the placement of riprap on the upper bank of the left abutment. Downstream from County Road 5, the sharp bends did not erode significantly due to relief provided by flood conveyance over the inside bend, although the more moderate bends experienced some bank erosion that could threaten private drives and access roads.

1. Stabilize right bank near Sta 705+00.
2. Bank stabilization near Sta 741+00.
3. Removal of debris is recommended along the channel and overbanks in areas where the debris could affect flood conveyance. Some of the woody debris could be used as bank and slope stabilization measures where recommended. Removal of the sandy material deposited in the overbanks may also be necessary at a number of locations to reclaim farmland.

Co. Rd. 5

700+00

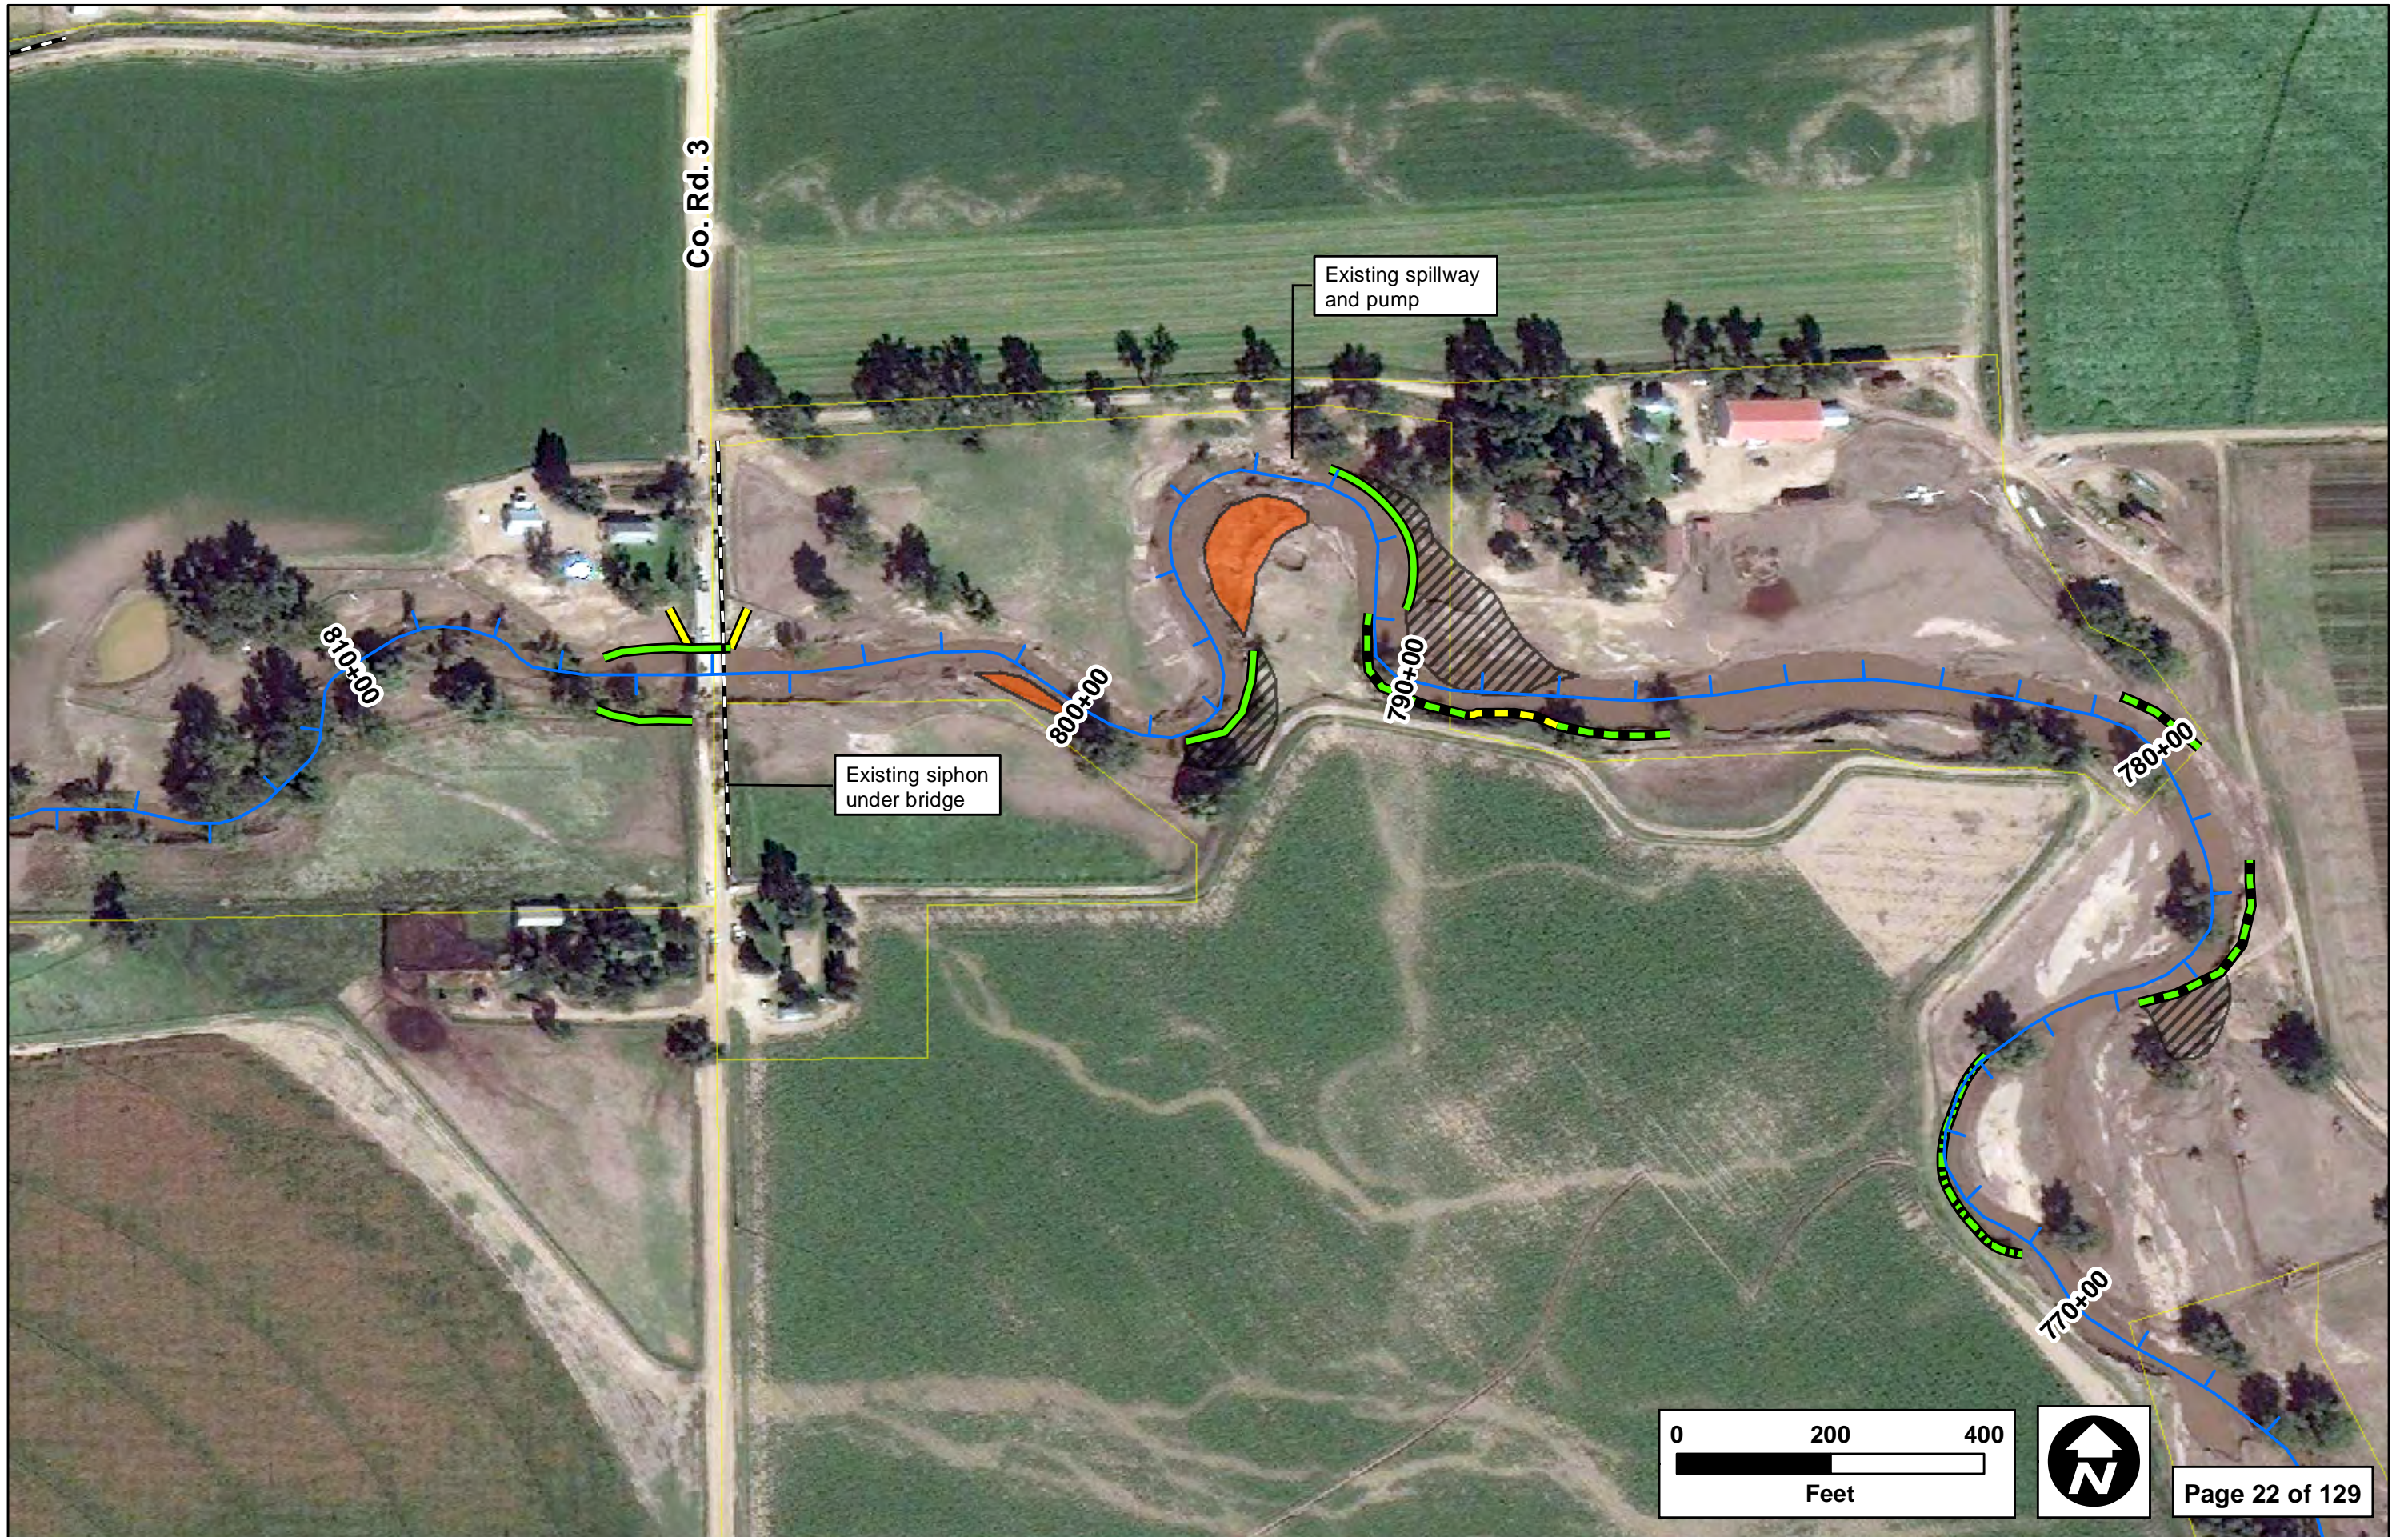
**NEIGHBORHOOD:** Berthoud  
**SHEET:** 22  
**STATION:** 766+00 to 815+00  
**RESTORATION RECOMMENDATIONS:** 781+00 to 815+00

Bank erosion and lateral migration were limited due to the presence of historical bank protection (concrete rubble, automobiles, etc.). Some localized bank erosion that extended from toe to top of bank was observed locally, including in the vicinity of County Road 3. Upper bank erosion was observed in areas where overbank flows returned to the channel, but the bank toes in these areas appear stable. The most significant bank erosion was observed in the vicinity of County Road 3, especially in the reach between Sta 787+00 and Sta 796+00 and just upstream from County Road 3. Some repair work has occurred at the County Road 3 Bridge, including the placement of riprap on the upper banks of the right abutment and placement of riprap in a scour hole.

1. Stabilize banks in vicinity of County Road 3 Bridge to protect against flanking of the structure.
2. Siphon crossing below County Road 3 currently protected only by concrete rubble and may require additional stabilization.
3. Removal of debris is recommended along the channel and overbanks in areas where the debris could affect flood conveyance. Some of the woody debris could be used as bank and slope stabilization measures where recommended. Removal of the sandy material deposited in the overbanks and grading may also be necessary at a number of locations to reclaim farmland.
4. Stabilize right bank near Sta 773+00.
5. Fill and stabilize upper banks near Sta 779+00.
6. Fill and stabilize upper banks between Sta 788+00 and Sta 801+00 and at Sta 798+00.

Co. Rd. 3

Existing spillway and pump

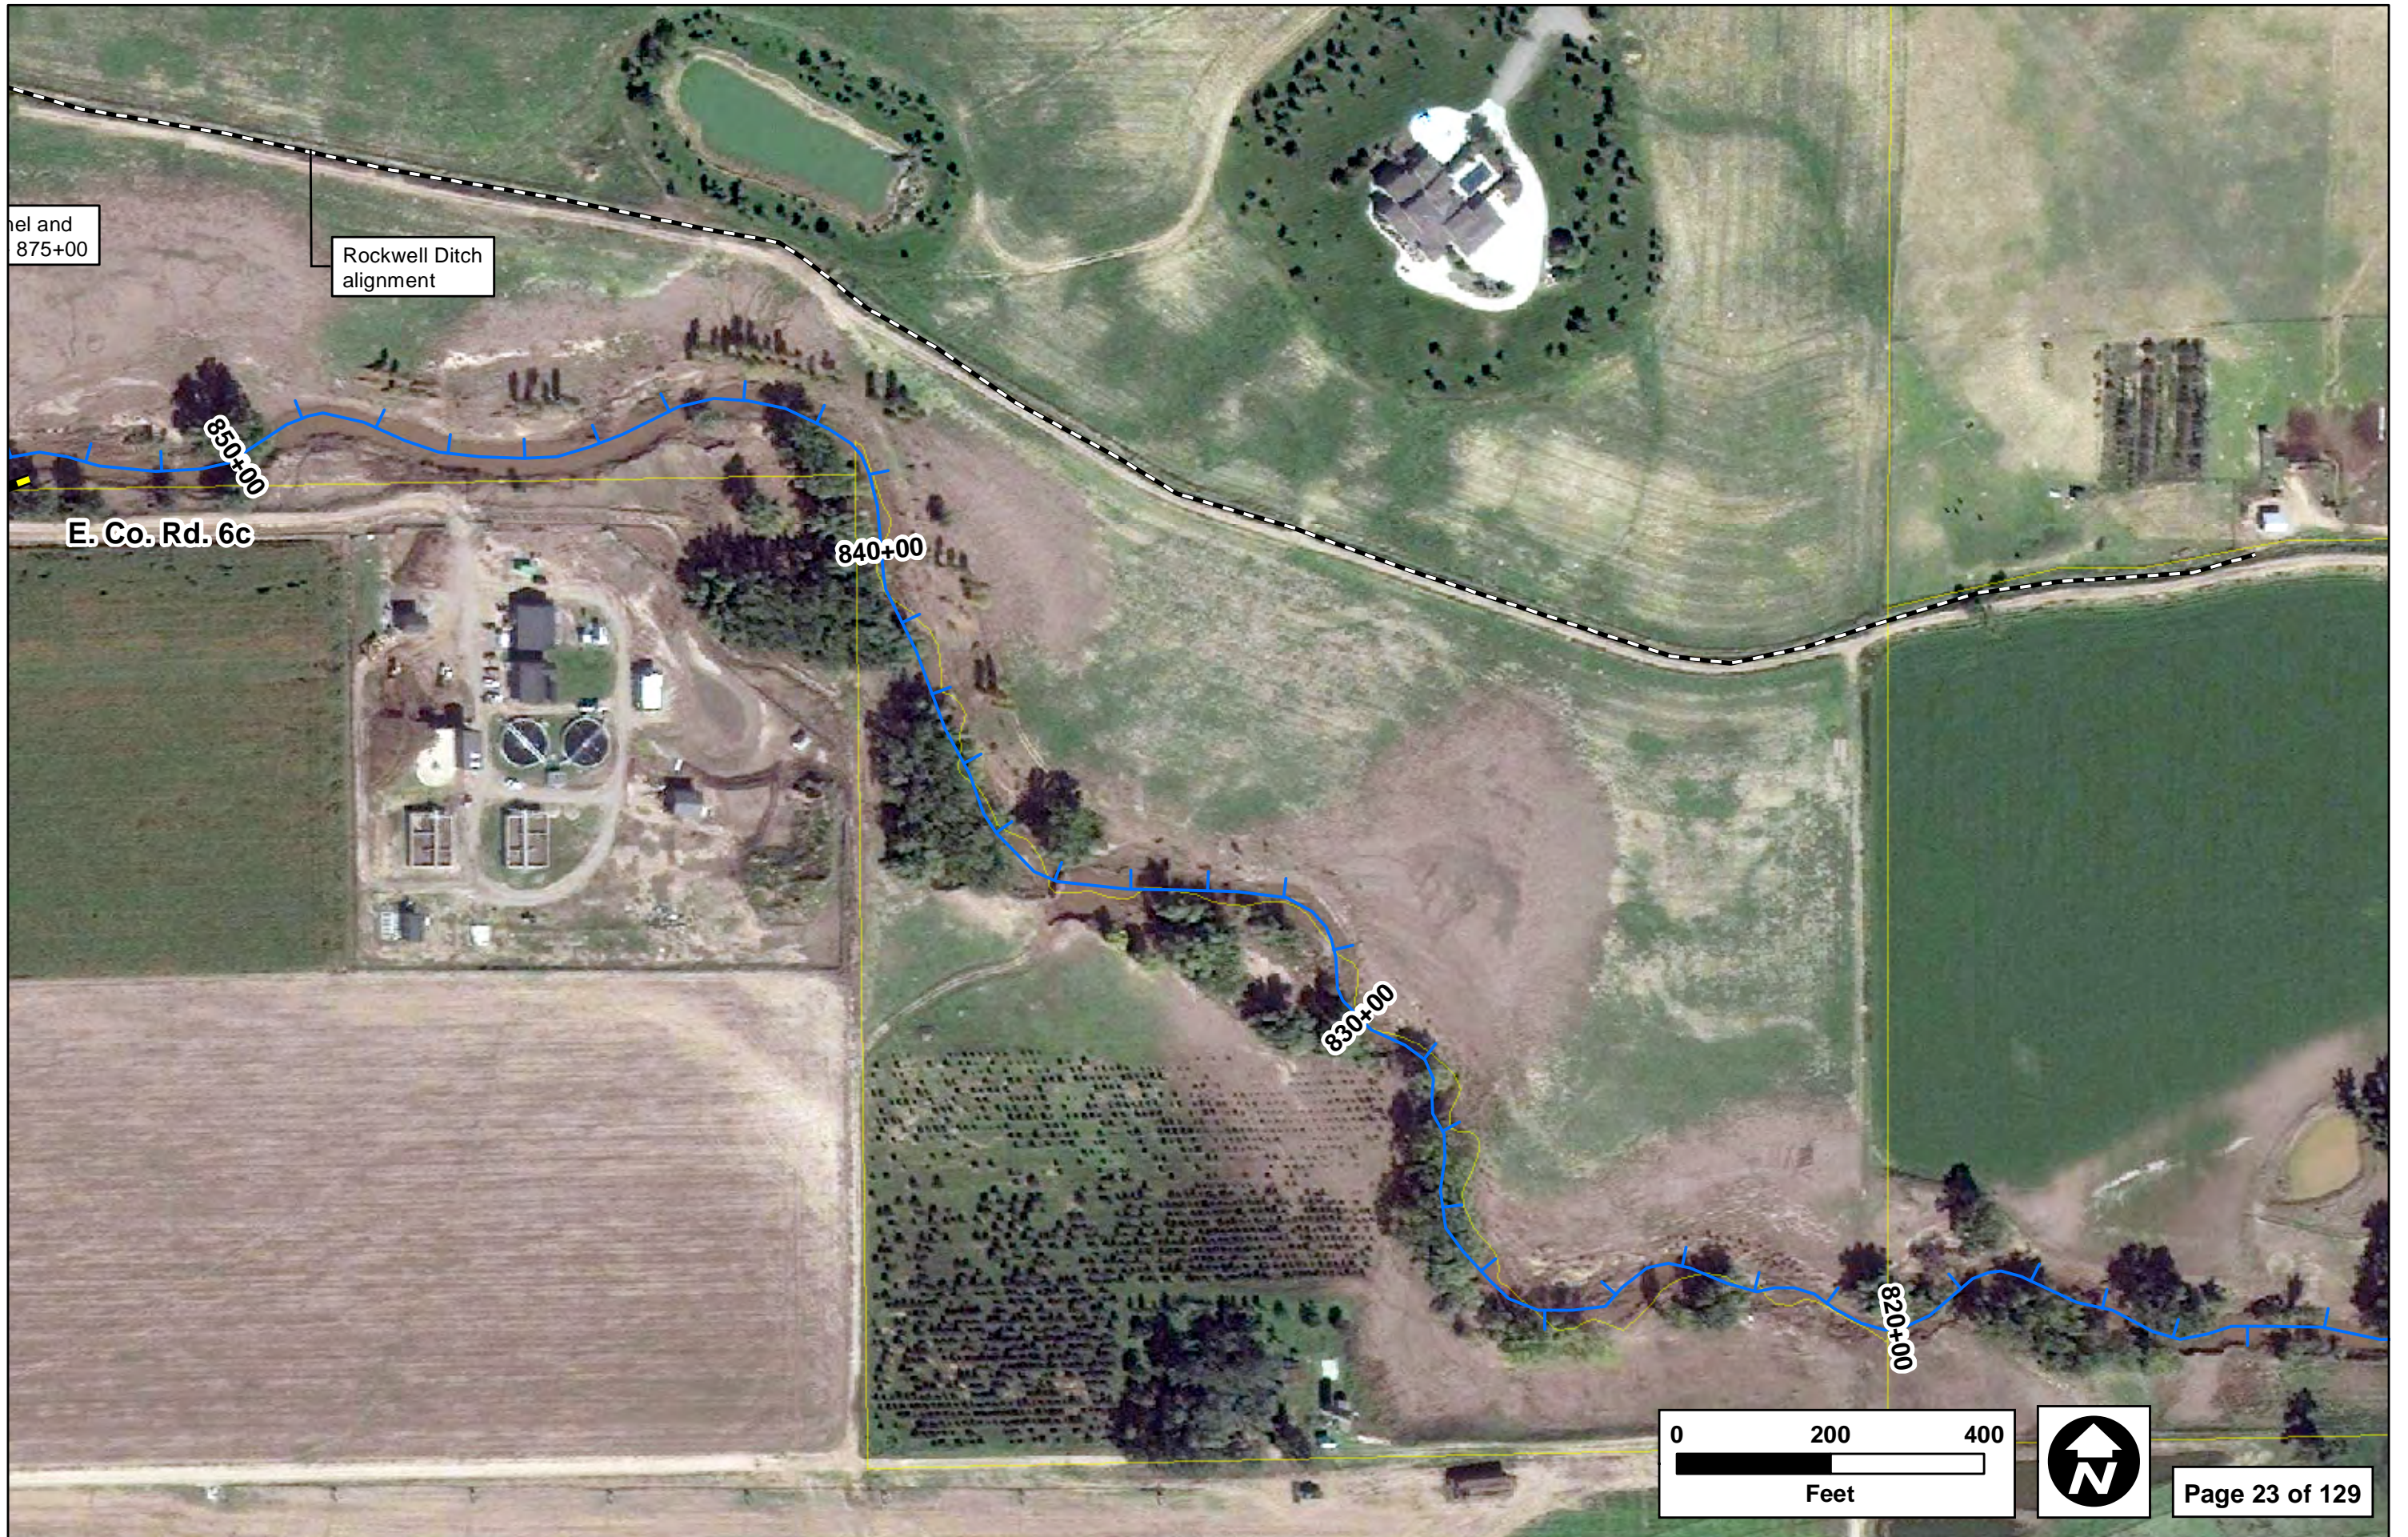
**NEIGHBORHOOD:** Berthoud  
**SHEET:** 23  
**STATION:** 814+00 to 853+00

For the most part, the general channel planform was maintained during the 2013 flood event. Lateral migration, significant bank erosion, and channel downcutting are limited, although localized areas showing evidence of each of these items were observed. The most significant and consistent problem through this reach appears to have been aggradation in the main channel, along the channel margins, and in the overbanks, well as accumulation of debris.

Bank erosion and lateral migration were limited due to the presence of historical bank protection (concrete rubble, automobiles, etc.). Upper bank erosion was observed in areas where overbank flows returned to the channel, but the bank toes in these areas appear stable.

1. Geomorphic functions of this reach are fairly sufficient to convey flow and to allow for the regeneration of riparian species through natural seeding and cloning without any further restoration. However, removal of debris is recommended along the channel and overbanks in areas where the debris could affect flood conveyance.
2. No further actions are suggested at this time.

nel and  
875+00

Rockwell Ditch  
alignment

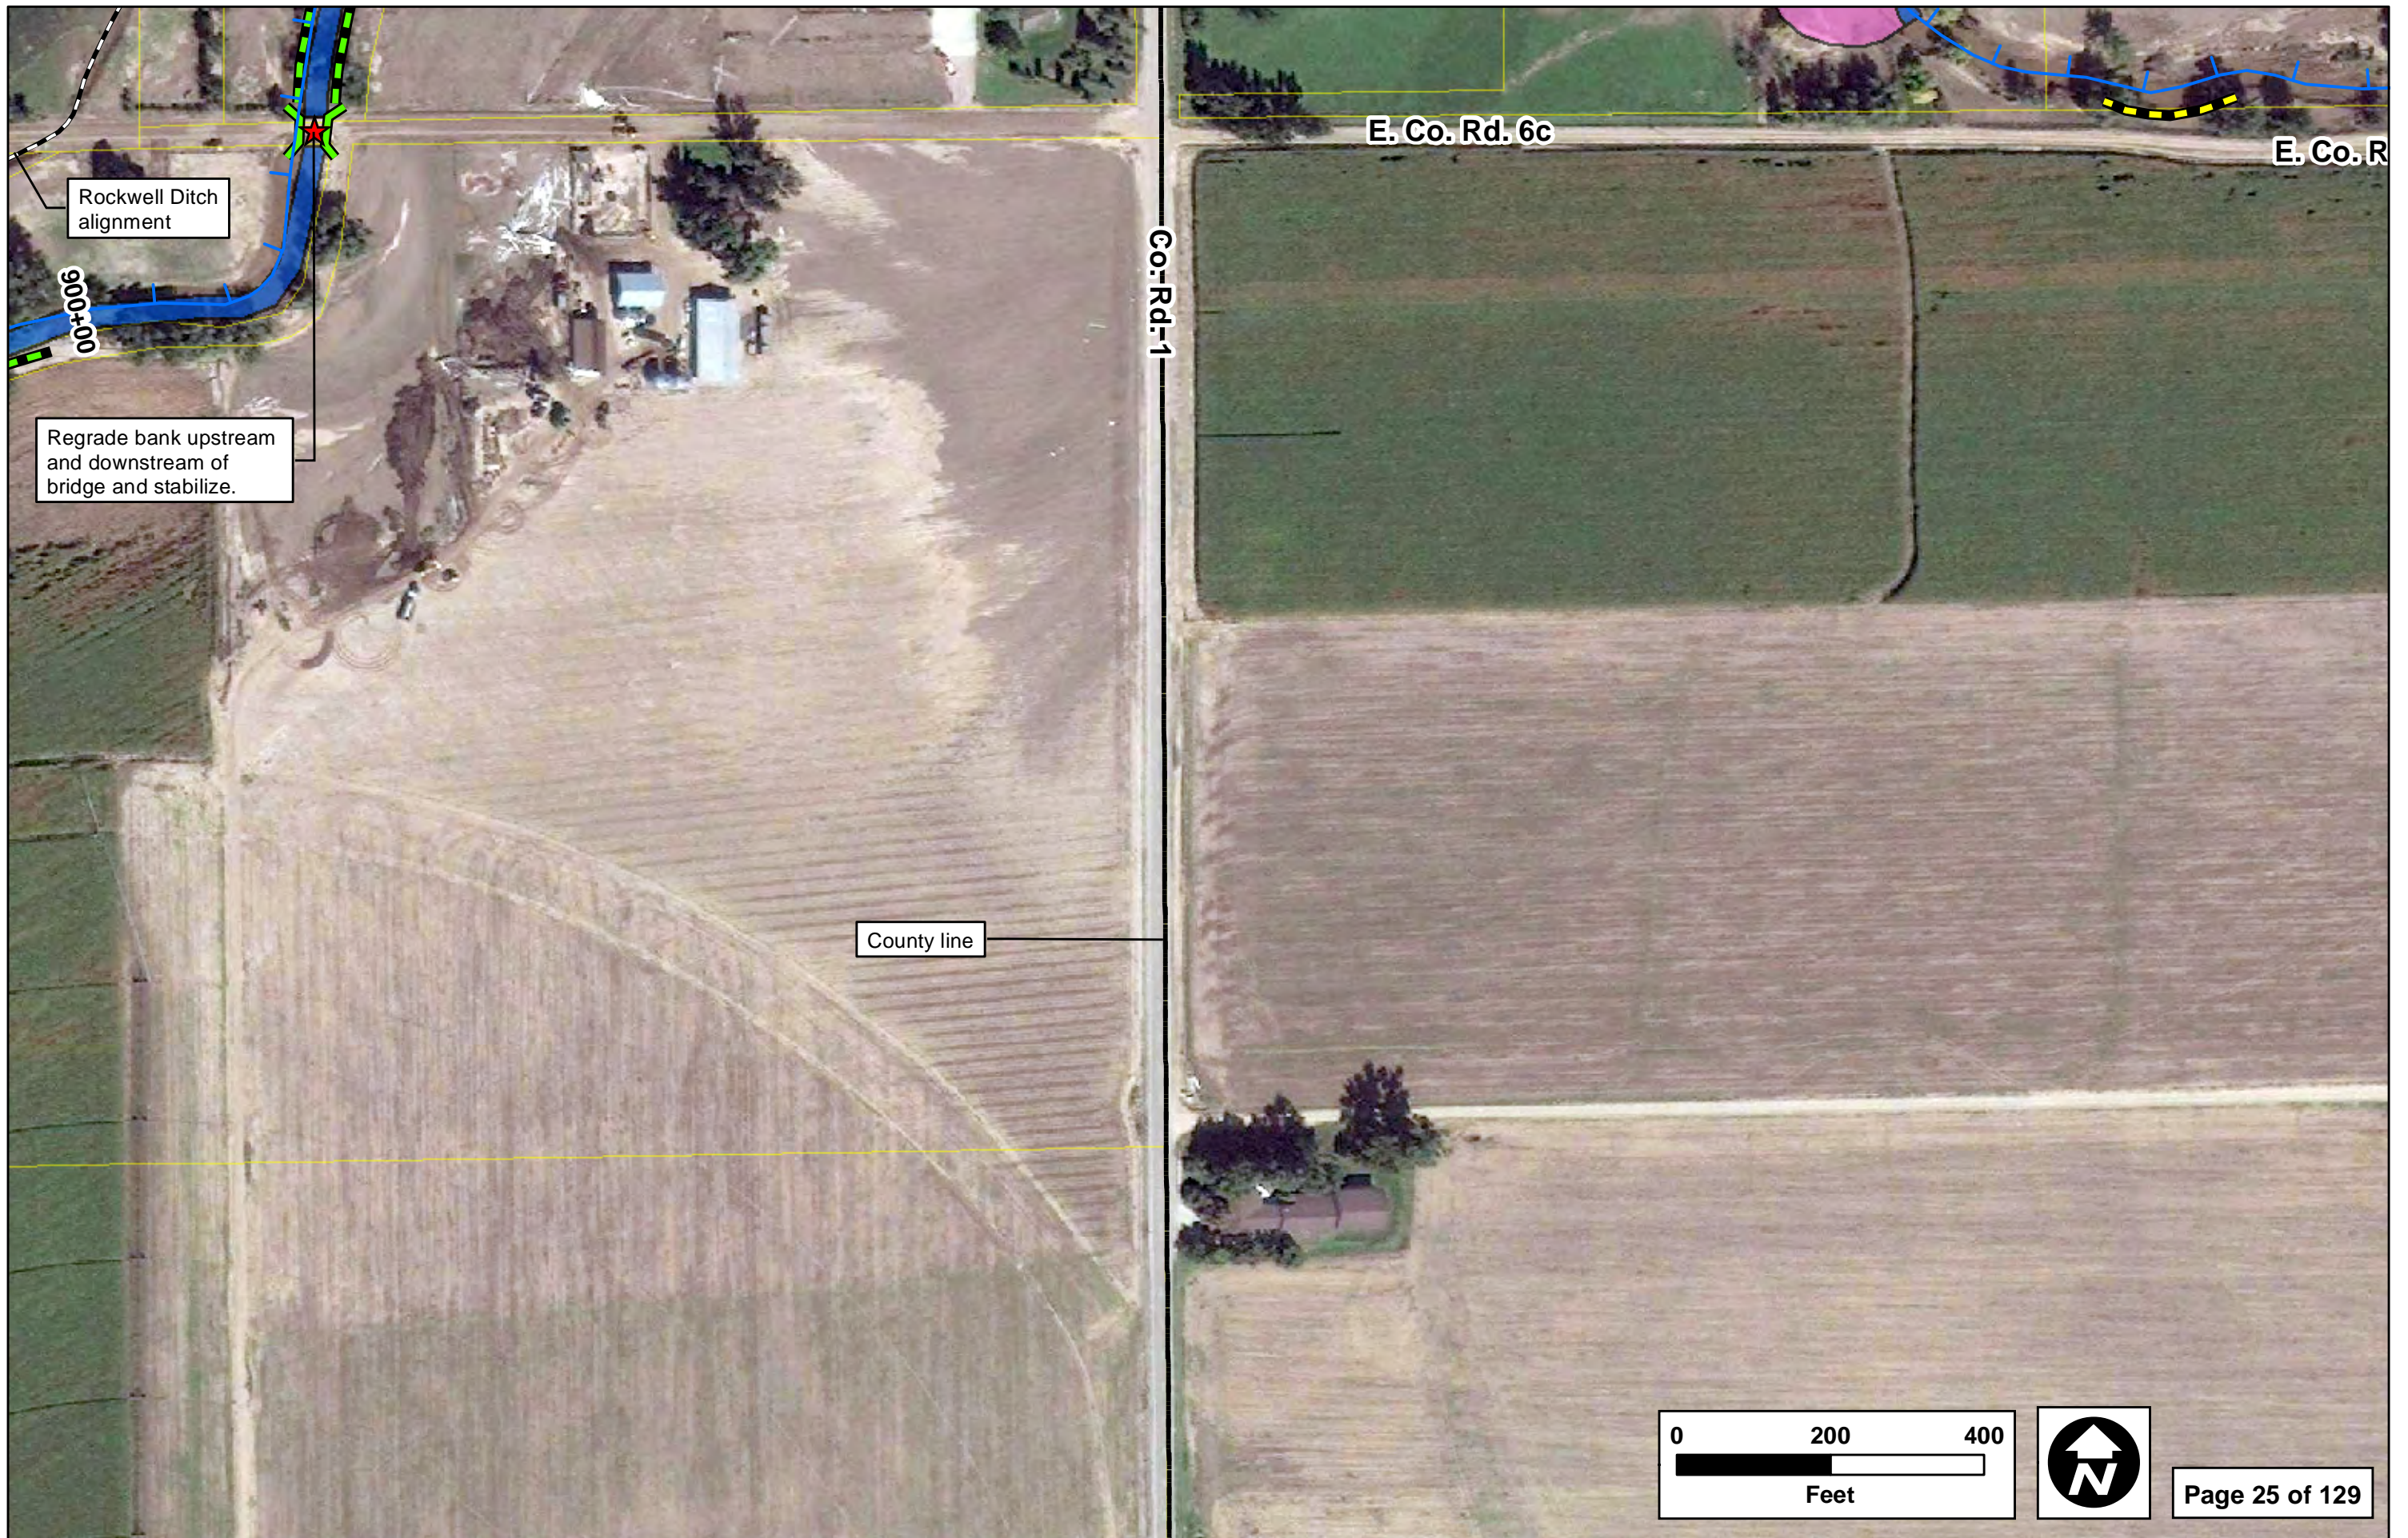
Rockwell Ditch alignment

Regrade bank upstream and downstream of bridge and stabilize.
