# **APPENDIX A**

# **ASSESSMENT PROTOCOL**

# **APPENDIX C**

# **SITE DESCRIPTIONS**

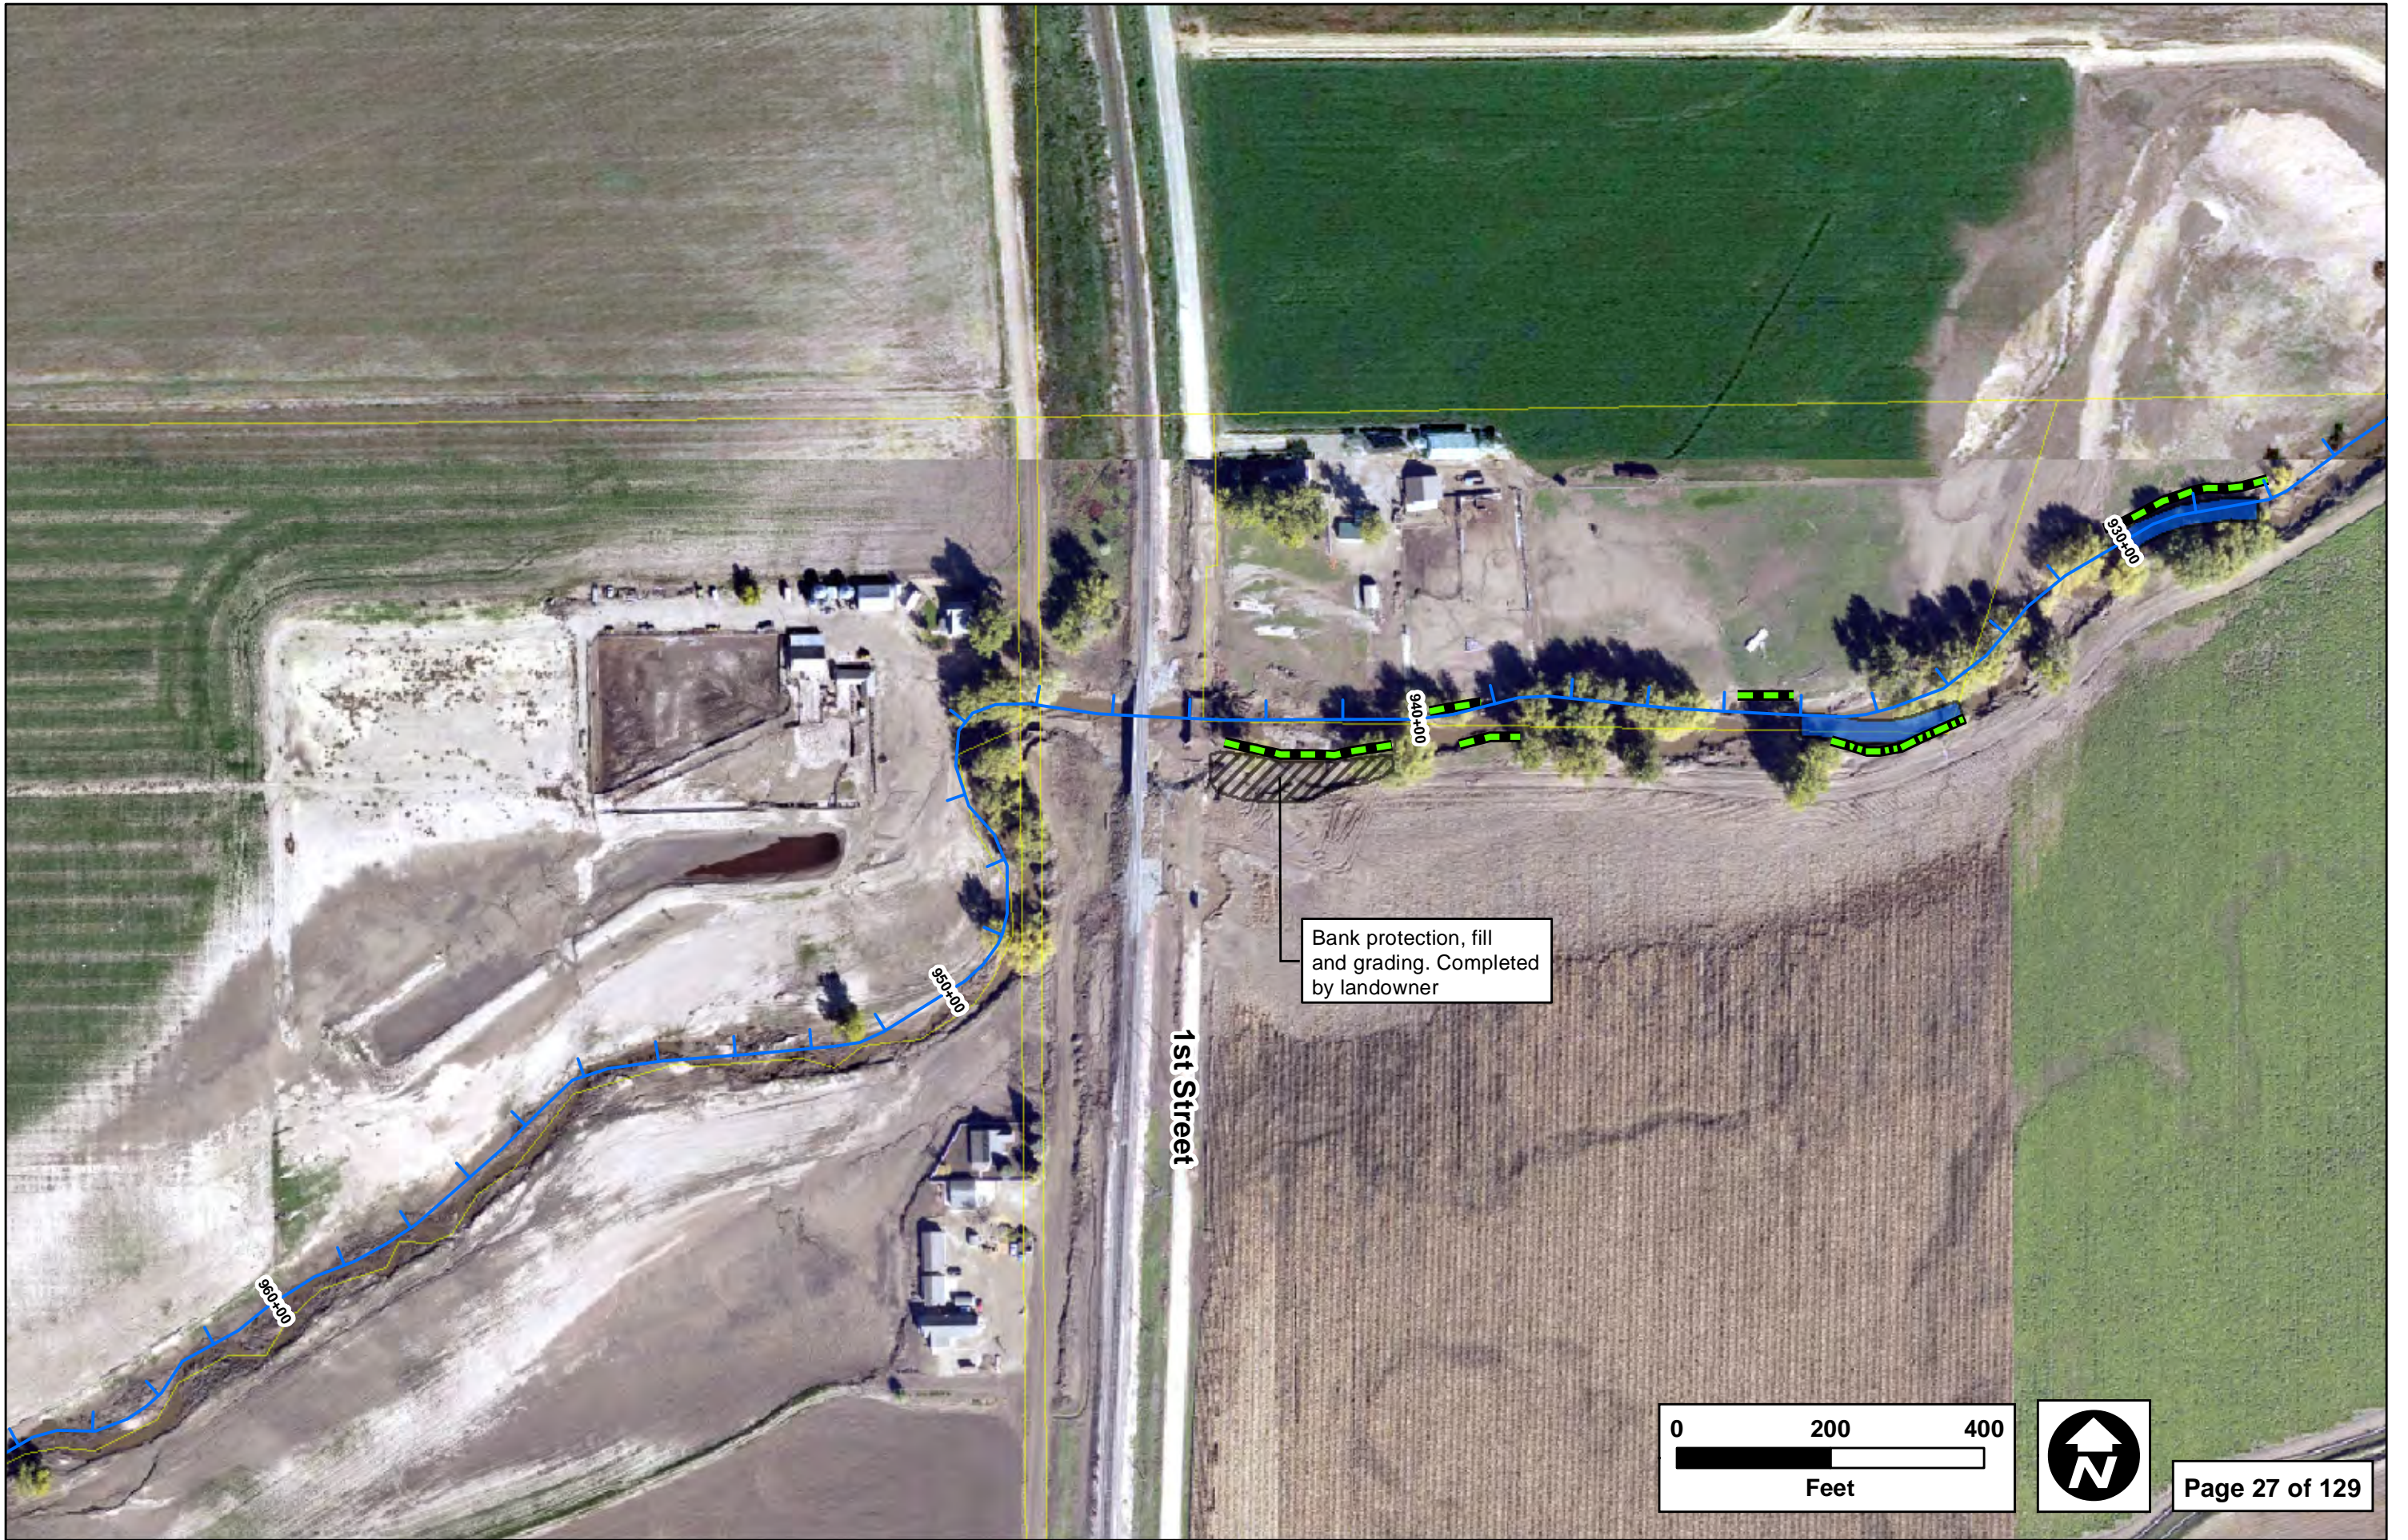
Bank protection, fill and grading. Completed by landowner

1st Street

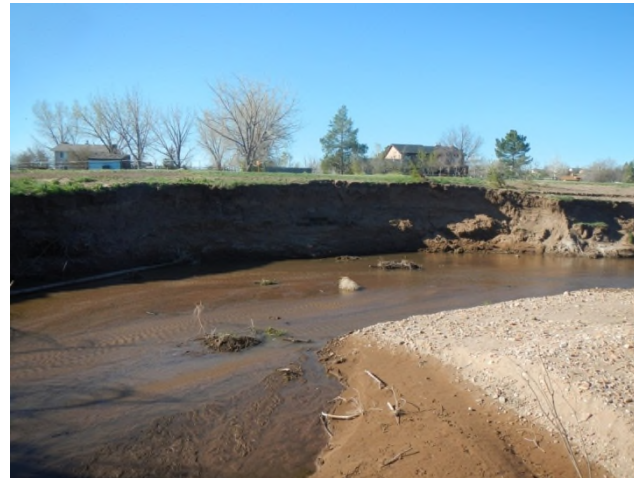
The County Road 17 Bridge and the Osborne Caywood Ditch Diversion Structure was severely damaged during the flood. To date, most of the repairs have been made to both structures.

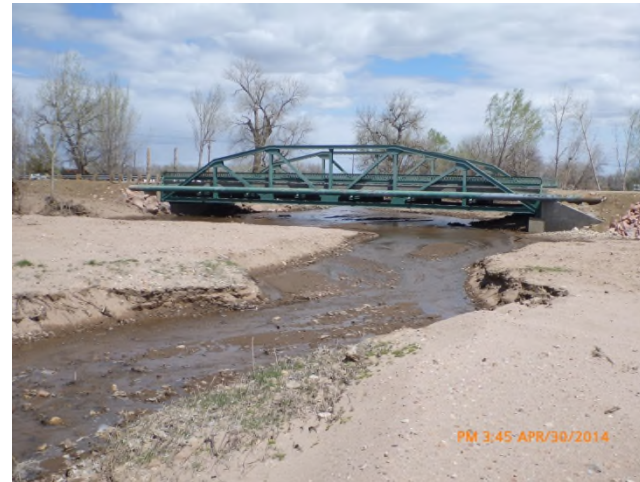
Significant flooding issues associated, in part, by the limited capacity of the Mountain River Road Bridge, and the 90-degree turn the river makes at County Road 4 occurred within the area. This resulted in significant infrastructure and residential damages. Sedimentation caused the channel to avulse, drastically changing the planform. Low-flow channel upstream of Sta 1103+00 does not have adequate sediment transport capacity at low to moderate flows, and flood flow capacity in this area is severely diminished.

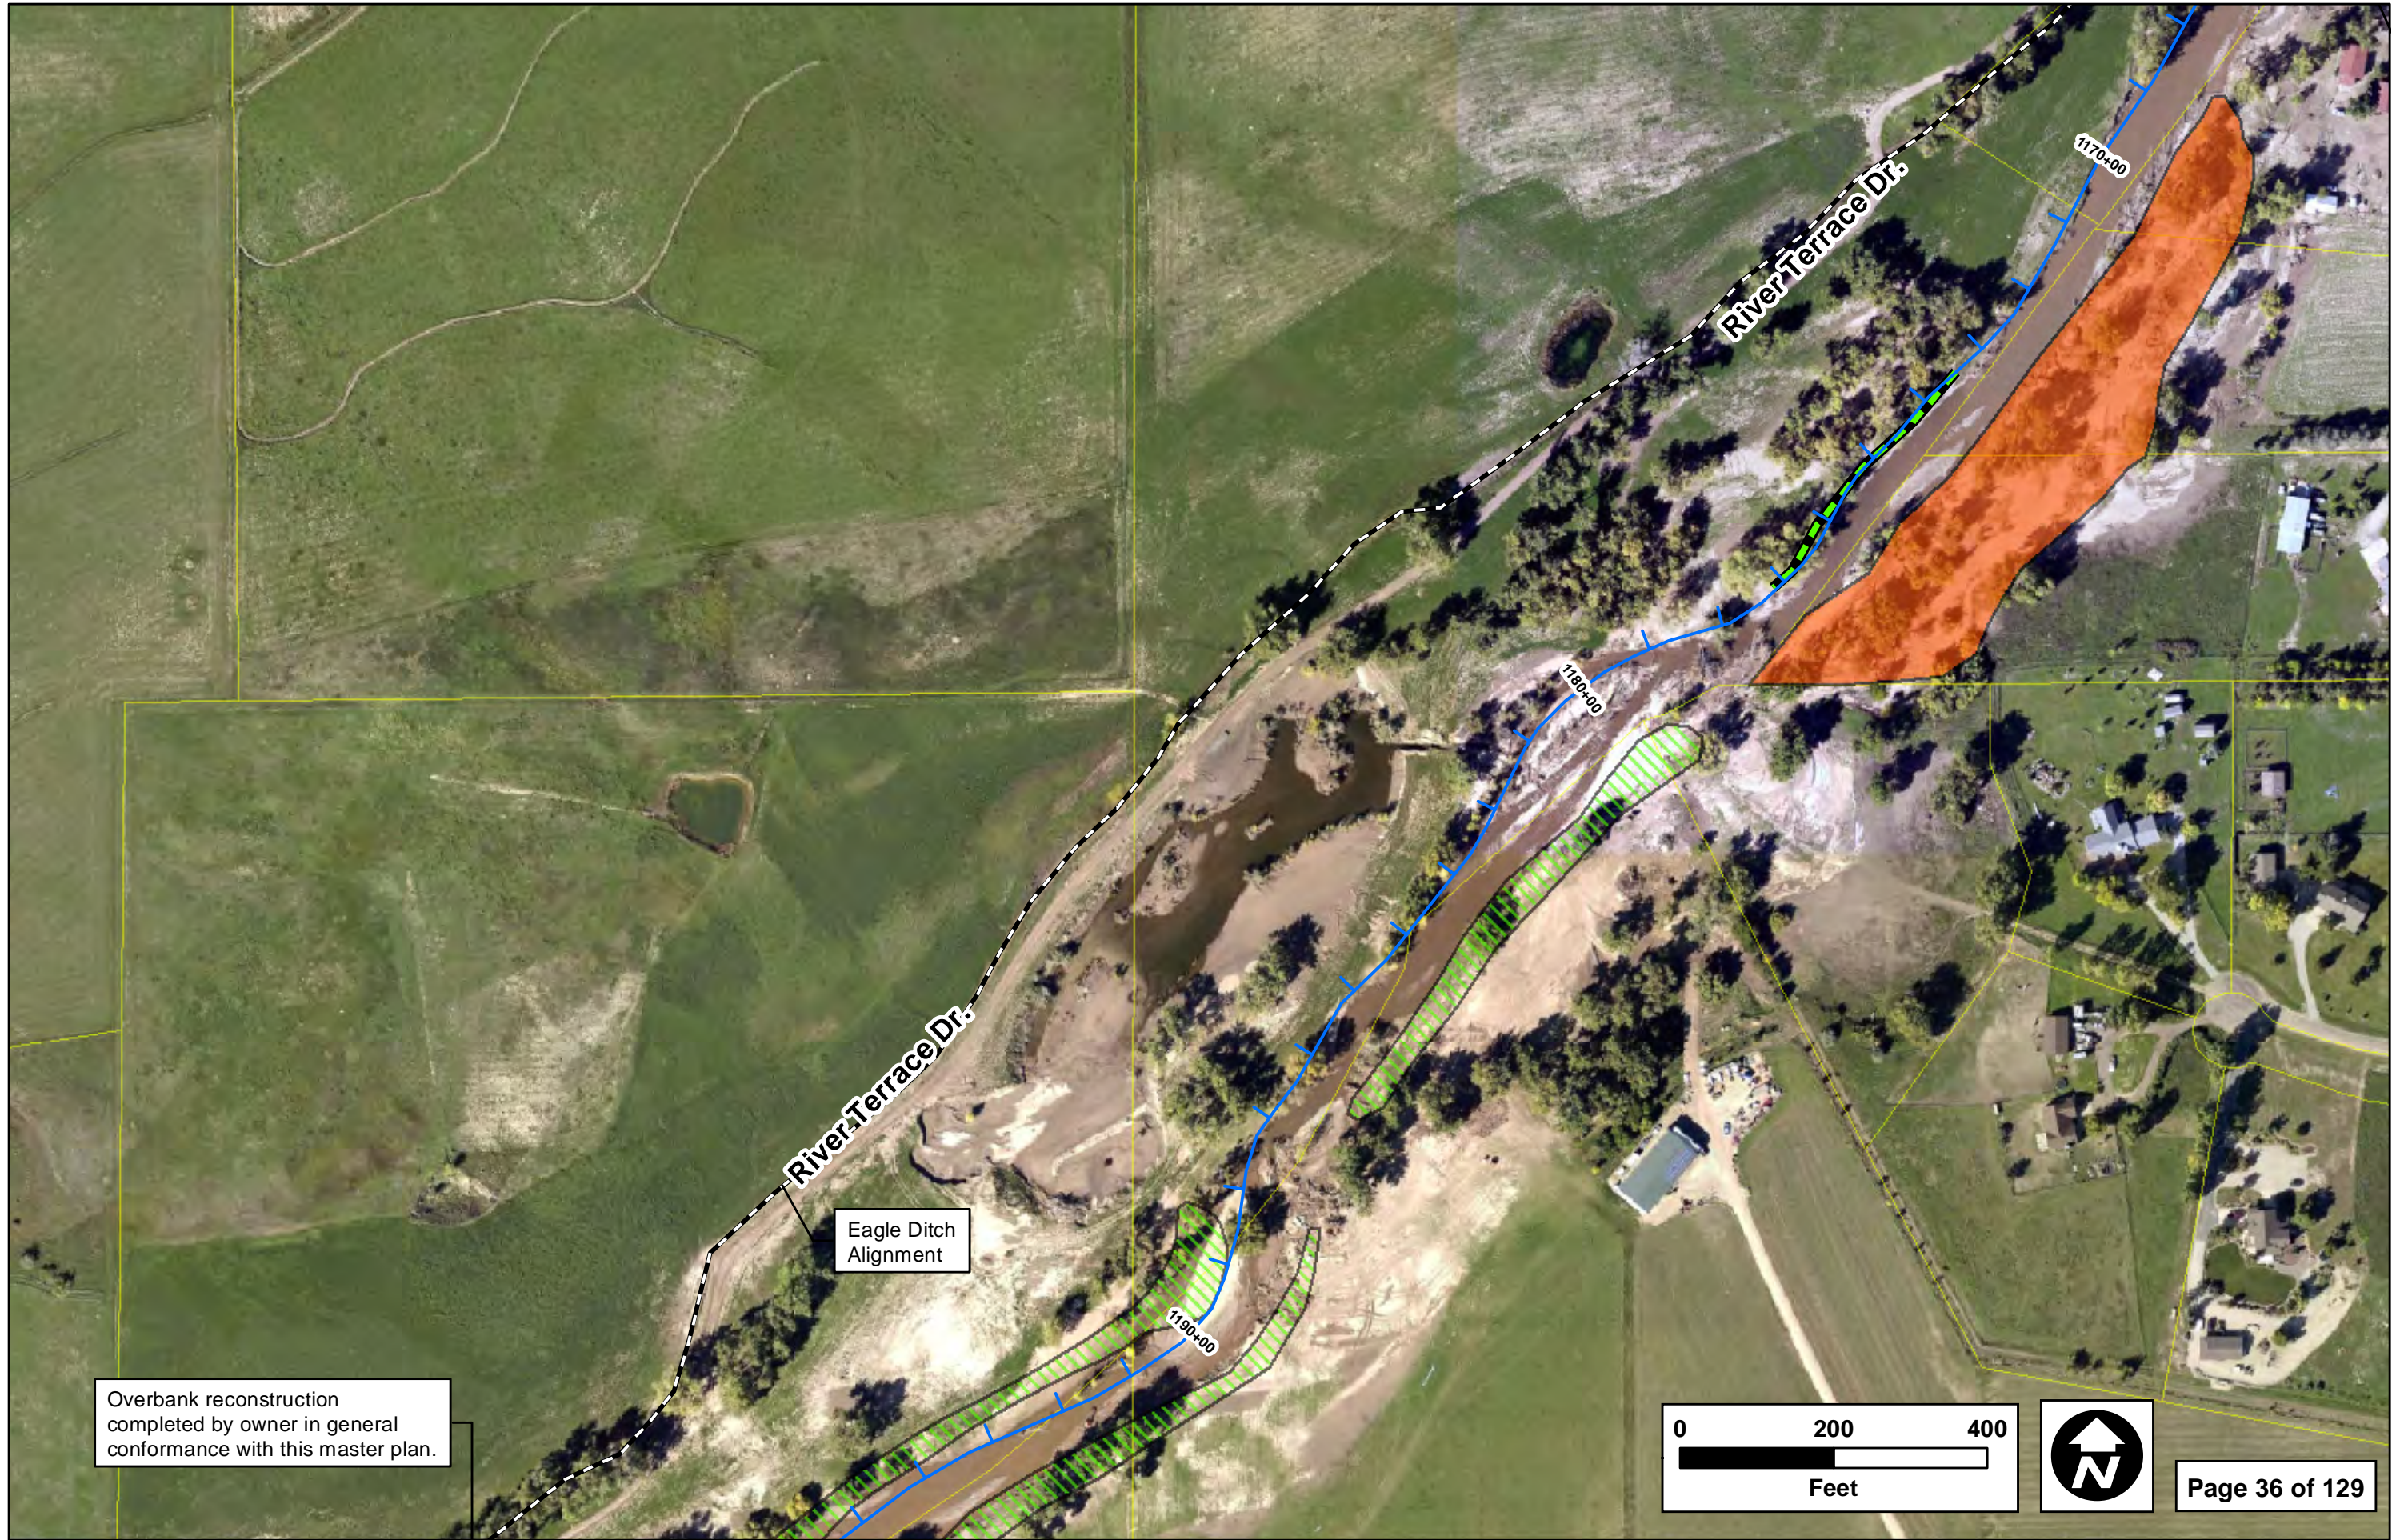
Eagle Ditch Alignment

Overbank reconstruction completed by owner in general conformance with this master plan.

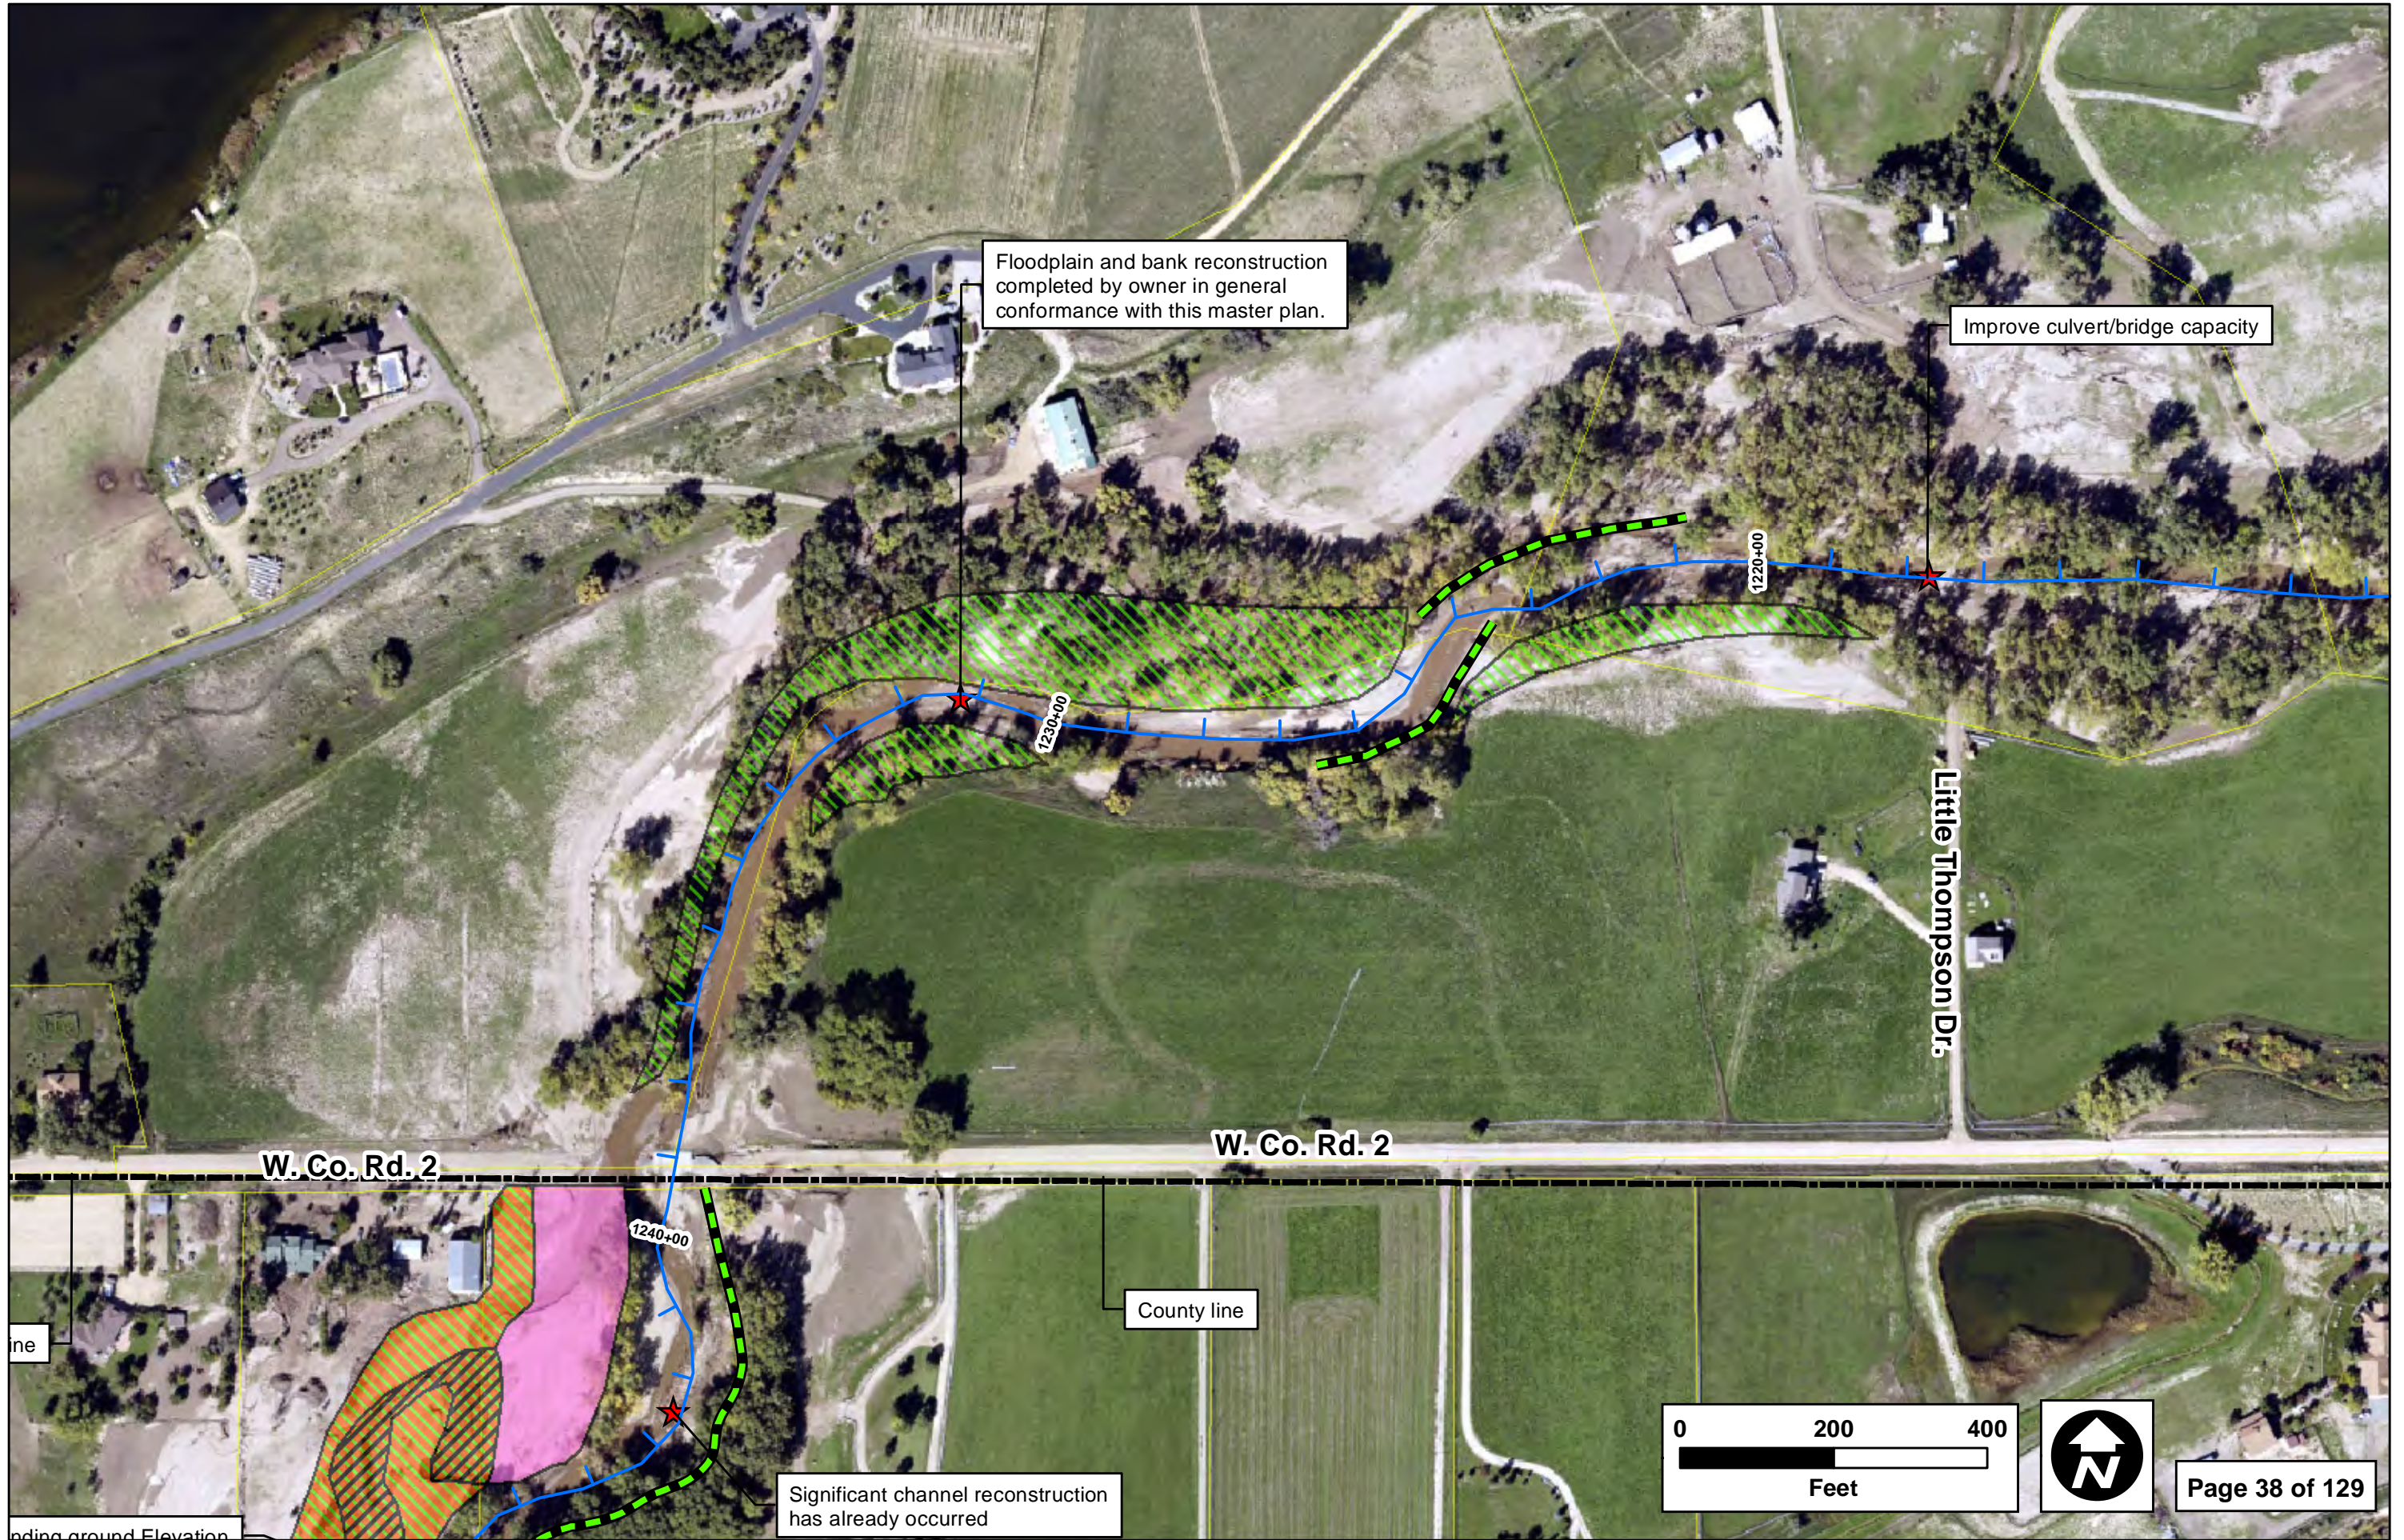
Floodplain and bank reconstruction completed by owner in general conformance with this master plan.

Improve culvert/bridge capacity

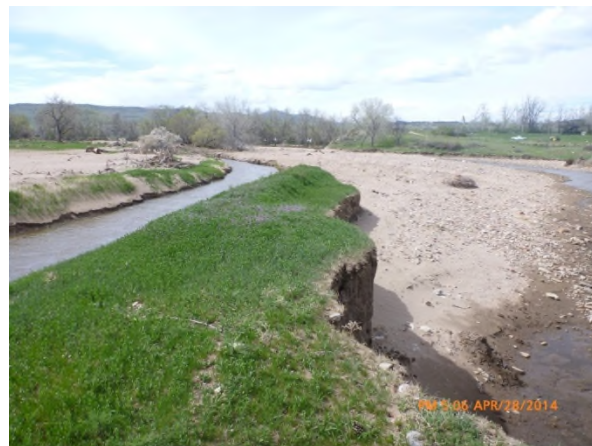
Significant overbank flows breached the left channel bank near about Sta 1296+00, which primarily reentered the channel corridor near Sta 1284+00. Significant bank scour and severe damage occurred to the Blower Ditch and associated diversion structure at Sta 1284+00.

The 2013 flood event caused some of the larger channel bends to erode laterally into overbank surfaces that have primarily been used as cropland, and sinuosity of the channel was also generally reduced as flood flows scoured a more direct flowpath along the floodplain. However, relatively high overbank and terrace surfaces limited the amount of lateral channel erosion.

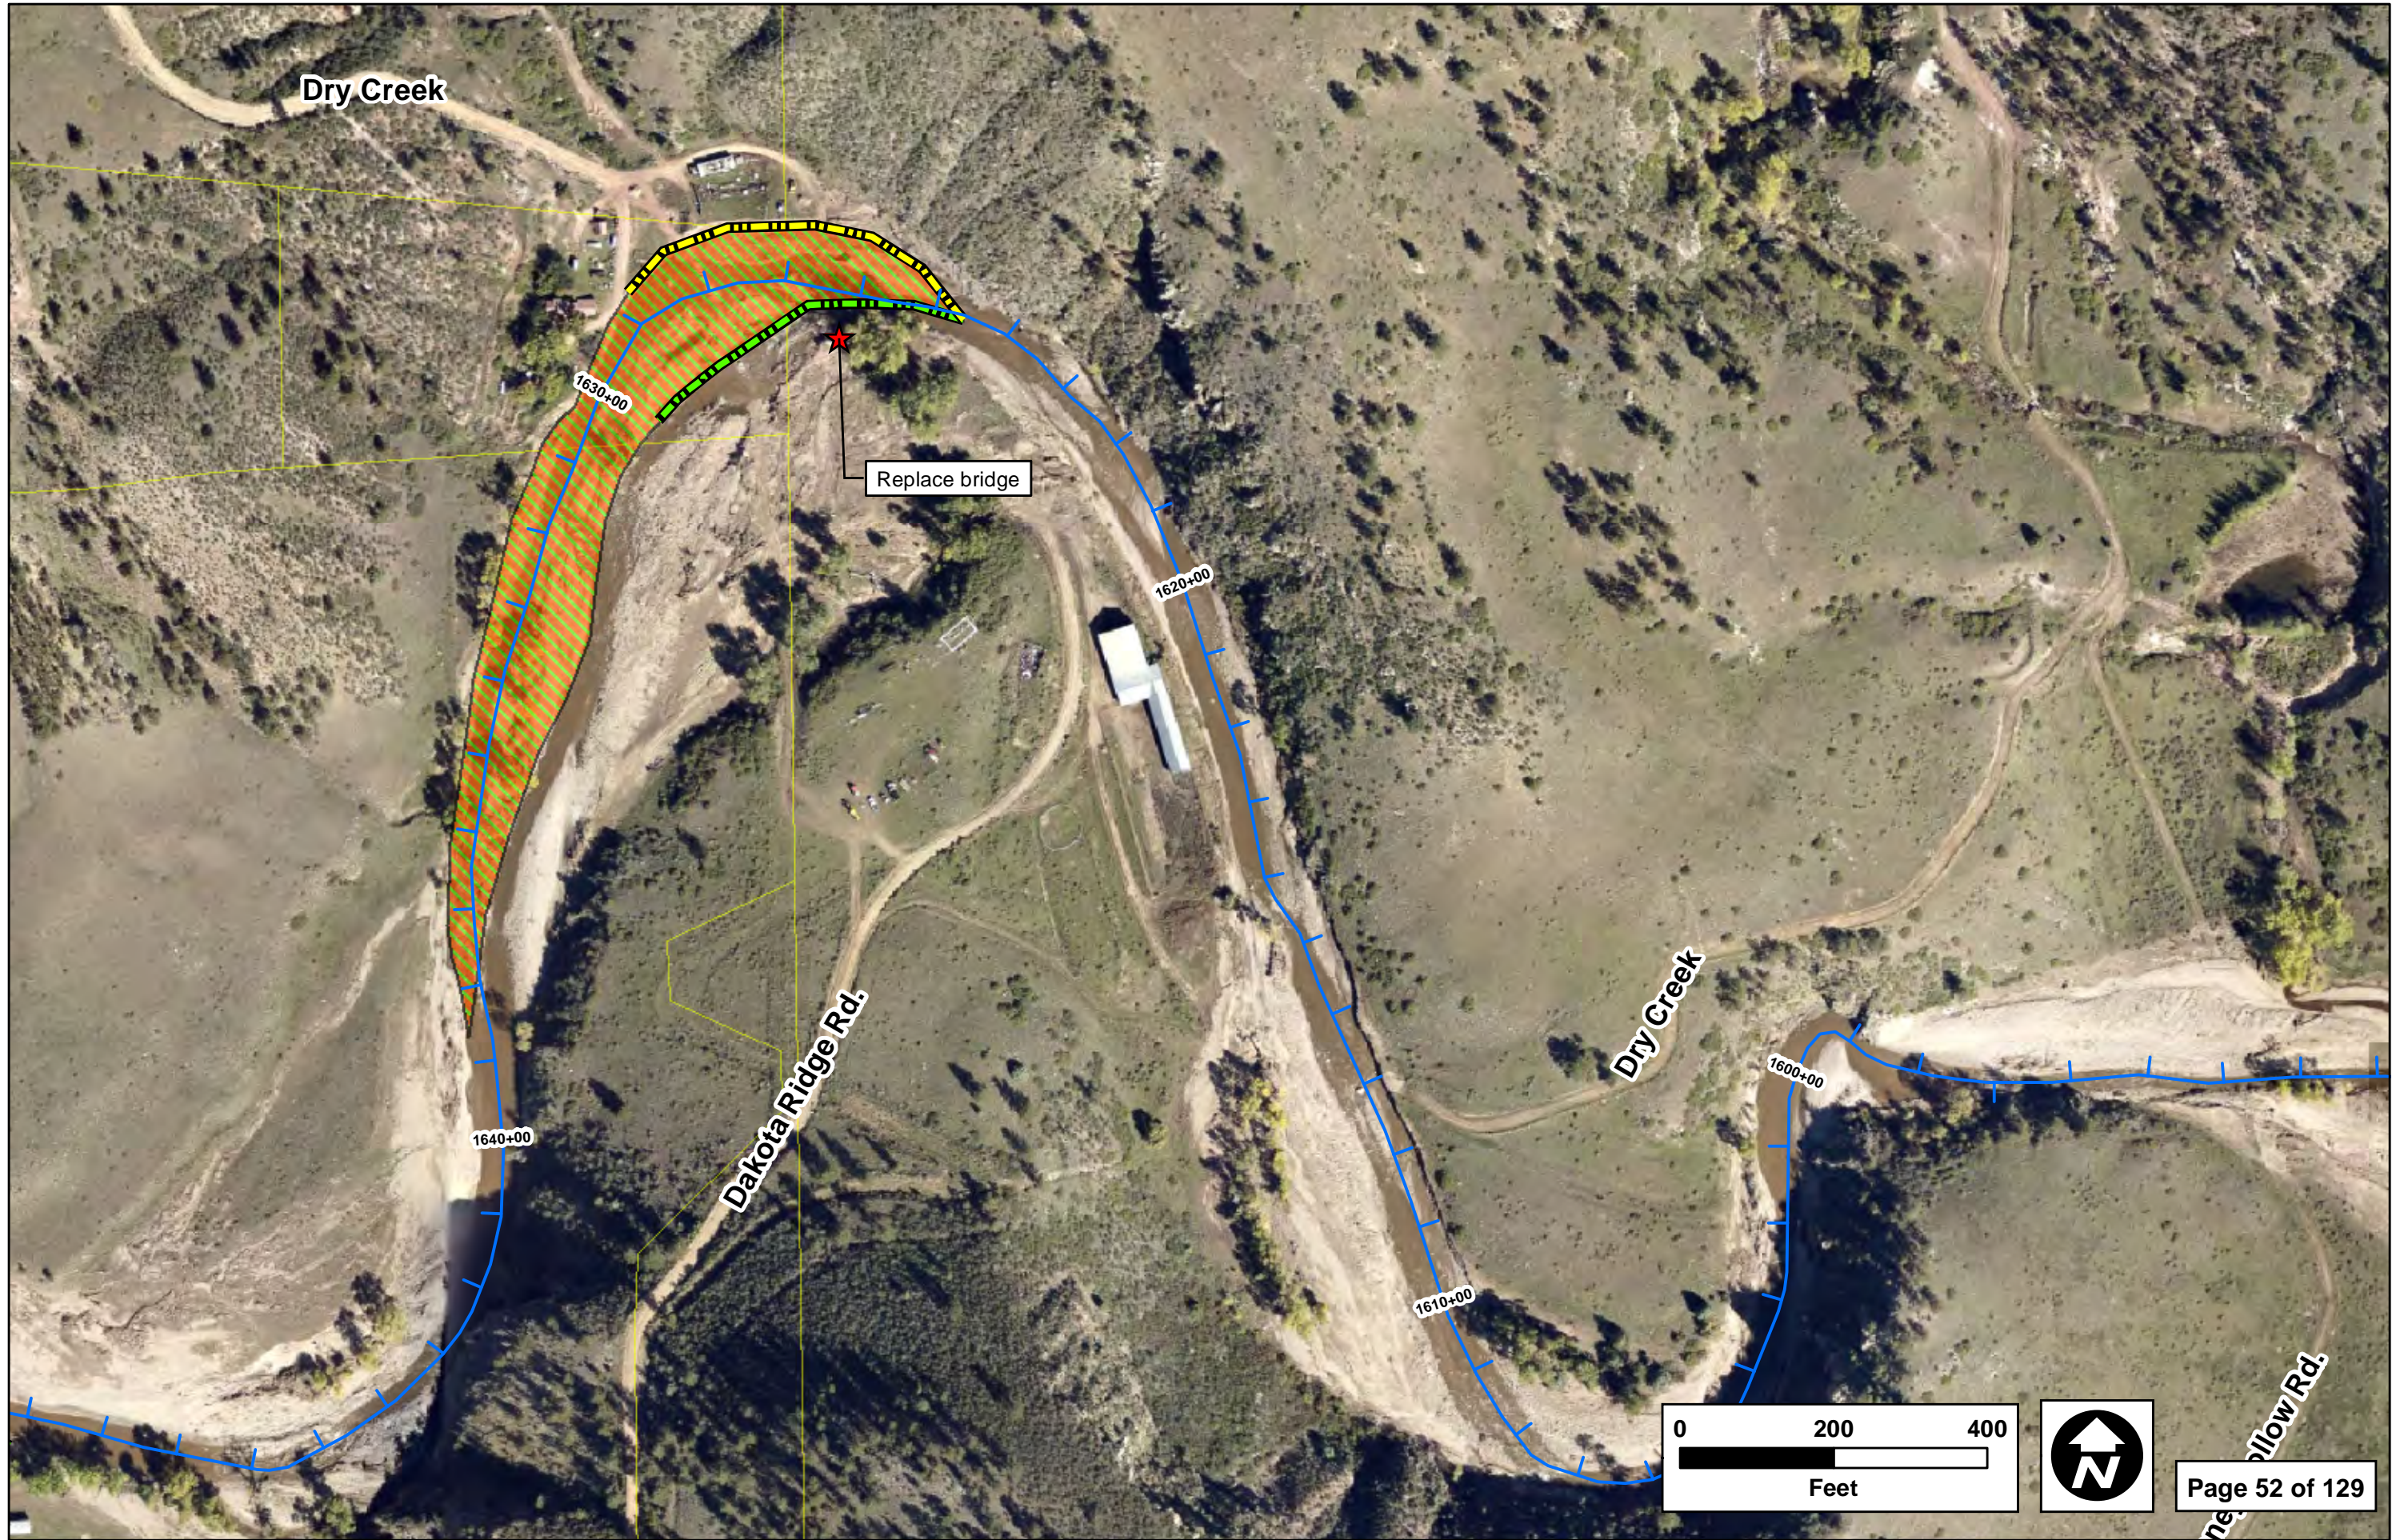
1. Bank stabilization along the left bank at Sta. 1627+00.
2. Overbank stabilization along the left bank at Sta 1628+00.
3. Floodplain stabilization and grading.
4. Replace bridge (driveway crossing).

Replace bridge

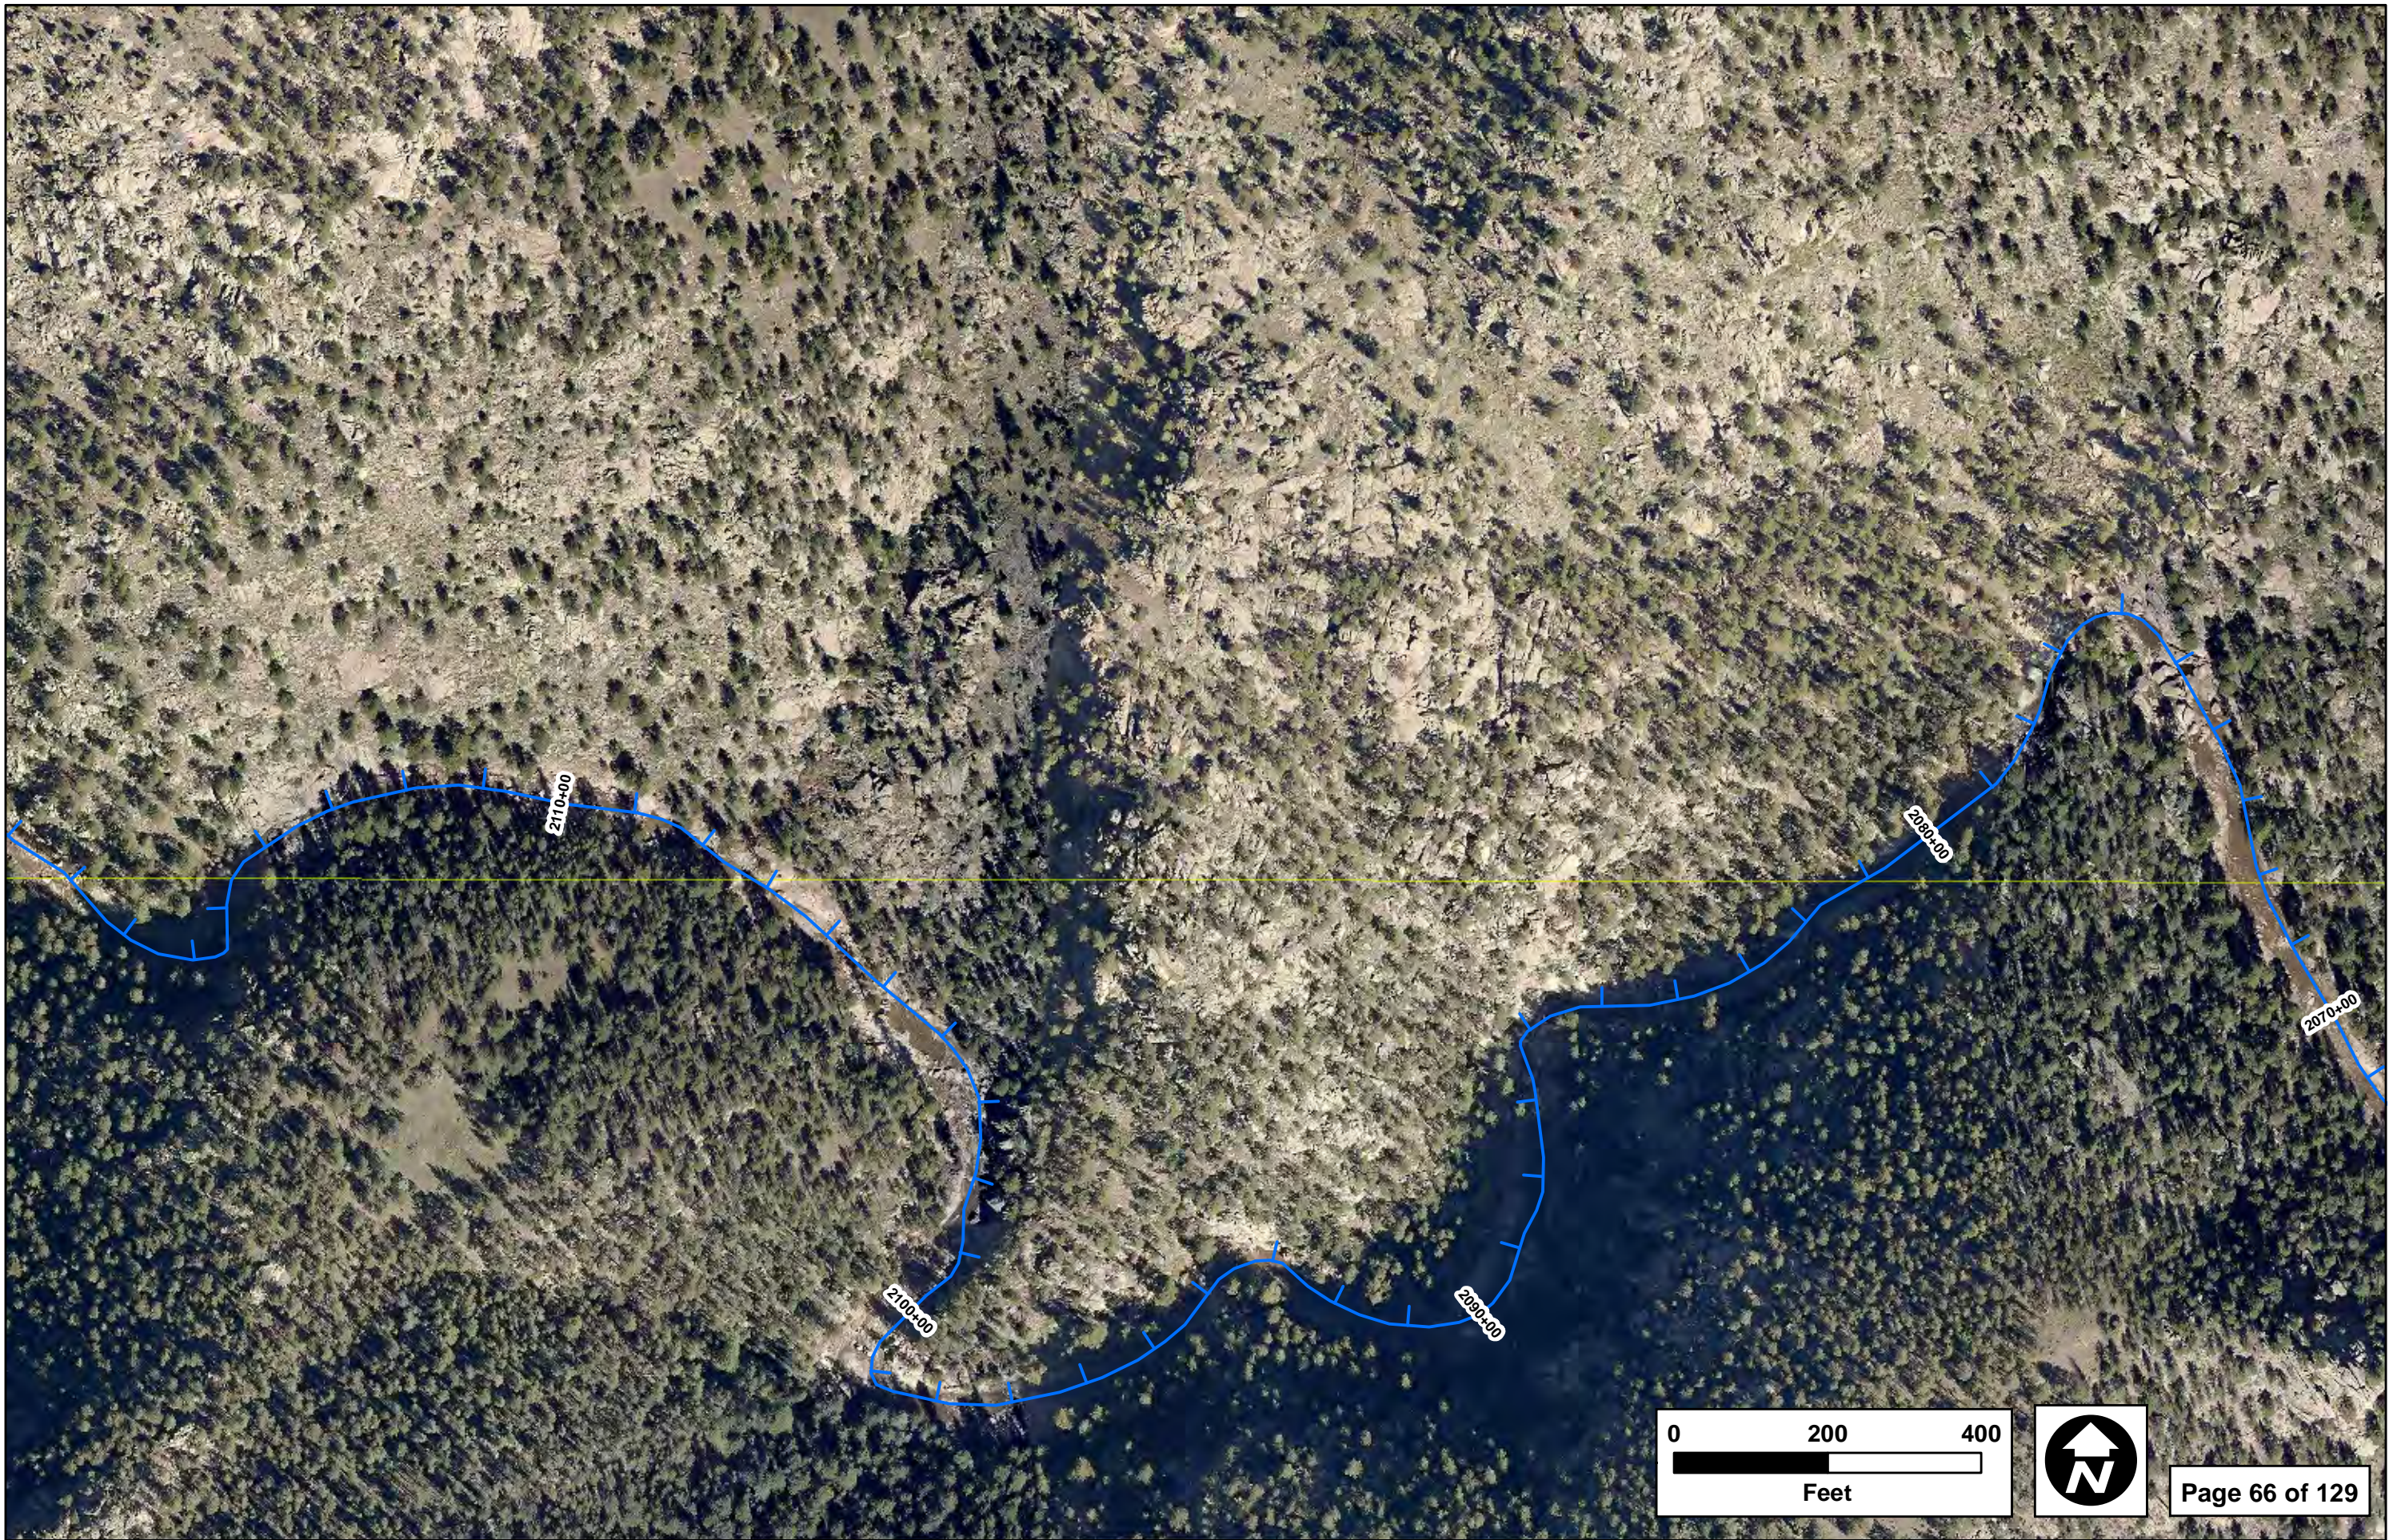
**NEIGHBORHOOD: Pinewood Springs to Blue Mountain****SHEET: 67****STATION: 2110+00 to 2140+00**

Aerial photos of pre-flood conditions and anecdotal information indicate this reach had a vegetated riparian corridor, 50 to 100 feet wide, comprised primarily of fir trees and willows, much of which were torn out during the flood. The river corridor is narrow and canyon bound, setting the sinuosity and river corridor alignment.

Geomorphic functions of this reach is likely sufficient to allow for the natural regeneration of willow, and other riparian species through seeding and cloning without active restoration. No further actions are suggested at this time.
