# **APPENDIX A**

# **ASSESSMENT PROTOCOL**

# **APPENDIX C**

# **SITE DESCRIPTIONS**

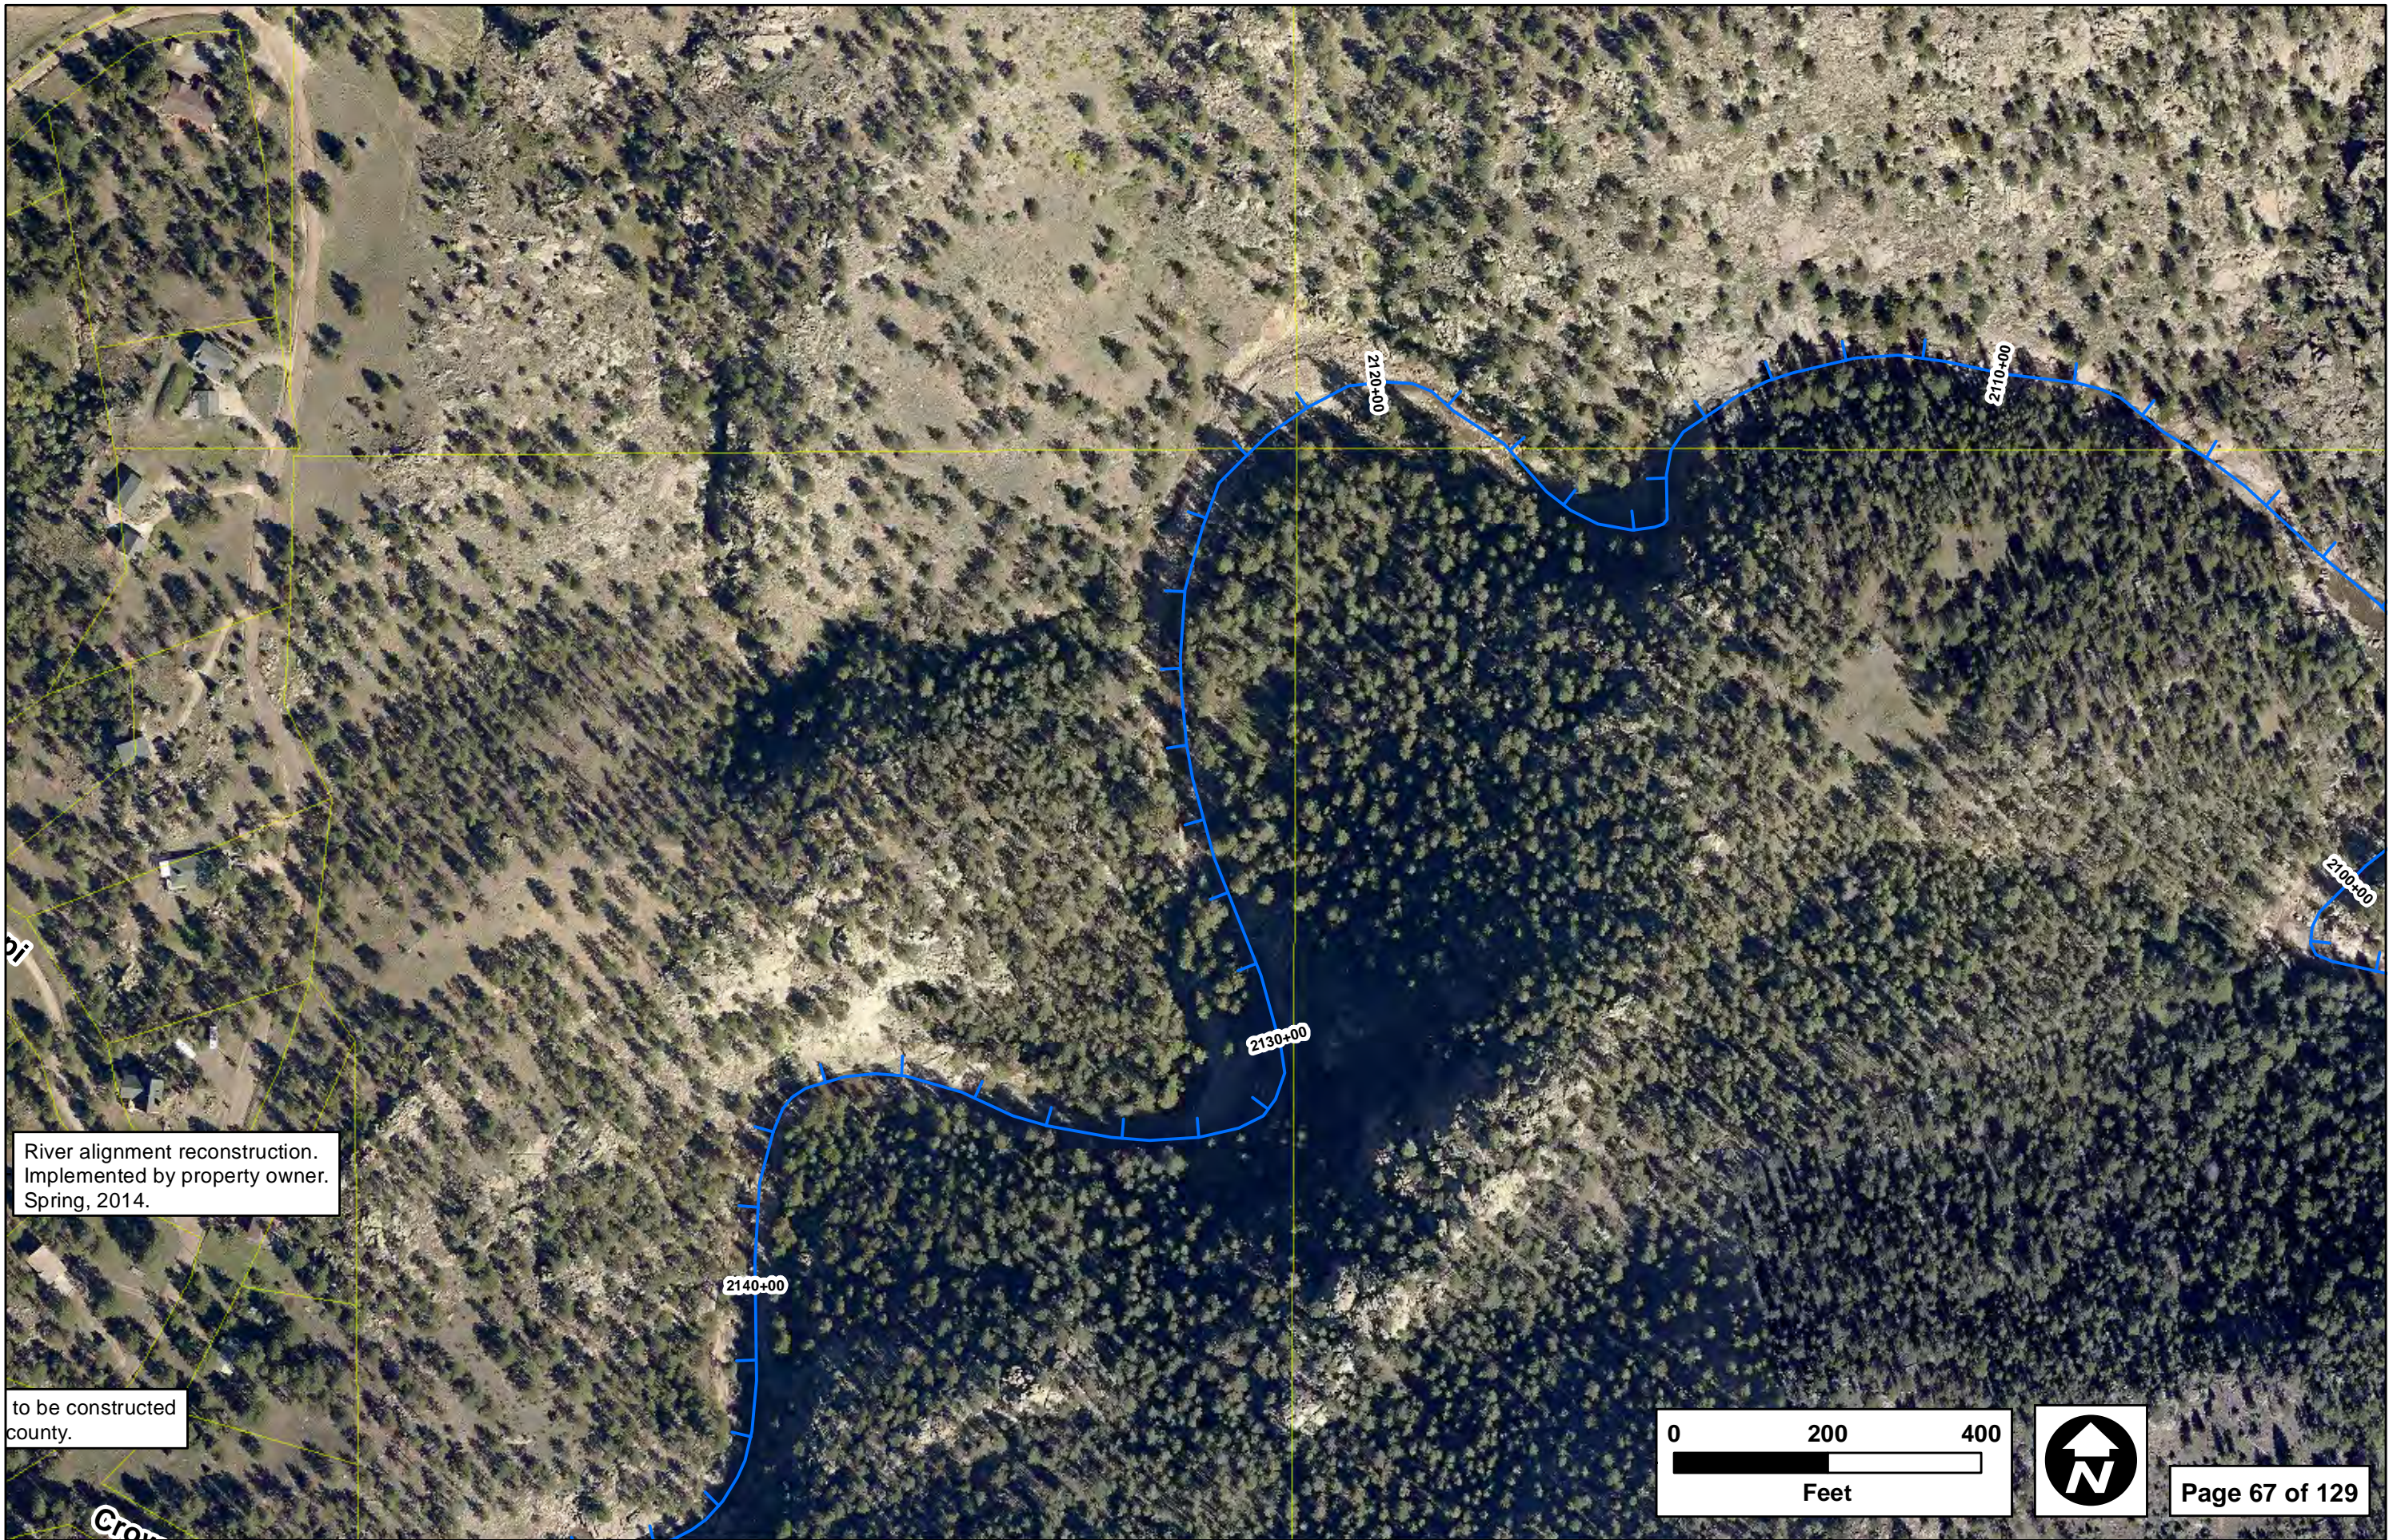
River alignment reconstruction.  
Implemented by property owner.  
Spring, 2014.

to be constructed  
county.

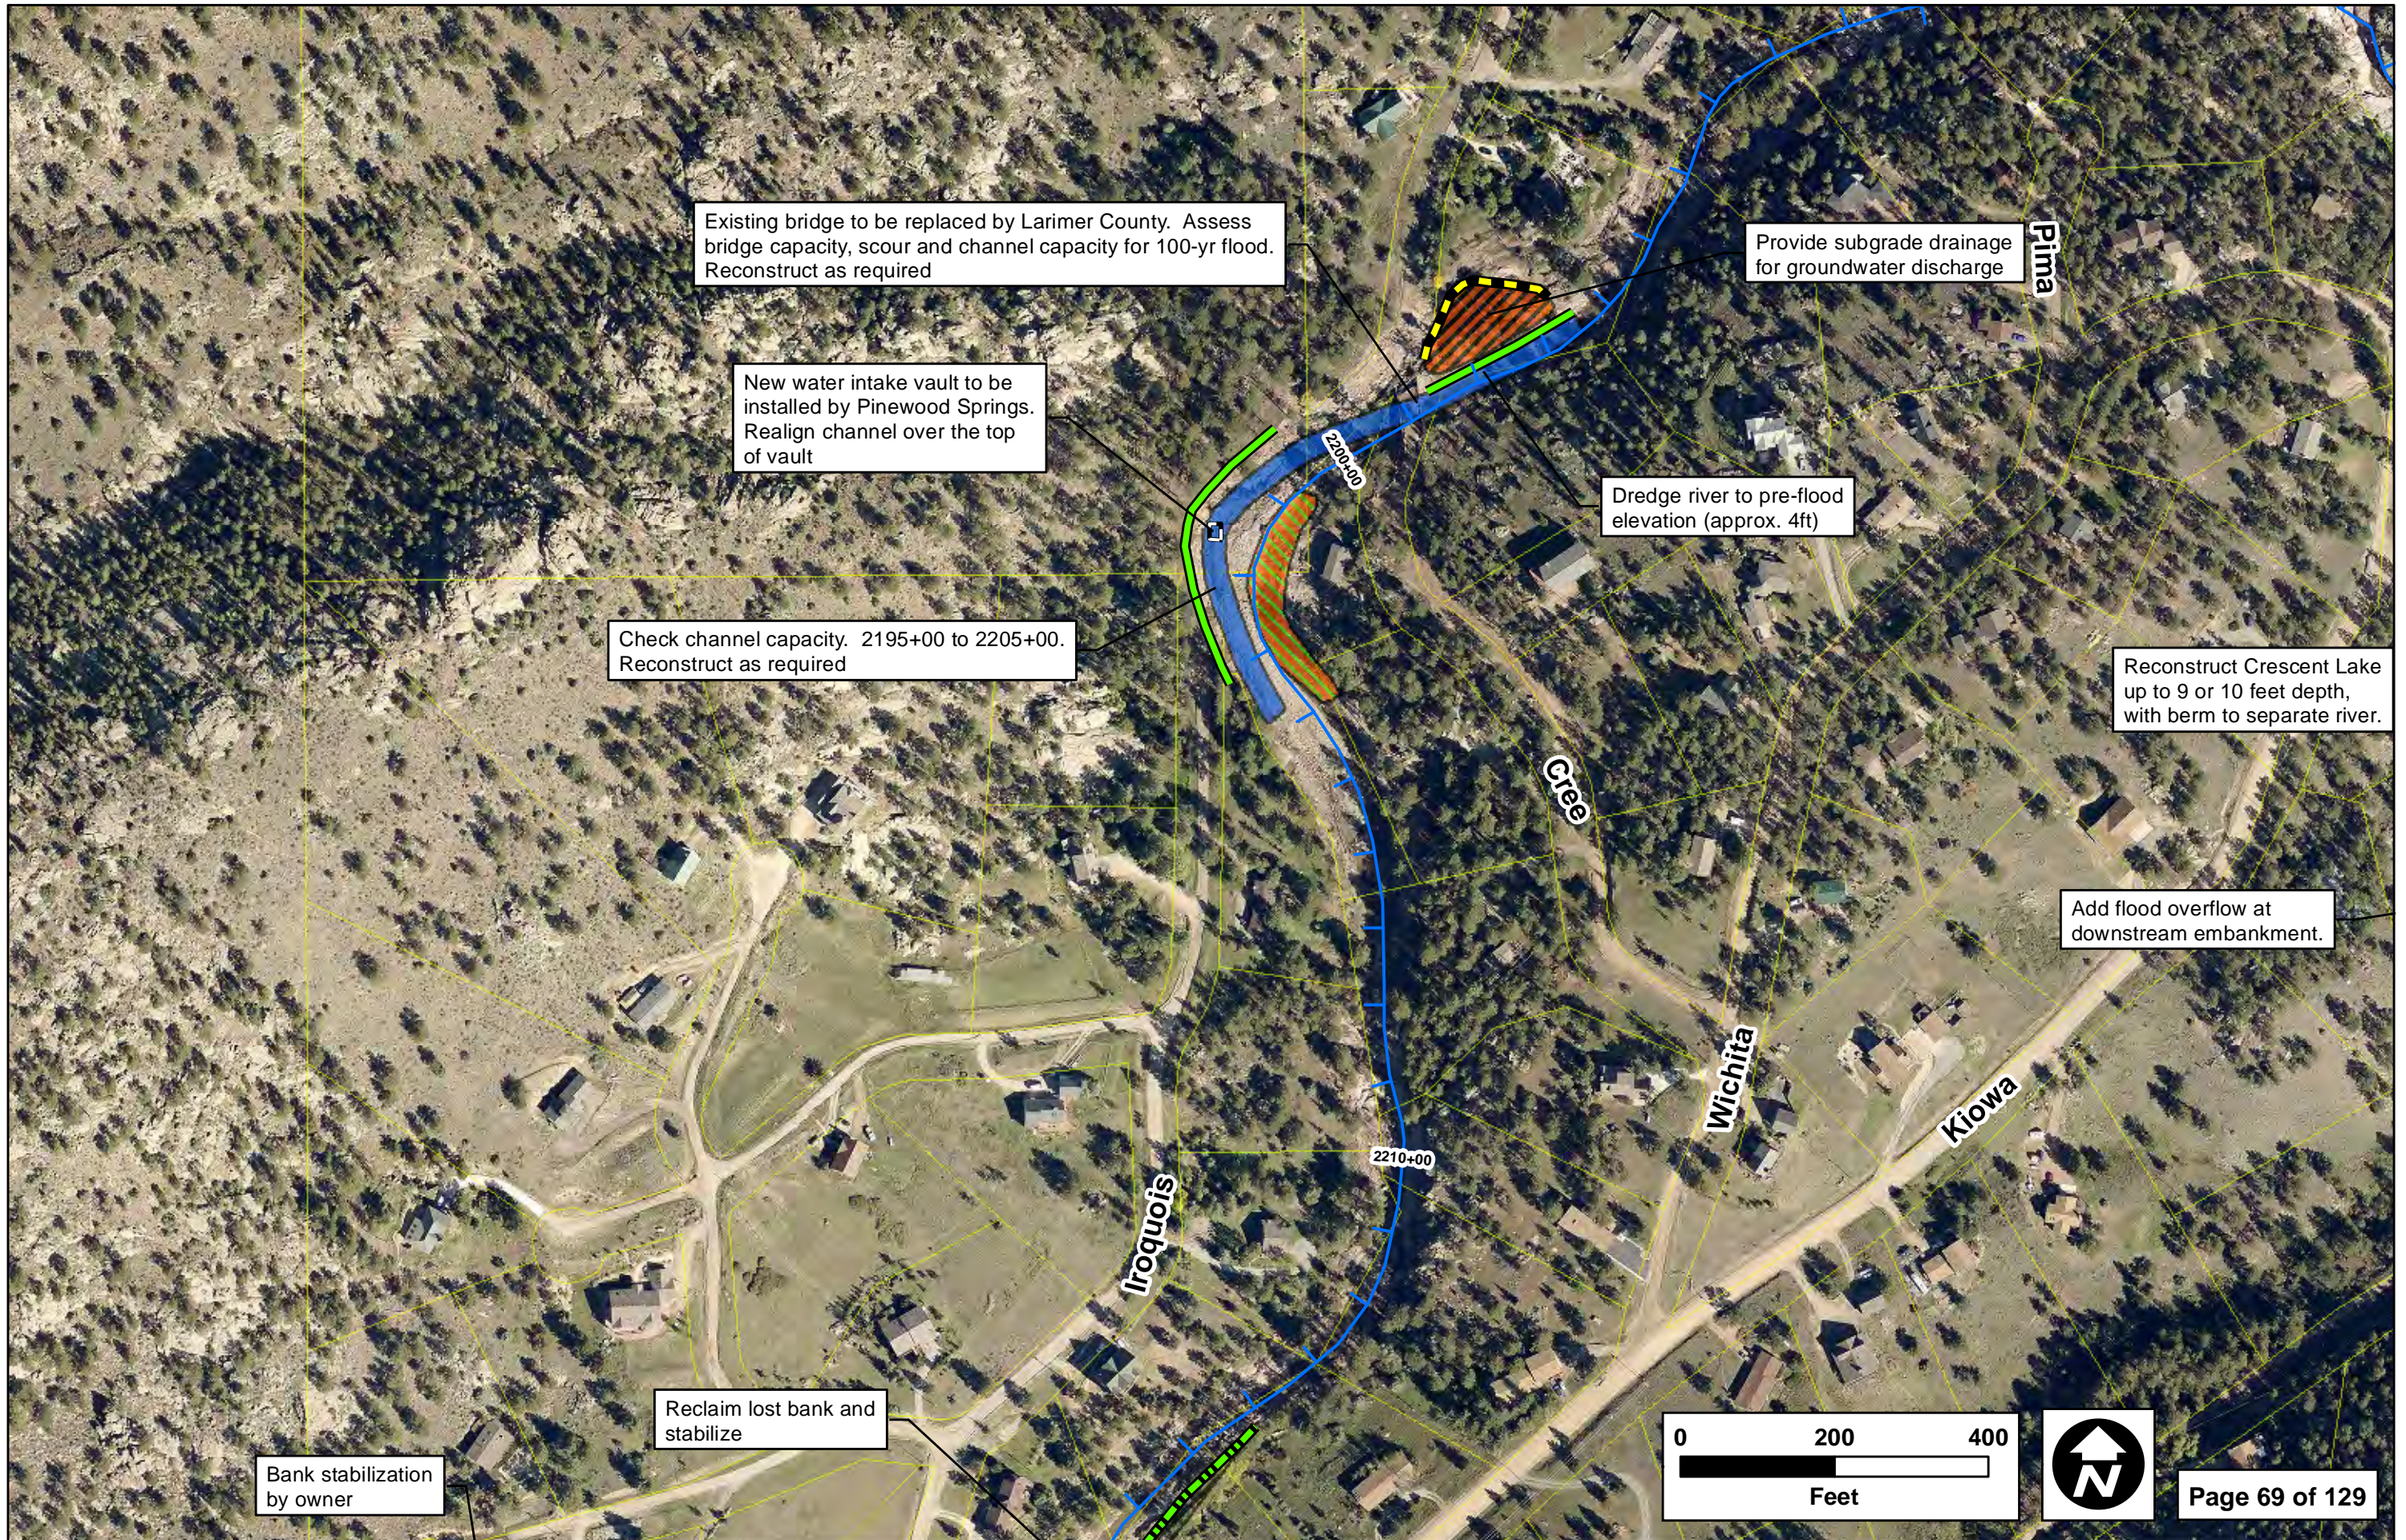
Existing bridge to be replaced by Larimer County. Assess bridge capacity, scour and channel capacity for 100-yr flood. Reconstruct as required

Provide subgrade drainage for groundwater discharge

A temporary culvert crossing exists today and Larimer County is planning to repair the bridge in accordance with the County criteria for bridges. Recommendations include an analysis of overtopping flows and consideration of the grades along the approach roads as a perched bridge may result in the same bank erosion should another overtopping event occur.

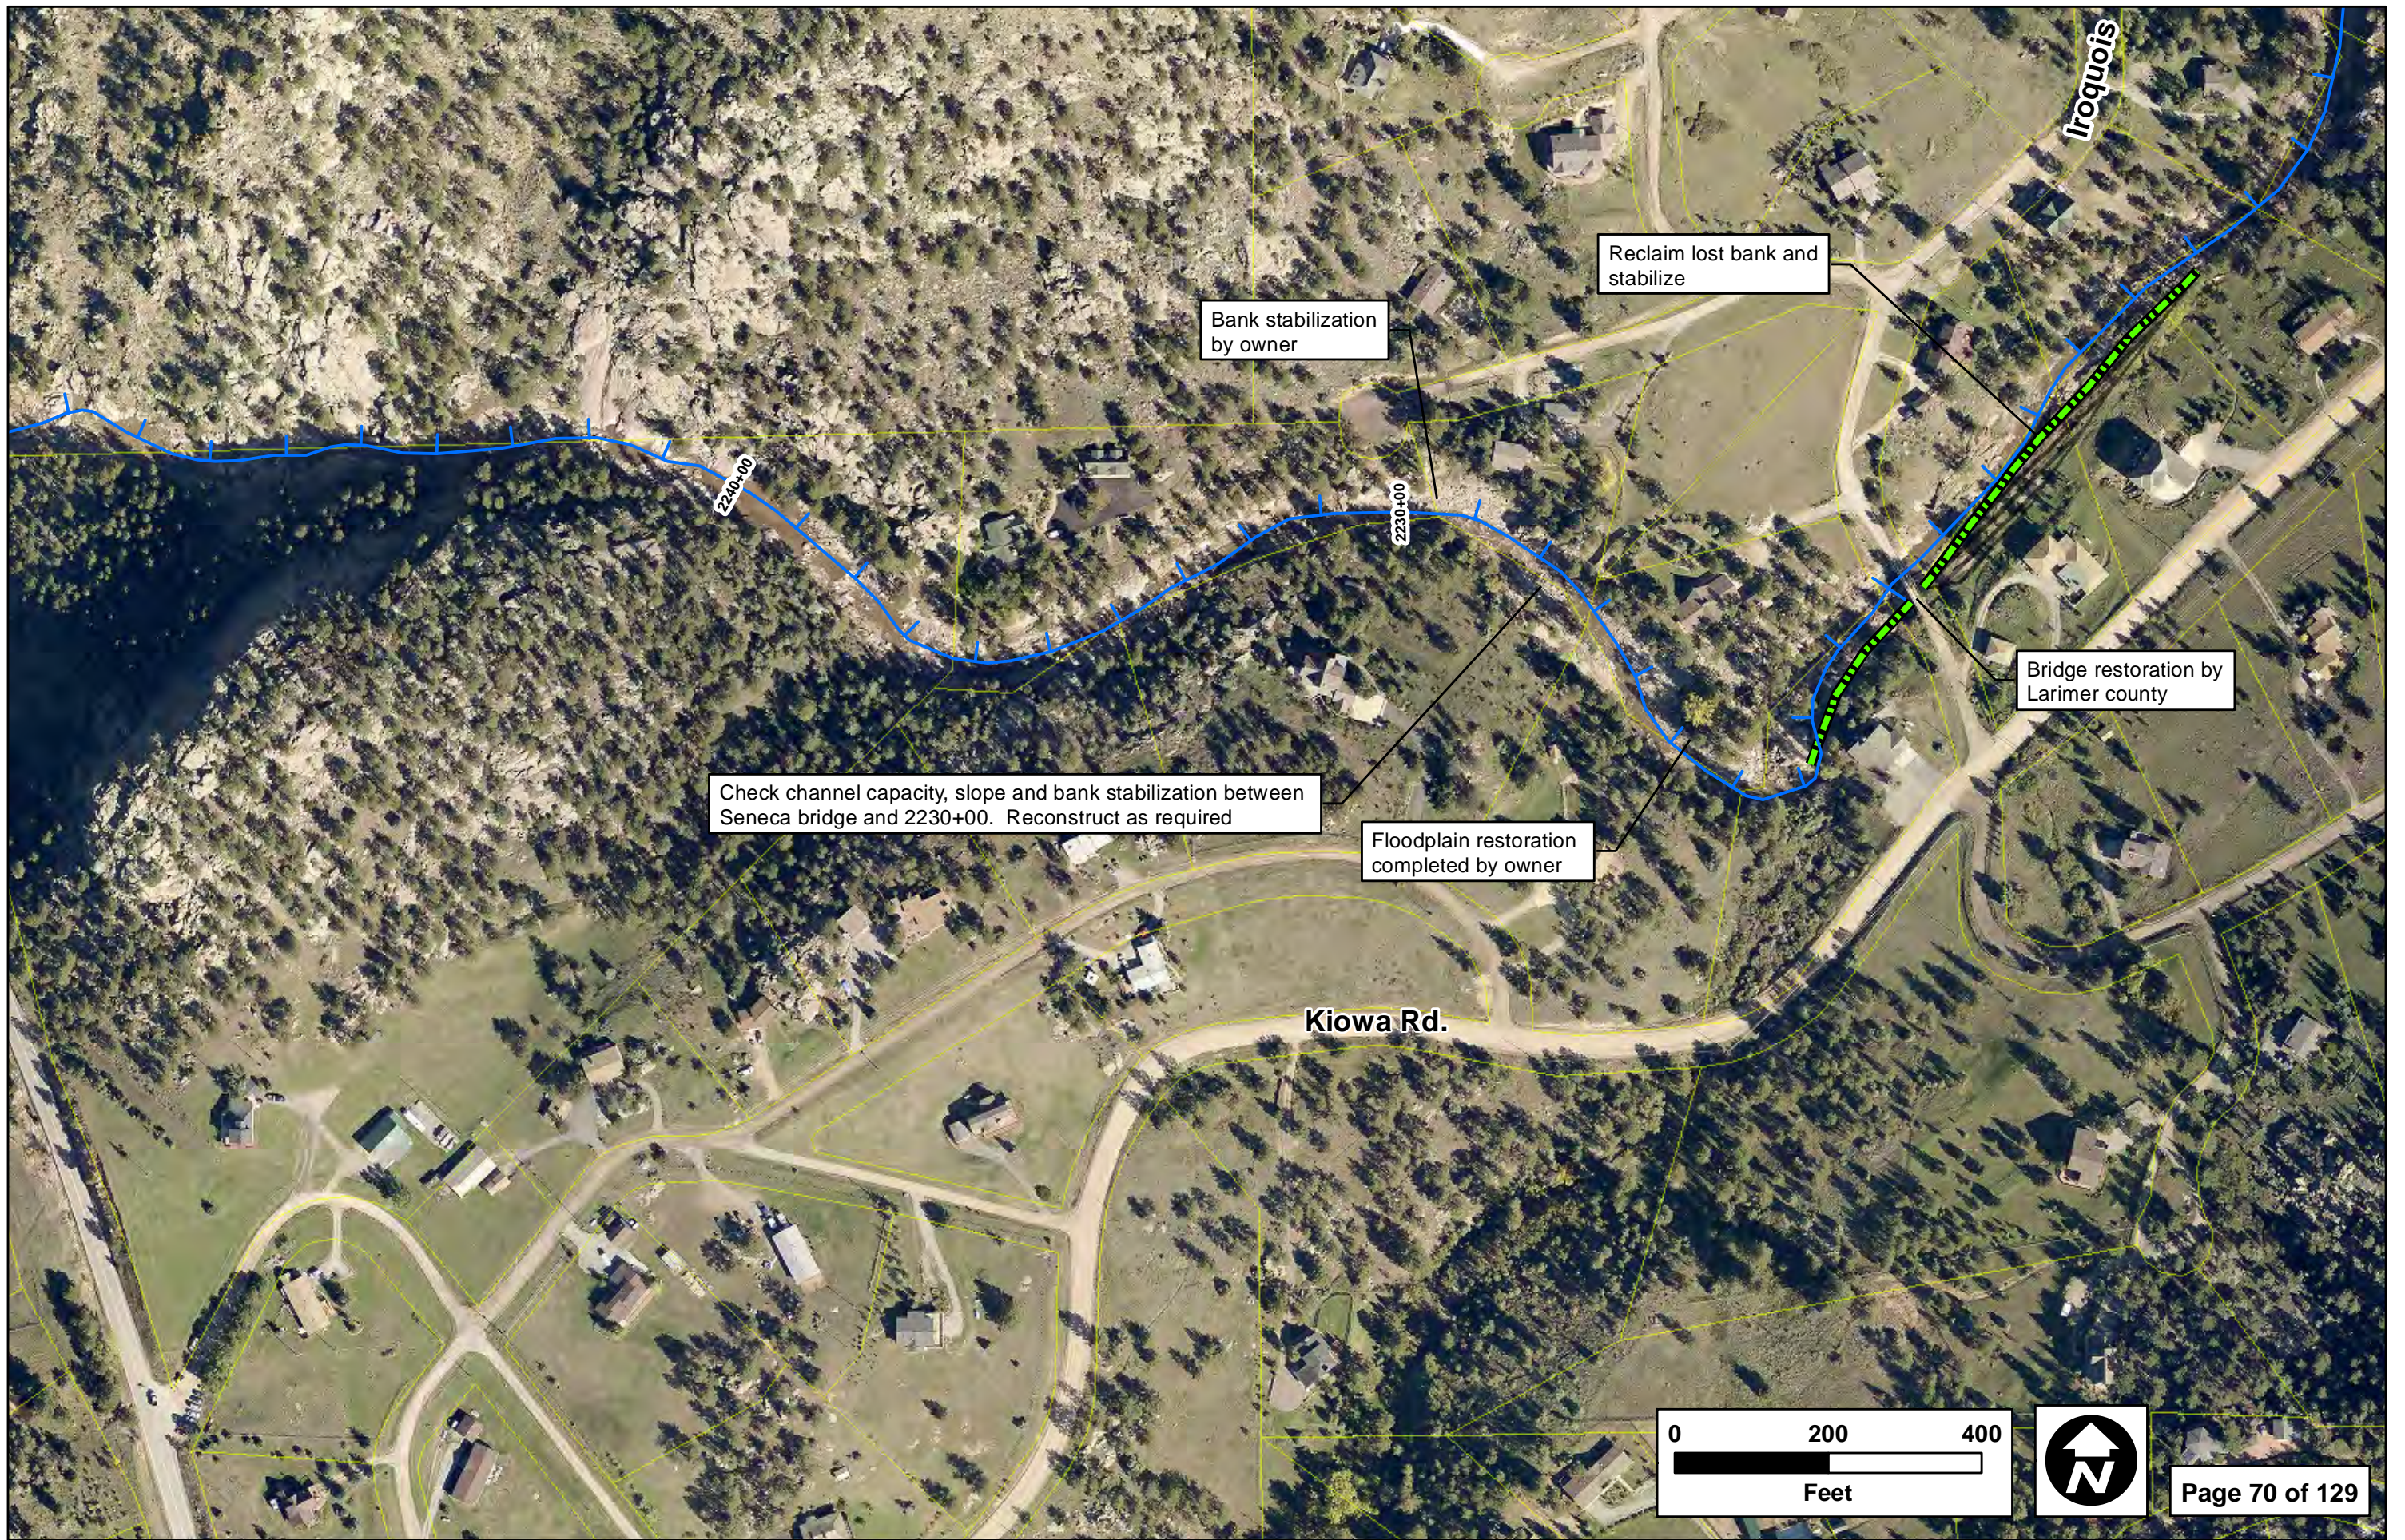
**NEIGHBORHOOD:** Pinewood Springs  
**SHEET:** 70  
**STATION:** 2210+00 to 2249+00  
**RESTORATION RECOMMENDATIONS:** 2214+00 to 2230+00

Reclaim lost bank and stabilize

Bank stabilization by owner

Near the Seneca Bridge the river experienced some scour from the 2013 flood, along with debris accumulation at the bridge, bank scour downstream and degradation along the channel flow line. Velocities were high as evidenced by the size and amount of debris that snagged in the bridge structure, the transport of large boulder and cobble material and loss of vegetation. The crossing on Seneca is a truss bridge with two spans both which experienced significant debris accumulation and some undermining of a mid-channel footing. Larimer County is planning to repair the bridge.

Upstream of the Seneca Bridge the channel makes a significant bend at Sta 2220+35. During the 2013 flood, flows reportedly overtopped the bar at this bend, alternating in waves of deposition and degradation. At the time of the site assessment the property owner had already removed debris and cleared the bar. The channel adjacent to the bar may have accumulated material and subsequently lost capacity. Immediately upstream, near Sta 2220+80 the property owner had already reconstructed the riverbanks, although channel deposition has likely reduced the capacity of this reach, which could result in increased frequency of bank overtopping.

1. Coordinate with Larimer County on bridge repair and debris removal.
2. Assess channel capacity and bank stabilization upstream of the Seneca Bridge along portions of the channel that have already been repaired and reconstructed. Also assess for reduced capacity due to deposition. Excavate and/or upsize the channel as required.
3. Stabilize the banks downstream of Seneca Bridge for 50 to 75 feet.
4. Reseed overbank areas particularly upstream of Seneca Bridge to help stabilize the large exposed bars.

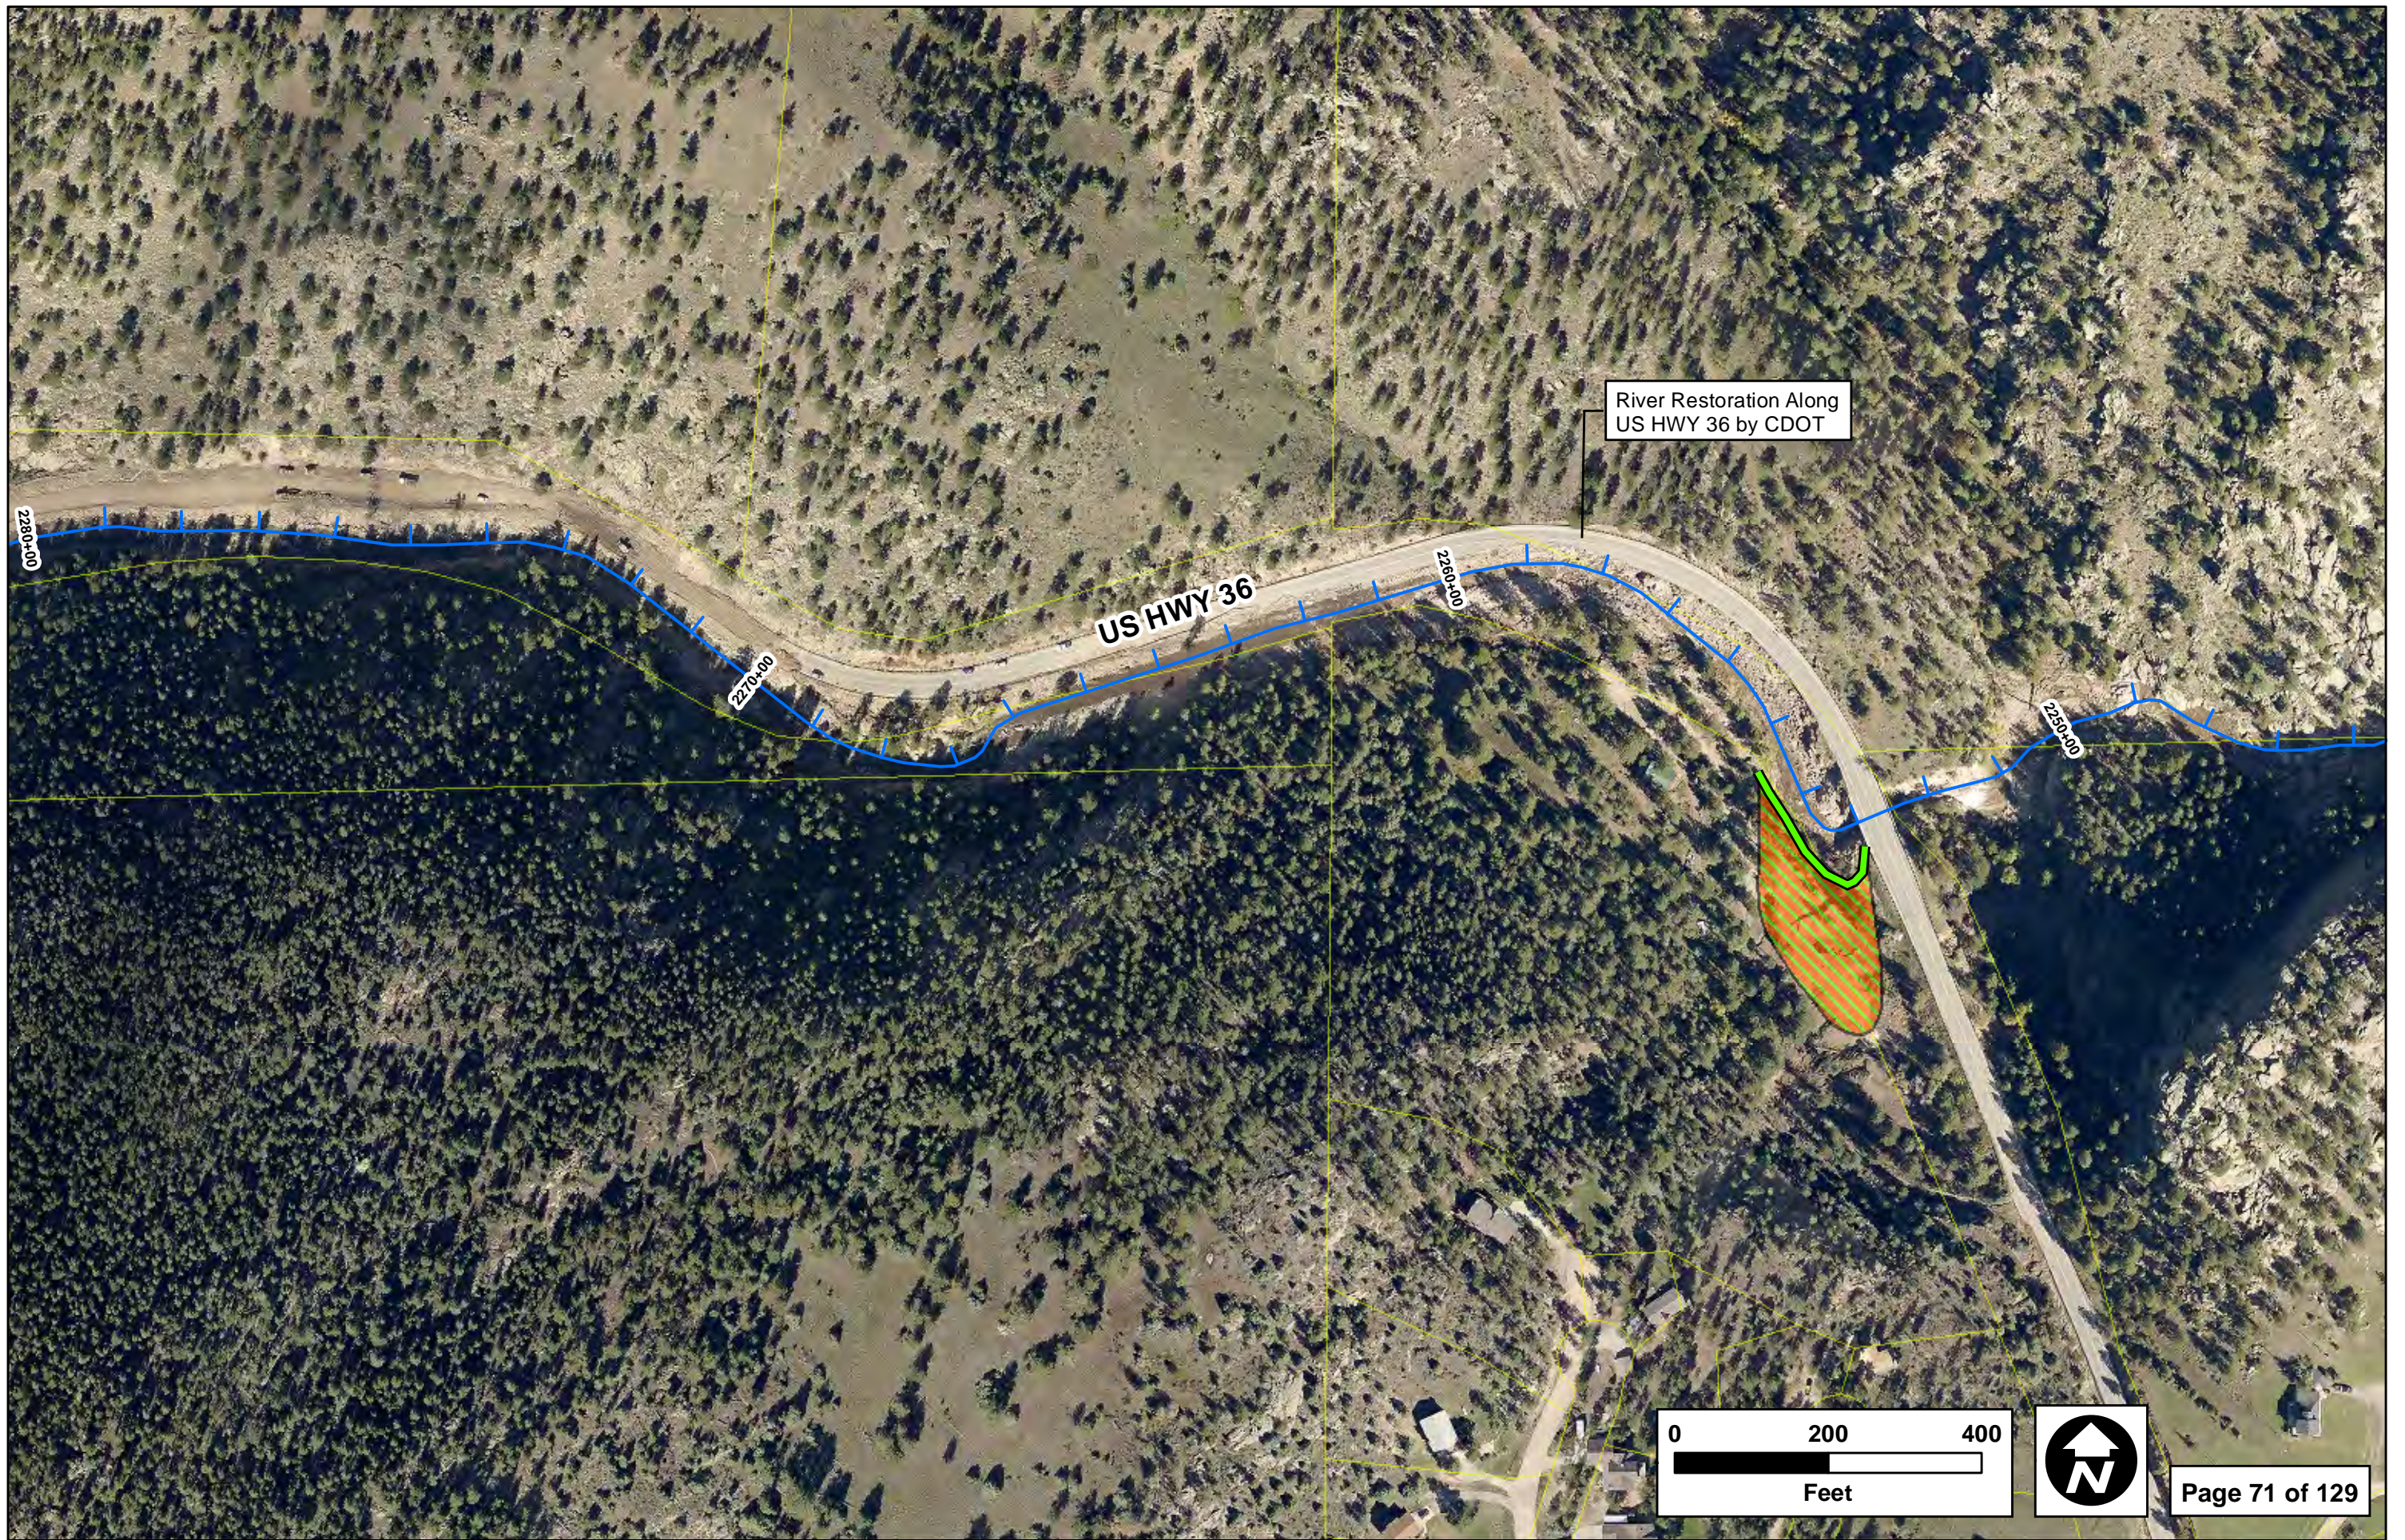
River Restoration Along  
US HWY 36 by CDOT

US HWY 36

Highway damage was extensive as well as property damage at the Lucero residence, including bank degradation, loss of a driveway and significant deposition in the field immediately south of the channel bend and inlet to the U.S. Highway 36 Bridge. Channel restoration is being undertaken by CDOT in conjunction with the U.S. Highway 36 reconstruction and in collaboration with the USFS. River improvements consist of the construction a low-flow channel, and the reconnection to the floodplain corridor. Restoration plans for the Lucero residence river bank property is unclear, but should include, as a minimum, bank stabilization and protection on the upstream banks of the U.S. Highway 36 Bridge (Sta 2250+30). Capacity of both the channel and bridge should also be assessed and considered in the reconstructed accordingly. Restoration not implemented as part of CDOT improvements should be considered in the master plan, except for the driveway, which was reconstructed by the Lucero's.

1. Coordinate with CDOT and the USFS on reconstruction at Lucero residence.
2. Assess channel capacity upstream of the U.S. Highway 36 Bridge and design restoration accordingly.
3. Stabilize the banks upstream of U.S. Highway 36 at Sta 2250+30 and, grade and stabilize floodplain.

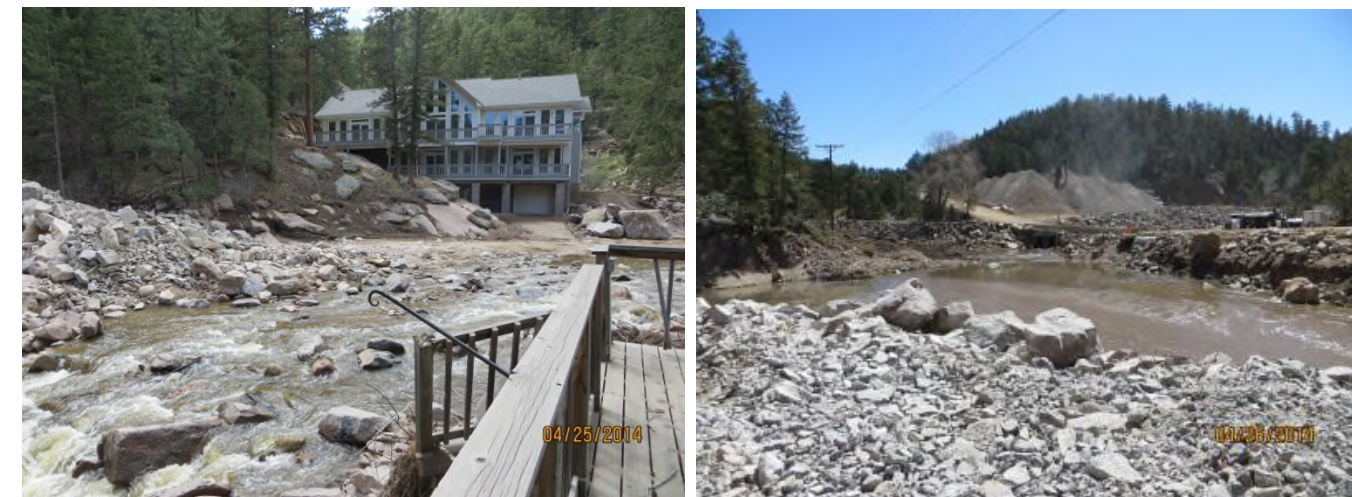
Assess road alignment along County Rd. 47 to reduce culvert crossings. Replace culverts to increase capacity, aquatic passage and connectivity

Replace driveway crossing

The West Fork runs immediately adjacent to County Road 47, crossing it five times in less than 2 miles. These crossing were all destroyed during the 2013 flood and field evidence indicates the road was likely overtopped, with the road and canyon walls conveying floodwater. Larimer County replaced the culverts shortly after the flood. The USFS has expressed an interest in replacing the culverts with culverts of increased capacity and culverts that can provide connectivity for aquatic species. As of the fall of 2014 Larimer County, FEMA, the USFS and Central Federal Lands are working to repair the road and permanently replace the culverts.

1. Coordinate with CDOT and the USFS on reconstruction at Larson residence.
2. Coordinate with Larimer County, FEMA, the USFS and Central Federal Lands on culvert replacements along County Road 47.

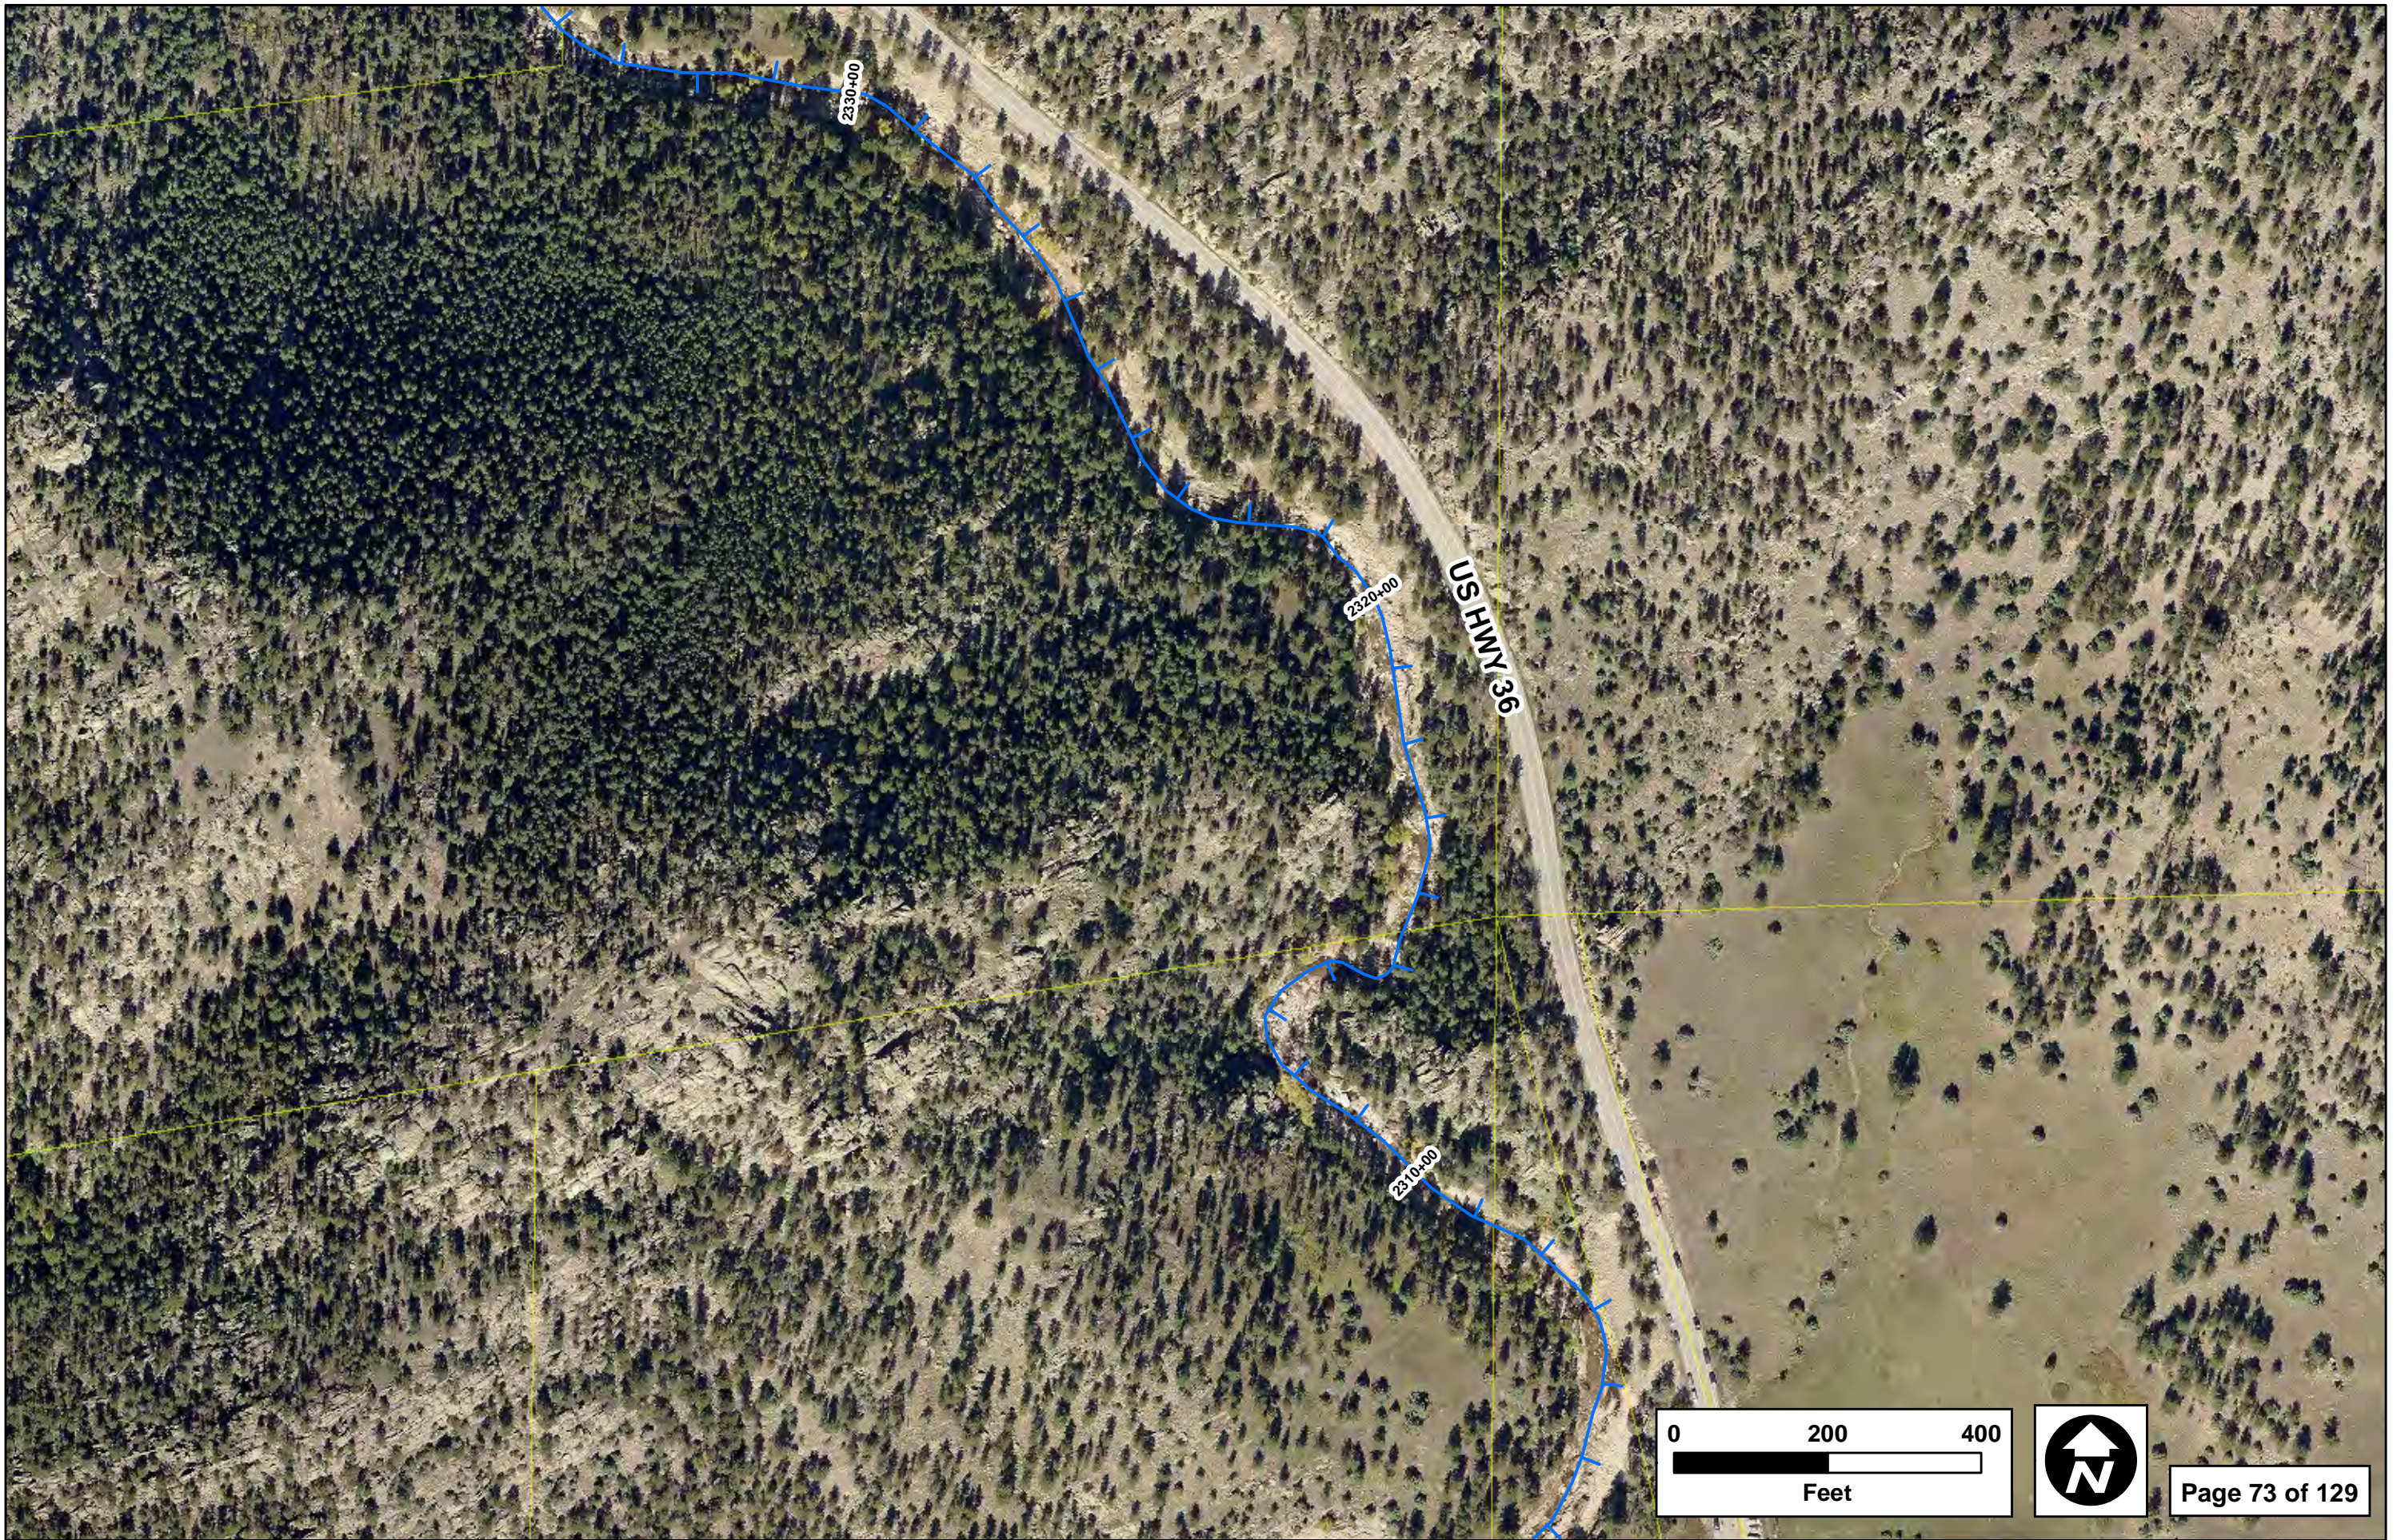
**NEIGHBORHOOD: Headwaters****SHEET: 74****STATION: 2334+00 to 2361+00**

This portion of the Little Thompson River runs immediately adjacent to U.S. Highway 36. The river traverses land owned privately and land managed by the USFS. Aerial photos of pre-flood conditions and anecdotal information indicate this reach had a vegetated riparian corridor, typically less than 50 feet wide, comprised primarily of fir trees and willows, much of which were torn out during the flood. The river corridor is steep (in excess of 3 percent) narrow, and canyon bound, setting the sinuosity and river corridor alignment.

This reach sustained flood-related damage primarily due to large debris and boulders moving through the system and significant scour and loss of soils and vegetation. The most severe damage appeared to occur at culvert crossings or where the floodplain had been encroached by anthropogenic activities. Evidence of mud and debris flow was observed from an unnamed tributary from the northwest, crossing under U.S. Highway 36.
